Post Hurricane Zeta Road Assessment

CITY OF DIAMONDHEAD

The City of Diamondhead
March 19, 2021

Southern Mississippi Planning and Development District
and
Civil-Link, LLC

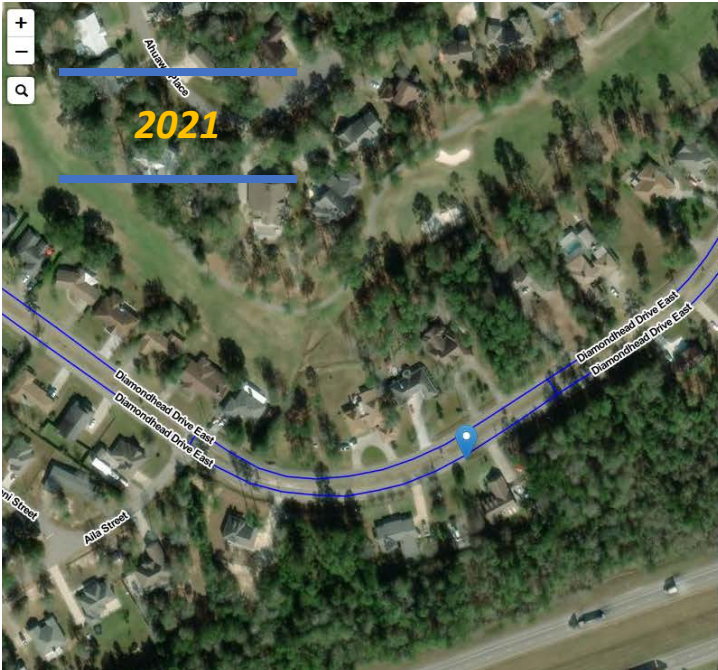
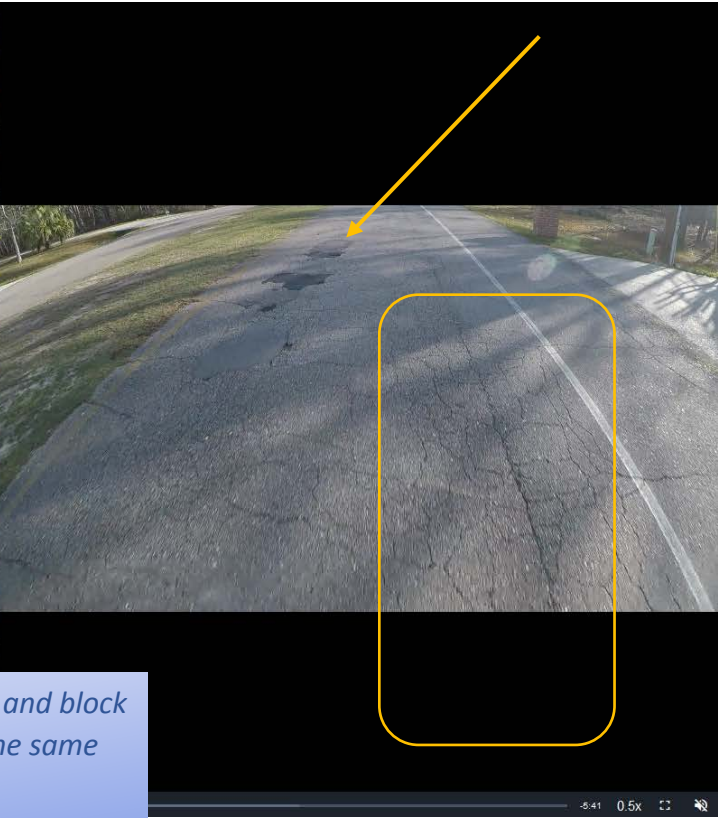
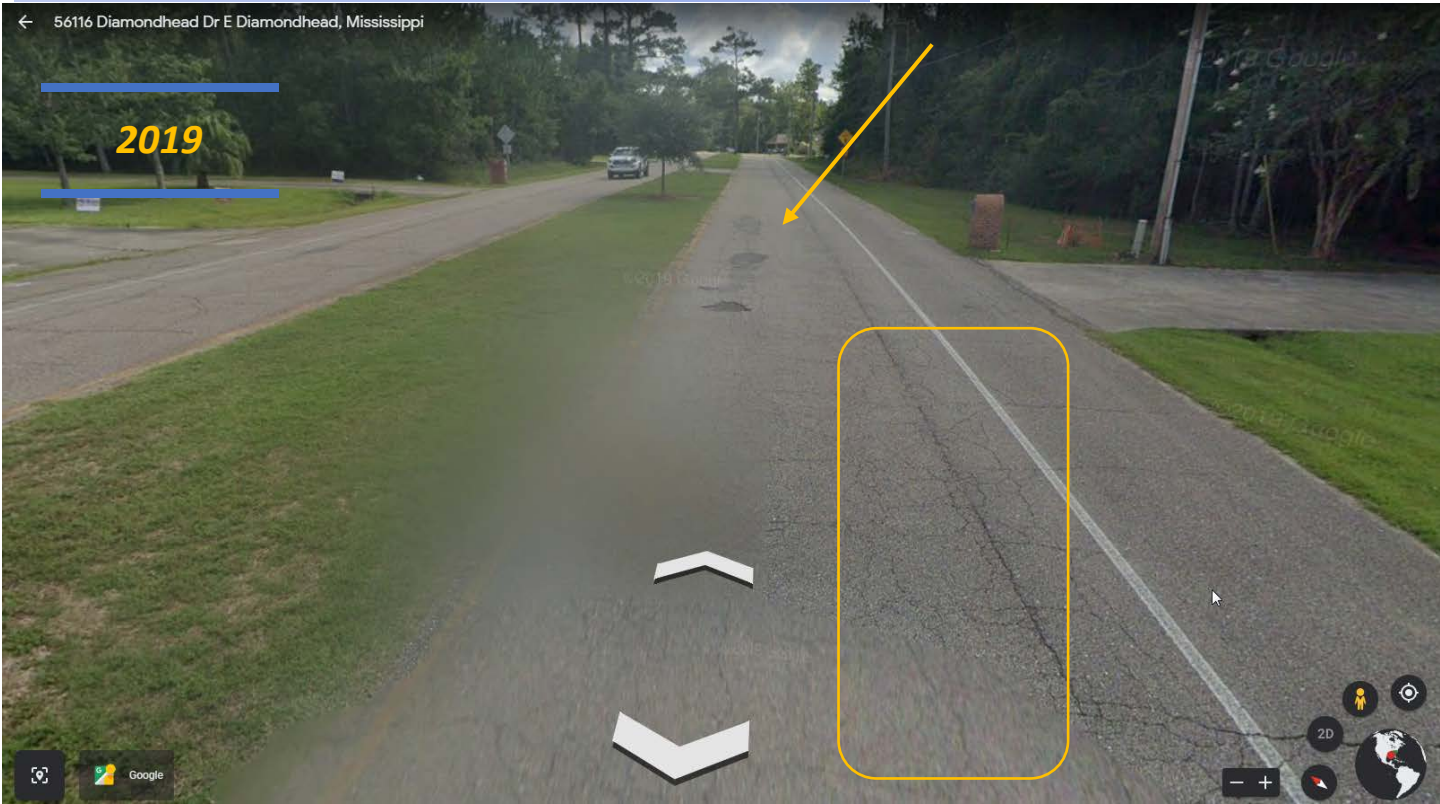
Diamondhead Drive East

These distresses, potholes, mass cracking, transverse and block cracking, are visible in current and 2019 imagery in the same locations and general severity.

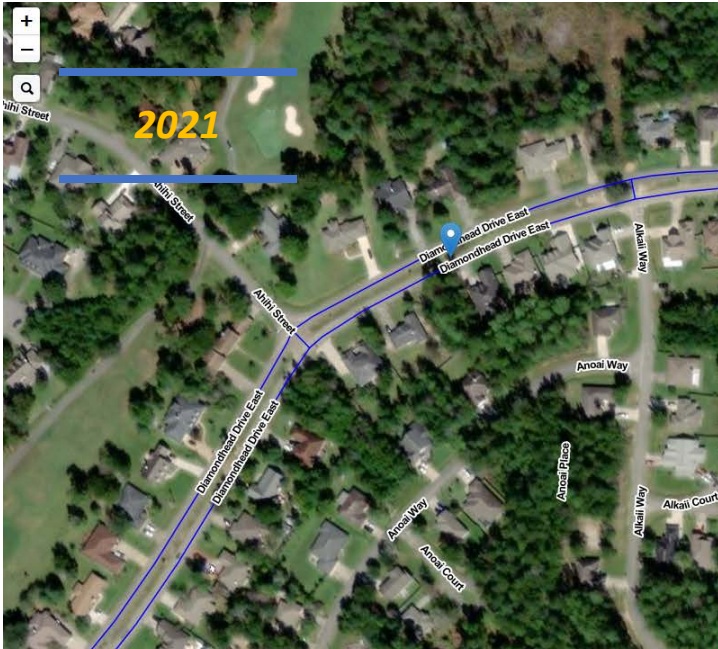
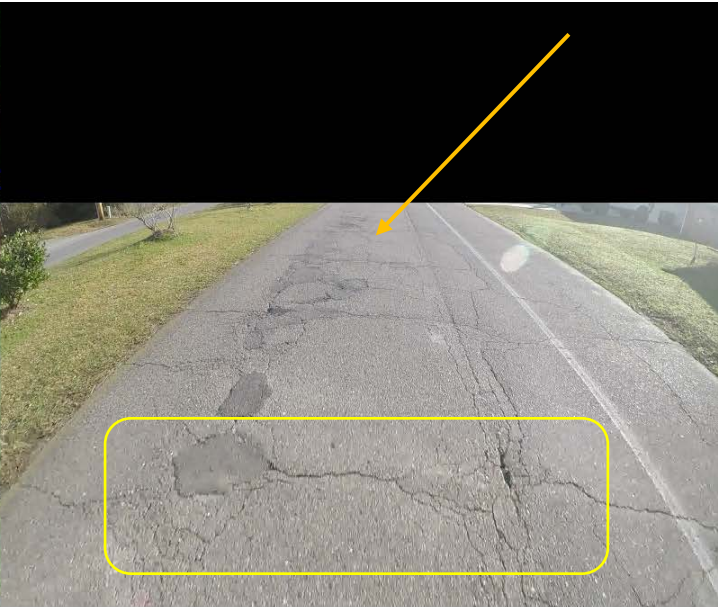
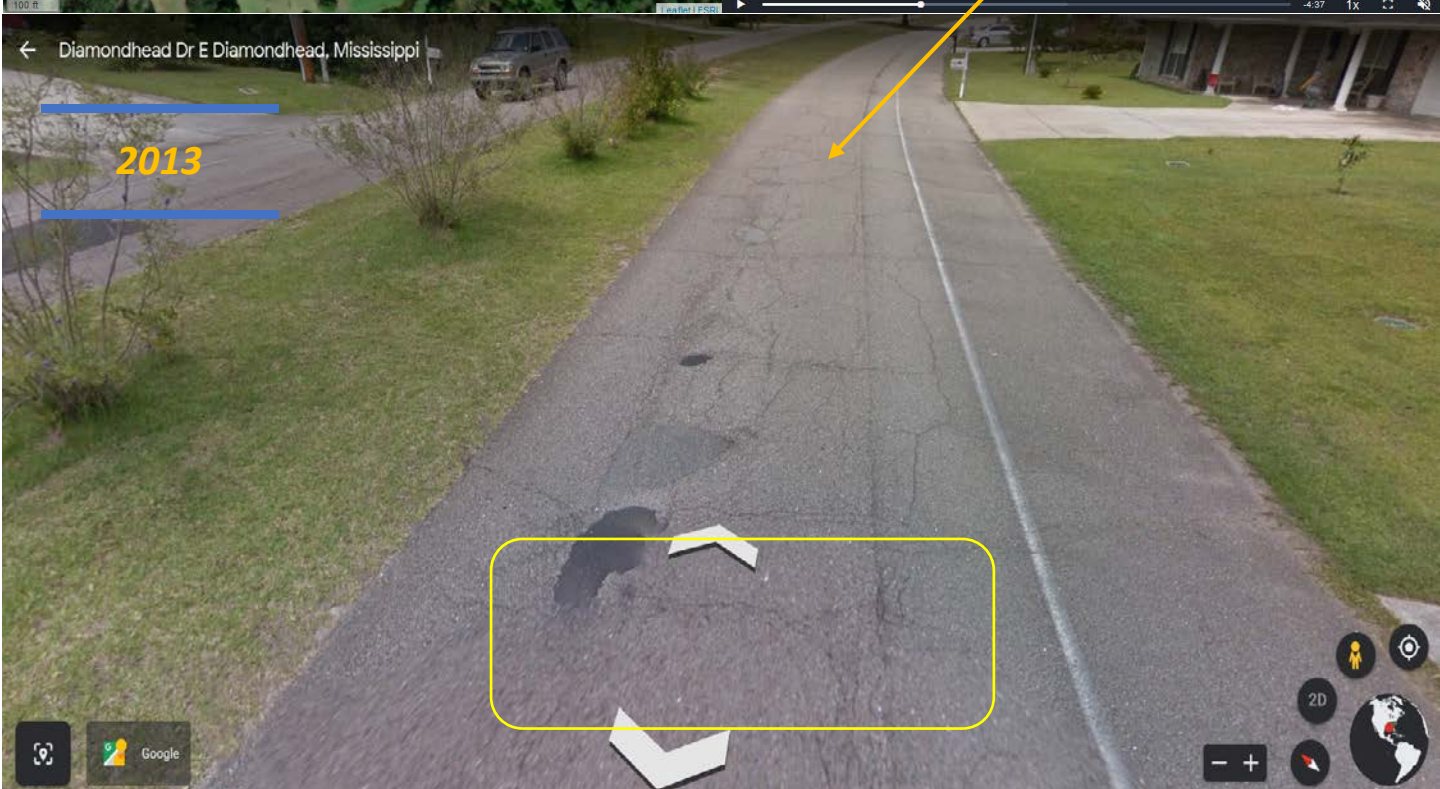
Diamondhead Drive East

These potholes and distresses have worsened over time, but they have been present since 2013. Current conditions are consistent with eight years of traffic over a distressed area such as this.

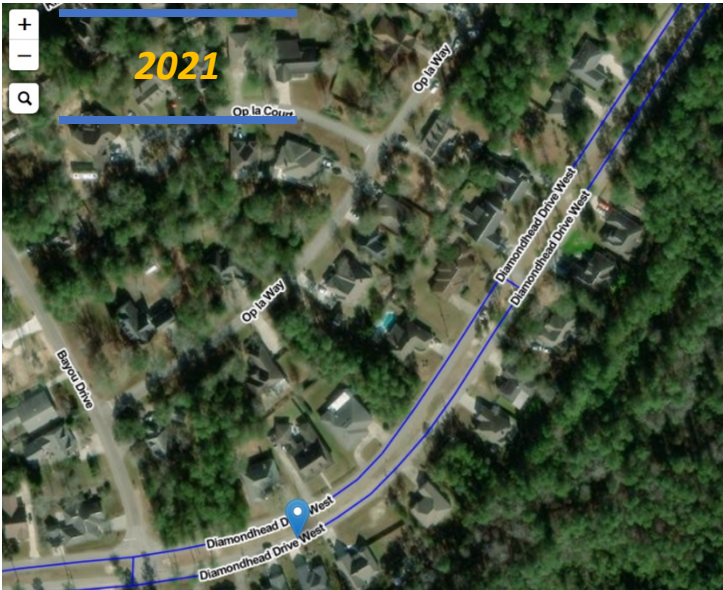
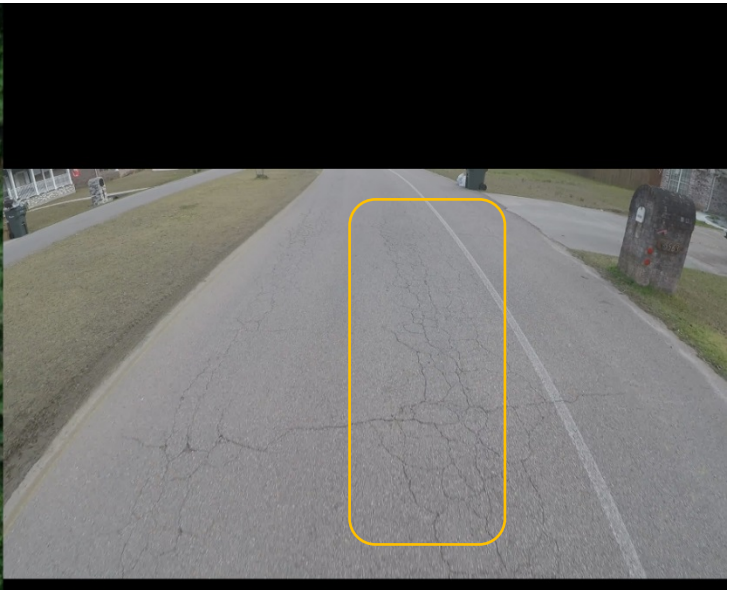
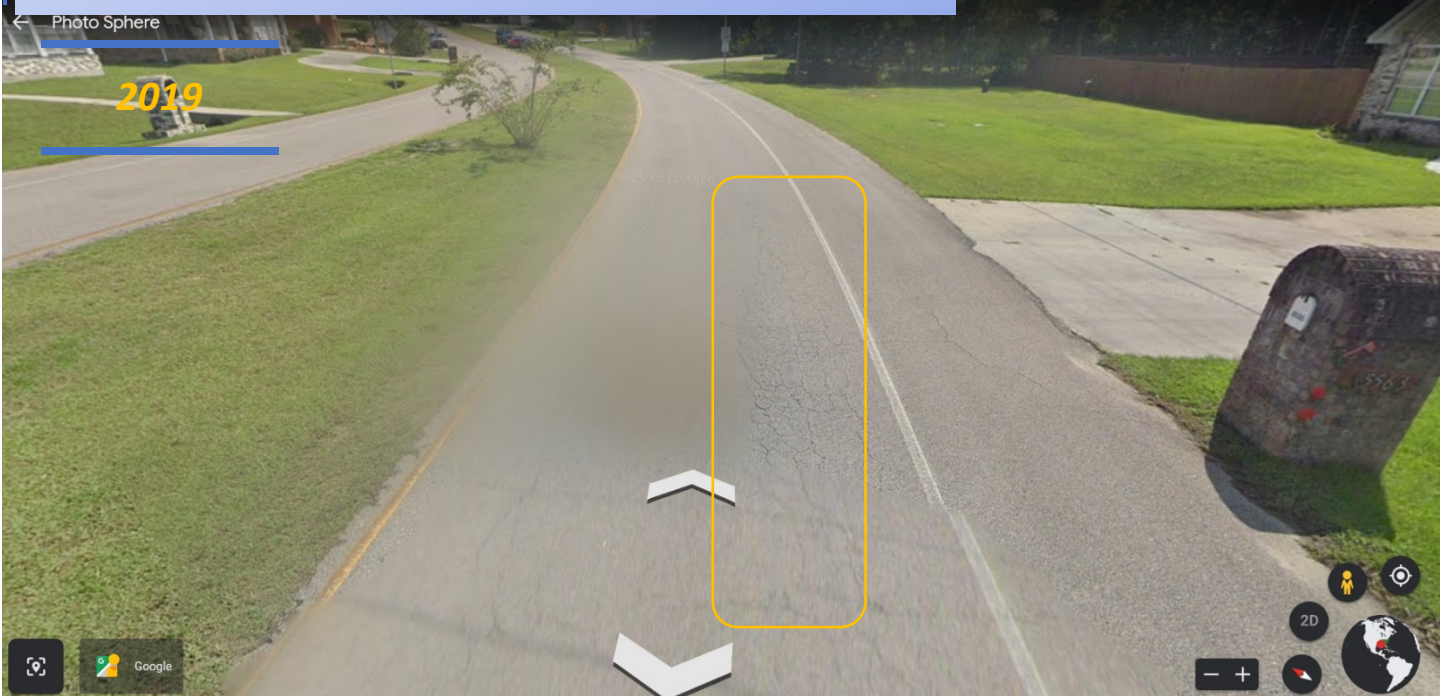
Diamondhead Drive West

There is significant mass cracking and fatigue cracking along the area between Bayou Drive and 85553 DH Drive West. However, these issues were present in 2019 as indicated in the rectangular areas.

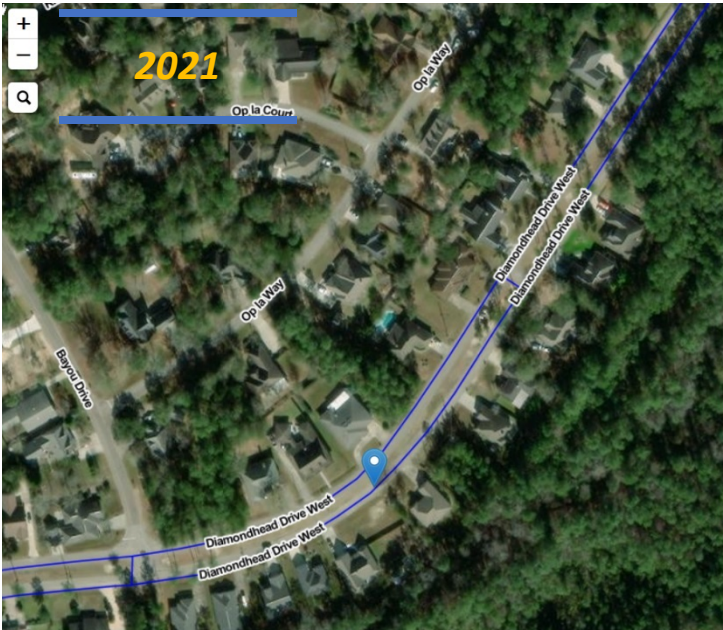
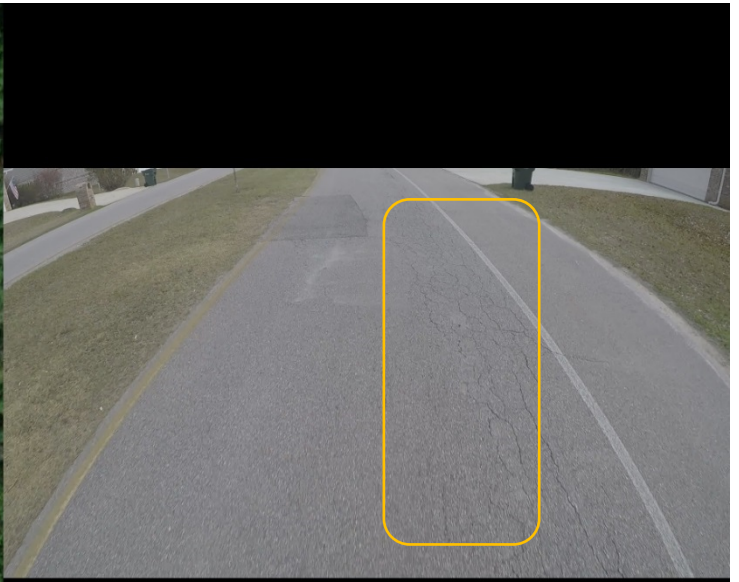
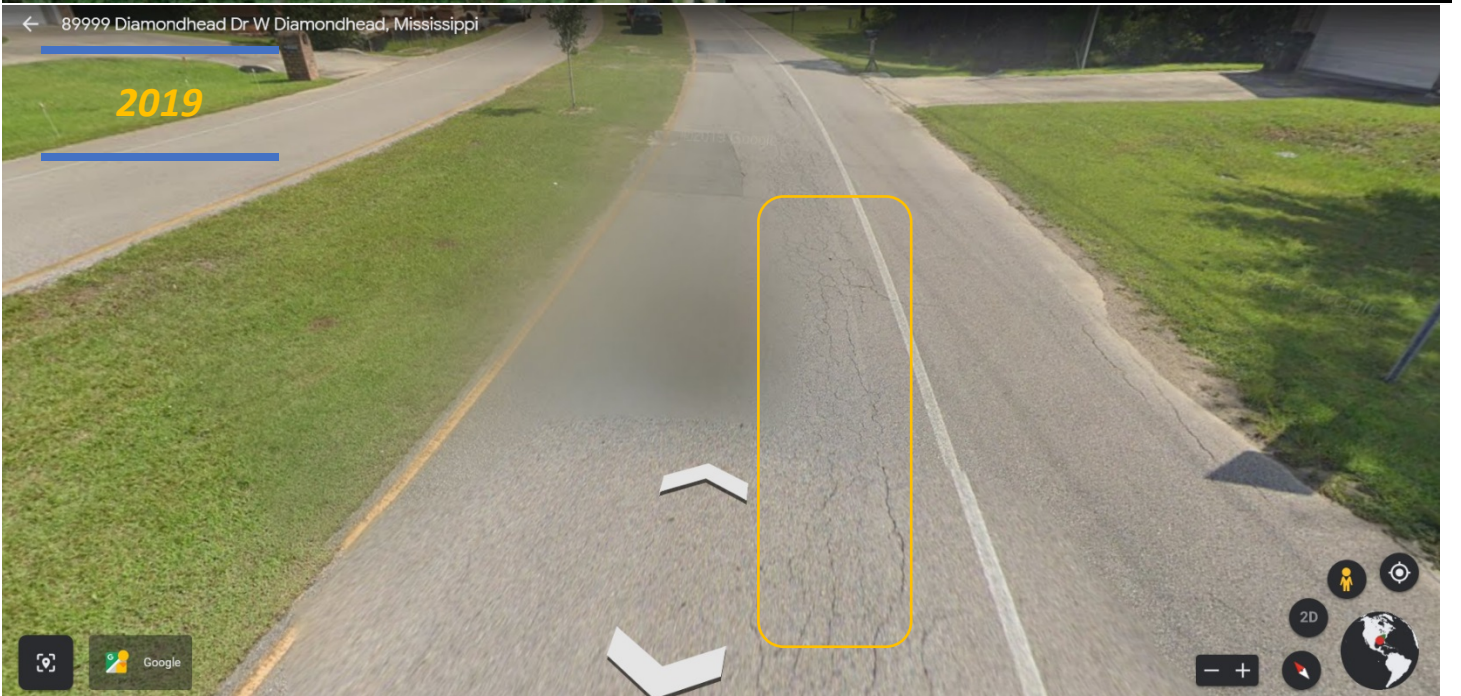
Diamondhead Drive West Continued

Fatigue cracking along the wheelpath was evident in 2019.

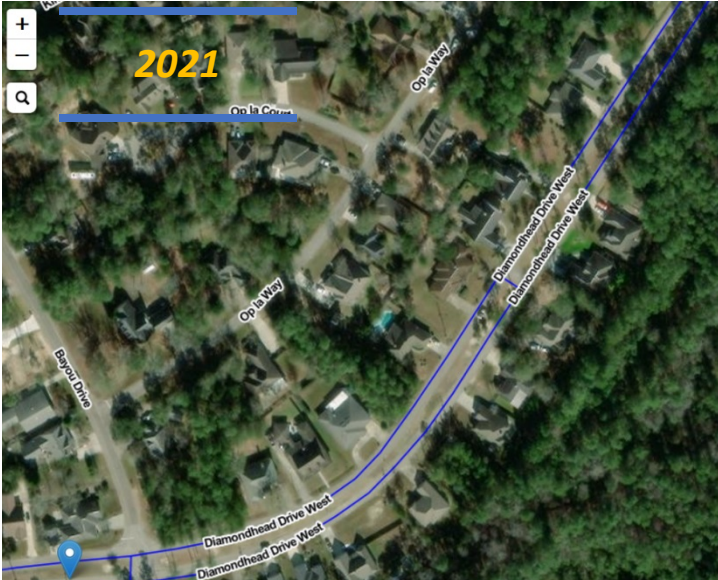
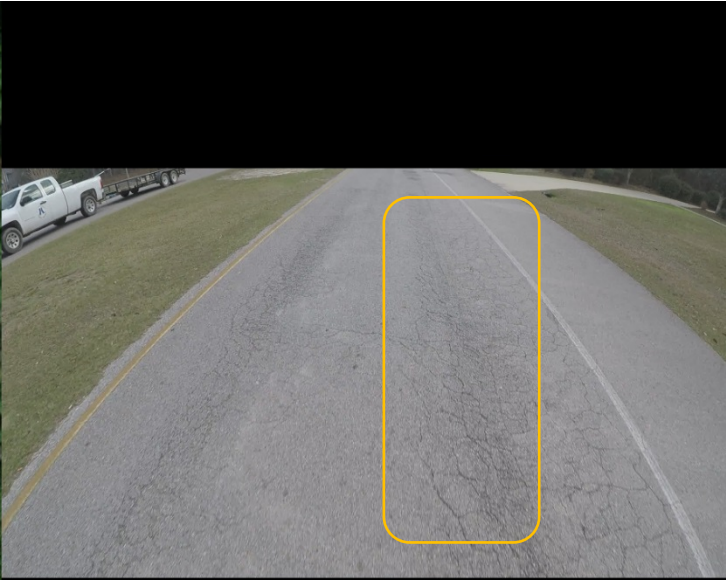
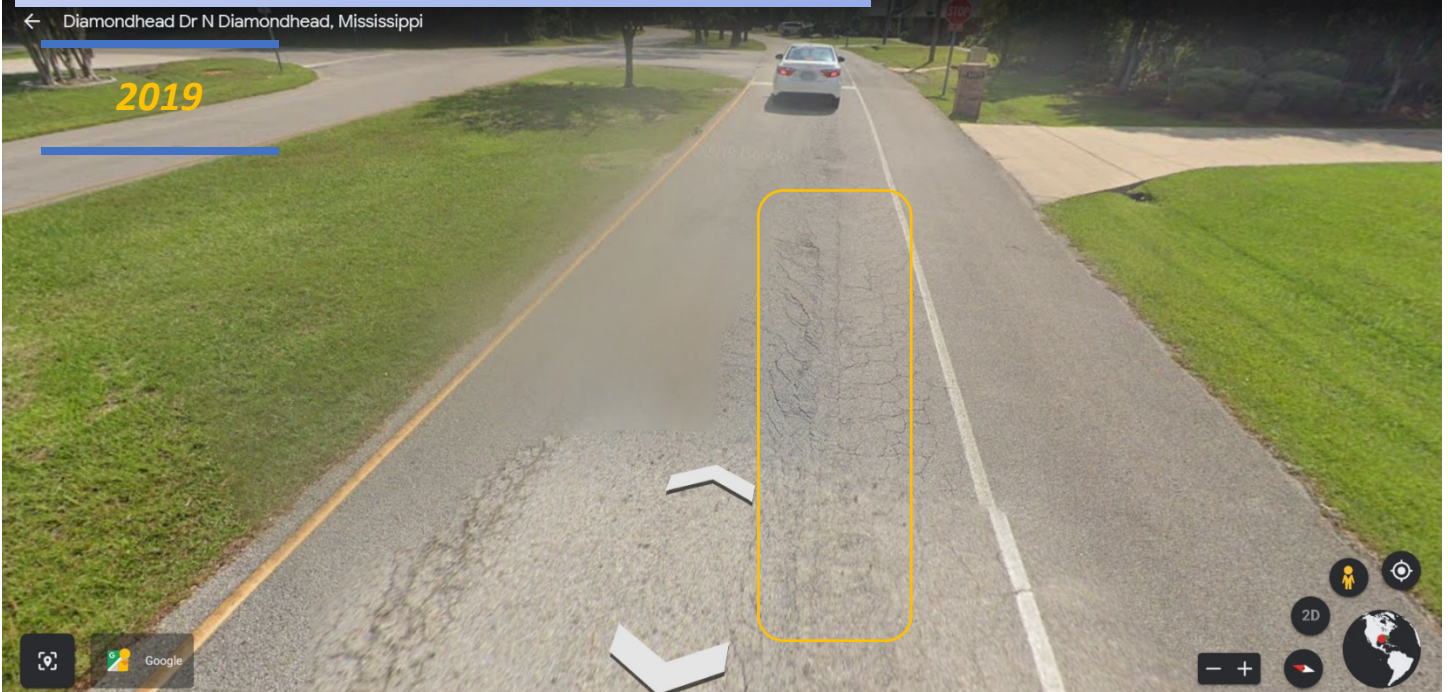
Diamondhead Drive North Shoving

Severe shoving and fatigue cracking at the intersection of Bayou Drive and Diamondhead Drive West in past imagery and present.

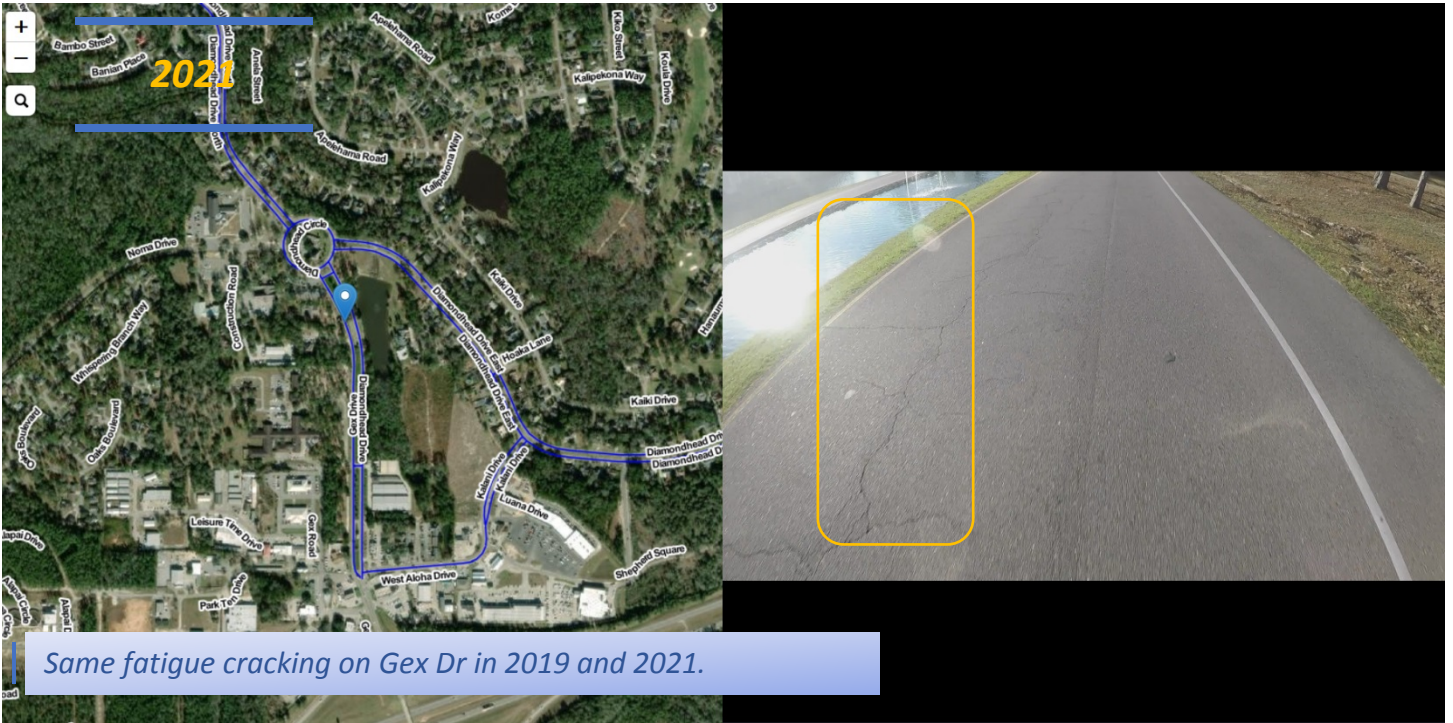
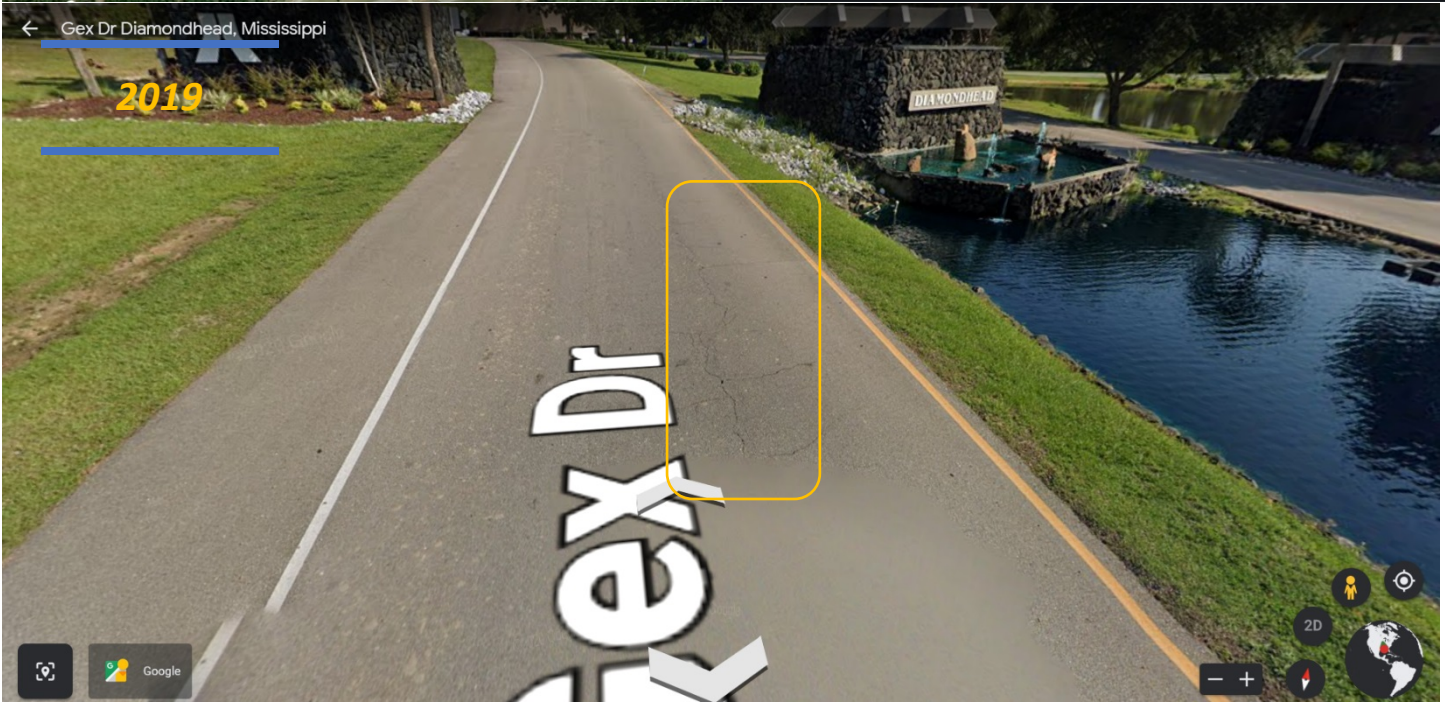
Same fatigue cracking on Gex Dr in 2019 and 2021.

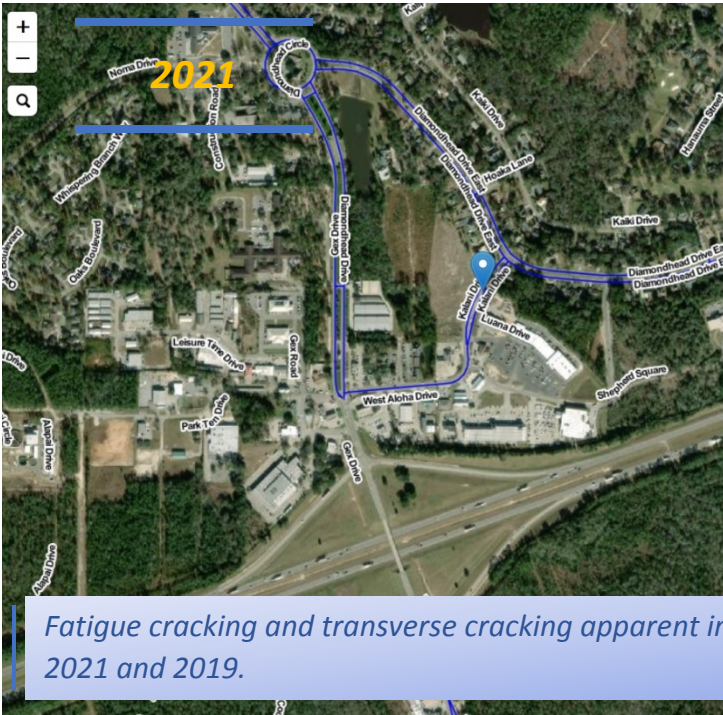
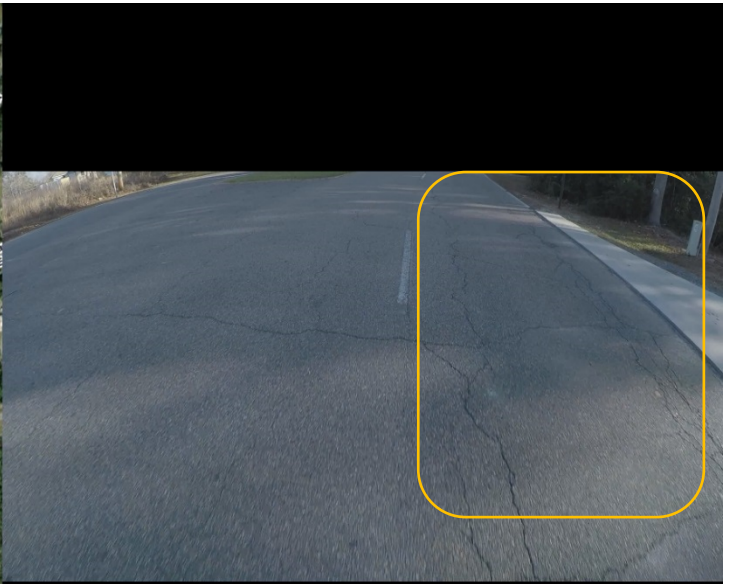
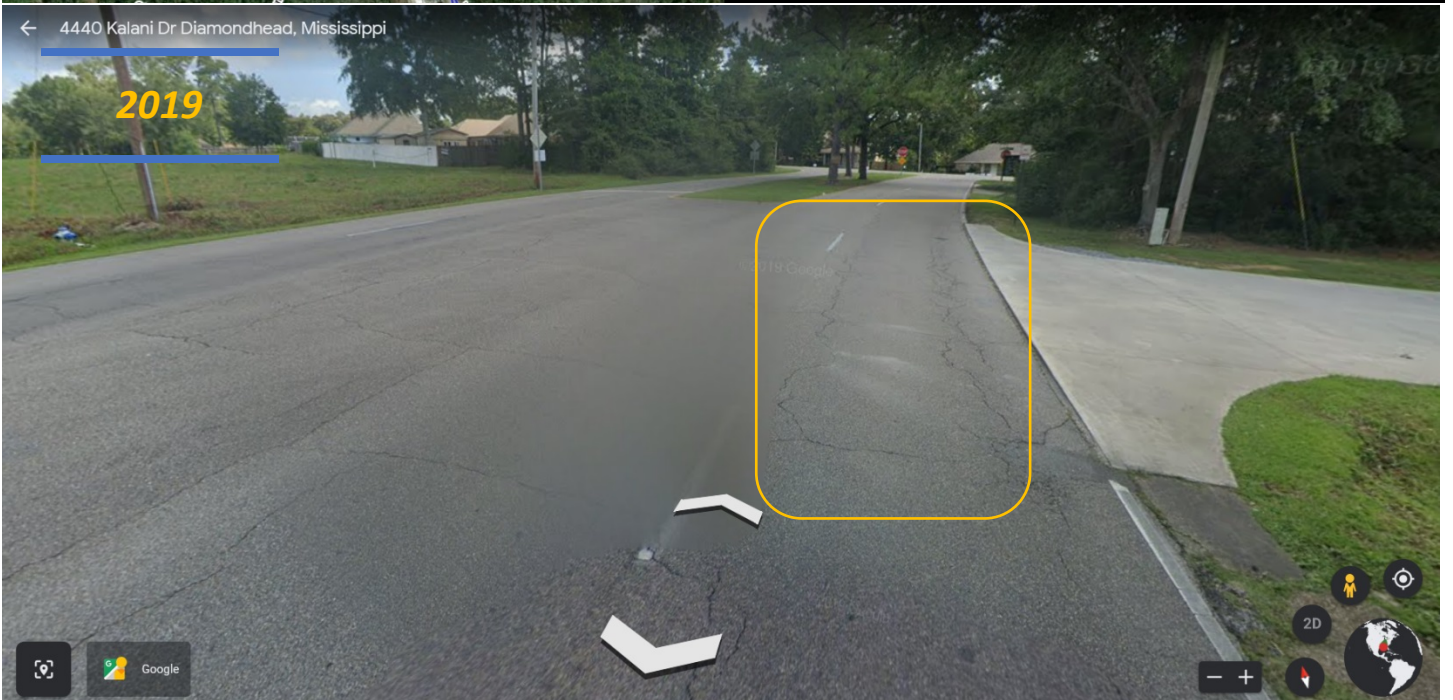
Kalani Dr

Fatigue cracking and transverse cracking apparent in both 2021 and 2019.

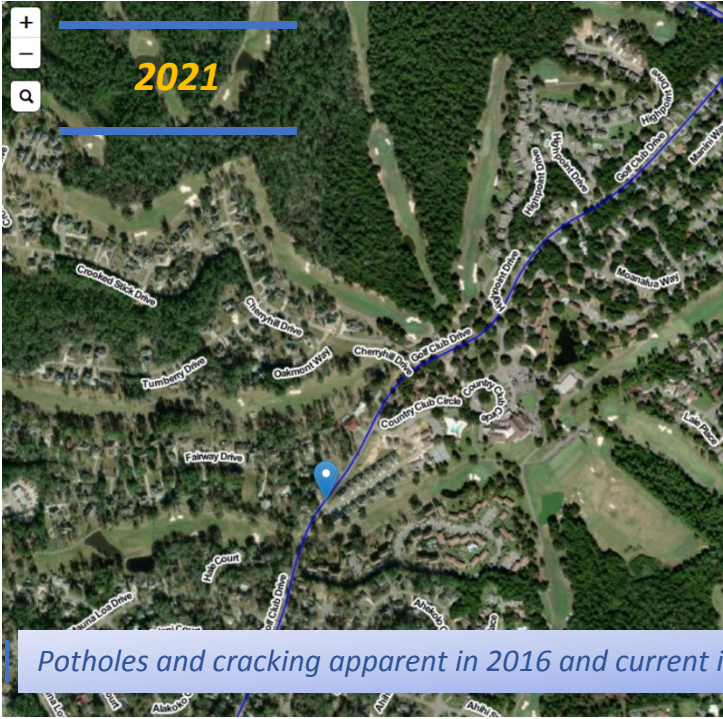
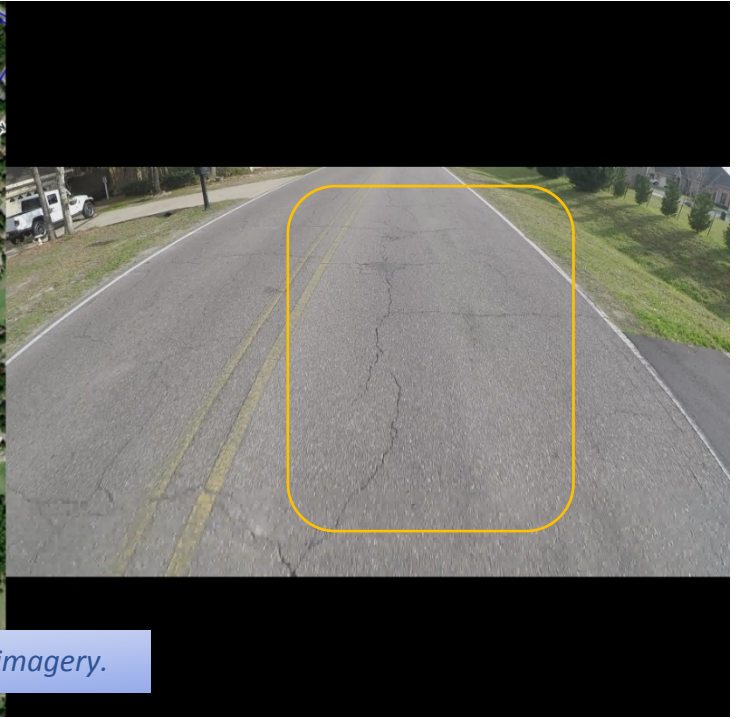
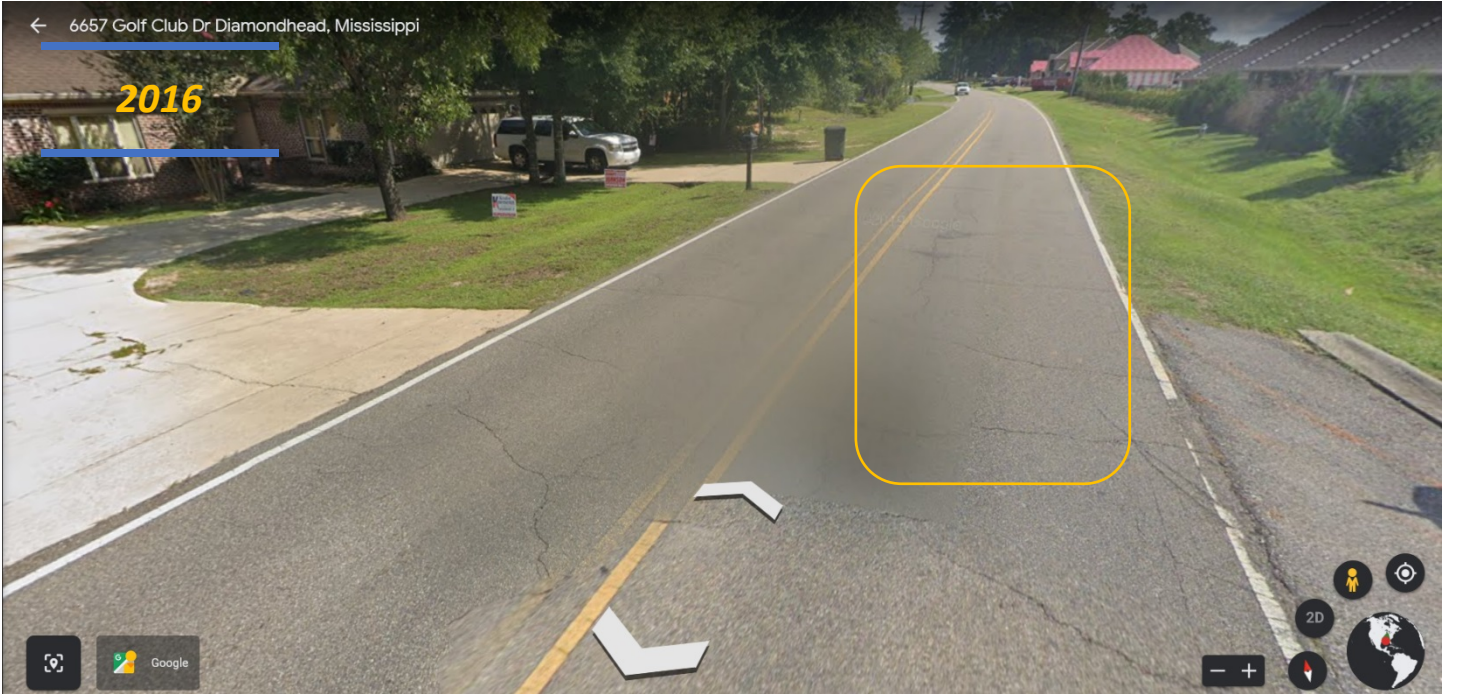
Golf Club Dr

Potholes and cracking apparent in 2016 and current imagery.

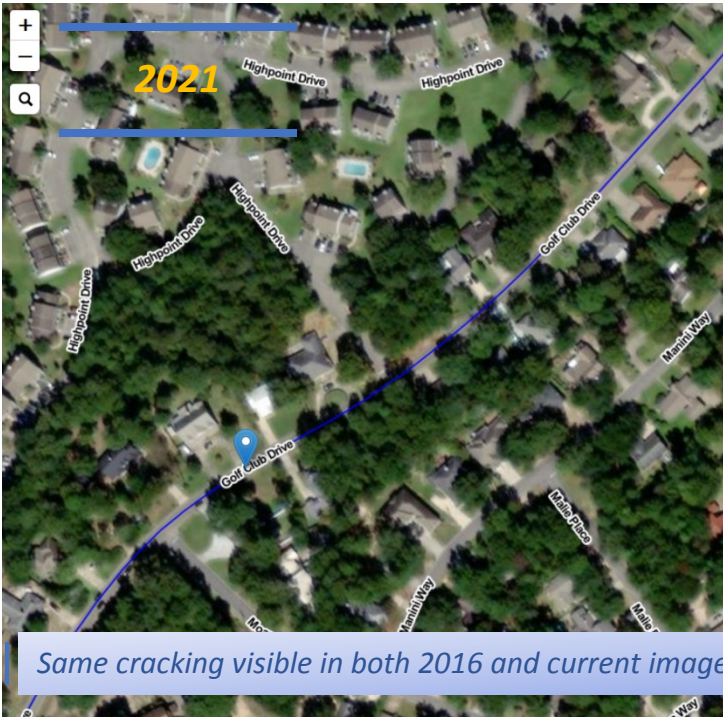
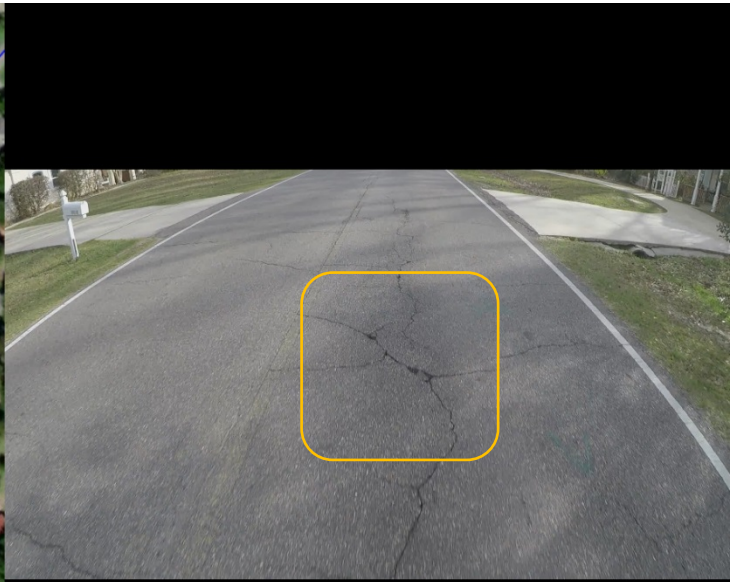
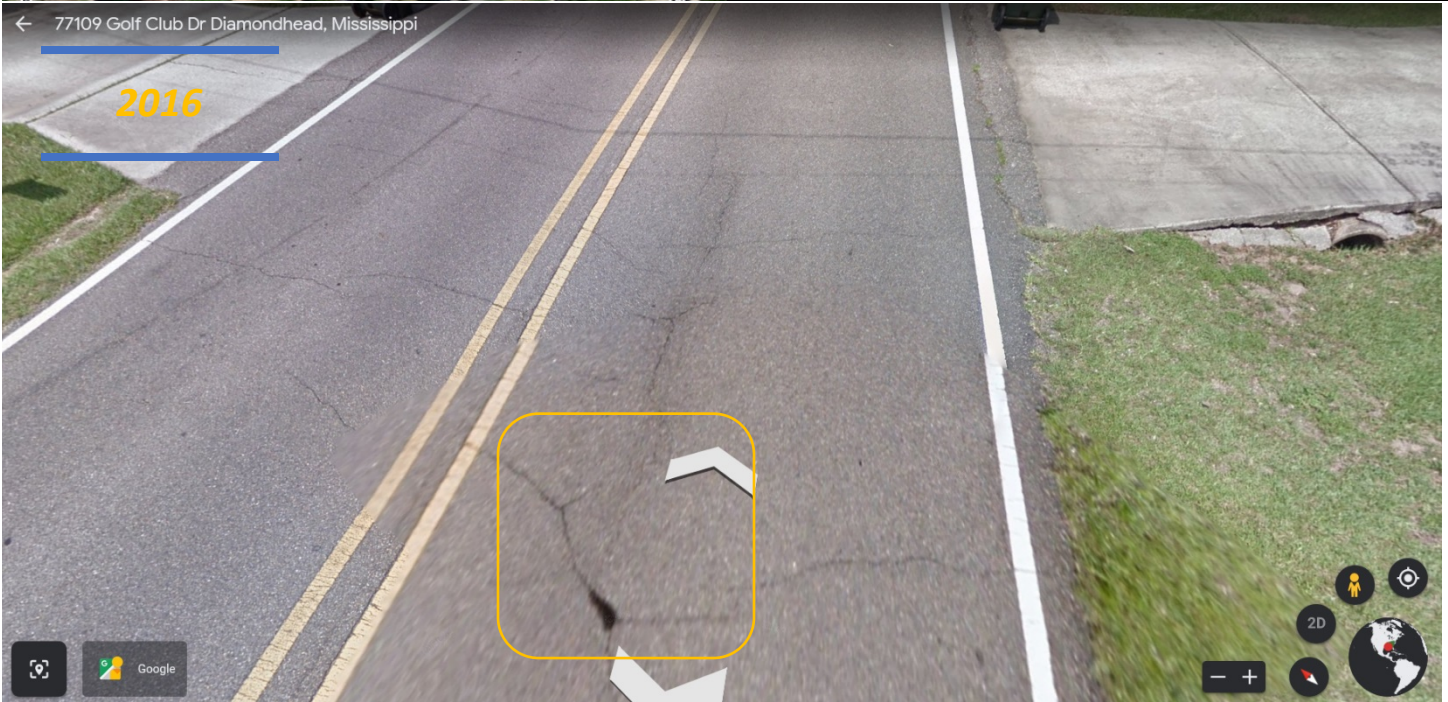
Golf Club Dr

Same cracking visible in both 2016 and current imagery.
