# Technical Memorandum

**Date:** March 5, 2025  
**To:** Phil Baumgartner, Dillingham Public Works Director  
**From:** Beau Counts, P.E. – Project Engineer, CRW Engineering Group, Inc.  
**Project:** Dillingham Dock Lighting Improvements  
**Project No:** (CRW#60143.34)  
**Subject:** Dock Lighting Condition Assessment & Recommendations

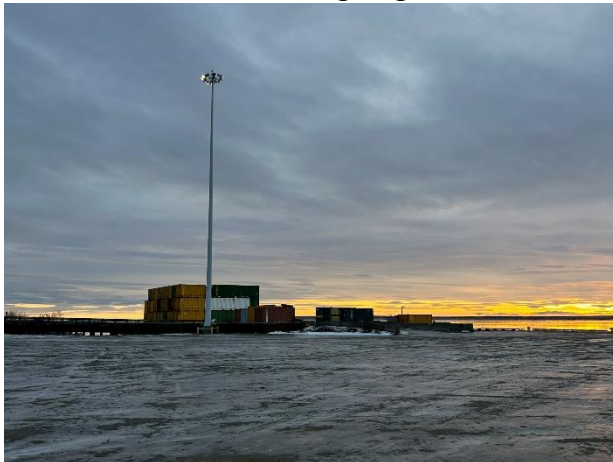
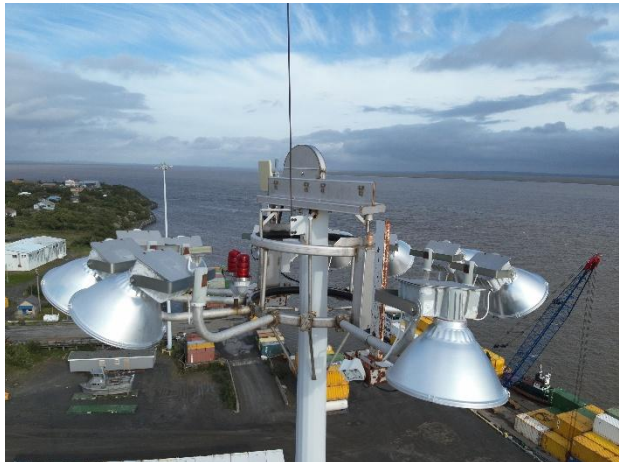
The existing lighting system includes two (2) tapered steel masts, 150 feet in height. The masts are rated for a wind velocity of 100mph with gusts up to 130mph. Each mast is equipped with a lowering system operated via a motorized pulley. The masts are equipped with 1,000W hi-mast metal halide fixtures. The lowering ring for the mast on the west end of the dock includes ten fixtures while the lowering ring for the mast on the east end includes twelve fixtures.

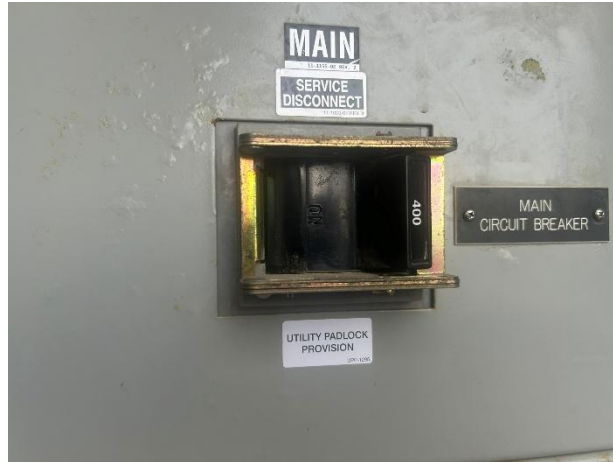
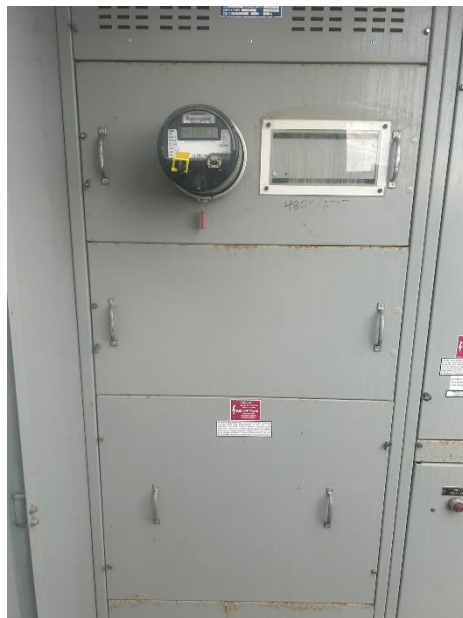
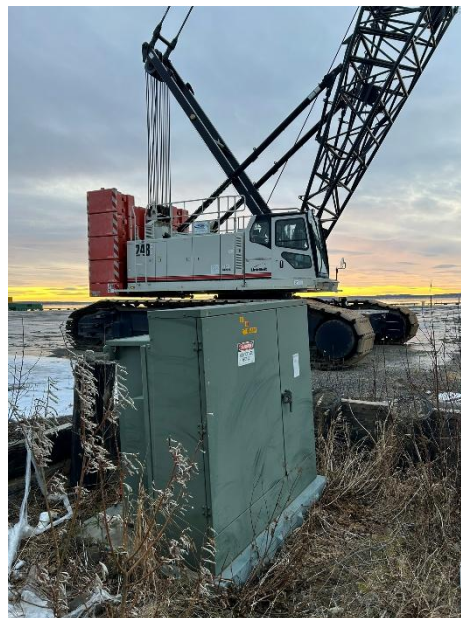
The existing electrical service is 400A, 277V/480Y, 3Ø connected to a nearby 75kVA utility transformer. The service laterals are landed on a 400A exterior, pad-mounted switchboard with CT cabinet and 480V branch circuit distribution. The switchboard consists of a 400A main breaker, (5) 20A branch circuit breakers, (1) 30A branch circuit breaker, and a switchboard mounted surge protecting device. The branch circuits are distributed via #12AWG and #10AWG conductors to the contacts and relays located in the lower section of the MDP.

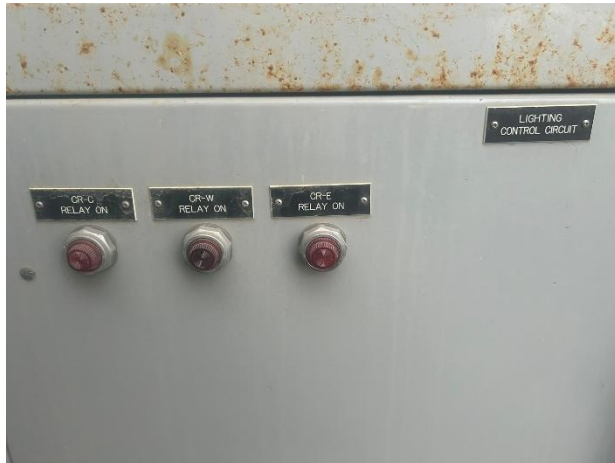
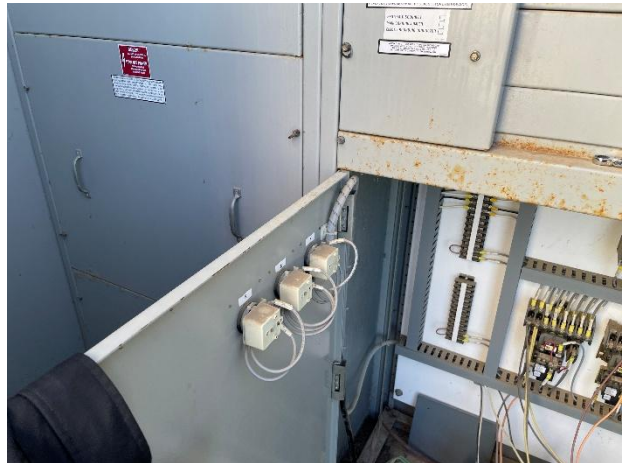
Control relays & coils are located in the lower section of the MDP with lighting control provided via circuit breakers. There are some newer stainless-steel enclosures within the bollard protected area of the west mast which are not associated with the lighting system/controls.

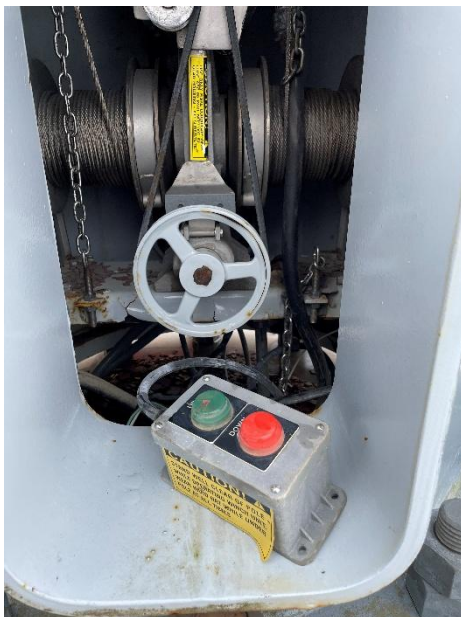
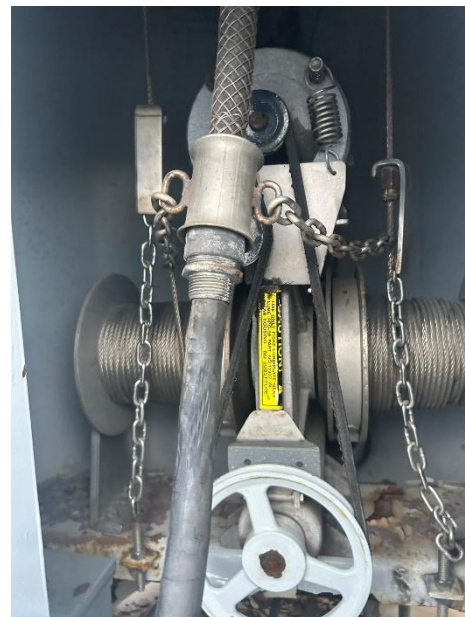
The pulley system appears to be in good working condition. The belts are starting to wear and show cracking. It's recommended that the belts be replaced regularly and a service log maintained onsite at each mast.

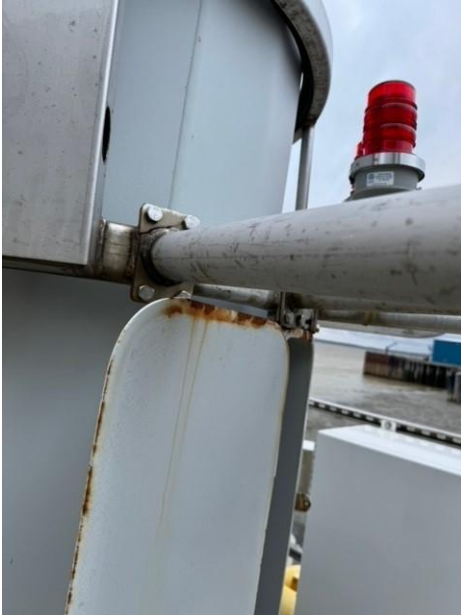
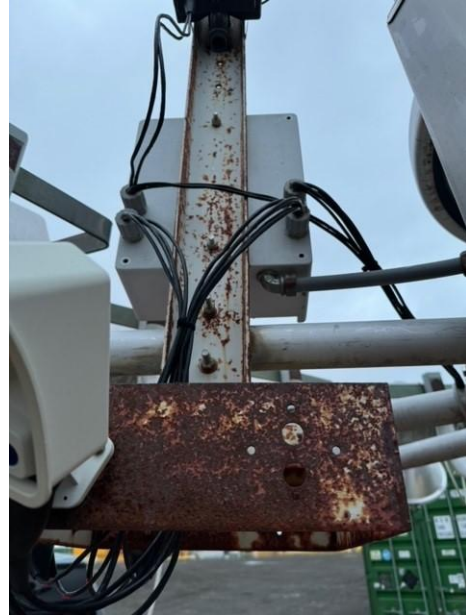
The lowering rings on both masts appear to have significant corrosion and some damaged components. Most of the screws used for securing cover plates are heavily corroded and near the point of failure.

The corroded components on the masts and lowering ring would be refurbished and any damaged components would be replaced with factory recommended replacement parts. The masts, foundations, and lowering rings would be inspected by a structural engineer licensed in the state of Alaska to ensure those components are rated for 100mph wind velocity with 130mph gusts and not compromised.

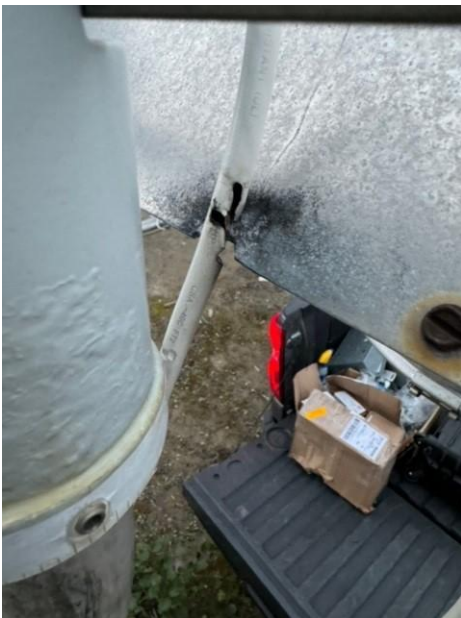
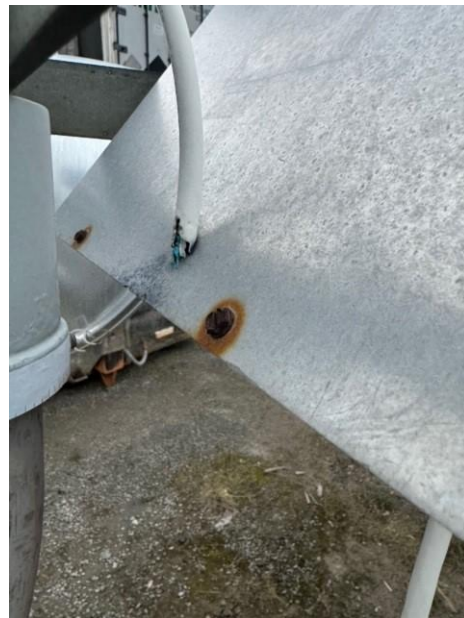
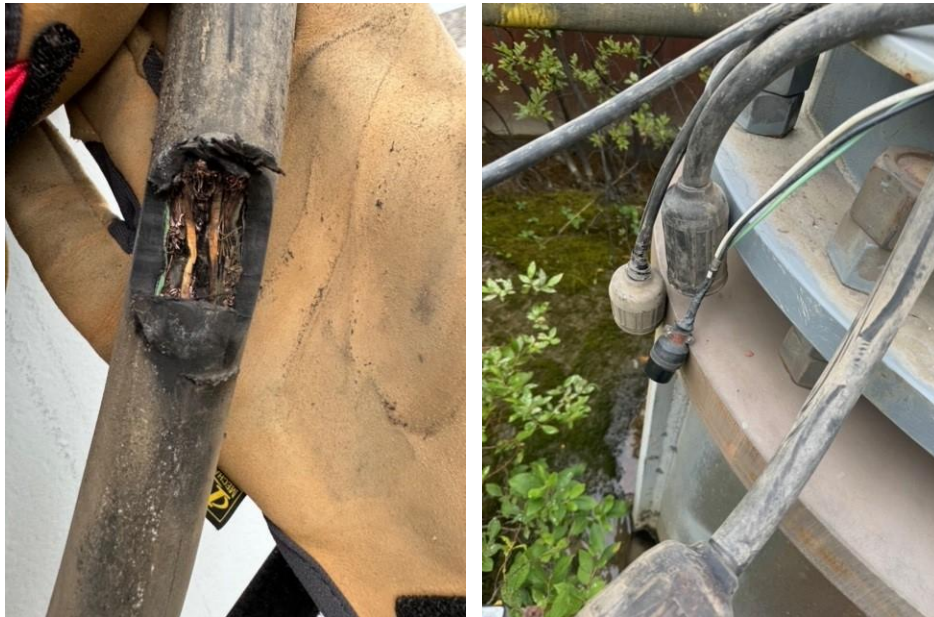
There are multiple instances of damaged wire & insulation including some circuits that have been severed and short circuited on the metallic ring and mounting components.

All of the branch circuit wiring from the switchboard needs to be tested and the insulation inspected. Any sections of wiring that are damaged or that don't pass testing need to be replaced. At a minimum, testing should include megger testing and conductor continuity testing.

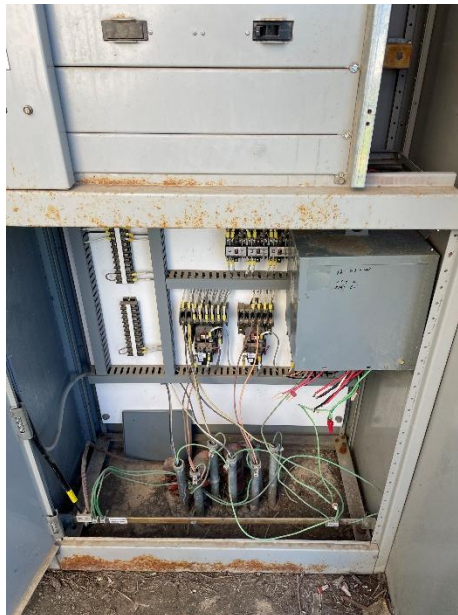
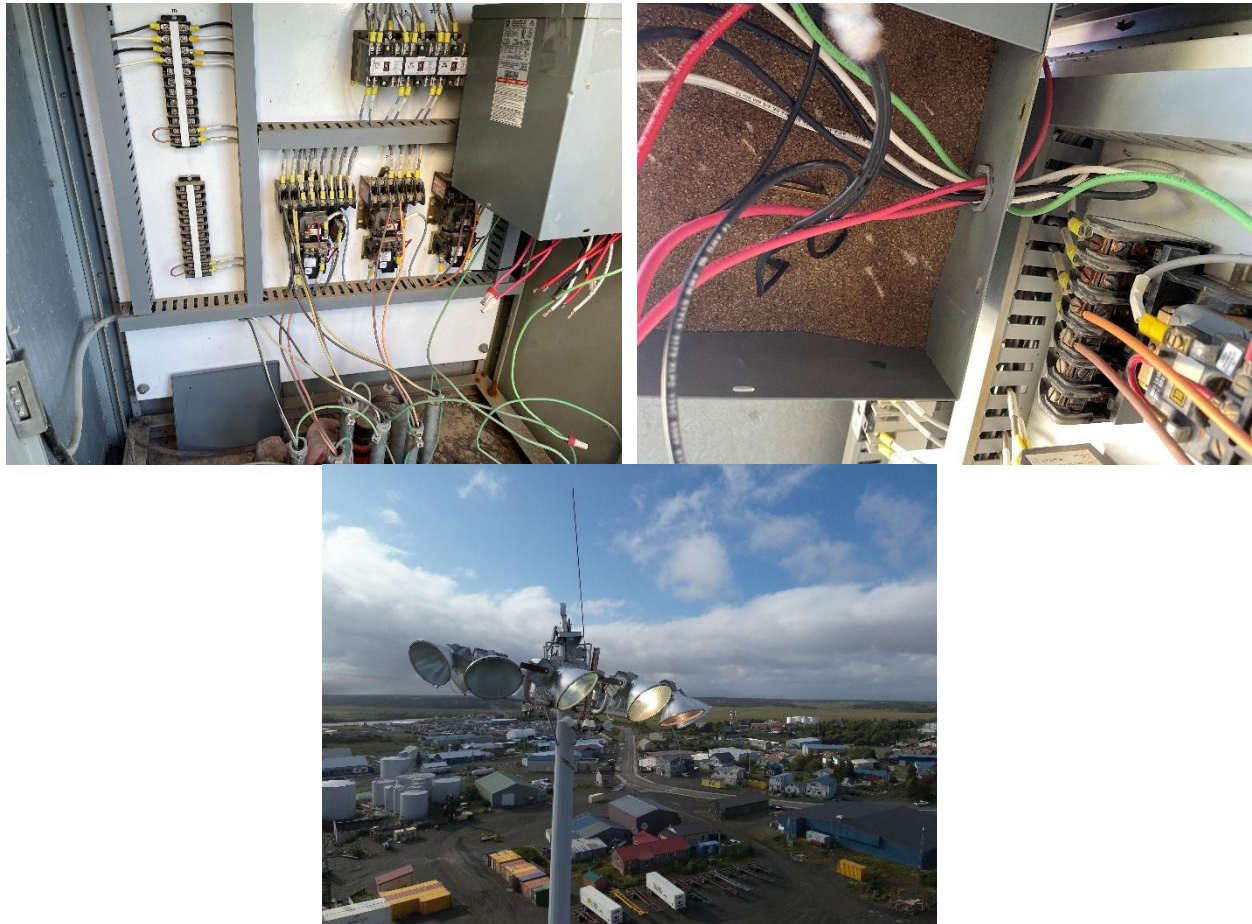
The lighting controls appear to have been originally designed for multiple mechanically held lighting contactors to be mounted adjacent to the MDP, but a system of relays and coils were installed in the lower portion of the MDP. There are several circuit conductors that have been cut and abandoned. Most of the light fixtures do not turn on when the system is energized.

The power and control wiring in the switchboard should be rewired to match existing labeling and provided with complete circuit designations to ensure all lighting is properly connected. The overall condition and configuration of the switchboard should be brought up to code. Any abandoned or unused wiring in the switchboard and light masts should be demolished. Any corroded components on the masts should be refurbished to factory condition and any damaged components should be replaced with factory recommended replacement parts.

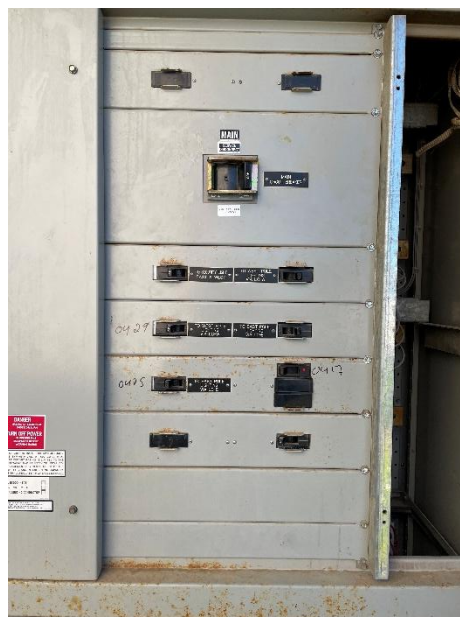
The switchboard and components are mildly corroded. The switchboard is missing a cover panel needed to protect personnel from arc flashes. The switchboard is a discontinued model and spare parts may not be readily available.

A new 480V CT, meter base, and panelboard would be provided and installed on a new strut rack to replace the discontinued switchboard. New control schema would be designed to achieve the desired lighting operation to be discussed with the City of Dillingham. New lighting

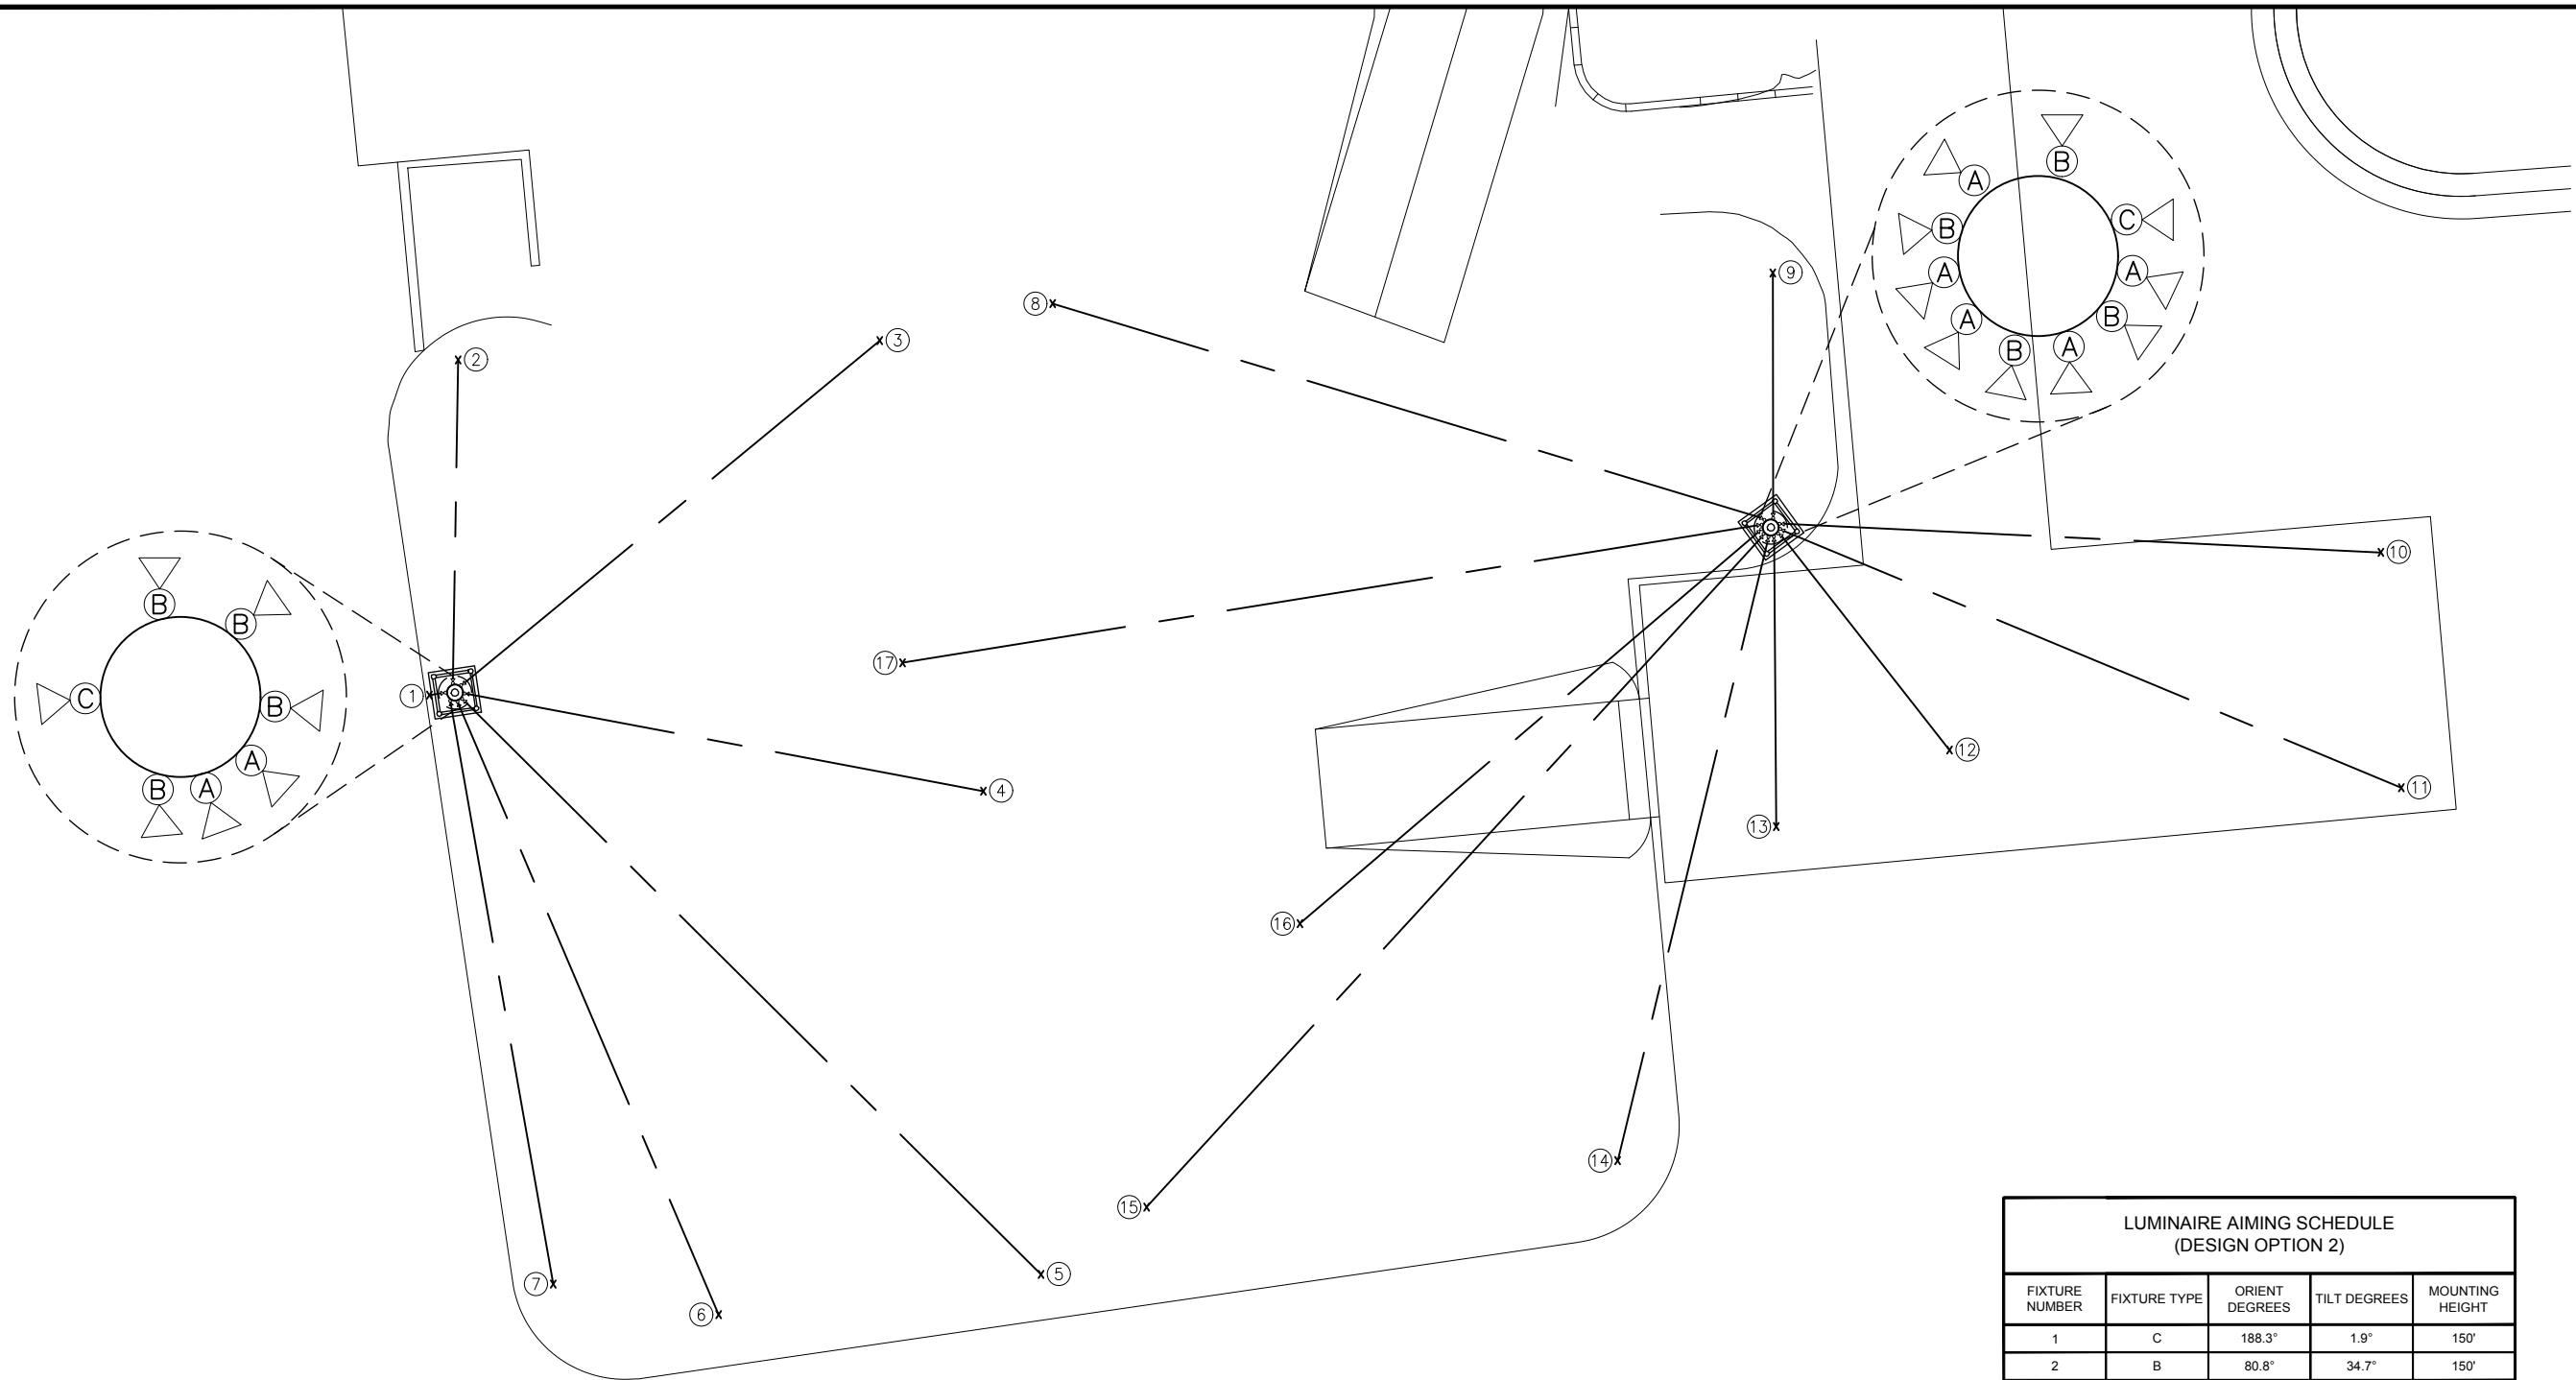
## DOCK SITE LIGHTING PLAN - DESIGN OPTION 2

New LED light fixtures would be provided and installed on the existing lowering rings at each existing 150' mast. Initial calculations indicate the required quantity of new LED light fixtures would be eight for the west mast and ten for the east mast. The final quantity and fixture configuration would be designed to exceed the performance of the existing design. All new wiring for lighting power and controls from the new panelboard branch circuits would be provided and routed in existing conduits.

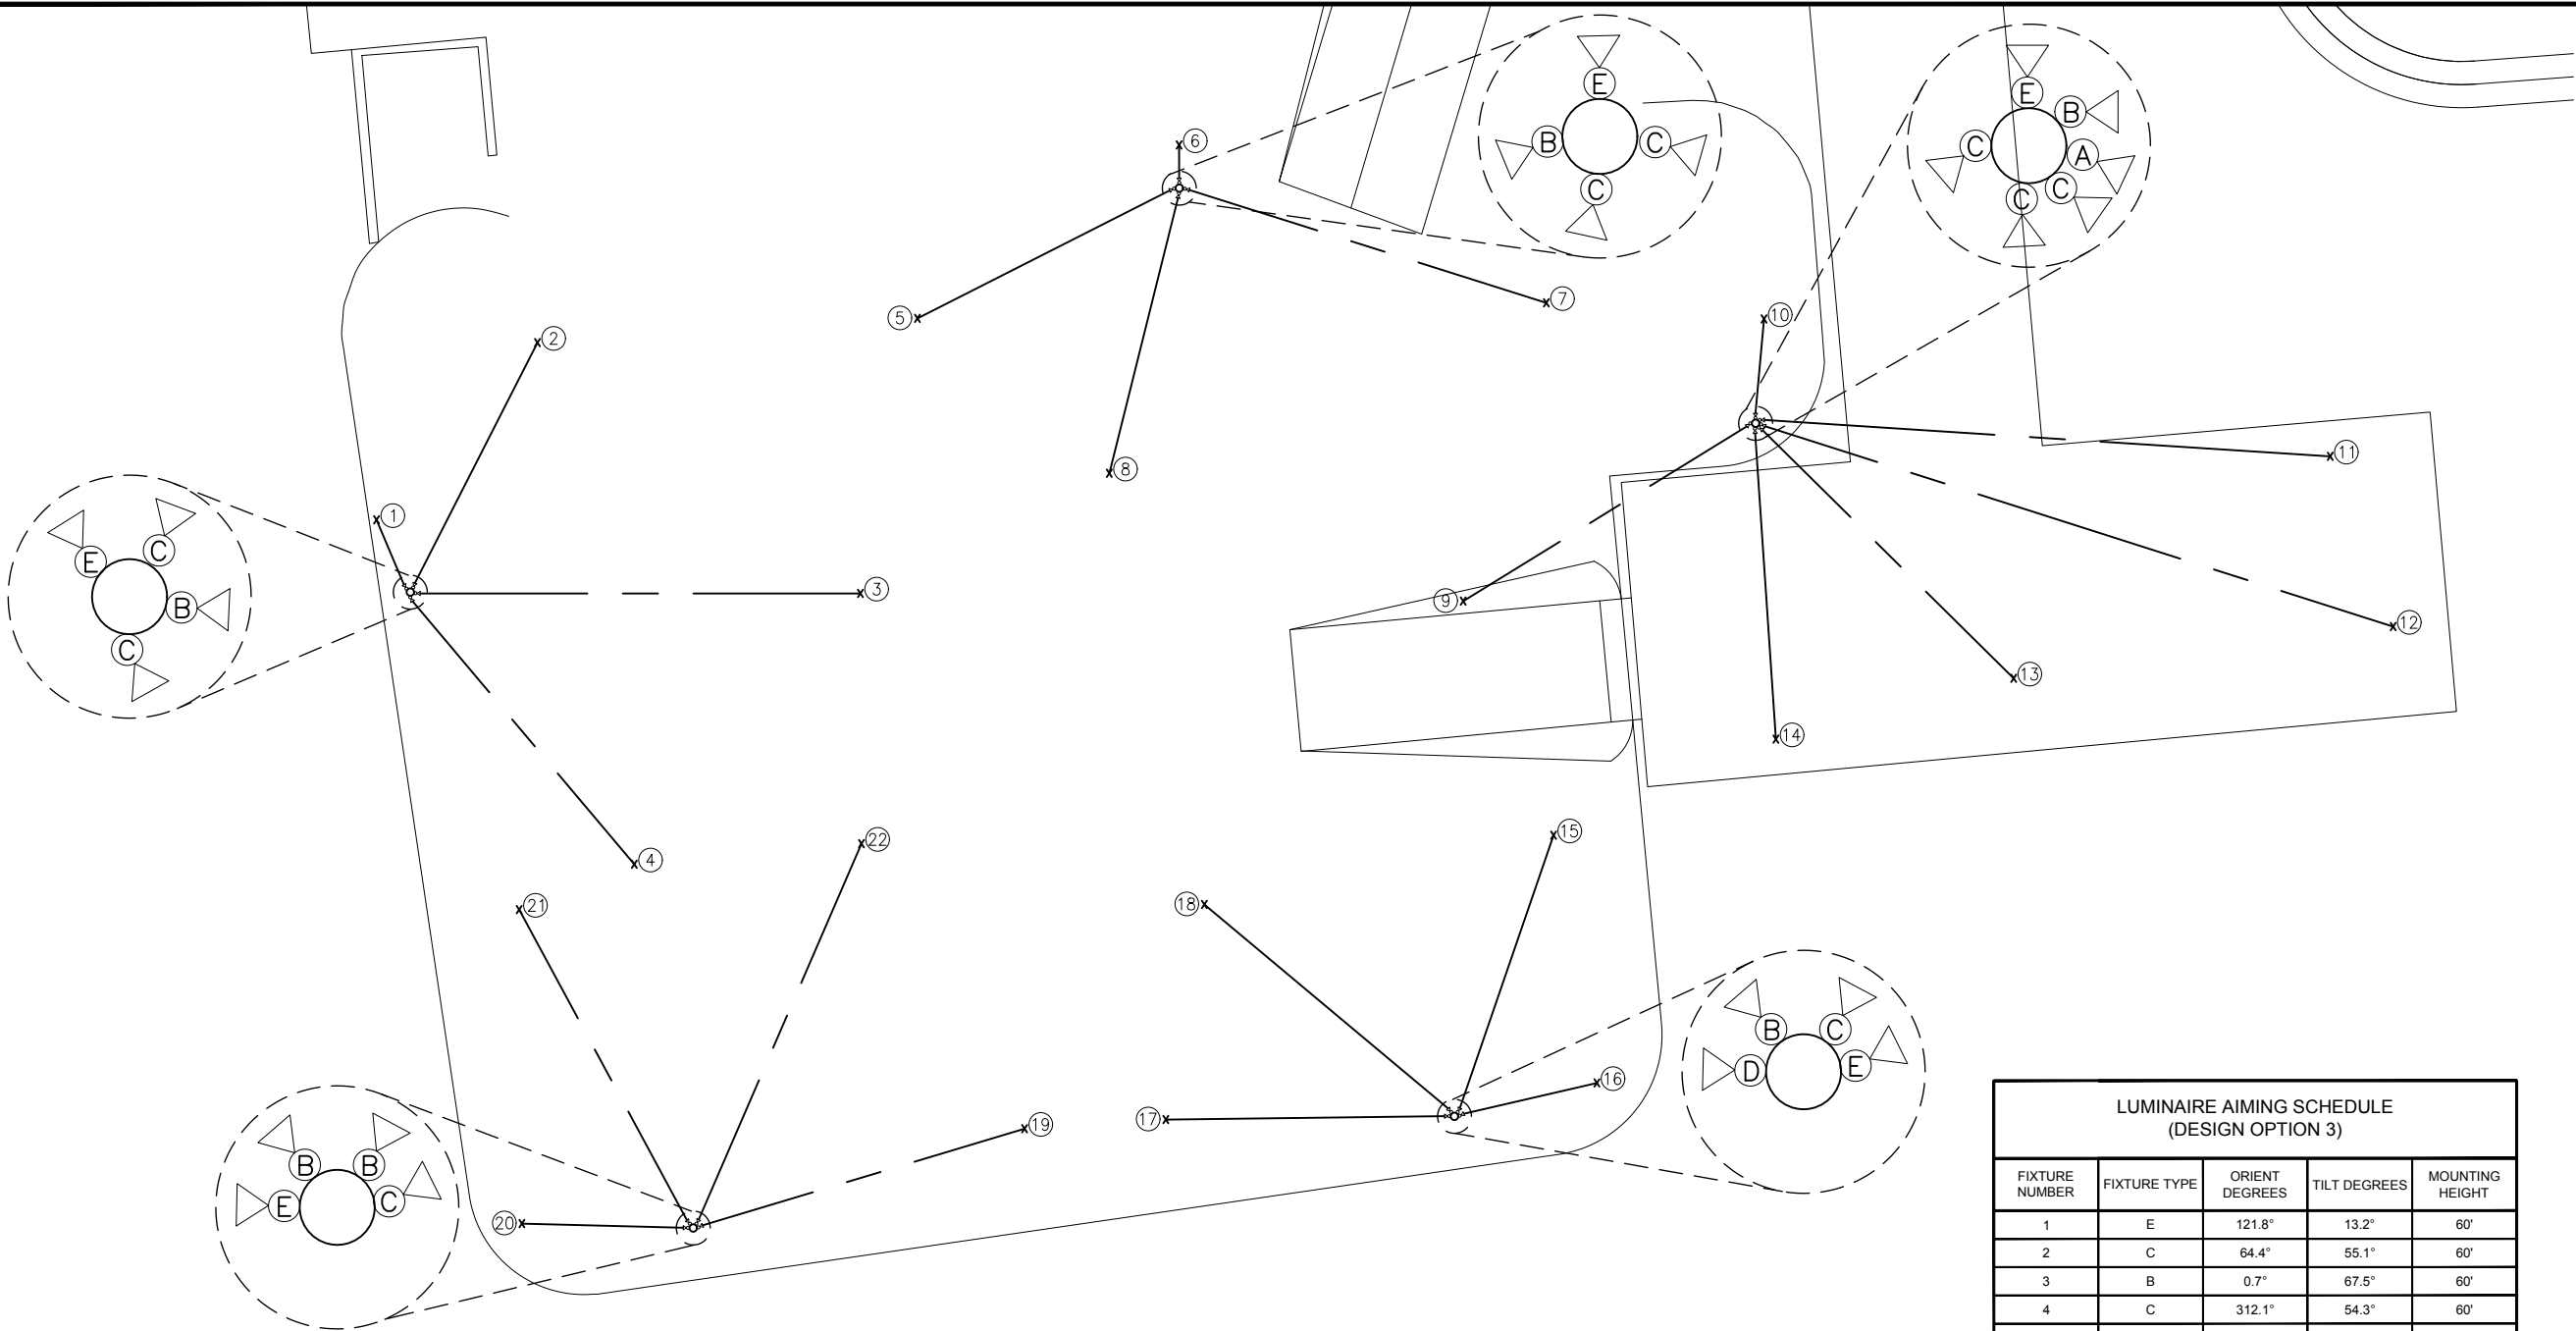
DOCK SITE LIGHTING PLAN - DESIGN OPTION 3

New 60' poles would be installed at five locations around the perimeter of the dock area including at the two existing 150' mast locations. Each 60' pole would have up to six LED light fixtures mounted on them with approximately twenty-five new LED fixtures total. All new wiring and raceways would be provided to the new locations.
