# Structural Evaluation Report

**Date:** August 21, 2023  
**To:** City of Dillingham Attn: Kim Johnson, Acting City Manager  
**From:** Jesse Gobeli, PE, SE  
**Location:** Dillingham  
**Project:** City of Dillingham Building structural review  
**Project No:** CRW# 60123.09  
**Subject:** Structural Evaluation Report  
**Date of site visit:** August 16, 2023

## TERRITORIAL BUILDING

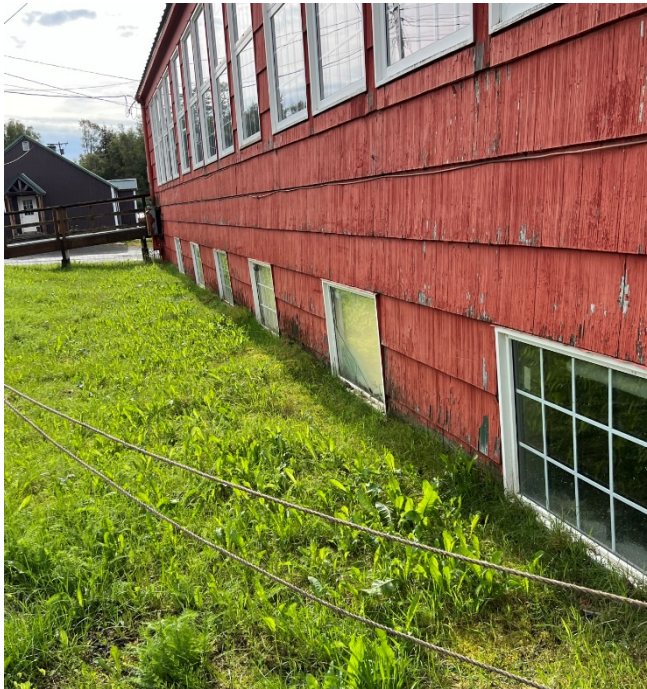
1. North side lower level concrete retaining wall. This retaining wall is a noted issue from the 2012 Wilson report. The north wall is structurally unstable, and has continued to deflect inward due to the outside pressure of the soil. During my site visit, we noticed broken windows on the north side, potentially caused by the wall movement.

*Figure 1: North side retaining wall*

The undermined slab and foundation described in #3 above is a serious structural problem that will lead to building collapse. The unstable retaining wall identified in #1 above is also a structural problem. Due to these two dangerous conditions, the building should not be occupied, and access in and around the building should be restricted to limited visits by authorized personnel only for short duration. Repair of the foundation problems will be costly, intrusive, and time-consuming. Further geotechnical exploration and recommendation would be required as the solution would likely involve some kind of pile foundation to underpin the existing foundation. Demolition of the building would be most economical.

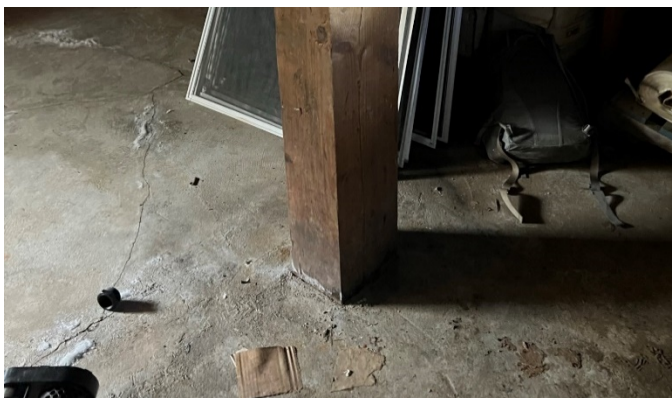
2. Water main leak. There was ongoing water leak in Main St, visible by water bubbling up through the keybox access in the sidewalk adjacent to the building. The water leak has occurred uphill and within a few feet of the Territorial building. I understand that the water leak may have been repaired since my site visit. However, the water leak had been saturating the soil on the north side of the building, increasing the soil load on the north retaining wall, and causing undermining of foundations inside the building.
3. Undermining of existing concrete slab and foundations. Figure 2 shows a primary building column, and Figure 3 shows a large void beneath what was a concrete footing for the primary building column. This is a dangerous condition for the structure and could result in collapse. The soil at the bottom of the void was saturated.

*Figure 2: Building column*

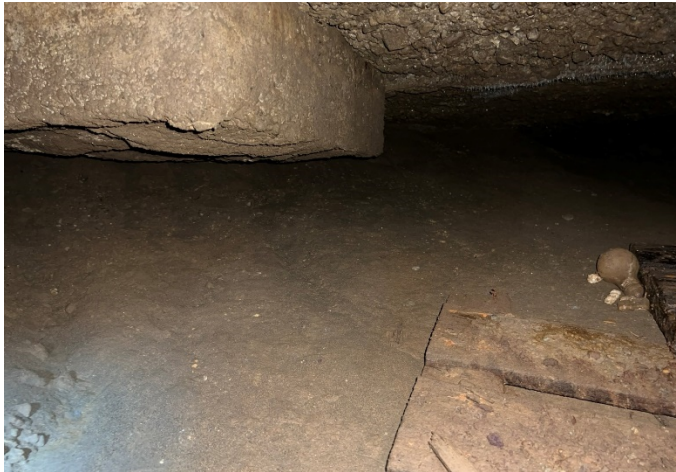
*Figure 3: Void beneath column footing*

Any repair work on the water main that requires excavation will need to proceed with extreme caution and due consideration of the precarious nature of the adjacent structural foundations. Digging in the vicinity of the Territorial building should not be permitted without engineering review.
