Bristol Alliance Fuels Site Erosion Report

Dillingham, Alaska

Bristol Project No. 32170071

November 2016

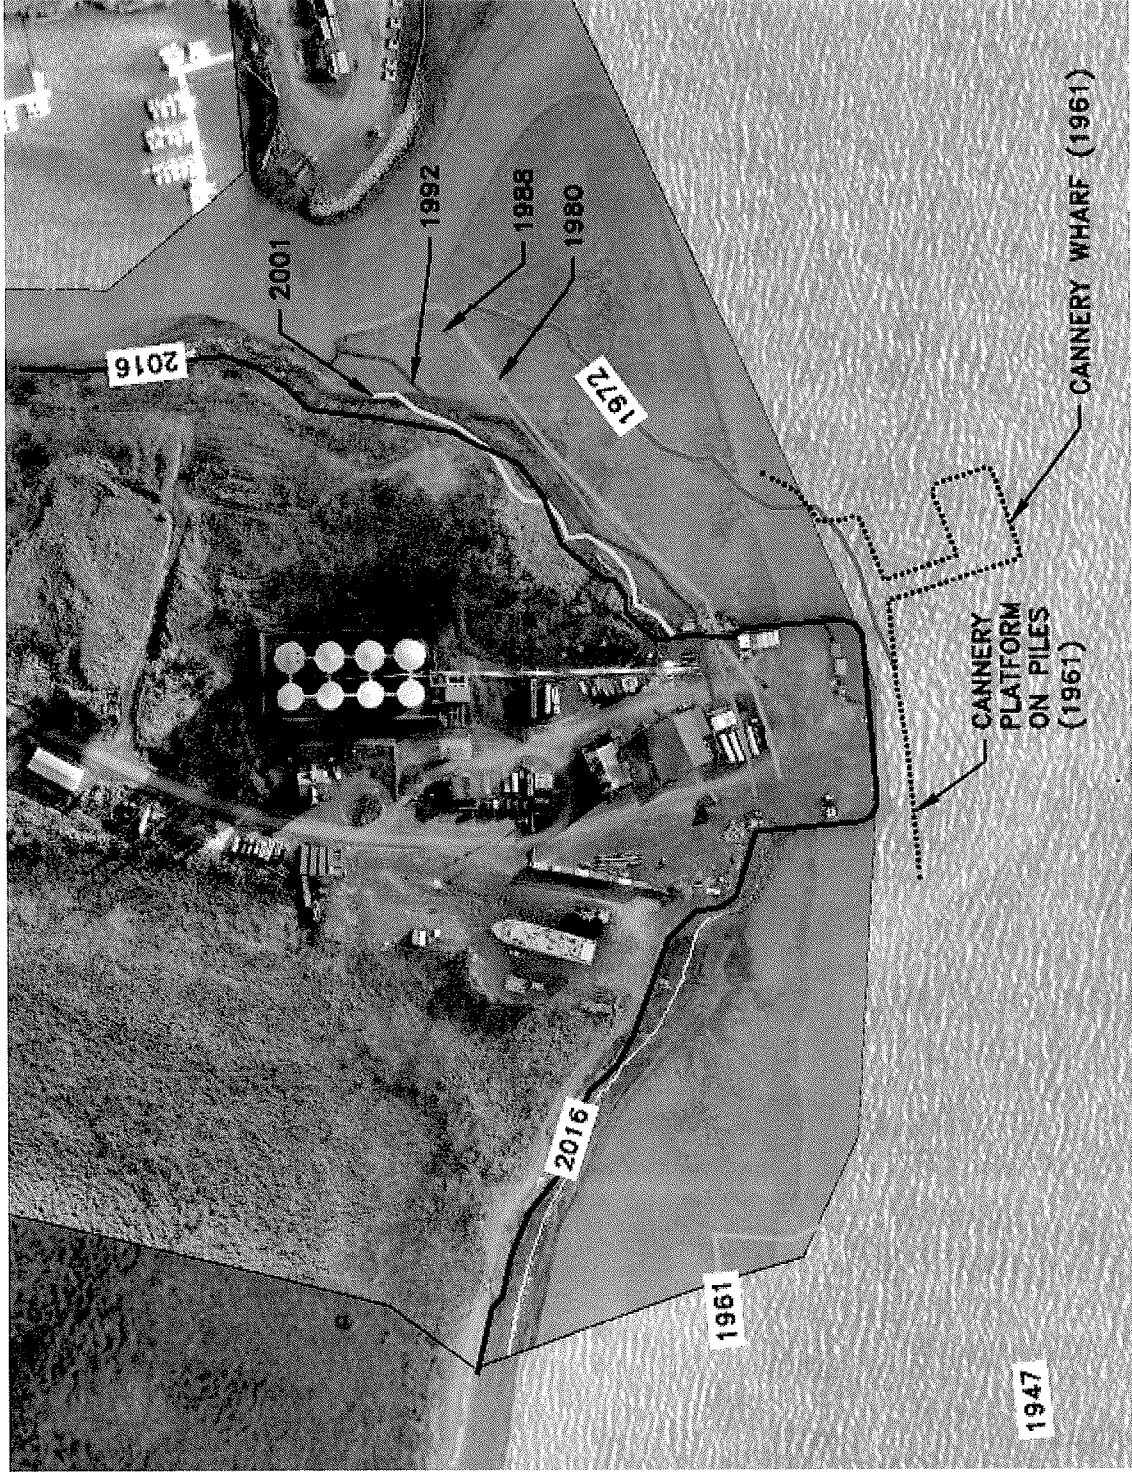
Figure 2: Shoreline Erosion History of BAF Site

Erosion of the BAF-owned lands has been under constant threat of erosion as far back as 1899, as recorded on Plat 62-135 Bristol Bay Recording District when the land was transferred from the North Coast Packing Company to the New England Fish Company. See Figure 2 for historical erosion of the site.

The Dillingham Small Boat Harbor has historically been protected by the point of land near Scandinavian Beach. Surveys performed for the 1960 boat harbor project show Scandinavian Beach extending 700 feet from the top of the west bank, across the opening of Dillingham Harbor with a top elevation of 10 to 15 feet above MLLW. Topographic information collected in 2001 shows that this entire 700-foot section has eroded away, with the west top of bank receding by about 300 feet. It is hypothesized that this extreme rate of erosion is likely caused by a combination of factors. The most likely contributing factor is that the point forced a hard 90-degree bend in Scandinavian Creek. This bend was subject to the constant erosive forces of the creek. Very similar to any other meandering stream or creek in the region, banks erode away due to the loose sandy silt soils prevalent in the area, which are easily erodible. Figure 3 and Figure 4 are the historical photos of Scandinavian Beach, which depict the land lost from 1981 to 2001. In recent years, erosion along the west side of the un-stabilized bank area has progressed to an extent that it has washed away the point of land at Scandinavian Beach that protected the small boat harbor. In turn, exposure to open water has increased wave action within the harbor basin and subjected the fine soils along the inner harbor banks to erosion.

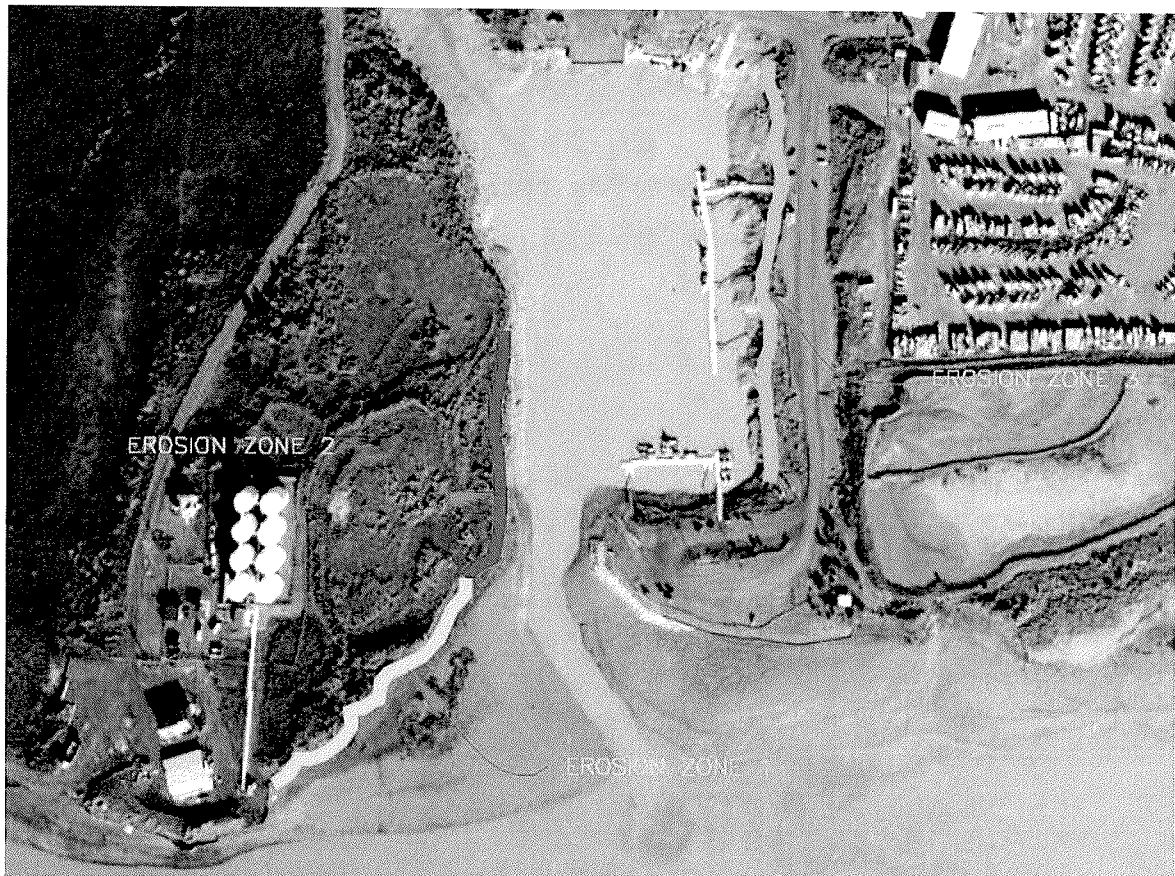
Figure 5: Erosion Zone Delineation

The USACE Reports outline different areas, and rates of erosion, for the land immediately adjacent to the small boat harbor. The erosion areas are broken into three zones. Zone 1 represents the western boundary of the BAF site, which lies outside of the small boat harbor. Zone 2 represents the western boundary of the BAF site, which lies within the small boat harbor. Zone 3 represents the western bank of the inner harbor. These zones are identified in Figure 5.

Table 1 shows the land lost from erosion for each zone and Table 2 shows the erosion rate for each zone. The USACE Reports indicated that the average erosion for the Western boundary of the BAF Site for the period of analysis from 1972 through 2001 was 10.8 linear feet per year, with an estimated 5.7 acres lost since 1972.

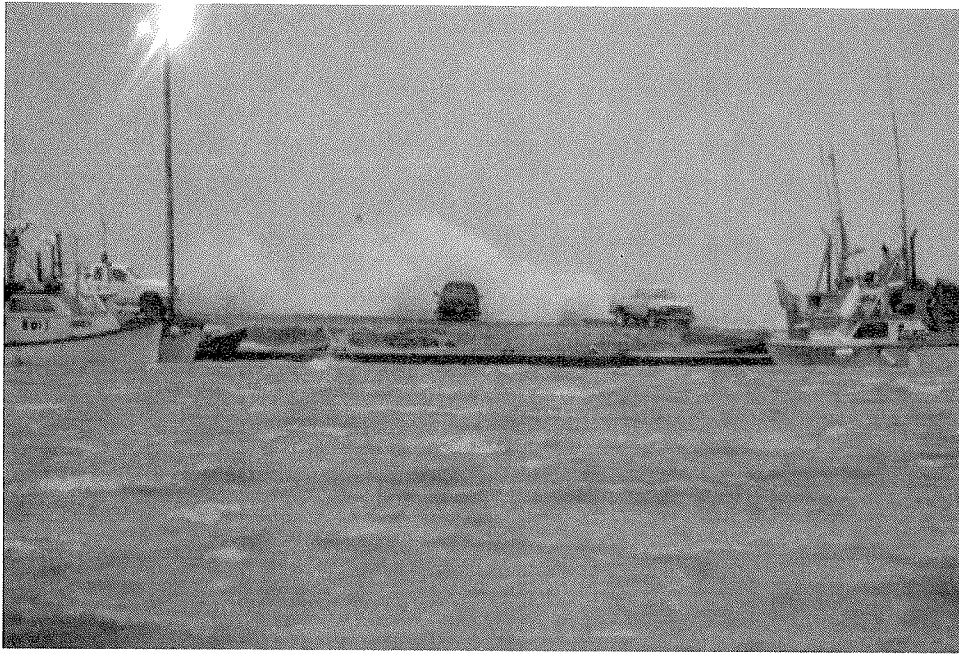
In August 2005, a storm surge has inflicted major damage to the Dillingham shoreline. The August 2005 storm washed away up to 10 feet of the shoreline, overtopped the sheet-pile seawall at the parking lot by at least 2 feet, washed parked vehicles into the harbor, and washed boats that were moored in the harbor up onto dry land, see Figures 6 & 7. Water elevation at the time of overtopping included a tide elevation of about 20 feet MLLW. Based upon an estimated surge of 3 feet, the total height of water when the wave crest was at the wall was estimated at 23 feet MLLW.

Figure 6: Waves breaking over outer bank

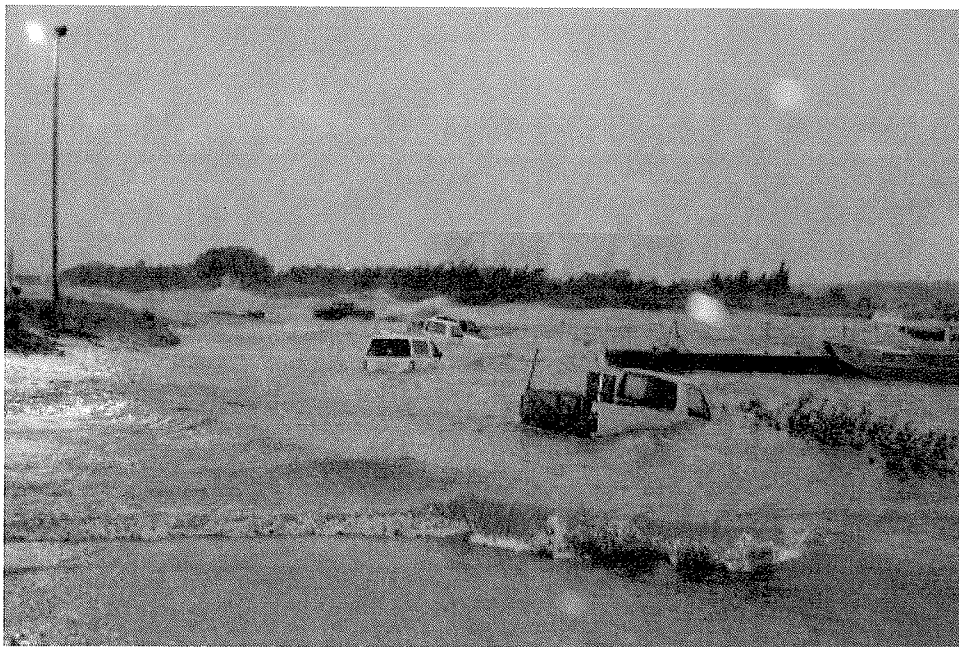
Figure 7: Storm surge in the harbor

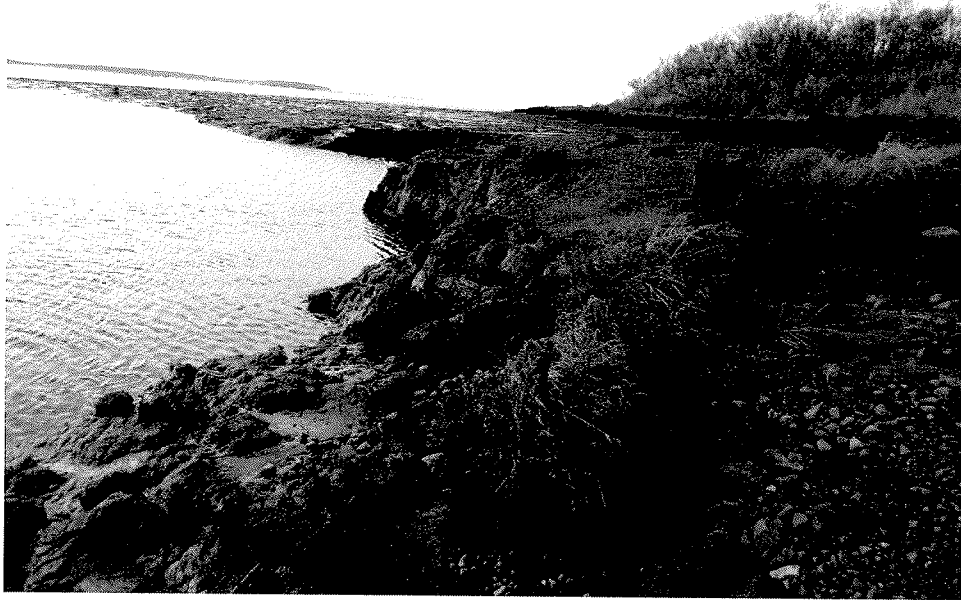
In 2015, a large piece of the shoreline on the west side of Scandinavian Creek eroded away. This piece of land is adjacent to the BAF fuel tanks. Additional land on the west side of Scandinavian Creek north of the harbor has also recently eroded and is threatening the access road to the BAF facilities, see Figures 8 & 9.

Figure 8: Erosion that occurred in 2015 on west side of harbor

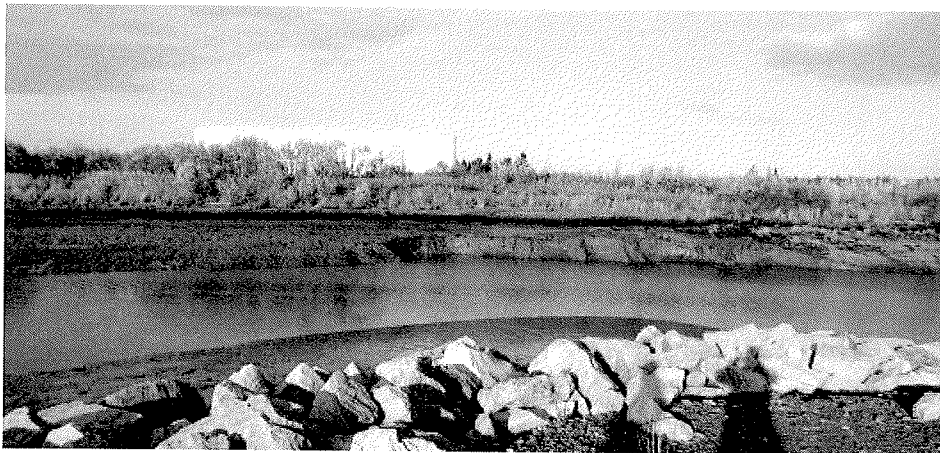
Figure 9: Looking west from harbor at the erosion adjacent to the fuel tanks

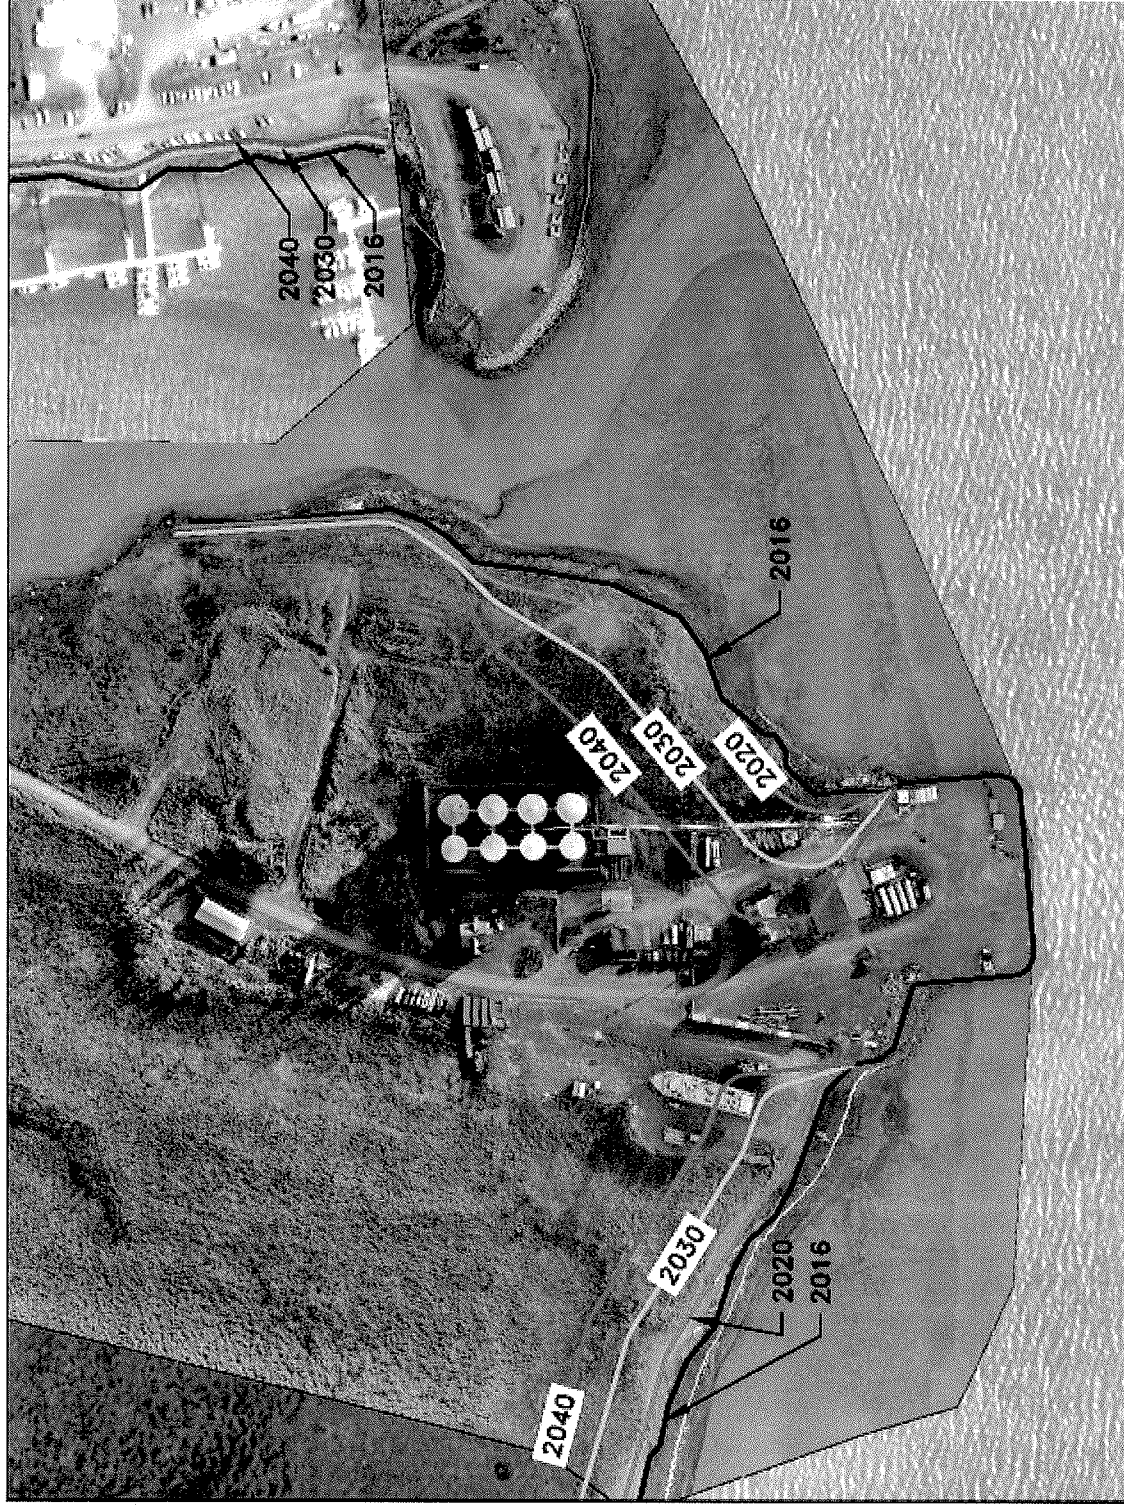
Figure 10: Predicted MHW Bank Locations over Time

See Figure 10 for a visual representation of the predicted erosion limits, as a basis of time. Please note that this figure is for planning purposes only and is subject to the assumptions made as part of this analysis.

Based on a comparison of the shoreline locations from 1961 to 2016 it was determined that an annual loss of 5.9 feet occurred in Zone 4. This value was used in the visual representation of the predict erosions limits shown in Figure 10. The approximate area of area lost during this time period in Zone 4 is 7.2 acres.

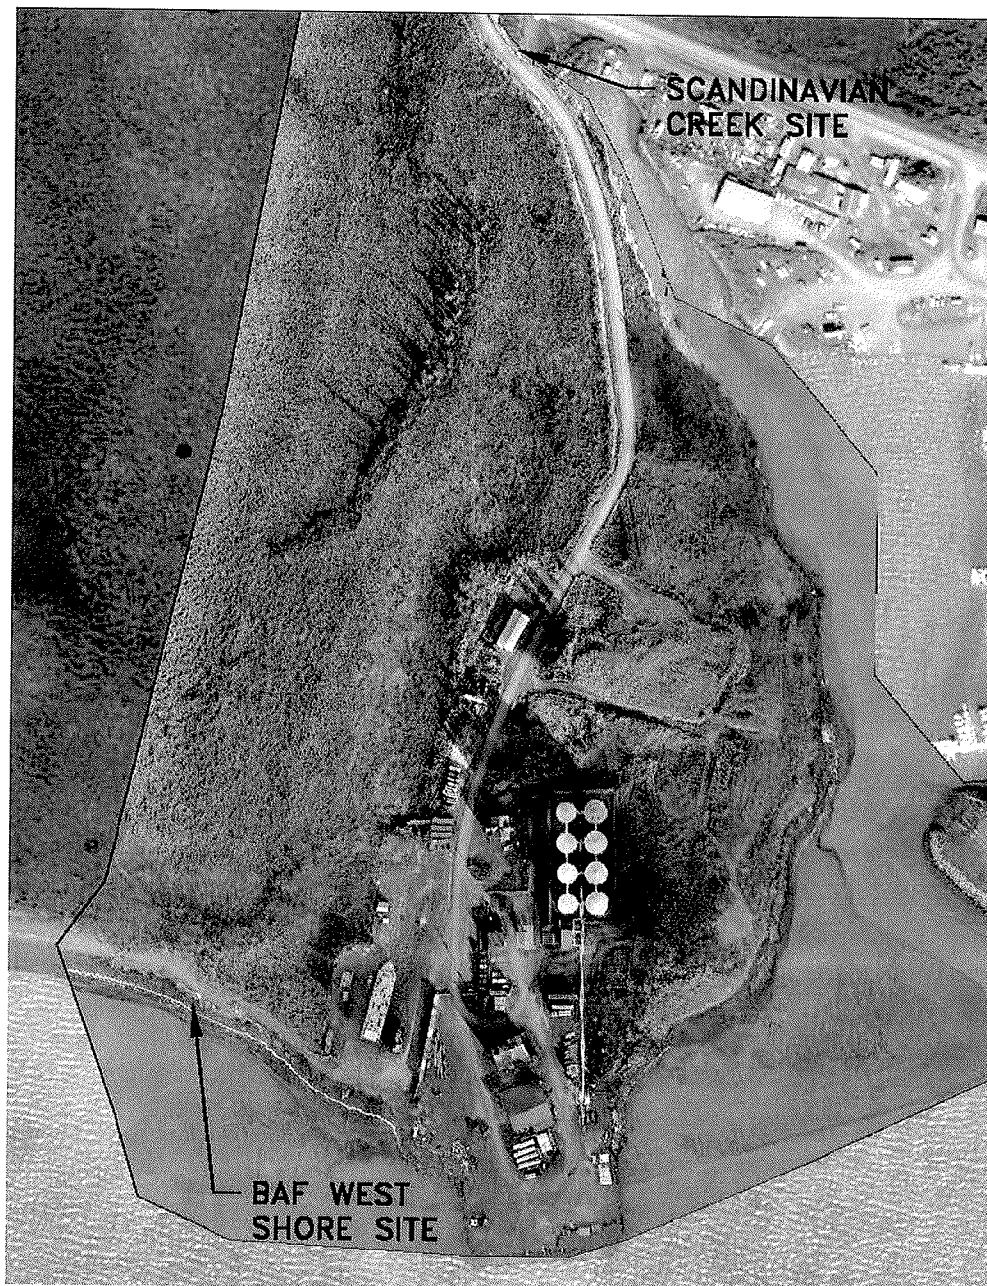
Figure 21: Other Erosion Protection Areas

Two other locations of erosion were identified that are not covered in the USACE 2009 reports. One area is along the BAF site access road due south of the culvert that Scandinavian Creek passes through at Kanakanak Road. The other site is along the shoreline of the BAF property west of the sheet pile dock, Figure 21.

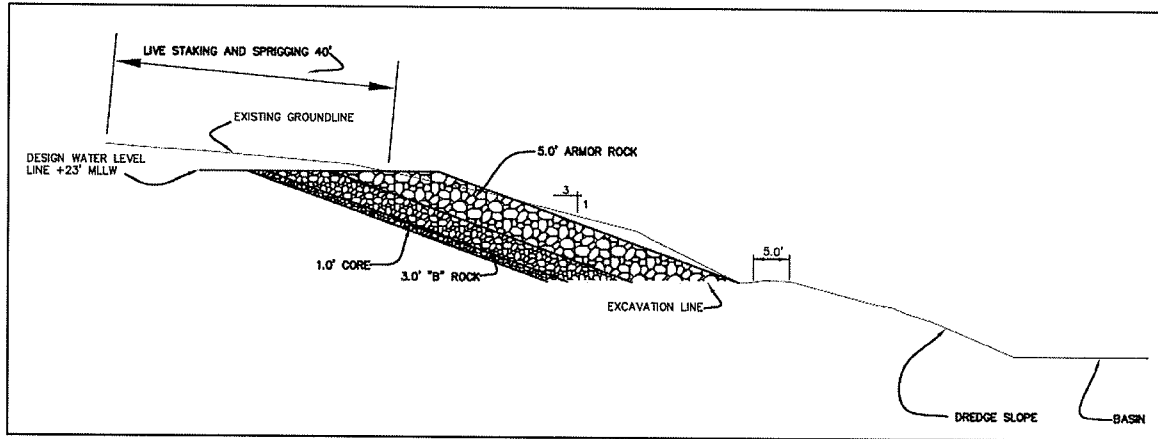
Figure 23: West shore revetment typical section.

BAF has plans to expand and upgrade their existing pad and barge haul-out ramp, see Figure 21. Armor stone has already been placed between the sheet pile dock and the barge ramp. The shoreline west of the barge ramp will need to be protected from wave erosion. For the purpose of the memo, it is assumed that a revetment similar to Alternative W1 as shown in Figure 23 will be used to prevent further erosion from occurring in this area. This revetment is thicker than the revetment used in Alternative W2 and assumes there is no breakwater to reduce the wave impact on the shore.

The rock revetments would have a top of +32 feet MLLW. The top elevation of the revetments was determined from 6 feet of wave run-up with a design water level of 26 feet. The length of this revetment will be approximately 380 feet long. The design water level equates to the mean higher high water level plus 6 feet of storm surge. approximately 3,560 yd³ of armor rock would be used that range in size from 1,914 to 1,148 pounds. Secondary rock size would be from 1,148 to 115 pounds and would require 2,140 yd³, and 710 yd³ of core rock would be placed behind the secondary layer and would range in size from 115 to 11 pounds. Using costs previously established in the USACE report and adjusted to 2016 values using a CPI increase of 14.5% from 2008, the cost of this section of erosion control is estimated to be approximately \$2,122,900. See Table 9 for a breakdown of costs.
