**APPLICATION FOR
CERTIFICATE OF APPROPRIATENESS**

Address of Property Where Structure/Site Located: 100 Old Fitzhugh Road

“Phase I: Protection and Stabilization Program” to address & further investigate extensive repairs & deferred maintenance, arrest decay, stop water intrusion, correct declining & substandard performance of building foundation, structure, envelope, roof, electrical, plumbing & HVAC systems and yard utilities. See attached “Scoping List” with supporting “Property Inspection Report.”

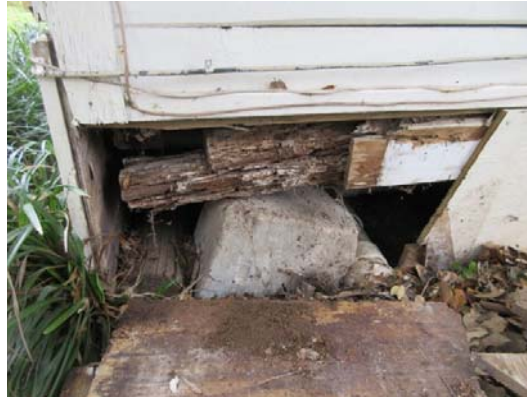
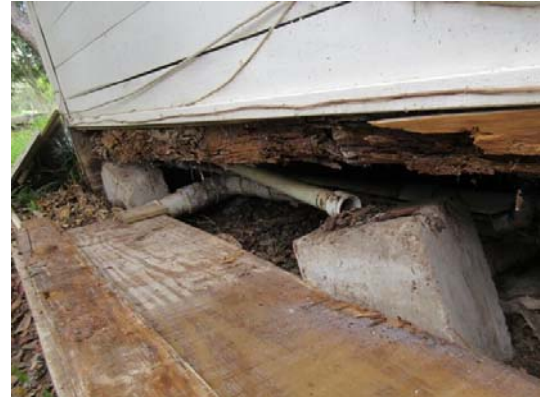
Support inadequate at back left corner: The beam at the back left corner of the structure has sustained significant damage from water and termites. In addition, the pier at this location is failing. Support for this corner is insufficient and structural damage is anticipated.

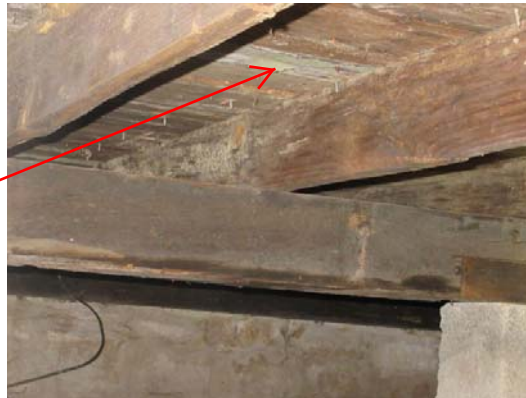
possible mold from
underventilation

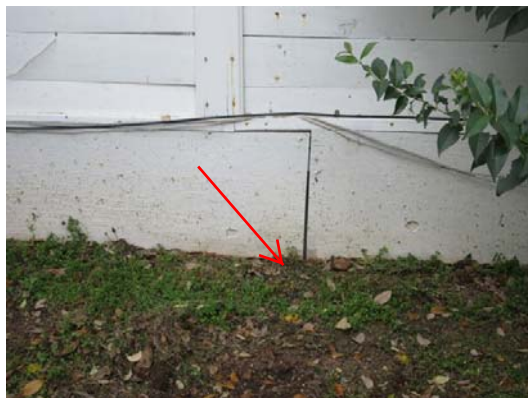
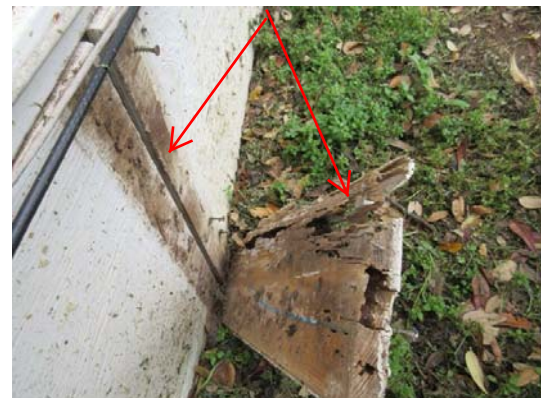
Wood touching ground at perimeter: The skirting is wood that is touching the ground at various locations around the perimeter. Water damage and termite infestations are possible when wood is in contact with the ground. Excessive wood rot and termite damage were observed at some areas. I recommend having this evaluated by a pest control company and have all wood-to-ground areas treated.

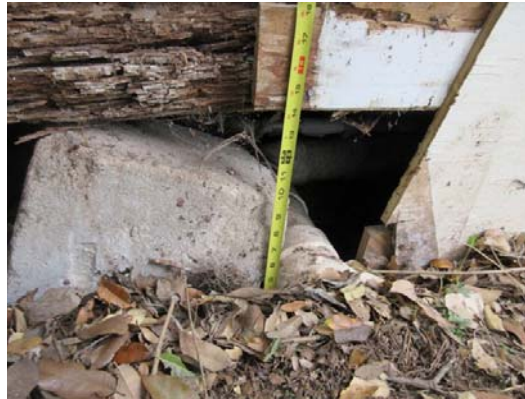
Crawlspace not accessible: The foundation crawlspace was not accessible as there is no door or access. Most of the crawlspace could not be inspected. The minimum clearance under the house should be 18 inches. The crawlspace was observed from back left corner where skirting was removed. Since most of the crawlspace was not accessible, there will be some items not discovered in the process of this inspection. It should be noted that limited access under the house may prevent or limit access for foundation repairs, termite treatment, and plumbing and electrical repairs, if such repairs are needed.

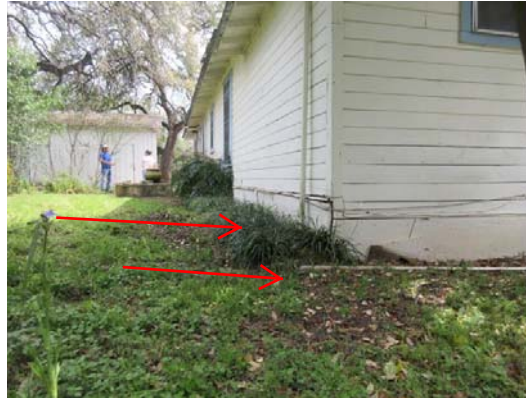
Water pooling: There are low areas at various locations around the foundation perimeter where water may be pooling when it rains. In some cases expansion and contraction of soils around the foundation can cause foundation issues.

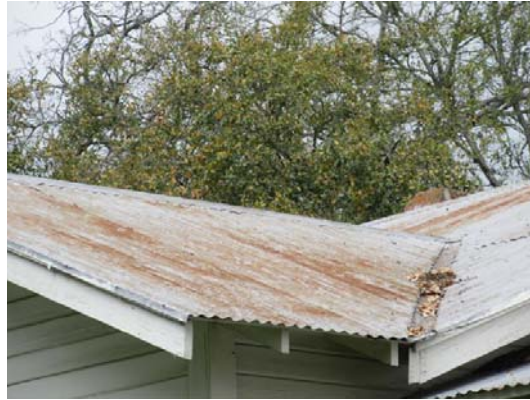
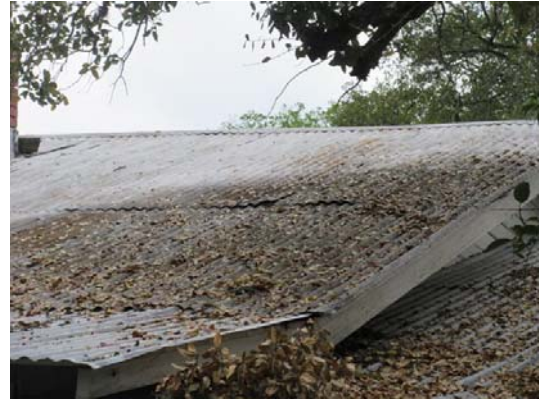
Possible roof leak: There appears to be evidence of a roof leak at the left back roof slope over master bathroom. Water evidence was observed at the bathroom ceiling. Recommend confirmation by a roofing contractor and repair as necessary.

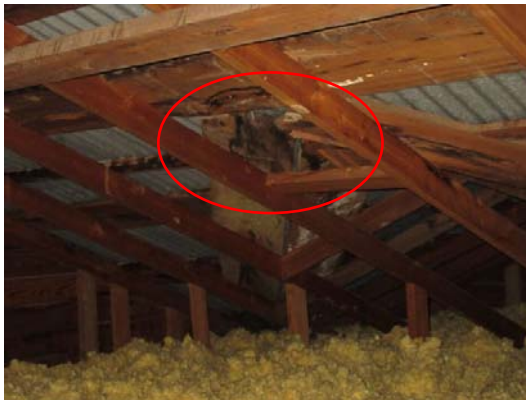
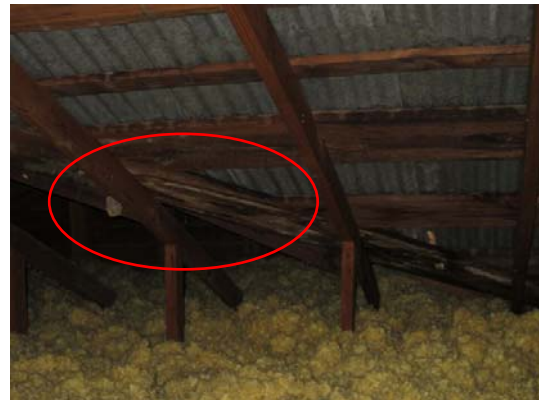
Possible roof leak at valleys: There appears to be evidence of roof leaks at the roof valleys. Water evidence was observed in the attic at framing. Recommend confirmation by a roofing contractor and repair as necessary.

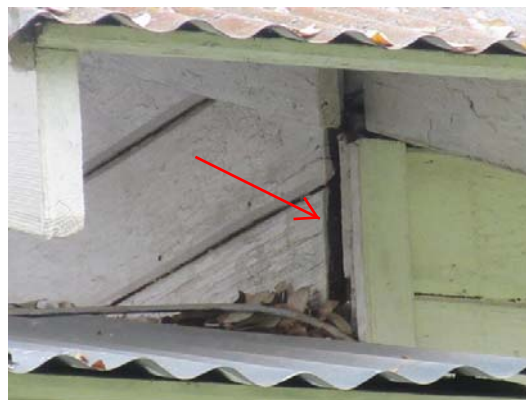
Flashing missing: There doesn't appear to be any counter flashing at the roof wall connections at various locations. There is a possibility of water damage to the siding and framing where ever flashing is missing.

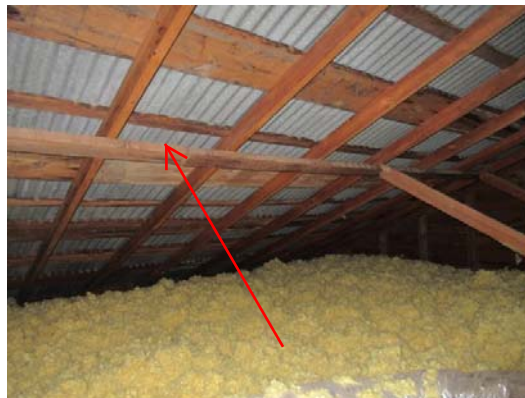
Rafter supports missing: Mid-span roof rafter supports or purlin bracing appears to be missing is some areas. According to modern construction standards mid-span roof rafter supports should be located every 48 inches. Proper support would include pulrins and purlin braces. Purlins, which are horizontal framing members should be placed on edge and not flat, under the rafters, and purlins should be braced with struts or kickers. Lack of adequate rafter support can contribute to depressions or deflections in the roof.

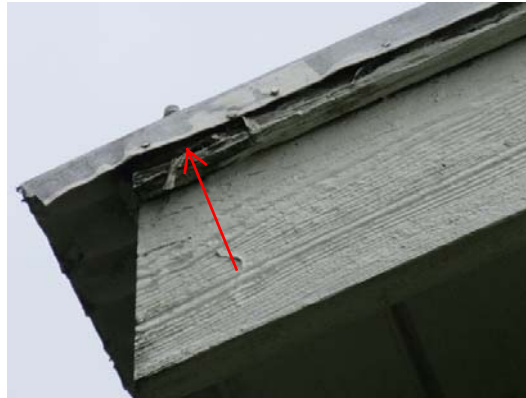
Fascias need maintenance: Some of the roof fascia boards need caulking and painting. Recommend caulking and painting as needed.

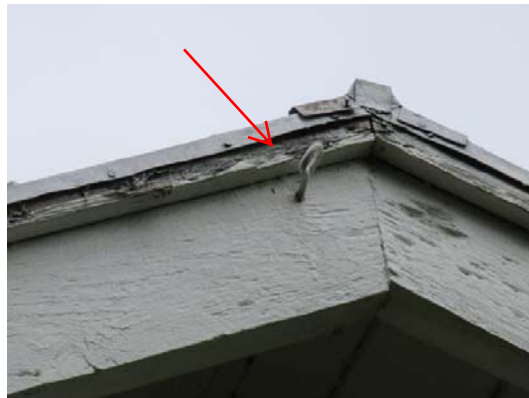
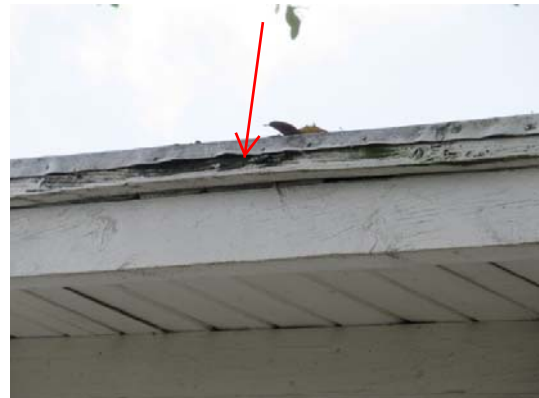
Fascias water damaged: The roof fascia boards are water damaged at some locations. Recommend replacement of water damaged wood, and recommend caulking and painting fascias as necessary.

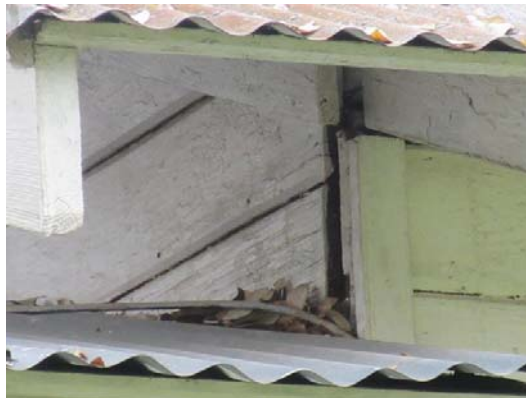
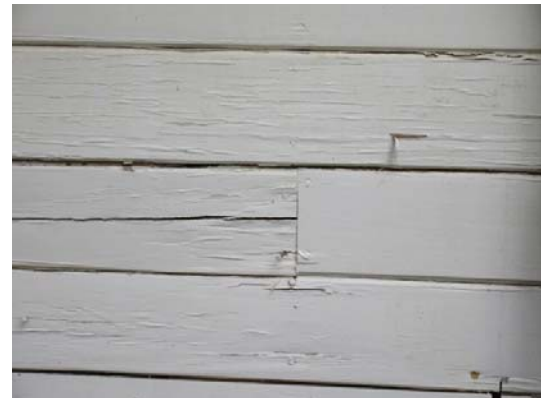
Exterior needs maintenance: The exterior trim and siding is in need of maintenance. The exterior siding and trim has open seams and gaps that are not sealed. In addition, the exterior paint is in poor condition at some areas. General maintenance is needed at various locations around the exterior to prevent moisture intrusion and water damage. Recommend caulking and painting as needed to prevent water damage. See additional comments below:

Seal openings in walls: Recommend sealing all openings or gaps in the exterior walls to prevent water intrusion and damage. Areas that should be sealed include: light fixtures, plumbing pipes, and around electrical panels. Also there are may gaps at siding and trim areas that need to be sealed. Because there are many unsealed areas, the walls may be subject to water intrusion under heavy rains. Some historic water damage may be concealed at some areas.

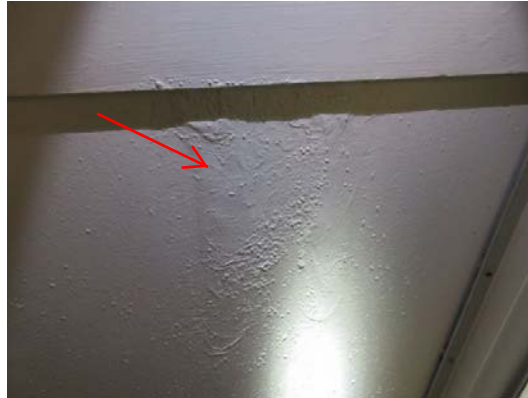
Possible mold like substance: There appears to be a mold like substance on the interior walls at master bathroom (sink cabinet). This appears to have been caused by a current moisture or water issue possible due to leaks at this area. All water damaged or mold damaged drywall should be removed.

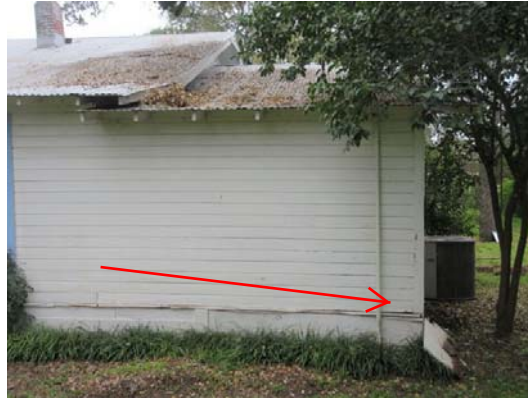
Siding damage: Siding shows signs of damage and is loose in one area at the left side of the house.

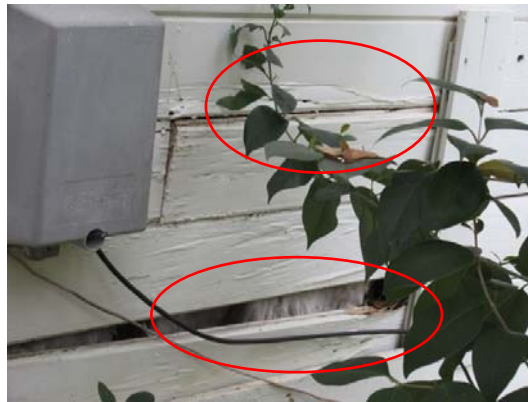
Foliage touching house: There is foliage in contact with the structure at some locations around the exterior. This is considered a conducive condition for carpenter ants which are a wood destroying insect. I recommend trimming back all foliage at least 12 inches. Foliage prevented visibility of various exterior walls and the foundation in some areas. Inspection of areas obscured by heavy foliage is very limited.

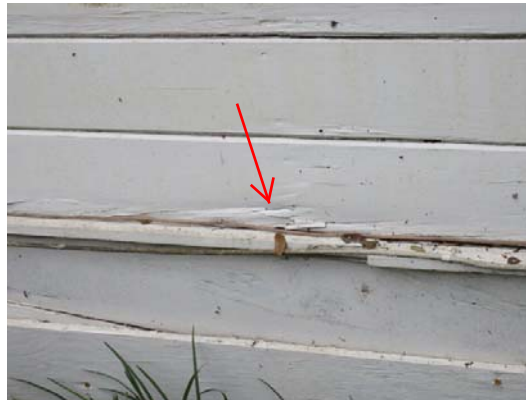
Moisture barrier missing: There does not appear to be a moisture barrier behind exterior siding. This is not uncommon with homes from this era.

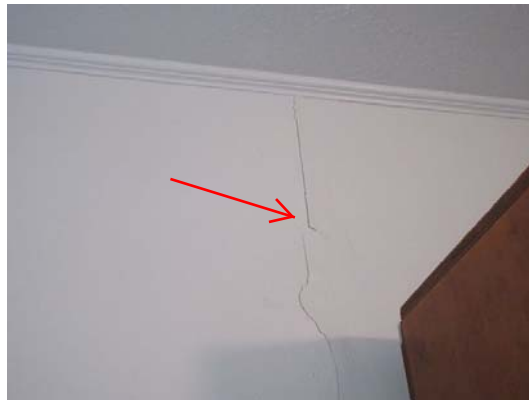
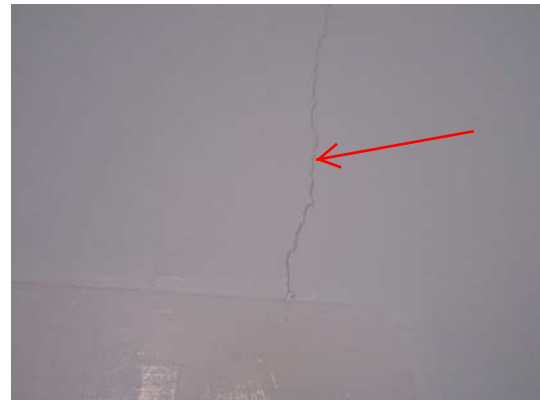
Settlement cracks in walls: There are cracks (and possible crack repairs) in the interior walls at a various locations. These cracks appear to be an indication of structural settlement or foundation movement.

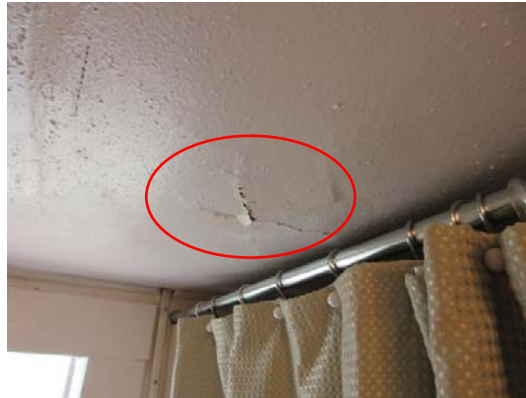
Water damage from roof leak: The ceiling appears to have water damage at the master bathroom. The cause of this damage appears to be related to a roof leak at this area. See roofing section of this report.

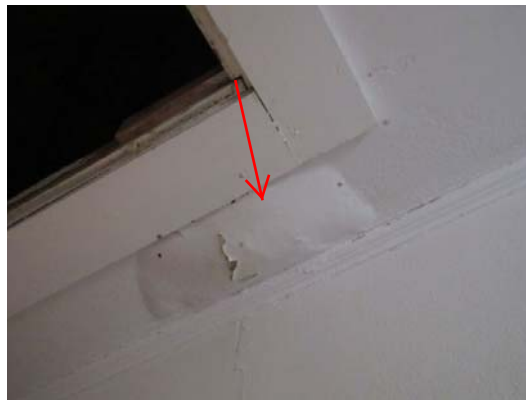
Ceiling water damage: There appears to be water damage on the ceiling at the hallway near attic access. Since the HVAC system may be over this area, this may be related to a past AC/drain backup or other water related HVAC problem.

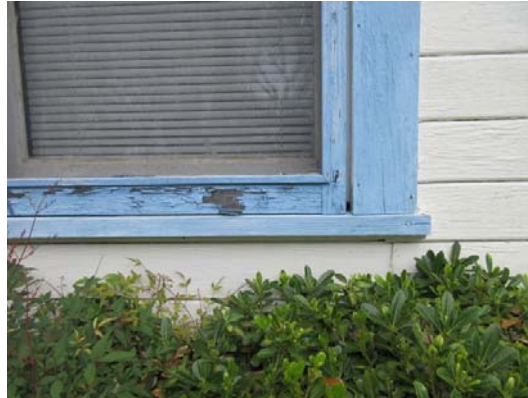
Windows in poor condition: The windows are older wood frame windows which appear to be in poor condition. Windows are damaged, leaky and drafty. In addition, the glass in some of the windows is loose and some wood rot was observed.

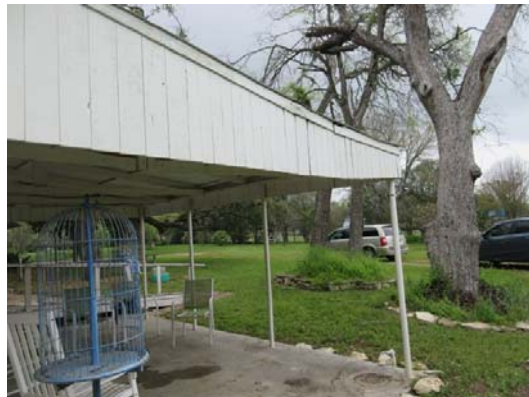
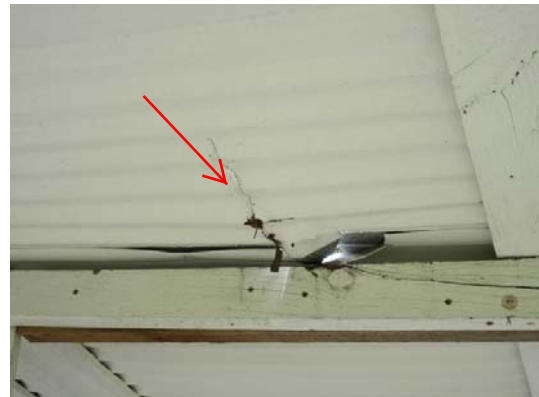
Patio roof structure poor condition: The right patio roof structure is in poor condition. Rafters are damaged, broken and not providing sufficient support and the roof is damaged and leaking. Roof structure is not safe in present condition.

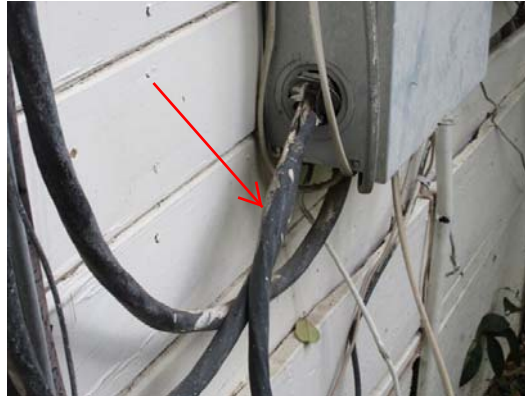
Conductors not in conduit: The conductors routed at the exterior are not in conduit. Although some conductors are approved for exterior use it is always better to route conductors in conduit.

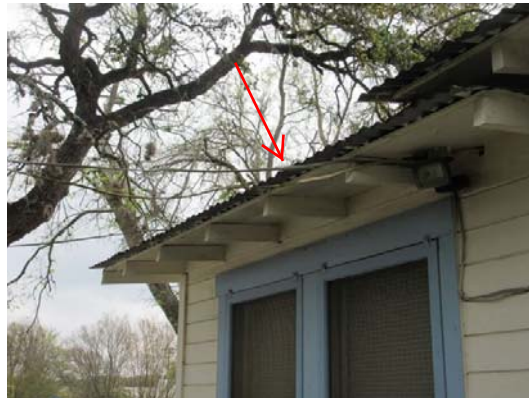
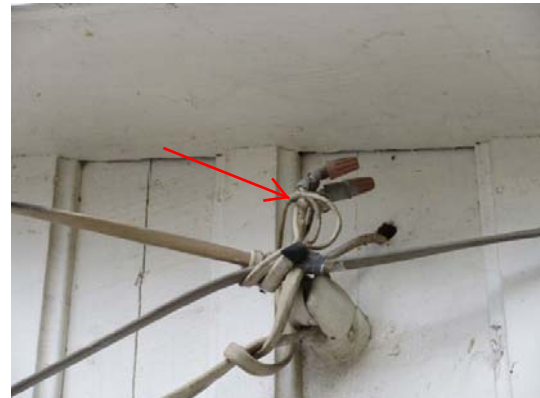
Switch not approved for exterior: The light switch at the patio exterior is not approved for exterior use. Recommend changing out the switch/cover for a weatherproof switch or cover.

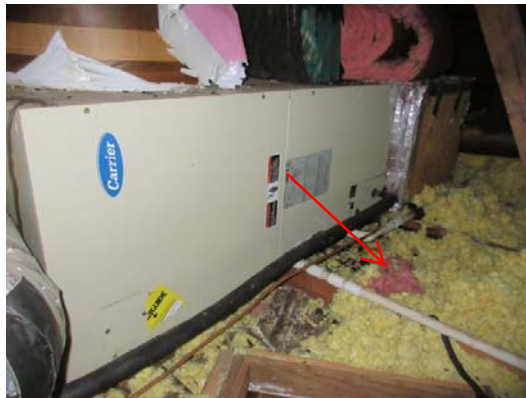
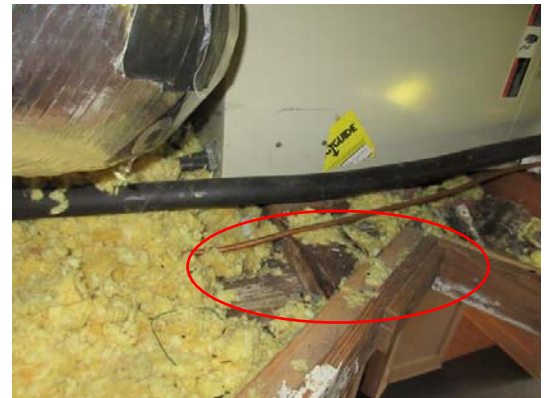
Pan missing: There should be a pan under the coils in the attic. Without the secondary protection of a pan under the system, water can potentially damage the house in the event of a failure of the AC coils or drain line. It should be noted that there is evidence of a past coil or drain failure. Water damage was observed under system. Future damage may occur.

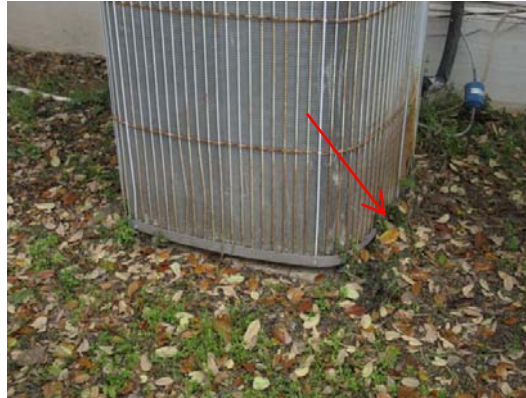
Fins are damaged: The AC compressor fins are bent and damaged. This does not appear to be effecting performance at this time.

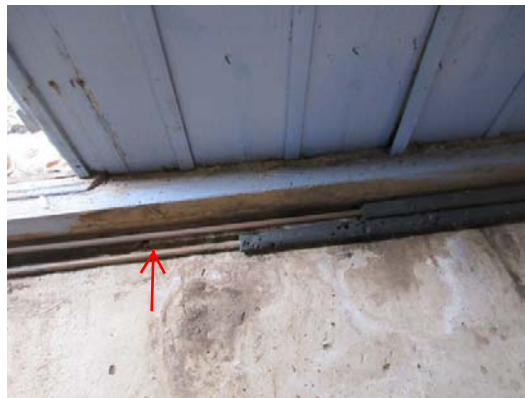
Supply piping not protected: The supply piping in the garage at the water heater is not protected at the floor areas.

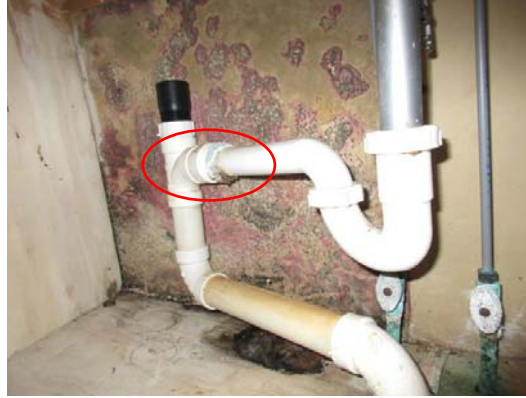
Active plumbing leak: There is an active leak at the drain under the master bathroom sink. Recommend immediate repair to prevent water damage.

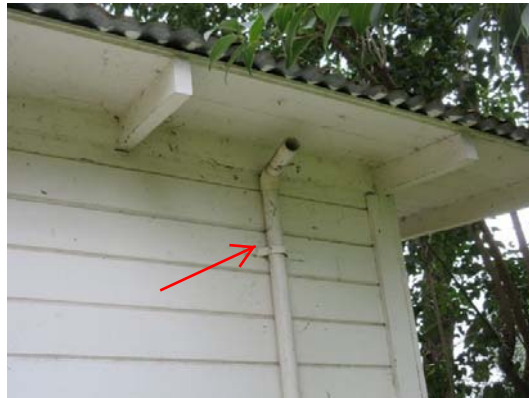
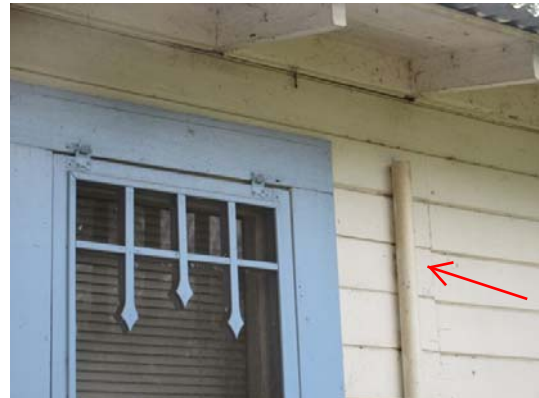
Vent pipe termination: The plumbing vent pipe at back exterior does not appear to terminate correctly. Should terminate above roof.

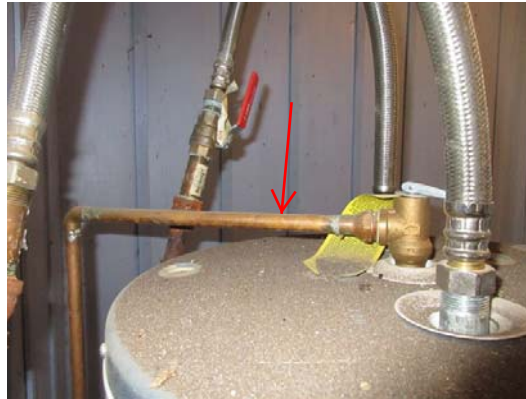
TPRV drain line reduced: The TPRV (temperature pressure relief valve) drain line should be 3/4 of an inch in diameter and should not be reduced.
