## Stephenson High School

### **Feasibility Study**

Dripping Springs, Texas  
Hays County  
May 11th, 2020

AT Project No. 1970

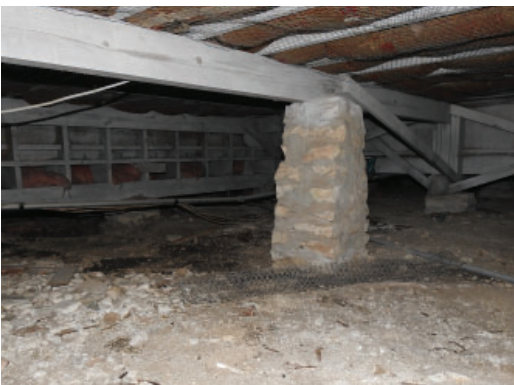
Figure 3.3: Limestone masonry foundation pier and wood beam structure in crawl space under stage at north end

The limestone masonry pier and wood beam foundation is in good condition. The following conditions were noted:

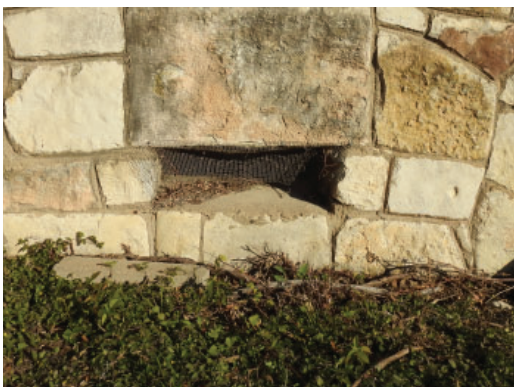
Figure 3.4: Crawl space masonry opening with damaged wire screen

1. Biological growth on limestone was noted at all elevations near grade. This could be attributed to improper grading/drainage at the site and water splashback from the roof due to damaged or missing gutter/downspout assemblies.
2. The wire screens installed at foundation masonry openings are damaged or missing at all locations (see Figure 3.4). However, the foundation and crawl space generally appeared dry.
3. The crawl space access hatch has been recently replaced and is properly secured.

1. *Insulate crawl space to meet IBC standards for proposed occupancies.*
2. *Replace wire screens at all crawl space masonry opening locations.*
3. *Clean stone masonry at all elevations with mild cleaner and low-pressure wash.*

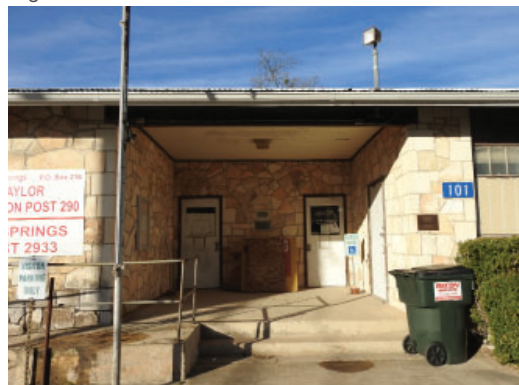
Figure 3.6: Recessed opening at the east elevation

1. Biological growth was noted at all elevations. This could be attributed to improper grading/drainage at the site and water splash back from the roof due to damaged or missing gutter/downspout assemblies.
2. Penetrations from previous and current mechanical and electrical equipment installed on masonry facades have not been sealed or filled correctly.
3. Metal sheet signage is installed on the east elevation (see Figure 3.6).
4. Historic markers exist on the east elevation noting WPA funding, dedication to Allen Stephenson, and the placement of the building on the National Register of Historic Places (see Figure 3.6).

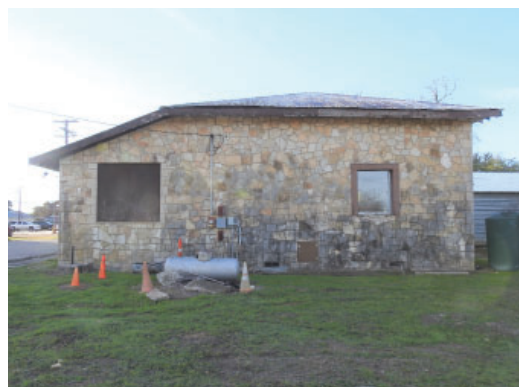
Figure 3.7: North elevation, note biological growth

1. *Clean soiled masonry at all elevations with mild cleaner and low-pressure wash.*
2. *Repoint damaged and deteriorated mortar joints. Match composition, color, surface texture, and joint profile of existing mortar.*
3. *Remove all mechanical and electrical equipment on the north and west elevations. Seal all holes with light-colored buff mortar to match existing.*
4. *Remove metal sheet signage on east elevation and repair mounting holes as needed with light-colored buff mortar to match existing.*

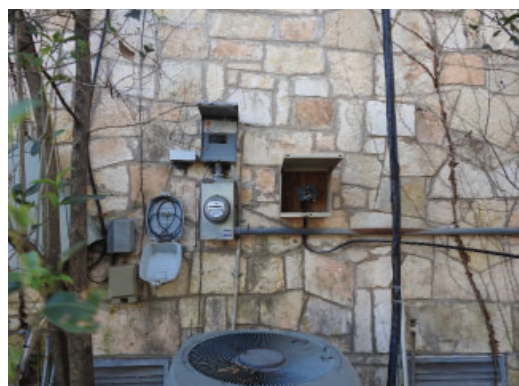
Figure 3.8: Electrical equipment and masonry penetrations at the west elevation

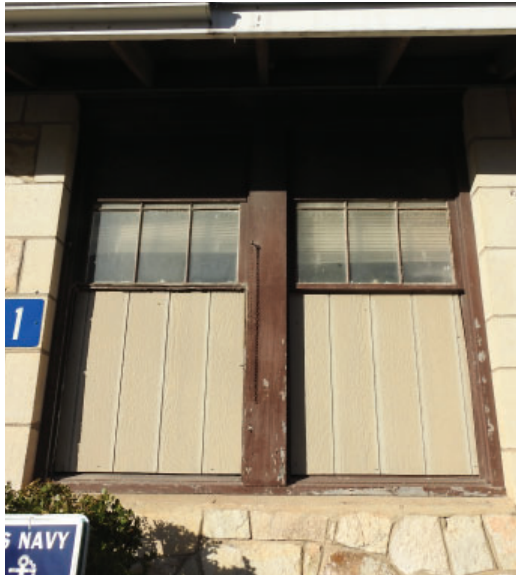
Figure 3.13: Typical double-hung window pair, lower panes boarded-over from exterior.

1. All windows have deteriorated paint coatings, sealants, and glazing putty. (see Figures 3.14-3.15).
2. All original windows are partially boarded-over with wood (see Figures 3.13-3.19).
3. One original window has been completely boarded-over on the exterior and has been covered by a furred-out restroom wall on the interior (see Figure 3.17).
4. Windows on the west elevation have several broken lites and vegetative growth on the exterior. On the interior, remnants of construction for dropped ceilings remains (see Figures 3.19-3.21).

- *Conduct an exterior window survey to determine damage on each frame and sash unit.*
- *Repair damaged wood elements and provide perimeter sealants. Replace sashes and frames that are damaged beyond repair.*
- *Fix windows in place reinstall glazing and provide supplemental single pane glass to match original.*
- *Install new glazing putty throughout.*
- *Provide new windows at addition.*
- *Paint frames and sashes.*
- *Install window film on inside of glazing at all windows to improve energy efficiency.*

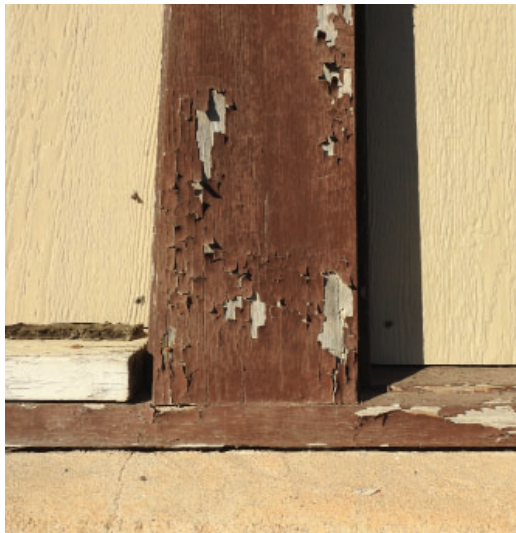
Figure 3.14: Loose paint on window frame assembly

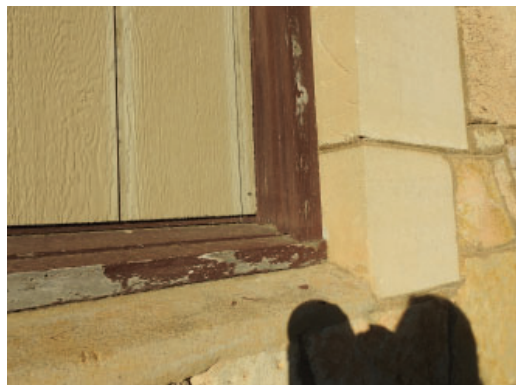
Figure 3.15: Loose paint on window frame assembly

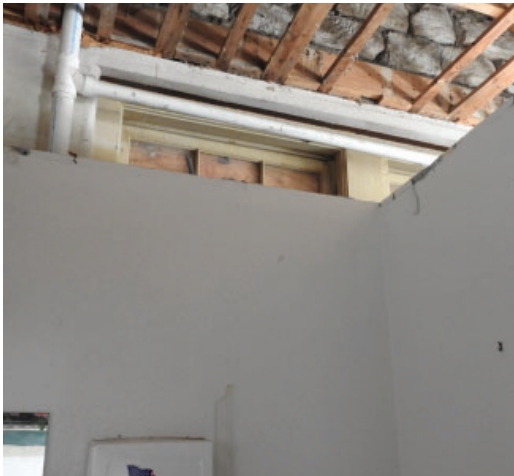
Figure 3.17: Original window boarded-over on exterior with restroom furr-out wall on interior

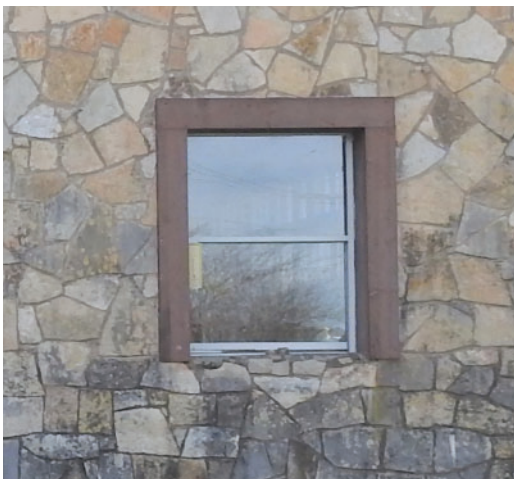
Figure 3.18: Non-original aluminum window on north elevation

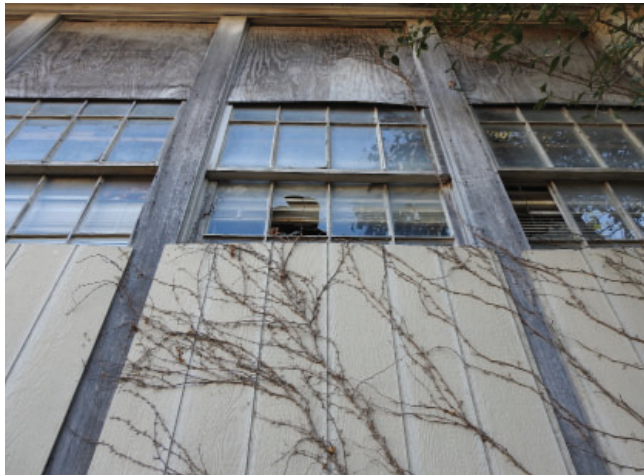
Figure 3.20: Windows have multiple broken lites and vegetative growth

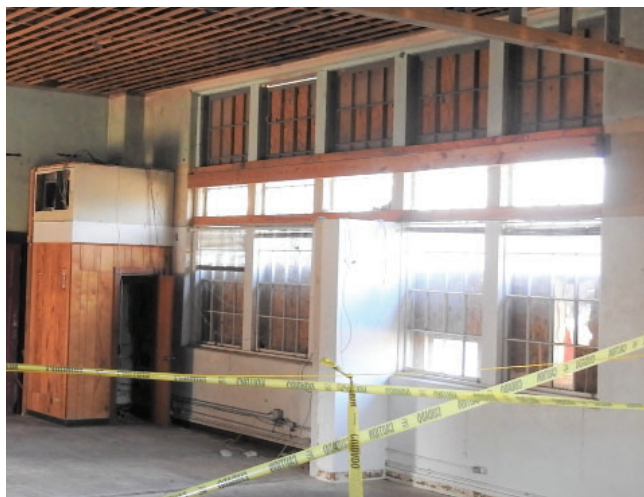
Figure 3.21: Interior with remnants of two dropped ceilings over windows

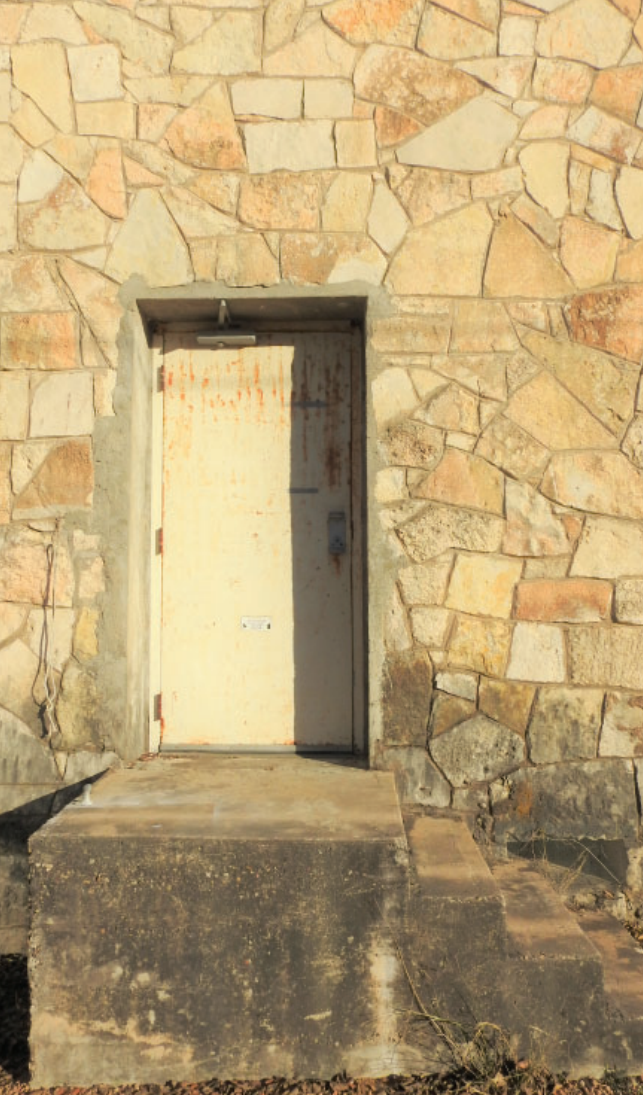
1. Wood doors are splitting and deteriorating.
2. Hollow metal door and frames show visible signs rusting (see Figure 3.24).
3. All entry hardware is non-complaint to ADA standards (see Figure 26).
4. All doors and frames have flaking and chipped paint.

Figure 3.24: Non-original hollow metal door in non-original masonry opening

1. *Prior to renovation work, review environmental report for extent of lead containing paint. Lead paint should be properly abated/encapsulated per current regulatory requirements.*
2. *Restore existing wood frames, repaint.*
3. *Treat existing hollow metal door and frame for rust, repaint.*
4. *Replace deteriorated, non-original wood doors with period appropriate wood doors with ADA compliant hardware.*

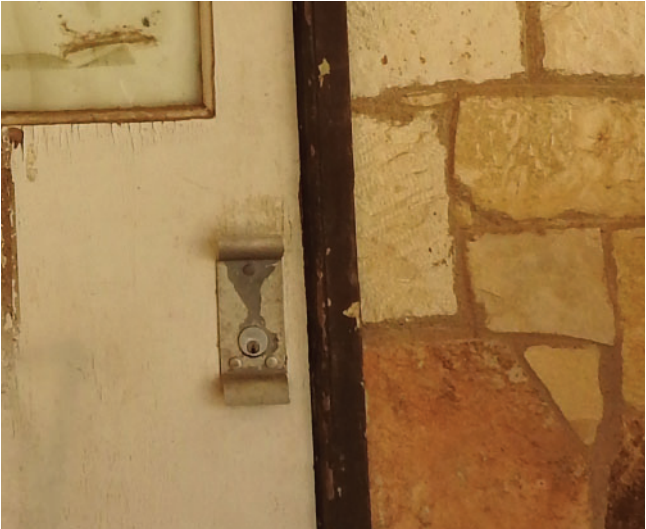
Figure 3.26: Existing hardware not compliant with ADA standards

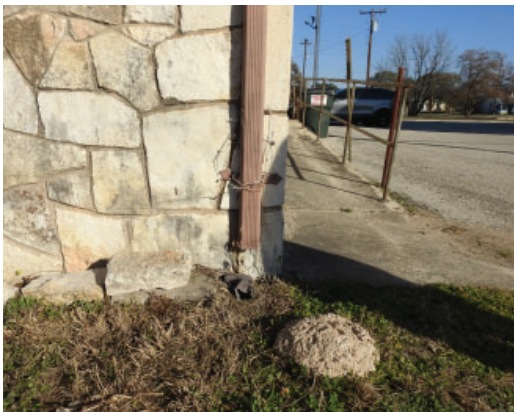
Figure 3.32: Gutter at southeast corner, note missing spout

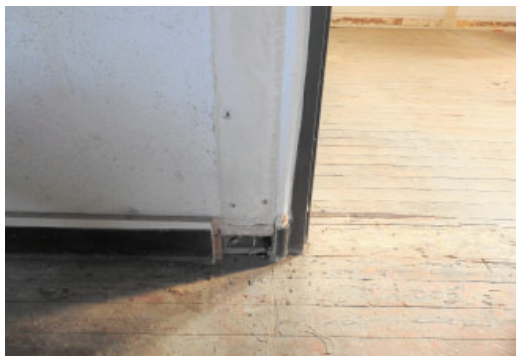
Figure 3.36: Damaged original 1"x6" wood base

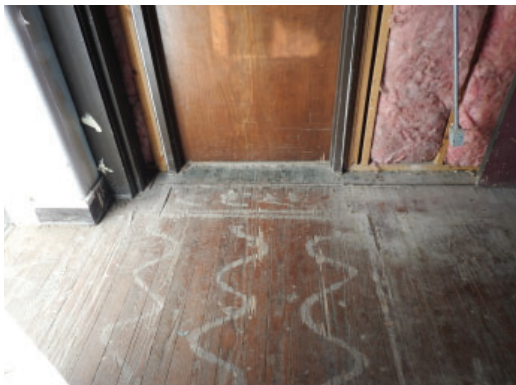
Figure 3.38: Remnants of carpet glue on original wood flooring

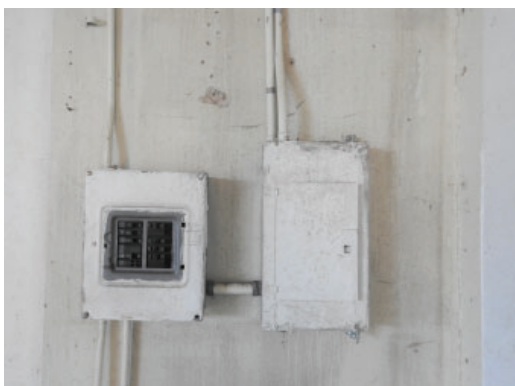
Figure 3.49: Mounted electrical equipment on back wall of stage area
