May 10, 2024

City of Dripping Springs
Dripping Springs Ranch Park
511 Mercer Street
PO Box 384
Dripping Springs, TX 78620

Pruning Damage on Trails at Dripping Springs Ranch Park

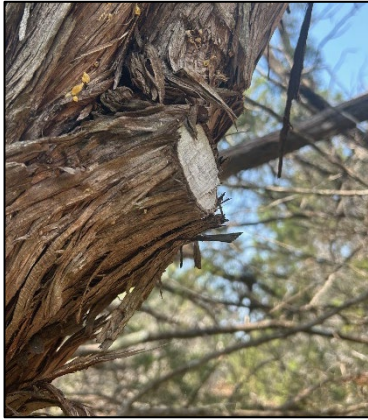
Photo 1. Example of a proper pruning cut that was found on site.

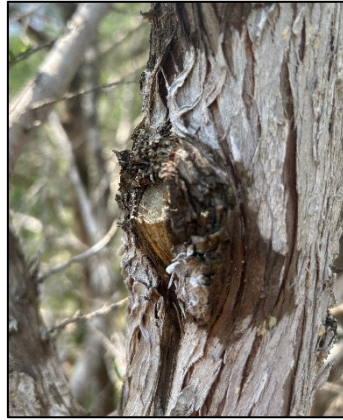
Photo 2. Example of a pruning cut on site that is in the process of healing but creating new tissue around the wound.

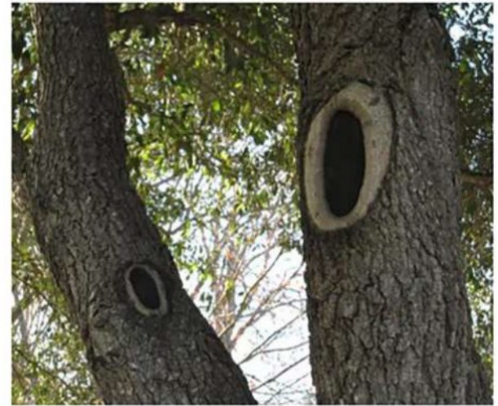
Photo 3. Example of an improper flush cut that should not be performed (image not taken from site).

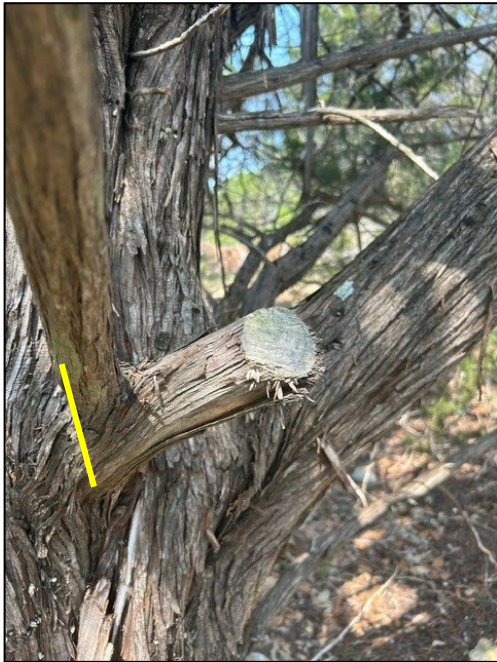
Photo 4. An improper fresh stub cut that was found on site. The proper cut should be made at the yellow line.

- Pruning should be done under the supervision of an ISA Certified Arborist.
- Proper pruning tools should be used under the ANSI-300 pruning standard.
- Stub cuts should be corrected.
- Flush cuts should not be allowed.
- Torn and ripped branches should be pruned corrected.

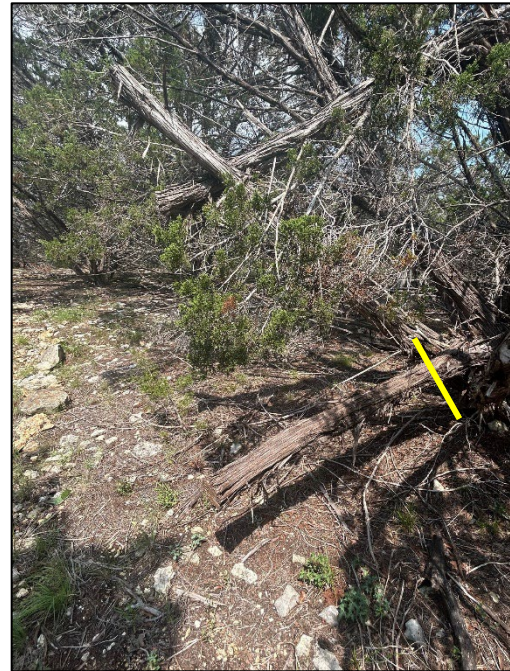
Photo 5. An old stub cut that was found at the site. The proper cut should be made at the yellow line where the stub meets the live stem.

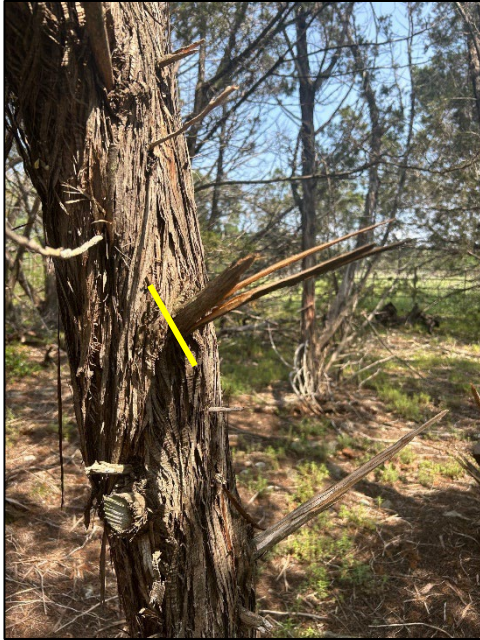
Photo 6. A tearing wound that should be cleanly pruned at the yellow line. Proper pruning tools would avoid wounds exhibited in this photograph.

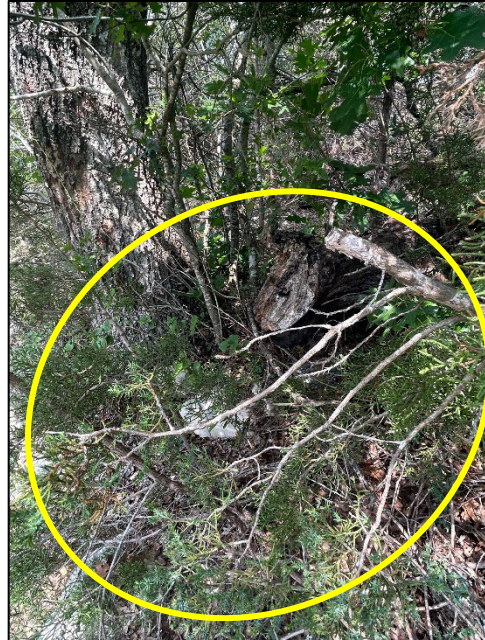
Photo 7. Pruning cuts were found on branches that were dead. The entire dead branch should be removed.

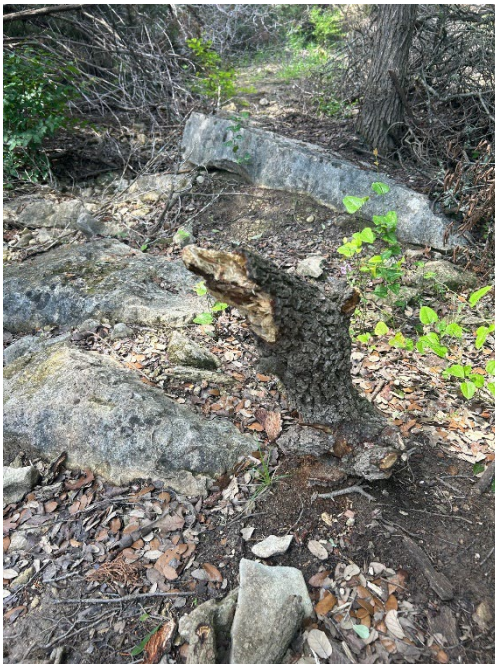
Numerous trees along the trails were found to be improperly pruned, leaving torn branches or stub cuts. These wounds varied in age, but several were found that were fresh, recent cuts. I was told by the client that the new wounds were the main concern of this visit. My findings are located in the map and table below. Affected tree species included *Juniperus ashei* (juniper), *Quercus virginiana* (live oak), *Ulmus crassifolia* (cedar elm), *Quercus buckleyi* (red oak), and *Diospyros texana* (Texas persimmon). In total, 37 trees were found to have torn branches and 28 were found with stub cuts. These improper pruning practices have left wounds on the tree that should be repaired with proper cuts that allow wound healing. I also found three 4-inch diameter trees to have been recently removed with fresh cuts left on the remaining stumps (#35-37).

Photo 8. One of three 4" diameter trees that was recently removed.

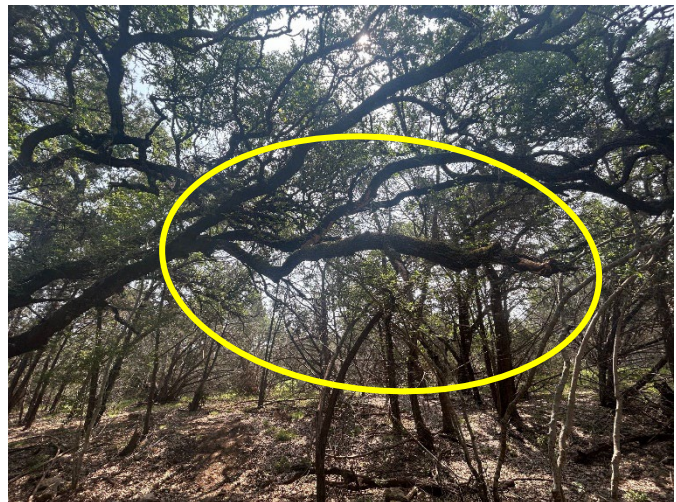
Photo 9. A large live oak was found with tearing cuts on two dead branches. These branches should be cut back to the live stem with a proper pruning cut. The pruning cut should be painted.

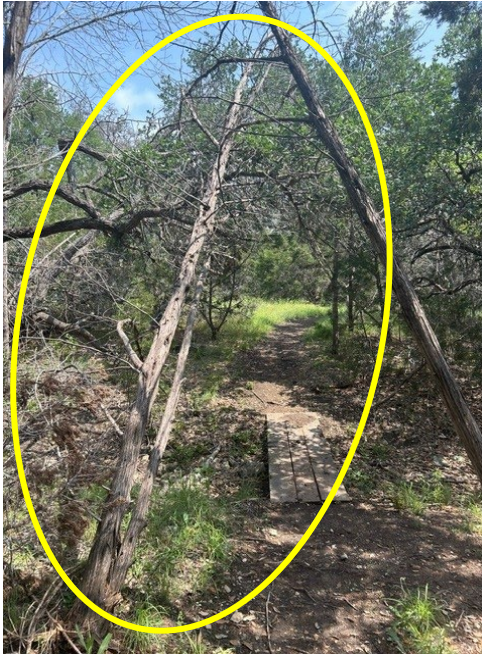
Additionally, numerous dead branches and dead trees were found that were overhanging the trail. Extended branches over trail are recommended to be pruned and/or removed. These trees were not inventoried. It was also noted that several large oak trees were dead away from the trail, and these large oak trees were inventoried in the table below (#67-77) . These trees do not warrant removal unless there is a target. Oak wilt is a concern in Hays County and evidence of the disease should be investigated and monitored.

Photo 10. Dead trees over walkways should be removed.

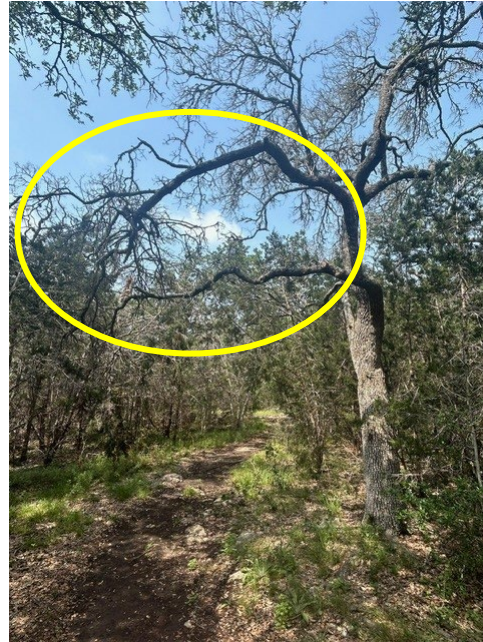
Photo 11. Dead branches over walkways should be removed.
