RESOLUTION NO. 23-32

A RESOLUTION OF THE TOWN COMMISSION OF THE TOWN OF DUNDEE, FLORIDA MEMORIALIZING A DECLARATION OF EMERGENCY AS TO THE REPAIR, MAINTENANCE, AND MANAGEMENT OF THE HICKORY AND RINER CONCRETE GROUND STORAGE WATER TANKS; MAKING FINDINGS; MAKING A FINDING OF EMERGENCY UNDER STATE LAW AND SECTION 2-159(c)(2) OF THE CODE OF ORDINANCES OF THE TOWN OF DUNDEE; AND AUTHORIZING THE TOWN MANAGER TO TAKE ANY AND ALL NECESSARY FURTHER ACTIONS INCLUDING, BUT NOT LIMITED TO, NEGOTIATING AND APPROVING AN AGREEMENT WITH SOUTHERN CORROSION, INC. FOR THE EMERGENCY REPAIR, MAINTENANCE, AND MANAGEMENT OF THE HICKORY AND RINER CONCRETE GROUND STORAGE WATER TANKS.

GENERAL

This report is a supplement to the visual and video inspection undertaken for the Town of Dundee by Liquid Engineering Corporation of Billings, MT. Tank No. 1 is an on-grade concrete storage tank. The tank has a 750,000-gallon capacity and is 22' high and is approximately 76' in diameter.

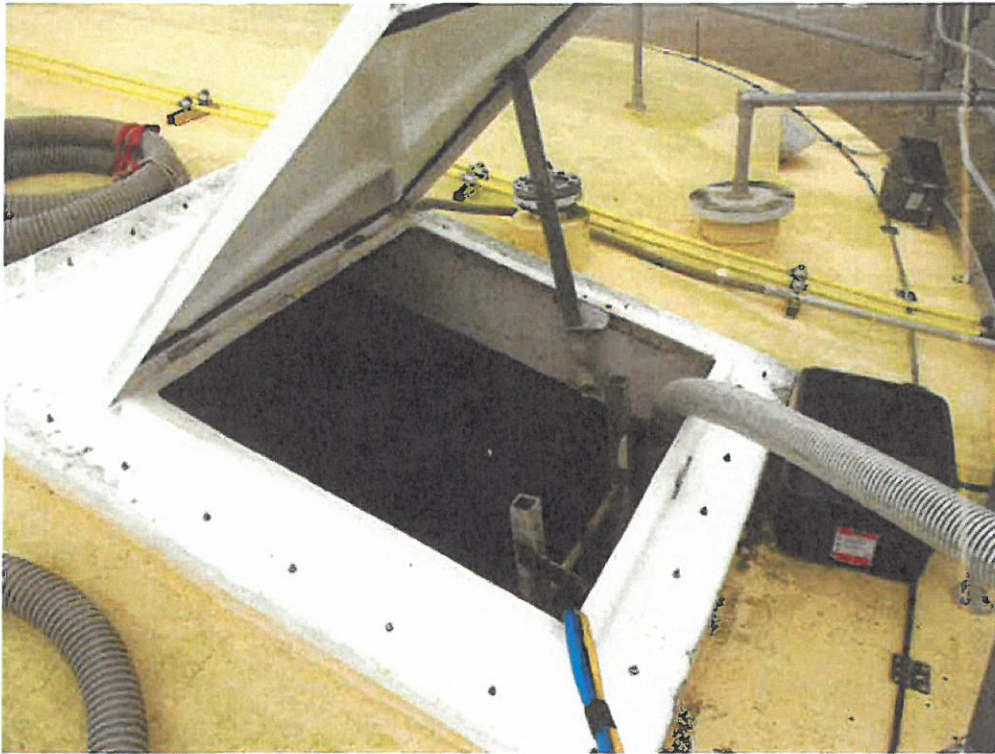
Condition of Access Hatch

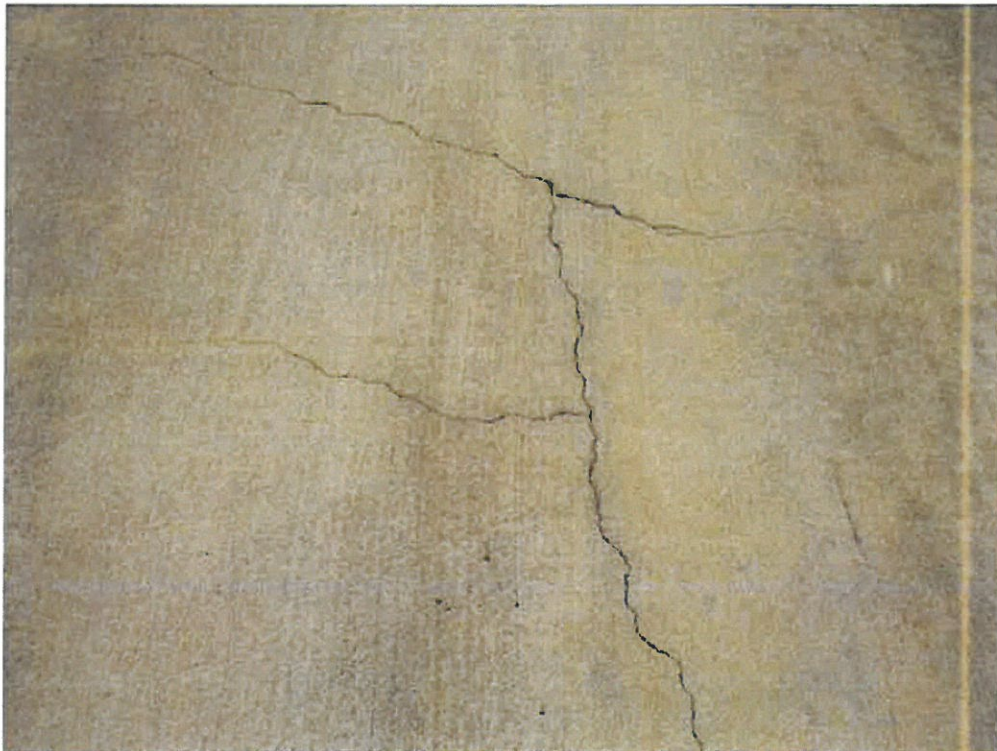
- ✓ **Roof** – Light discoloration and moderate cracking are noted, but the roof does appear to be in satisfactory condition.
- ✓ **Vents** – No discrepancies are noted in regard to the vents / screens.
- ✓ **Roof Hatch** – The primary access hatch, hinges and lock and hasp, are in good condition overall.
- ✓ **Hatch Cage** – The rail surrounding the hatch appears to be securely attached and in good condition.
- ✓ **Coating** – The exterior coating is cracked and stained, but otherwise in satisfactory condition.

Cracking and Staining on Roof

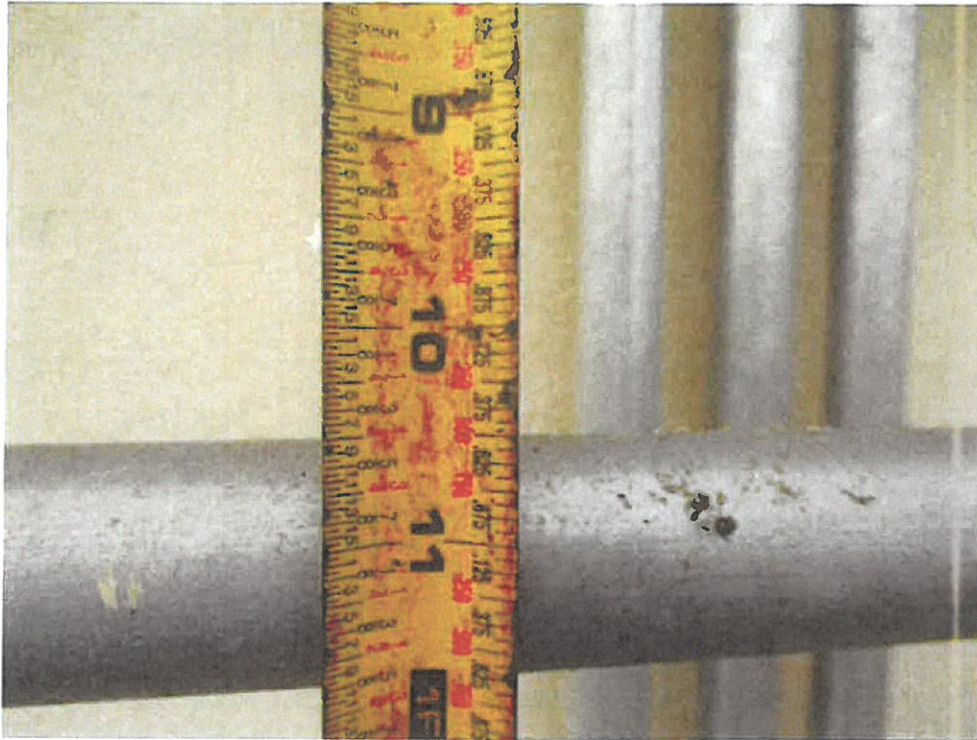
- **External Ladder** – The exterior ladder measures 22' in height and is in overall good condition. It is equipped with a locking vandal guard, and although there are no missing or damaged rungs, they are not of anti-skid construction.

Ladder Rungs (note lack of anti-skid surface)

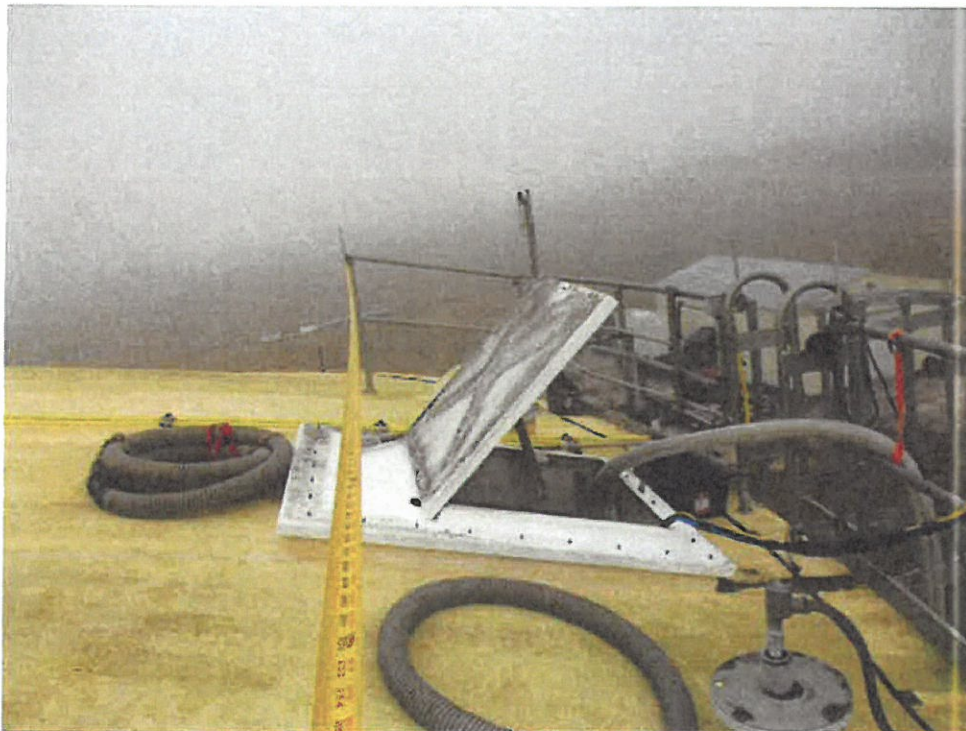
- **Balcony & Railing** – The walkway is 22' wide. It is surrounded by a 2-piece safety rail which measures 45" in overall height, 24" at mid-rail, and there is a 4" toe kick in place. It should be noted there is no swing gate in place where the ladder meets the railing.

Ladder and Safety Rail (note lack of swing gate)

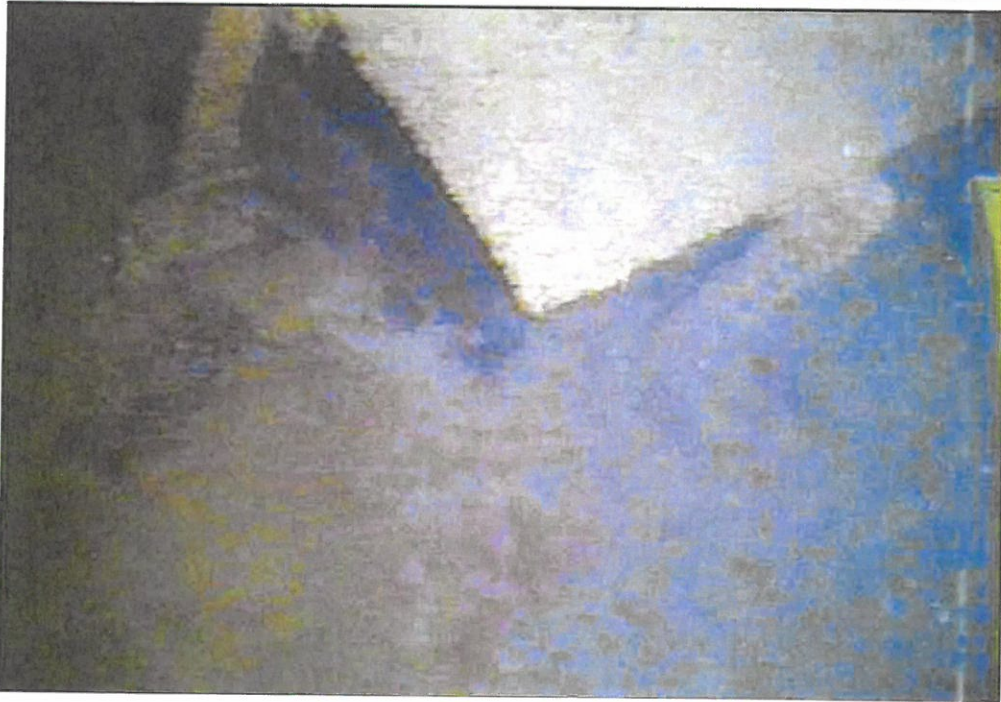
- Repair | • Outlet Structure – The outlet is also located in Quadrant 1. It measures 20" diameter with a 7" silt stop riser. As is the case with the inlet, it is heavily rusted and rates as a "1". The inspector also reports corrosion with metal loss on the anti-vortex guard.

Condition of Outlet and Anti-Vortex Guard (note substantial corrosion)

- Significant corrosion is present on the interior plumbing, specifically the inlet and outlet pipes. No metal loss is apparent at this time, but the utility should consider replacement options.

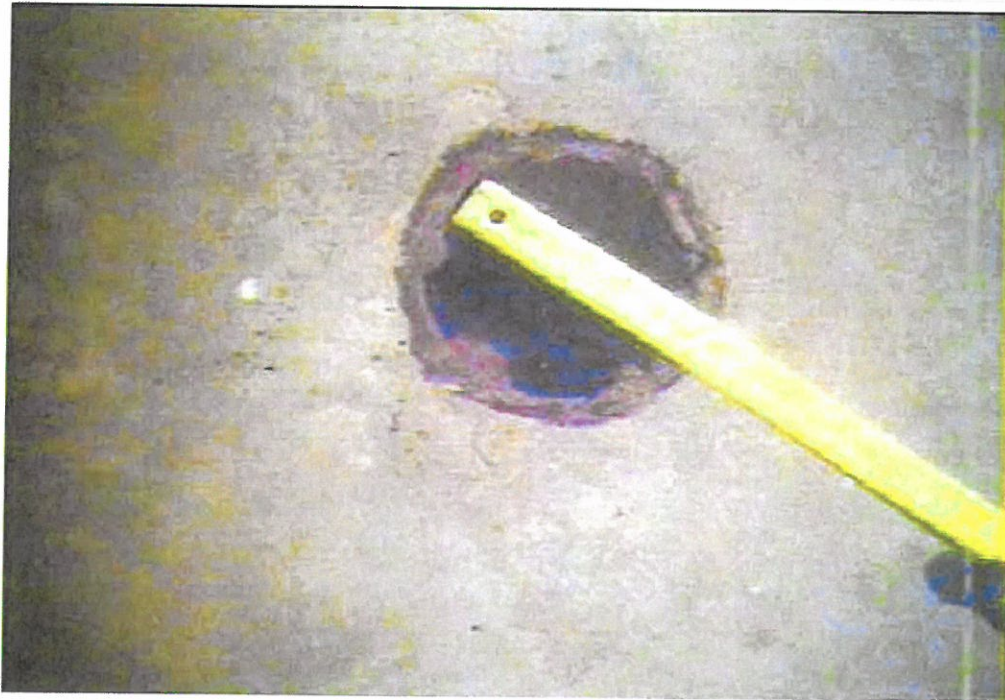
- • Drain – The 5 ½" floor drain is positioned near the inlet. Several rust nodules have formed along the perimeter of the penetration, but it does appear to be unobstructed.

Floor Drain (note rust nodules at perimeter)

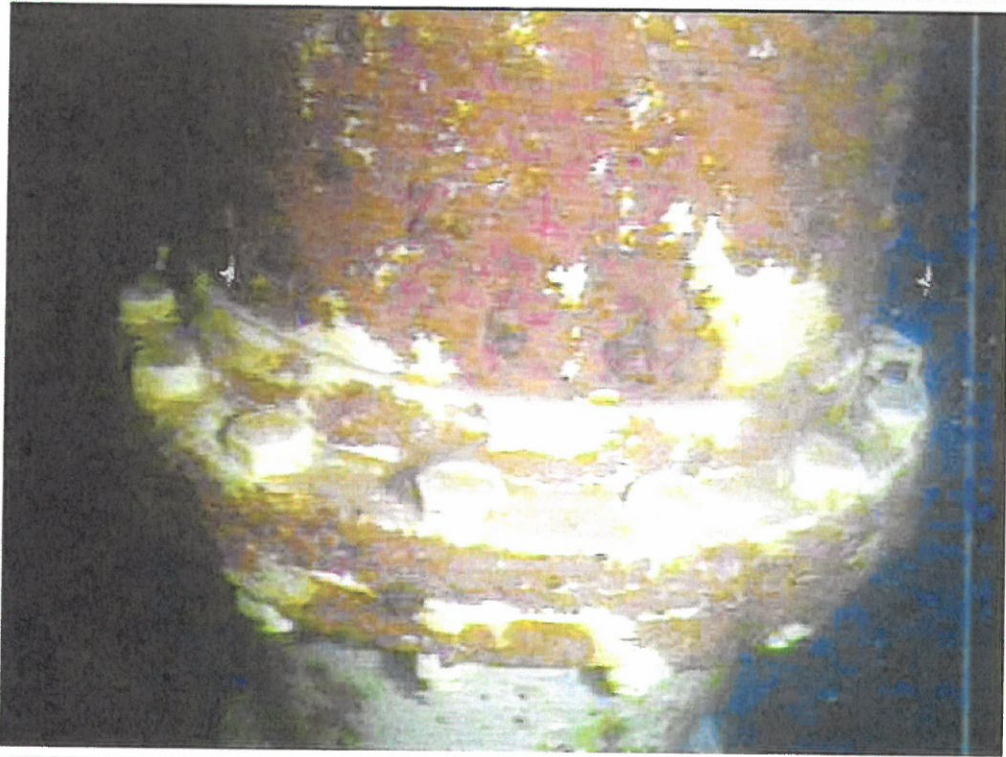
- Repair | • Inlet Structure – The inlet penetrates the floor of the tank and extends into the aeration unit before returning to the water column. Significant corrosion is reported on the pipe, which measures approximately 15" in diameter. Using the SSPC scale with "10" being the least corroded, the inlet is given a "1". The two PVC pipes that direct the water back into the tank appear stained but are otherwise in good condition.

Inlet Pipe (note coating failure and corrosion)

- Tank interior rated as **Fair**, since significant corrosion is present on interior plumbing – inlet and outlet pipes – utility should consider replacement options of these items and coat the interior of tank. **Repairs to be made to continue functioning as designed.**

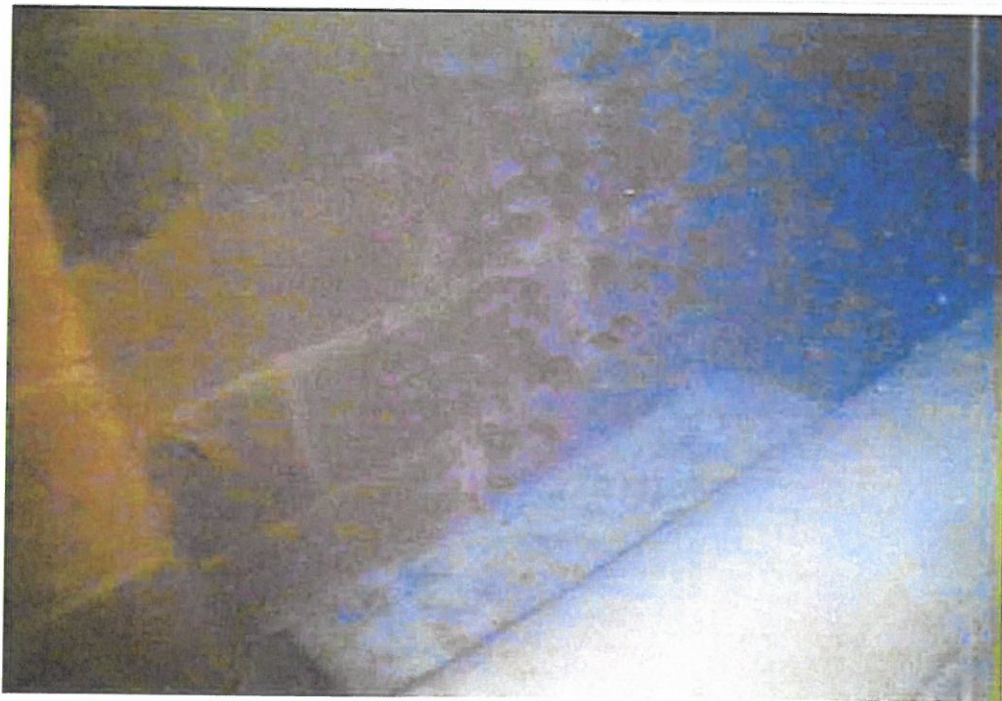
Condition of Baffle Wall

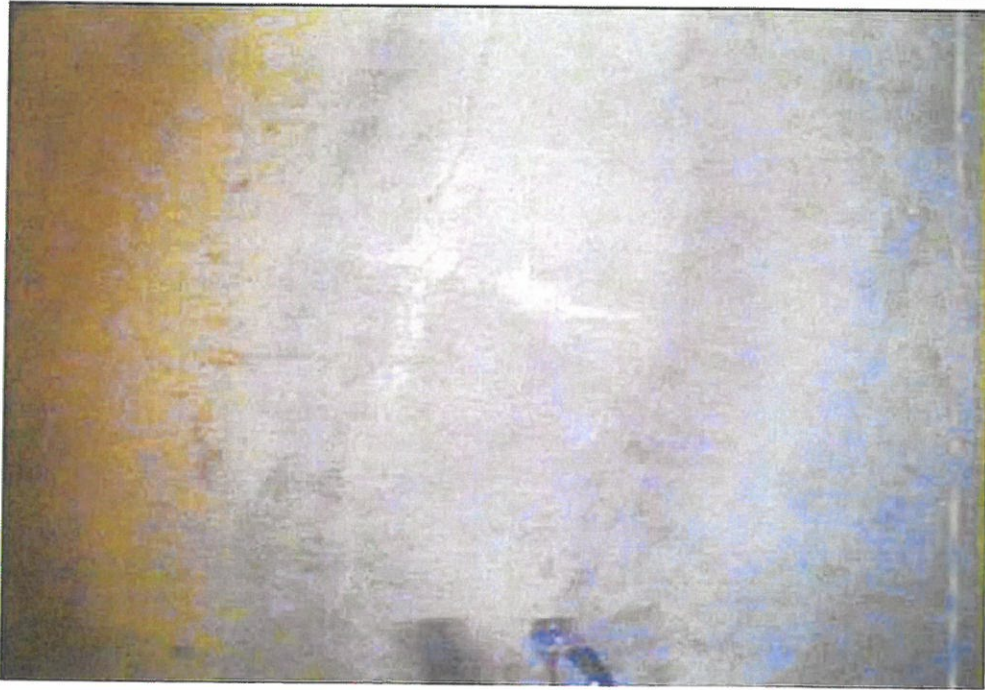
Isolated Cracking

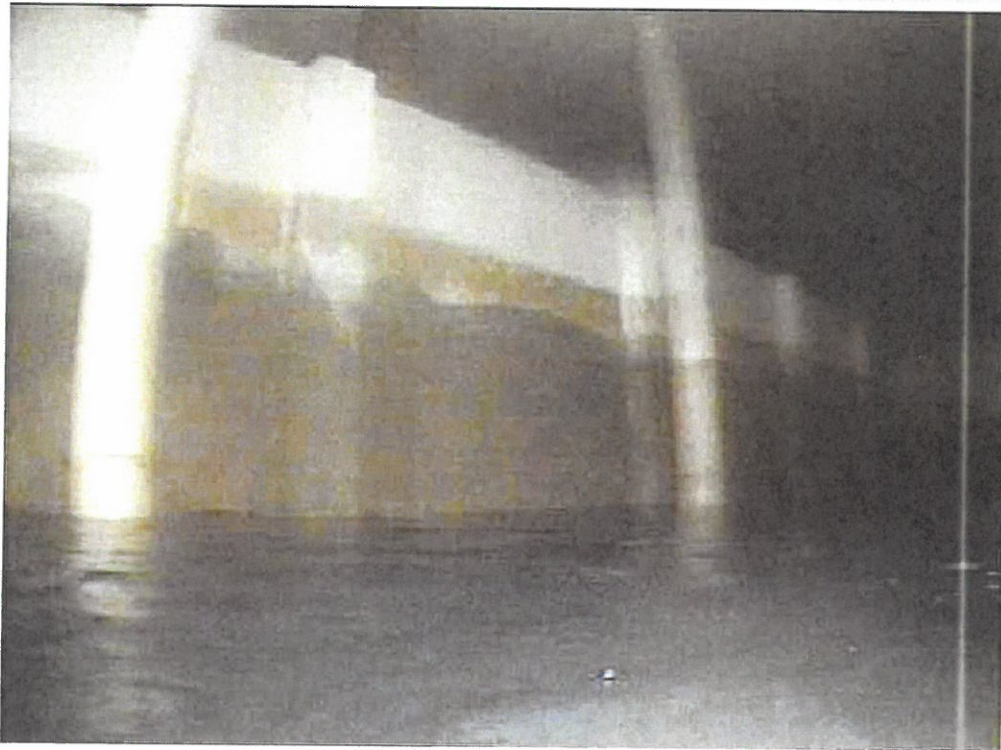
Upper Section of Baffle Wall and Aeration Returns

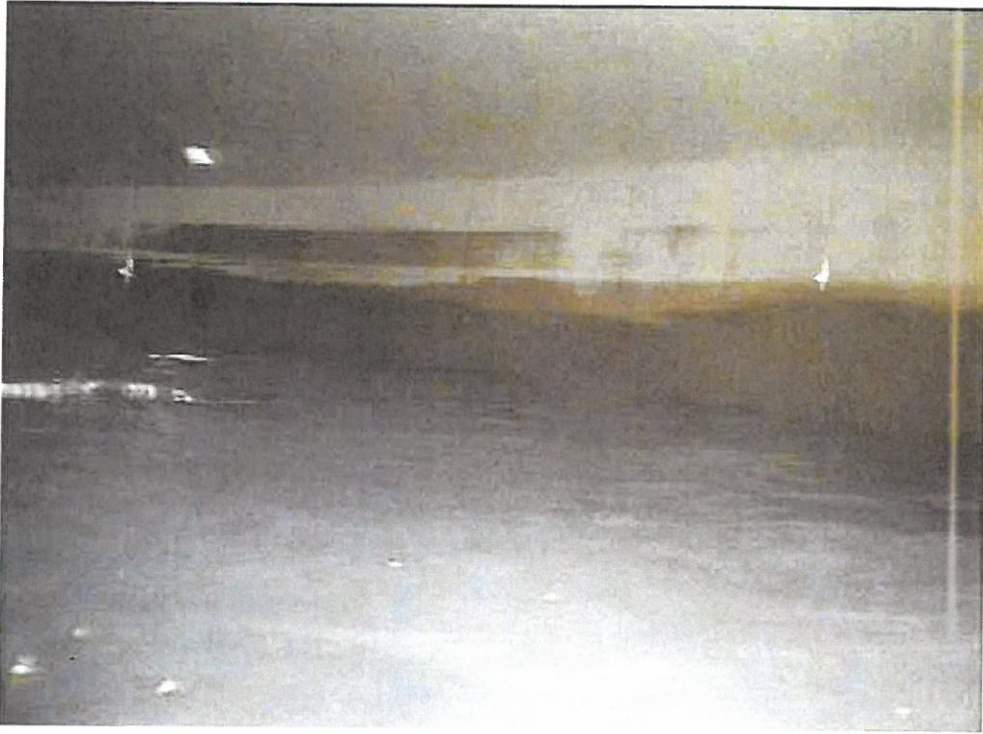
Condition of Upper Walls

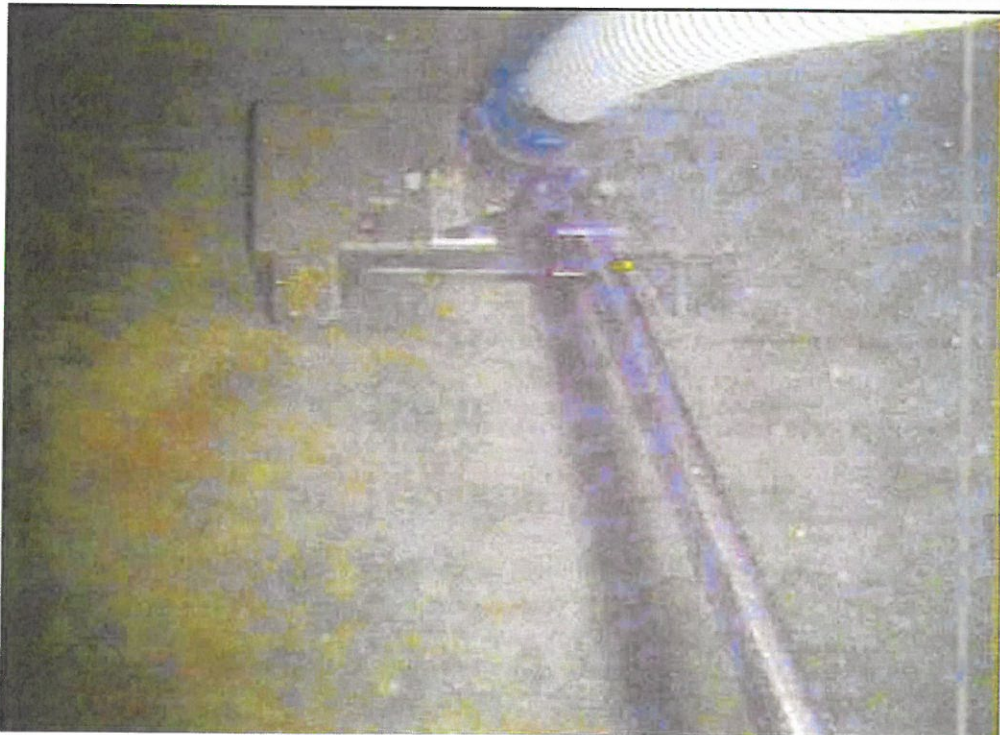
- Perimeter Joint – In addition to staining, the inspector reports cracking with efflorescence in each quadrant.
- Floor Slabs – Prior to beginning the final inspection, a skiff of sediment was removed allowing for a full evaluation of the slabs. The sediment ranged in depth from a skiff to nearly ½" in Quadrant 2. Staining and efflorescence are noted in each quadrant, and there is also an isolated area of minor cracking in Quadrant 4.

Condition of Floor Slabs (during sediment removal operations)

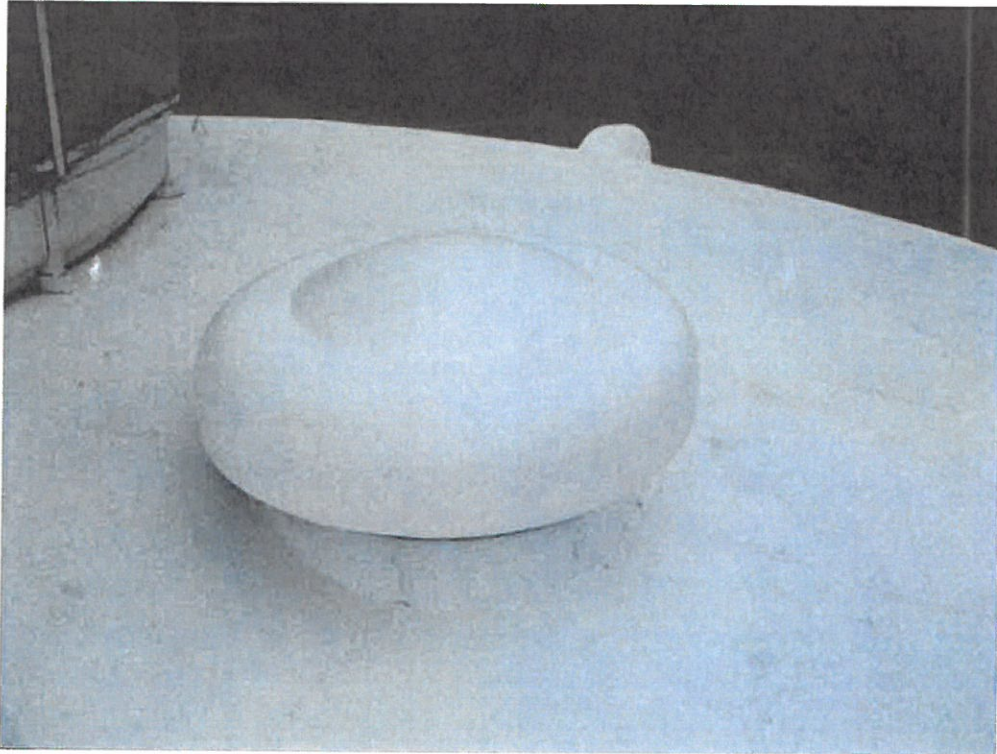
Condition of Mushroom Vent

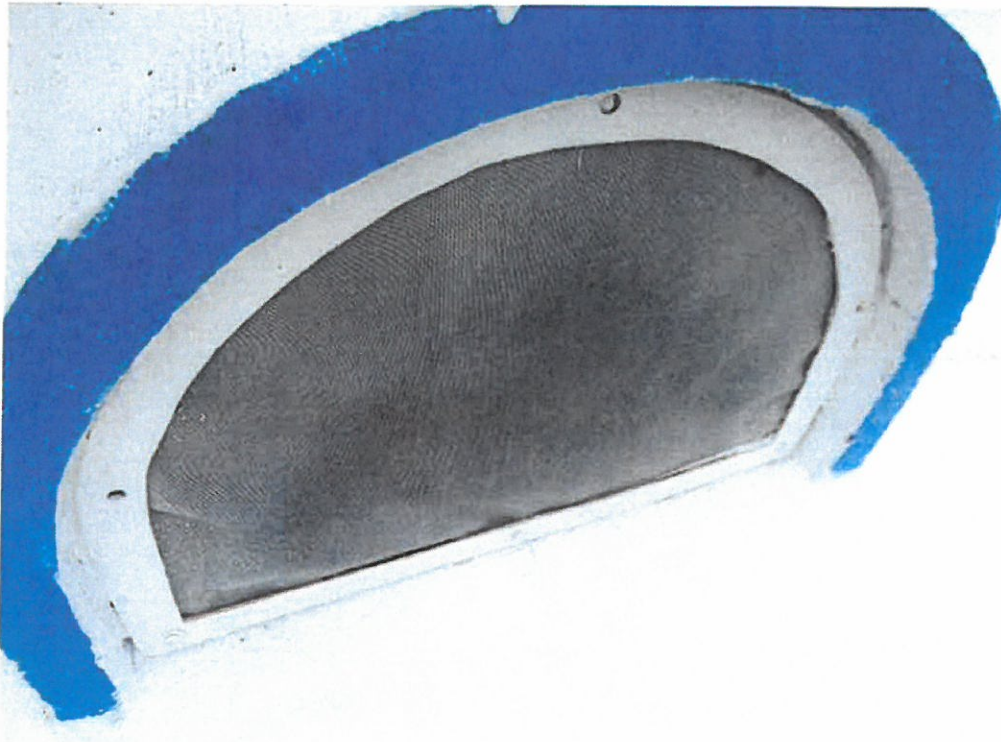
Typical Condition of Integrated Vent / Overflow (1 of 4)

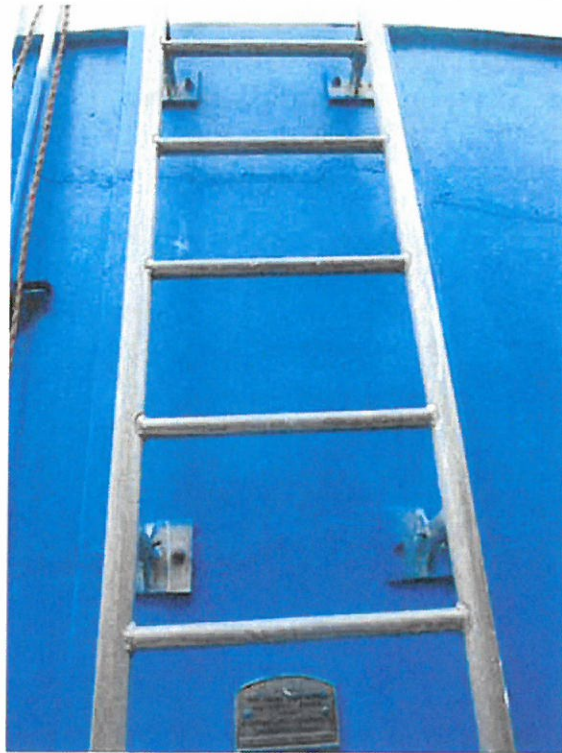
Ladder Rungs (note lack of anti-skid surface)

- *Significant corrosion is present on the interior plumbing, specifically the inlet structure.*
- *On the tank exterior, the lid height of the hatch should be increased to at least 2”.*
- *A locking vandal guard should be installed on the exterior ladder, and perimeter lighting added to deter vandalism.*
- *In accordance with current OSHA standards, an anti-skid material should be installed on the rungs of the access ladder.*

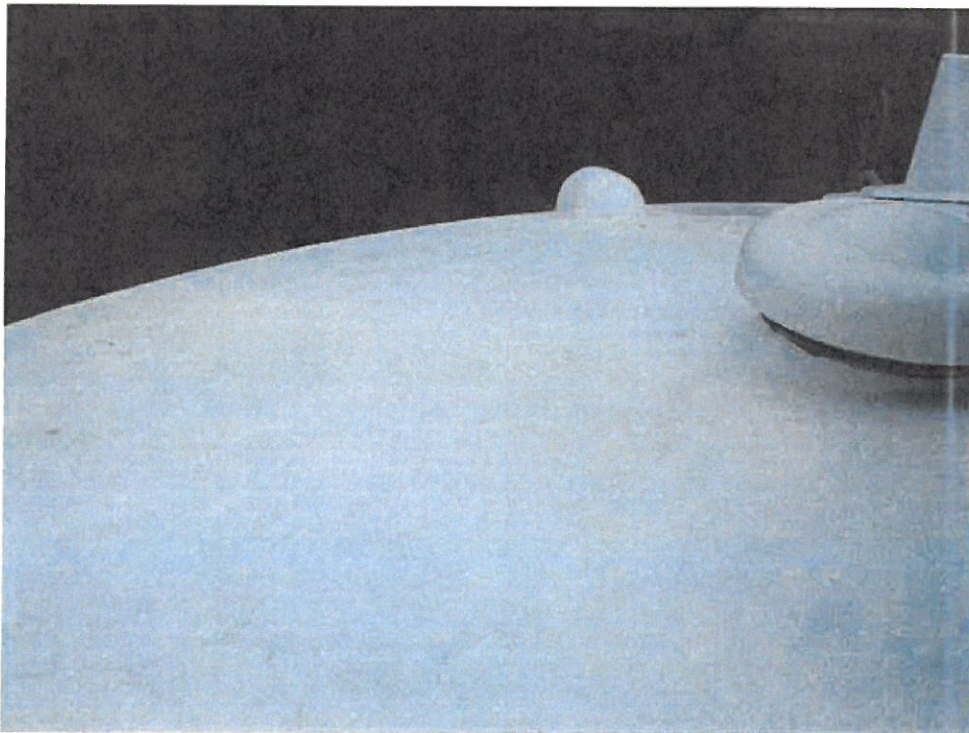
Condition of Roof Slabs (note staining and minor cracking)

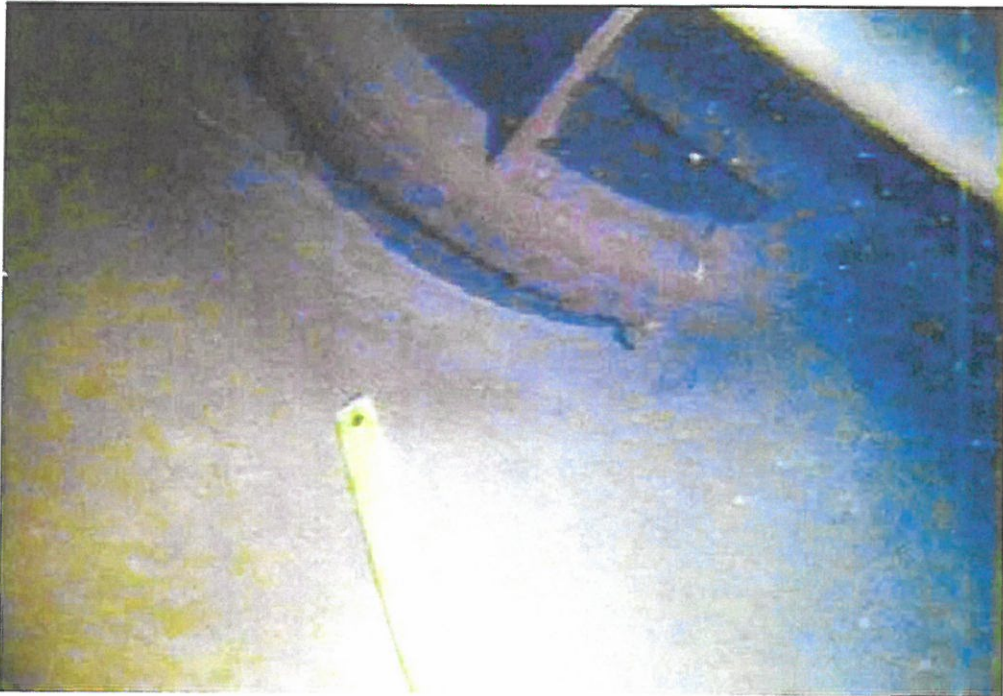
Condition of Outlet and Anti-Vortex Guard

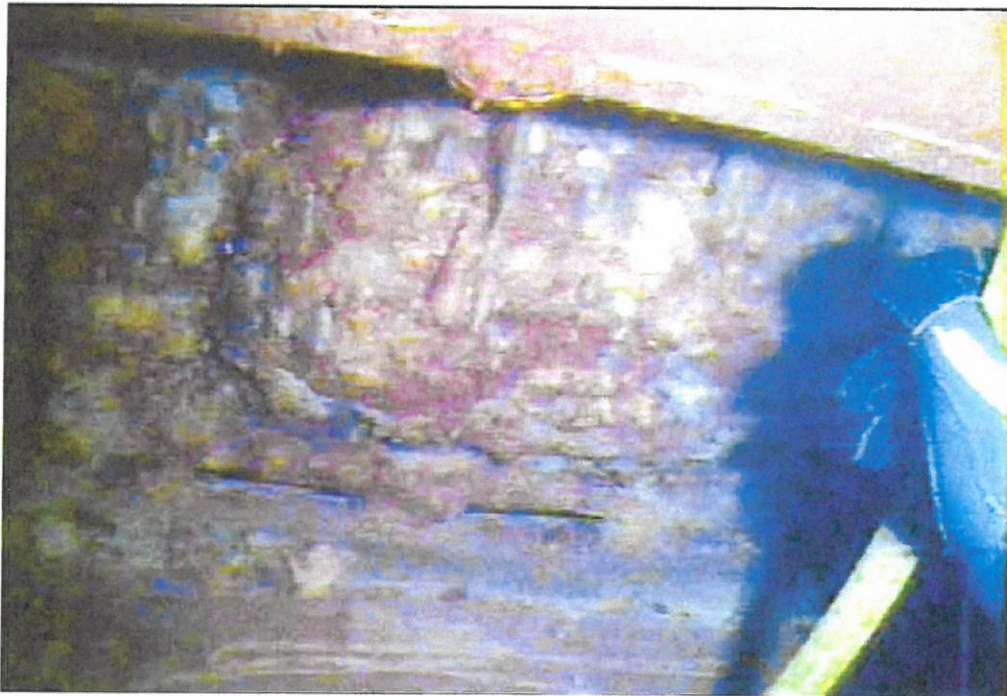
Manway (note heavy corrosion of faceplate)

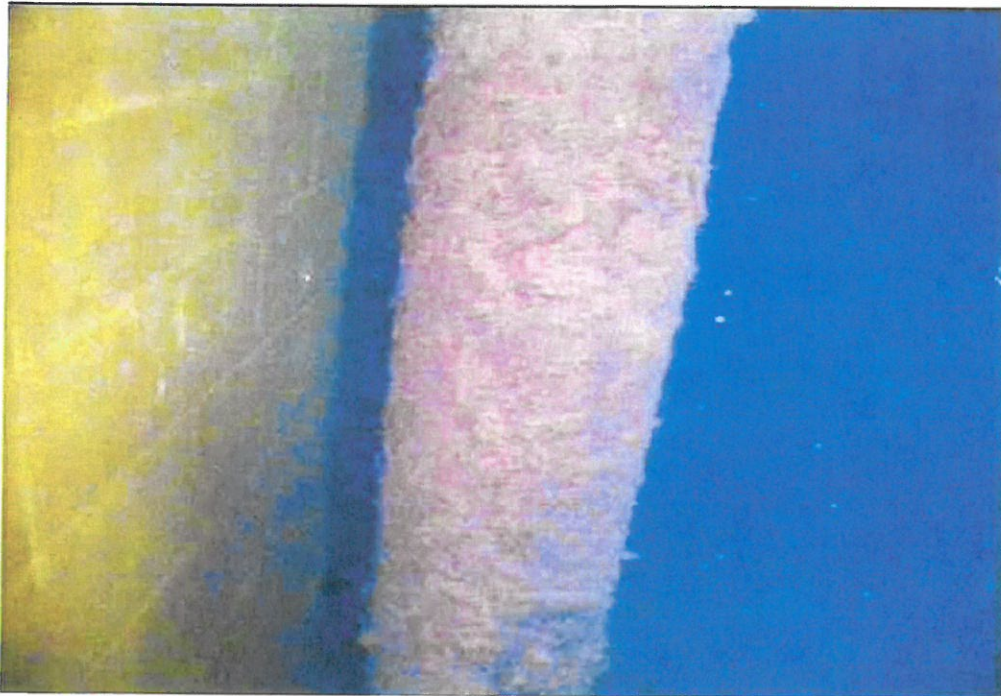
Inlet Pipe (note significant corrosion)

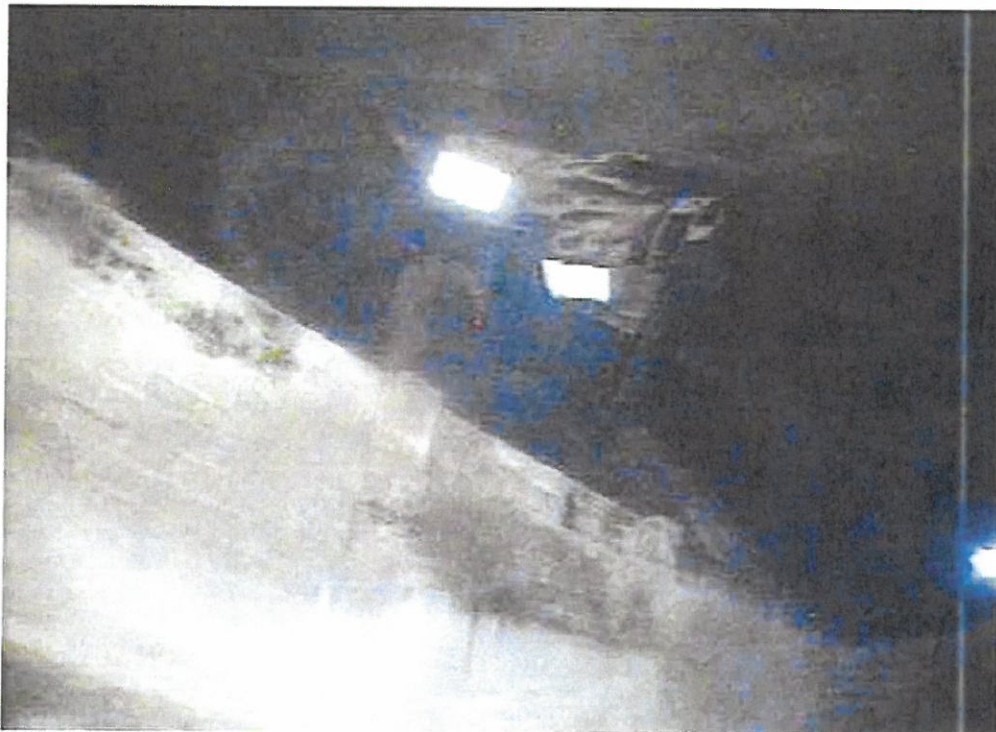
Condition of Baffle Wall and Aerator Ports

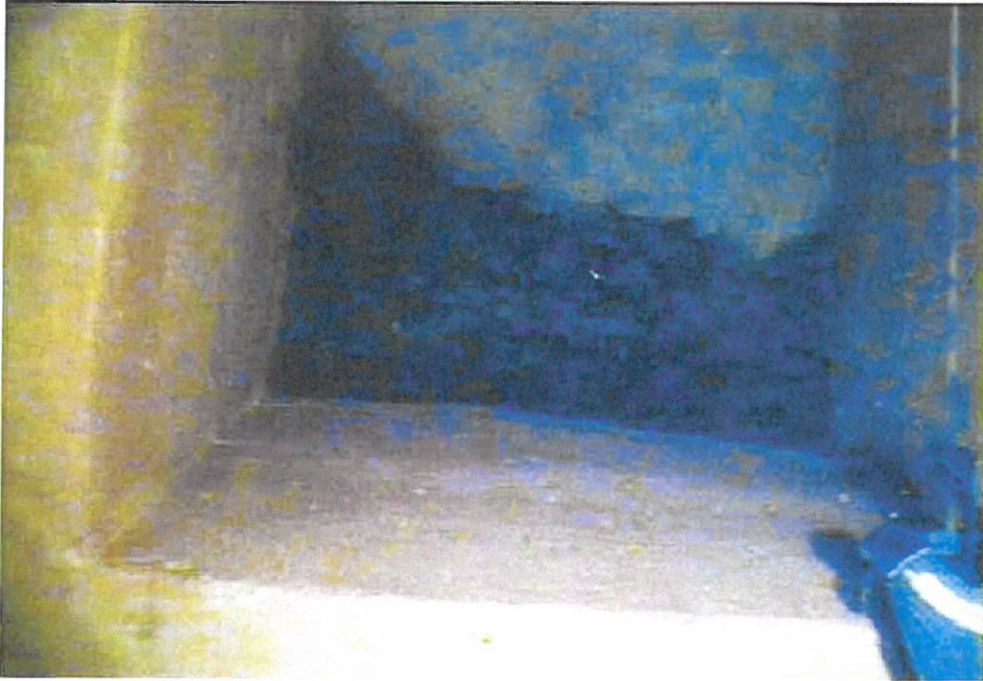
Drain Sump

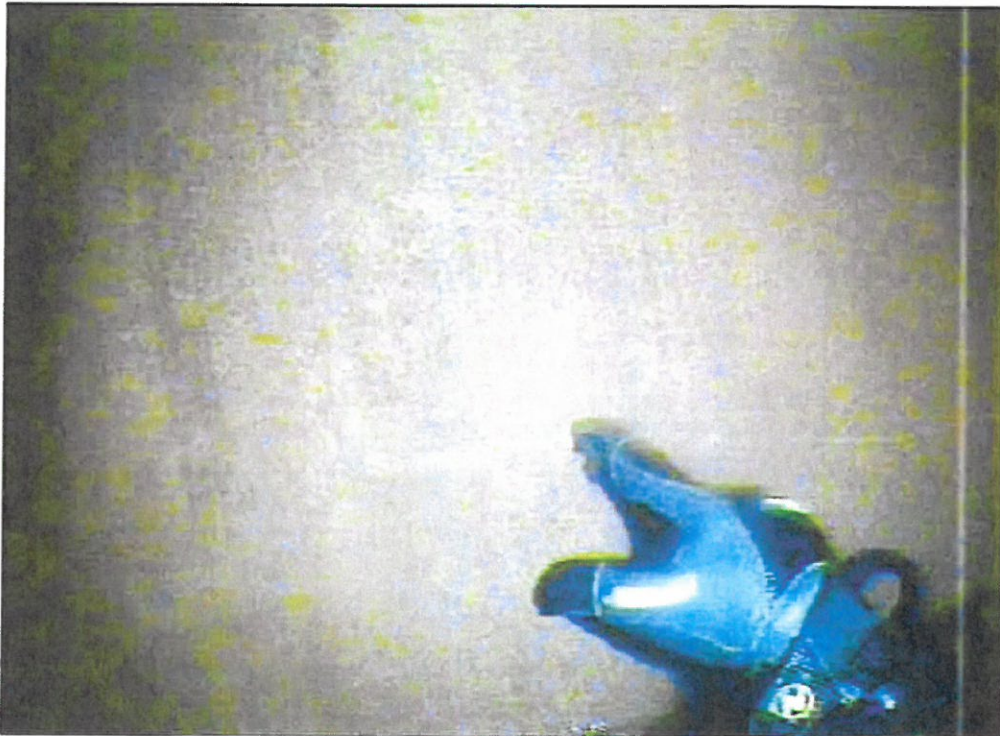
Minor Cracking on Upper Wall
