ASBESTOS INSPECTION REPORT

**City of Dyersville
Vacant House
703 2nd Ave SW
Dyersville, IA 52040
Project: 25-30220W**

**City of Dyersville
340 1st Ave E
Dyersville, IA 52040
Attn: Mick Michel**

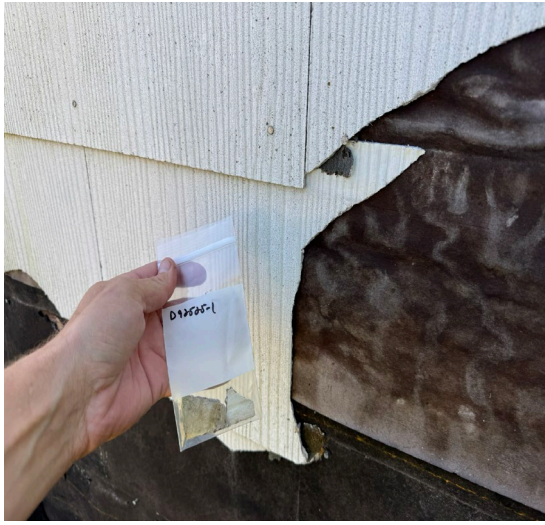
Sample D92525-1: Exterior transite siding positive for asbestos.

1. Exterior transite siding needs to be removed prior to demolition.
2. Floor tiles on both floors are positive for asbestos. Adhesive tested <1% asbestos (point count) on the first floor. It is Advanced Environmental current understanding of Iowa Division of Labor position on materials containing <1% asbestos that it can remain in during demolition.
3. Caulking in the basement, along the front of the house in the rim joist are positive. The caulking is holding Styrofoam in the rim joist in.
4. Plaster in several areas tested with <1% asbestos. The material was point counted and contained <1% asbestos. It is our current understanding the material can remain in during demolition.

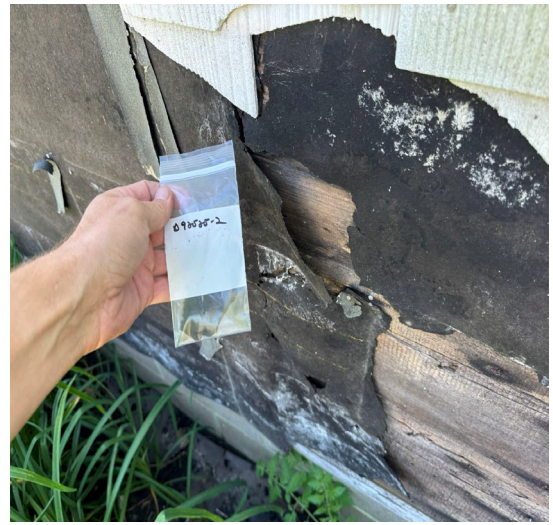
Sample D92525-2: Exterior tar paper behind siding negative for asbestos.

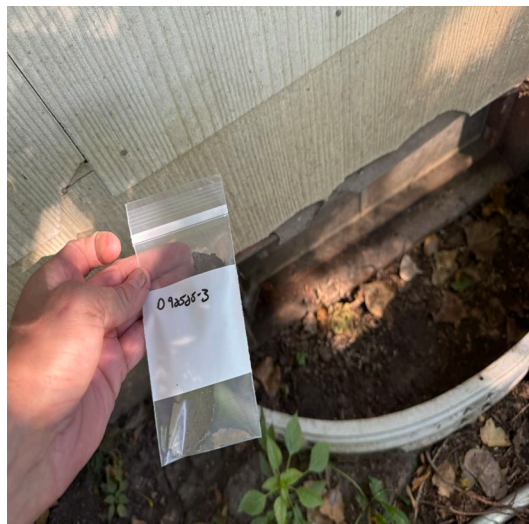
Sample D92525-3: Exterior tar paper behind siding negative for asbestos.

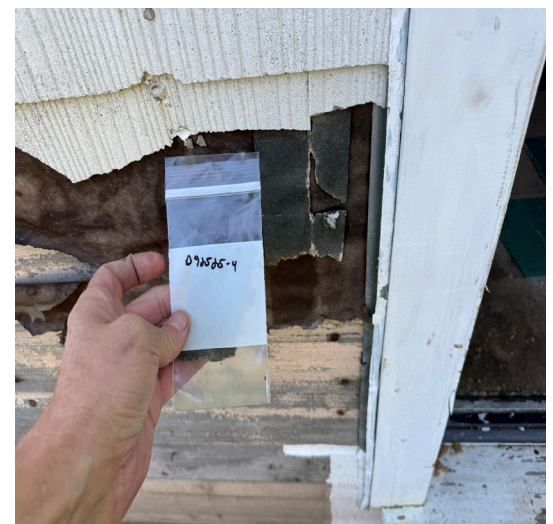
Sample D92525-4: Tar strips behind siding negative for asbestos.

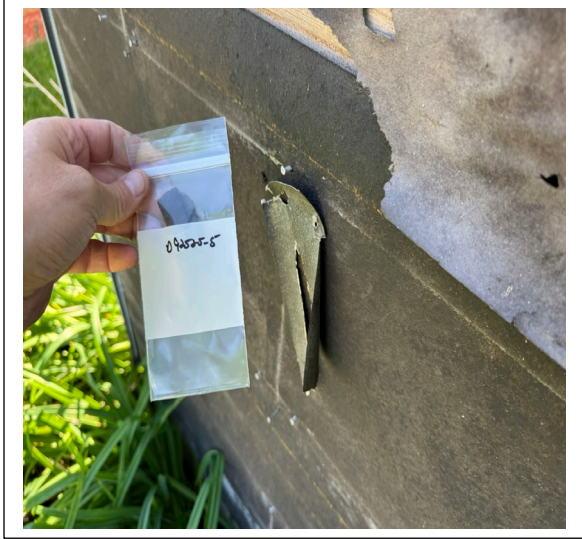
Sample D92525-5: Tar strips behind siding negative for asbestos.

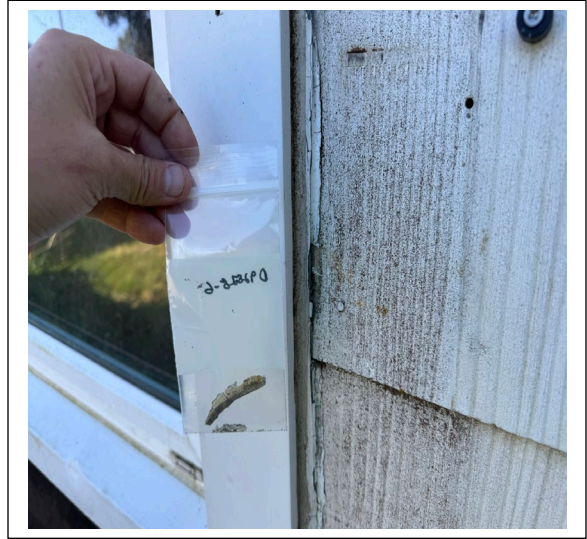
Samples D92525-6: Caulking around exterior windows negative for asbestos.

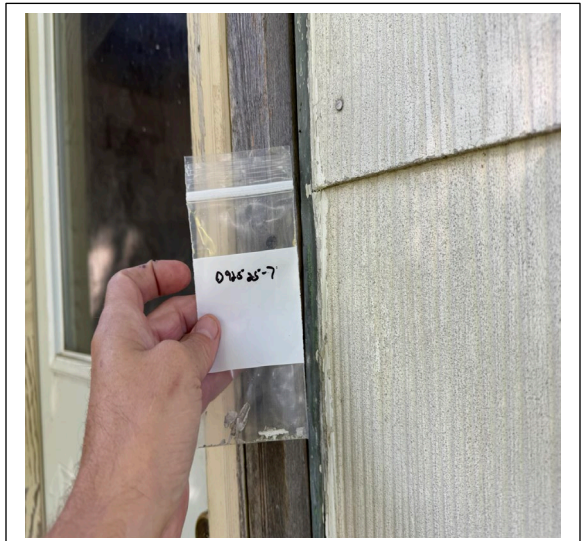
Samples D92525-7: Caulking around exterior windows negative for asbestos.

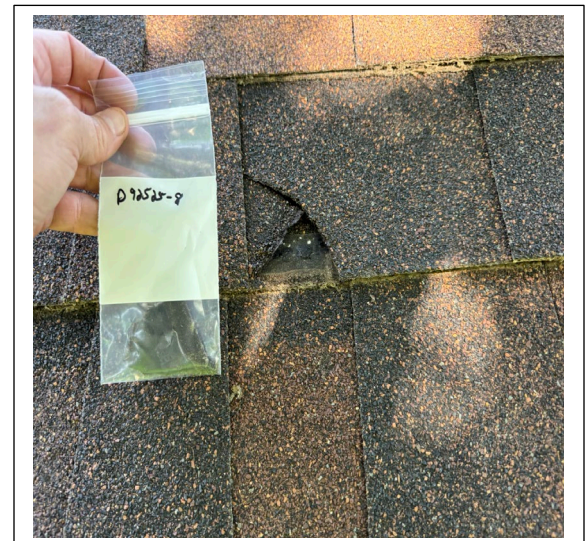
Sample D92525-8: Singles/ice dam on roof negative for asbestos.

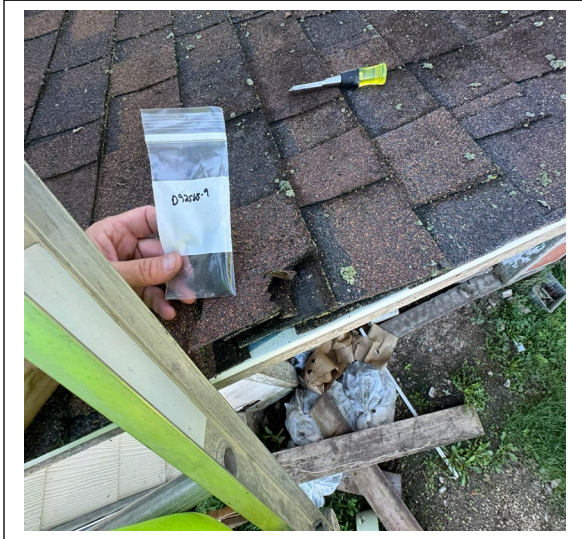
Sample D92525-9: Singles/ice dam on roof negative for asbestos.

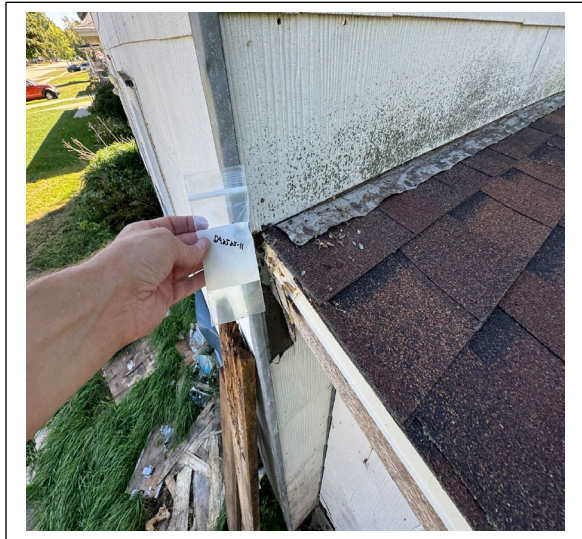
No sample in bag when it reached lab.

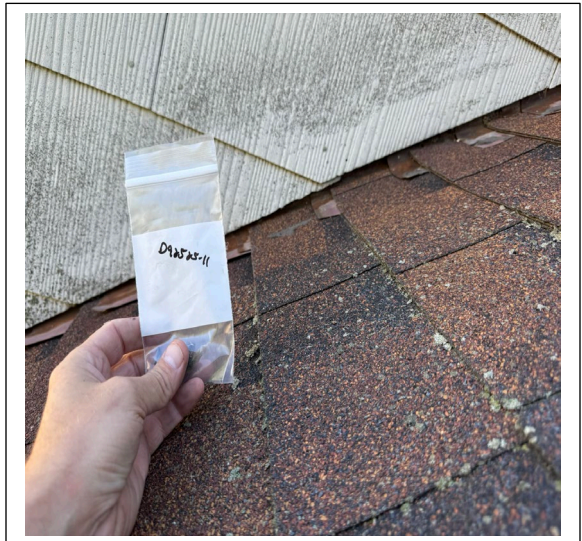
Sample D92525-11: Tar on roof negative for asbestos.

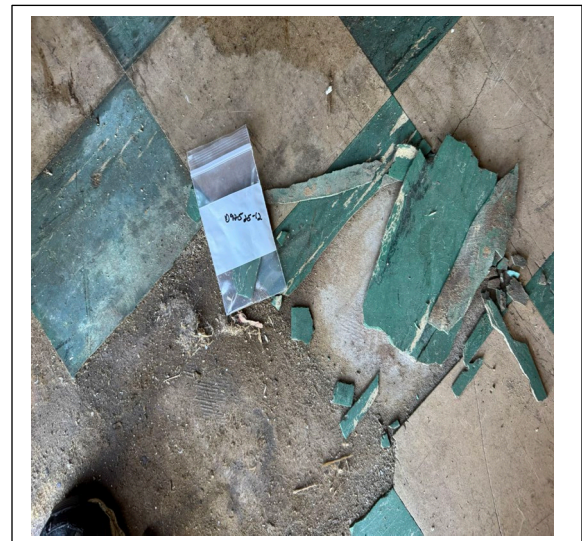
Sample D92525-12: Floor tile positive for asbestos, throughout first floor (Mastic PC less than <1%)

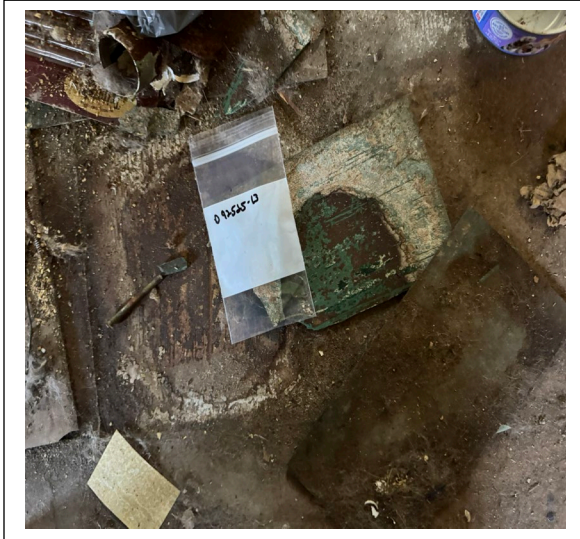
Sample D92525-13: Floor tile positive for asbestos, throughout first floor (Mastic PC less than <1%)

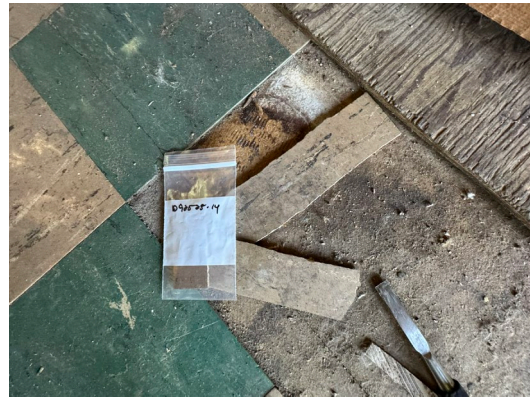
Sample D92525-14: Floor tile positive for asbestos, throughout first floor (Mastic PC less than <1%)

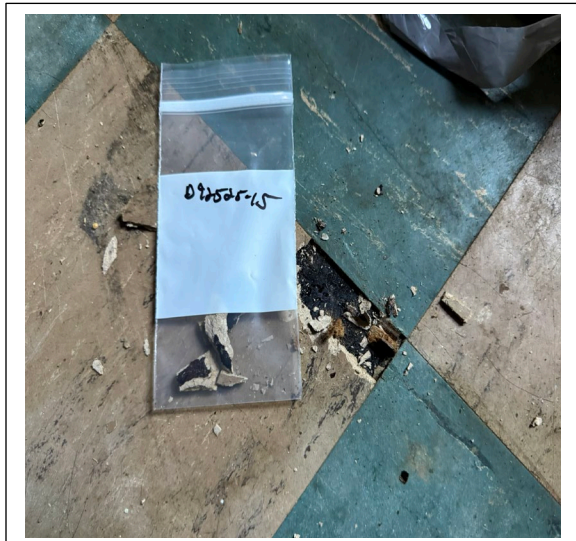
Sample D92525-15: Floor tile positive for asbestos, throughout first floor (Mastic PC less than <1%)

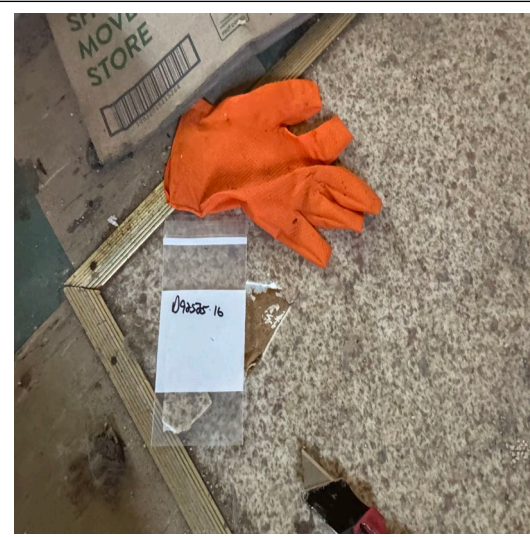
Sample D92525-16: Linoleum/mastic in kitchen negative for asbestos.

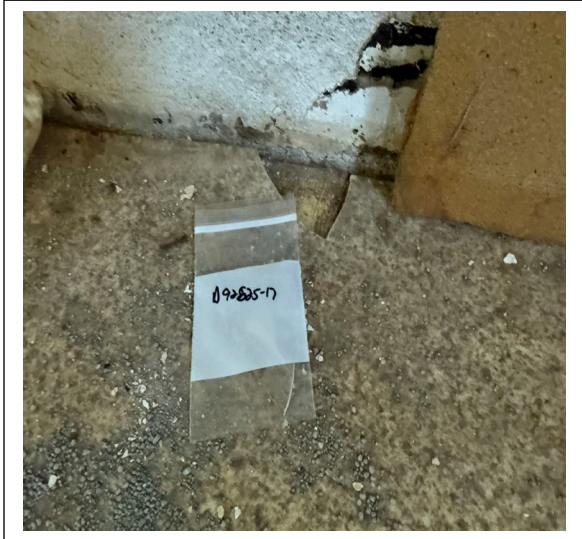
Sample D92525-17: Linoleum/mastic in kitchen negative for asbestos.

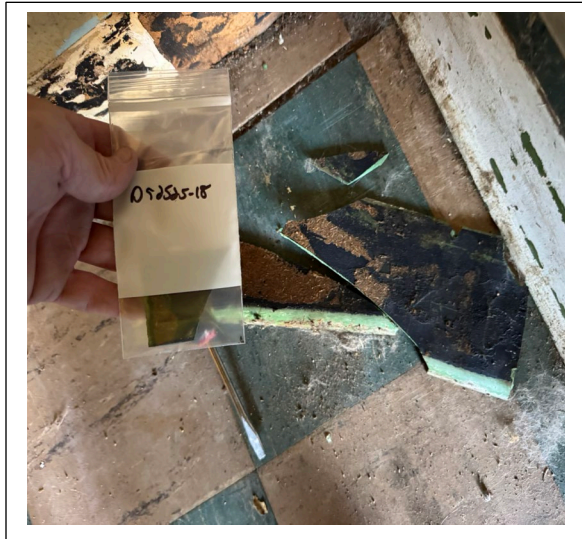
Sample D92525-18: Vinyl base/adhesive in main room negative for asbestos.

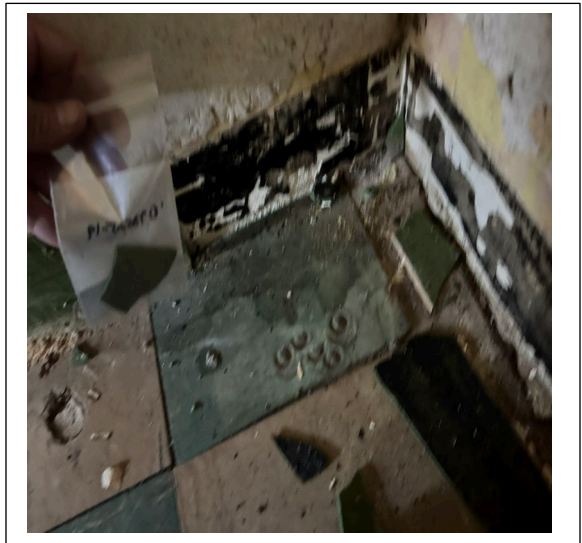
Sample D92525-19: Base cove/adhesive in kitchen negative for asbestos.

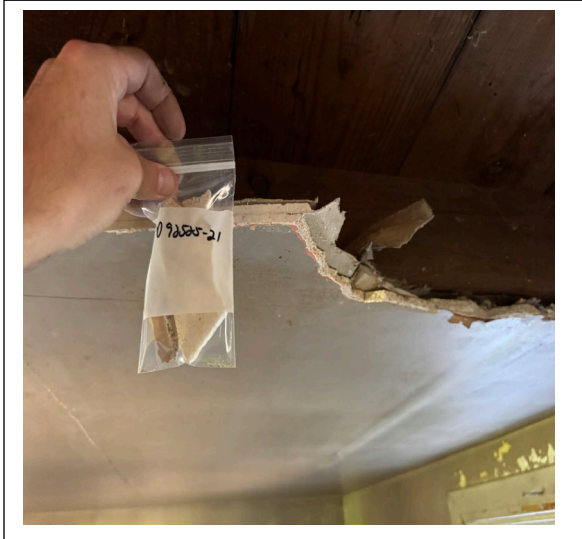
Sample D92525-21: Plaster/drywall backer in kitchen ceiling negative for asbestos.

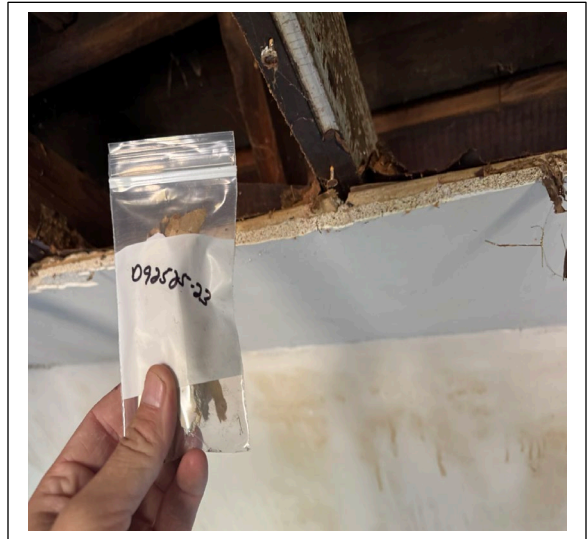
Sample D92525-22: Plaster/drywall backer basement landing <1% asbestos (PC).

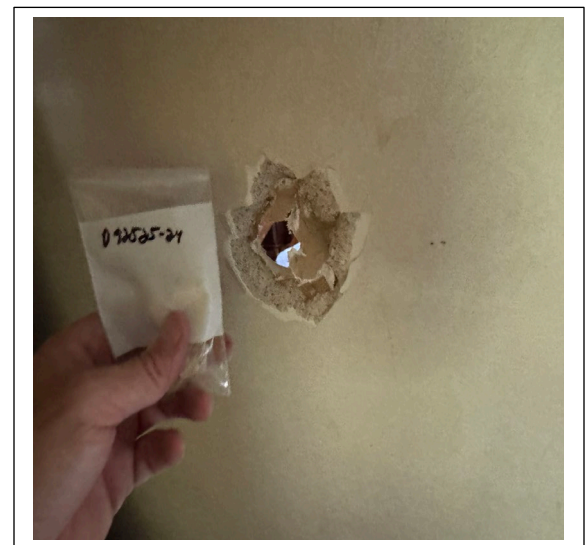
Sample D92525-24: Plaster/drywall backer 2nd floor West bedroom <1% asbestos. (PC)

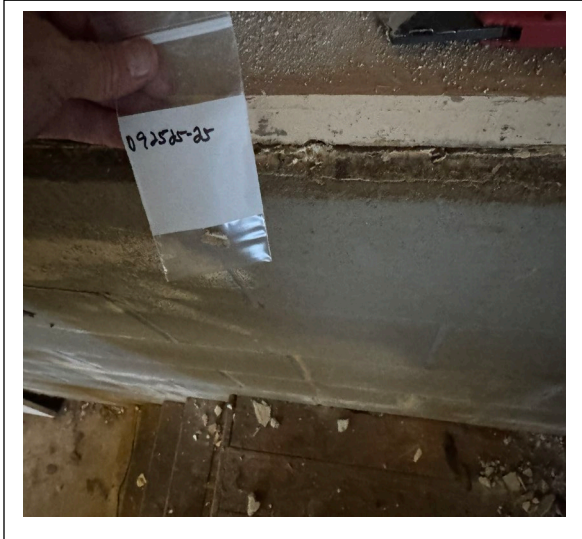
Sample D92525-25: Caulking, White, at rim joist in basement negative for asbestos.

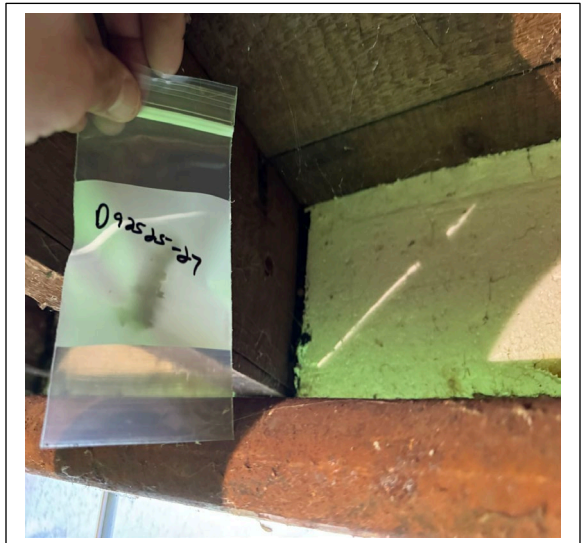
Sample D92525-27: Black caulking in the basement, rim joist, positive for asbestos.

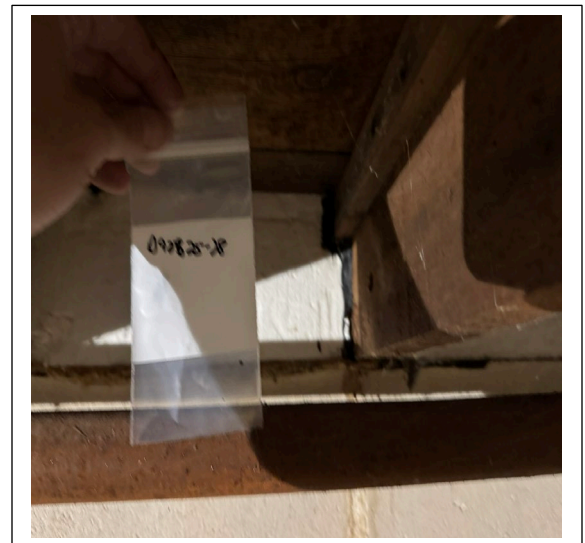
Sample D92525-28: Black caulking in the basement, rim joist, positive for asbestos.

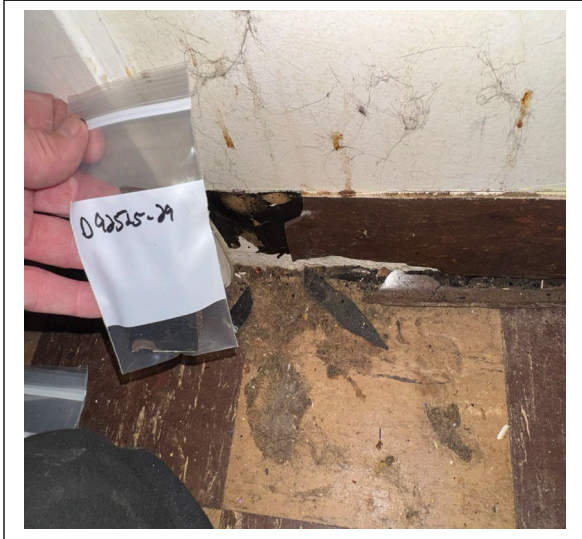
Sample D92525-29: Base cove/adhesive end floor bedroom negative for asbestos.

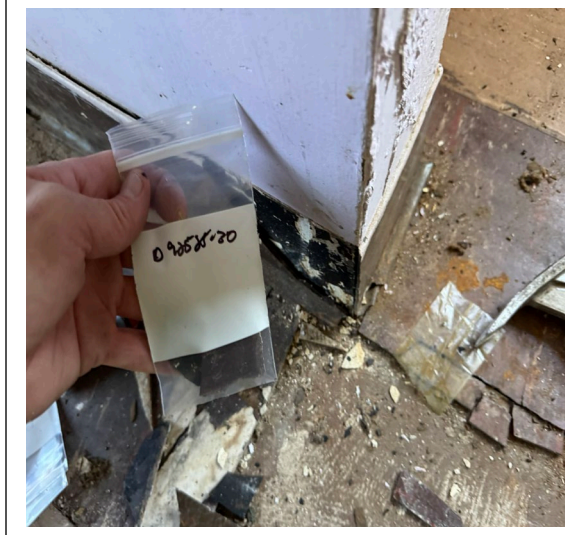
Sample D92525-30: Base cove/adhesive end floor bedroom negative for asbestos.

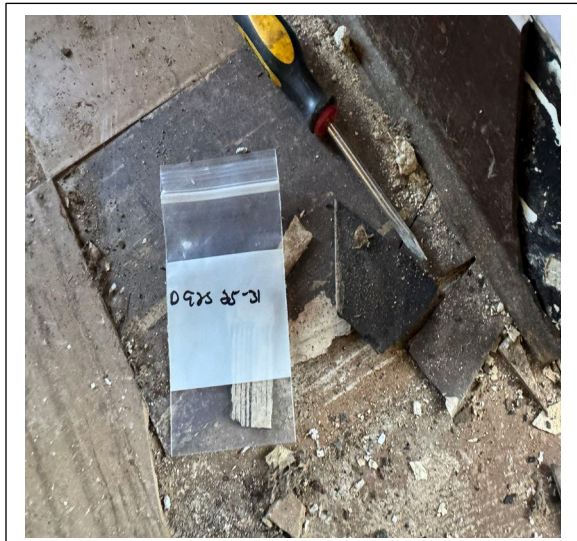
Sample D92525-31: Floor tile 2nd floor positive for asbestos.

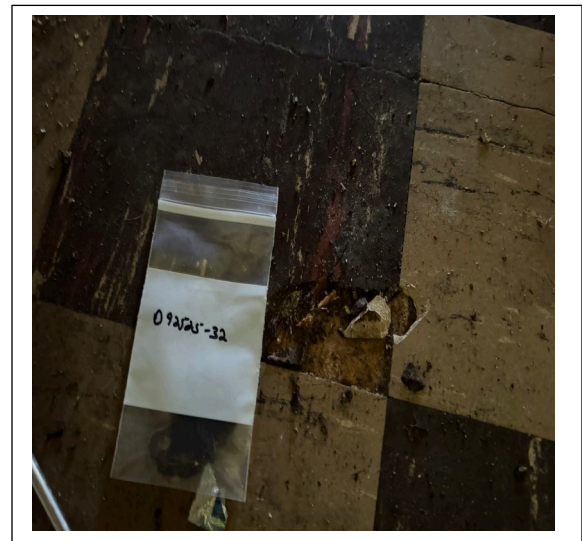
Sample D92525-32: Floor tile 2nd floor positive for asbestos.
