**Re: Pump Inspection & Televising Report – Dyersville Well #4**

# Well Televising Report

| Project Name | Dyersville Well #4 |

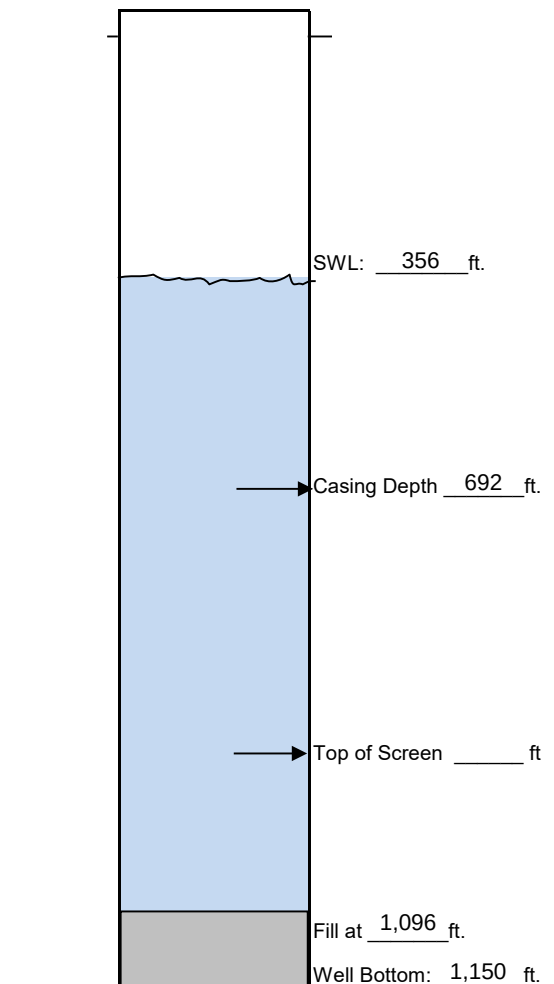
## Well Diagram

| Results |
|---|
| <p>Lots of scale build up and iron casing below static<br/> In line check valve was leaking back into the well through the pitless<br/> Hit a small blockage at 722' was able to knock it down with the camera.<br/> Not a lot of voids or cracks in formation, Hit bottom at 1096', Appears to have around 50' of fill in bottom of the well,</p> |

| Recommendations |
|---|
| <p>Brush and bail fill, I think this well is a good candidate for an air shock with the medium gun and a chemical treatment with acid,<br/> Please Note this is a lime stone well build pressure with the acid</p> |

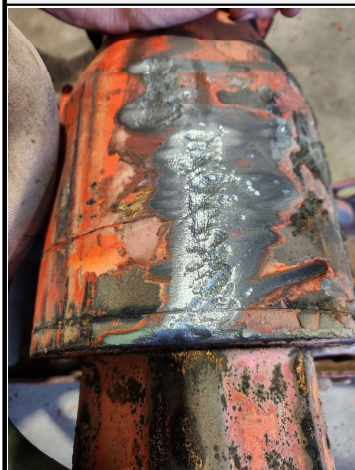
- The bowl assembly removed from the well is in poor condition. The bowls are extremely soft, and the metal thickness has significantly deteriorated. When separating the bowls to inspect the interior of the pump, one of the bowls broke, leaving a hole.
- The submersible motor is in good condition and can be reused.
- **Recommendation:** Replace the bowl assembly with your spare pump that was previously rebuilt. Reinstall submersible motor.

1. Bowl Assembly

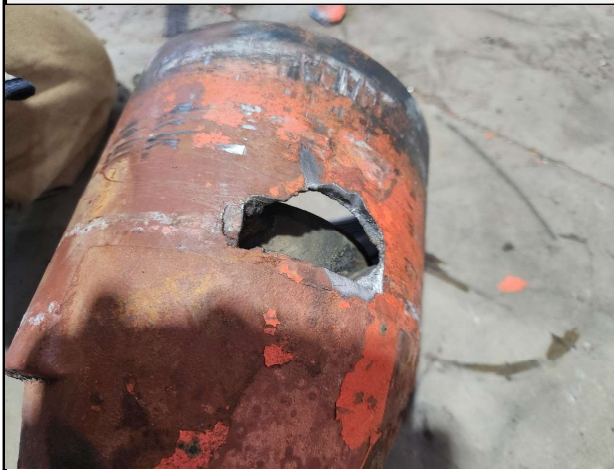
2. Bowl Assembly

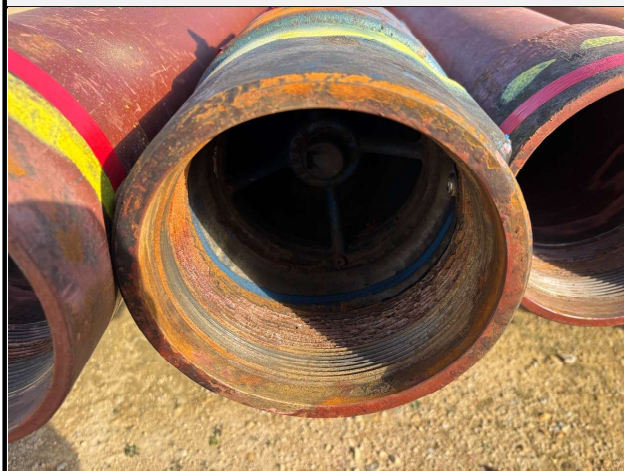
- All the couplings have threads that are washed out and corroded.
- Both check valves have significant erosion issues on the interior, and the threads are washed out.

3. Check Valve Threads

- The 6" x 8" swage nipple coming out of the pitless spool is corroded and will need to be replaced.
- **Recommendation:** Replace 8 sections of column pipe completely and have the remaining 15 sections cut and rethreaded. All couplings, check valves, and the swage nipple are in rough shape and will need to be replaced.

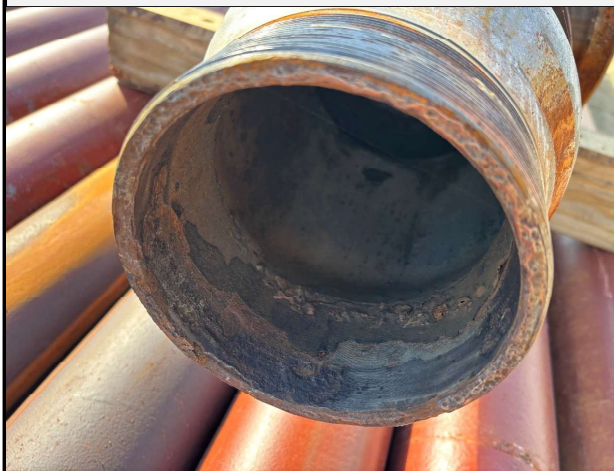
4. Swage Nipple Corrosion

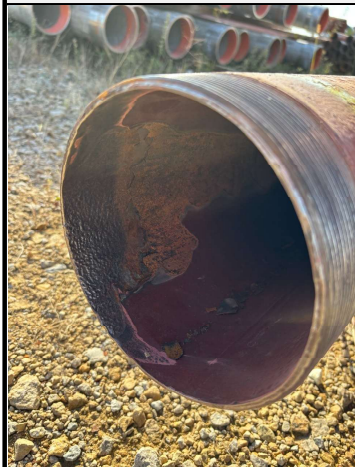
- Eight (8) sections of the column pipe exhibit significant pitting and corrosion throughout the pipe.
- Fifteen (15) sections of column pipe have corrosion occurring near the threads of the pipe and the threads on these pieces are starting to wash out. The faces on these sections of pipe are also starting to wear down, but are not a major concern.

5. Column Pipe - Interior Pitting

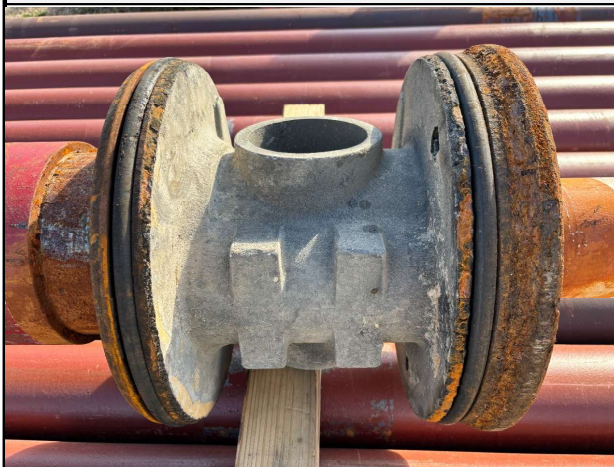
- The pitless spool is in poor condition with significant corrosion, but this was determined during the last pump pull.
- **Recommendation:** A new pitless spool was ordered at the beginning of the project and will be replaced during reinstallation of the pump equipment.

6. Pitless Spool
