## Bridge Assessment Report

<b>Bridge ID</b>	3 <sup>RD</sup> AVE SW – N FORK	<b>Date</b>	08.18.2022
<b>Location</b>	3 <sup>rd</sup> Avenue SW over North Fork Maquoketa River	<b>Program Manager</b>	Nathan Miller, P.E.
<b>Description</b>	Concrete Slab	<b>Project No.</b>	2200201
<b>Orientation</b>	Westbound Traffic: North Lane – Eastbound Traffic: South Lane

3RD AVE SW - N FORK | 004305

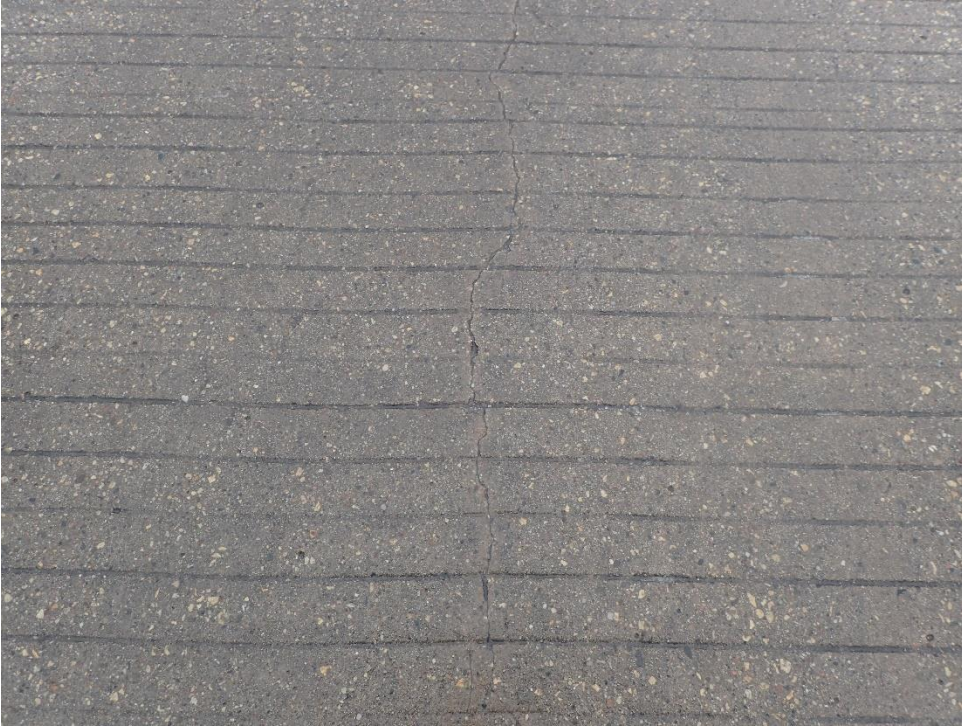
**DECK**

Longitudinal cracking on deck and sidewalk.

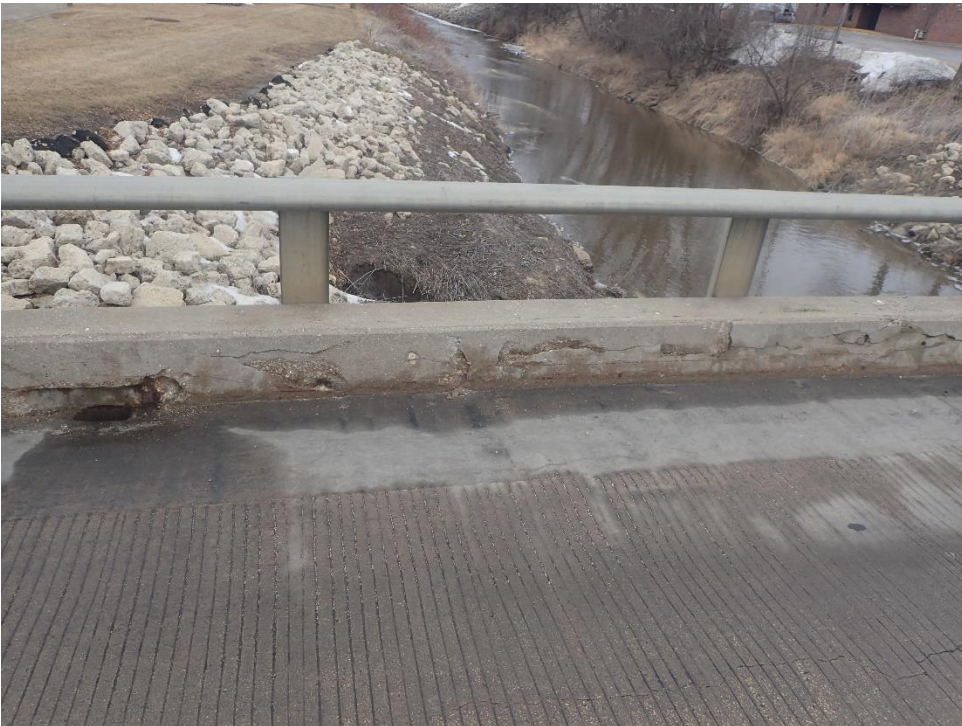
**NORTH CURB**

Spalling and cracking concrete along the north curb.

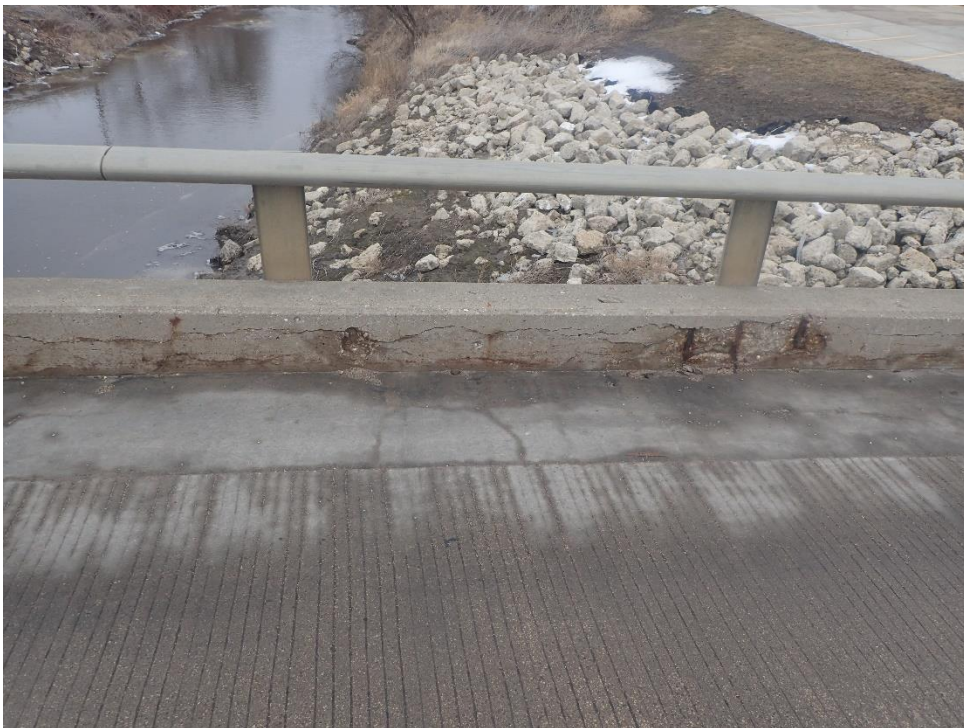
**NORTH CURB**

Spalling and cracking concrete along the north curb.

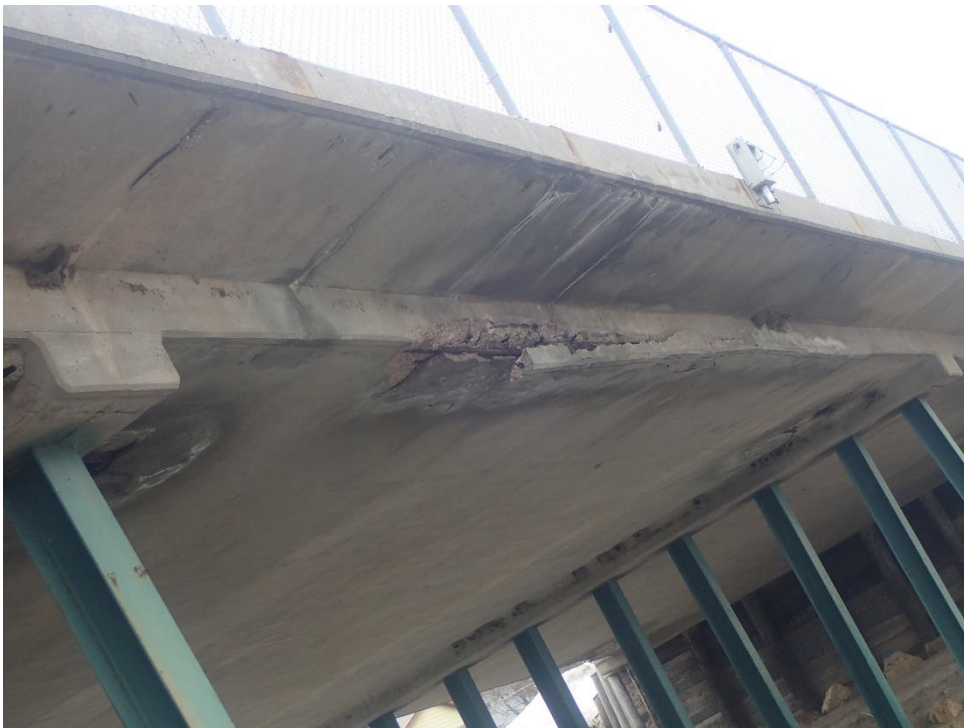
**UNDERSIDE OF SIDEWALK ALONG  
SOUTH EDGE OF DECK**

Spalling concrete with exposed reinforcement along the south edge of deck under the sidewalk.

- The areas of loose, overhead concrete pose a falling debris hazard which should be mitigated through selective demolition or through the installation of exclusionary fencing to prevent public access to the underside of the bridge.

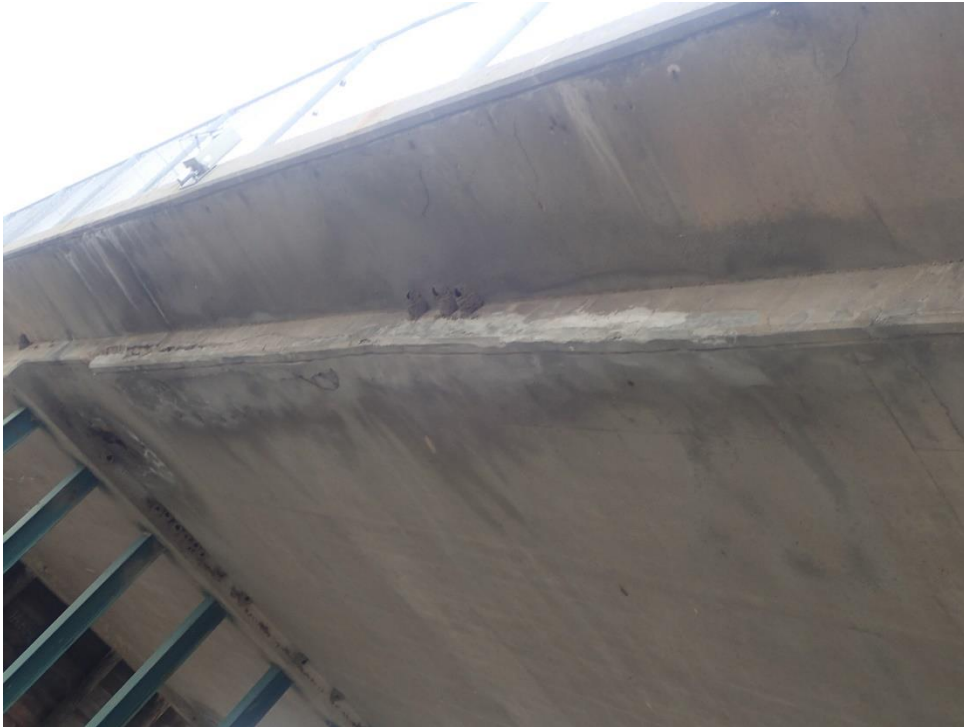
**SOUTH EDGE OF DECK UNDER  
CENTER SPAN**

Spalling concrete with exposed reinforcement along the south edge of deck under the center span.

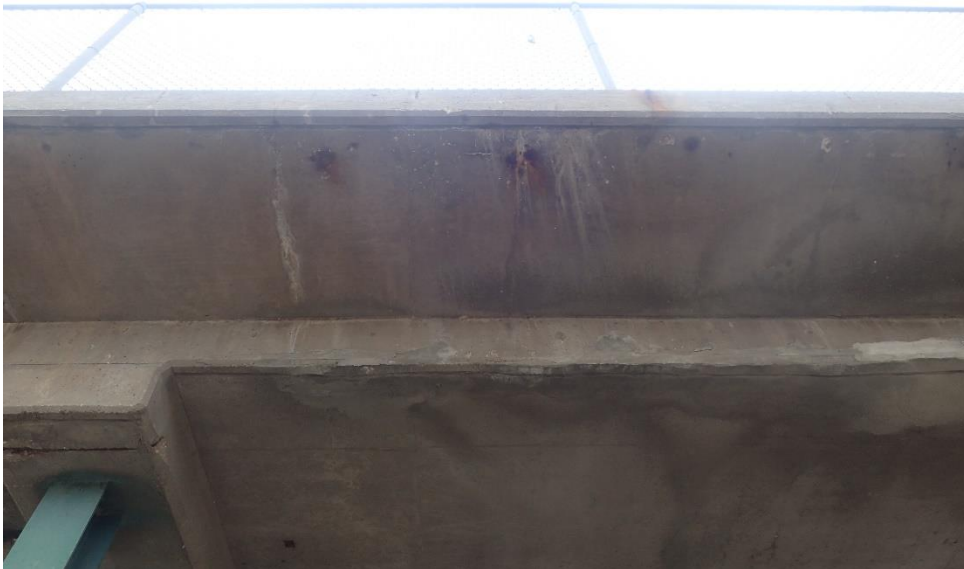
**SOUTH EDGE OF DECK UNDER  
CENTER SPAN**

Spalling concrete with exposed reinforcement along the south edge of deck under the center span.

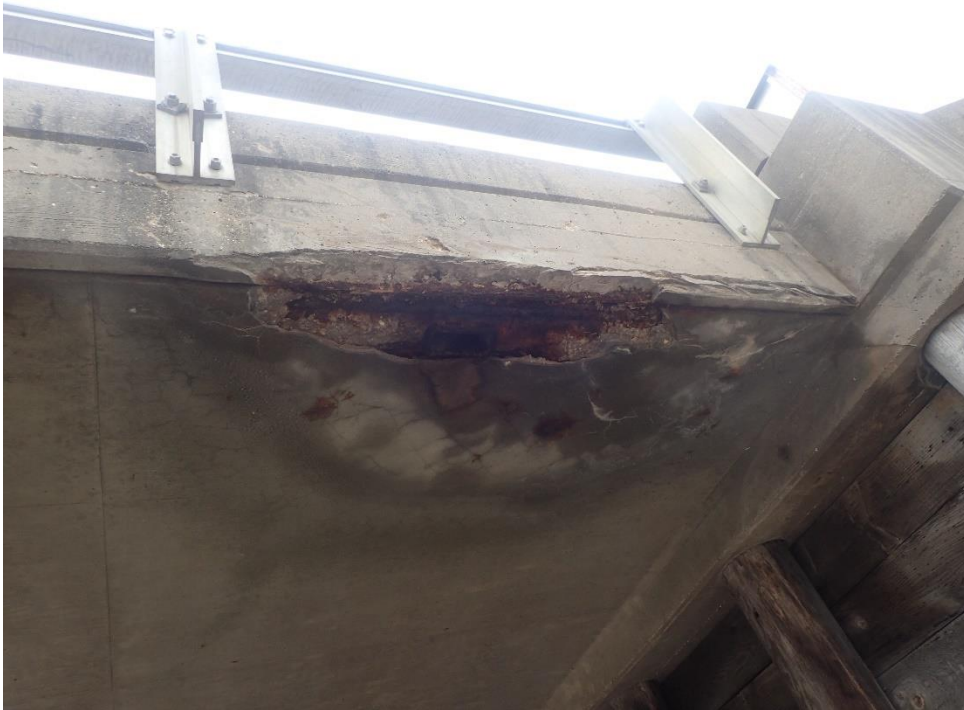
**UNDERSIDE OF SIDEWALK ALONG  
SOUTH EDGE OF DECK**

Spalling concrete with exposed reinforcement along the south edge of deck under the sidewalk.

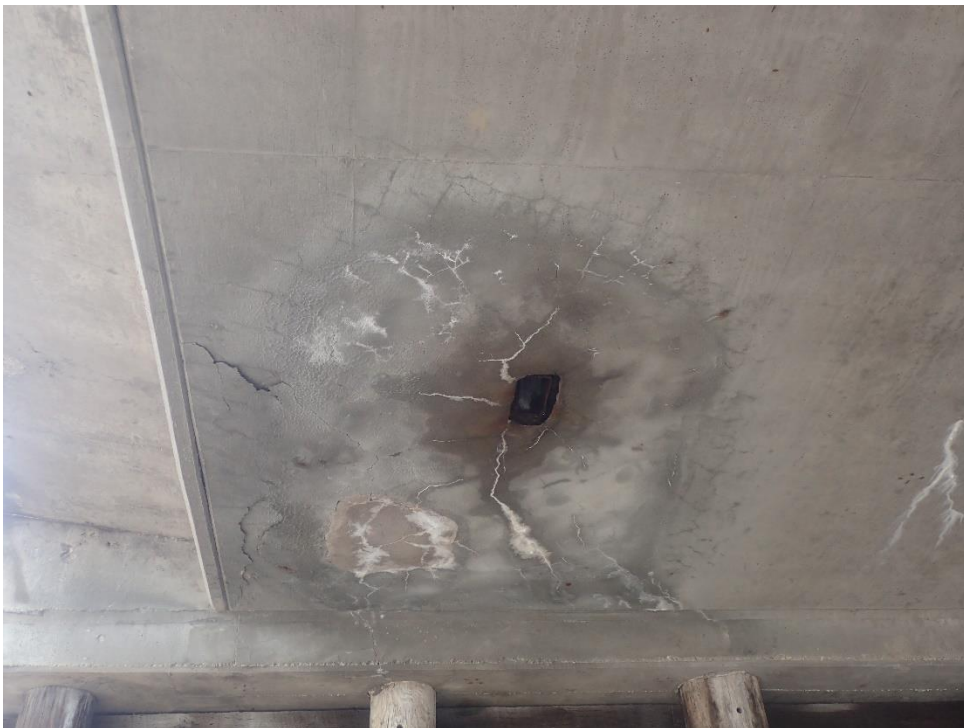
**NORTH DECK DRAIN IN WEST SPAN**

- Numerous areas of loose and delaminated concrete were observed on the underside of deck, largely concentrated near the deck drains and outermost edges of the deck. There is also evidence that the previously patched areas on the underside of the bridge have delaminated from the underside of the slab.

Spalling concrete with exposed reinforcement and efflorescence underside of deck around the north deck drain in the west span.

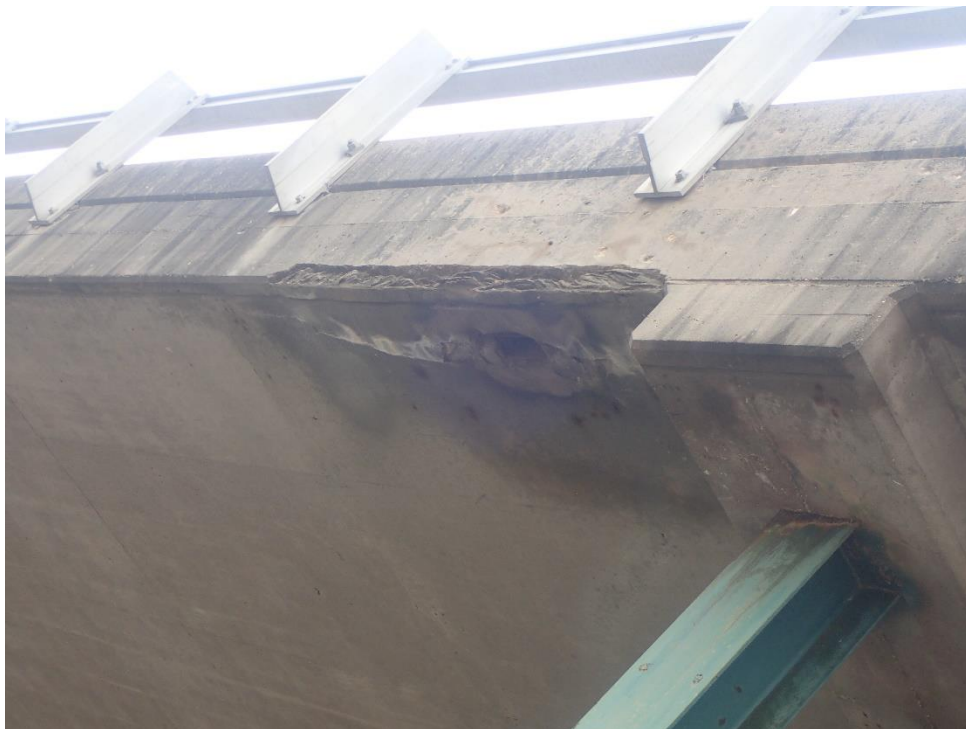
**SOUTH DECK DRAIN IN WEST SPAN**

Delaminated and cracked concrete with efflorescence underside of deck around the south deck drain in the west span.

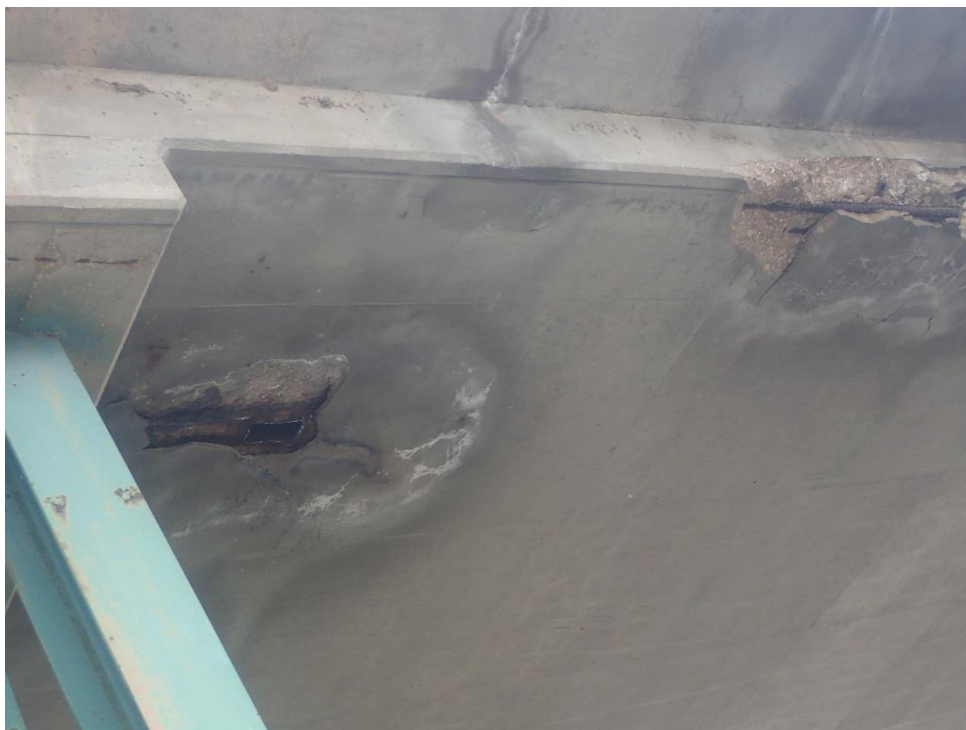
**NORTH DECK DRAIN IN CENTER SPAN**

Spalled, delaminated and cracked concrete with efflorescence underside of deck around the north deck drain in the center span.
