Baker Park Improvements Existing Facilities Assessment

Date Visited:
November 1, 2022
Existing Facilities Assessment

Project: Baker Park Improvements
Project No.: 1220746
Date: November 1, 2022
Time: 1:30-3:00
Address: 216 Courthouse Road Ext., Springfield, GA. 31329

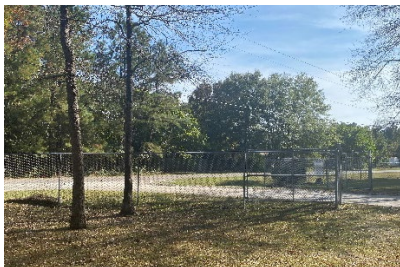
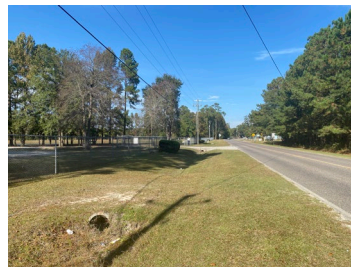
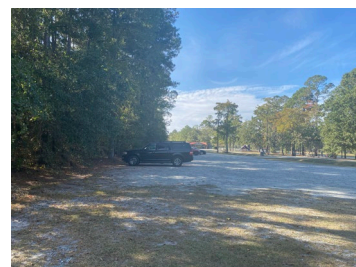
- a. The park entry is currently situated at the Southeast corner of the property boundary. Vehicles enter East to West from Courthouse Road onto a gravel road through a galvanized chain link fence. Overhead powerlines run the length of the East property boundary. Two existing culverts exist with the southernmost one being favored for the future entry abandoning the current entry location. An existing swale was observed along Courthouse Road and will need to be accounted for in the future design. The park does not currently have a monument sign. The client has expressed adding one at the park entrance as well as one on highway 21.

- b. Parking areas are crushed gravel or crushed concrete. The largest parking area is just inside the entry located along the south property boundary. No pavement markings or directional signage was observed. 4"x4" white posts are currently being used to delineate parking boundaries. A culverted swale separates the parking from the entry drive. No sidewalk has been observed connecting the surrounding neighborhoods to the park. Large mature shade trees align the driveway and will need to be protected during construction

- c. The park currently has galvanized chain link fencing along Courthouse Road. The client has expressed an interest in removing this fence and replacing with stained wooded rail fence matching that found at McCall Park. The northwest portion of the property has an adjacent private property with approximately 850' of barb wire fencing. Being that this barb wire is on the private property and more than likely it can't be removed or changed, the idea of using evergreen planting in this area was requested by the client.

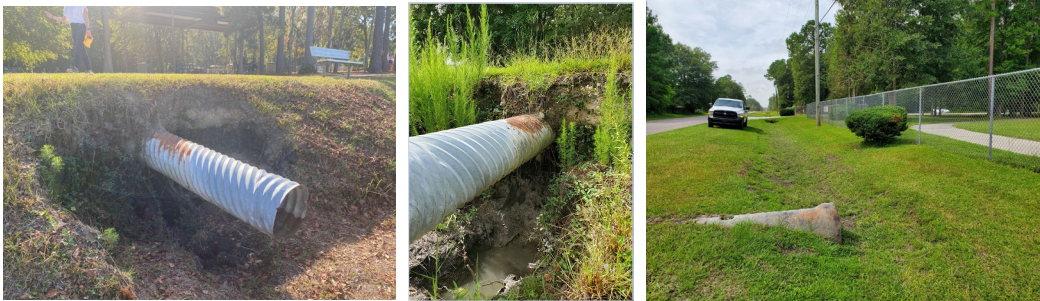
- a. Stormwater for the site is directed into the lake via natural sheet flow, culverts, and outfall pipe as seen in the images. Repair will be necessary to all outfalls where erosion has been experienced. The east and west portions of the tennis courts will need to be addressed as it appears drainage was not addressed when installed. The addition of parking, sidewalks, and pickle ball courts will necessitate additional infrastructure to capture the additional surface runoff incurred.

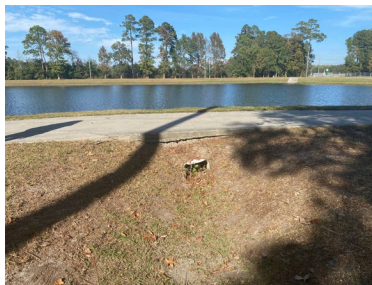
- a. Landscape throughout the park is minimal with very little plant beds or overall theme. Additional landscape beds were mentioned with a possible 18,000 budget for improvements. The client has assured us that there is an irrigation system that needs repair, around 8 to 10 zones for an estimated cost of 15,000.

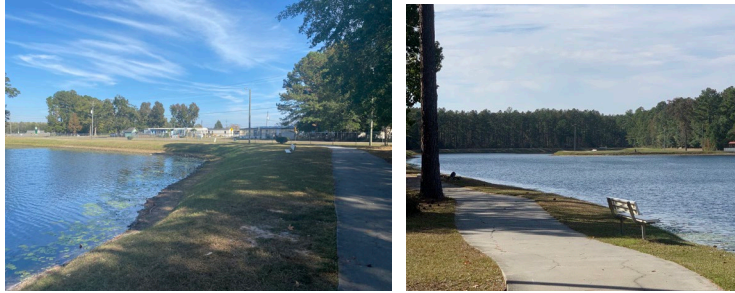
- a. The seating is currently provided through bench style seating around the lake, movable tables at the main pavilion, small pavilion, and bleachers at the tennis courts. The client has expressed a desire to remove and replace the bench style seating around the lake as well as provide suggestions for other seating options.

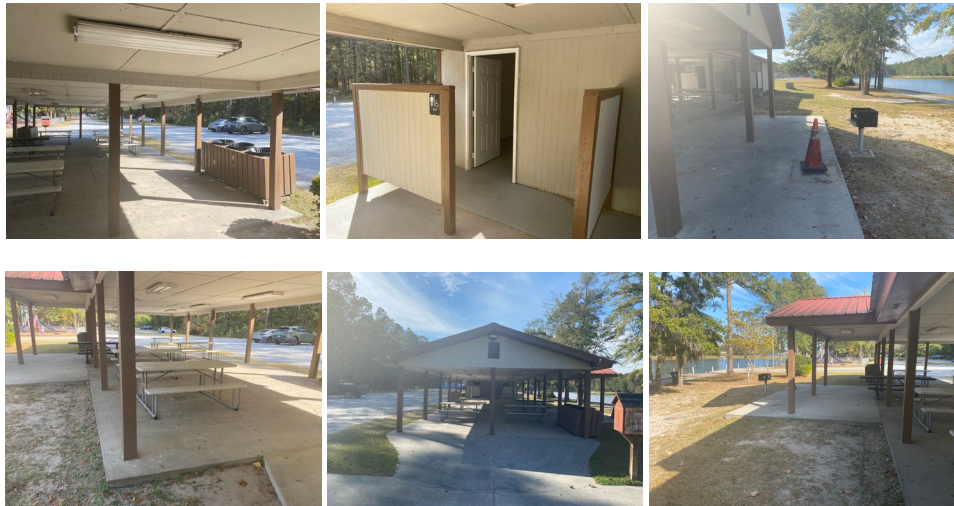
- a. The state of the existing restrooms and main pavilion could be rated a poor condition. Weather and other seasonal elements have played a role in degrading these facilities. Wood rot and water damage was evident throughout. Several posts were observed to have been added post construction to possibly support sagging elements of the roof structure of the pavilion. Various additions to the concrete surface as well as roof appear to have been made post original construction.

Only one small grilling station was observed. Trash cans were exposed without lids providing opportunities for the surround wildlife. No performance test was performed on the existing drainage system in the bathrooms but was suggested to understand their current state. Movable tables have been provided by the county and could be repurposed.

- Remove extra post, support, look at making roof lone with new brick columns around posts to match building.

- 3 locations, main one having a serving table

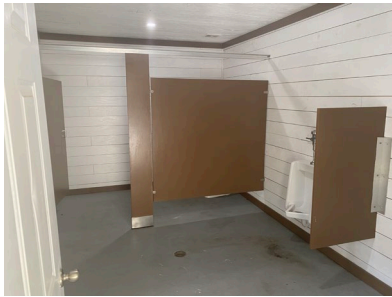
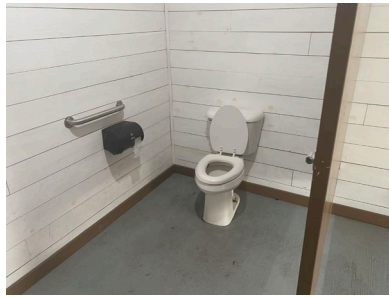
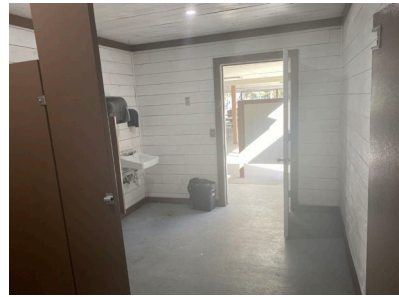
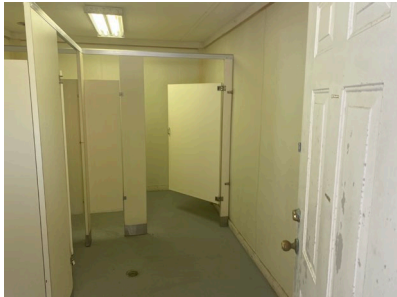
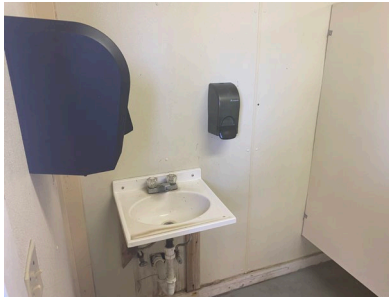
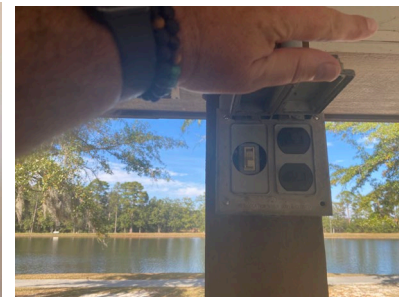
- a. Exposed plumbing could be seen under the sinks posing a risk for vandalism. No automated locking mechanisms were observed only keyed locks. Several light fixtures were completely exposed causing concern for possible electric shock. Paint was peeling in both the women's and men's bathroom.

- Men's side: 2 toilets, one being handicap, 2 urinals.
- Add door off back side to a new pavilion.
- Ladies side: 3 toilets one being handicap
- Add a door off back side to new pavilion
- Both require changing tables
- Cut face block and brick

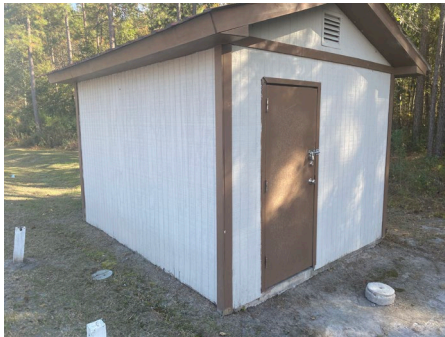
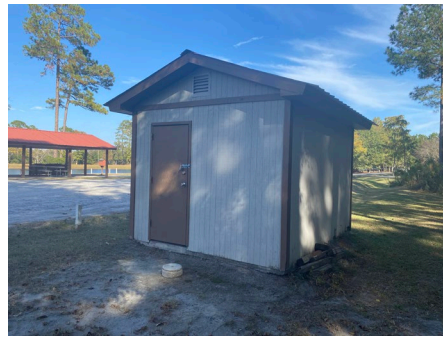
- a. The existing pump house is made of wood material with a shingled gable roof. Access was not provided to view the inside of the structure. A padlock was observed to be added possibly due to the existing locking devices malfunctioning. No automated locking mechanism were observed only keyed.

- The client expressed interest in rebuilding the existing pump house to match the bathrooms. The addition of video surveillance of the park was mentioned with the pumphouse being a viable option for the equipment cabinet and tower to be located.

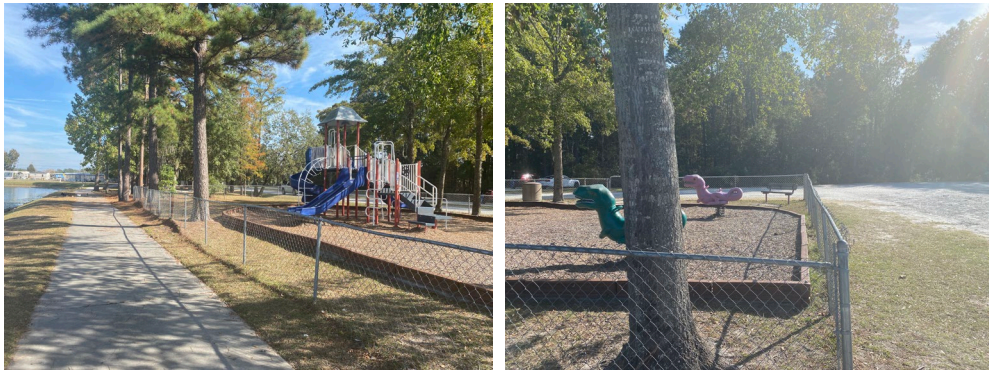
- a. The playground is outdated and recommended to be replaced. The location is centralized near the pavilion and provides the best availability for views in and out of the areas for parents to watch their kids. Low chain link fencing has been used to corral the children and should also be replaced. The playground area benefits from existing shade trees but selective pruning is recommended for safety. The client has shared a 150,000 budget for this amenity to include a rubber surface, two walkthrough gates, one maintenance gate and follow specifications used at McCall Park.

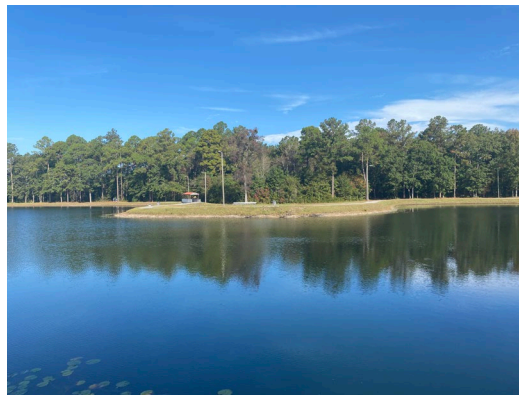
- a. Opposite of the pavilion and sport courts is the Gazebo area located on the north side of the lake. The bank protrudes out in this area providing a great location for a destination point and Gazebo. This area will require fill soil to bring to level and can serve as a destination point for park patrons. There is an existing electrical pole that can be used for lighting or power for the desired gazebo. This area also has a small wooden bridge that is in disrepair and should be removed and replaced. The client is interested in a complete redesign of this area and bridge crossing.

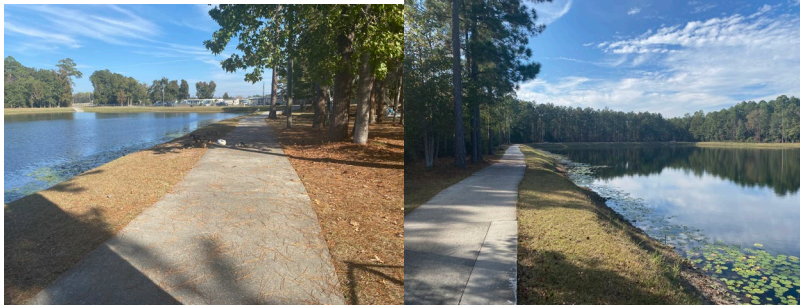
- a. The walking trail is the most used amenity of the park. People from all over the county come to Baker Park for the walking trail which is exactly one mile. The paving surface is weathered and uneven in multiple locations throughout the trail. Roughly ten to 15 trees were observed as needing to be removed with roots extending to the lake and heaving the trail. As a result, root pruning is recommended along the tree side of the trail. Several trees need to be flagged by a certified arborist for pruning. The client discussed an interest in a complete demo and reinstall of a 10' wide trail in concrete or asphalt with an aggregate base but would like to get a cost estimate prior to deciding. No mile marker signs were observed and would be recommended.

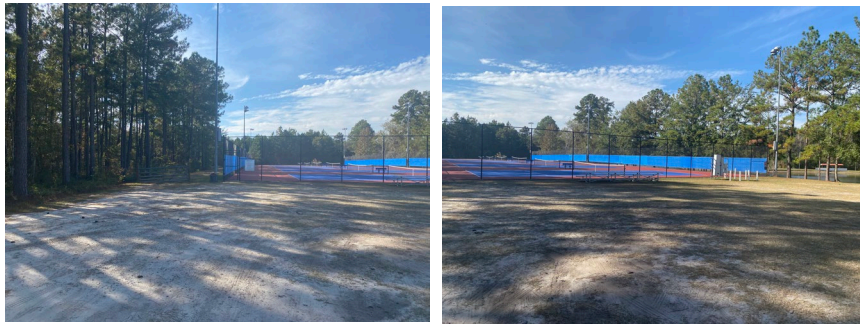
- a. The tennis courts are newly constructed and in excellent shape. An existing access way runs along the south property line toward the rear pickle ball area on the west side of the tennis courts. This is the most viable option for egress and maintenance. No shade structures or baseline judge seating for tournaments. Topography appears to slope to the southwest of the property in this location into a wetland.

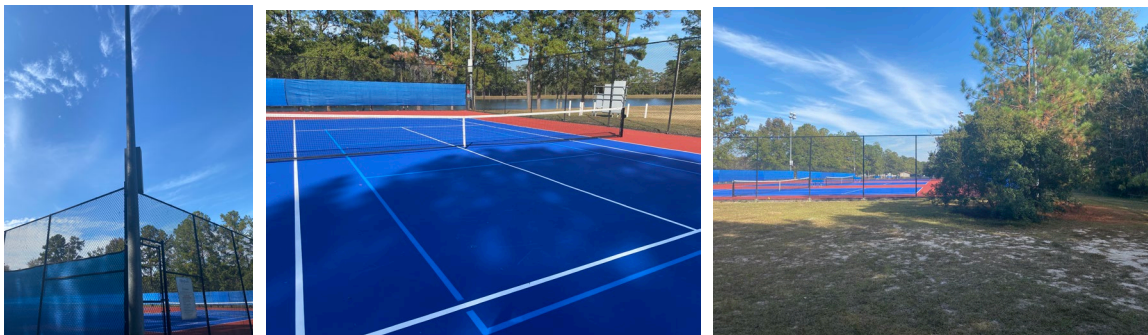
- a. Bleachers were observed at the west side of the courts but do not provide ample accommodations for major events. Drainage concerns were observed along both the east and west sides of the court and appear to have been recently dug. Court lighting was not observed but assured that it works and can be accessed via a mobile app. We were unable to locate a manual switch or timer and no locking mechanisms were observed on the gates only latches. An electrical panel is located the northeast corner of the tennis courts and should be screened or protected. No available voltage or amperage was provided for the electrical panel but will need to be coordinated for additional demand when the pickle ball courts are installed.

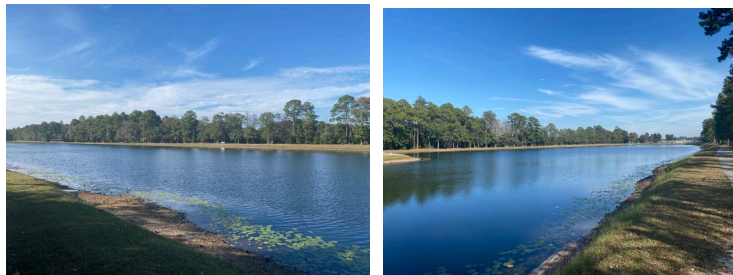
- a. Several washouts and outfall pipes were observed and need to be repaired or replaced. Additional drainpipes need to be added at the tennis and pickle ball courts and at the covered bridge to promote better drainage and work with the natural flow of the land. Additional shade trees are recommended along the trail to provide a more comfortable walking experience.

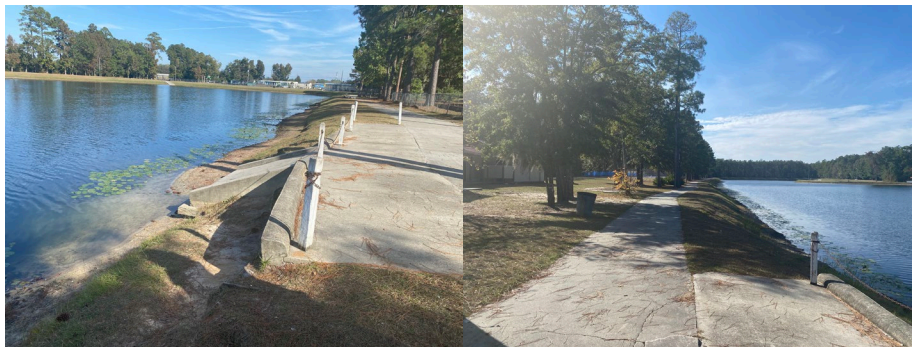
- a. Because Baker Park is prized for its walking trail, the client has expressed an interest in a nature trail back into the wooded area at the southwest area of the property. Various features may be required like pedestrian bridges and boardwalks, if found to be wet. Further investigation will need to be made once the site survey is received.
- b. Several washouts and outfall pipes were observed and need to be repaired or replaced. Additional drainpipes need to be added at the tennis and pickle ball courts and at the covered bridge to promote better drainage and work with the natural flow of the land. Additional shade trees are recommended along the trail to provide a more comfortable walking experience.
- c. The area proposed for a future fishing dock currently serves as conveyance from the concrete parking at the main pavilion.

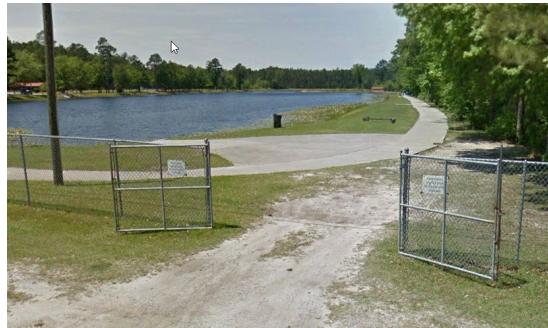
- a. The boat ramp and associated parking is located at the northeast corner of the property and exists of a gravel drive and concrete slip. Vehicles can enter through a chain link gate from Courthouse Road west into the park. The space is very limited and does not provide ample room for a safe turnaround movement. Vehicles are also required to cross the walking trail to enter the water blocking the walking trail while doing so. The client shared that typically there is no more than three boats at one time so the need for a large parking area is minimal.
