Intersection Road Safety Audit

SR 17 AT SANDHILL ROAD / MARLOW ROAD

EFFINGHAM COUNTY | GEORGIA

December 2016

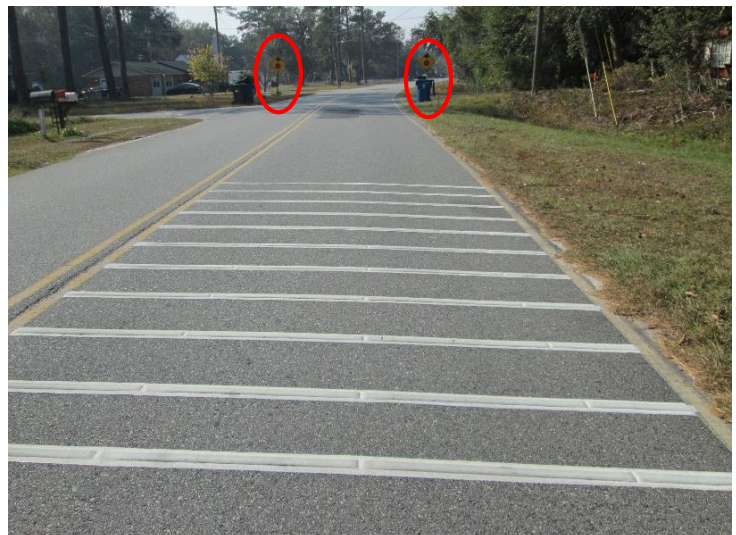
FIGURE 4-2. RAISED REFLECTIVE RUMBLE STRIPS ON MARLOW RD WITH ADVANCE WARNING "STOP AHEAD" SIGNS

1. Three sets of transverse rumble strips (Figure 4-2) are present on Marlow Road approaching the intersection. Advance warning "Stop Ahead" signs and word pavement markings are used to supplement the rumble strips. The audit team noted that the rumble strips are located far from the study intersection. An additional set closer to the intersection would enhance their purpose.

7. Consider installing additional transverse (a.k.a. in-lane) rumble strips on Marlow Road closer to the intersection to alert motorists to the stop sign ahead. Ensure at least one set of rumble strips is placed between Hickory Ln and SR 17 to warn drivers existing nearby driveways on the approach to SR 17.	Moderate	Moderate	Intermediate	Moderate

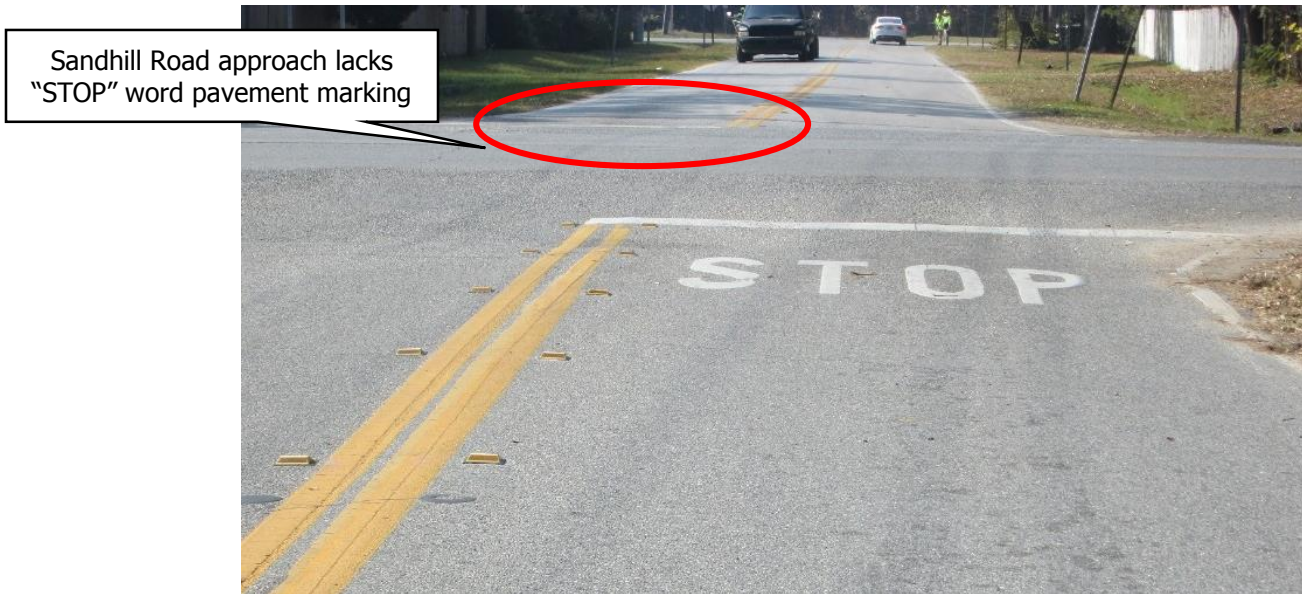
3. Raised pavement markings (RPMs) are in fair condition. During the nighttime inspection, RPMs and pavement markings were visible.
4. The double yellow center line, stop bar, and edge lines on the side street approaches immediately adjacent to the intersection were recently replaced. The center line and stop bar are in fair condition; however, the edge lines are already showing signs of wear and are obscured by debris on all legs of the intersection. Farther back from the intersection, pavement markings have not been replaced and are worn and faded.

FIGURE 4-3. VIEW OF PAVEMENT MARKINGS AND RPMs ON MARLOW ROAD AT STUDY INTERSECTION

3. Work with Effingham County to replace pavement markings and striping along Marlow Road approaching the study intersection (Marlow Road is a County Road).	High	Low	Short Term	Low

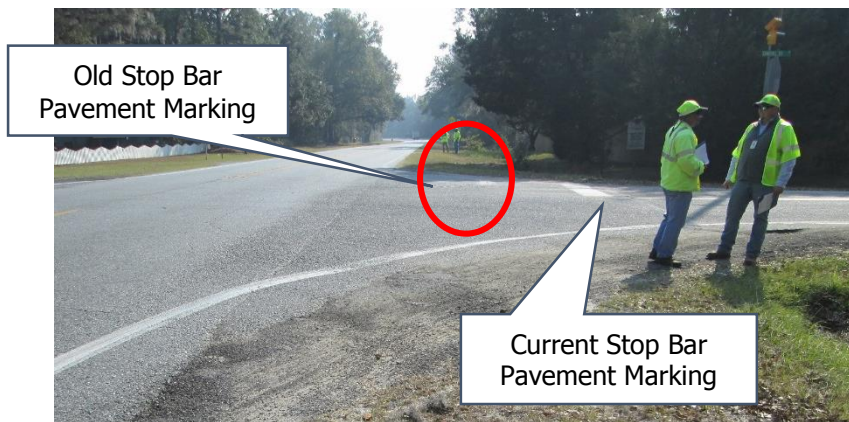
8. Along Marlow Road, approaching the intersection, grass and other vegetation has grown over the shoulder and covers the edge line pavement markings.
9. The old (former) stop bar on the Sandhill Road approach is worn yet is still visible (located approximately six feet closer to the center of the intersection than the new one, see Figure 4-4), even though a new stop bar has been installed. This may be potentially confusing to motorists.

FIGURE 4-4. VIEW FROM SANDHILL RD. STOP BAR LOOKING SOUTHBOUND ALONG SR 17. NOTE THE VEGETATION, MULTIPLE STOP BARS, AND WHITE FENCE IN THE SOUTHEAST QUADRANT.

3. A white fence on the church property in the southeast corner of the intersection may obscure the view of SR 17 from the Marlow Road approach.
4. The horizontal curve approximately 700 feet east of the study intersection along Marlow Road may limit sight distance. The audit team observed heavy vegetation growing that may obscure the view of the study intersection. Marlow Road is a County Road, therefore improvements to this portion of the road (away from the intersection at SR 17) would be the County's responsibility.

5. Clear debris and vegetation covering existing pavement markings, such as edge lines.	Low	Low	Short Term	Low
6. Remove former, yet still visible, worn stop bar on Sandhill Road approach to avoid potential confusion, since a newer stop bar has recently been installed.	Low	Low	Short Term	Low

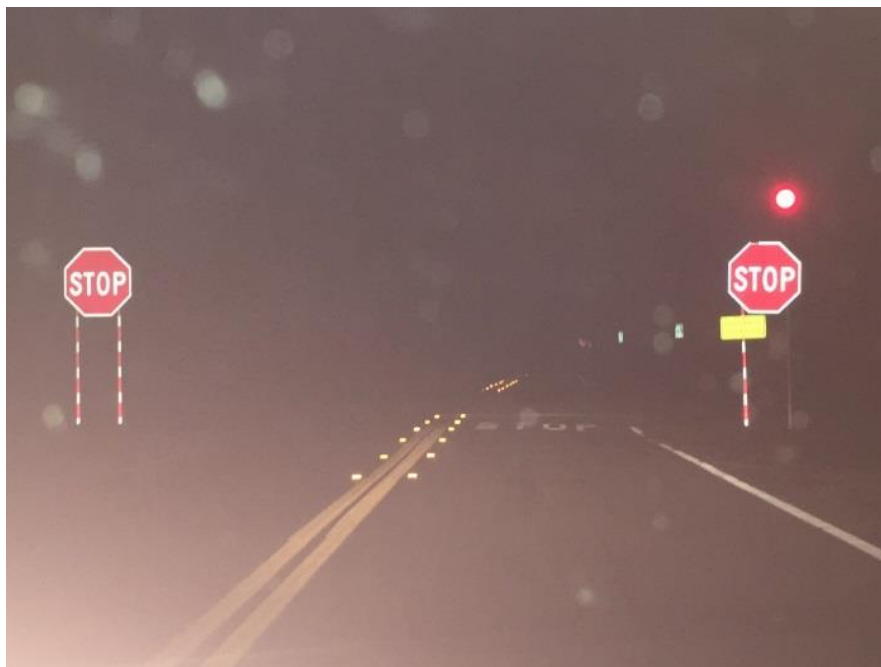
FIGURE 4-5. VIEW OF PAVEMENT MARKINGS, SIGNS AND RPMs ON MARLOW ROAD AT STUDY INTERSECTION DURING NIGHT INSPECTION

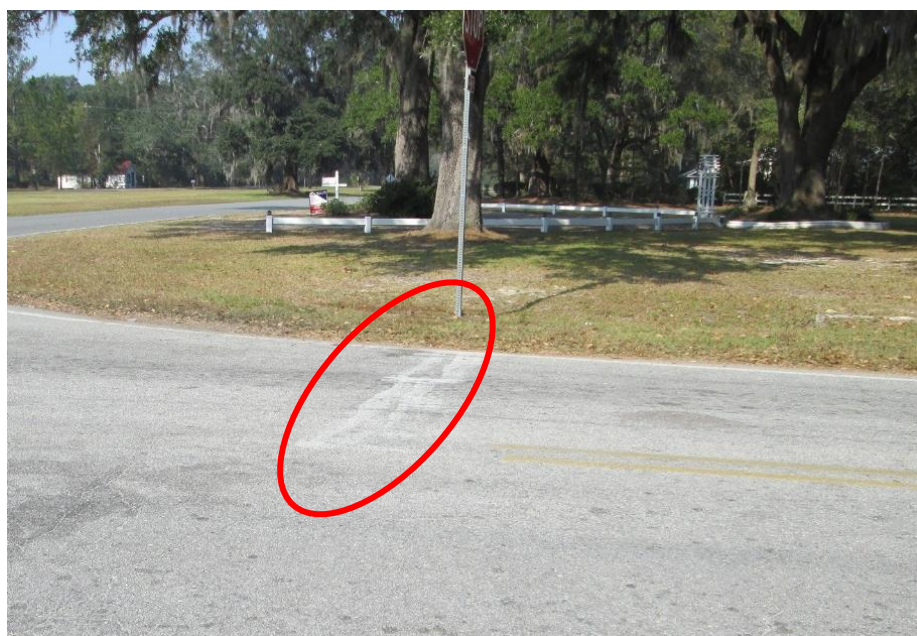
5. The yellow center line and edge line pavement markings on SR 17 are worn and faded.
6. Pavement markings at the intersection of Sandhill Road and Sandhill Road/Central Avenue are worn and faded.

FIGURE 4-6. WORN, FADED STOP BAR AT SANDHILL ROAD AT SANDHILL ROAD/CENTRAL AVENUE INTERSECTION

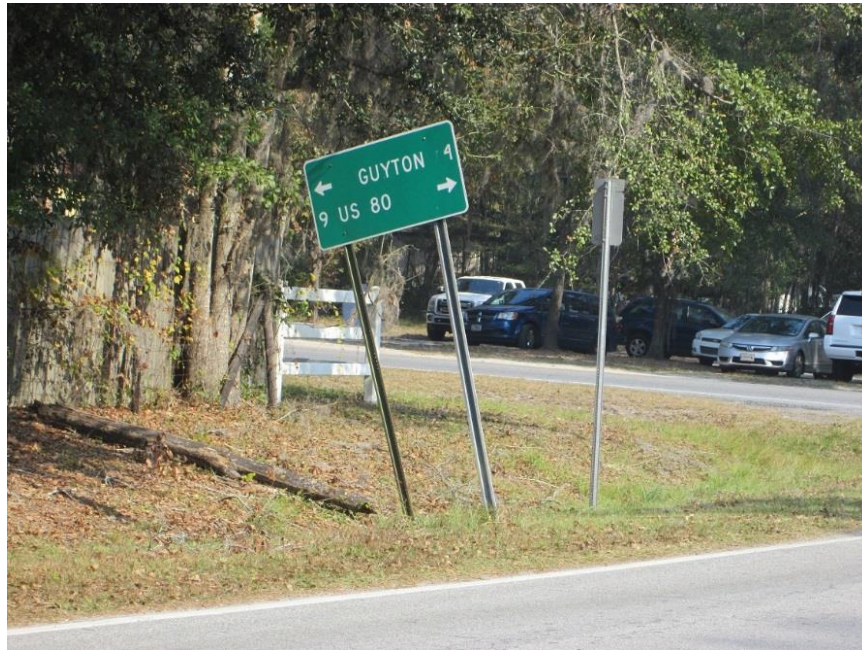
7. The directional sign on the left (north) side of the Sandhill Road approach is damaged.
8. Multiple bike route signs are located on individual posts. The audit team suggests consolidating the signs on one post to reduce visual clutter.

FIGURE 4-8. DAMAGED DIRECTIONAL SIGN ON NORTH SIDE OF SANDHILL ROAD APPROACH (NORTHWEST QUADRANT OF STUDY INTERSECTION)

5. Replace damaged directional sign on the left (north) side of the Sandhill Road approach.	Low	Low	Short Term	Low
6. Update and/or install red reflective strips on all "Stop" sign posts to meet current standards.	High	Low	Short Term	Low

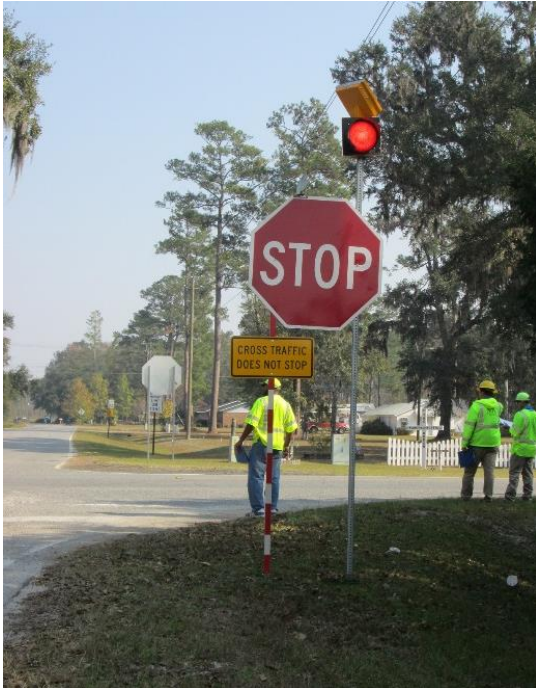
FIGURE 4-10. STOP SIGN ON SANDHILL RD WITH SUPPLEMENTAL "CROSS TRAFFIC DOES NOT STOP" SIGN AND FLASHING RED BEACON. NOTE THE REFLECTIVE RED AND WHITE STRIP. TO MEET CURRENT STANDARDS, A RED ONLY STRIP SHOULD BE ON BOTH POSTS.

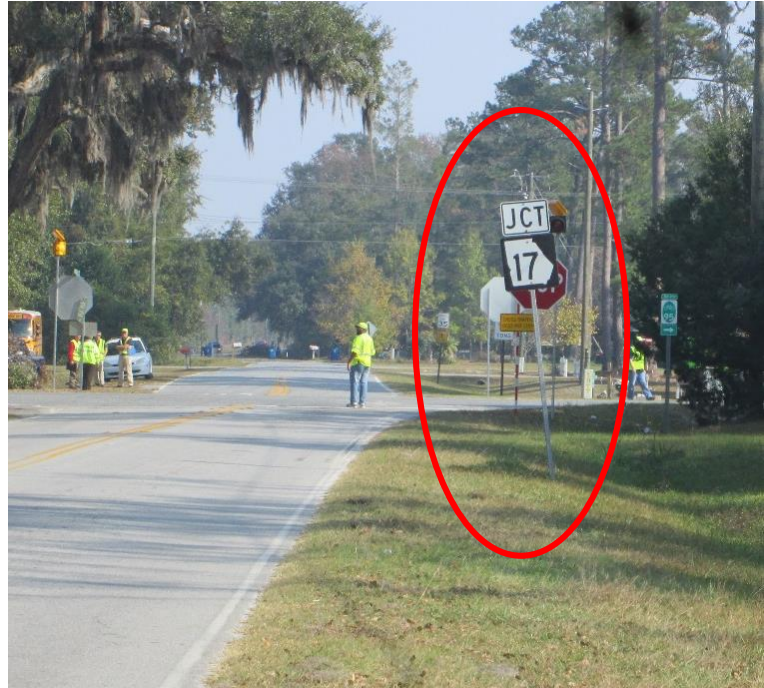
FIGURE 4-9. OVERLAPPING SIGNS ON SANDHILL RD APPROACH

8. Install SR 17 sign and auxiliary junction sign (M2-1) on Marlow Road approaching SR 17 to alert motorists to the intersection with the state route ahead. These signs are already present on the Sandhill Road approach (see Figure 4-9).	Low	Low	Short Term	Low

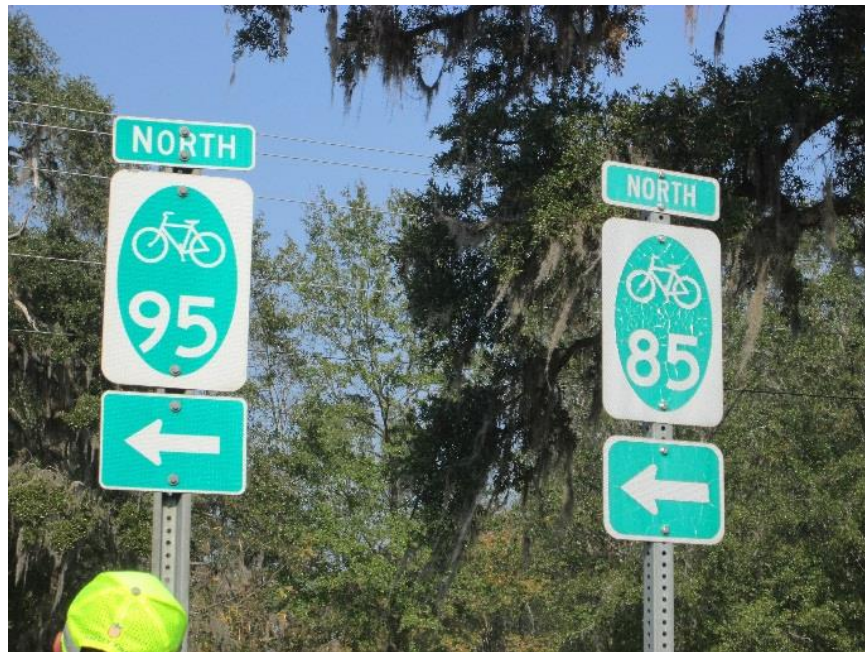
FIGURE 4-11. MULTIPLE BIKE SIGNS ON INDIVIDUAL POSTS

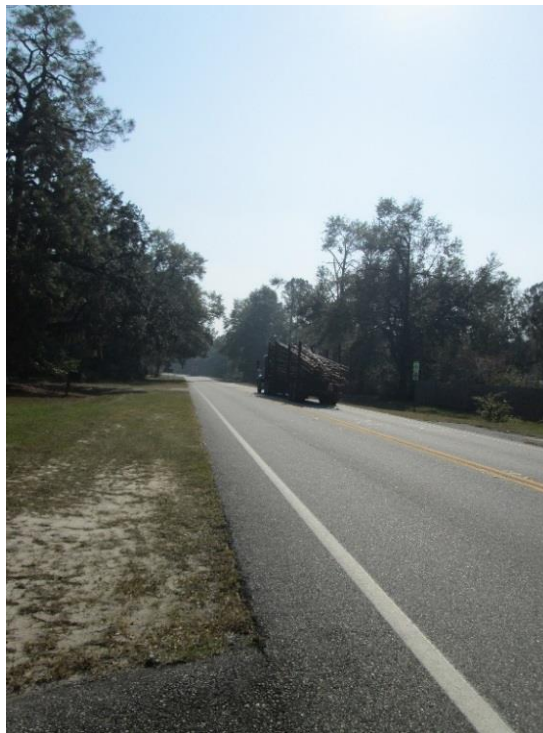
FIGURE 4-16. VIEW FROM SOUTHEAST CORNER OF STUDY INTERSECTION LOOKING SOUTHBOUND ALONG SR 17 TOWARD CURVE. NOTE THE LOG TRUCK TRAVELLING ALONG SR 17.

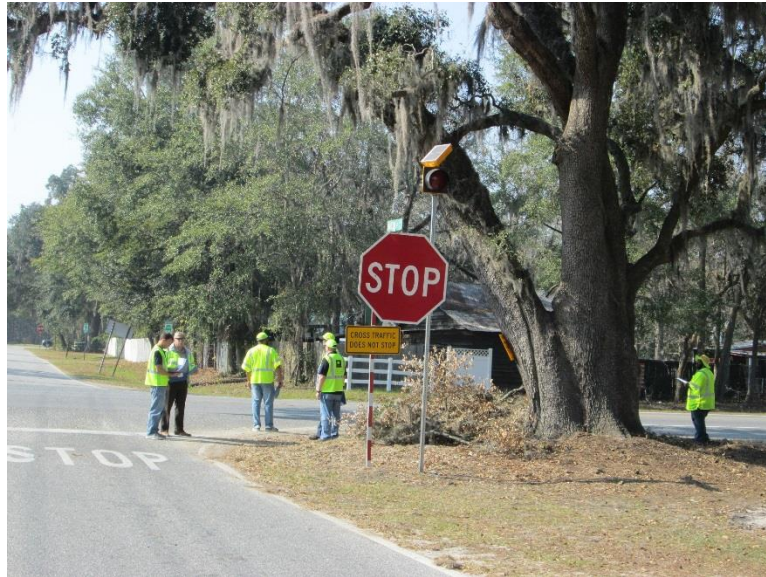
2. Trees and vegetation on intersection corners partially block sight lines and limit sight distance of vehicles traveling on SR 17. Although there are advance warning signs, drivers may not be aware of the intersection due to vegetation along the roadway.

FIGURE 17. VEGETATION MAY CONTRIBUTE TO DRIVERS NOT SEEING THE INTERSECTION CLEARLY.

SAFETY BENEFIT	LEVEL OF EFFORT	TIME FRAME	COST
1. Investigate sight distance at all intersection approaches and implement recommendations as appropriate, including trimming back or removing trees and vegetation.	Moderate	Low	Intermediate	Low
2. Install a narrow raised concrete splitter island with delineator posts on the side street approaches to SR 17 to channelize turning movements and help communicate the presence of the intersection to approaching motorists.	High	Moderate	Intermediate	Moderate
3. Trim/maintain vegetation near horizontal curve on Marlow Road.	Low	Low	Short Term	Low

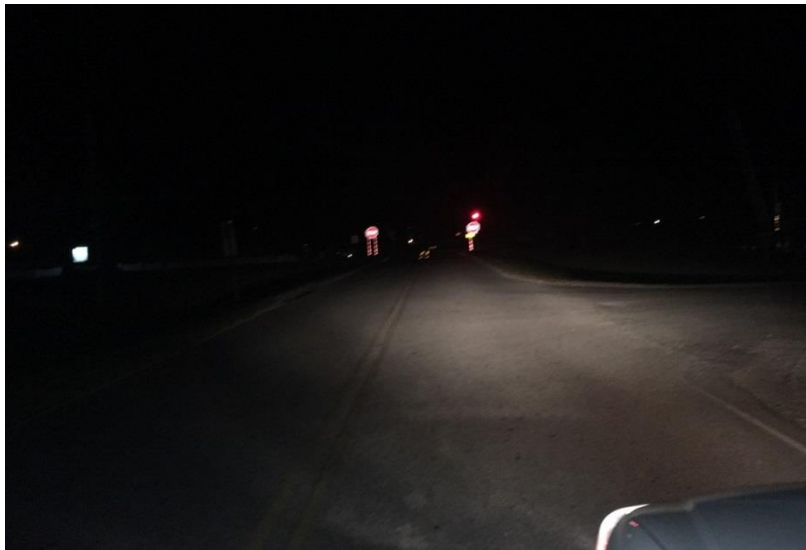
FIGURE 4-20. VIEW OF INTERSECTION AT NIGHT. THERE ARE NO STREET LIGHTS OR OTHER LIGHTING PRESENT

SAFETY BENEFIT	LEVEL OF EFFORT	TIME FRAME	COST
1. Install general lighting at the intersection to increase visibility and to illuminate the intersection itself.	High	Moderate	Intermediate	Moderate

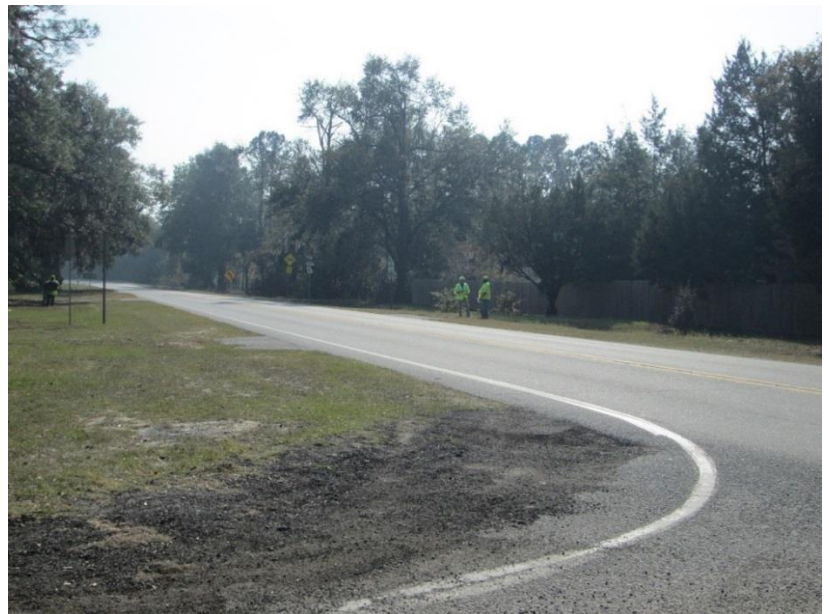
FIGURE 4-21. RUTTING IN THE SOUTHEAST CORNER, FROM VEHICLES TURNING FROM SR 17 ONTO EASTBOUND MARLOW ROAD
