## Folsom City Council Staff Report

| <b>ITEM TITLE:</b> | Resolution No. 11693 – A Resolution Authorizing the City Manager to Execute Amendment No. 2 to the Agreement (Contract No. 173-21 24-039) with West Yost & Associates, Inc. for \$402,886 from the Water Operating Fund (Fund 520) for Additional Construction Management and Inspection Services for the Tower Tank Rehabilitation Project (Project WA2402) and Appropriation of Funds |

| <b>Report #</b> 06052026 | | | |
| <b>Project Name:</b> | Misc. Tank Rehab Project – Tower Tank | <b>Inspector:</b> | Igor Tutelya |

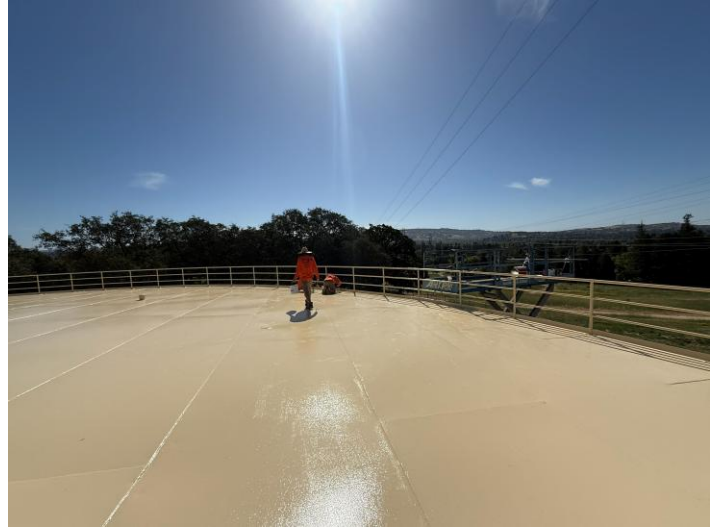
ESM crew members performing 2<sup>nd</sup> finish coat application to exterior roofs handrails.

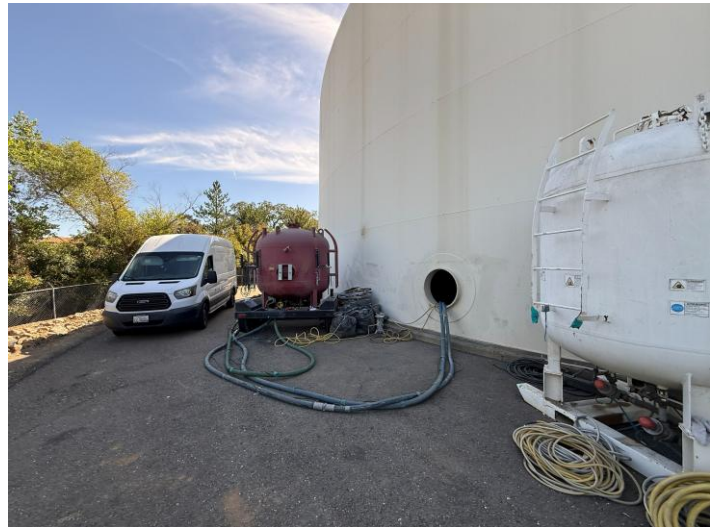
Abrasive blasting operations being performed on the interior floor of the Foothill Tank.

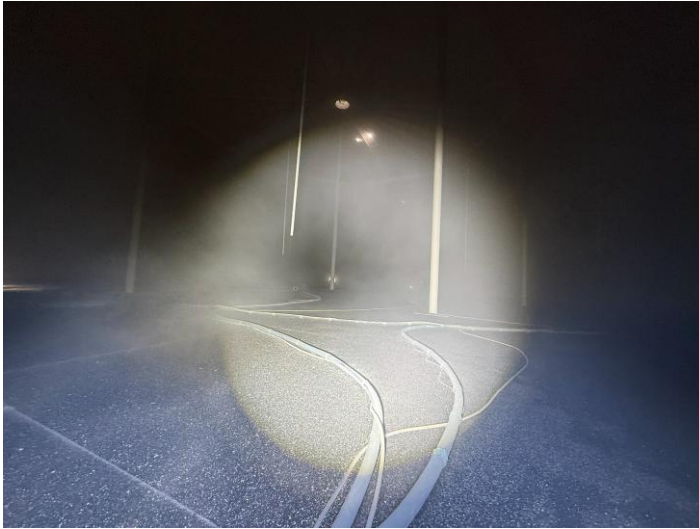
Sweep blasting operations being performed on the interior floor. Picture #1

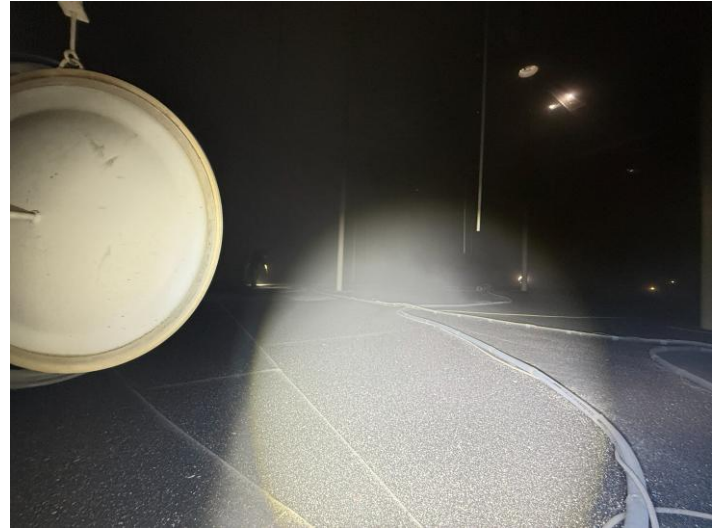
Sweep blasting operations being performed on the interior floor. Picture #2

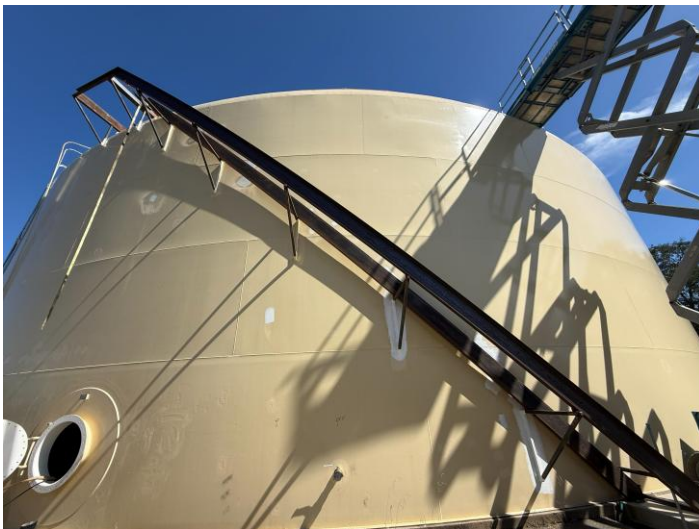
DFT measurements for the 1<sup>st</sup> spot prime coat located near the exterior shell's stairway were unable to be performed.

Spot primed areas located on the exterior shell of the Tower Tank near the stairway.

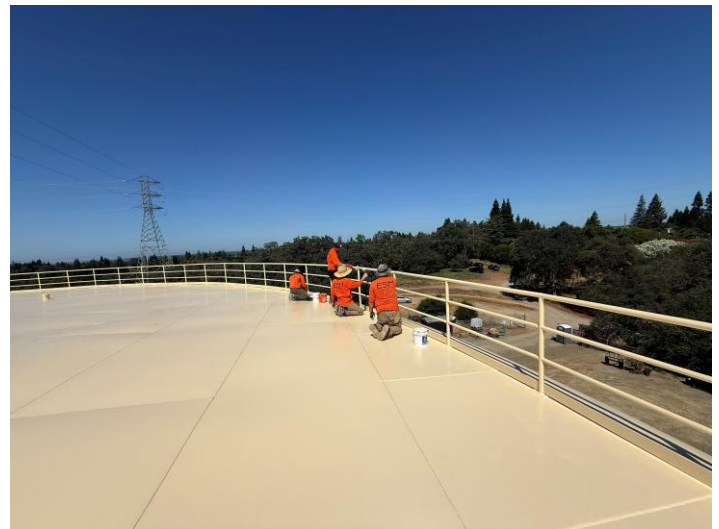
ESM crew members continuing 2<sup>nd</sup> finish coat application. Picture #1

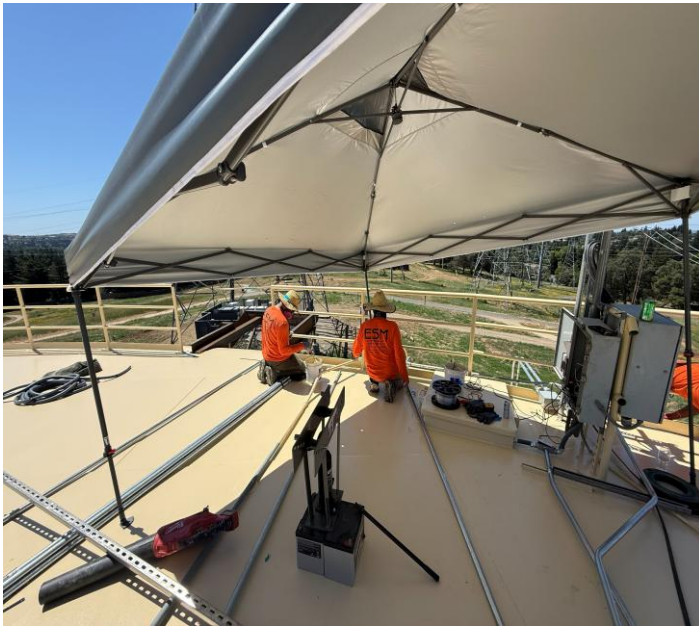
ESM crew members continuing 2<sup>nd</sup> finish coat application.  
Picture #2

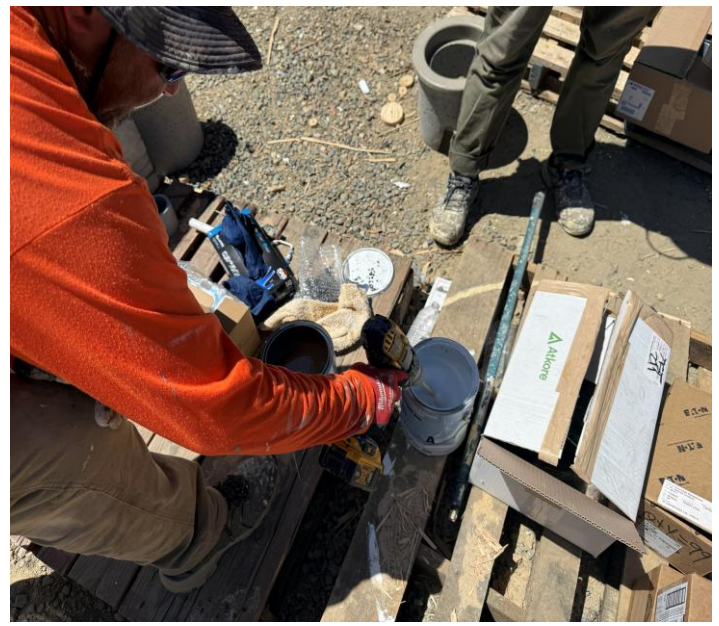
Part A & B of Macropoxy 646 being pre-mixed prior to  
beginning mixing operations.

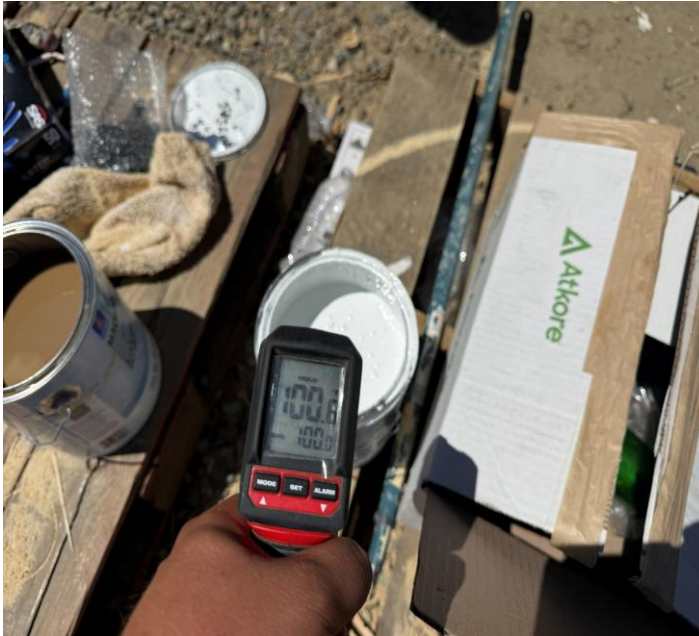
Coating material temperature at 100°F

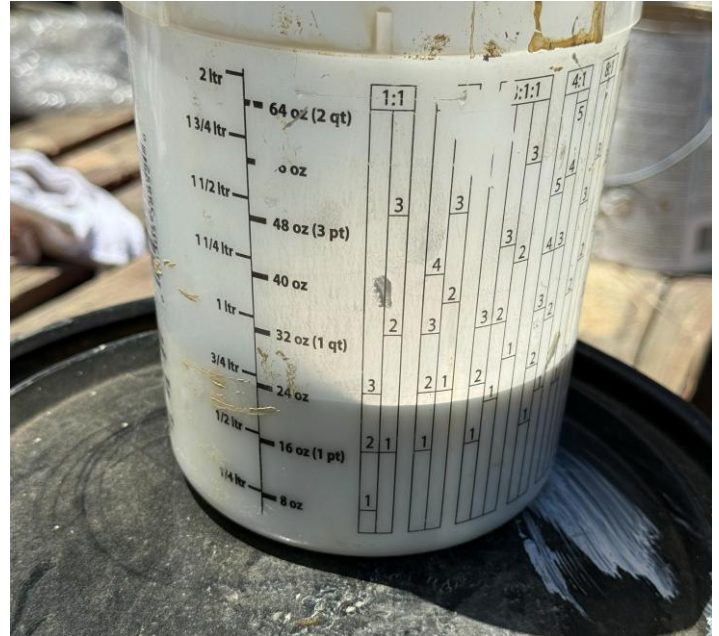
24 ounces of part A added to measuring cup.

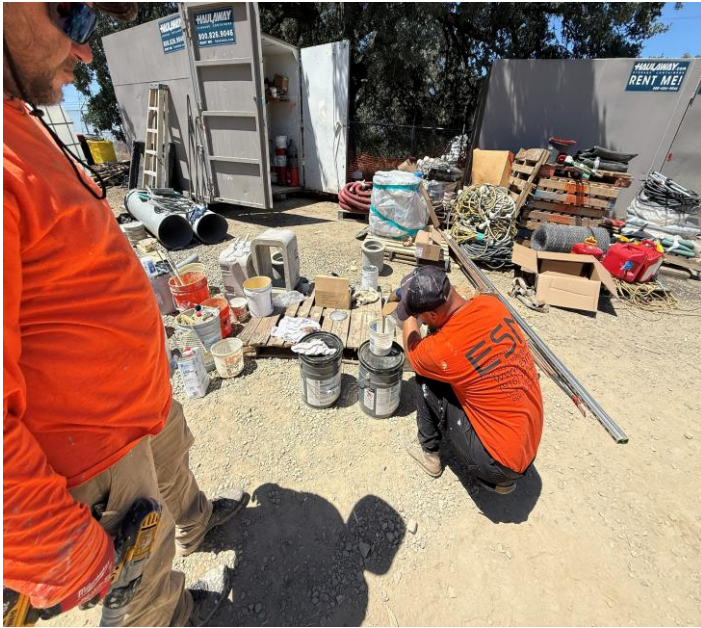
ESM crew members add part B to the measurement.

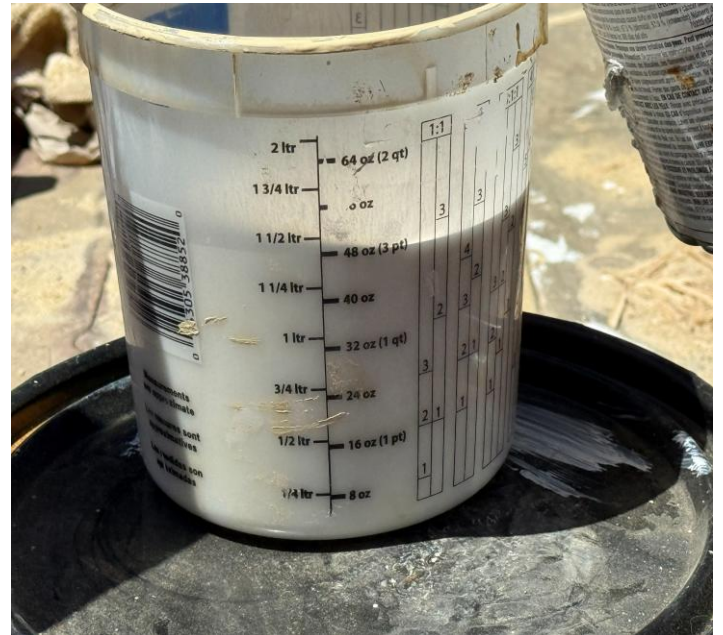
48 ounces verified. 1:1 ratio acceptable.

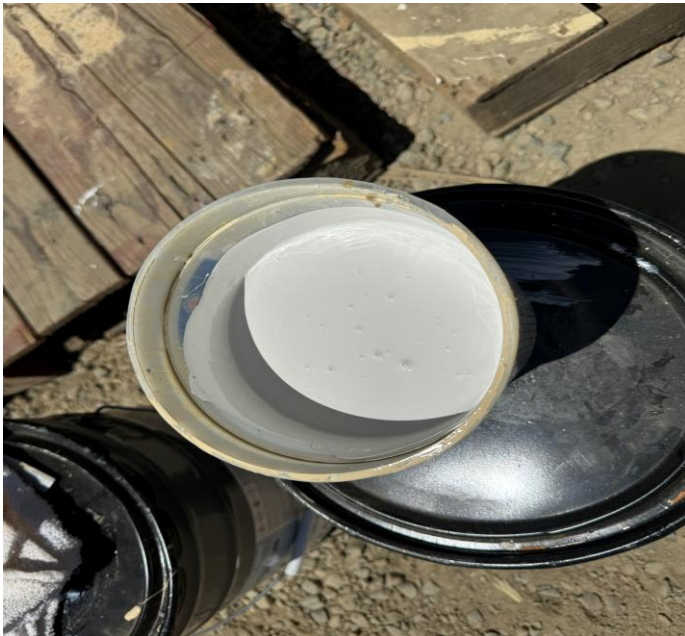
Mixed material undergoing induction.

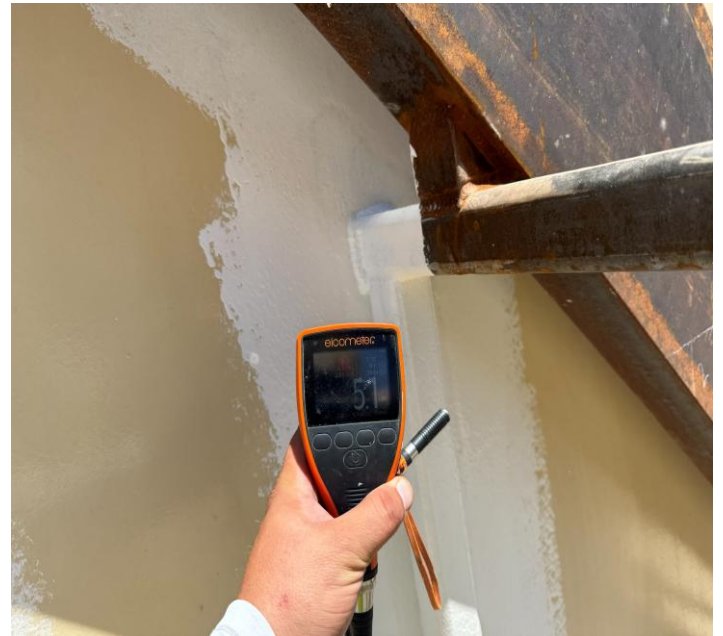
Lower sections of bare metal spot primed areas contained acceptable mil ranges.

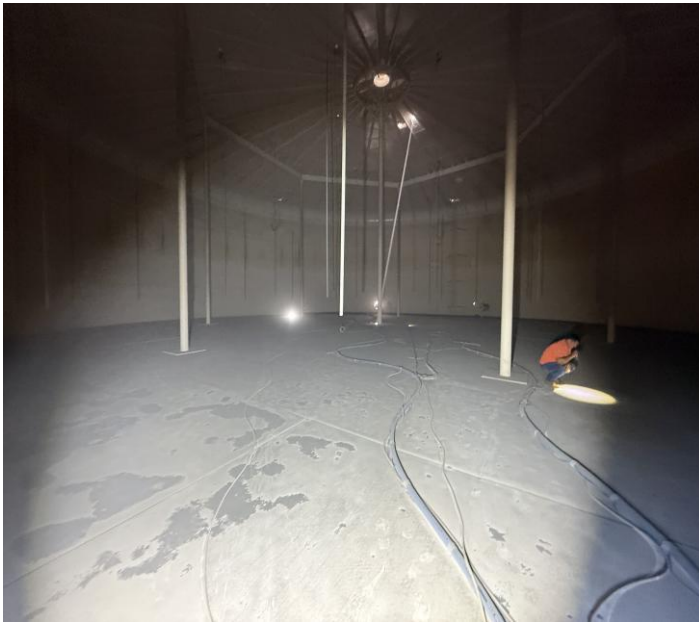
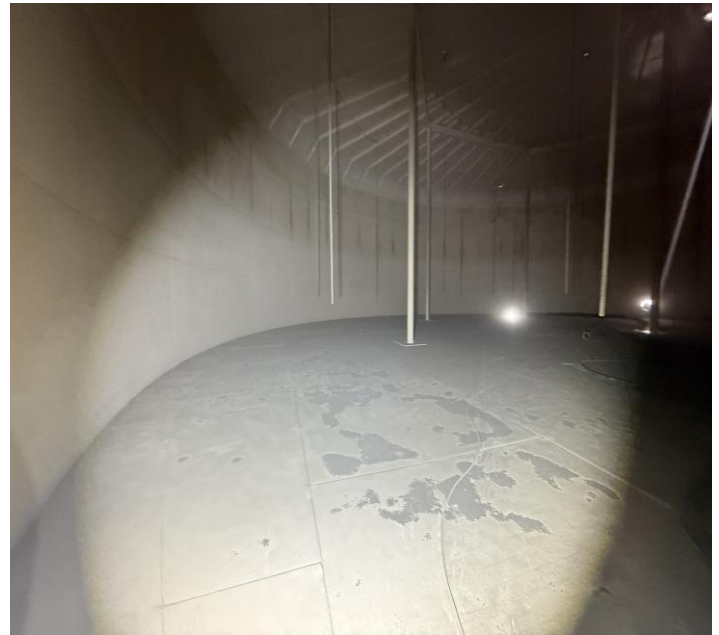
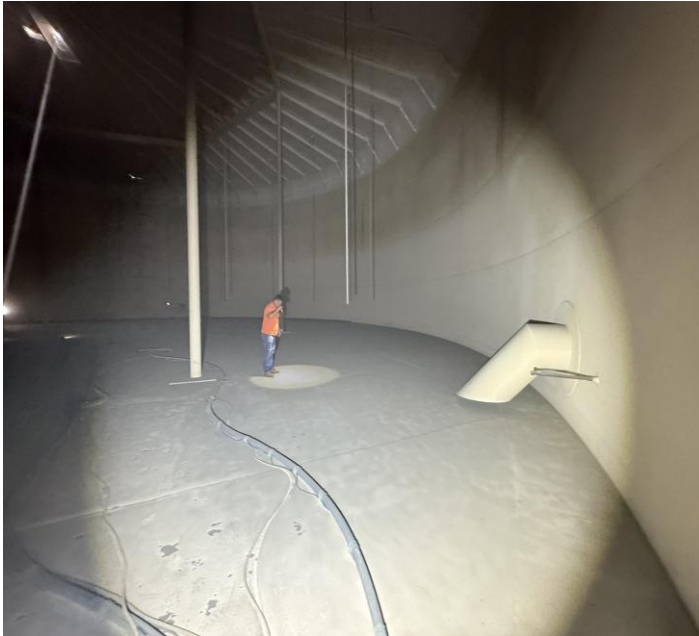
During today's operations, ESM crew members completed the second finish coat application on the Tower Tank exterior roof handrails and continued spot repair operations on the exterior shell. A preliminary blast inspection of the Foothill Tank interior floor revealed coating blistering, disbondment, and brittle coating failure in multiple locations.

Interior floor of the Foothill Tank. Picture #1

Interior floor of the Foothill Tank. Picture #2

Interior floor of the Foothill Tank. Picture #3

BACC recommends complete removal of the existing floor coating system prior to installation of a new coating system.

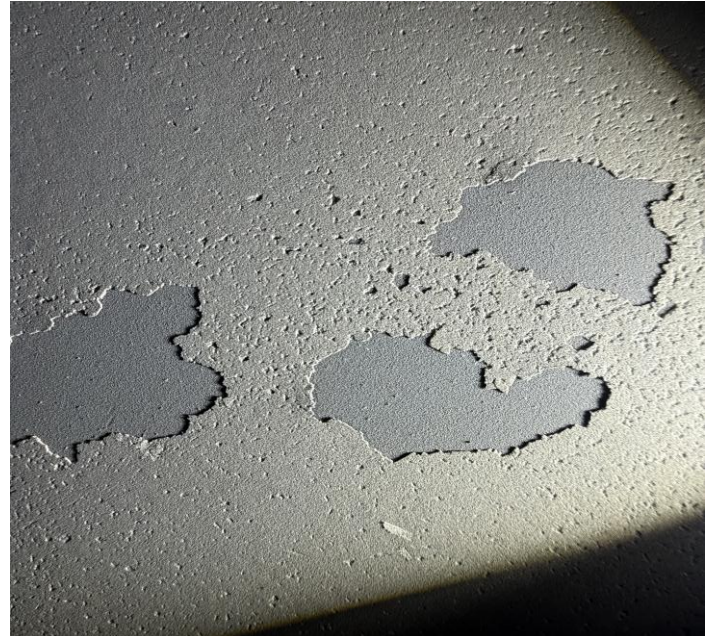
Visible lifting edges and fractures at bare substrate locations.

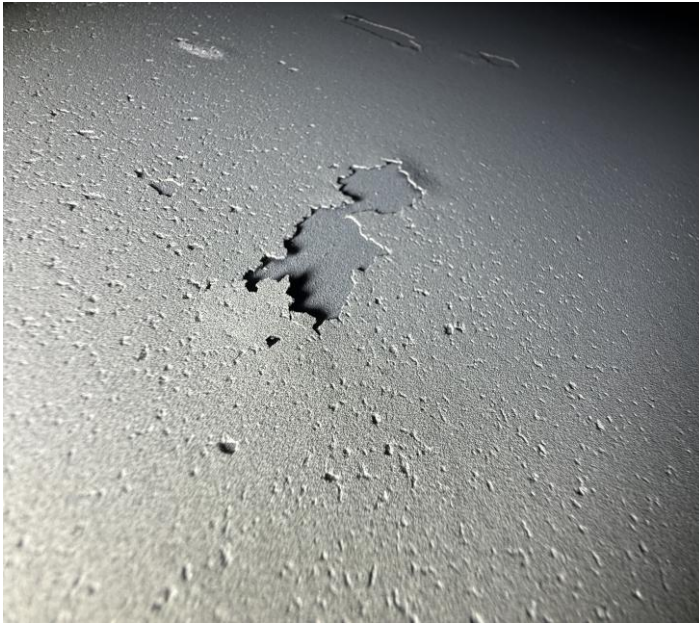
Lifted edges a visible brittleness.

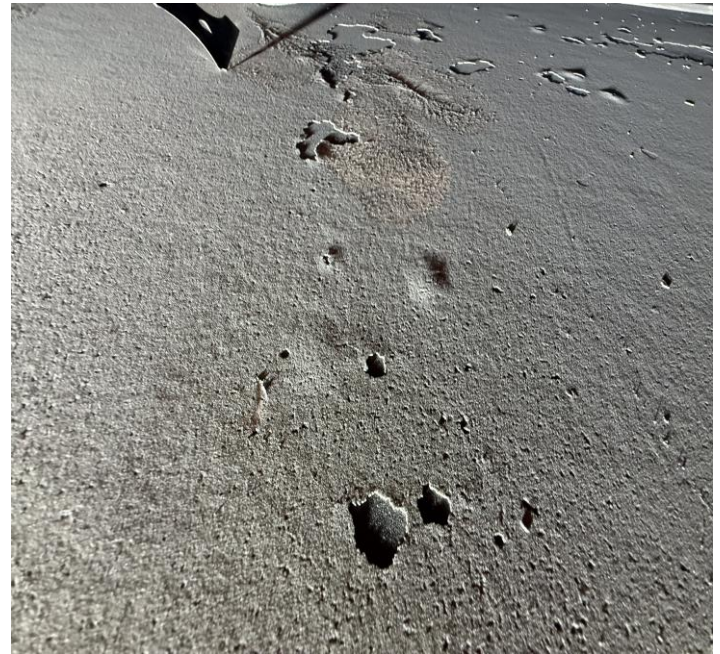
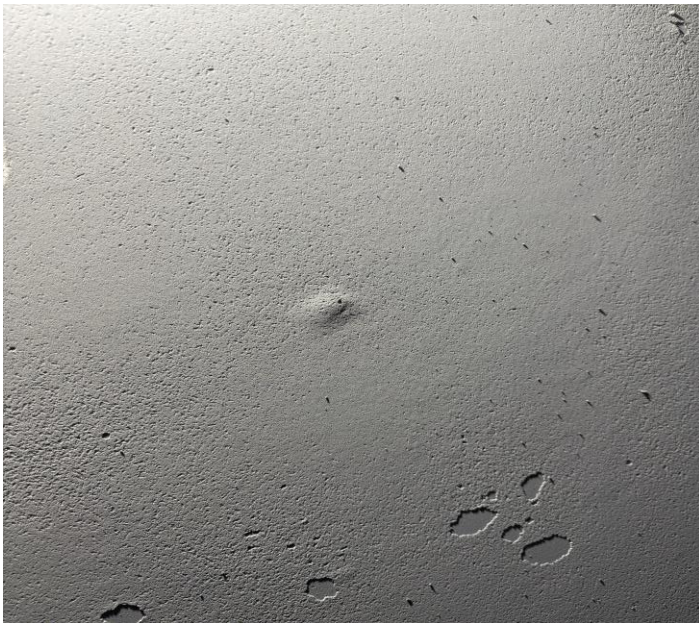
Visible blisters that remained intact after a sweeping blast.  
Picture #1

Visible blisters that remained intact after a sweeping blast.  
Picture #2

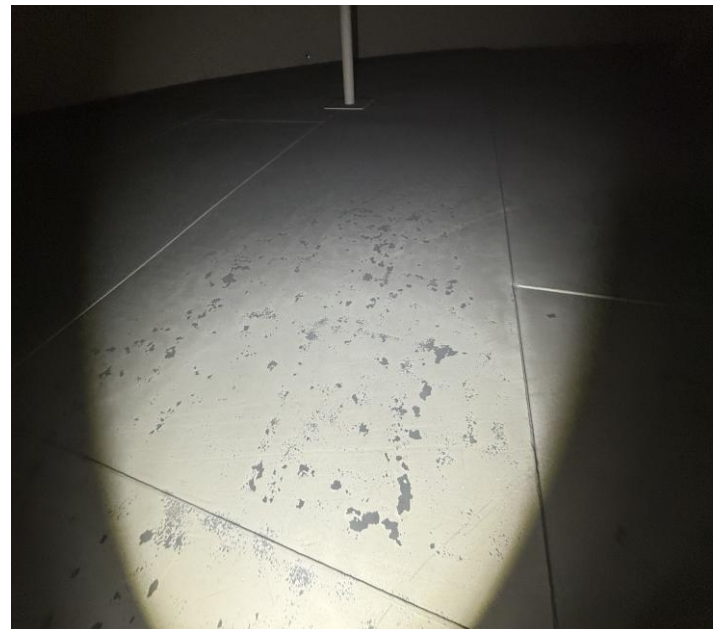
Some floor plate locations are completely widespread.

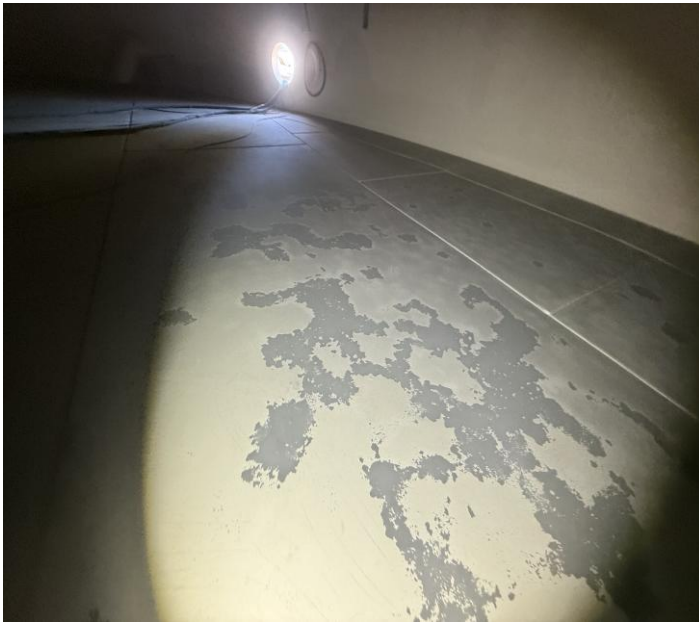
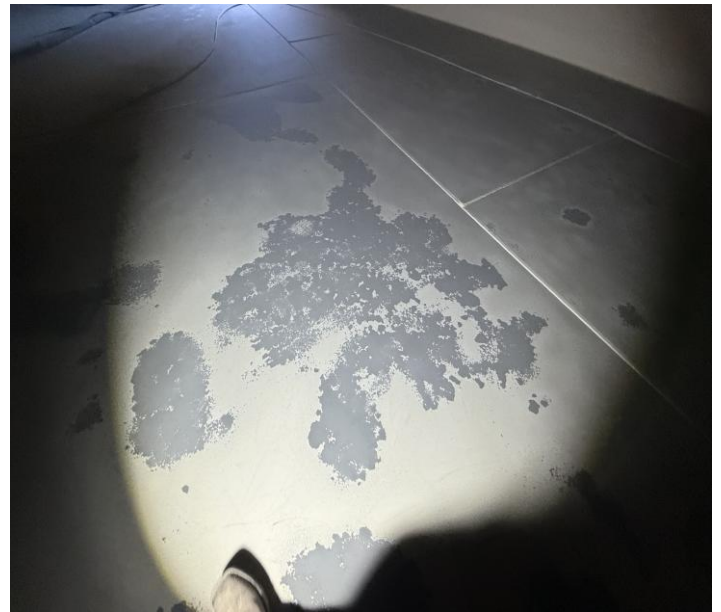
Additional photos of exposed substrate. Picture #1

Additional photos of exposed substrate. Picture #2

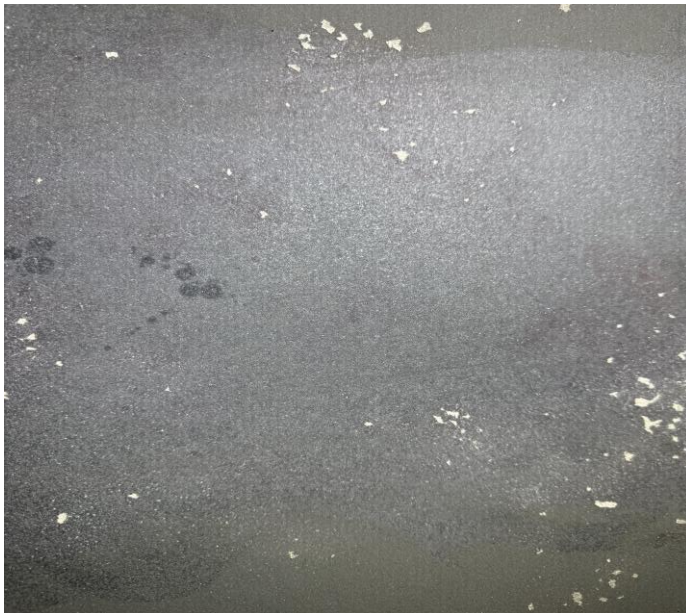
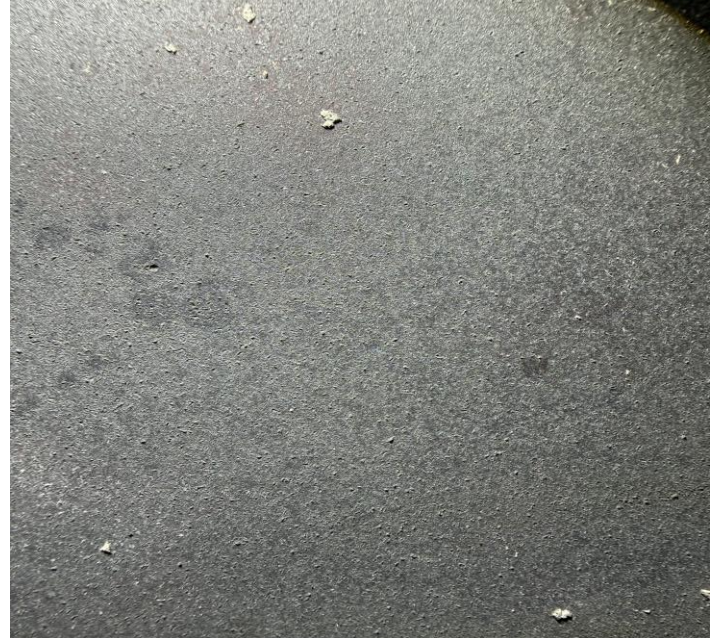
Substrate condition beneath existing coating. Picture #1

Substrate condition beneath existing coating. Picture #2
