**RE: FORT GILLEM WESTERN POND DAM INSPECTION
WA&A J.O. 4300100**

WALDEN, ASHWORTH & ASSOCIATES, INC.
FORT GILLEM WEST POND DAM VISUAL INSPECTION

Date: 11/04/22
Project: Fort Gillem West Pond Dam Visual Inspection
Project No.: 4300100
Project Location: Clayton County, Georgia
Report By: Jason Rapplean, P.E., E.O.R.

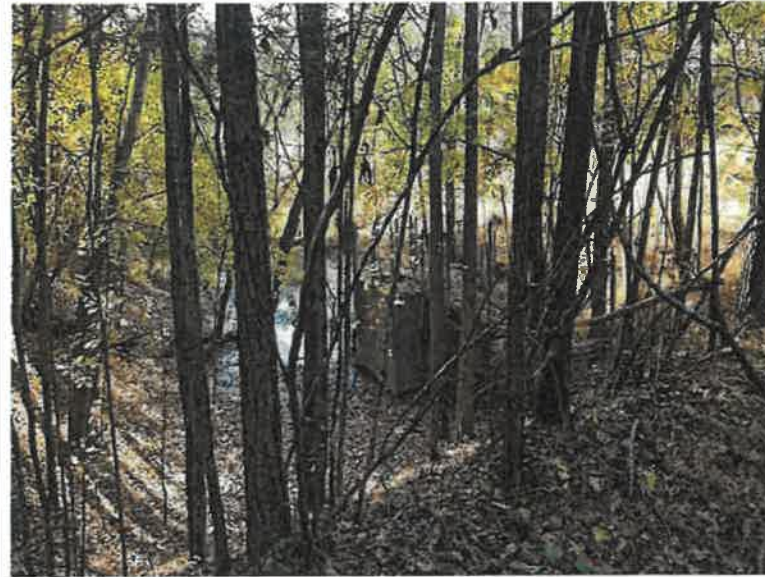
Photo No. 5
Description:

The outflow of the pond is controlled by the primary spillway which consists of a concrete riser structure, low level pipe, and an impact basin. The primary spillway structure is located near the center of the dam and appeared to be generally good condition. However, there was an abundance of debris collected at the trash rack making a detailed inspection of the structure not possible. No detailed observations were possible of the primary spillway structure because of this.

View of primary
spillway riser structure.

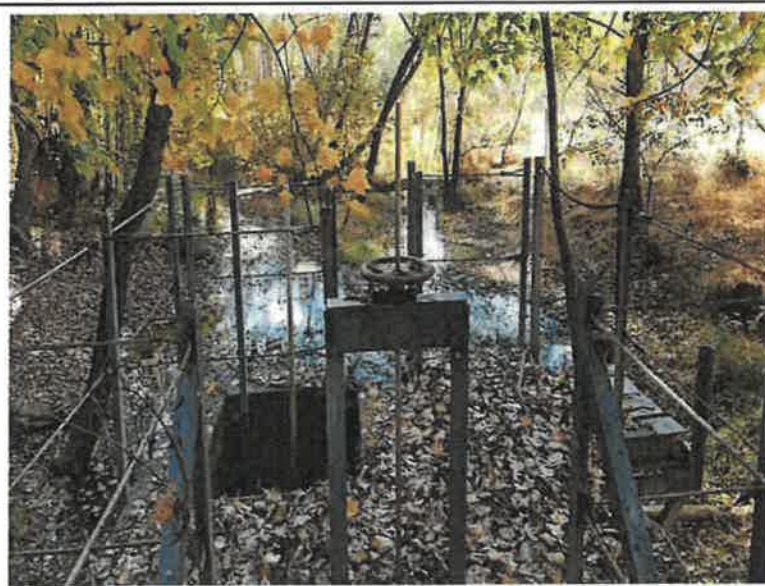
Photo No. 6
Description:

The drawdown outlet works, which is intended to provide a means for stopping outflow into the impact basin, consist of a control gate on the primary spillway concrete riser structure allowing the pond to drain through a low level pipe. The low level outlet pipe terminates at the downstream toe of the dam and discharges into an impact basin. The impact basin and channel appear to be providing adequate dissipation of the energy from flows discharging through the pipe. There was overgrown brush/vegetation growing around the impact basin and outlet channel making inspection difficult. This area should be cleared of overgrown brush to allow for easier inspection.

View of primary
spillway riser structure
and slide gate wheel.

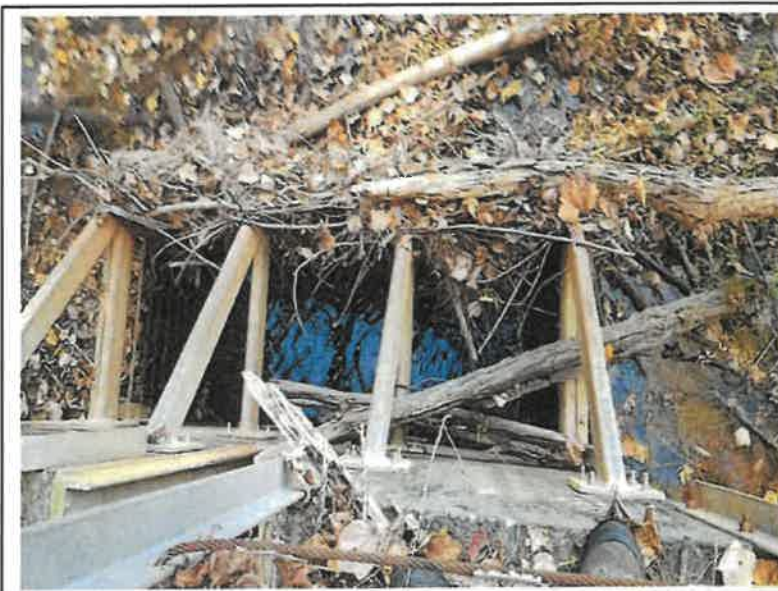
Photo No. 9
Description:

View of primary spillway riser structure trash rack. Note debris build up and blockage.

1. Clear the crest and upstream slope of the dam of trees and heavy brush.
2. Grass the cleared upstream slope and crest.
3. Clean off downstream embankment concrete armoring and look for any cracking.
4. Heavy vegetation and/or brush around the primary spillway outlet needs to be cleared to allow for easier inspection.
5. Clear debris from trash rack on primary spillway riser structure. Clear trees/debris from upstream pond area.
6. Apply grassing to all areas cleared in the upstream pond area.
7. Provide periodic maintenance/inspection of the dam (2-4 times a year). Look for any issues, clear any debris from trash rack etc.

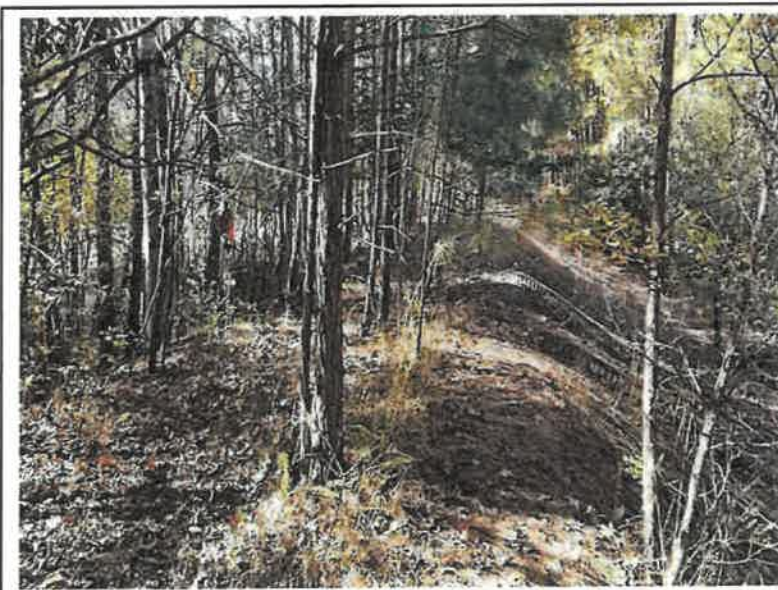
Photo No. 10
Description:

The downstream slope of the dam is armored with concrete with some vegetation growing on it. A detailed inspection of the condition of the concrete was not possible due to vegetation but appeared to be in good condition with no major cracking observed. This armoring is protection for the dam overtopping. No Hydrology or Hydraulic analysis has

been done to calculate if the dam overtops and if it does what storm event begins overtopping. The slope appears to be approximately 3 horizontal on 1 vertical (3:1). No signs of sloughing or sinkholes were observed.

View of downstream embankment. Note concrete armoring with some vegetation growing.

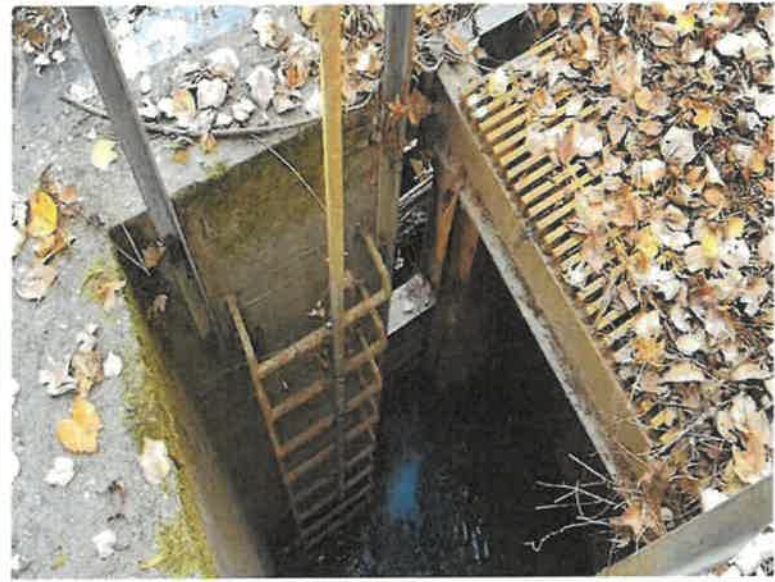
Photo No. 7
Description:

View of primary spillway riser structure. Note weir and access ladder.

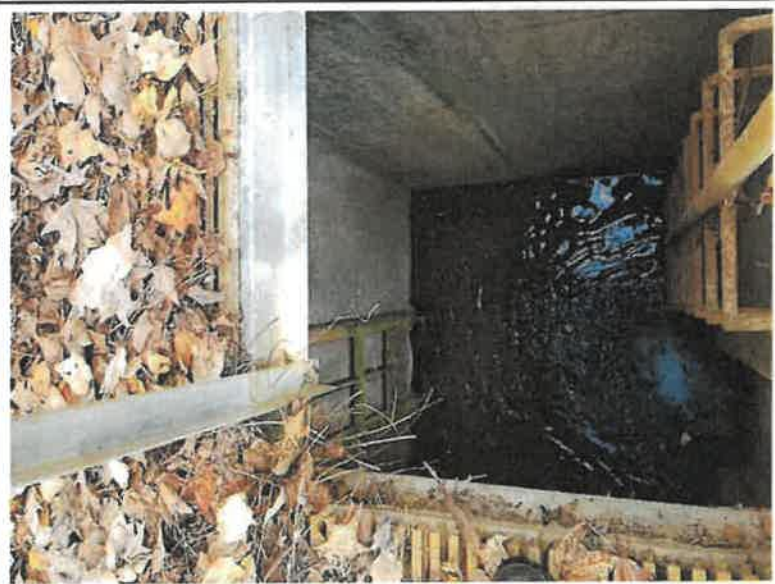
Photo No. 8
Description:

View of primary spillway riser structure. Note outlet pipe with slide gate.
