RE: Starr Park Indoor Pool - Soils and Building Foundation Investigation

Letter Report of Geotechnical  
Evaluation  
Starr Park Indoor Pool  
Forest Park, Georgia

RE: Letter Report of Geotechnical Evaluation  
**Starr Park Indoor Pool**  
Forest Park, Georgia  
Project No. ESSEN-23-GA-07217-01

Re: **Starr Park Pool – Foundation Evaluation.**  
SSE Project #: 23004

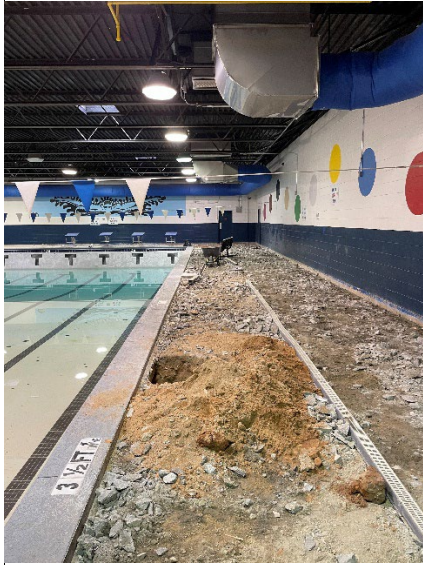
Our first site visit was on February 17, 2023. At the time of that visit the existing concrete slab between the west side of the pool and the existing adjacent building wall had been removed, as shown on Photos 1 and 2 in the attached Photograph Log. No soft or wet areas were observed with the exception of a localized area adjacent to a return inlet towards the northwest corner of the pool. This location is shown on attached Figure 1 (Pool Diagram) and on Photo 3. The contractor had dug an approximate 3 foot-deep excavation at the location and exposed an existing 1 ½ inch PVC return pipe, as shown on Photos 4 and 5. The pool operator turned on the pool pump and water was observed leaking from the piping. The water rapidly dissipated into what is suspected to be a gravel layer below the pool. No void or other signs of erosion were observed in the area of the leak. And no other signs leaks were observed in the pool area. No obvious signs of subsidence such as cracking, tilting, etc. were observed in the pool slabs or in the adjacent structure.

Photo 1: Demo area W of pool. View from N. 2/2023

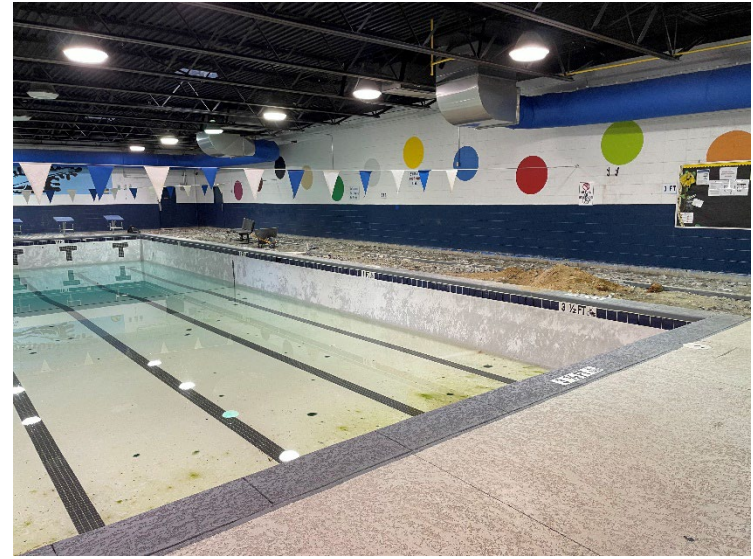
Photo 2: Demo area W of pool. View from NE. 2/2023

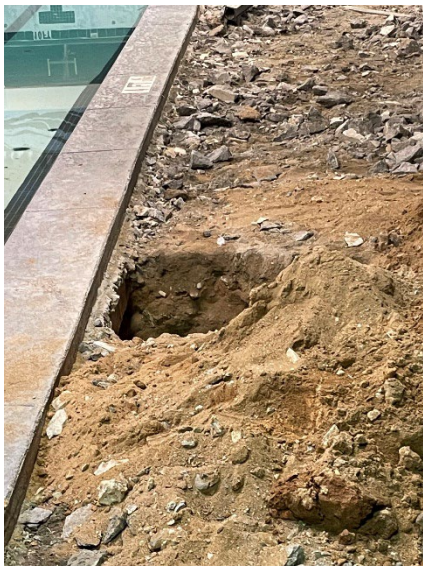
Photo 3: Excavation at inlet pipe leak. View from N. 2/2023

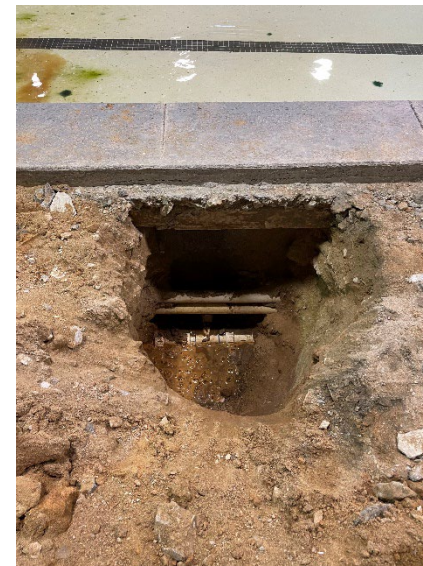
Photo 4: Excavation at inlet pipe leak. View from W. 2/2023

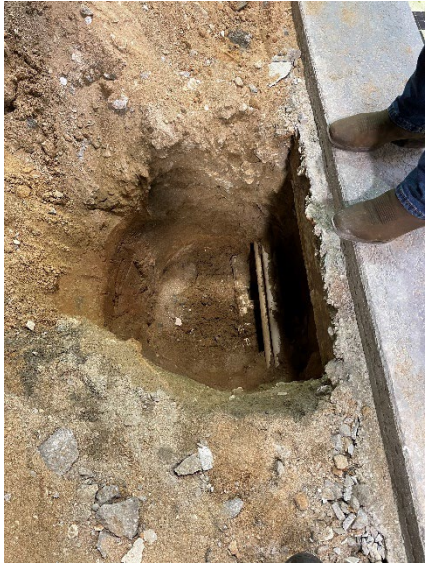
Photo 5: Excavation at inlet pipe leak. View from S. 2/2023

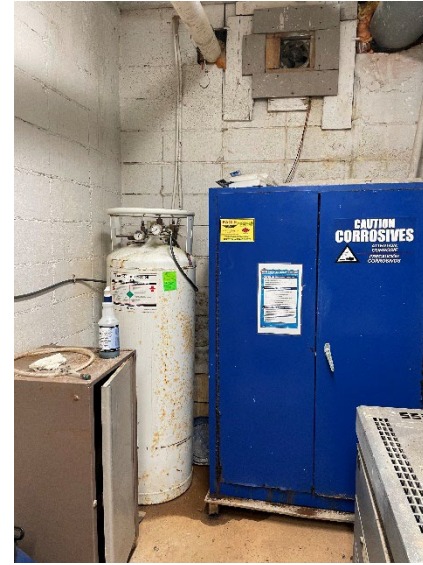
During this visit, we also observed wetness on the lower portion of the east below grade wall for an equipment building southeast of the pool, as shown in Photo 6. Based on our observations it did not appear that the wetness was associated with the pool leaks. We subsequently observed that the exterior ground surface above the wall was somewhat depressed and that there was an existing gutter down drain in this area (Photo 7). We suggested that the area outside the wall be repaired so stormwater flows away from the wall instead of ponding. We also suggested that the down drain be evaluated to determine if there may be a leak. At the end of the February visit, it was agreed that United Consulting would make another site visit once the excavations for widening the pool had been completed so that an additional evaluation of any potential leaks, voids or other signs of subsurface erosion could be made.

Photo 6: E. wall of equipment room. View from W. 2/2023

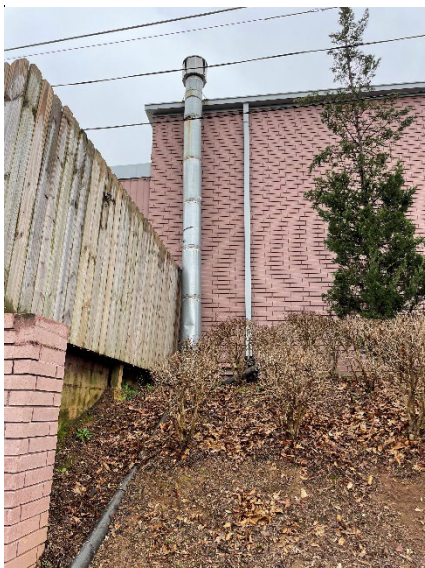
Photo 7: Exterior area E of equip room. View from E. 2/2023

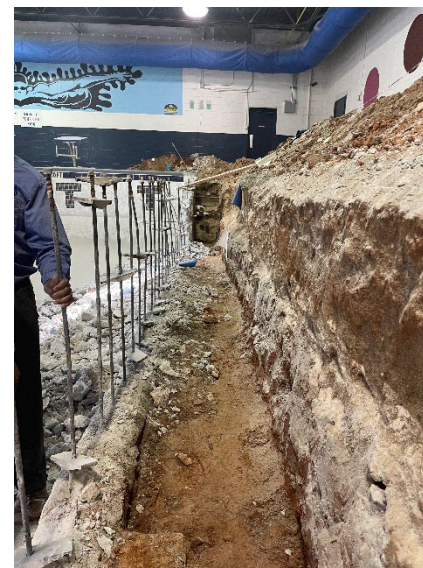
United Consulting returned for a second site visit on May 1, 2023. At this time excavations had been completed along the west and north sides of the pool (Photos 8 through 10). All exposed soils were firm and no signs of leaks, voids or other subsurface erosion were observed. We were also informed by the structural engineer that a 1H:1V plane extending down from the existing foundations did not intersect the excavation face. The contractor also reconfirmed that all pool piping would be removed and replaced.

Photo 8: Excavated area W of pool. View from N. 5/2023

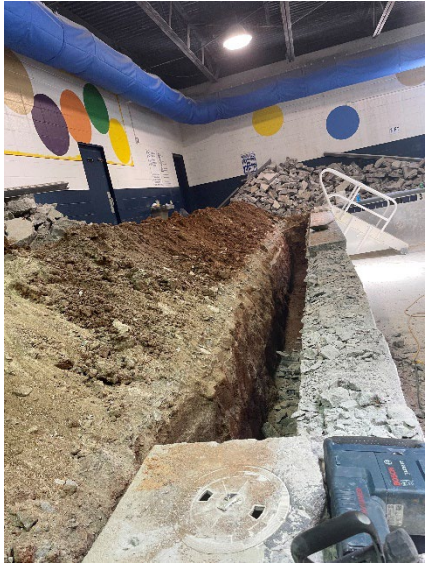
Photo 9: Excavated area N of pool. View from W. 5/2023

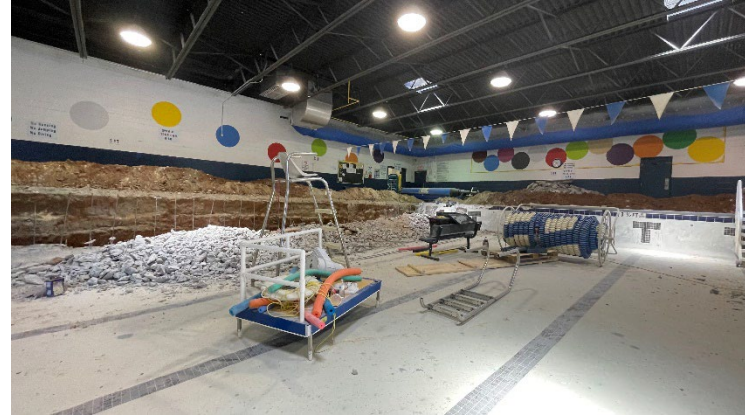
Photo 10: Excavated area W and North of Pool. View from SE 5/2023

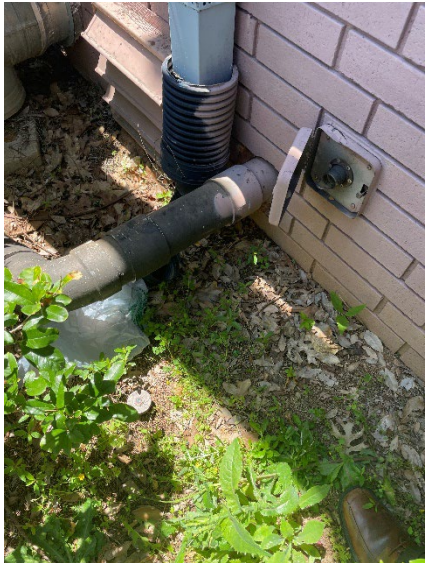
During the May visit, we again observed the exterior ground surface outside the east below grade wall of the equipment building where wetness had been observed during the February visit (Photo 11). The area was unchanged. We also observed the adjacent gutter down drain to the north was damaged and that there was an associated depression at that location (Photo 12). Based on those observations, we recommended that a roofing/gutter specialist be consulted to evaluate all of the building gutters and down drains for potential leaks and repairs.

Photo 11: Area exterior to equip room. View from N. 5/2023

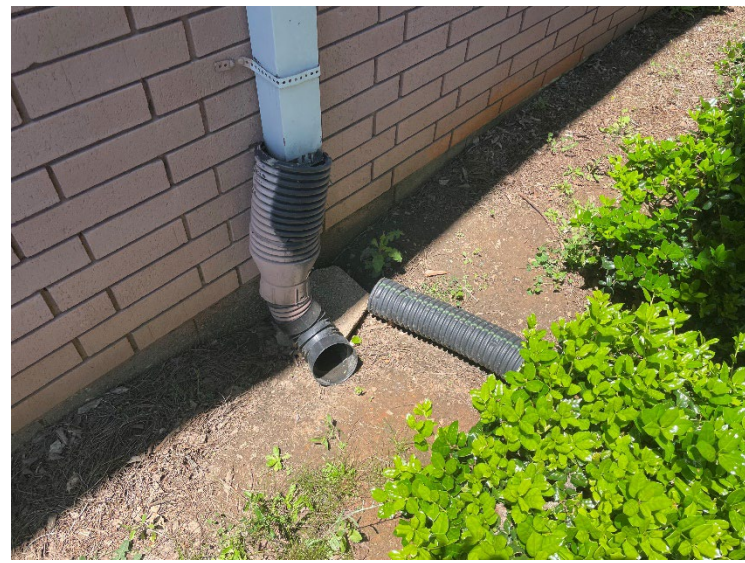
Photo 12: Down drain N of equip room. View from E. 5/2023

1. Allow United Pools to replace all existing piping pool recirculation piping with new PVC piping.
2. Allow United Pools to complete construction of the pool expansion as planned.
3. Under a separate contract, address leakage of storm water near the building's foundation by replacing broken storm drain leaders on the south and east sides of the entire building.

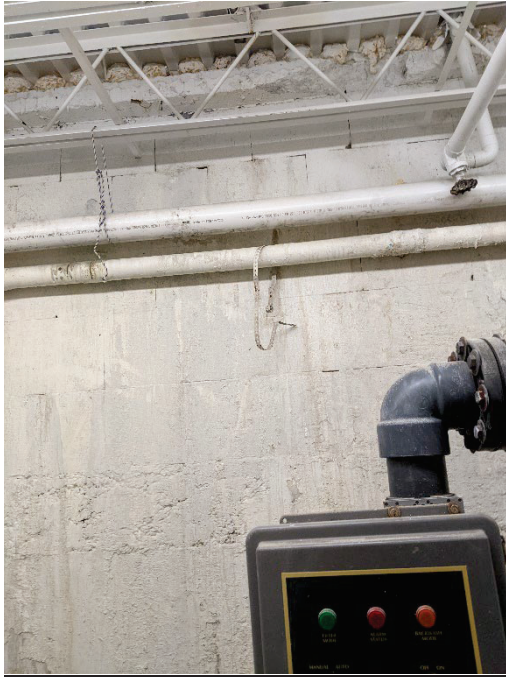
*Photo 1 Southern Pool Wall/Equipment Room Wall*

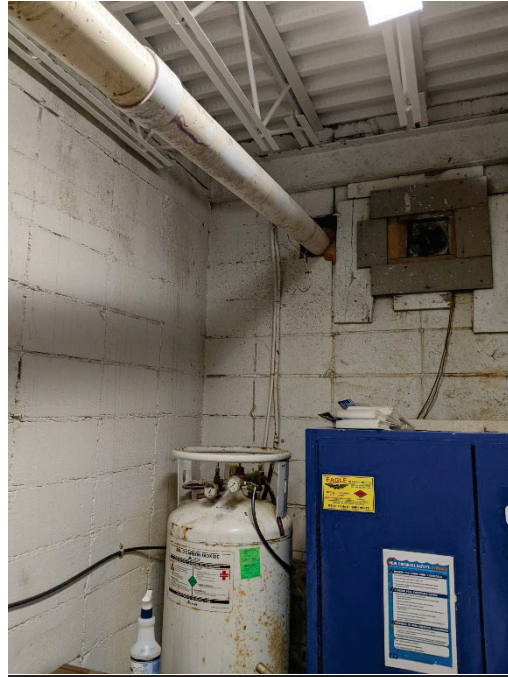
*Photo 3 Eastern Basement wall with water infiltration behind equipment*

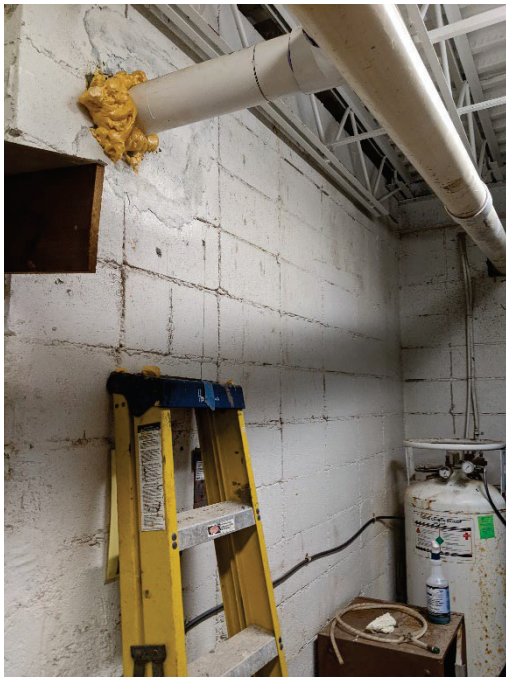
*Photo 2 Southern Pool wall/Equipment Room Wall*

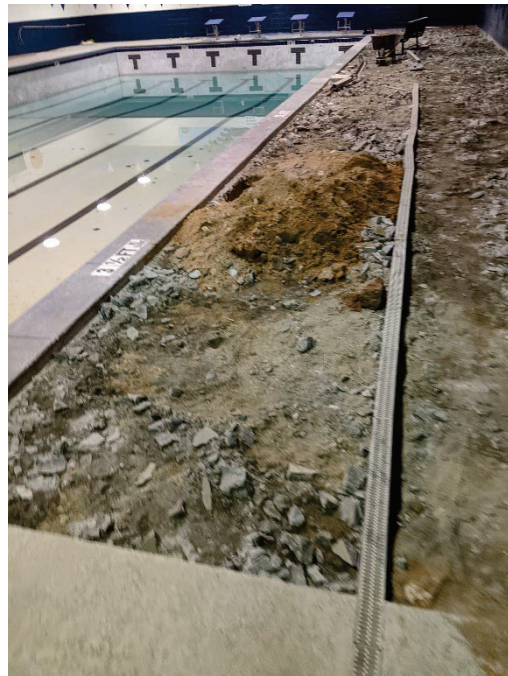
I revisited the site on February 17<sup>th</sup> to review the slab removal around the pool and observe the purported location of the pool leak, See photos 4 and 5. On the west side of the pool a section was excavated to expose a leaking pipe following activation of the pool's recirculation pump. The volume of water flow was too small to fill the excavation. When the system was shut down the water drained out, presumably beneath the pool. There is likely a gravel drainage layer below the pool based on typical construction practices of the 1960's. With absence of any structural foundation damage at or around the pool I concur that replacing all the piping during this renovation will relieve the leak issue and that the leak itself did not cause any structural damage regardless.

*Photo 4 Review of slab removal*

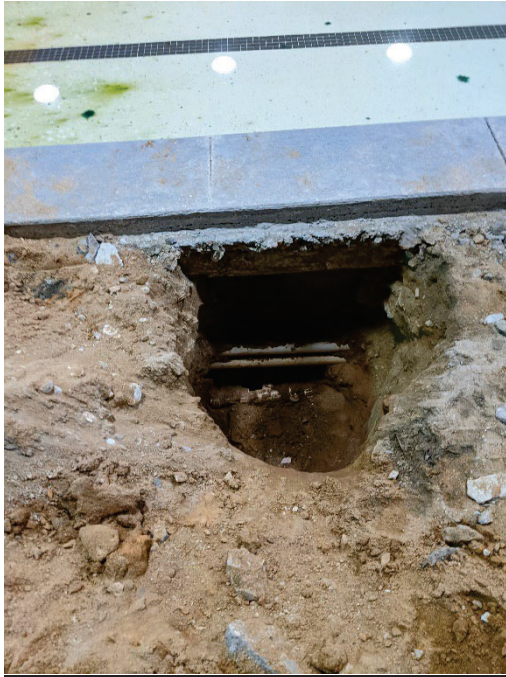
*Photo 5 Review of excavation at leak*

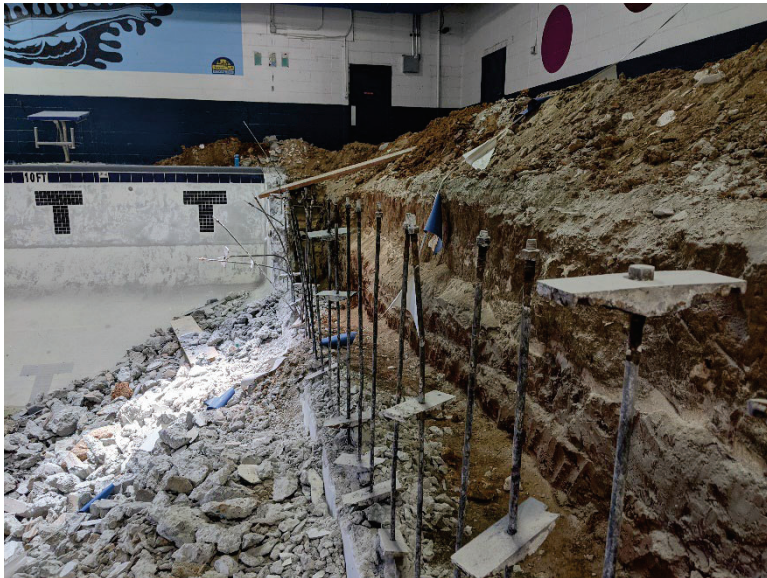
My last site visit to the site was on May 1<sup>st</sup> to review the excavation of the soil on the west and north side of the structure and to observe the surrounding structural walls and the soil conditions, See photo 6. The existing structure appears to be in the same condition and was not affected by the excavation. The soils also did not appear to show any signs of water infiltrating behind the pool on the west or north sides. Based upon my observations, the current pool excavation and planned modifications do not impose any risk of structural damage upon the existing adjacent walls, footings or other related structures for the building.

*Photo 6 Review of Pool expansion excavation*
