Essential Repair Finding – FCVINE-W.5-SUMV

Facility Carried: East Vine Drive

Feature Intersected: Lake Canal

Special Unscheduled Draft Report

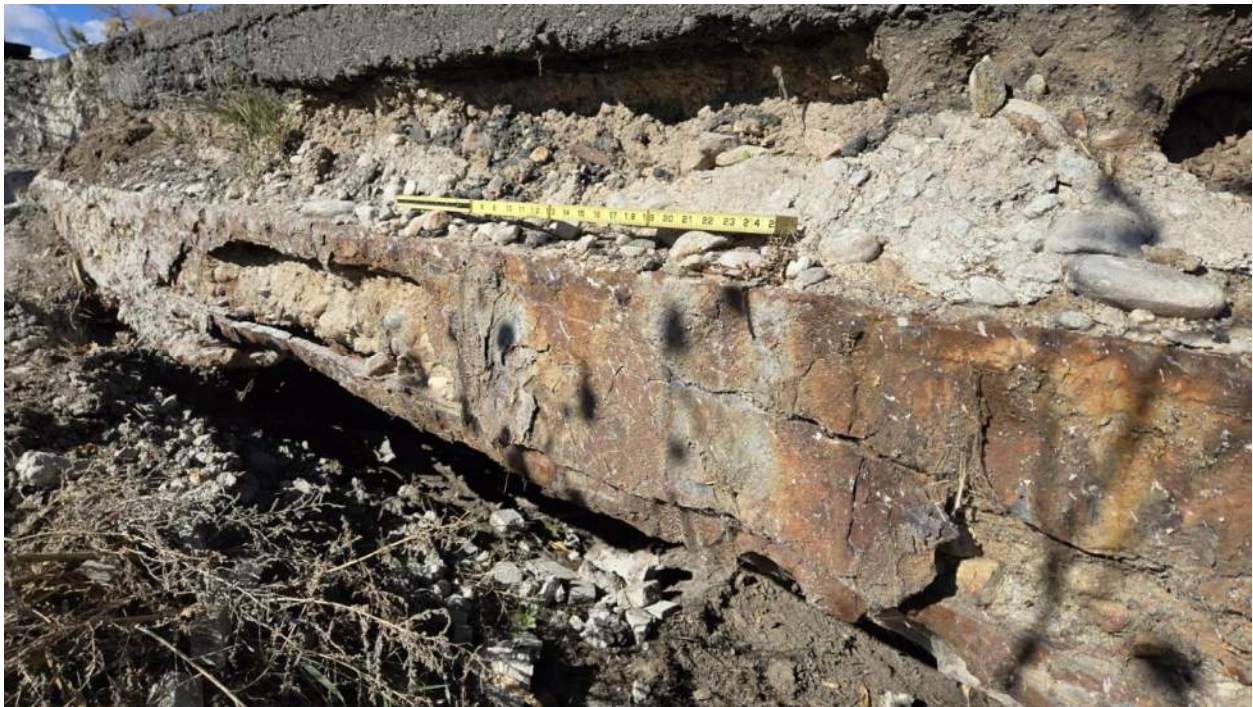
South vertical plate has R4 corrosion with 80-100% section loss

It is our office's recommendation to replace the bridge widening, including the south curb and rail. The Essential Repair for this structure is given a **YELLOW** priority.

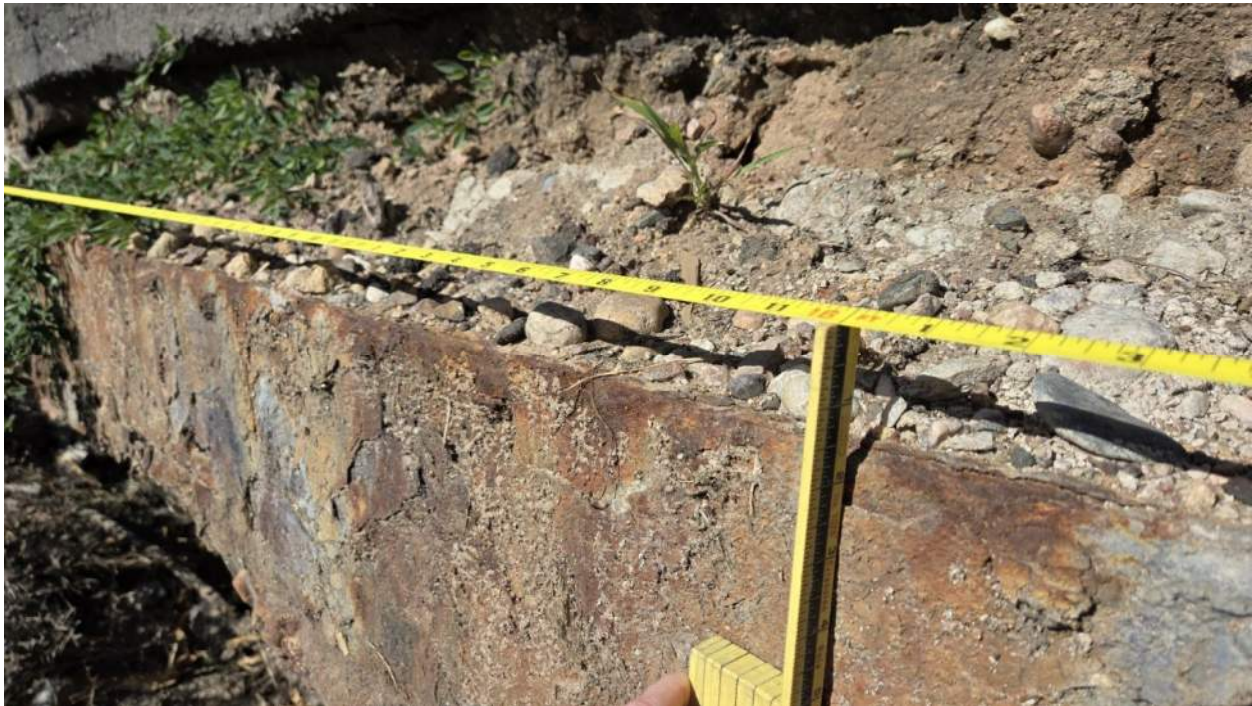
South member at midspan has 1.5 inch sag

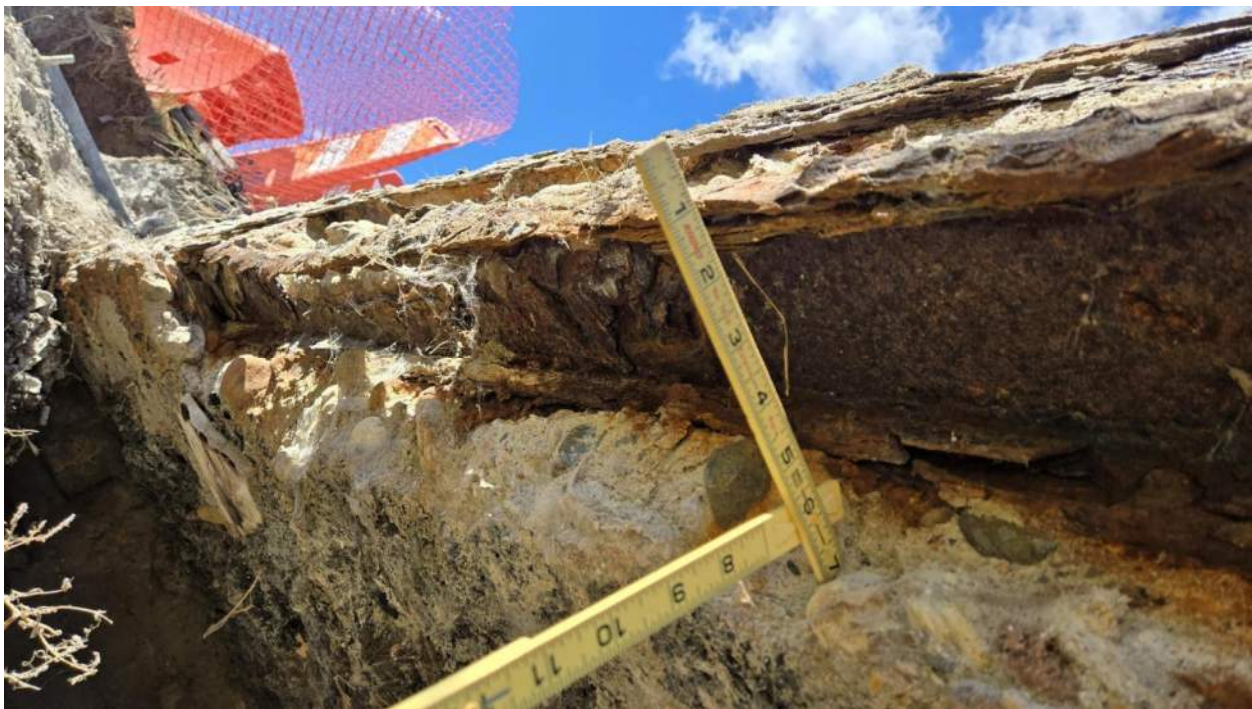
South member bottom channel south flange and web has R4 corrosion with 80-100% section loss

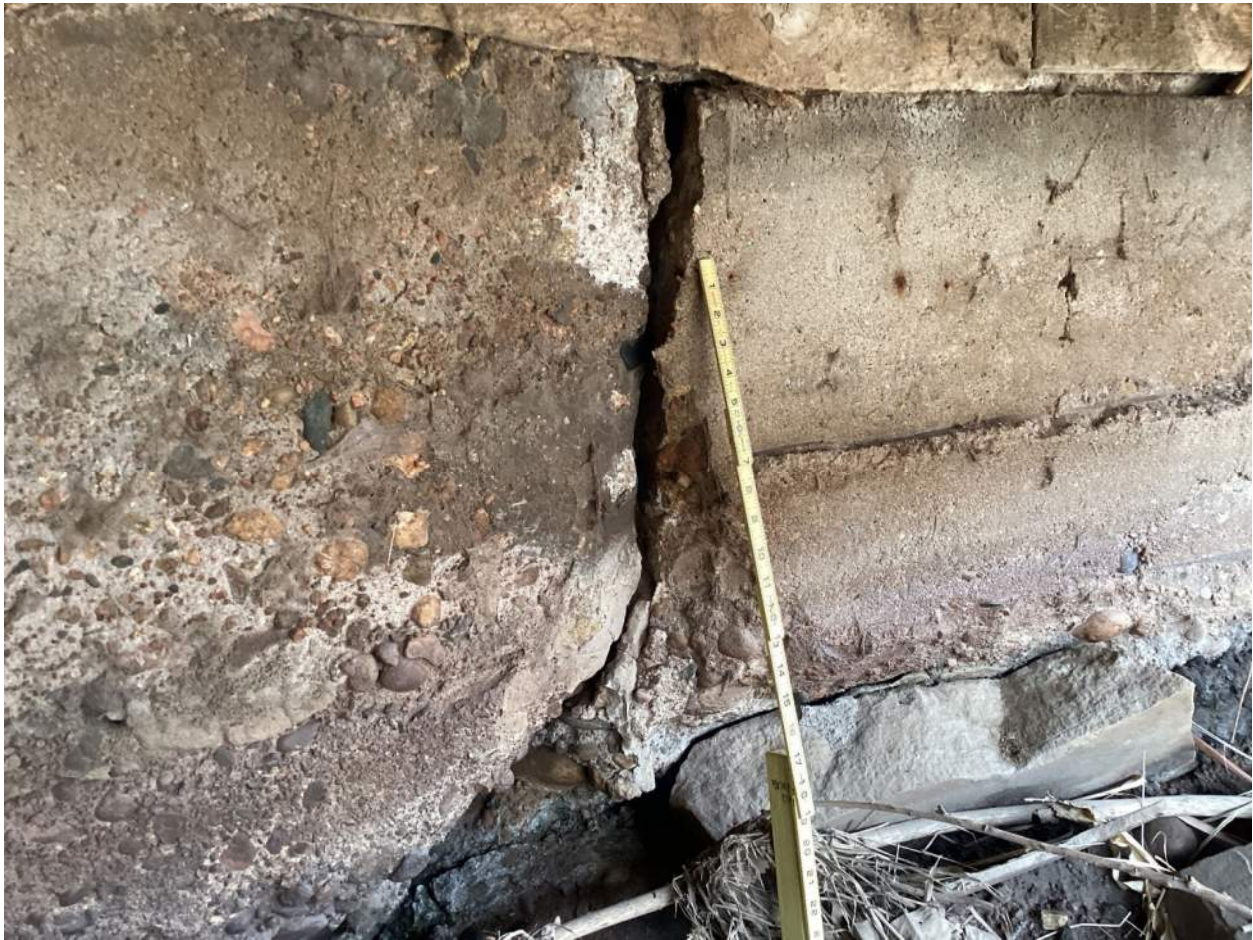
After the last routine inspection in April 2025, the south bridge rail and curb sustained significant impact damage, resulting in the complete removal of the south rail and curb, leaving a shear drop from the south edge of the eastbound lane to the channel bottom. A special unscheduled inspection on 10/28/2025 found that the south steel member of the widening exhibits severe corrosion with 80-100% section loss in the south vertical plate for 60% of its length and in the bottom channel south flange and web for 24% of its length. The bridge widening exhibits signs of structural distress: a 1.5 inch sag was measured in the south member at midspan. Additionally, Abutment 2 underneath the widening has a wide full height x full depth crack with spalling and abrasion.

Abutment 2 under widening has wide full height x full depth vertical crack with spalling and abrasion

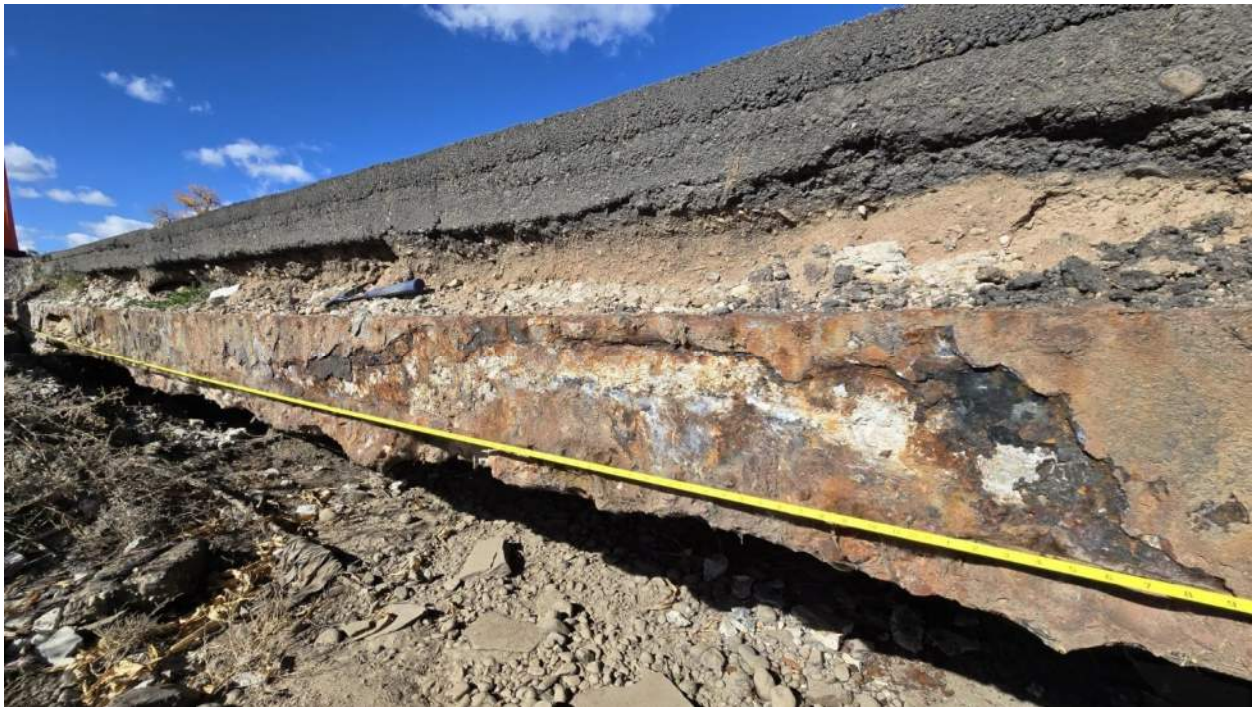
As a result of the load rating performed as part of the Off-System bridge inspection program, this bridge requires posting for all vehicles. The load rating is controlled by the concrete slab superstructure of the widened porting under the eastbound traffic lane due to severe corrosion of reinforcement.

South vertical plate has failed

It is our office's recommendation that load posting signs be installed in accordance with the sign diagrams shown in Attachment 1 and according to the guidelines in Attachment D – CDOT Load Posting Guidelines for the Colorado Posting Trucks, Specialized Hauling Vehicles and Emergency Vehicles. Per the most recent inspection report dated 10/28/2025 and load rating dated 10/30/2025, the bridge requires posting for all vehicles. To properly post the bridge, we recommend that the following be implemented:

- Install a Single Limit Posting Sign (MUTCD R12-1) at the west approach to the bridge as shown in Attachment 1 (total of 1 signs).

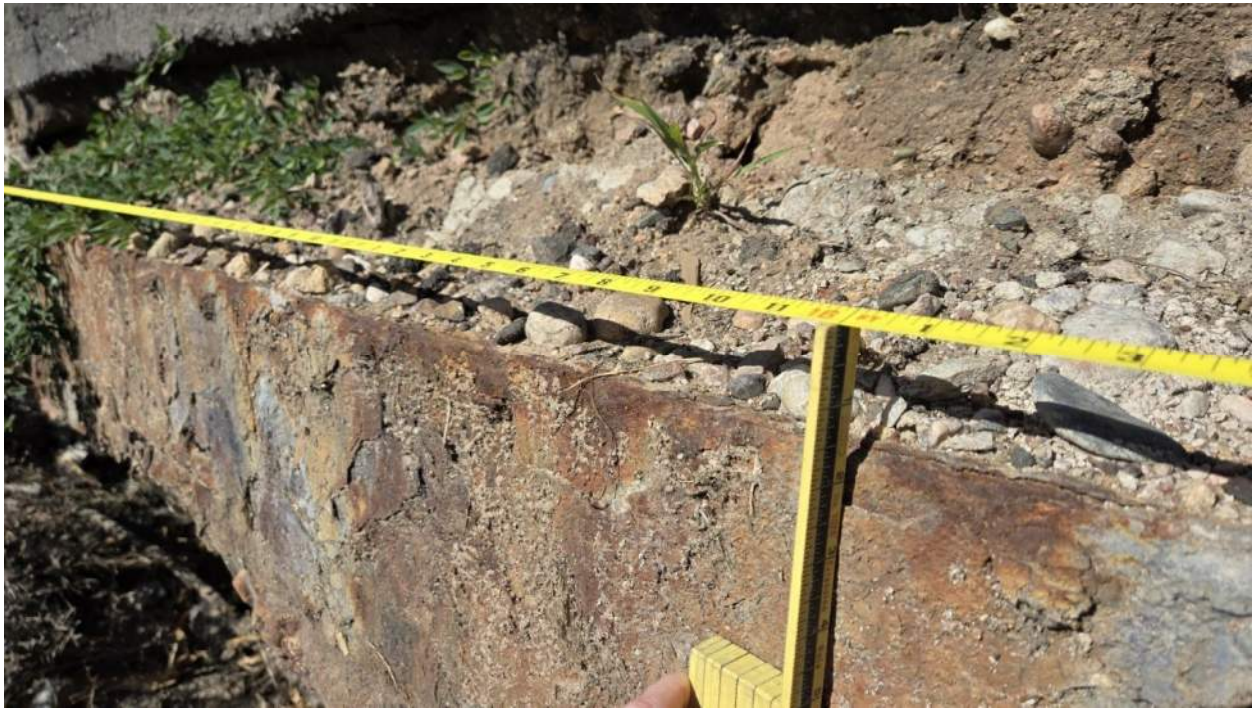
South member at midspan has 1.5 inches vertical sag

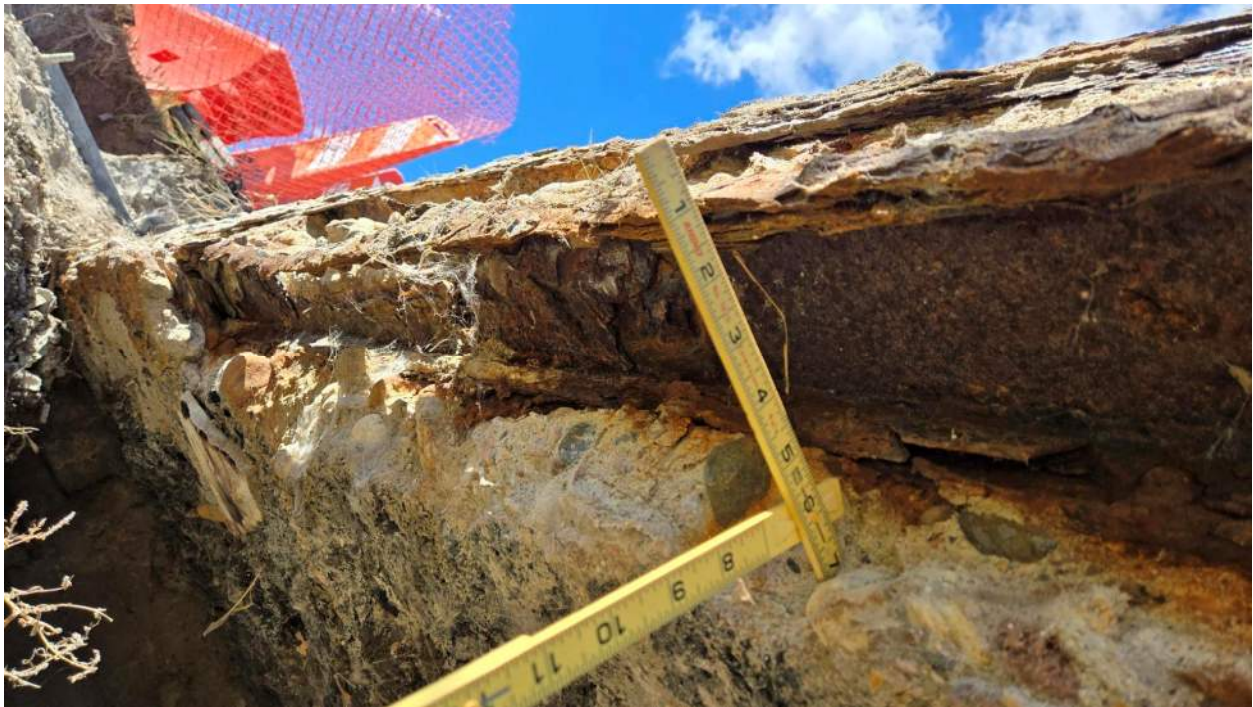
South member 4 feet from Abutment 1 bottom channel south flange and web have 80-100% section loss for 6 feet.

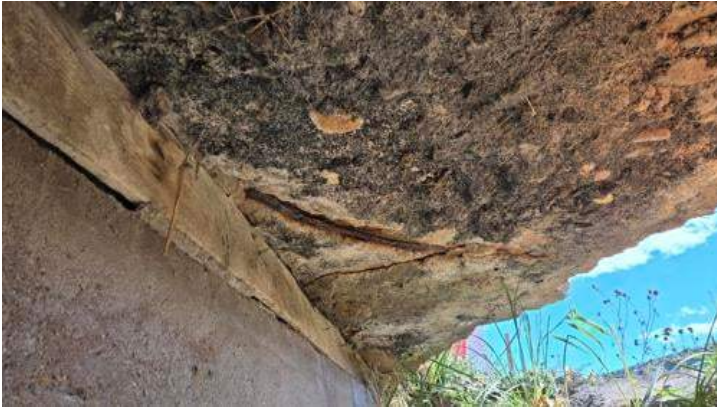
Area of exposed cross bracing shows no intermediate members

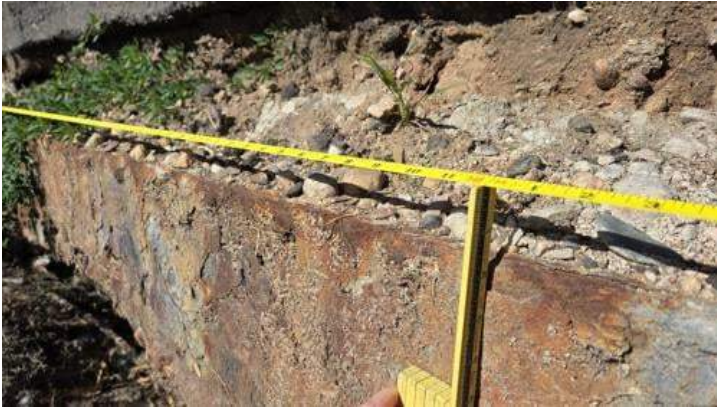
South member at midspan has 1.5 inch sag

Replace bridge widening under eastbound lane.

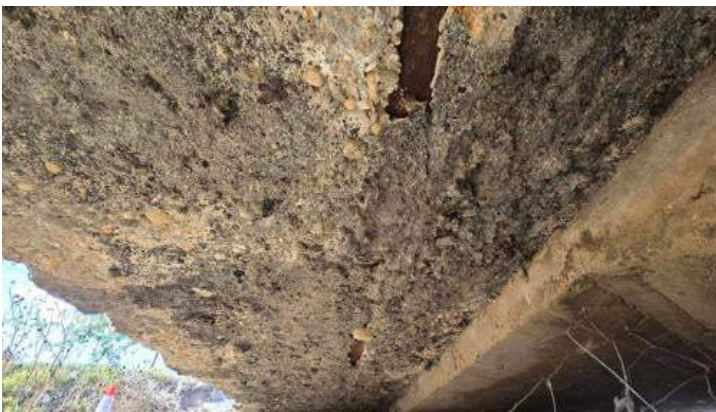
North member bottom flange is exposed at (2) areas of spalling with R2 to R3 corrosion at east end. (20 CS3 overlap)

North member bottom flange exposed, general

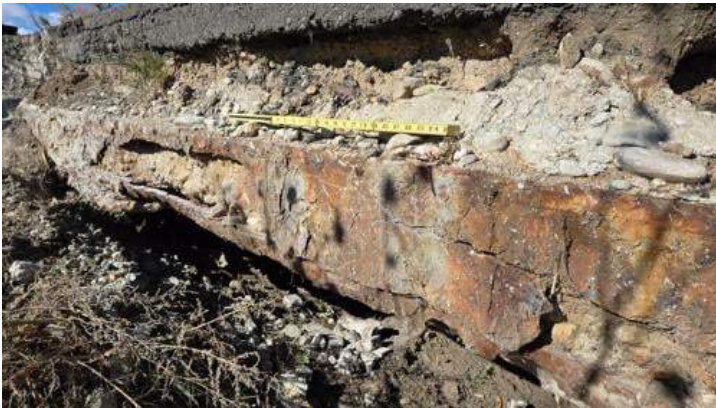
South member 4 feet from Abutment 1 bottom channel south flange and web have 80-100% section loss for 6 feet

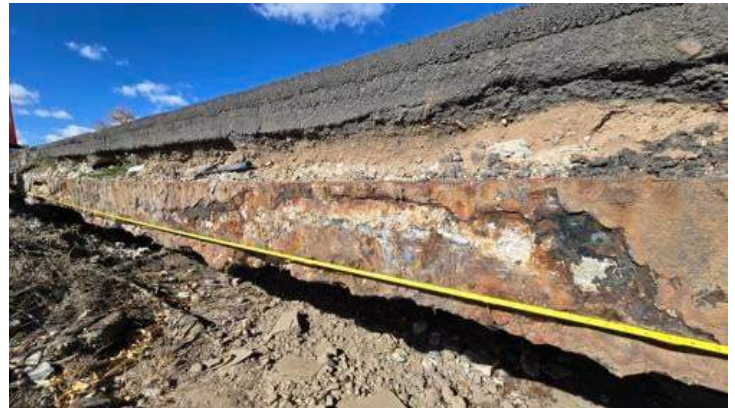
South steel member vertical plate has failed with up to 100% section loss for 21 feet 2 inches from Abutment 1. (21 CS4 1090)

CS4 defect has been reviewed by Benesch Program Engineer and affects the element or structure strength and/or serviceability. Bridge owner was notified of Essential Repair Finding on 10/30/2025.

South vertical plate has failed 21 feet 2 inches from Abutment 1
