FCVINE-W.5-SUMV

Bridge, CRF - Concrete Rigid Frame

Damage Human Induced

Draft Report

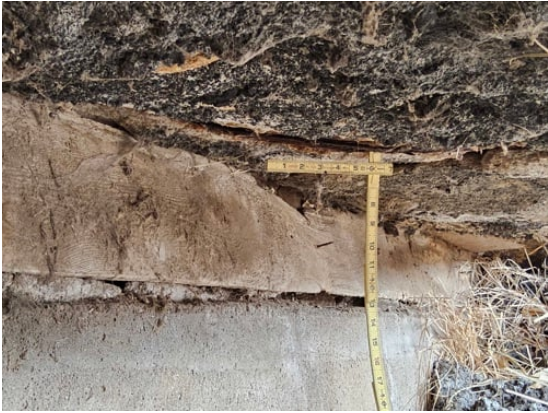
Exposed cross bracing at southeast corner, general

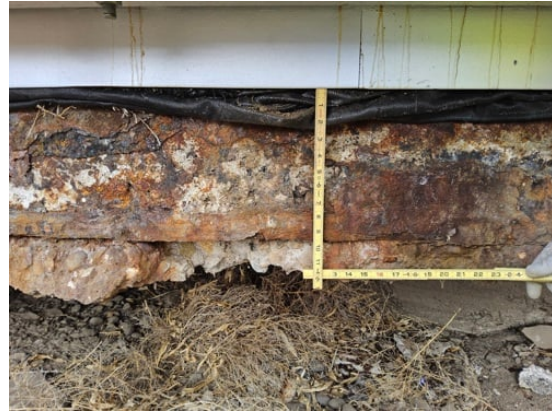
South member at midspan has 1.5 inch sag.

South member at midspan has 2.25 inch sag, an increase of 0.75 inch since the inspection on 10/28/2025.

Exterior member at midspan has sag

Replace bridge widening under eastbound lane.

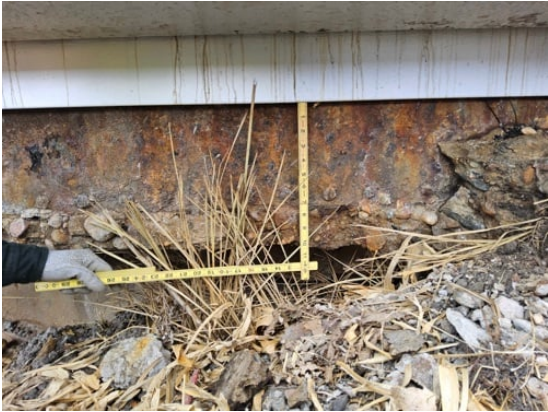
North member bottom flange is exposed at (2) areas of spalling with R2 to R3 corrosion at east end. (20 CS3 overlap)

Exterior member east end

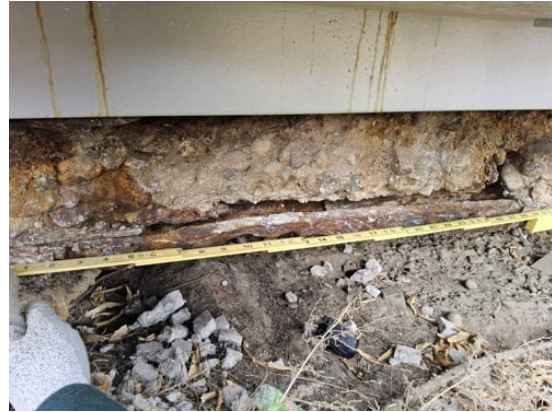
South member 4 and 13 feet from Abutment 1 bottom channel south flange and web have 80-100% section loss for 6 feet and 2.5 feet, respectively. Bottom channel south flange at 6 foot from Abutment 1 has 2 foot section up to 1.25 inch out of plane. (9 CS4 overlap)

Exterior member has 2 foot section out of plane

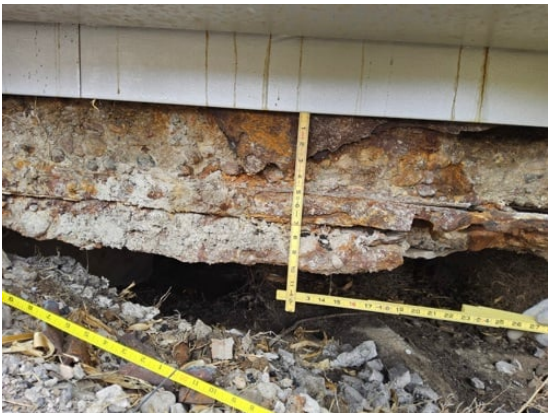
Exterior member west end

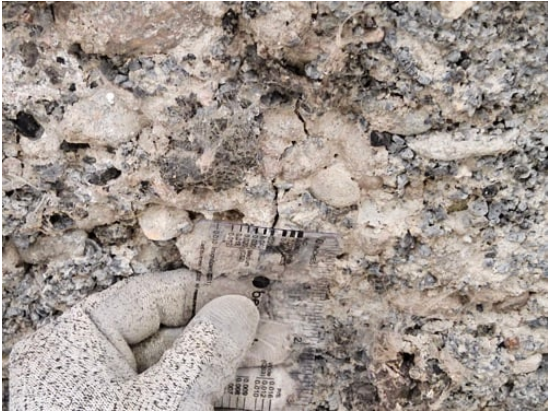
Slab at 12, 13, and 16 foot from Abutment 1 has up to 0.05 inch wide transverse cracks, not previously noted. (21 CS2 overlap)

Slab 16 feet from Abutment 1 has medium transverse crack, typical

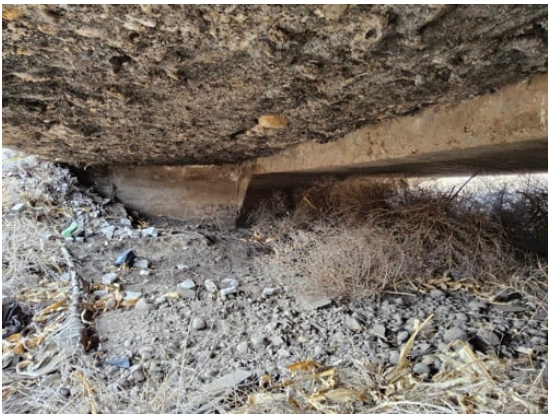
Abutment 1 general

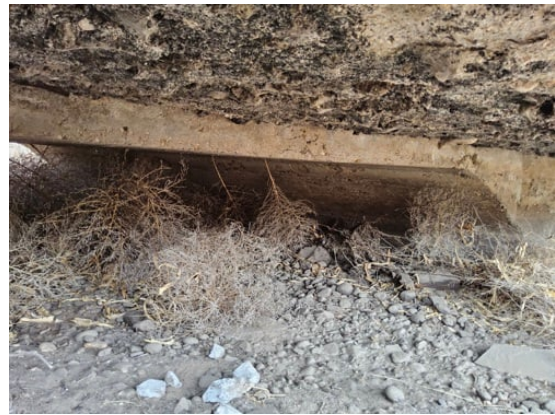
Abutment 2 general

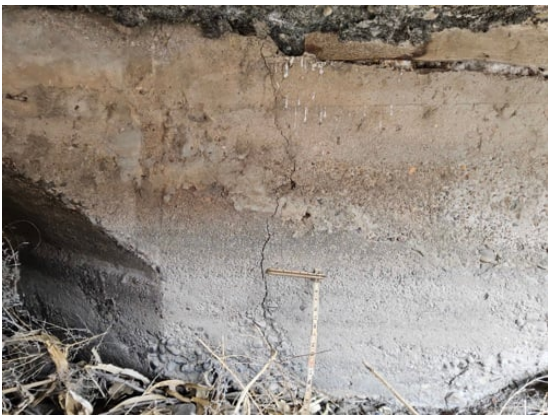
Abutment 1 at north end and center and Abutment 2 at south end and center have vertical cracks up to 0.25 inch wide. (4 CS3 1130)

Abutment 2 at north side of widening has medium vertical crack

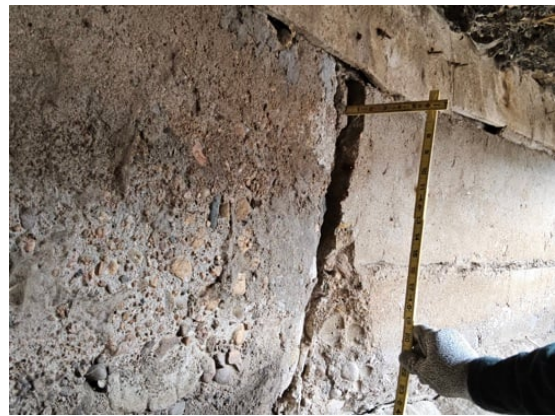
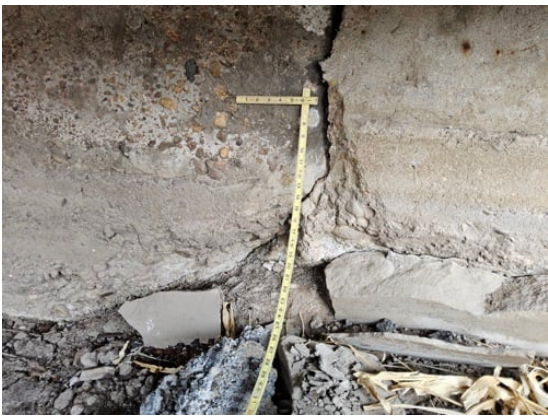
Abutment 2 6 foot from south end has 0.75 inch wide crack with east section at top leaning 1.5 inch towards channel. (1 CS3 overlap)

Abutment 2 southeast corner at crack at top is leaning into channel

Abutment 2 southeast corner has 0.75 inch wide crack

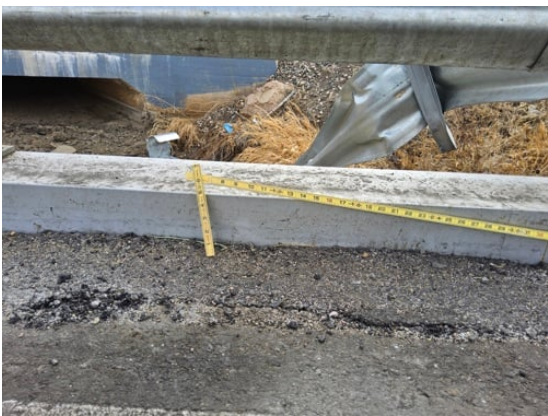
South curb and asphalt wedge at midspan general

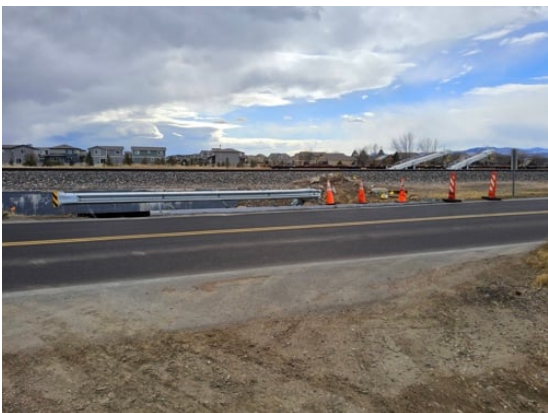
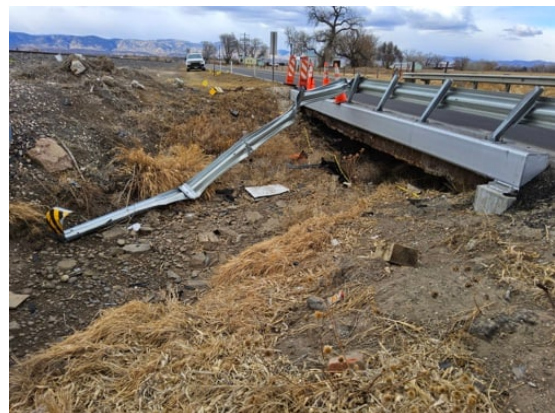
South rail west (3) posts detached by vehicle strike. Remaining (4) posts are approximately 45 degrees east. (35 CS4 7000)

South rail damage looking south

South rail damage looking west

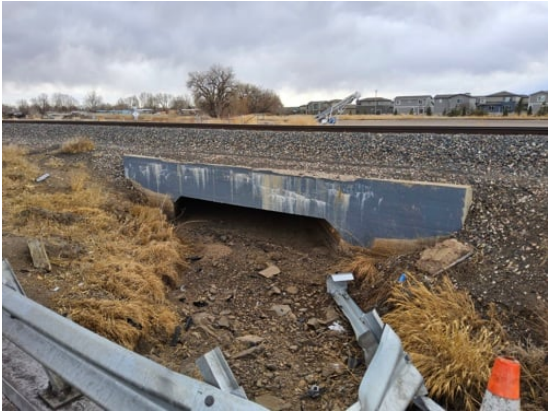
Channel looking south downstream

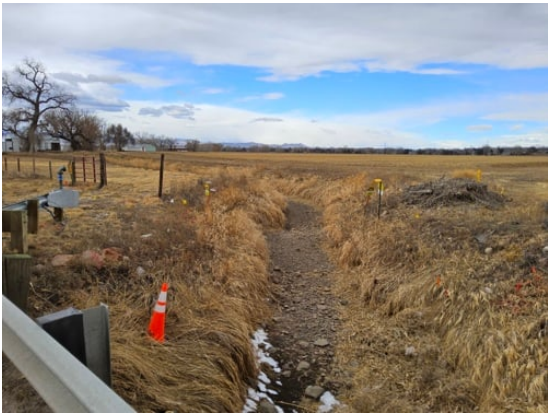
Channel looking north upstream

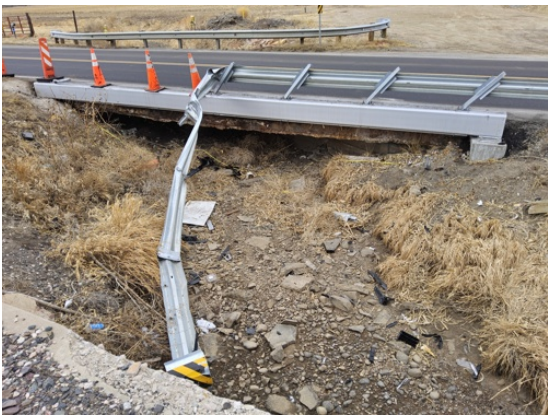
Elevation looking north

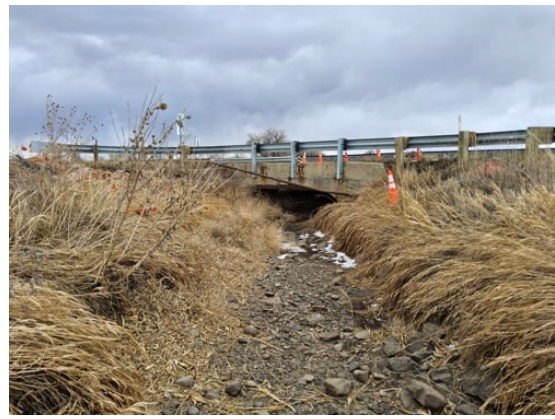
Elevation looking south

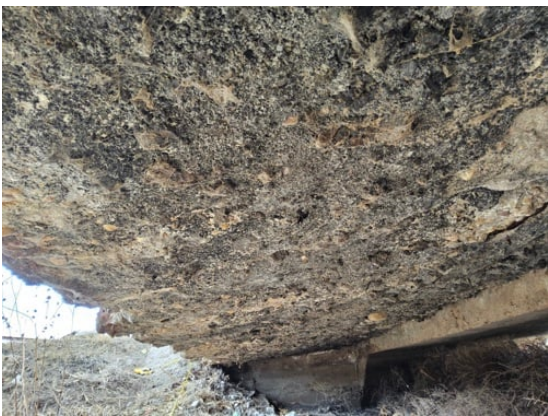
Superstructure looking west

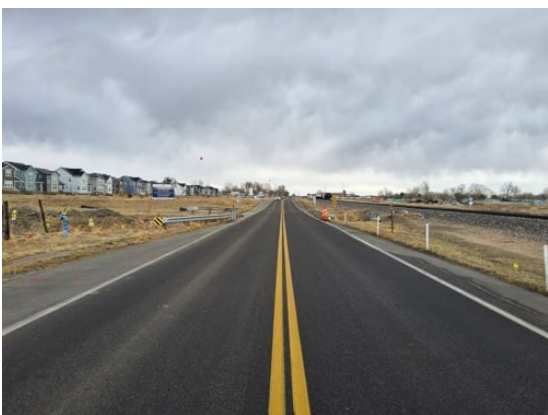
Roadway looking East

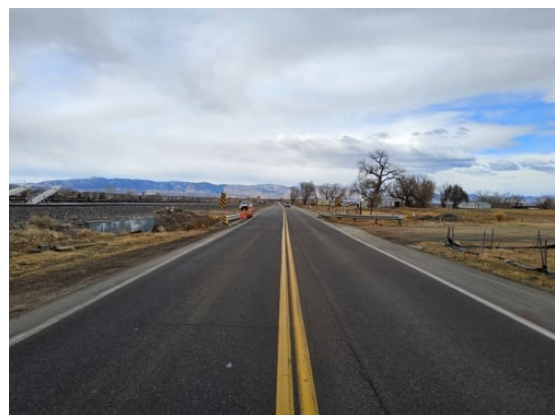
Roadway looking west
