STAFF REPORT August 21, 2024
Historic Preservation Commission

PROJECT NAME

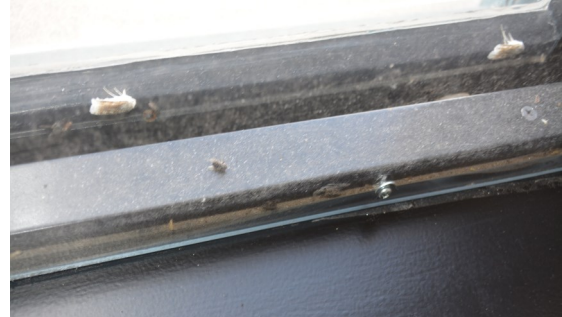
Sill Stop with New Acrylic Panel

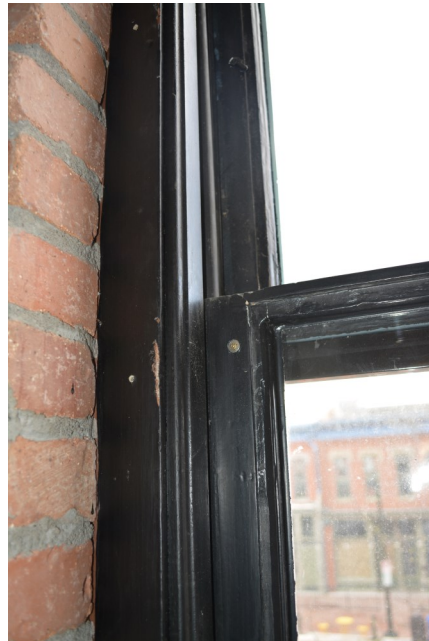
Sash Screwed Together

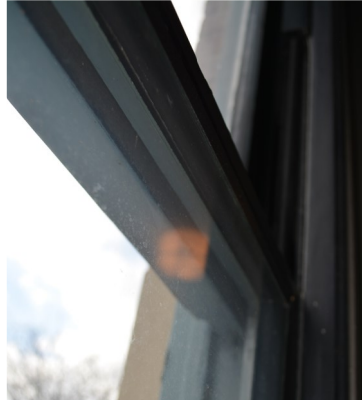
Upper Sash Sitting Below the Lower Sash at the Check Rail

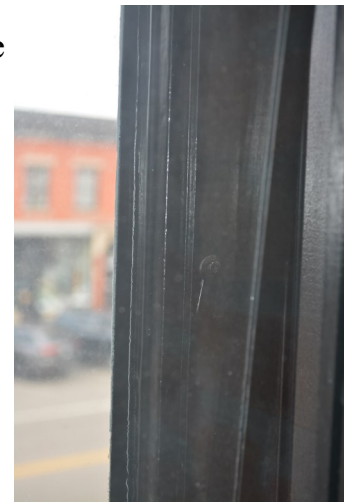
Tab Not Engaged, RDG is Loose

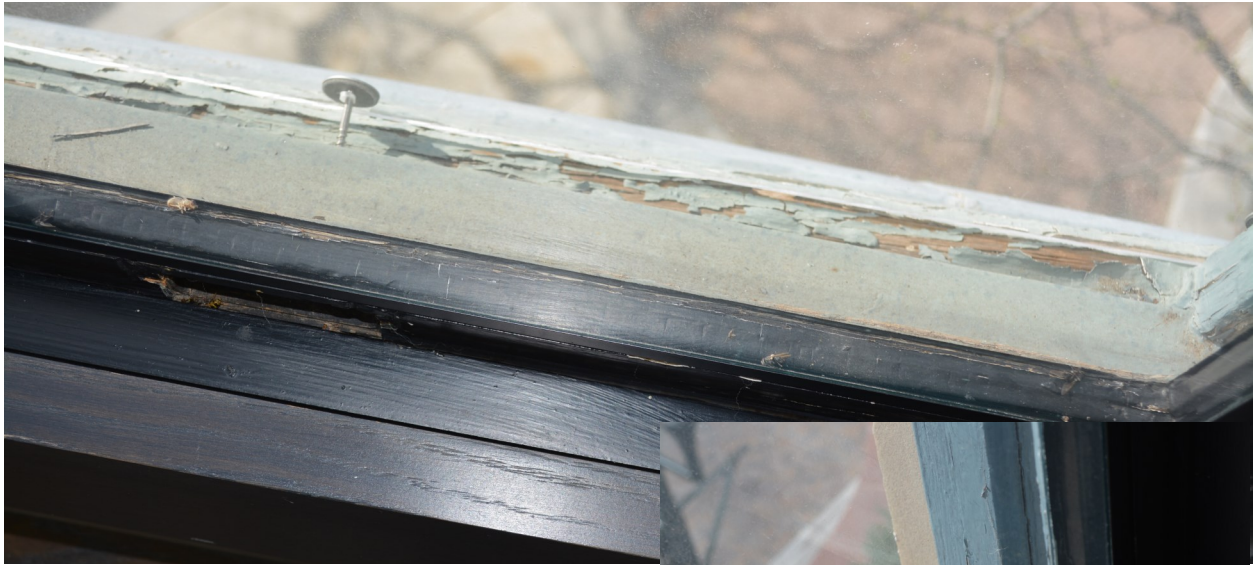
Exterior sill paint failing on all these.
Note the exterior acrylic panel in place
and in the photo below the interior
acrylic panel is still in place.

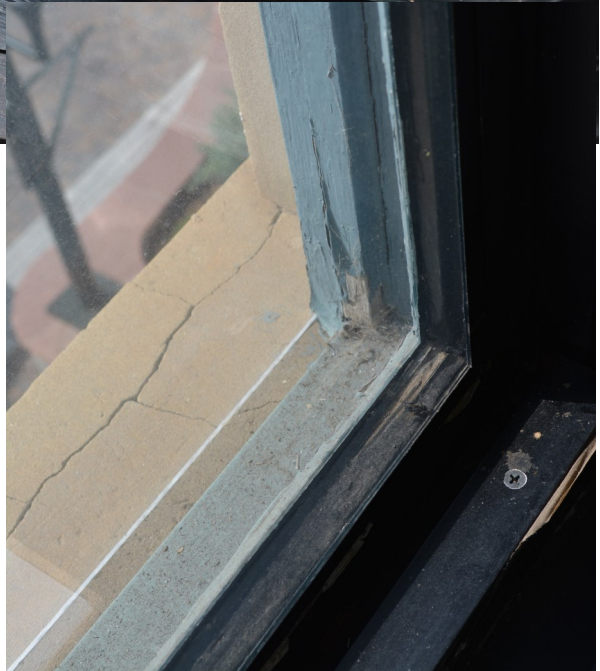
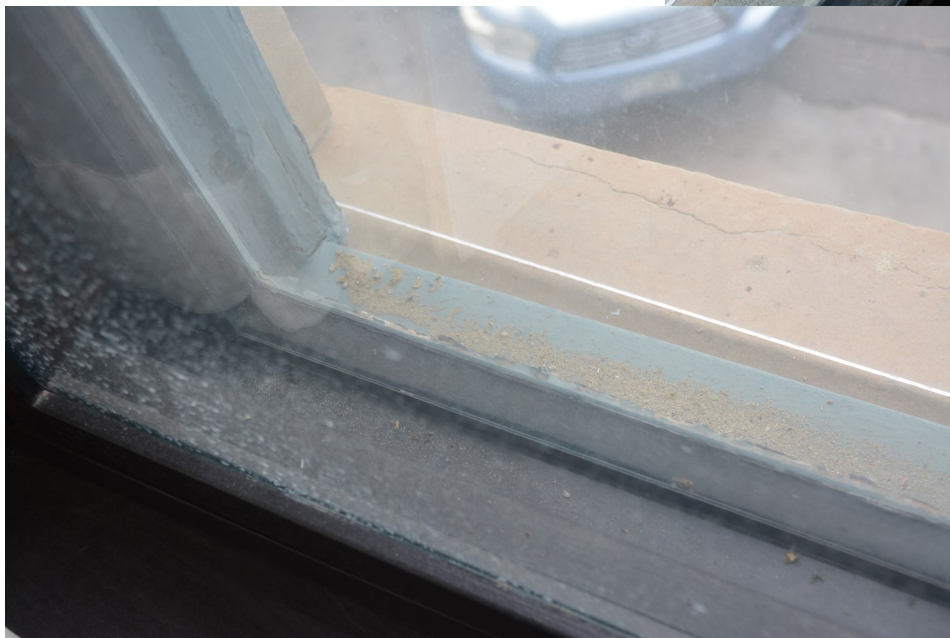
The one section we did key in on was the upper sash check rail. The check rail is the bottom of the upper sash and top of the lower sash where the two sash meet. We were told that one of the window parts came off and hit the sidewalk. We have photo of this sash and the missing part. With the restoration in 2019/2020 roughly 35% of these parts were replaced.

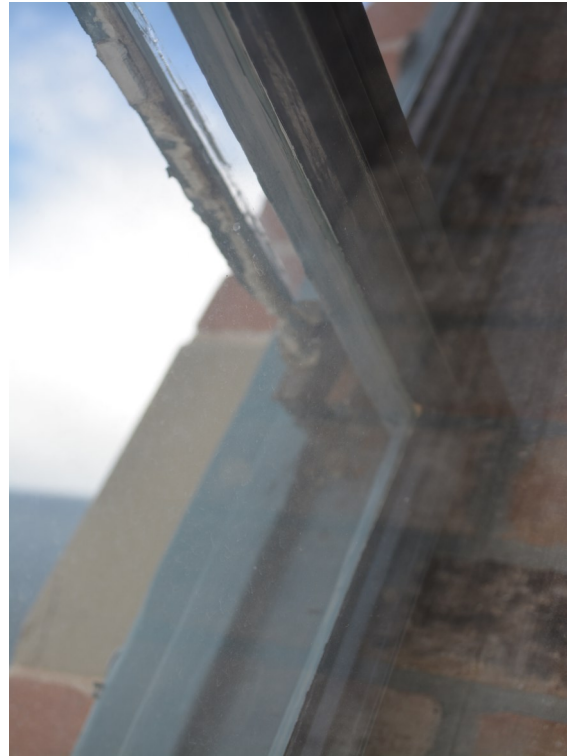
Sash With The Missing Check Rail

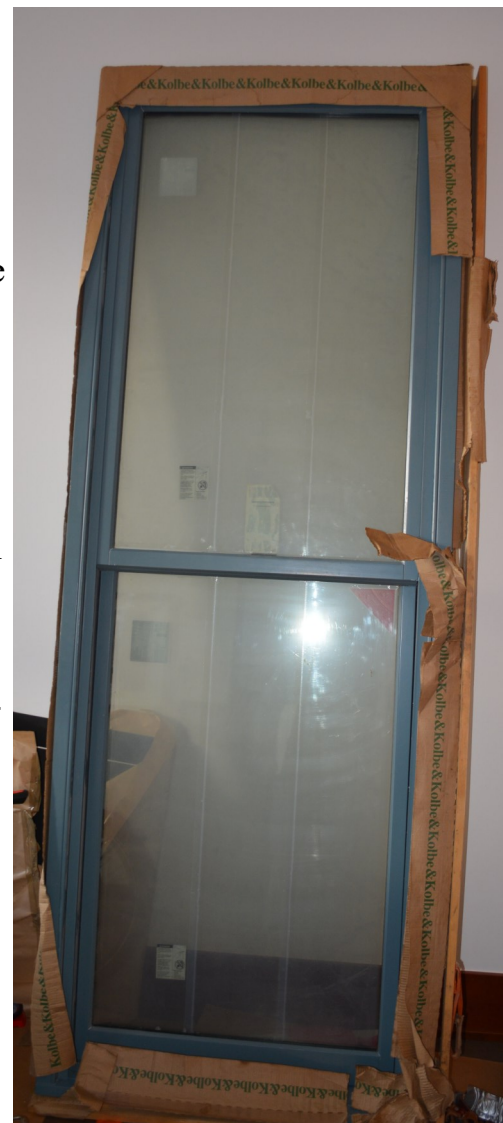
Sample Replacement Window in Storage

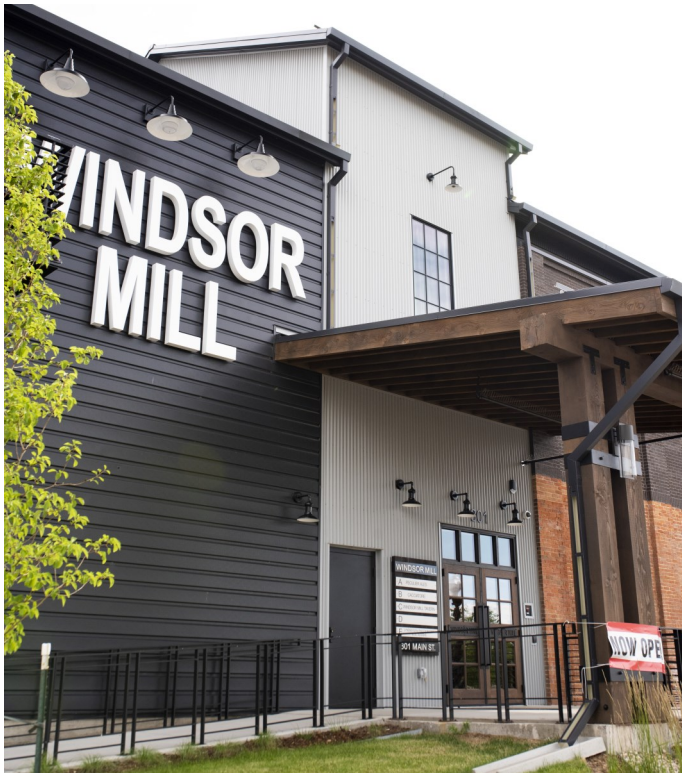
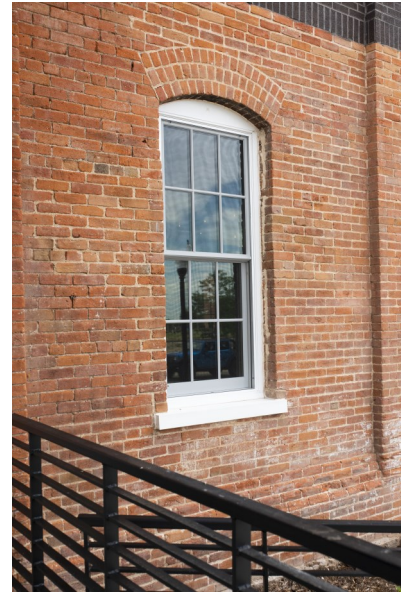
The Windsor Mill was replaced with aluminum clad wood windows. Similar brickmould as this project. The heavy timber sill was replicated as well as the radius trim. The different color top was done to note the section removed by the tornado but the window details are the same. This project has simulated divided lights to match the true divided lights of the original building

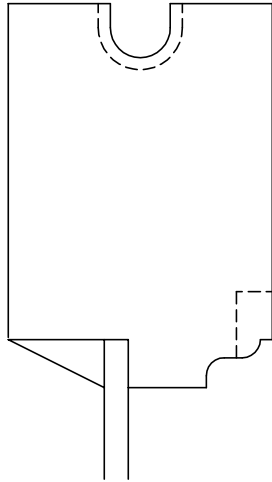
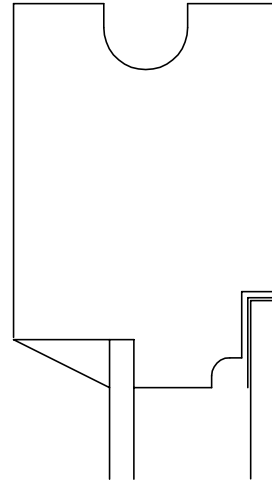
Existing Sash
Set for Rope and
Weight

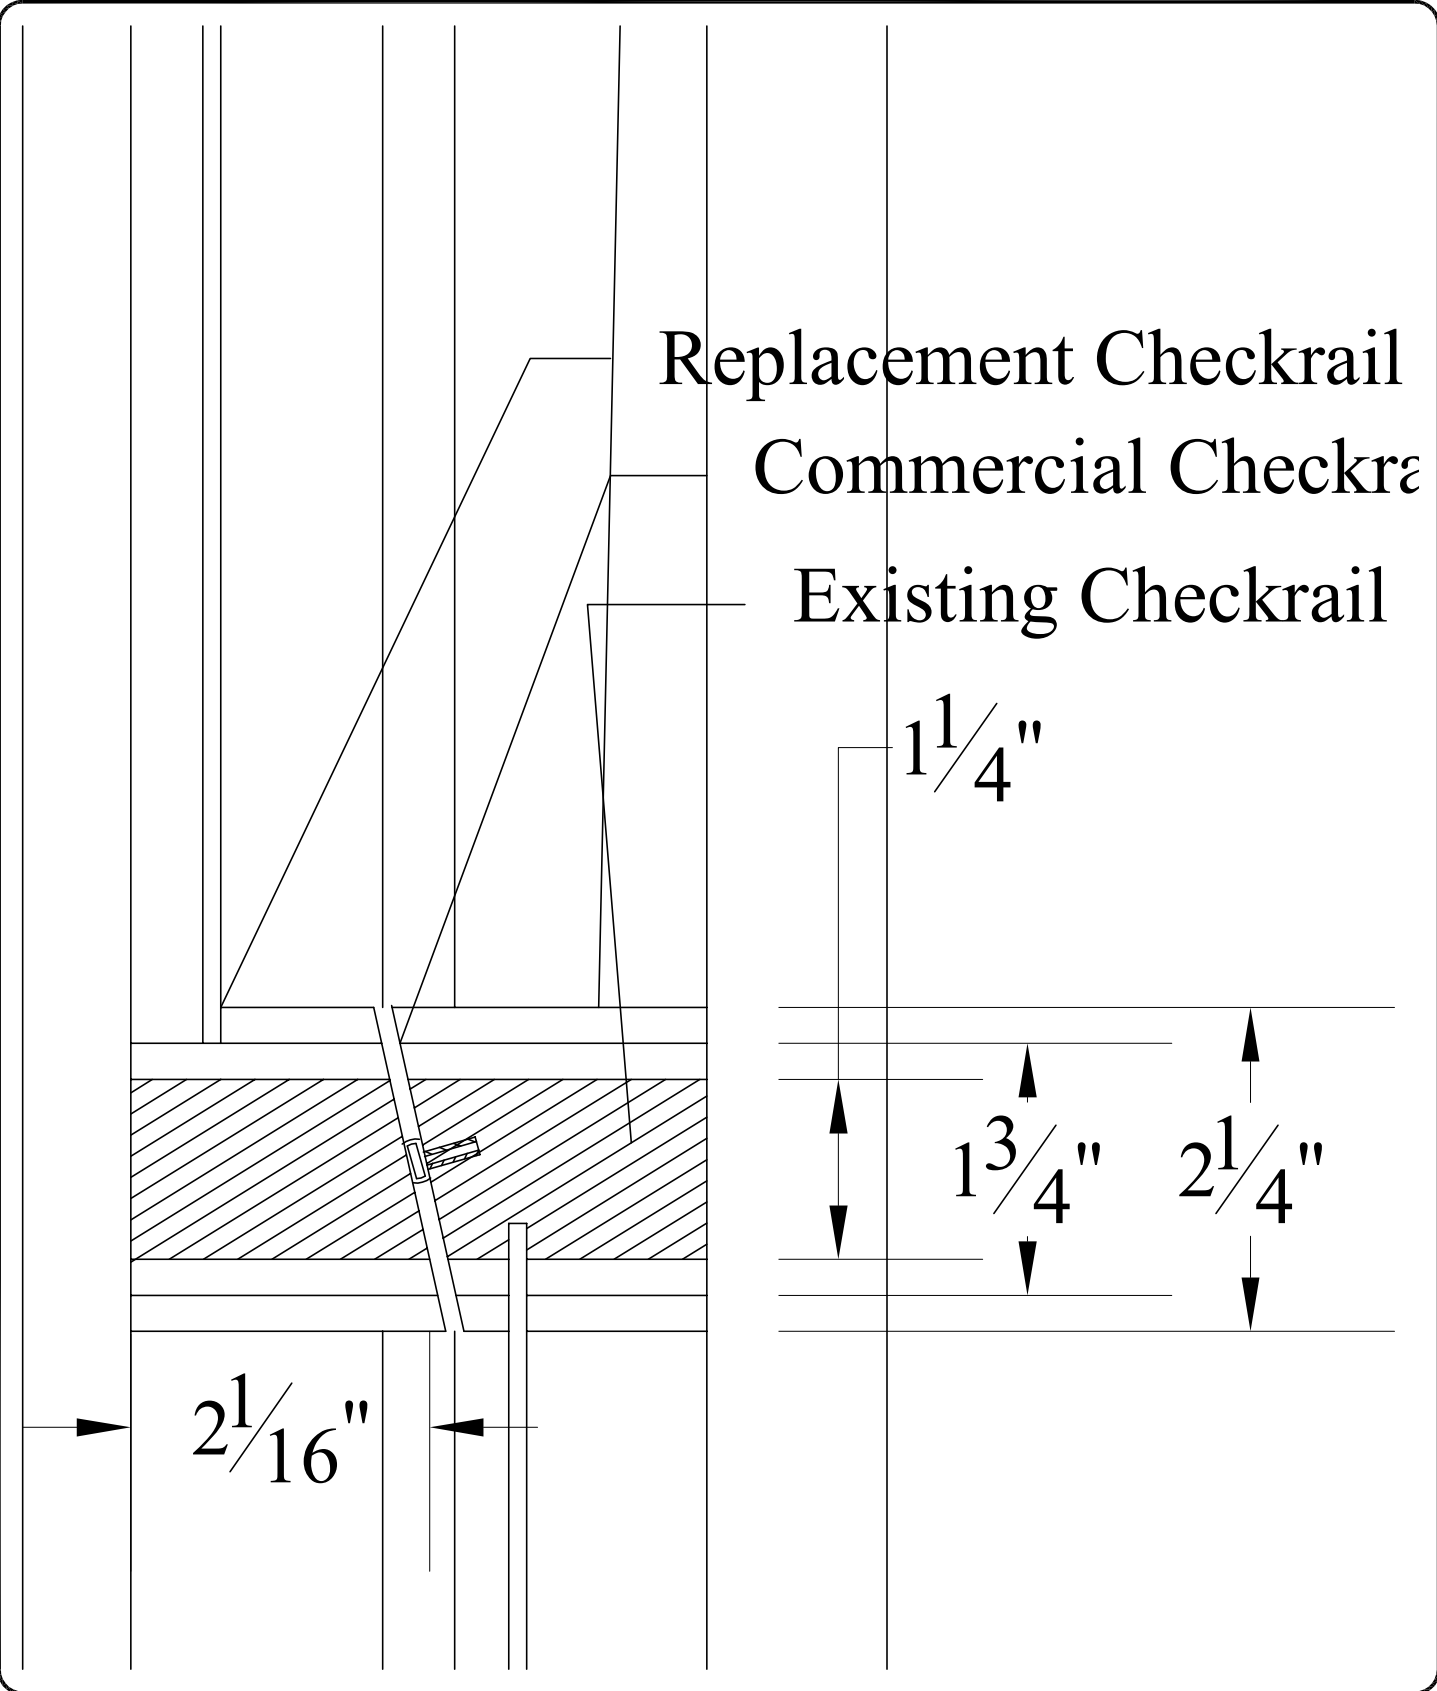
DRAWN BY
MJW
 SCALE
9" = 1'-0"
 FIRST ISSUE DATE
06/15/2024

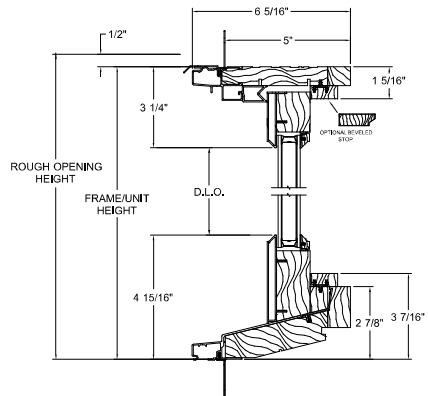
NOTE: Drawings are not to scale. Brickmould is shown factory-applied. Brickmould may be shipped loose for field application. Some units are shown with optional drip cap or nailing fin. For Ultra accessory or application drawings, see pgs. 206-212. Additional and the most current drawings are available at www.kolbewindows.com.

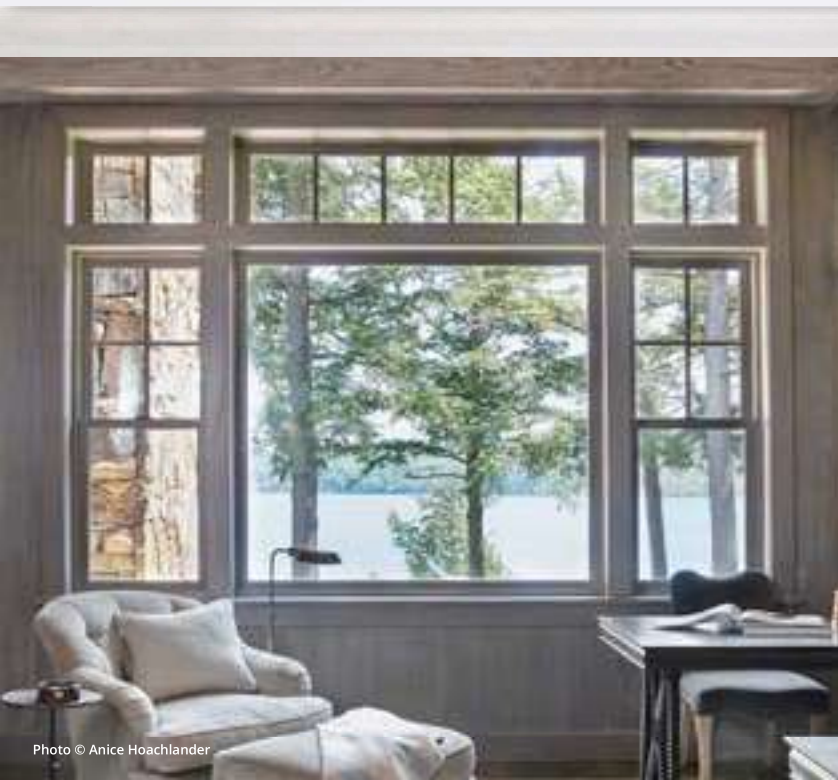
Photo © Anice Hoachlander

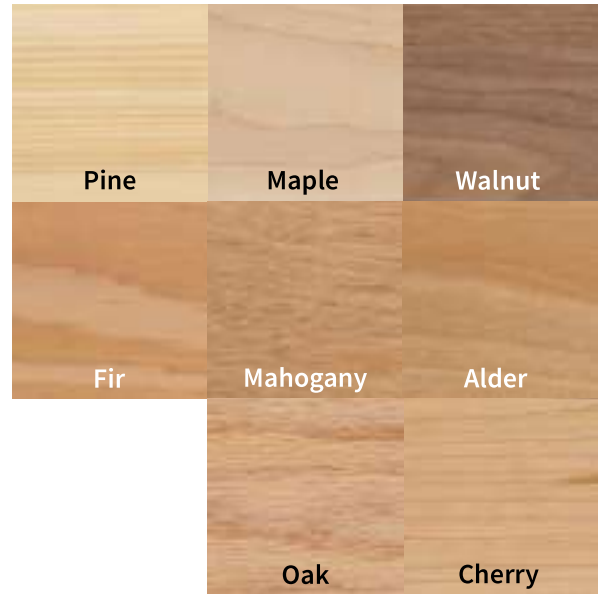
Ask about the availability of additional wood species.

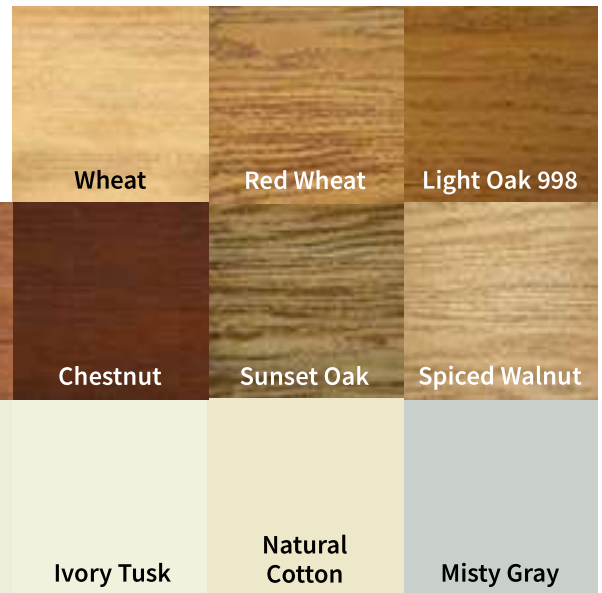
*Applied as a single coat of paint, with some visible wood grain.

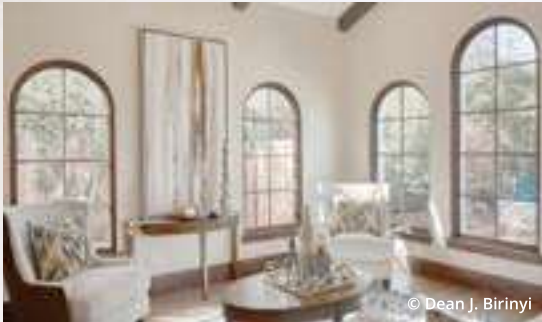
We're for people who are passionate about design, who care about the big picture and the smallest detail. We're for people who aren't satisfied with mainstream choices... who push the limits of what's possible with the options and innovations that can only be found in Kolbe windows and doors.

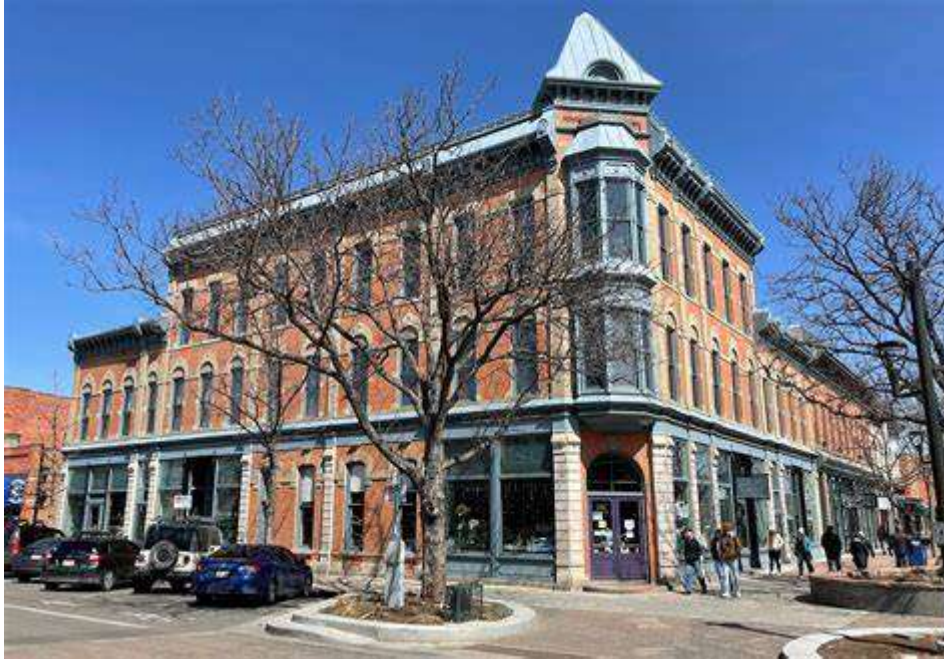
[LinkedIn profile](#)

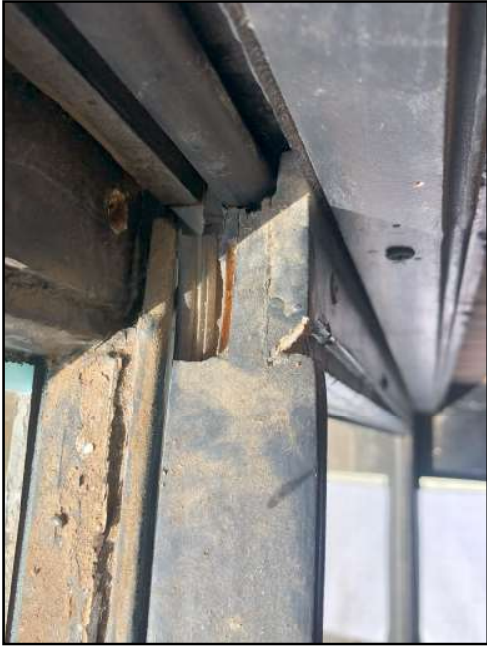
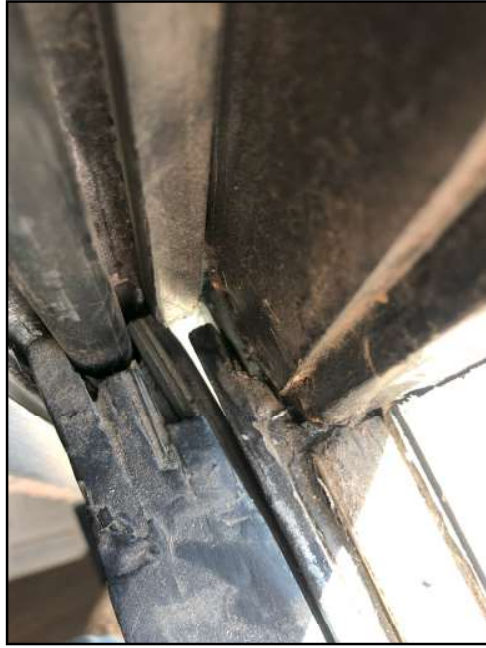
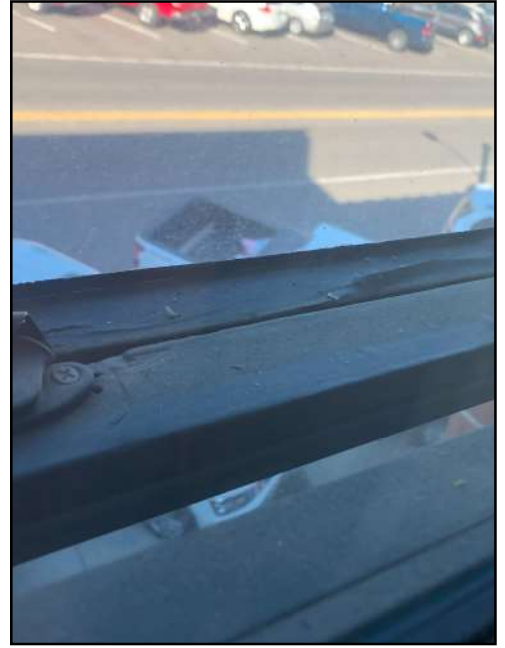
CHIPPING AT MEETING RAIL WHERE ROUTED FOR WEATHERSTRIPPING

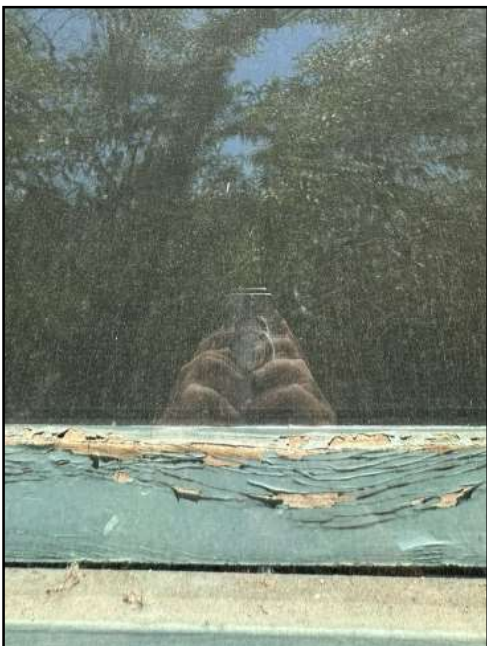
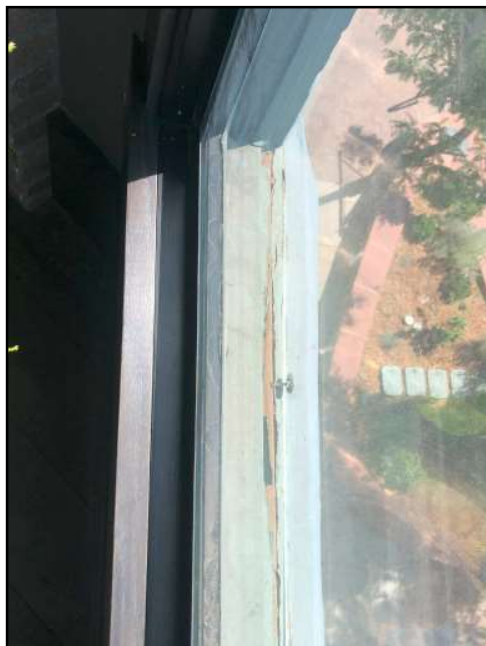
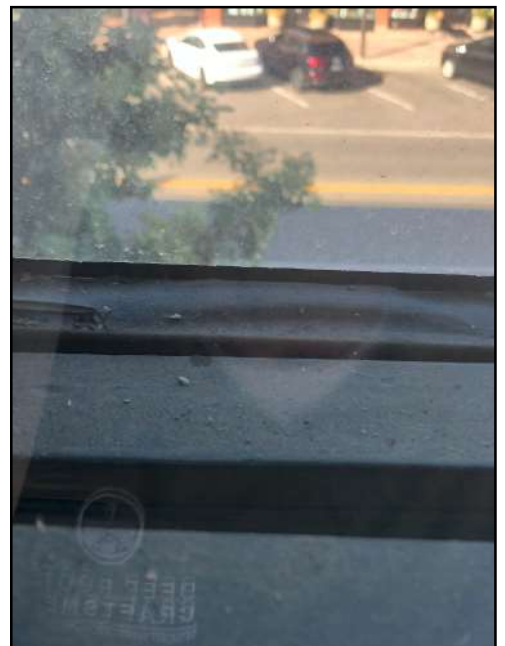
MISALIGNMENT AT MEETING RAILS

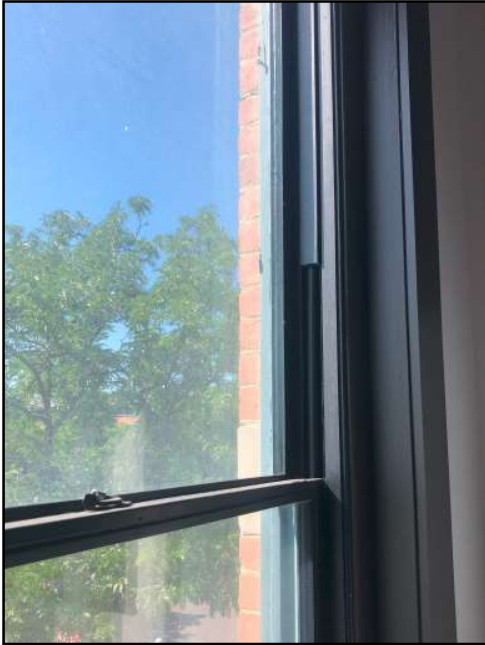
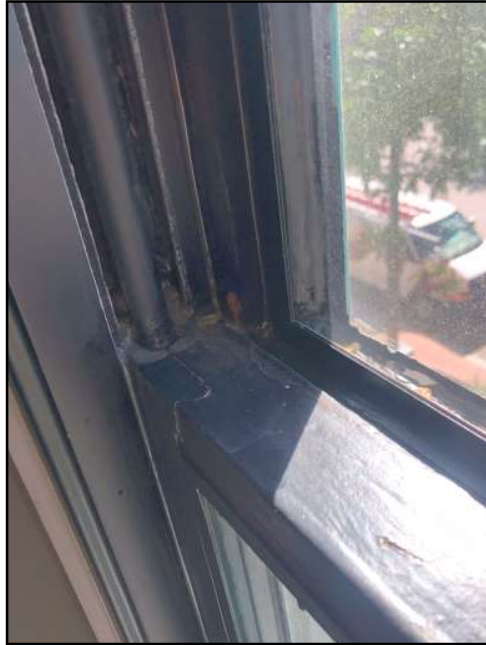
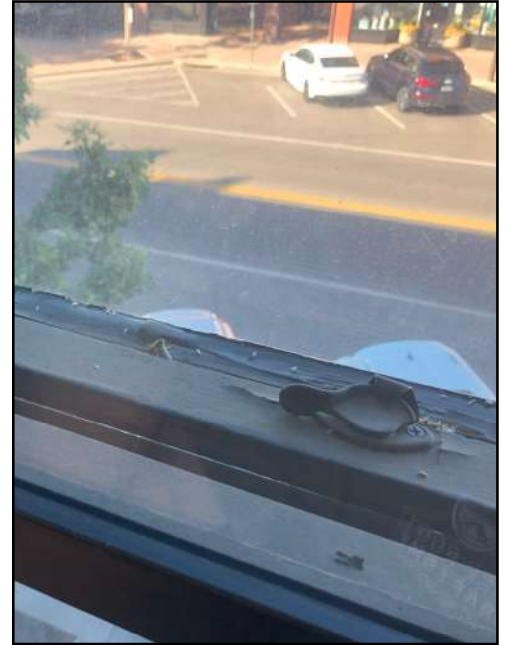
STRUCTURAL FAILURE AT MEETING RAIL

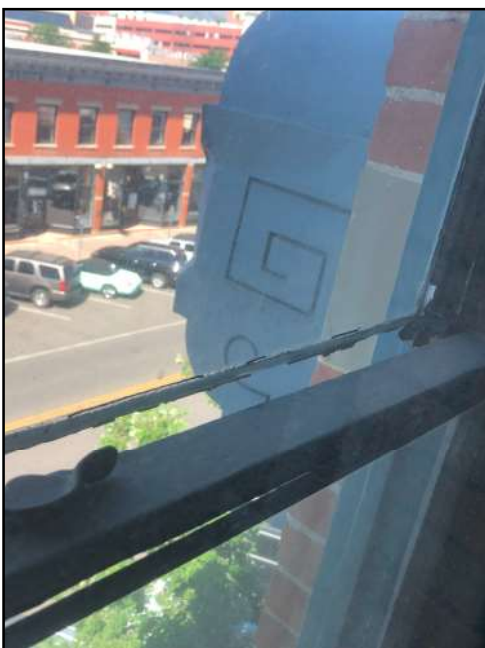
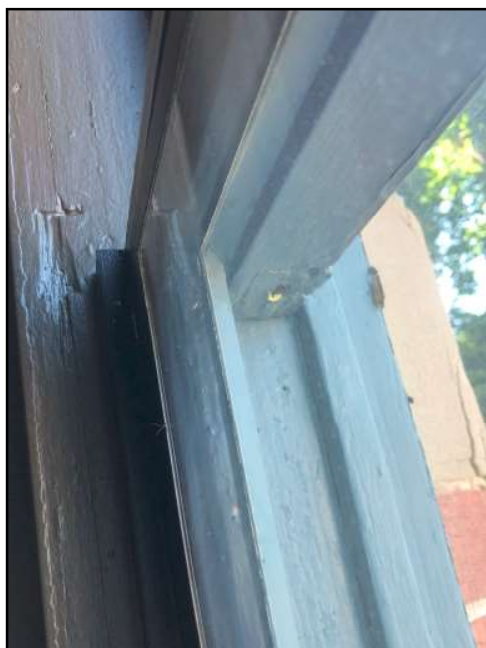
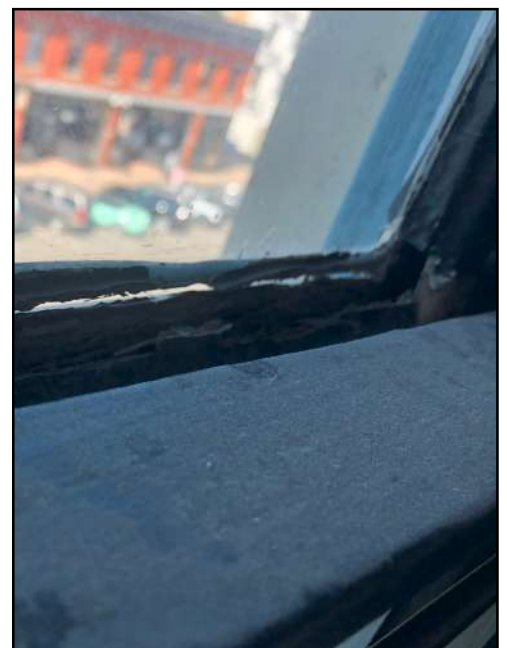
DISPLACED AND MISSING RDG PANELS

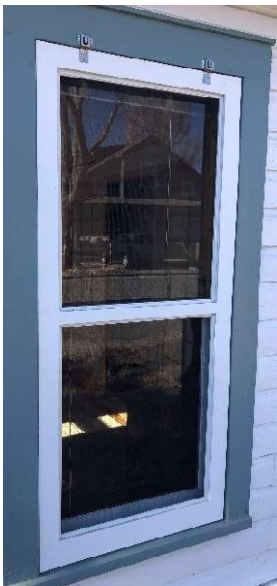
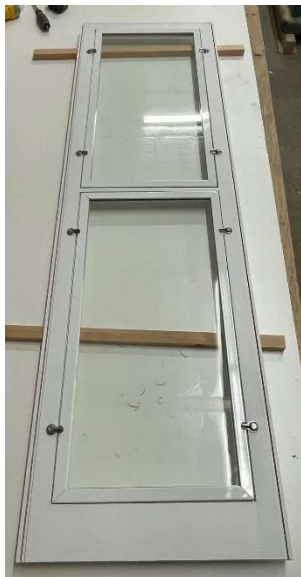
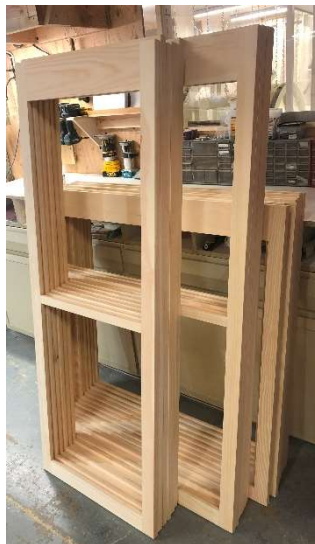
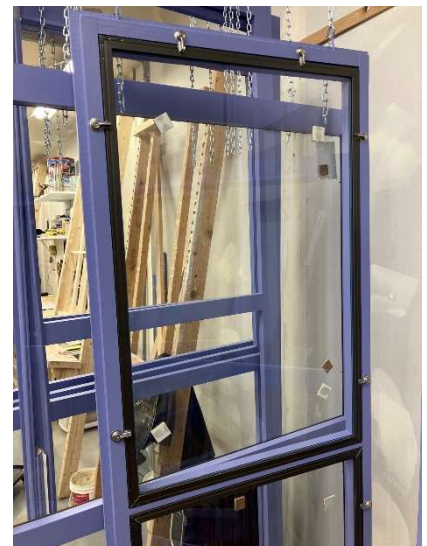
For a number of historic properties, we have fabricated combination storm/ screen units so that the lower panels may be changed out seasonally without removal of the frames themselves. The wood construction allows for a more traditional aesthetic and the aluminum framed storm/ screen panels are not only easily repaired but also nearly devoid of any visible aluminum from the exterior.

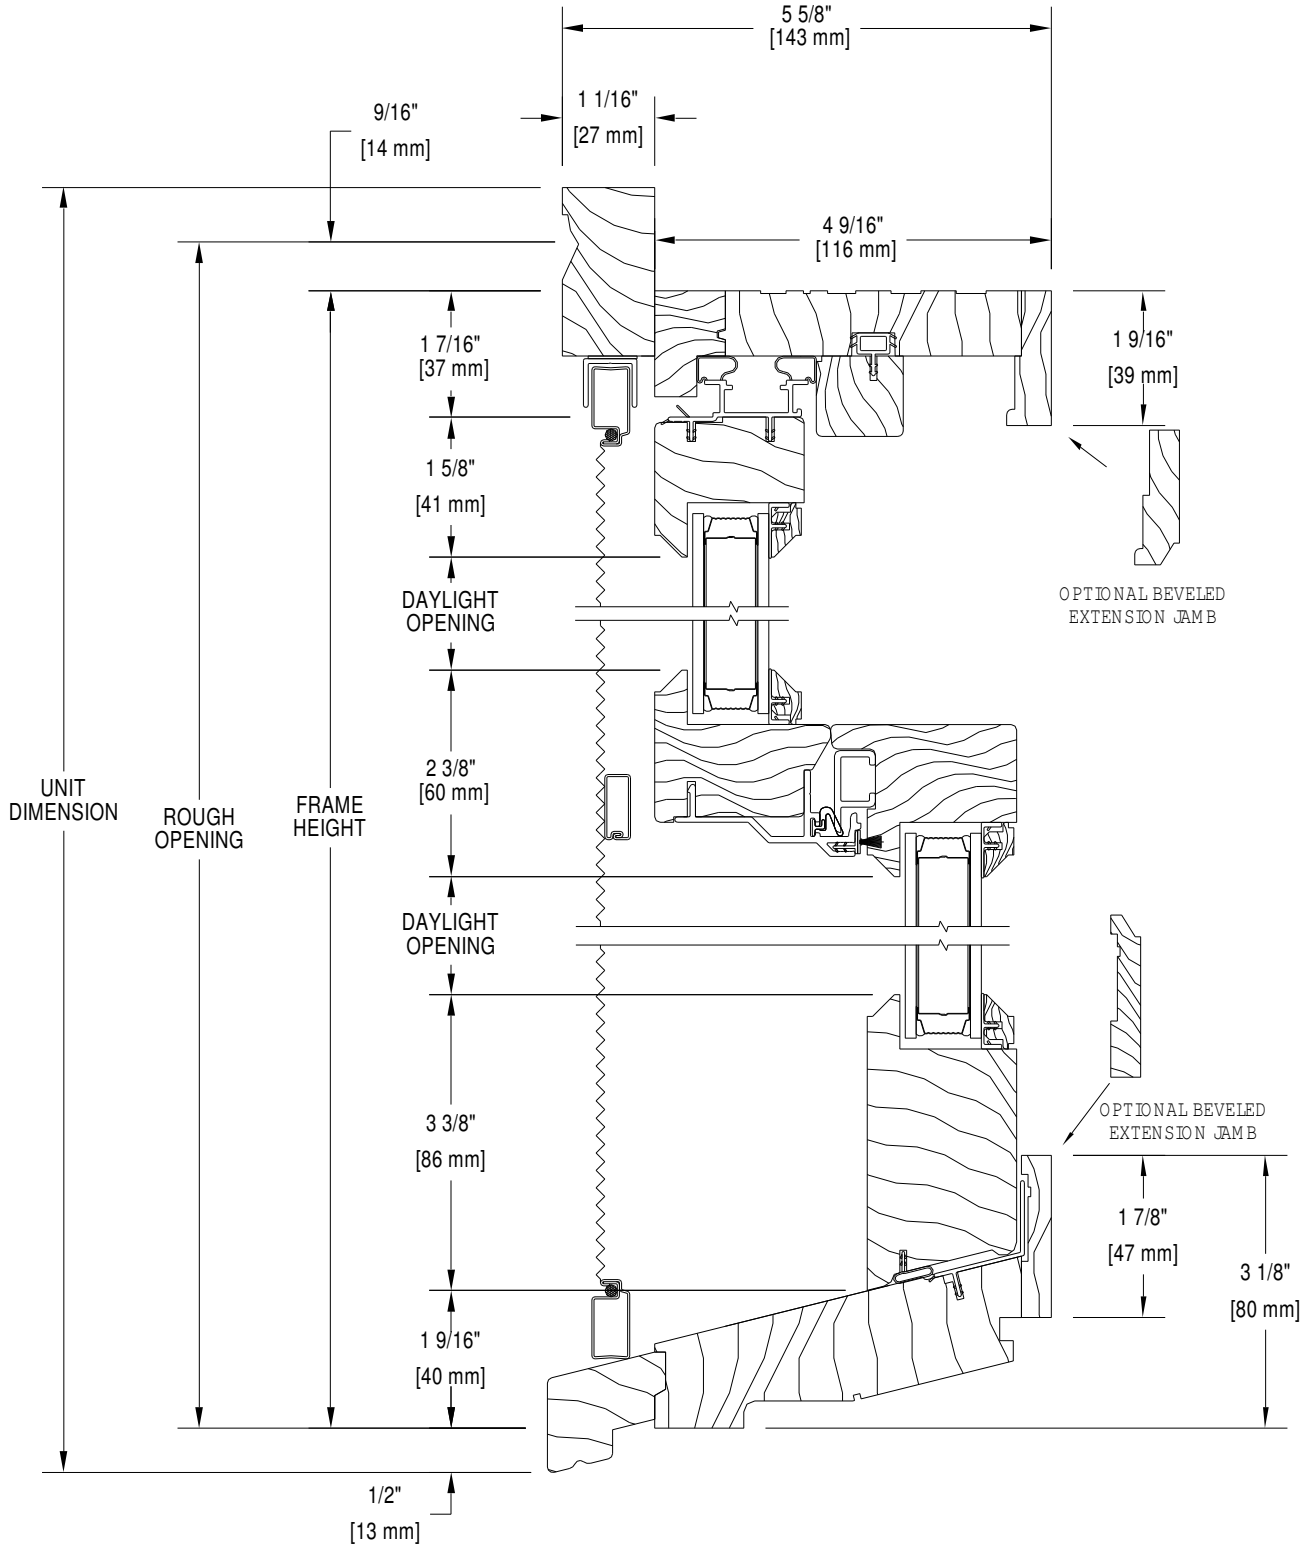
Mark J. Wernimont
President
Colorado Sash and Door, inc.

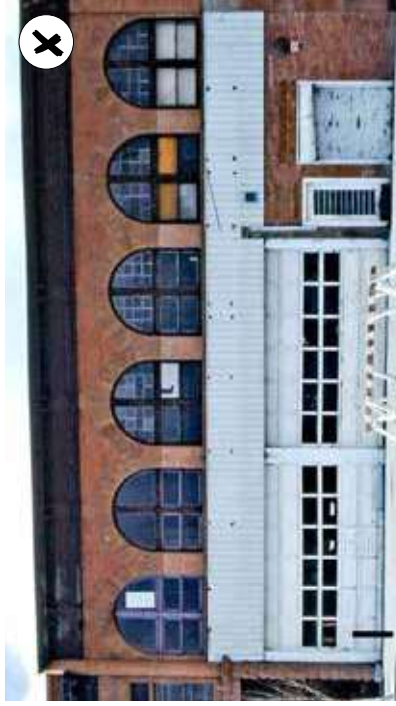
Before rehabilitation: upper story windows in need of repair.

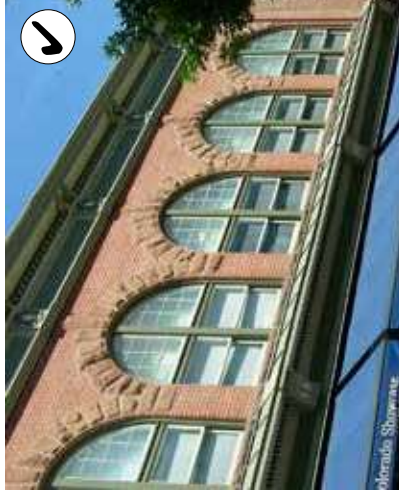
After rehabilitation: repaired windows.

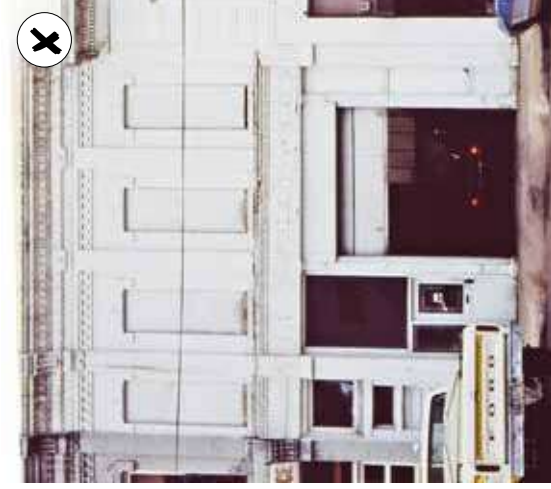
Before rehabilitation: historic windows are missing.

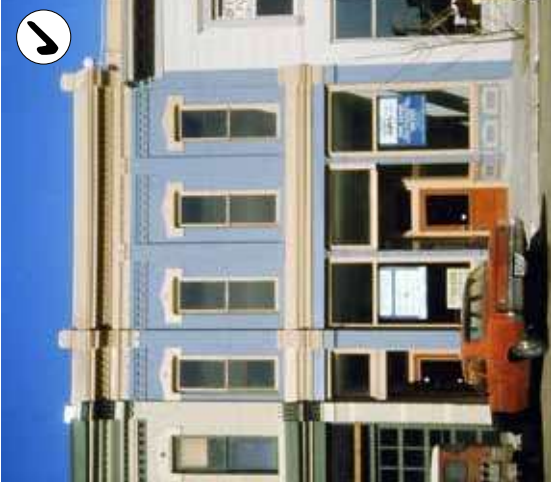
After rehabilitation: historic openings are restored.

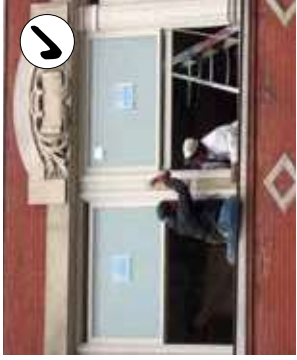
Match the appearance of a historic window design (i.e., if the historic is double-hung, use a double-hung replacement window).

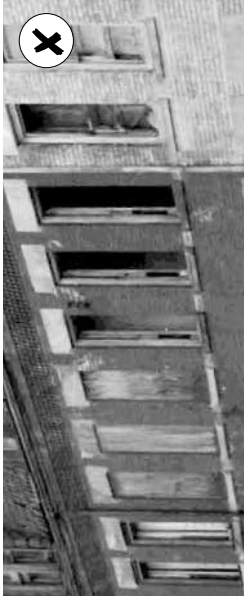
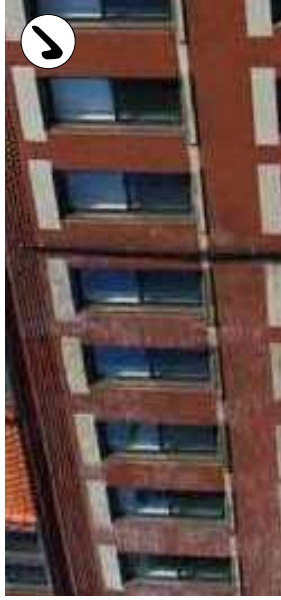
Replace historic windows (top) with a matching design (bottom), if repair is not possible.

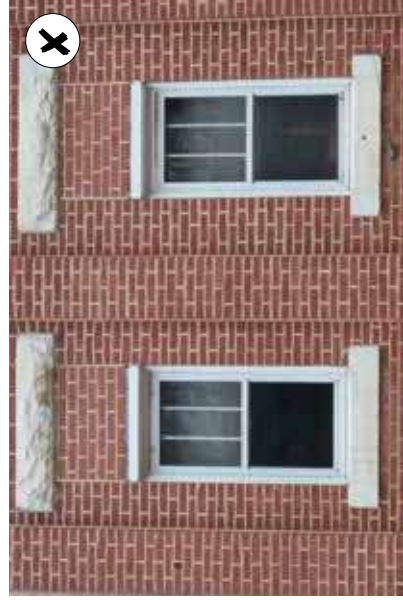
Do not reduce a historic opening to accommodate a smaller window or increase it to accommodate a larger window.

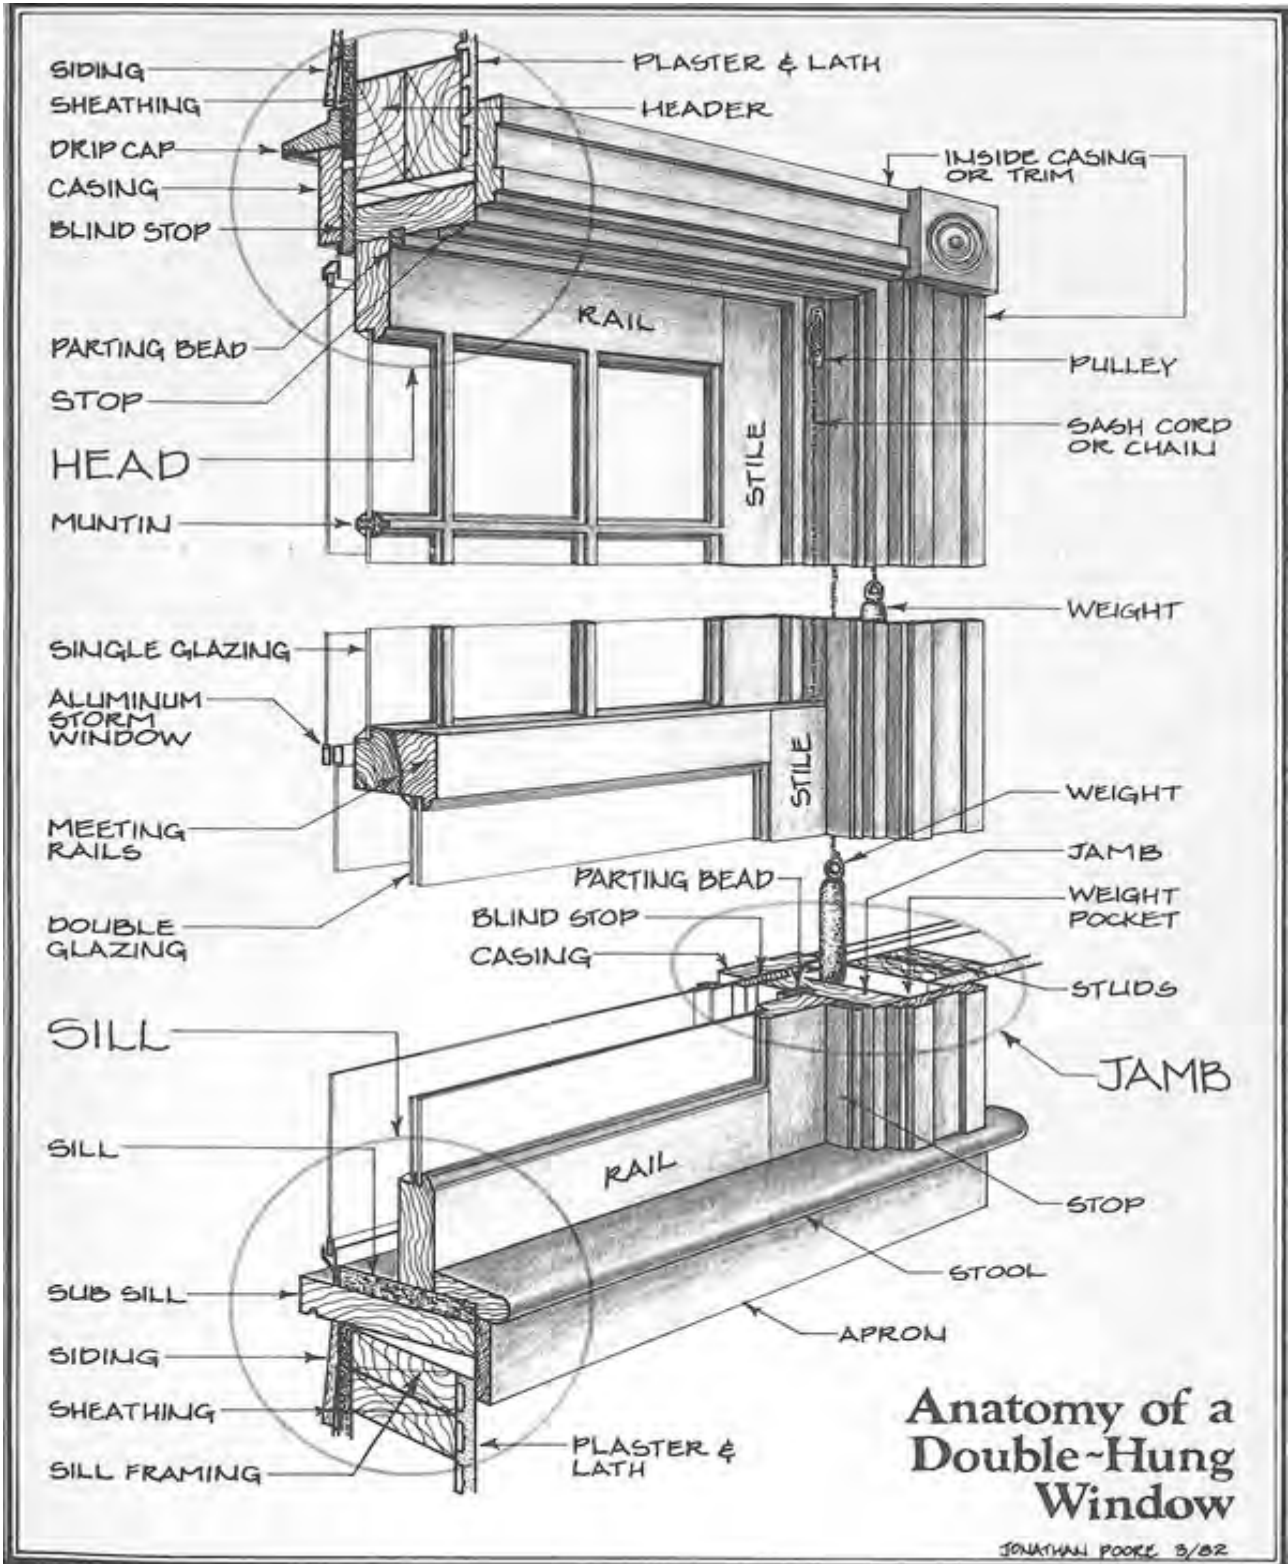
⁴ Old House Journal "Repairing Hopeless Windows" April 1982, pg. 87

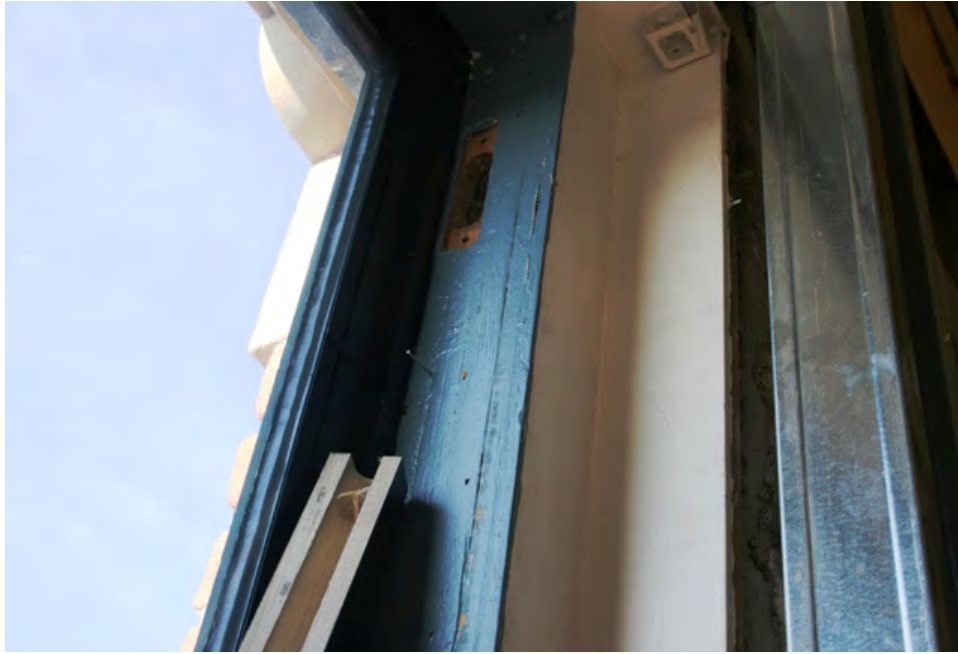
Image 1: Note missing window pulley. A cover, visible at the bottom of the image, was milled to prevent the window from opening fully, to cover the space left by the removed pulley, and to cover the end of the spiral balance.

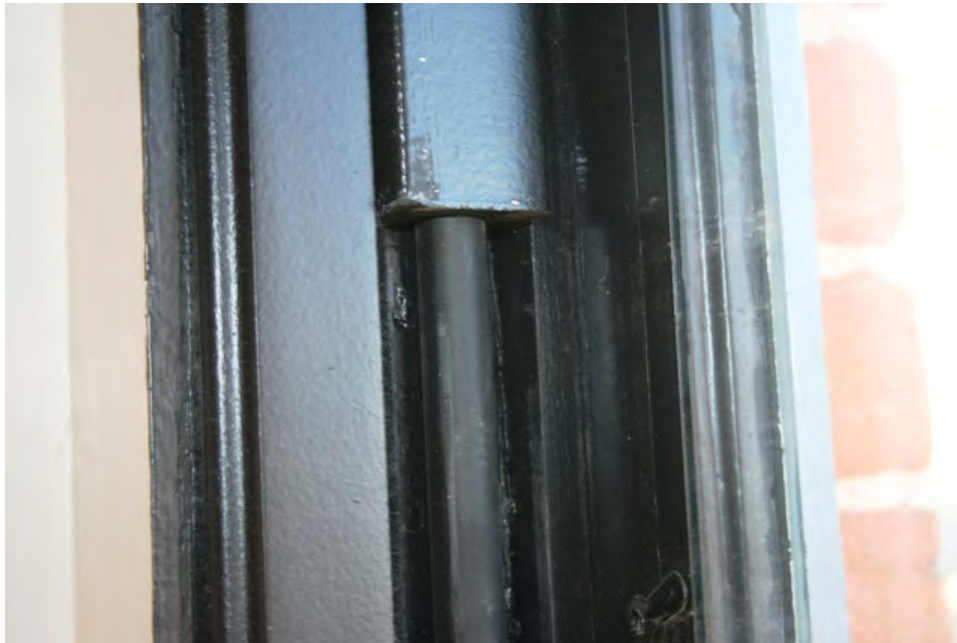
Image 2: Cover in place. Black plastic tube houses the spiral balance mechanism.

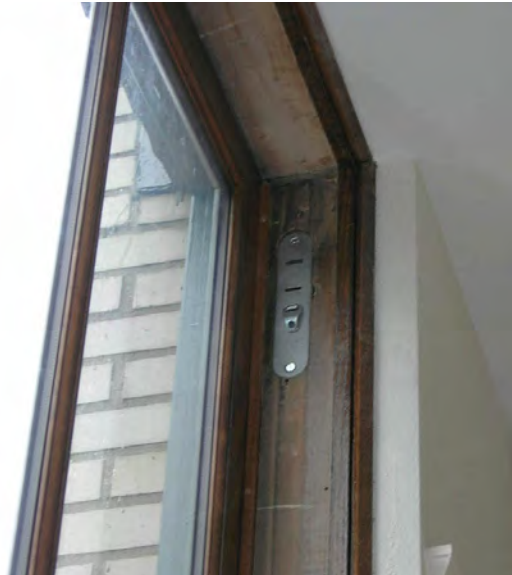
Image 3: Pullman balance installed in place of a window pulley. Photo courtesy of the Pullman website
