STAFF REPORT August 21, 2024
Historic Preservation Commission

PROJECT NAME

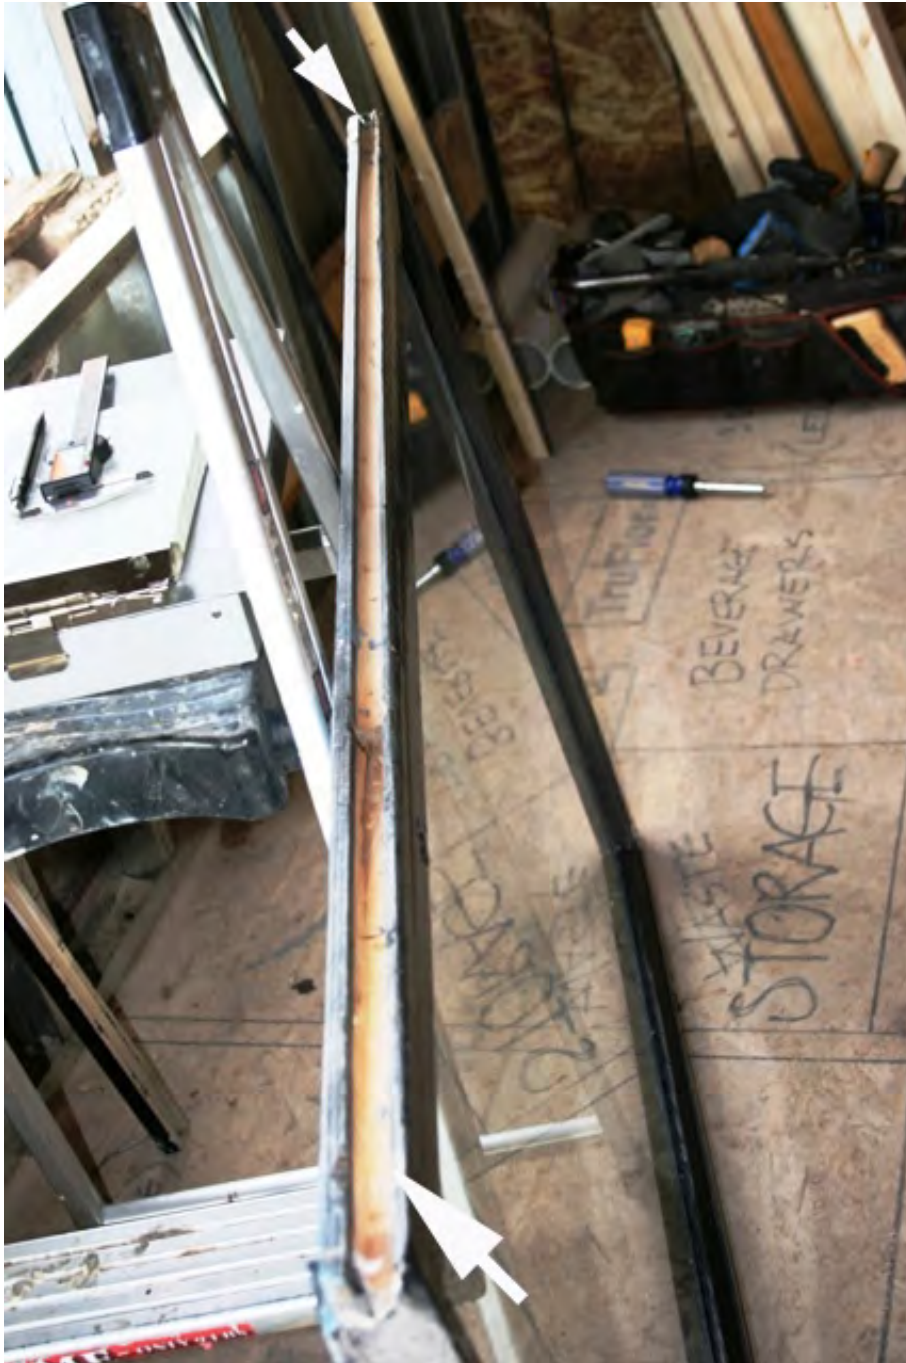
Image 4: Groove cut into one stile. White arrows note the groove.

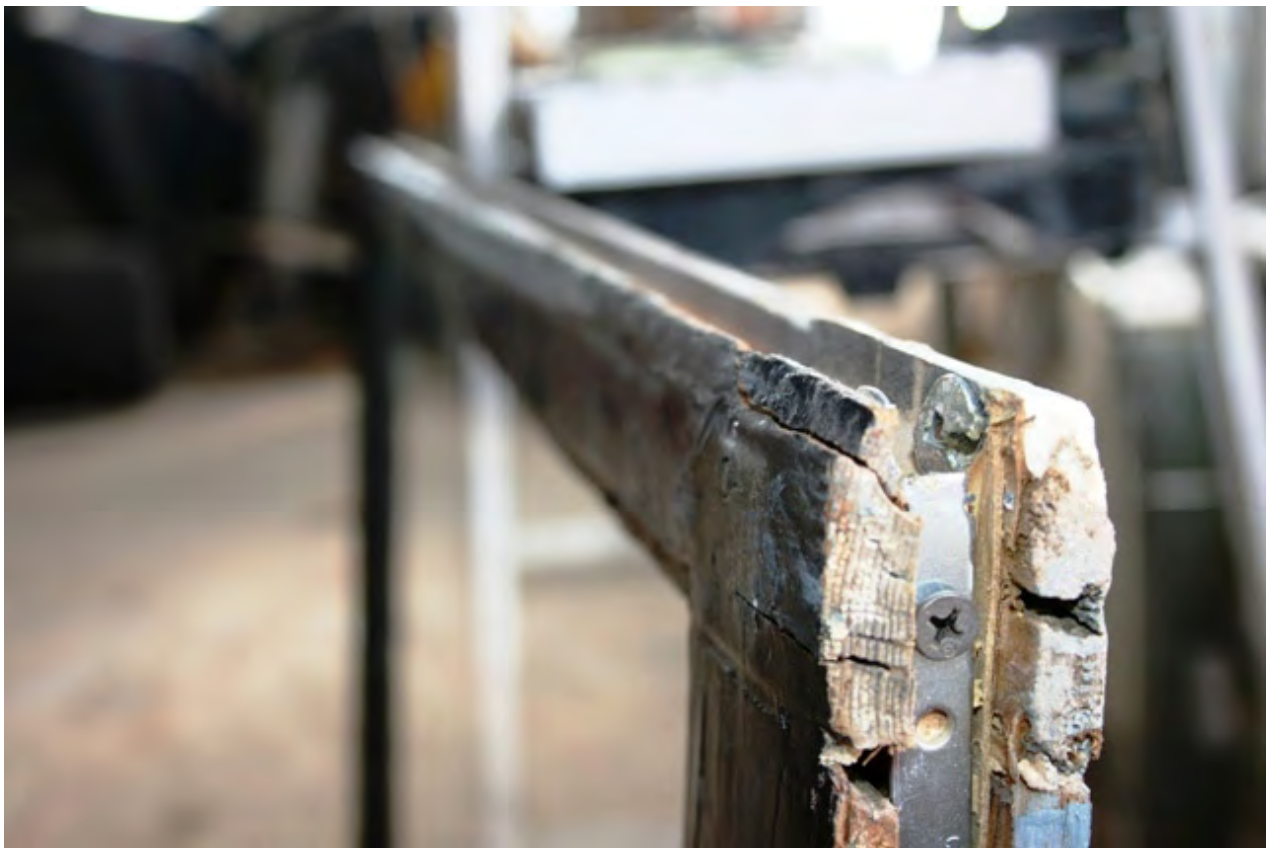
Image 6: Note the split that has already developed as a result of the removal of supporting material. In addition, note the thinly filled epoxy repairs that are adjacent

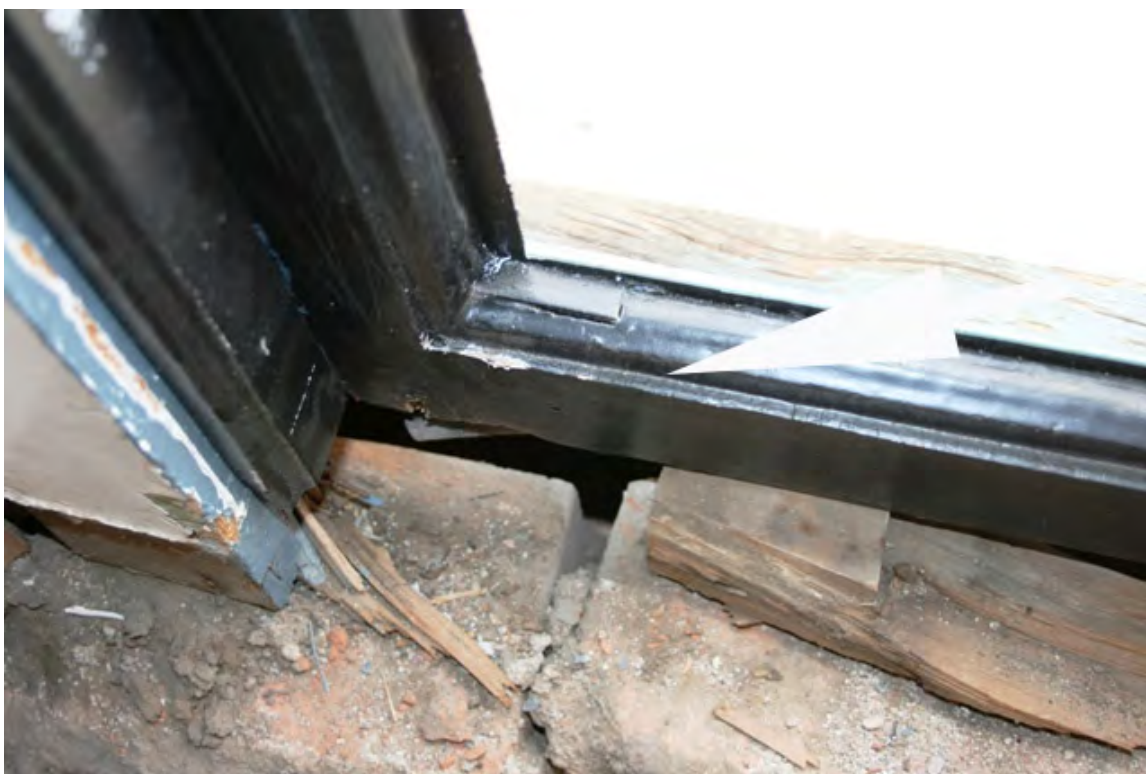
Image 7: Groove cut to house glass panel. The open space underneath the sash is due to the sill and stool being missing, presumably awaiting restoration.

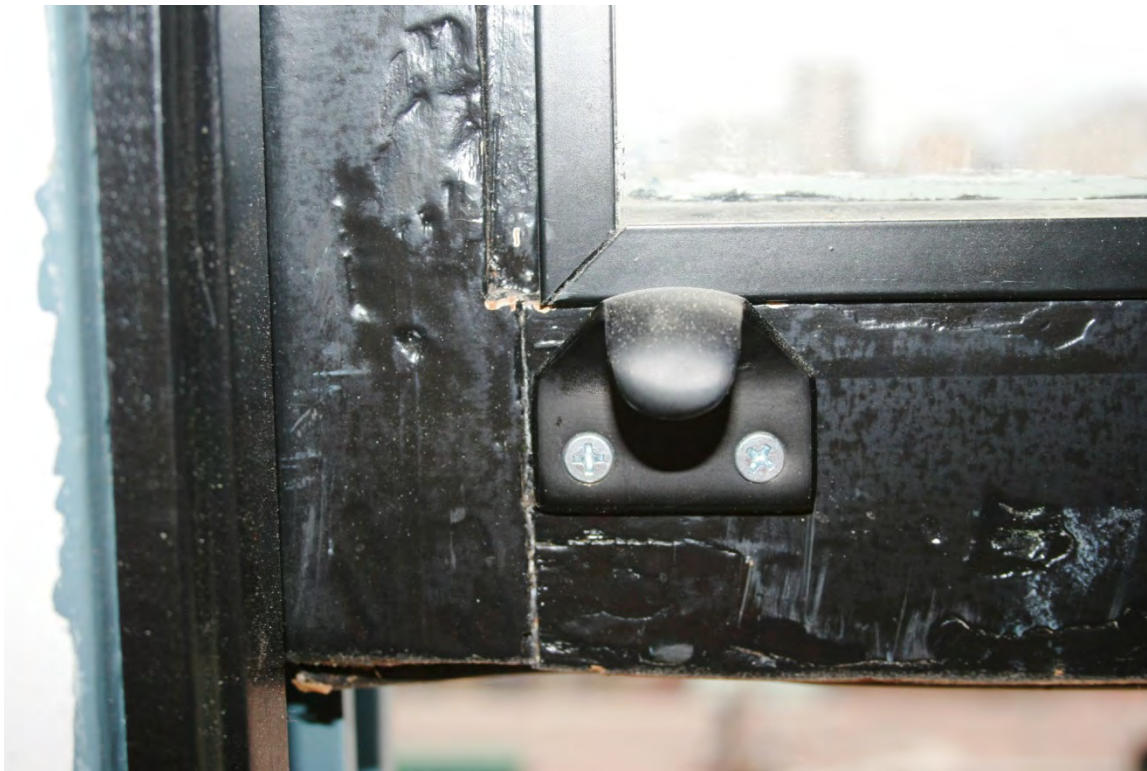
Image 8: Note that glass panel does not fit tight in groove

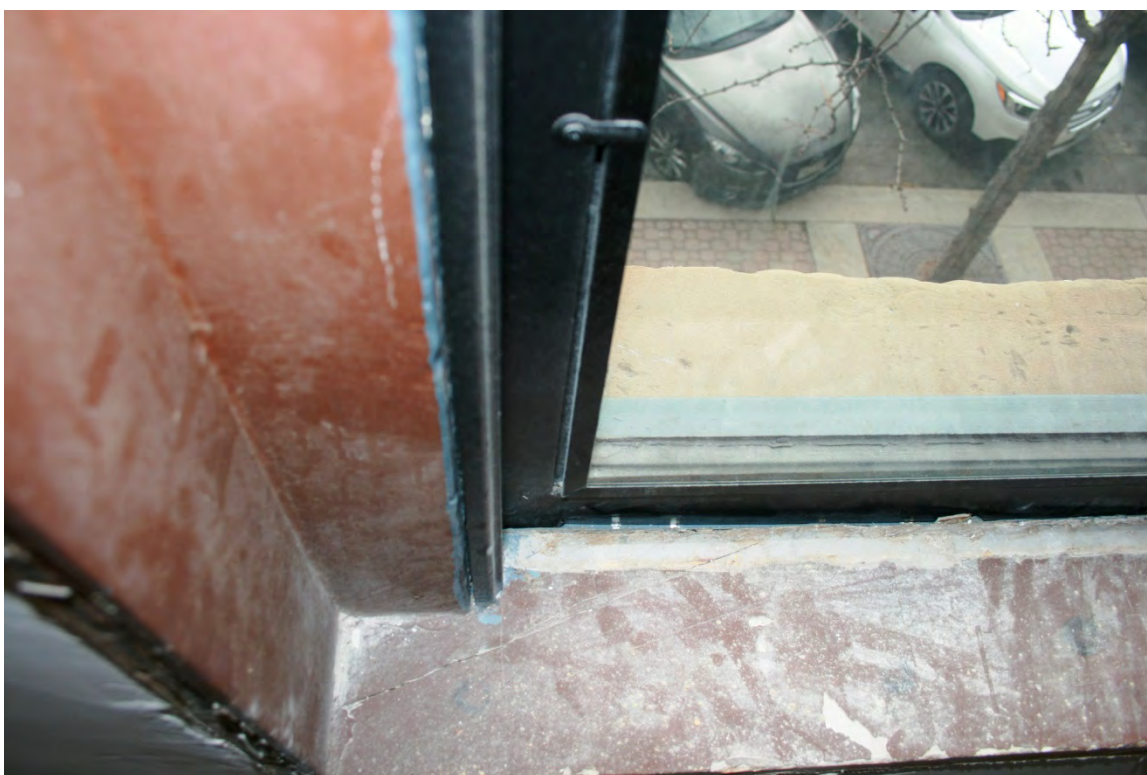
Image 9: Glass panel is slipping. Fit is loose

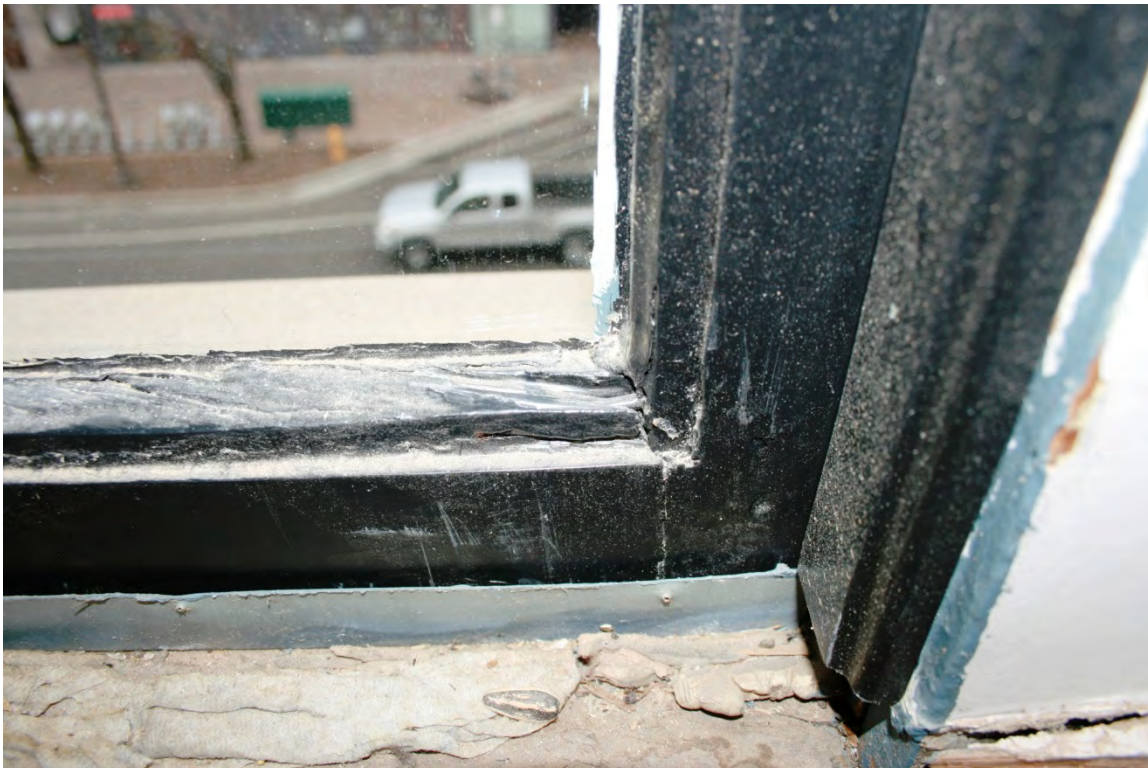
Image 10: Note the condition of the lower rail and the built-up paint

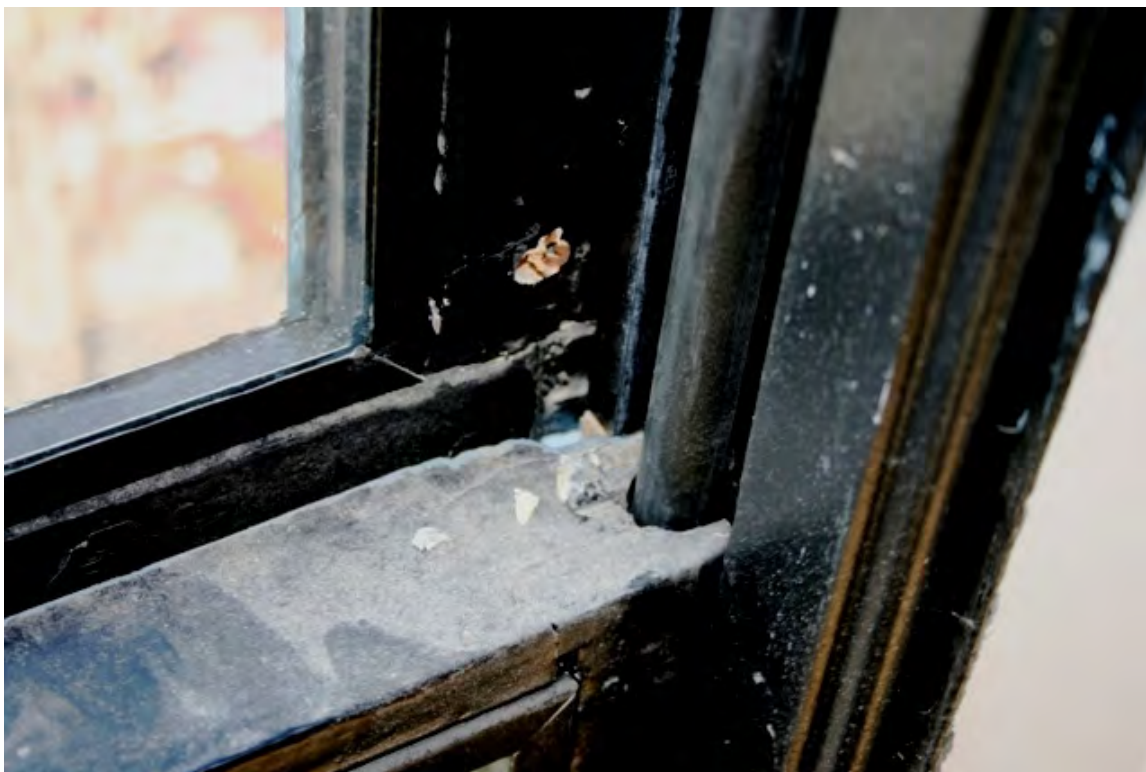
Image 11: Note flaking paint

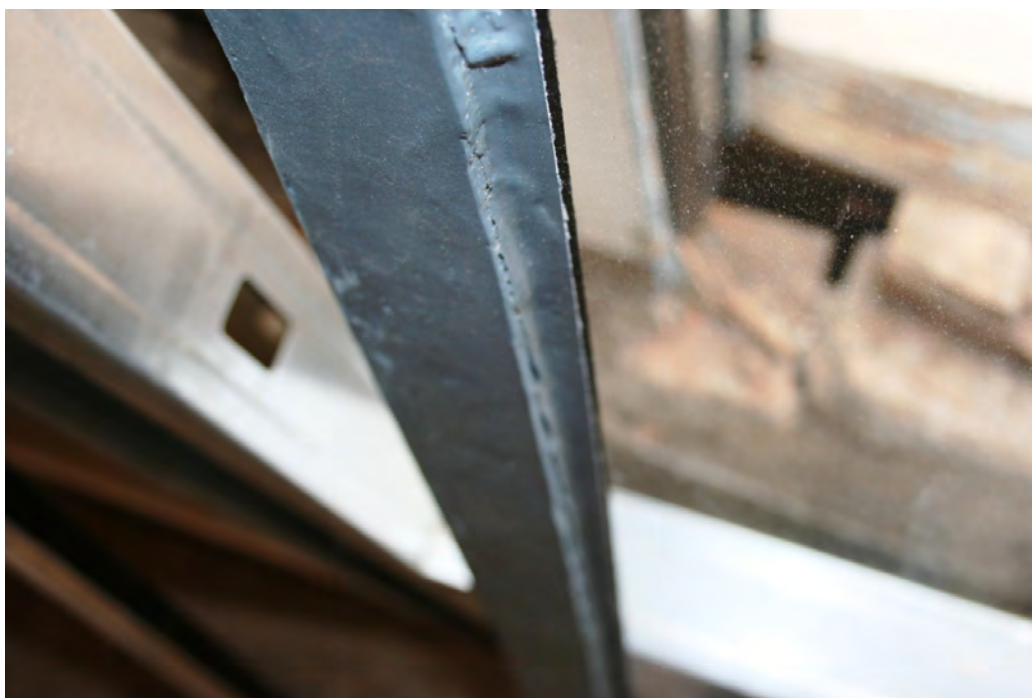
Image 13: Note the concave surface of the glazing compound. This is less effective at shedding water and does not replicate the historic appearance

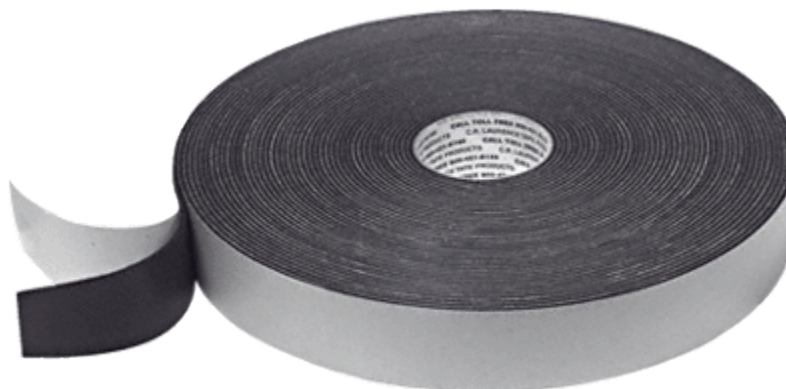
Image 16: Example of single-sided foam glazing tape

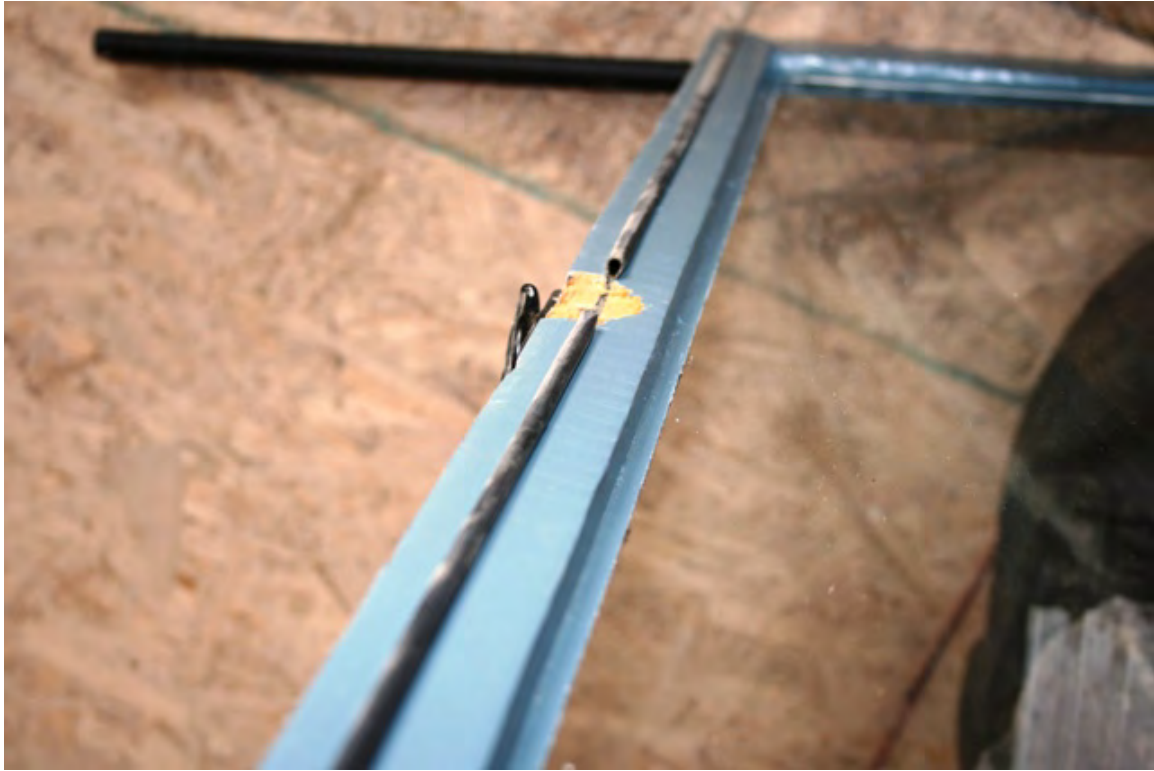
Image 17: Damaged seal at meeting rail

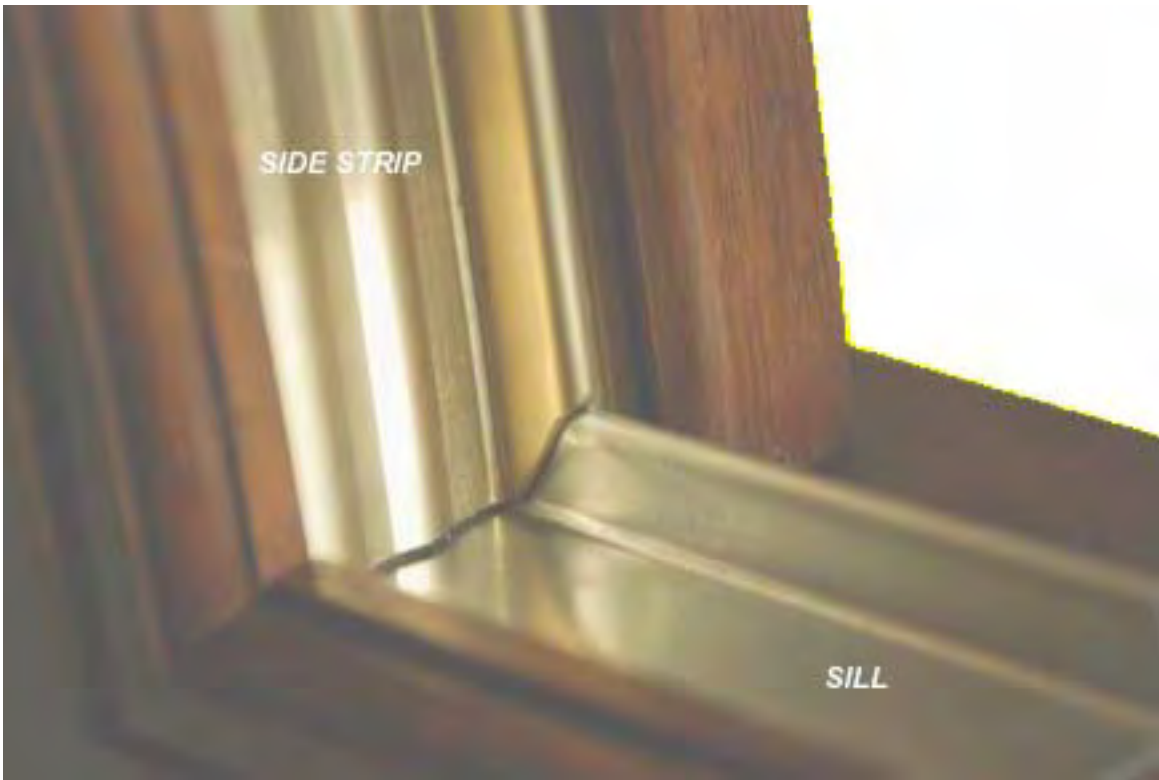
Image 18: Image from Accurate Weatherstripping. The sill strip can be omitted in the described application

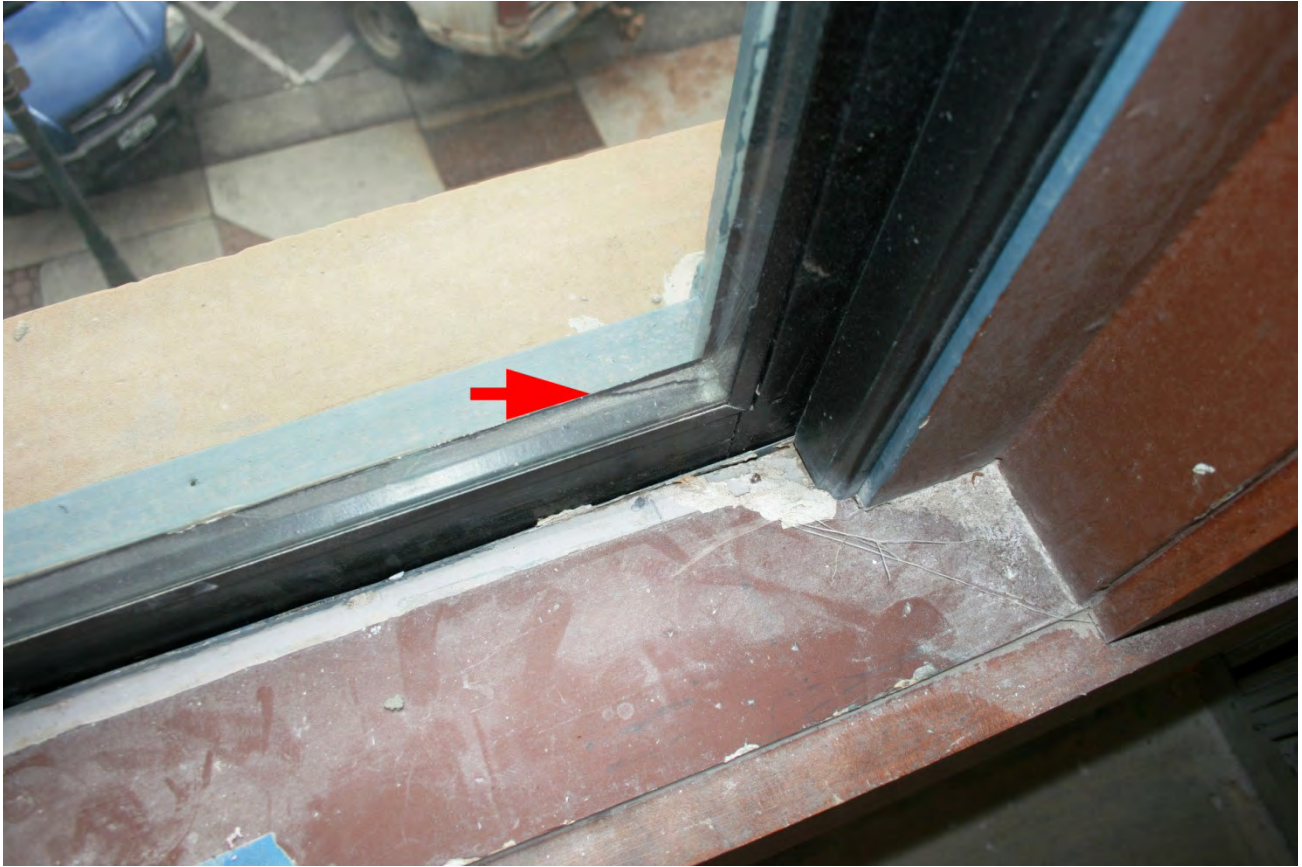
Image 19: Window 002-6, note crack in lower rail

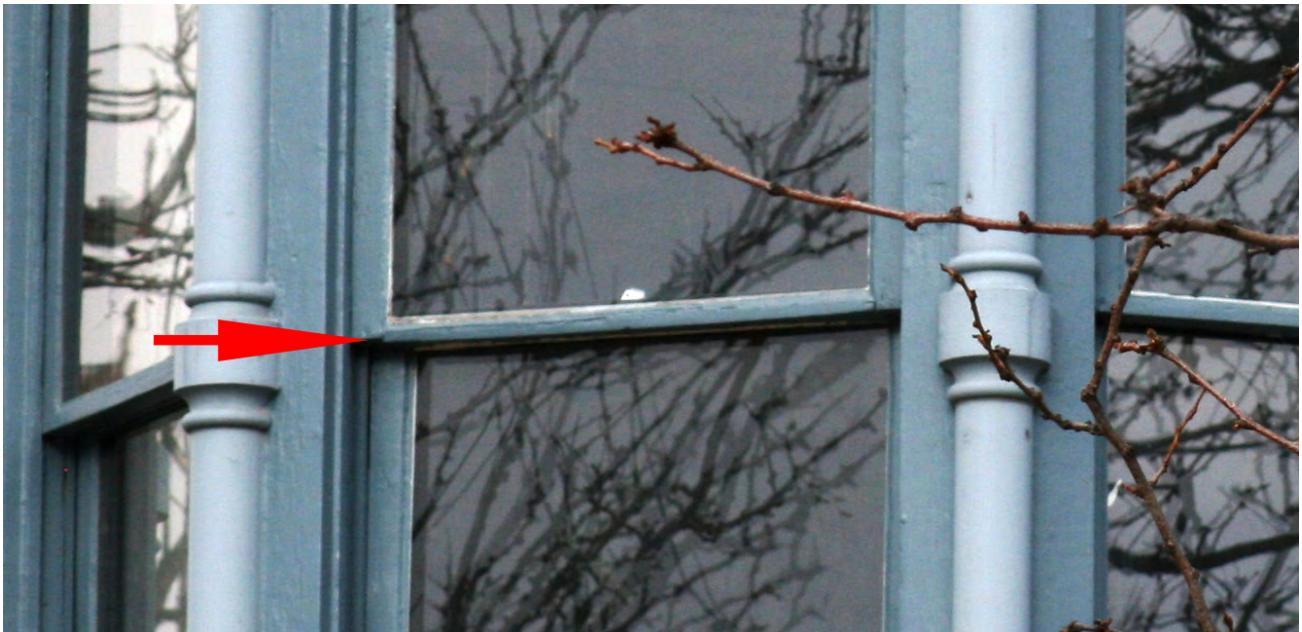
Image 20: Window 002-11, note meeting rail slipping down

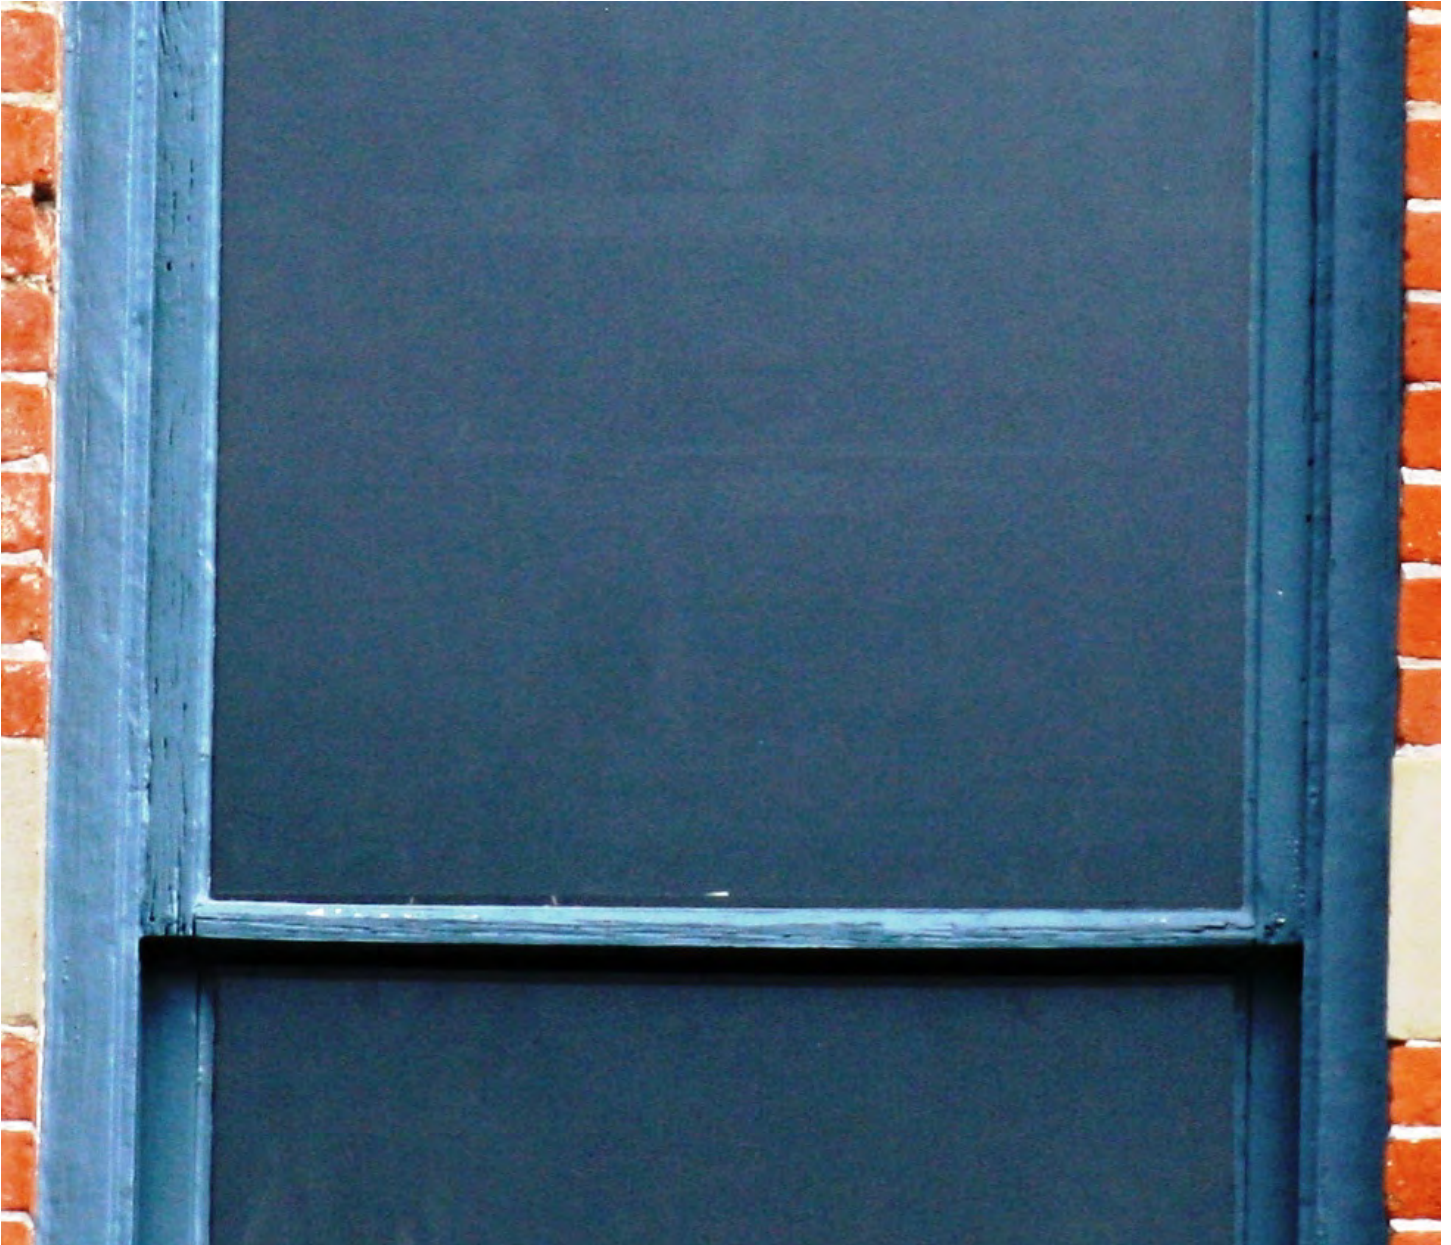
Image 21: Window 002-21 deterioration at the upper sash stiles and meeting rail left untreated

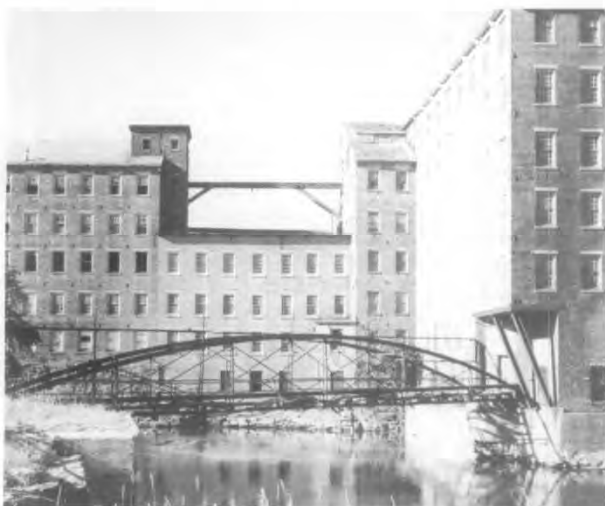
Figure 1. Windows are frequently important visual focal points, especially on simple facades such as this mill building. Replacement of the multi-pane windows here with larger panes could dramatically change the appearance of the building. The areas of missing windows convey the impression of such a change. Photo: John T. Lowe

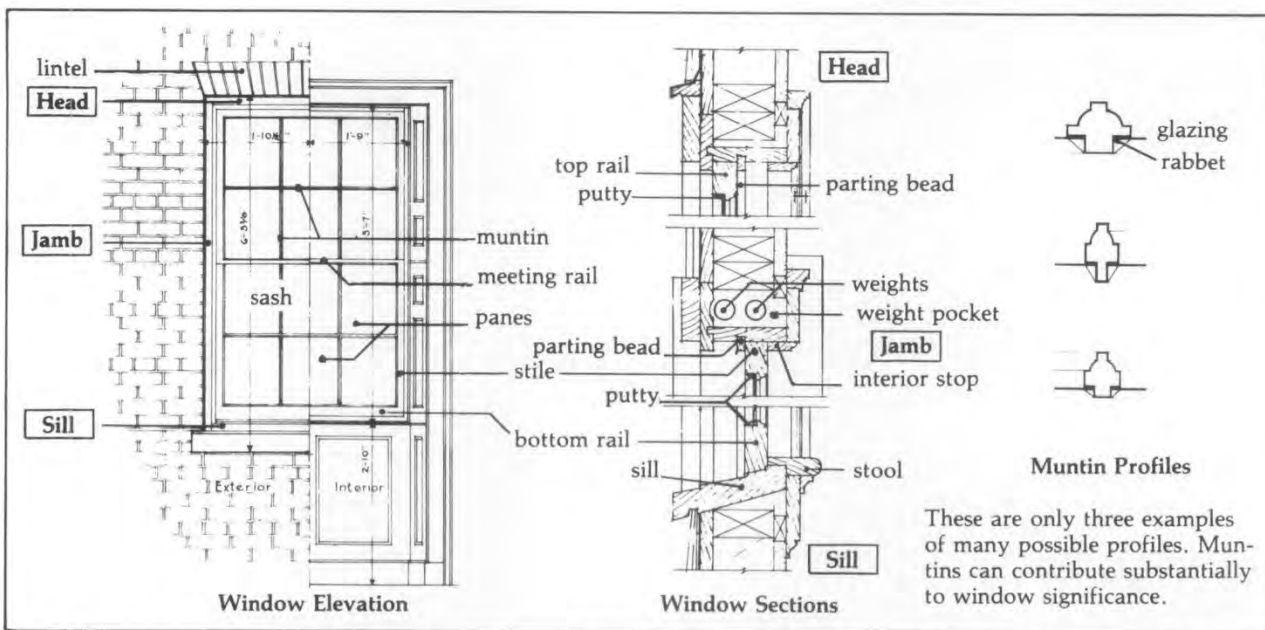
Figure 2. These drawings of window details identify major components, terminology, and installation details for a wooden double-hung window.

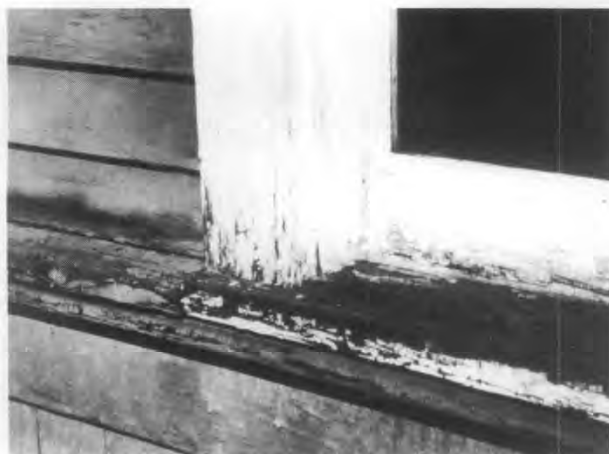
Figure 3. Deterioration of poorly maintained windows usually begins on horizontal surfaces and at joints where water can collect and saturate the wood. The problem areas are clearly indicated by paint failure due to moisture. Photo: Baird M. Smith, AIA

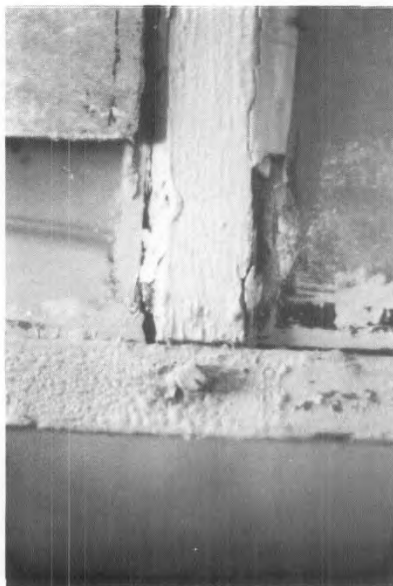
Figure 4a. The following series of photographs of the repair of a historic double-hung window use a unit which is structurally sound but has many layers of paint, some cracked and missing putty, slight separation at the joints, broken sash cords, and one cracked pane. Photo: John H. Myers

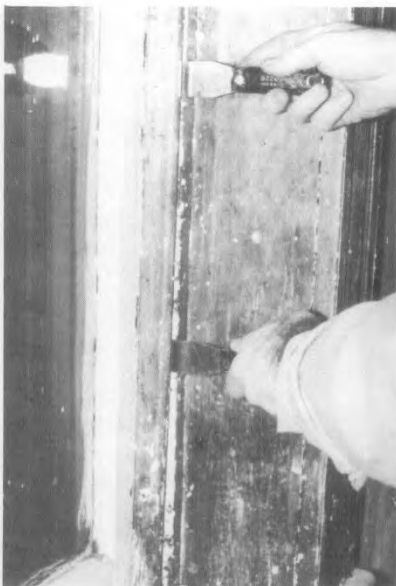
Figure 4b. After removing paint from the seam between the interior stop and the jamb, the stop can be pried out and gradually worked loose using a pair of putty knives as shown. To avoid visible scarring of the wood, the sash can be raised and the stop pried loose initially from the outer side. Photo: John H. Myers

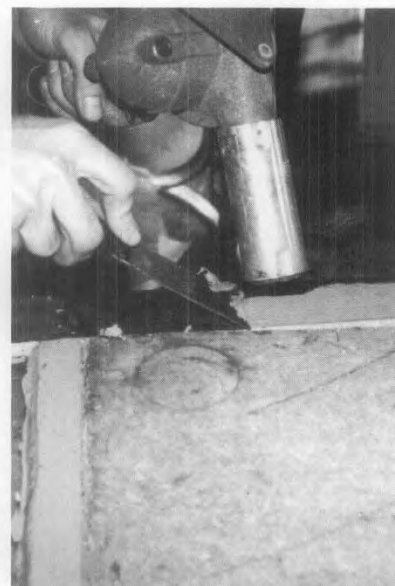
Figure 4c. Sash can be removed and repaired in a convenient work area. Paint is being removed from this sash with a hot air gun while an asbestos sheet protects the glass from sudden temperature change. Photo: John H. Myers

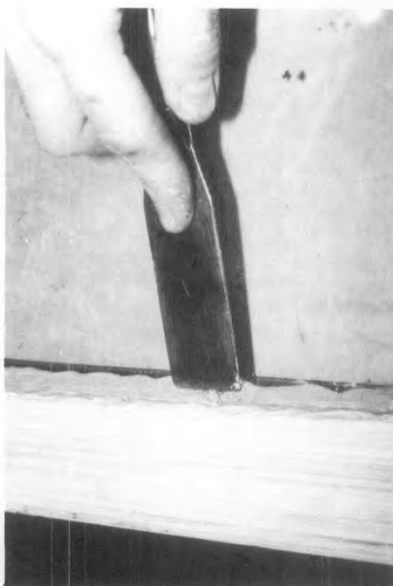
Figure 4d. Reglazing or replacement of the putty requires that the existing putty be removed manually, the glazing points be extracted, the glass removed, and the back putty scraped out. To reglaze, a bed of putty is laid around the perimeter of the rabbet, the pane is pressed into place, glazing points are inserted to hold the pane (shown), and a final seal of putty is beveled around the edge of the glass. Photo: John H. Myers

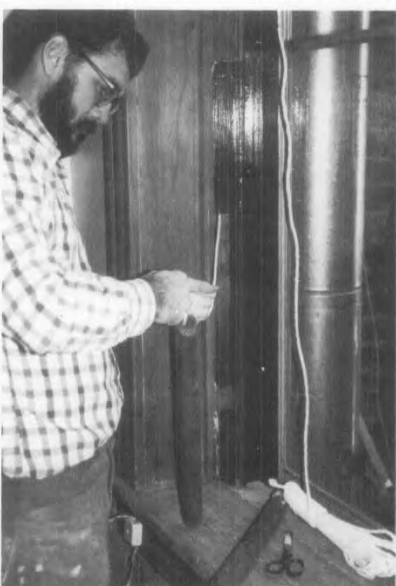
Figure 4e. A common repair is the replacement of broken sash cords with new cords (shown) or with chains. The weight pocket is often accessible through a removable plate in the jamb, or by removing the interior trim. Photo: John H. Myers

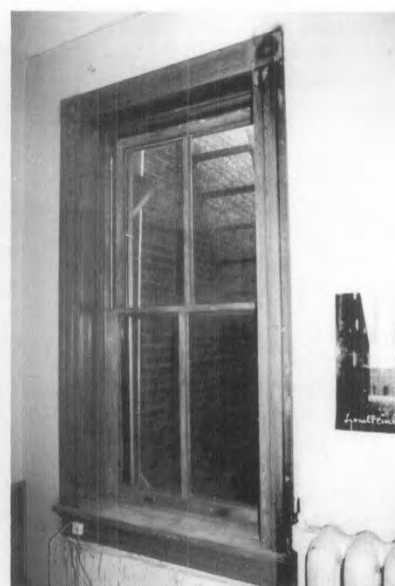
Figure 4f. Following the relatively simple repairs, the window is weathertight, like new in appearance, and serviceable for many years to come. Both the historic material and the detailing and craftsmanship of this original window have been preserved. Photo: John H. Myers

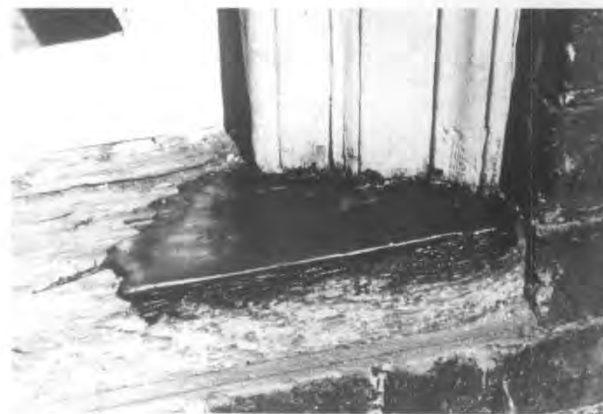
Figure 5. This illustrates a two-part epoxy patching compound used to fill the surface of a weathered sill and rebuild the missing edge. When the epoxy cures, it can be sanded smooth and painted to achieve a durable and waterproof repair. Photo: John H. Myers

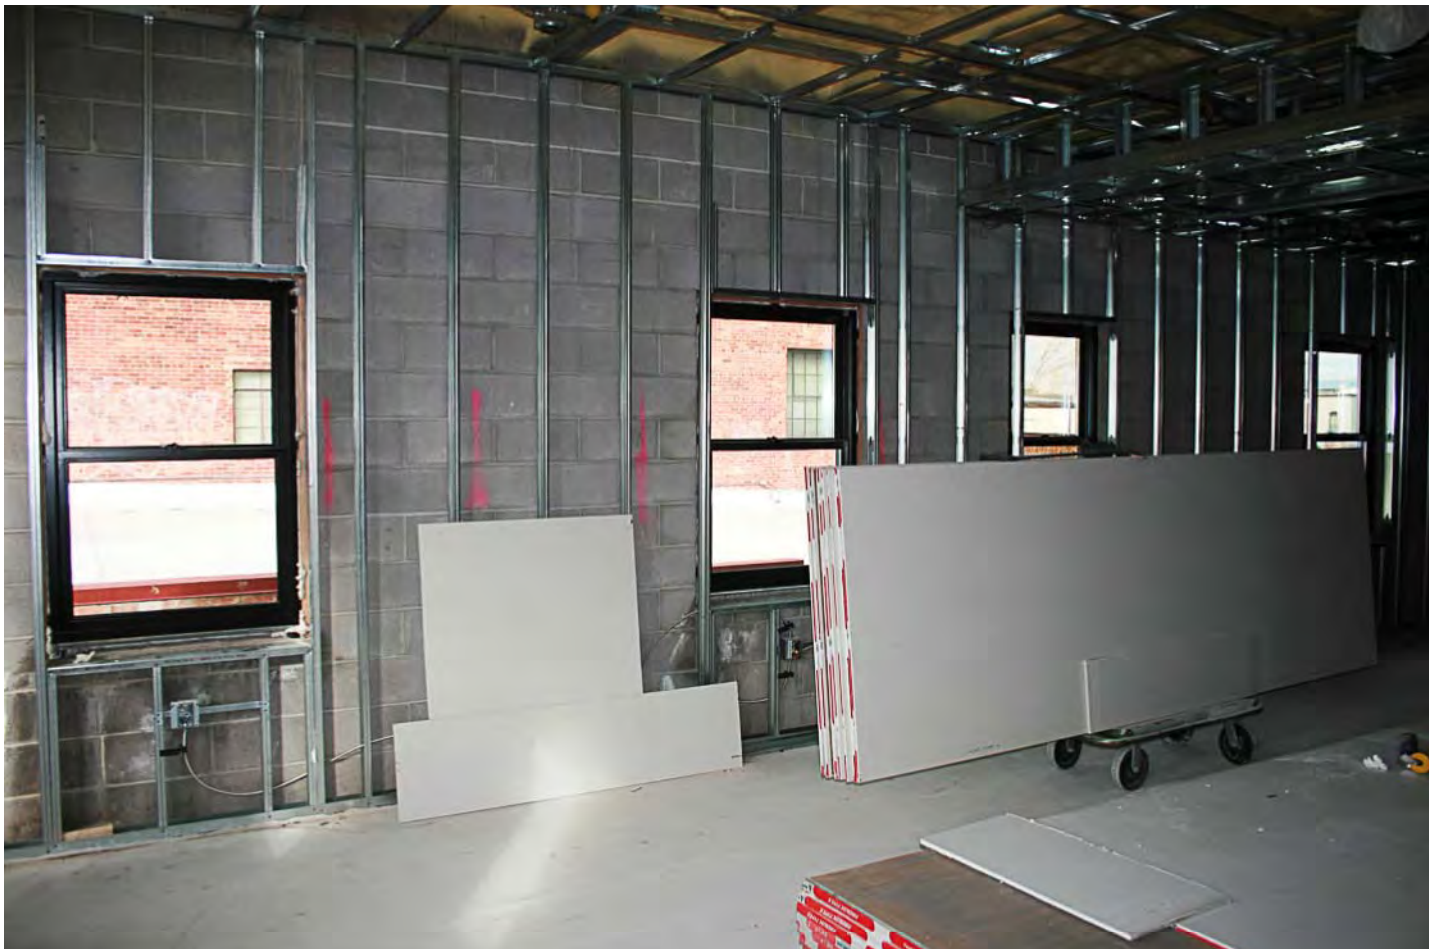
Replacement windows_Northwest elevation_Alley 2

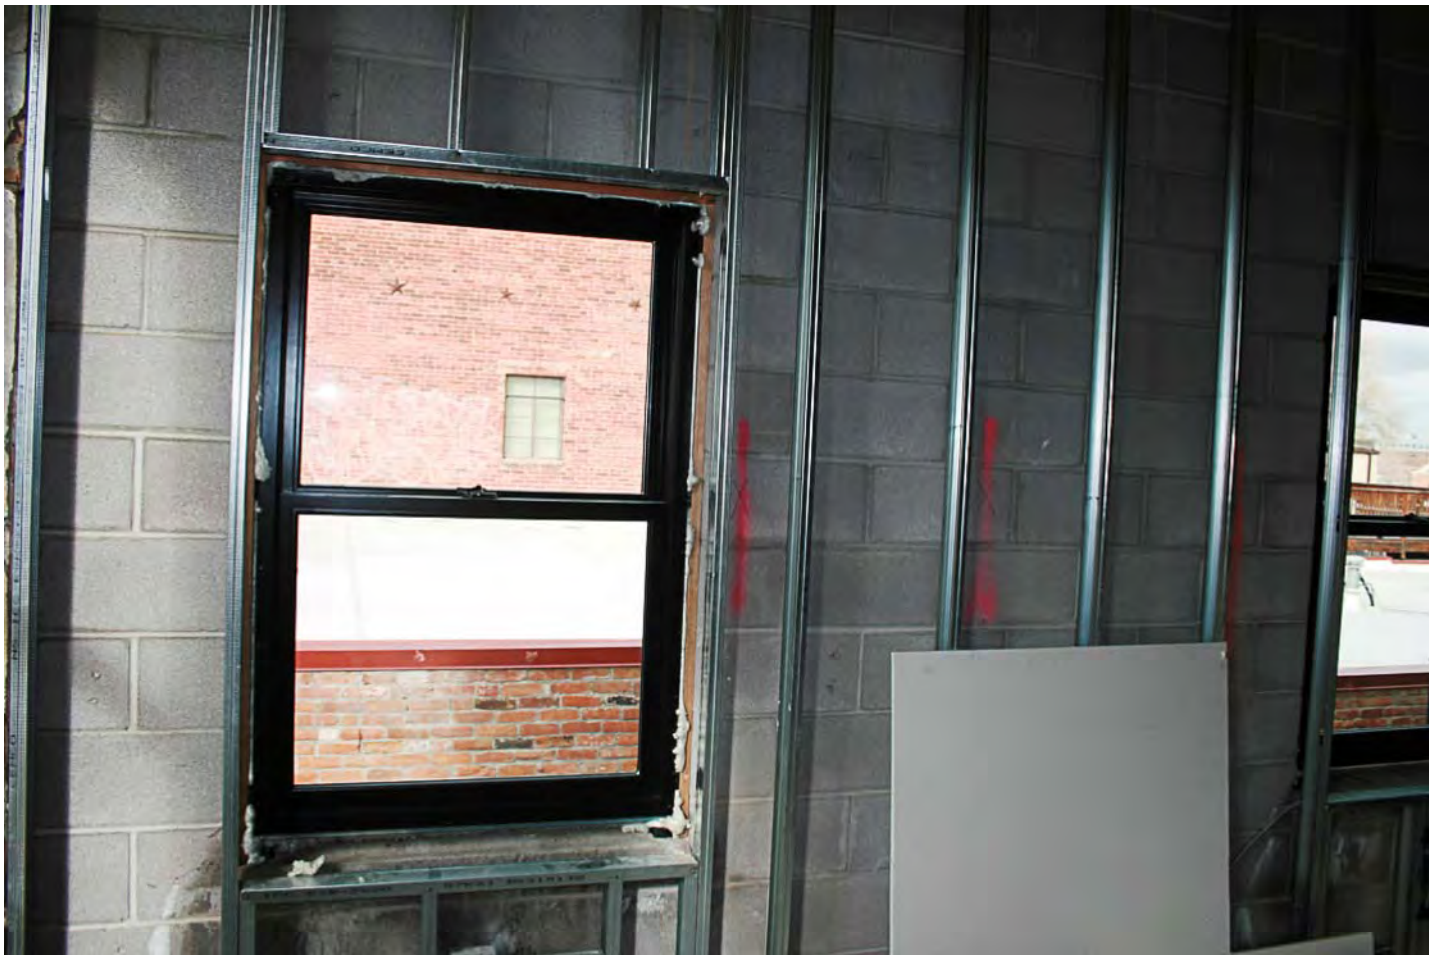
Replacement windows_Northwest elevation_Alley

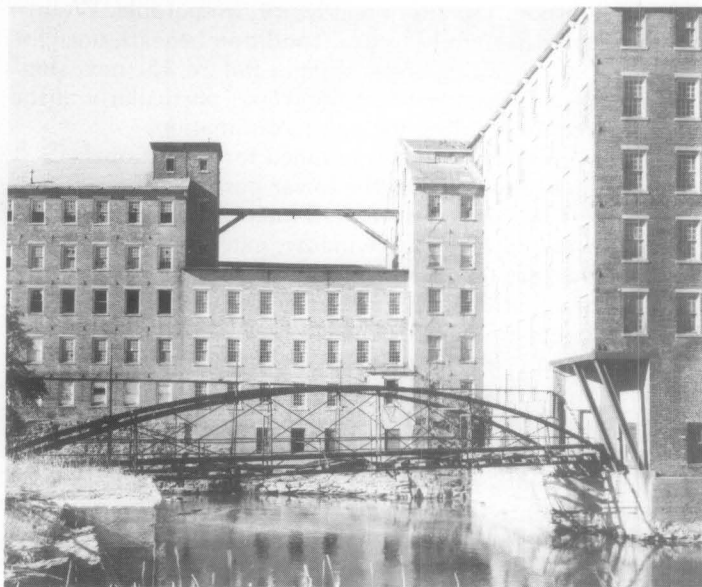
Figure 1. Windows are frequently important visual focal points, especially on simple facades such as this mill building. Replacement of the multi-pane windows here with larger panes could dramatically change the appearance of the building. The areas of missing windows convey the impression of such a change. Photo: John T. Lowe

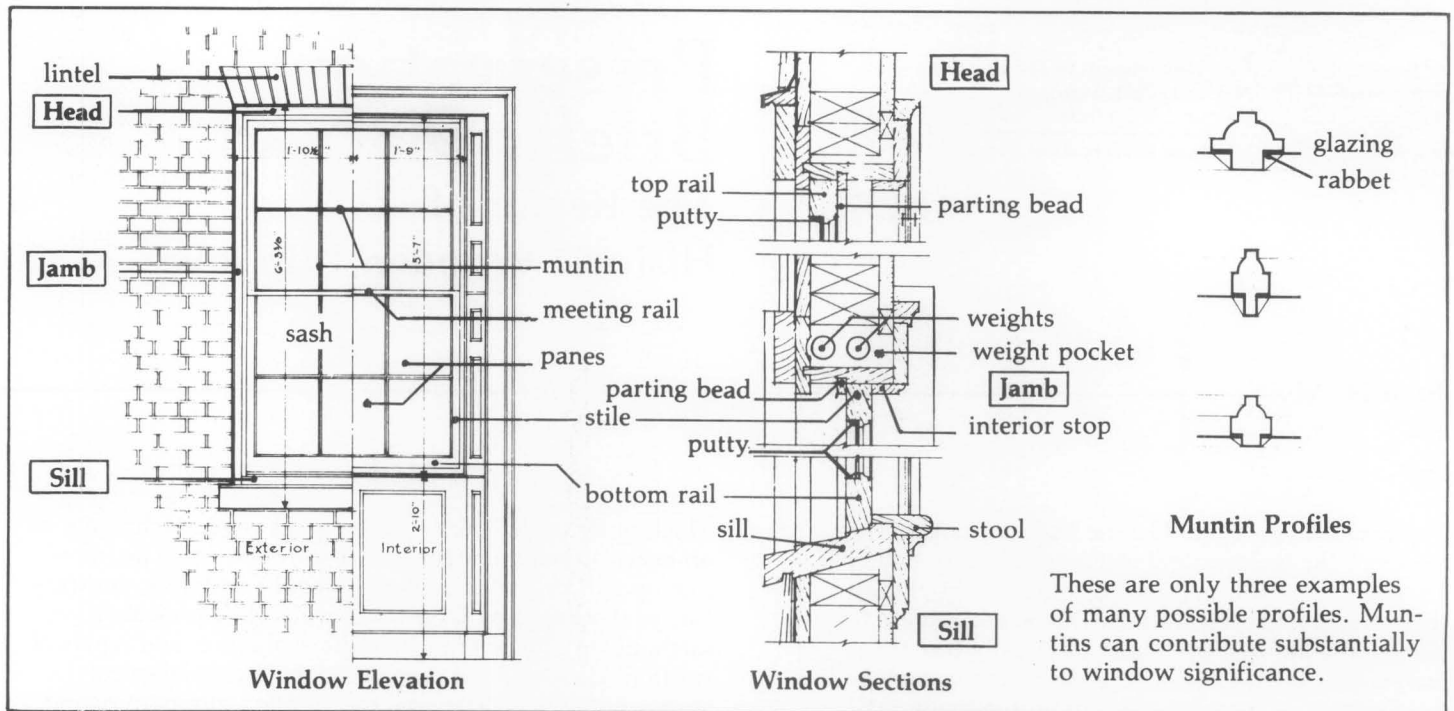
Figure 2. These drawings of window details identify major components, terminology, and installation details for a wooden double-hung window.

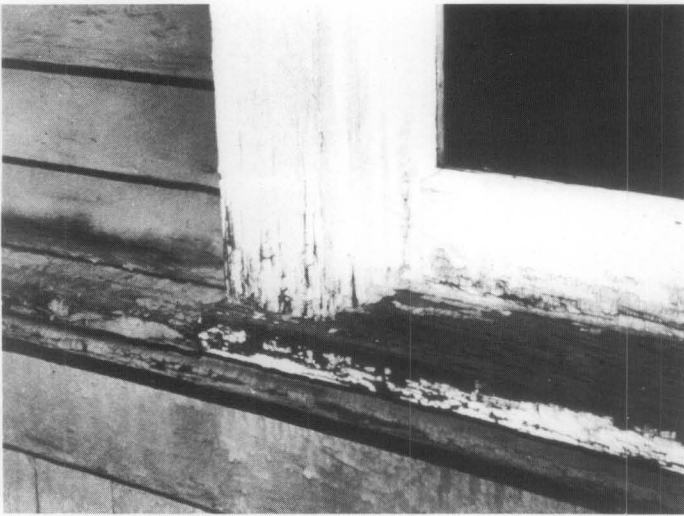
Figure 3. Deterioration of poorly maintained windows usually begins on horizontal surfaces and at joints where water can collect and saturate the wood. The problem areas are clearly indicated by paint failure due to moisture. Photo: Baird M. Smith, AIA

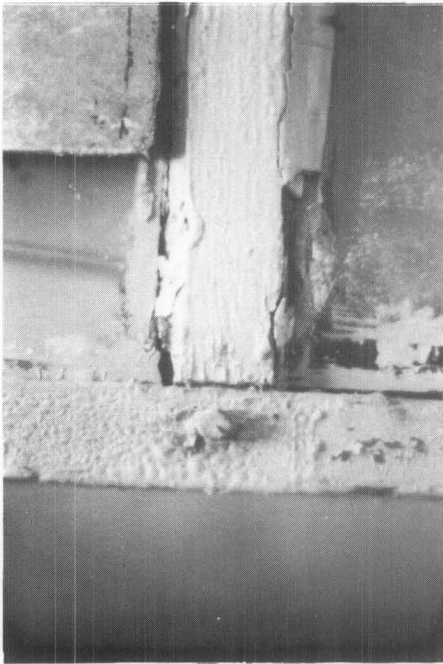
Figure 4a. The following series of photographs of the repair of a historic double-hung window use a unit which is structurally sound but has many layers of paint, some cracked and missing putty, slight separation at the joints, broken sash cords, and one cracked pane. Photo: John H. Myers

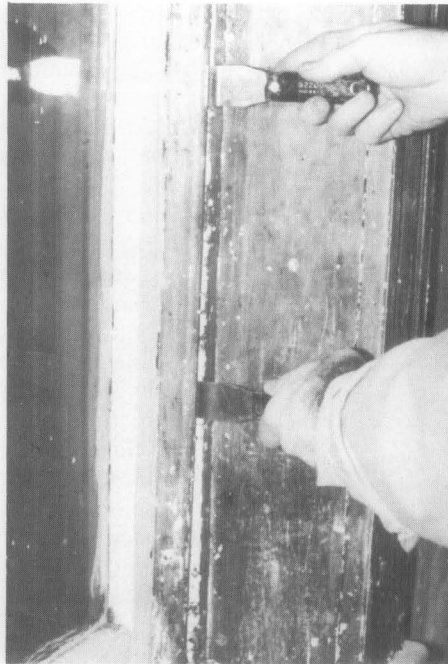
Figure 4b. After removing paint from the seam between the interior stop and the jamb, the stop can be pried out and gradually worked loose using a pair of putty knives as shown. To avoid visible scarring of the wood, the sash can be raised and the stop pried loose initially from the outer side. Photo: John H. Myers
