STAFF REPORT August 21, 2024
Historic Preservation Commission

PROJECT NAME

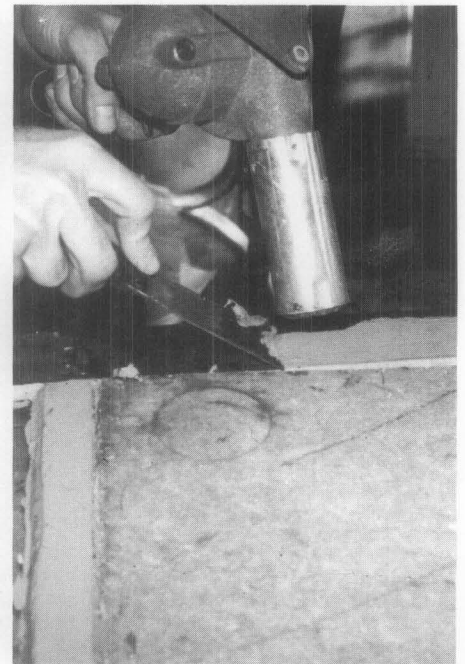
Figure 4c. Sash can be removed and repaired in a convenient work area. Paint is being removed from this sash with a hot air gun while an asbestos sheet protects the glass from sudden temperature change. Photo: John H. Myers

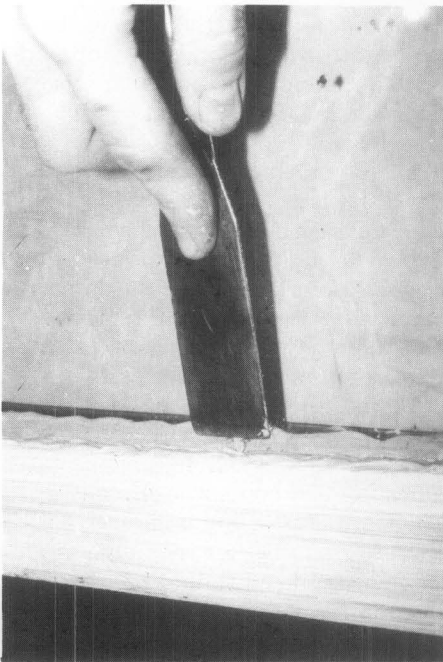
Figure 4d. Reglazing or replacement of the putty requires that the existing putty be removed manually, the glazing points be extracted, the glass removed, and the back putty scraped out. To reglaze, a bed of putty is laid around the perimeter of the rabbet, the pane is pressed into place, glazing points are inserted to hold the pane (shown), and a final seal of putty is beveled around the edge of the glass. Photo: John H. Myers

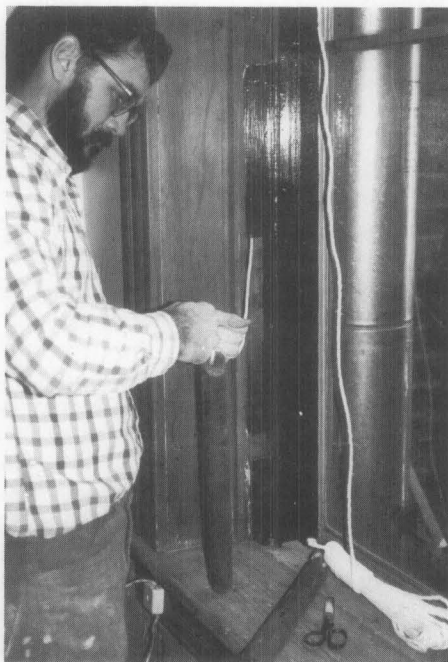
Figure 4e. A common repair is the replacement of broken sash cords with new cords (shown) or with chains. The weight pocket is often accessible through a removable plate in the jamb, or by removing the interior trim. Photo: John H. Myers

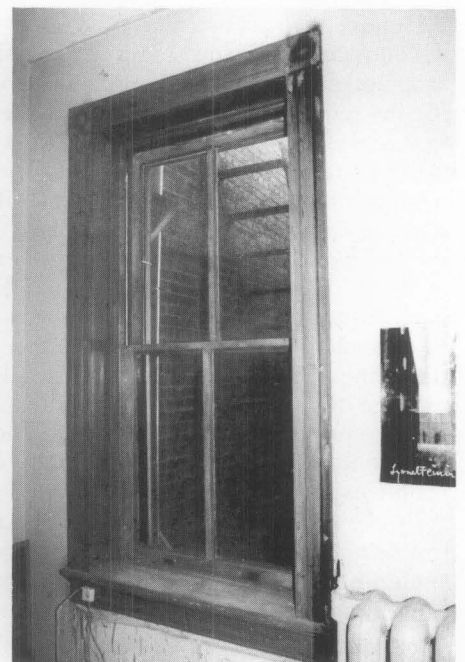
Figure 4f. Following the relatively simple repairs, the window is weathertight, like new in appearance, and serviceable for many years to come. Both the historic material and the detailing and craftsmanship of this original window have been preserved. Photo: John H. Myers

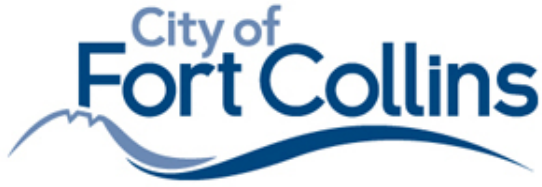
City Attorney's Office
300 Laporte Avenue
PO Box 580
Fort Collins, CO 80522
970.221.6520
970.221.6327
fcgov.com

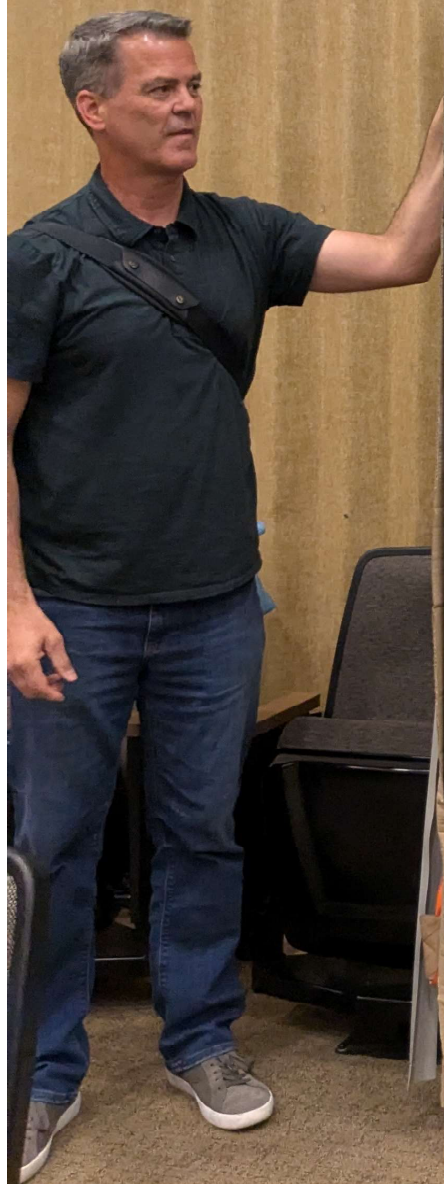
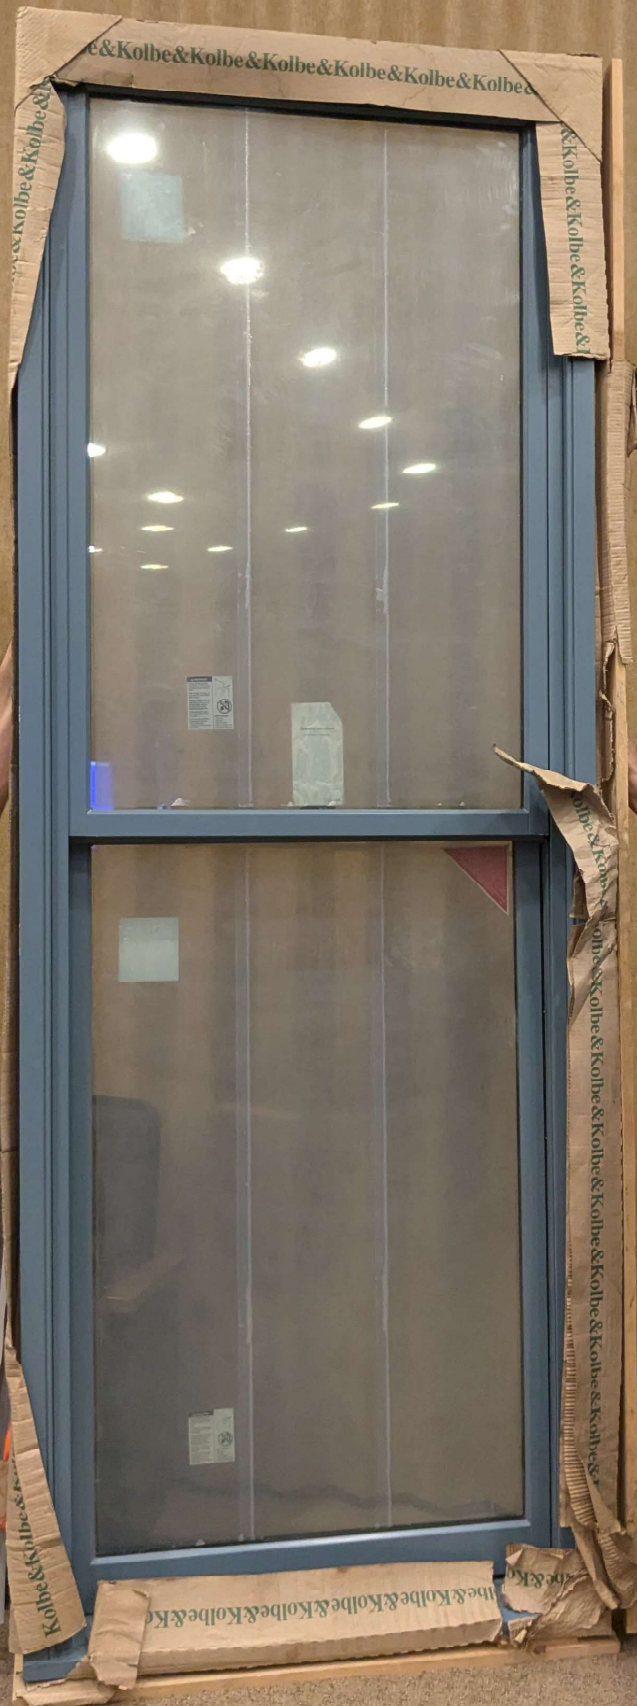
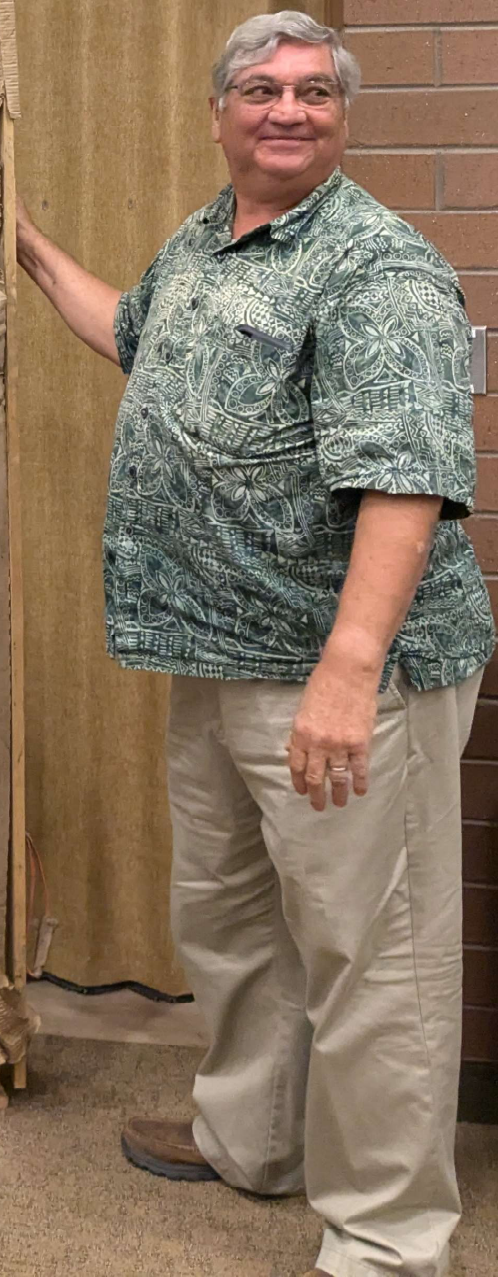
CC: Maren Bzdek, Historic Preservation Manager
Paul Sizemore, CDNS Director

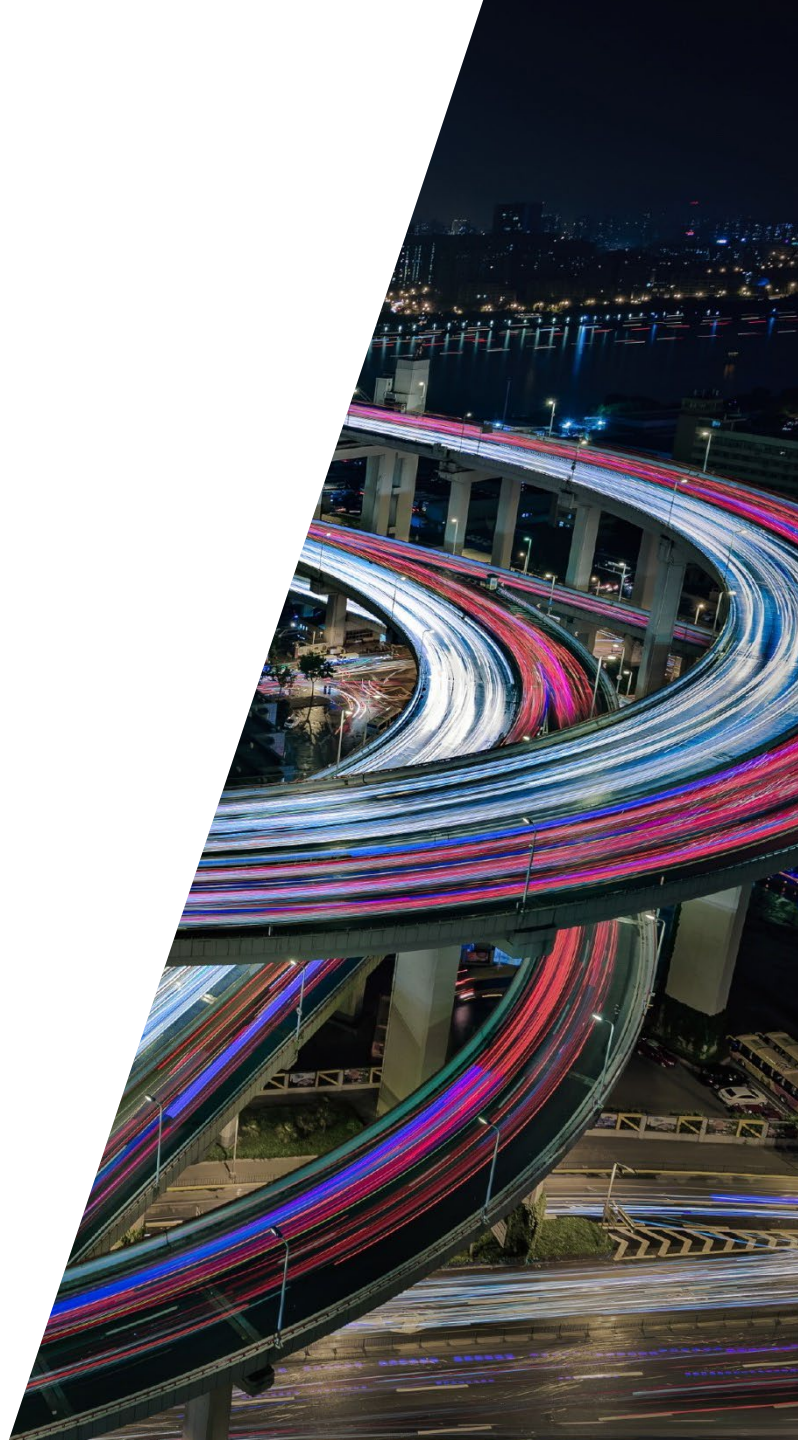
201 Linden Hotel Team

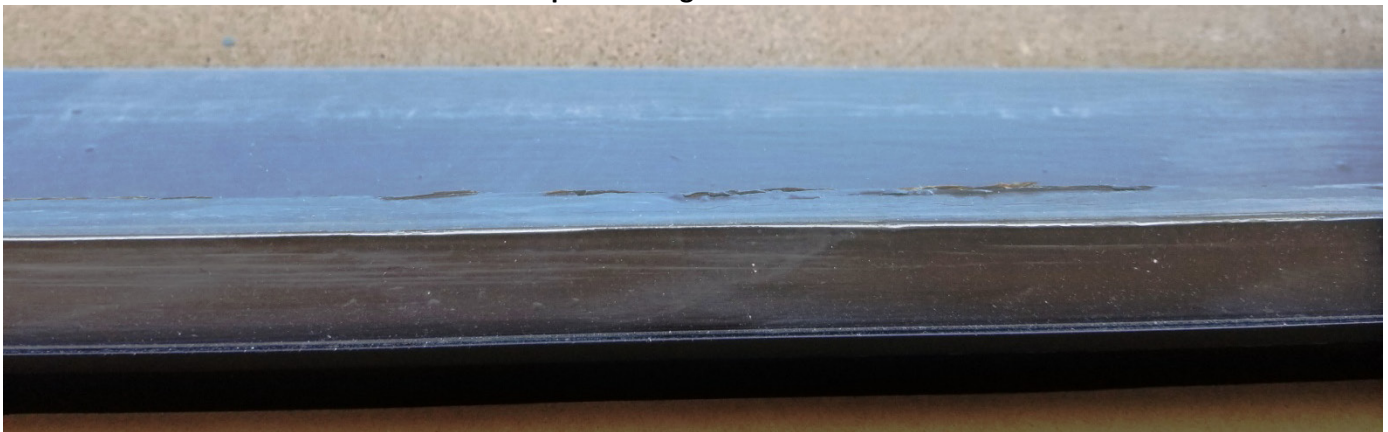
Image 1: Paint failure, lower sash

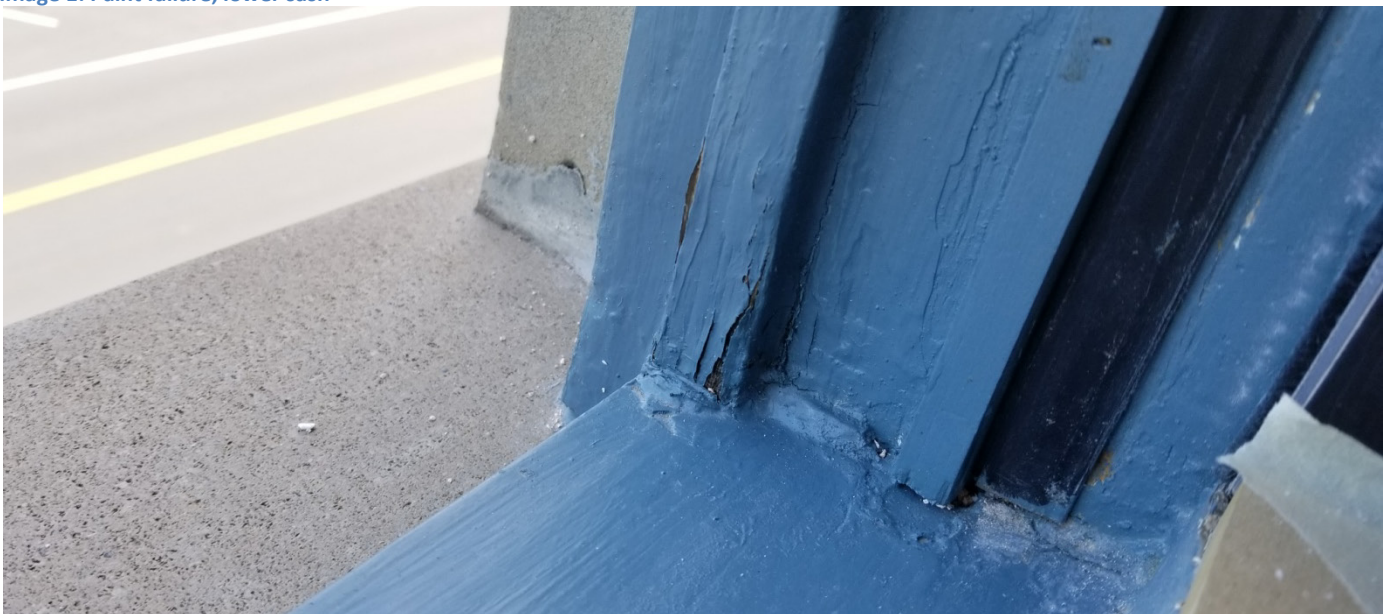
Image 2: Paint failure, blind stop

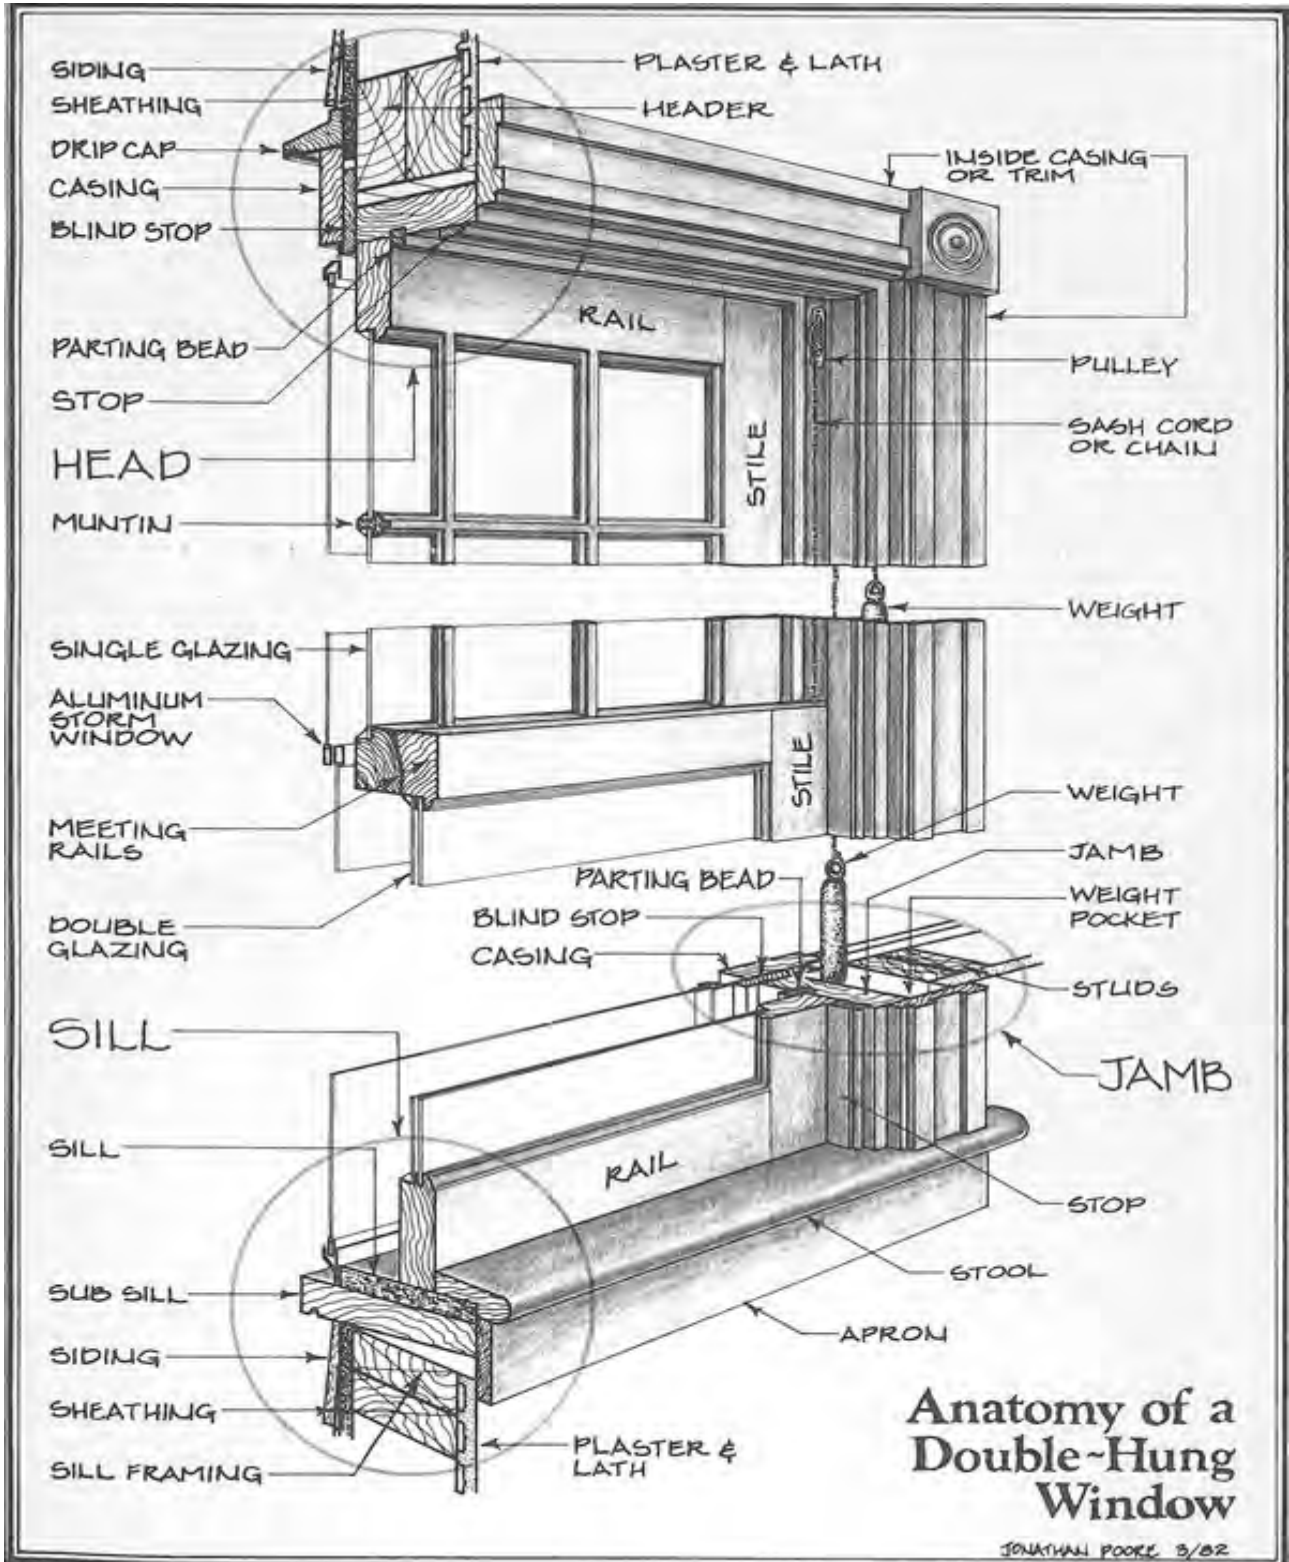
⁴ Old House Journal "Repairing Hopeless Windows" April 1982, pg. 87

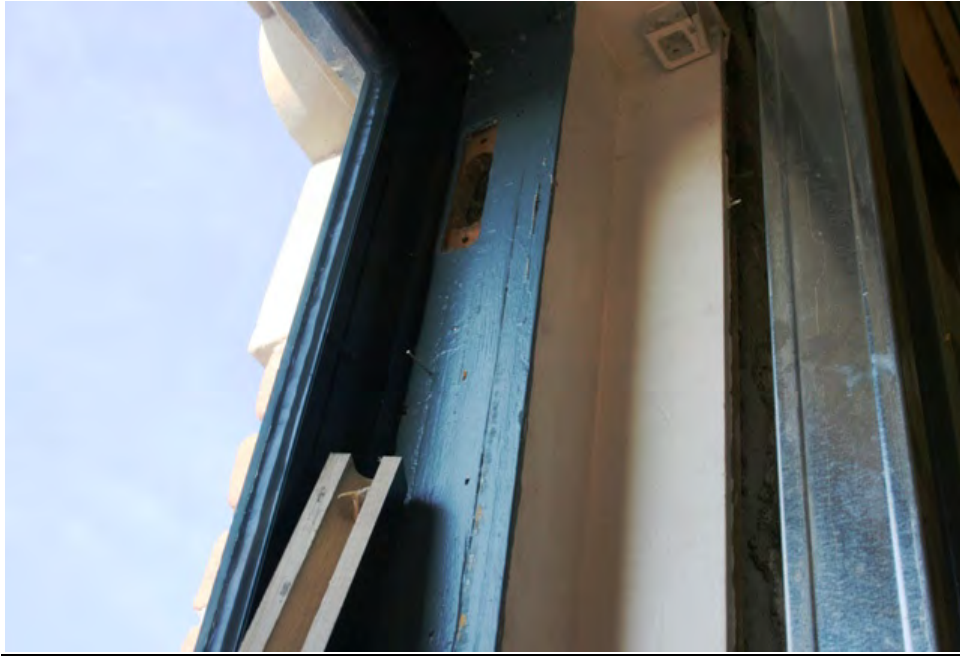
Image 1: Note missing window pulley. A cover, visible at the bottom of the image, was milled to prevent the window from opening fully, to cover the space left by the removed pulley, and to cover the end of the spiral balance.

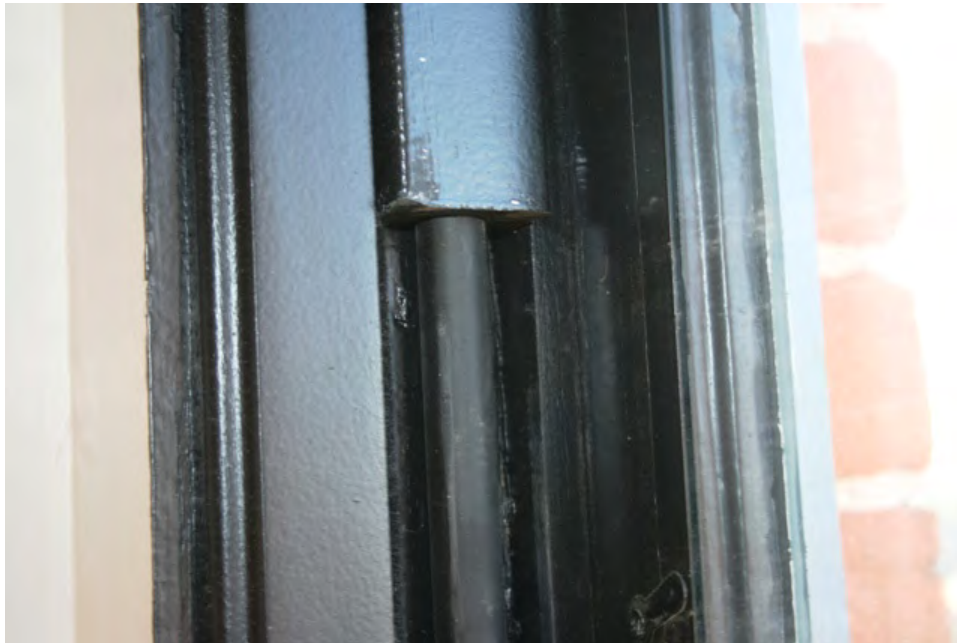
Image 2: Cover in place. Black plastic tube houses the spiral balance mechanism.

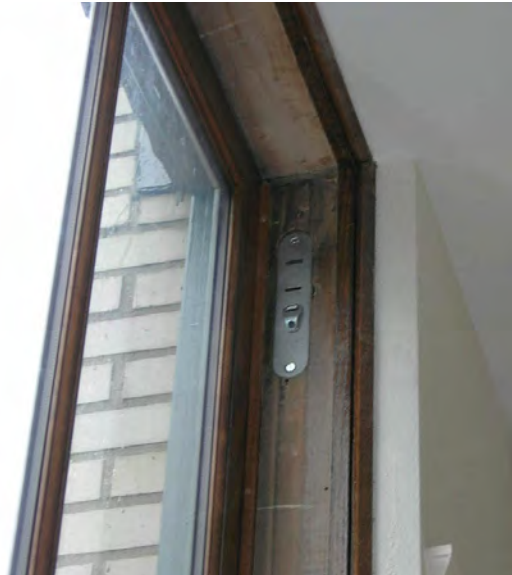
Image 3: Pullman balance installed in place of a window pulley. Photo courtesy of the Pullman website

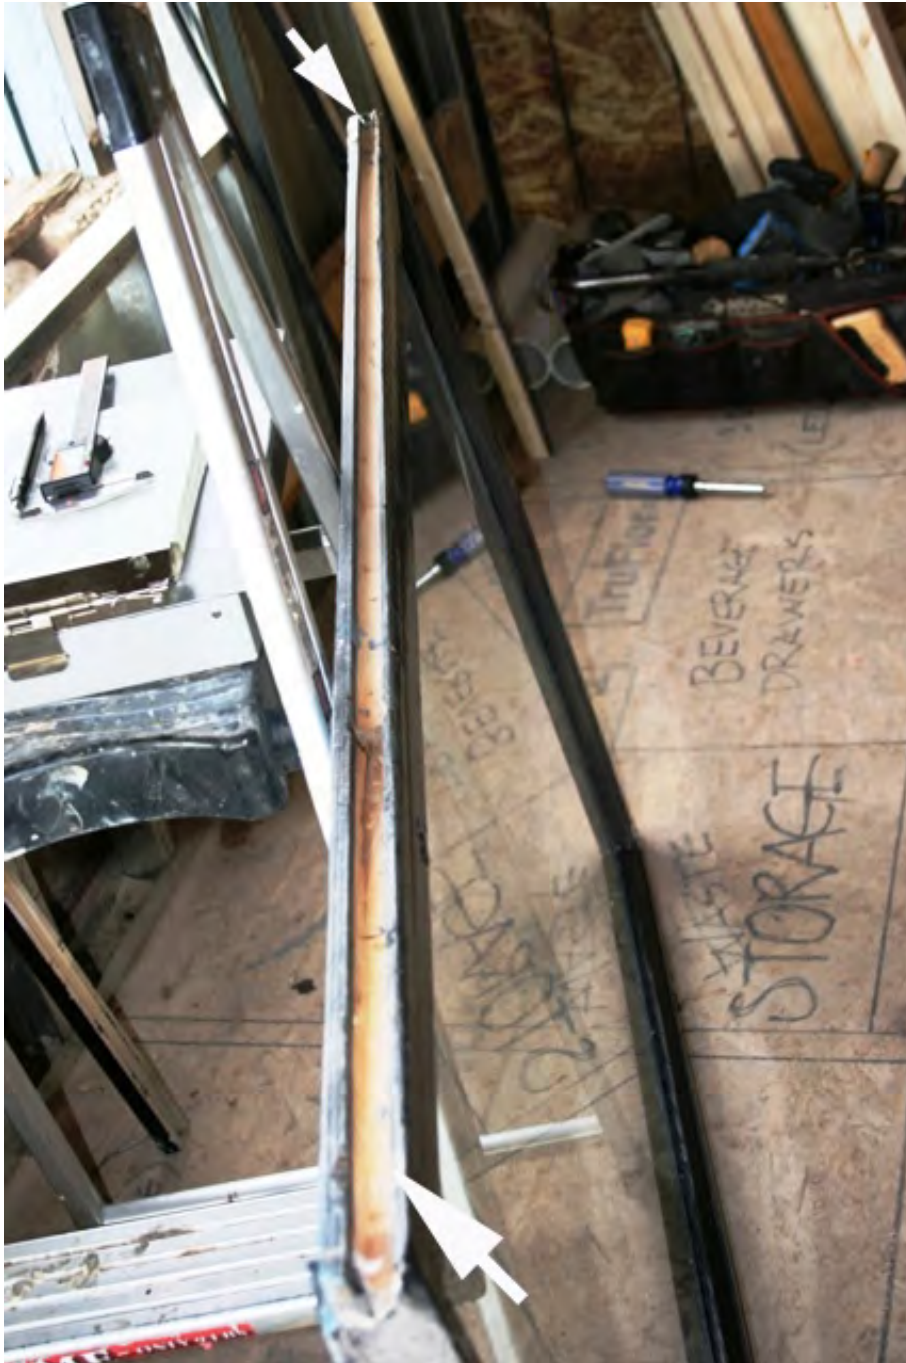
Image 4: Groove cut into one stile. White arrows note the groove.

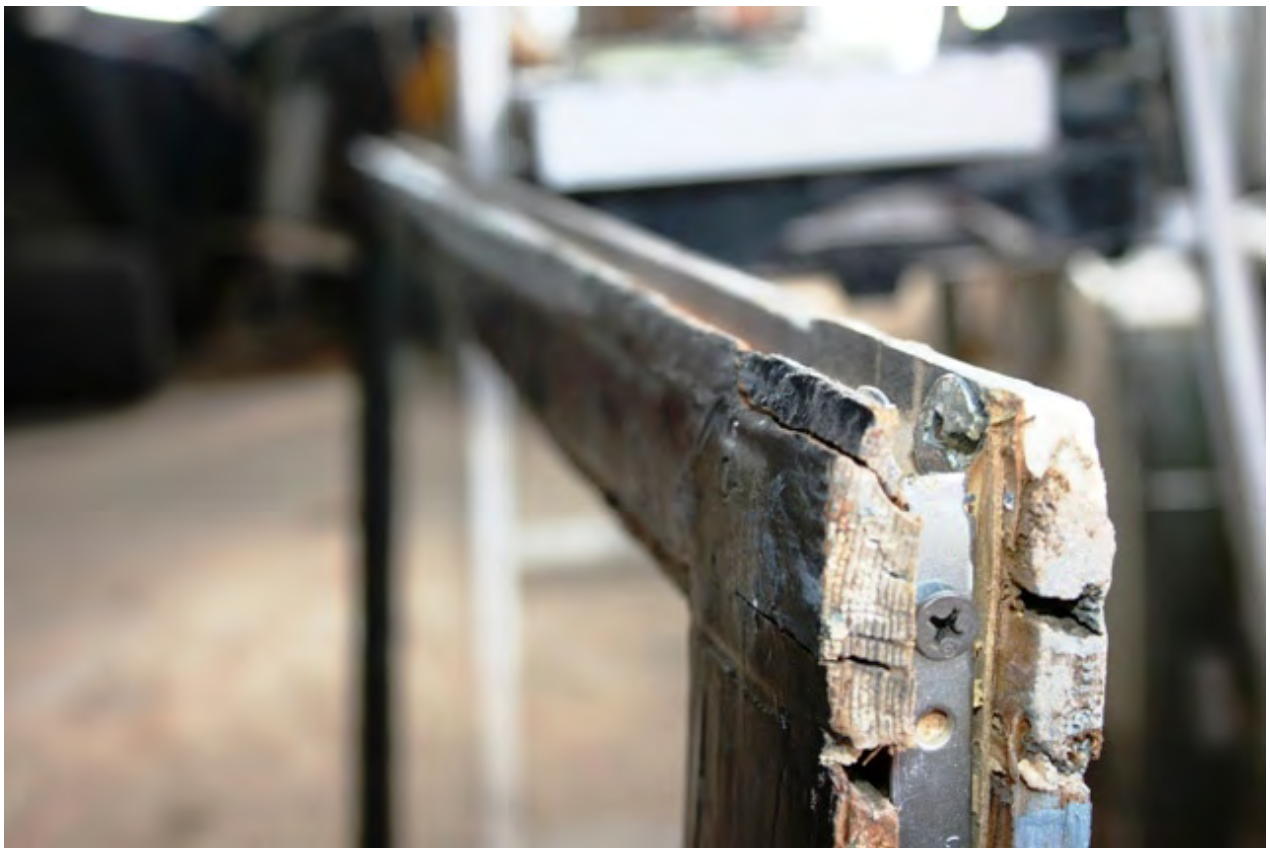
Image 6: Note the split that has already developed as a result of the removal of supporting material. In addition, note the thinly filled epoxy repairs that are adjacent

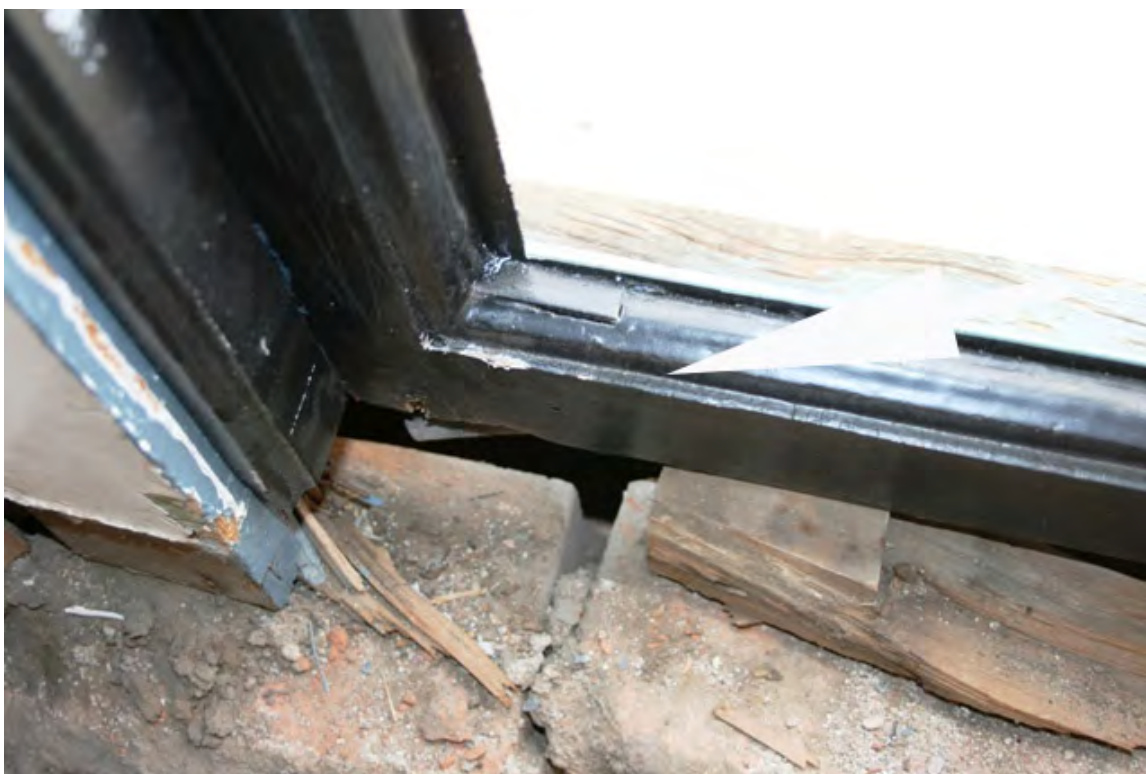
Image 7: Groove cut to house glass panel. The open space underneath the sash is due to the sill and stool being missing, presumably awaiting restoration.

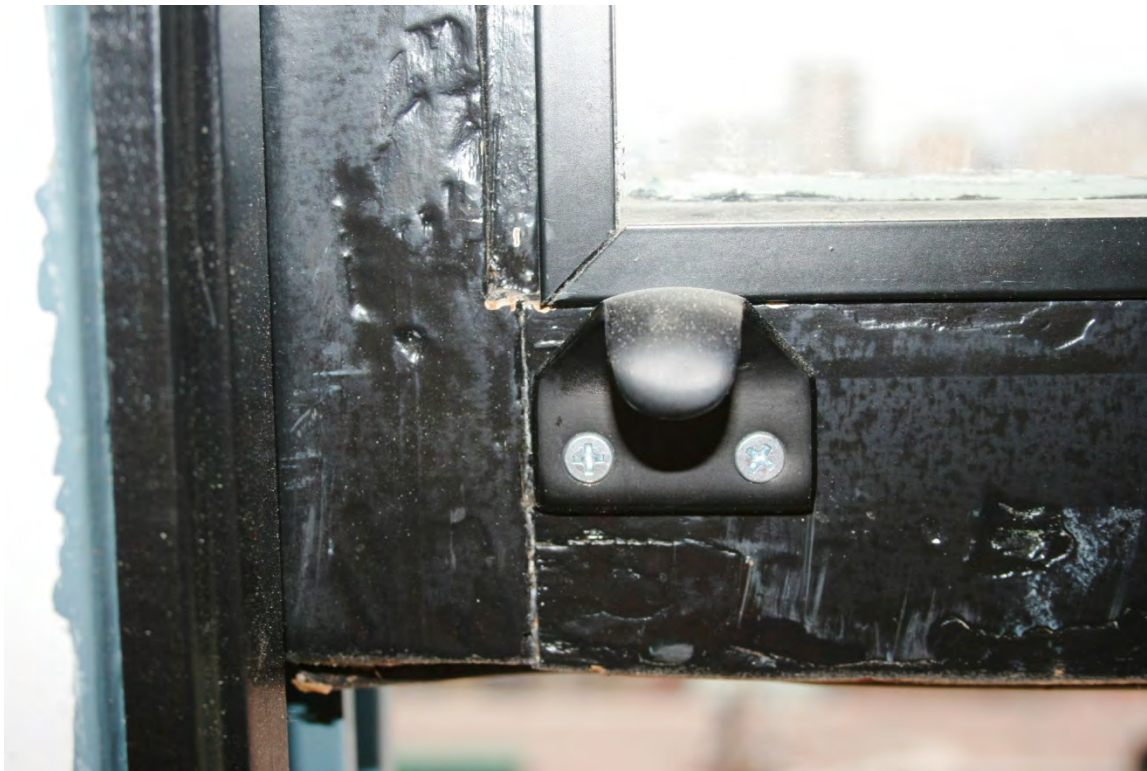
Image 8: Note that glass panel does not fit tight in groove

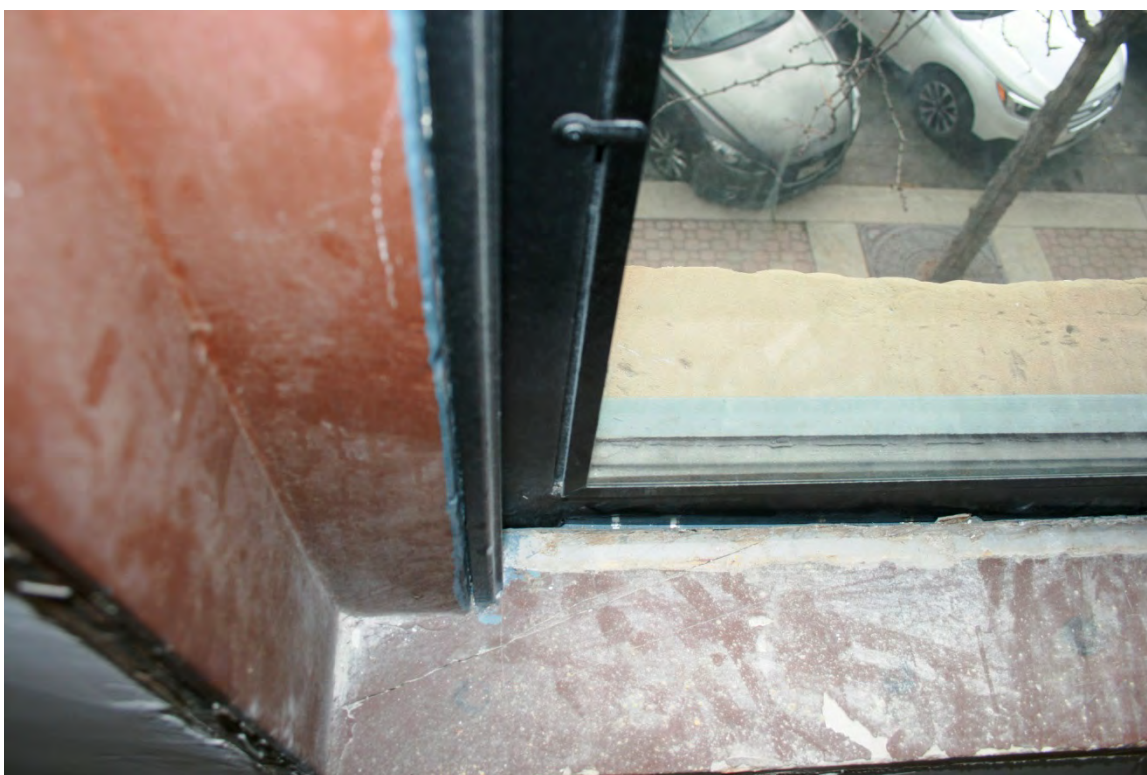
Image 9: Glass panel is slipping. Fit is loose

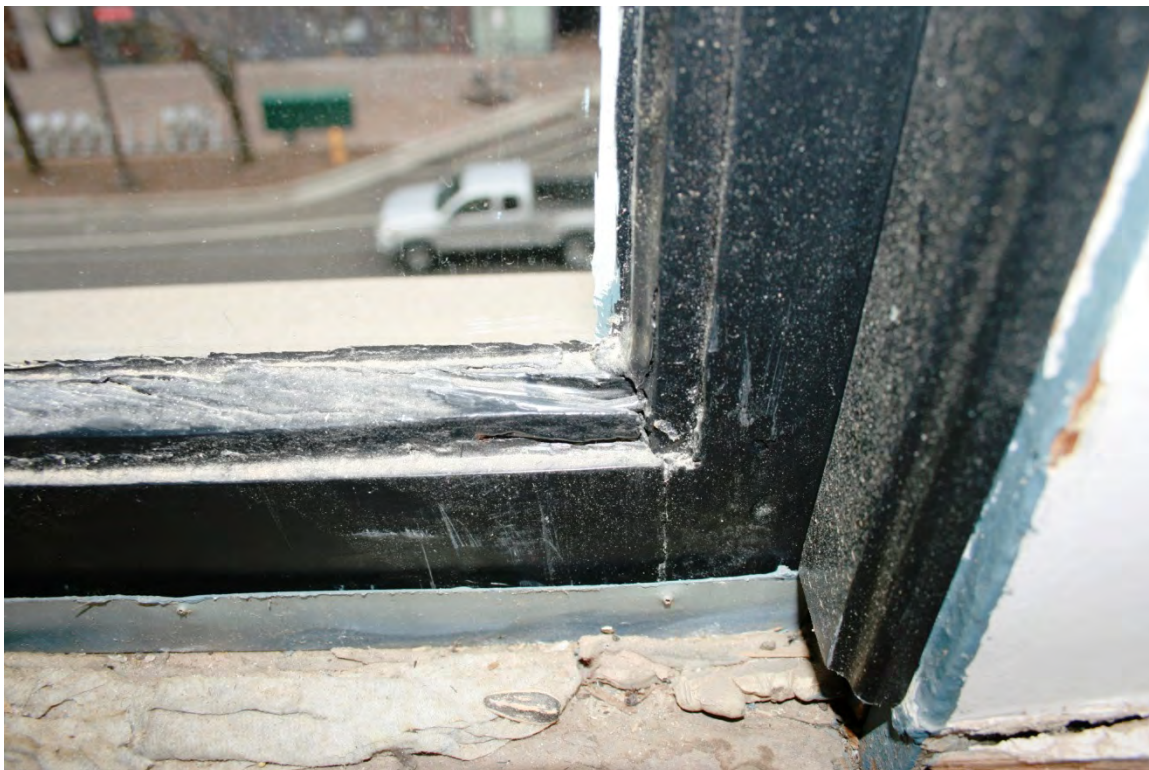
Image 10: Note the condition of the lower rail and the built-up paint

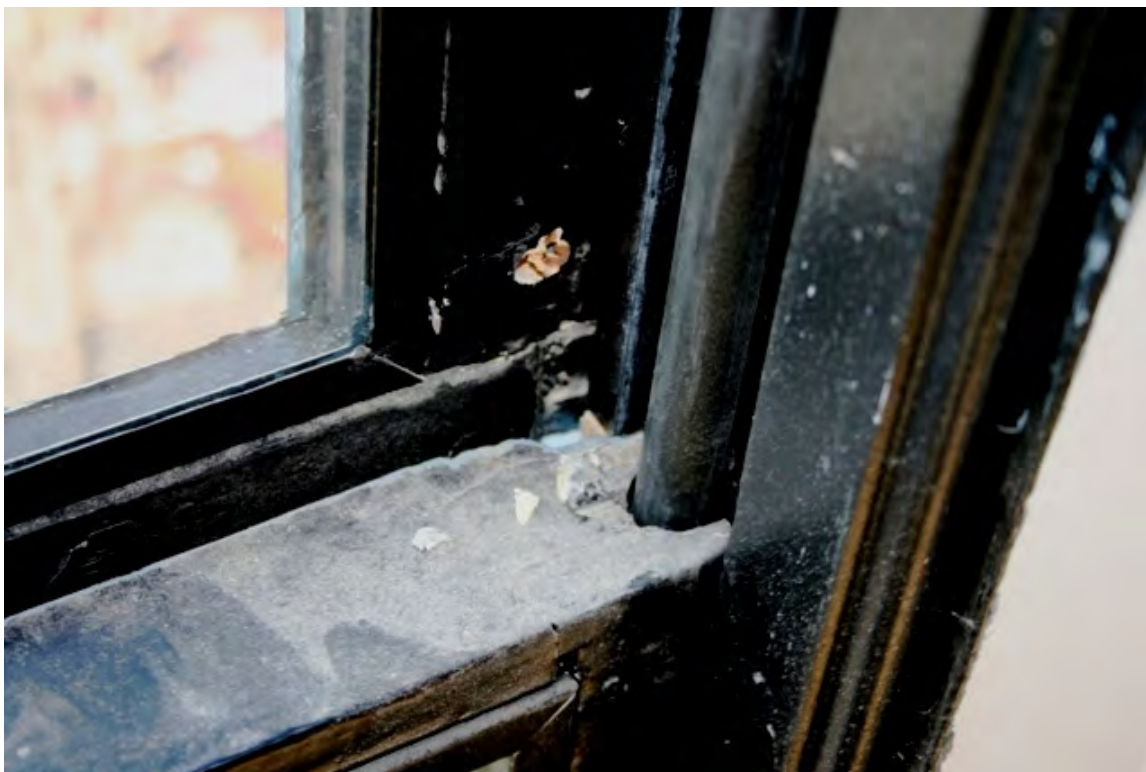
Image 11: Note flaking paint

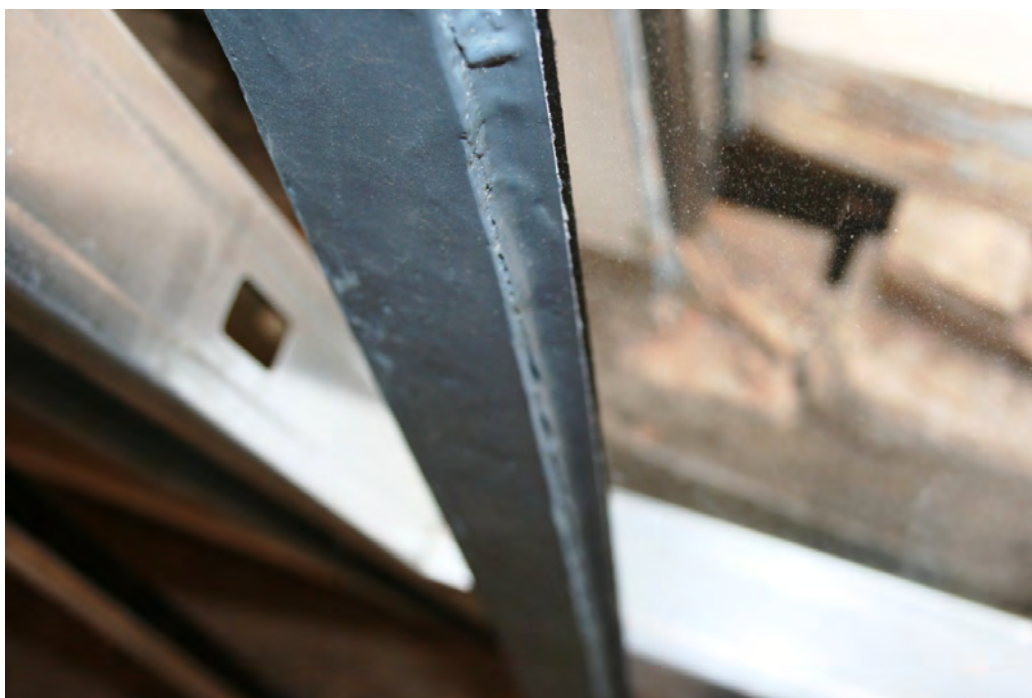
Image 13: Note the concave surface of the glazing compound. This is less effective at shedding water and does not replicate the historic appearance

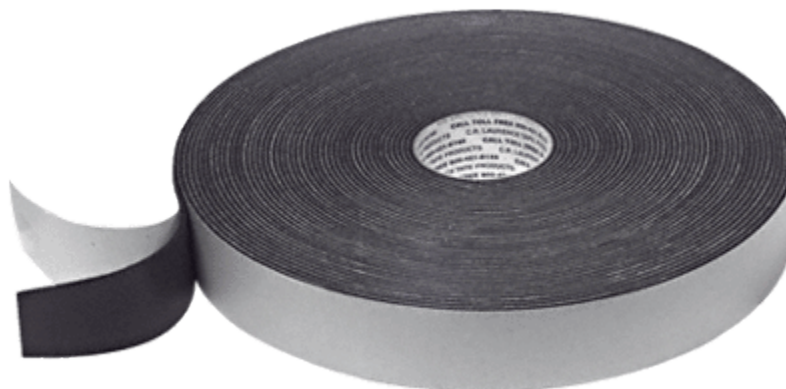
Image 16: Example of single-sided foam glazing tape

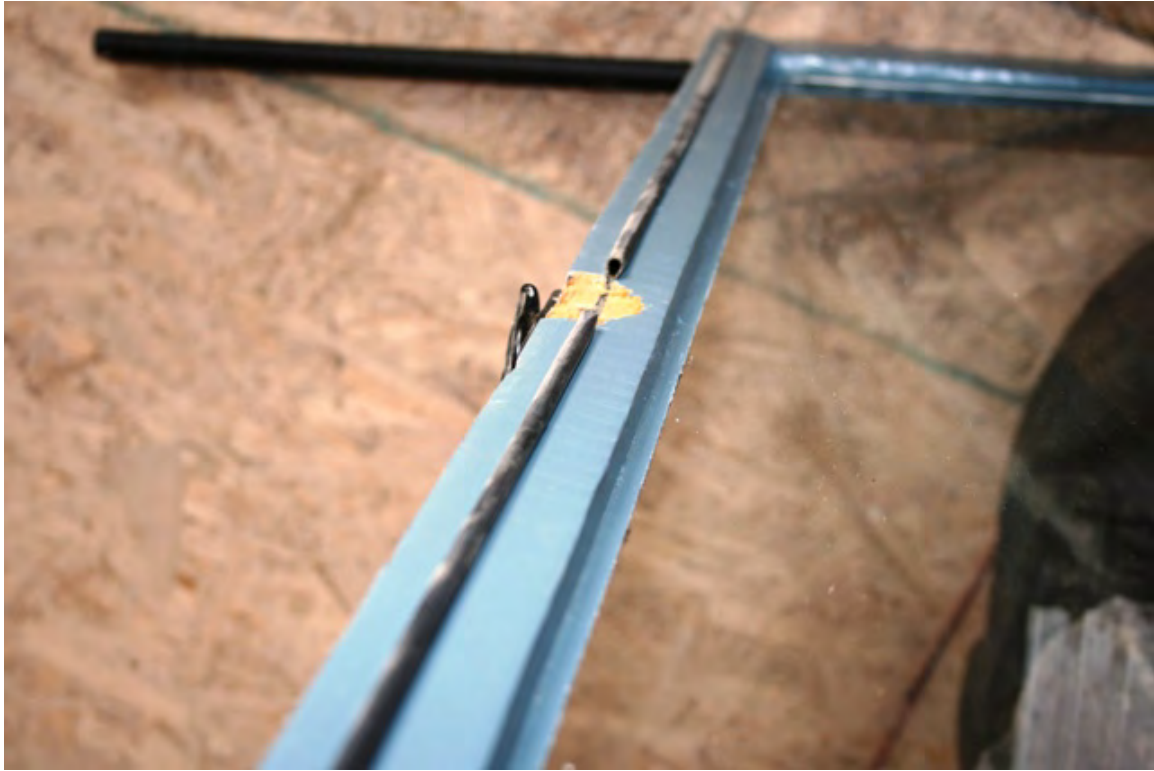
Image 17: Damaged seal at meeting rail

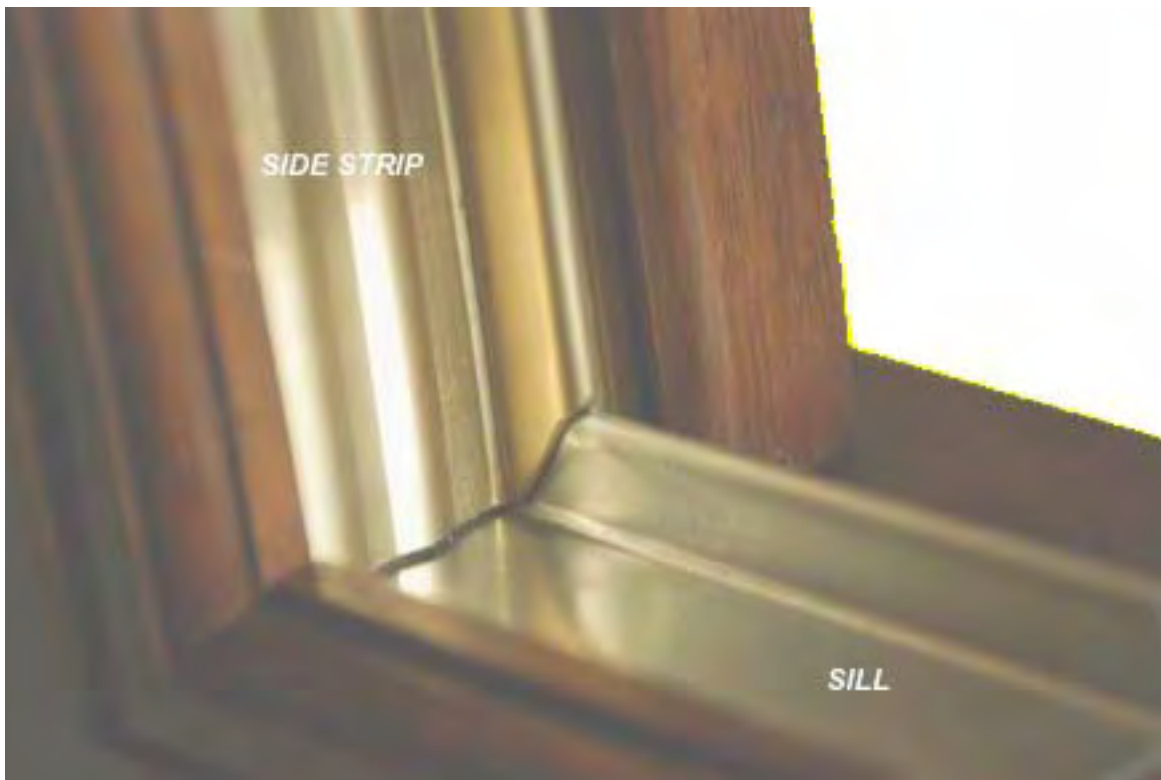
Image 18: Image from Accurate Weatherstripping. The sill strip can be omitted in the described application

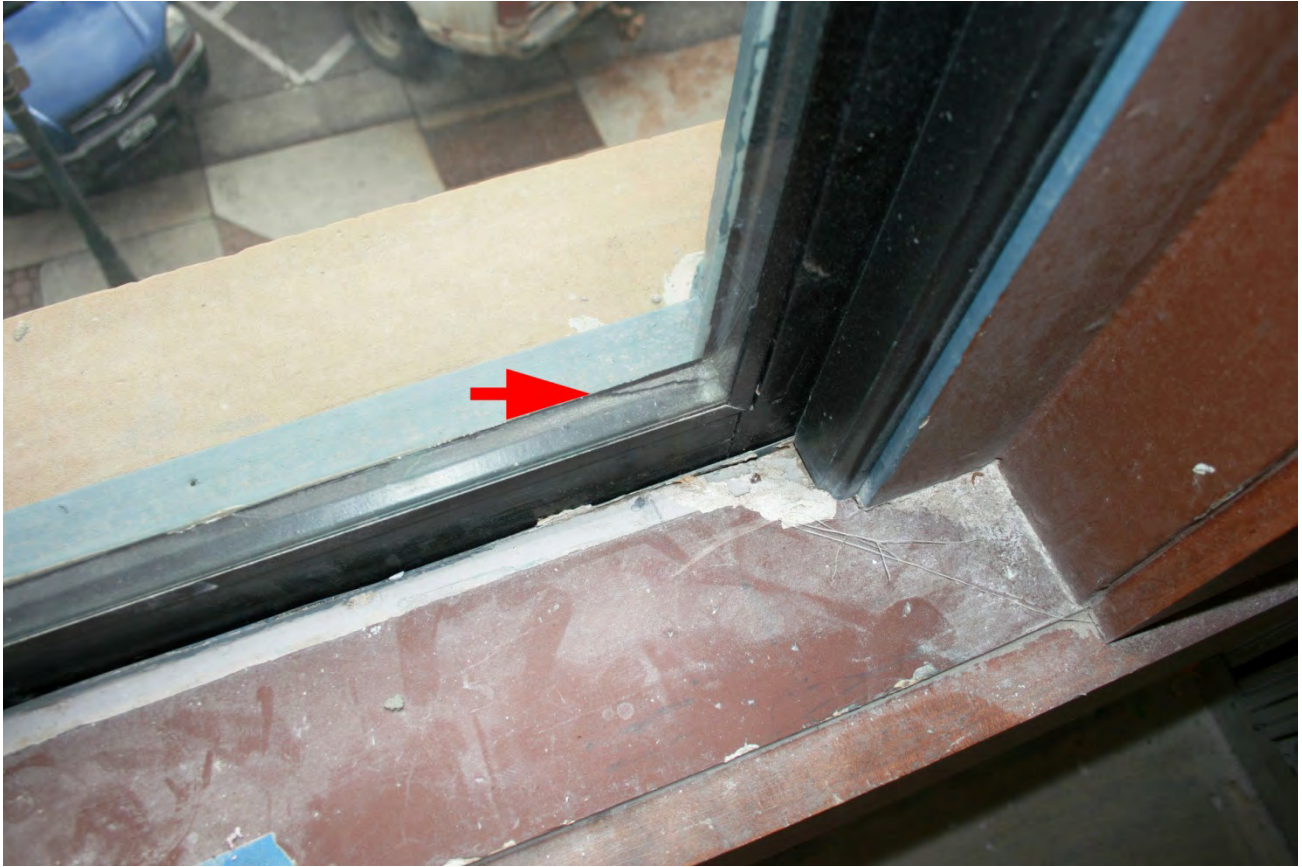
Image 19: Window 002-6, note crack in lower rail

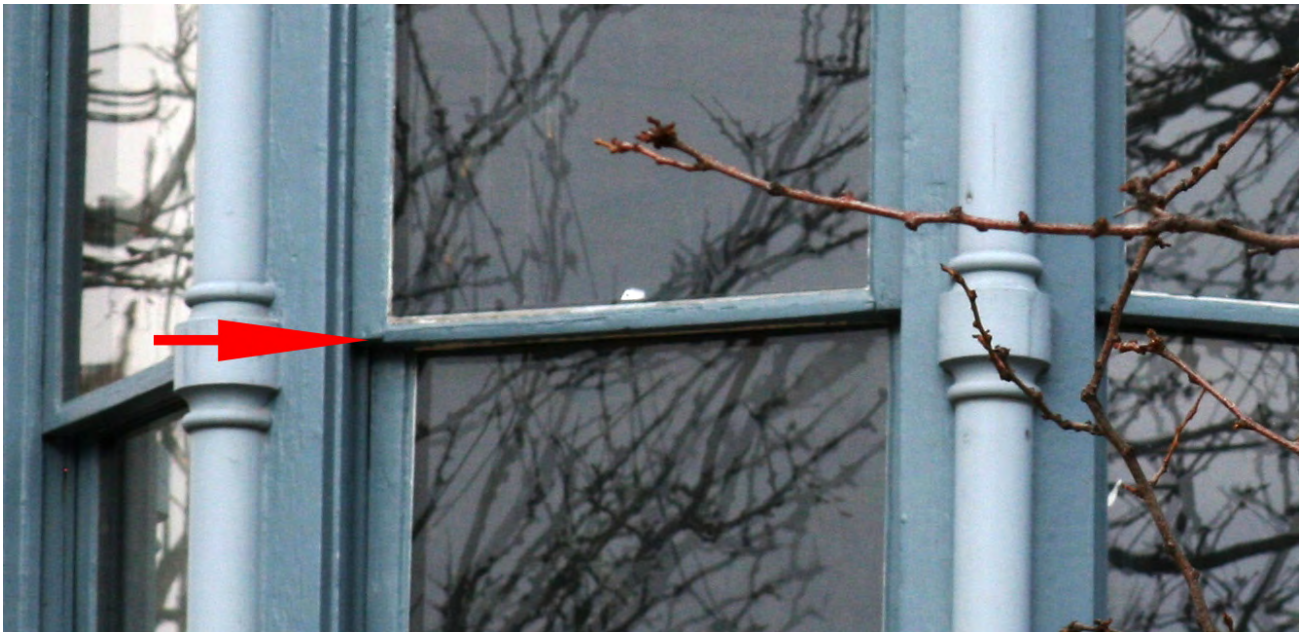
Image 20: Window 002-11, note meeting rail slipping down
