STAFF REPORT August 21, 2024
Historic Preservation Commission

PROJECT NAME

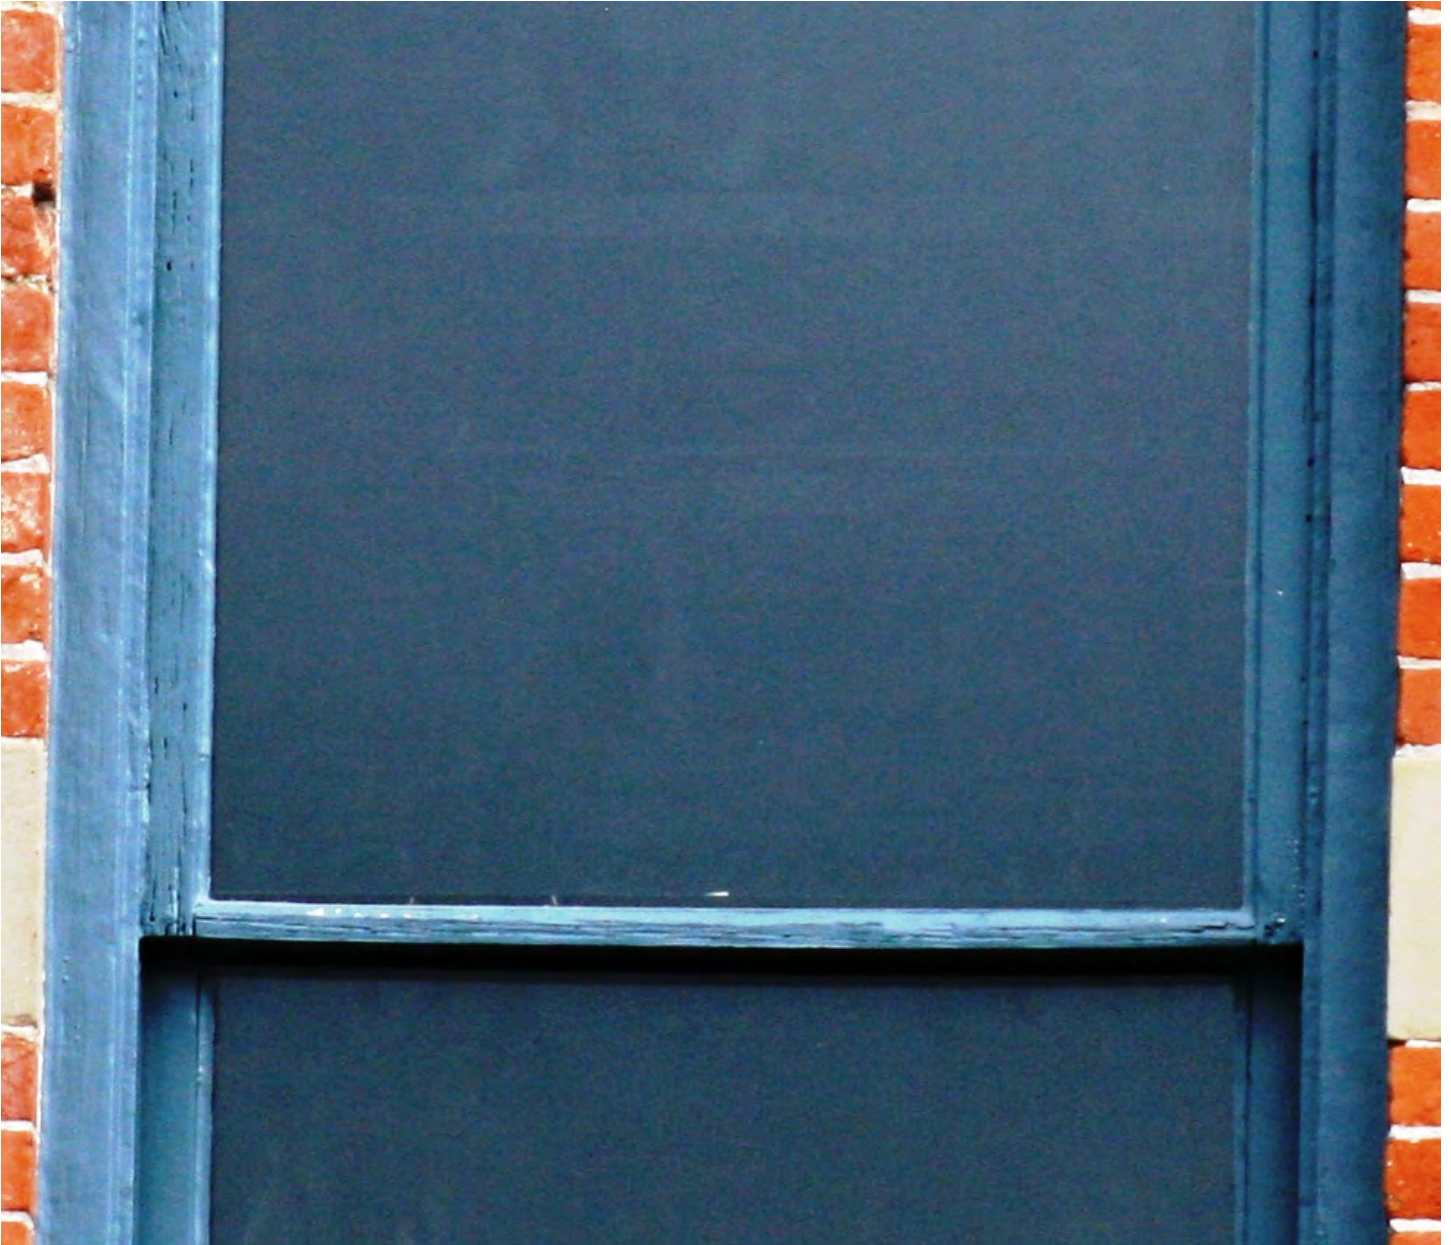
Image 21: Window 002-21 deterioration at the upper sash stiles and meeting rail left untreated

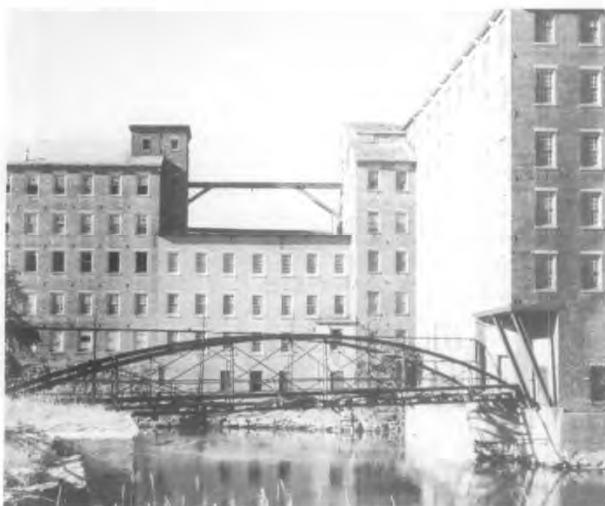
Figure 1. Windows are frequently important visual focal points, especially on simple facades such as this mill building. Replacement of the multi-pane windows here with larger panes could dramatically change the appearance of the building. The areas of missing windows convey the impression of such a change. Photo: John T. Lowe

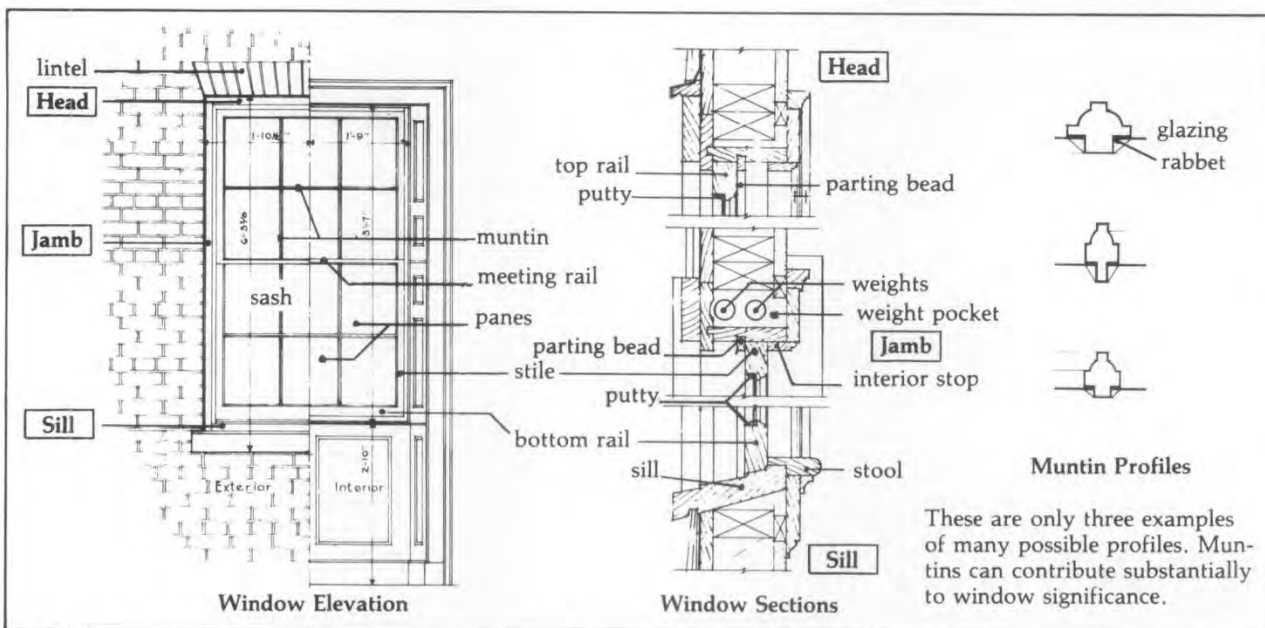
Figure 2. These drawings of window details identify major components, terminology, and installation details for a wooden double-hung window.

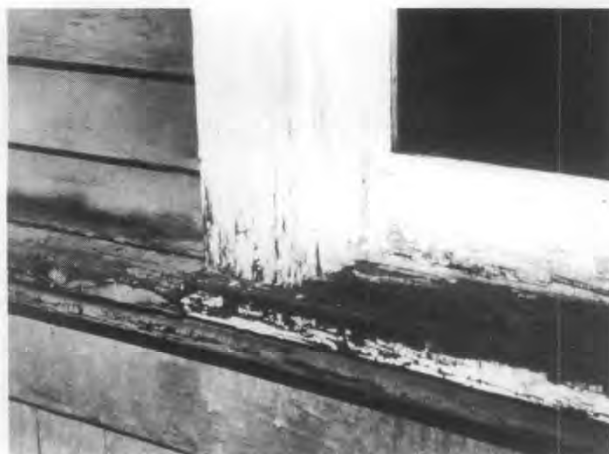
Figure 3. Deterioration of poorly maintained windows usually begins on horizontal surfaces and at joints where water can collect and saturate the wood. The problem areas are clearly indicated by paint failure due to moisture. Photo: Baird M. Smith, AIA

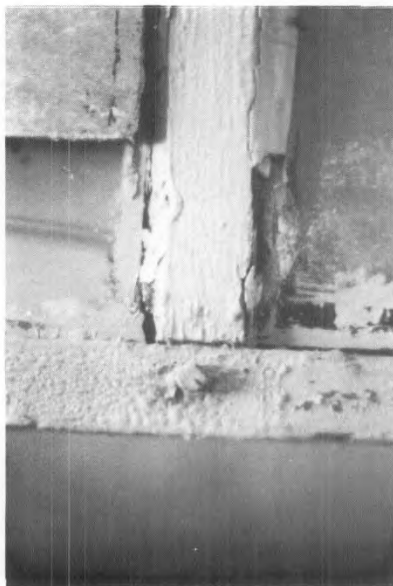
Figure 4a. The following series of photographs of the repair of a historic double-hung window use a unit which is structurally sound but has many layers of paint, some cracked and missing putty, slight separation at the joints, broken sash cords, and one cracked pane. Photo: John H. Myers

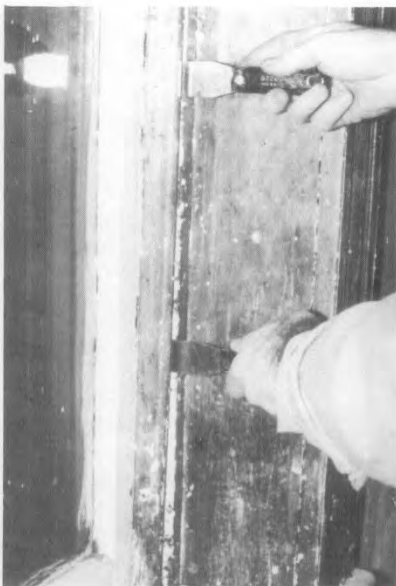
Figure 4b. After removing paint from the seam between the interior stop and the jamb, the stop can be pried out and gradually worked loose using a pair of putty knives as shown. To avoid visible scarring of the wood, the sash can be raised and the stop pried loose initially from the outer side. Photo: John H. Myers

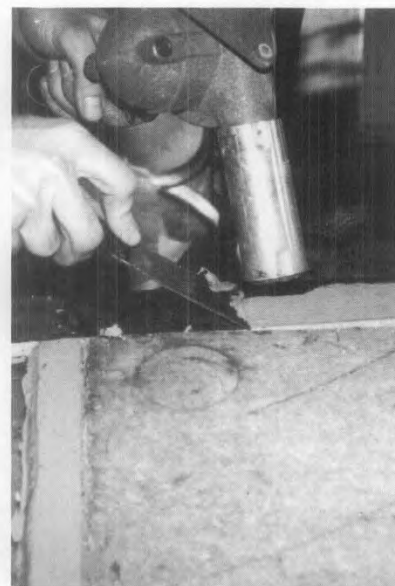
Figure 4c. Sash can be removed and repaired in a convenient work area. Paint is being removed from this sash with a hot air gun while an asbestos sheet protects the glass from sudden temperature change. Photo: John H. Myers

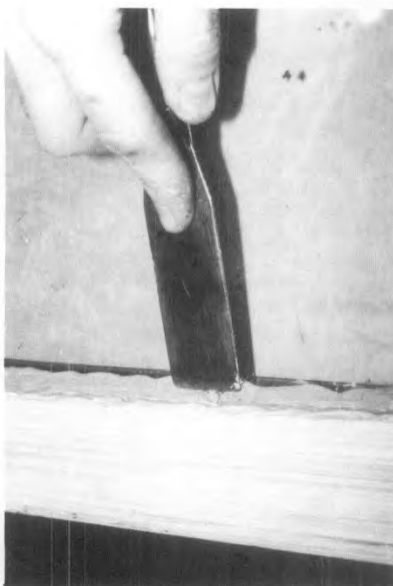
Figure 4d. Reglazing or replacement of the putty requires that the existing putty be removed manually, the glazing points be extracted, the glass removed, and the back putty scraped out. To reglaze, a bed of putty is laid around the perimeter of the rabbet, the pane is pressed into place, glazing points are inserted to hold the pane (shown), and a final seal of putty is beveled around the edge of the glass. Photo: John H. Myers

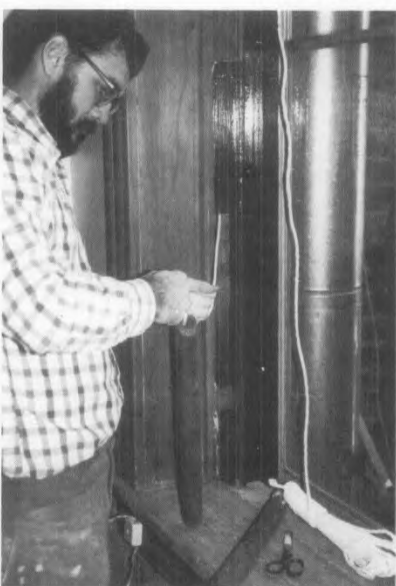
Figure 4e. A common repair is the replacement of broken sash cords with new cords (shown) or with chains. The weight pocket is often accessible through a removable plate in the jamb, or by removing the interior trim. Photo: John H. Myers

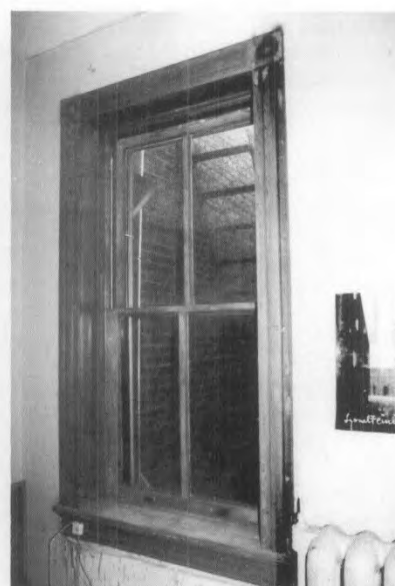
Figure 4f. Following the relatively simple repairs, the window is weathertight, like new in appearance, and serviceable for many years to come. Both the historic material and the detailing and craftsmanship of this original window have been preserved. Photo: John H. Myers

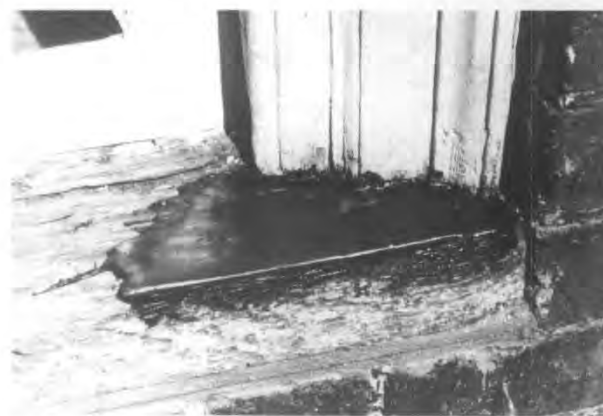
Figure 5. This illustrates a two-part epoxy patching compound used to fill the surface of a weathered sill and rebuild the missing edge. When the epoxy cures, it can be sanded smooth and painted to achieve a durable and waterproof repair. Photo: John H. Myers

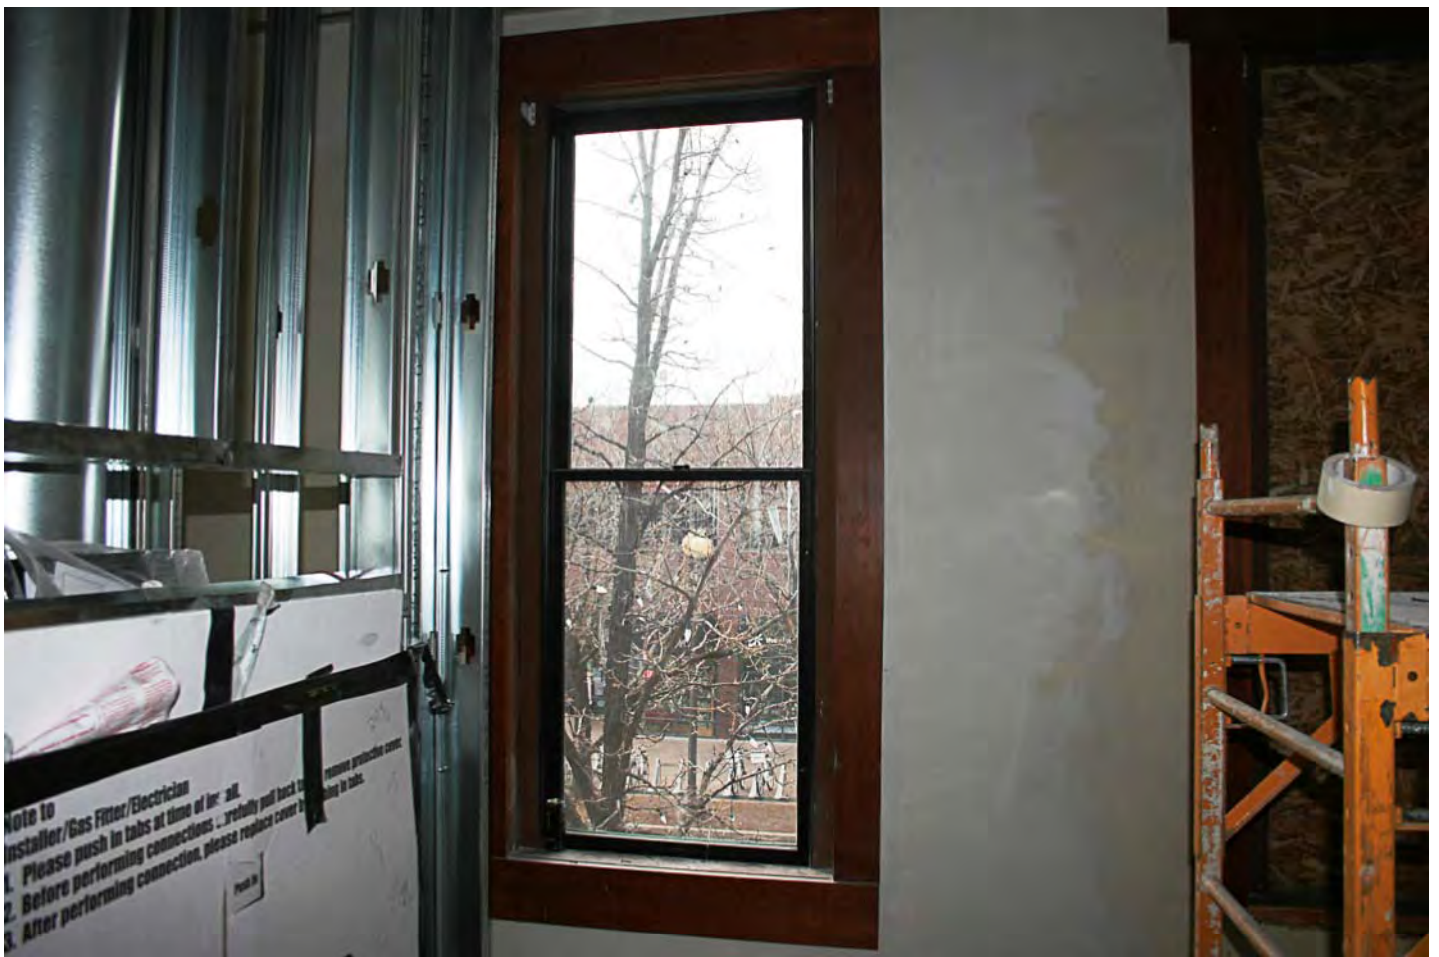
Note to
Installer/Gas Fitter/Electrician
1. Please push in tabs at time of in-
stallation.
2. Before performing connections, carefully pull back
cover to replace in tabs.
3. After performing connection, please replace cover
in tabs.

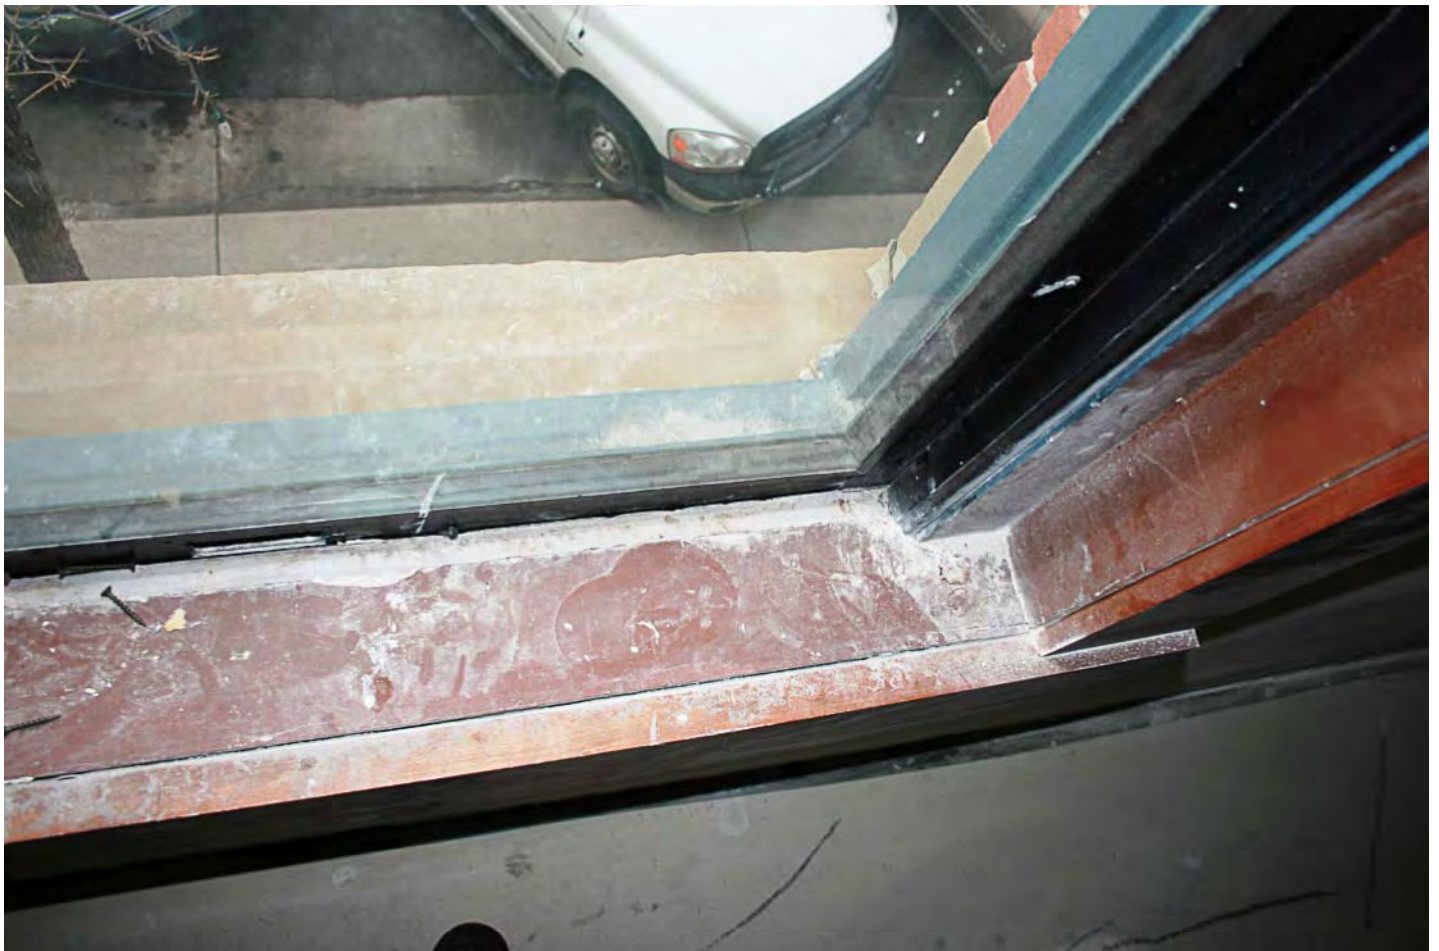
002-17-Interior Detail 1

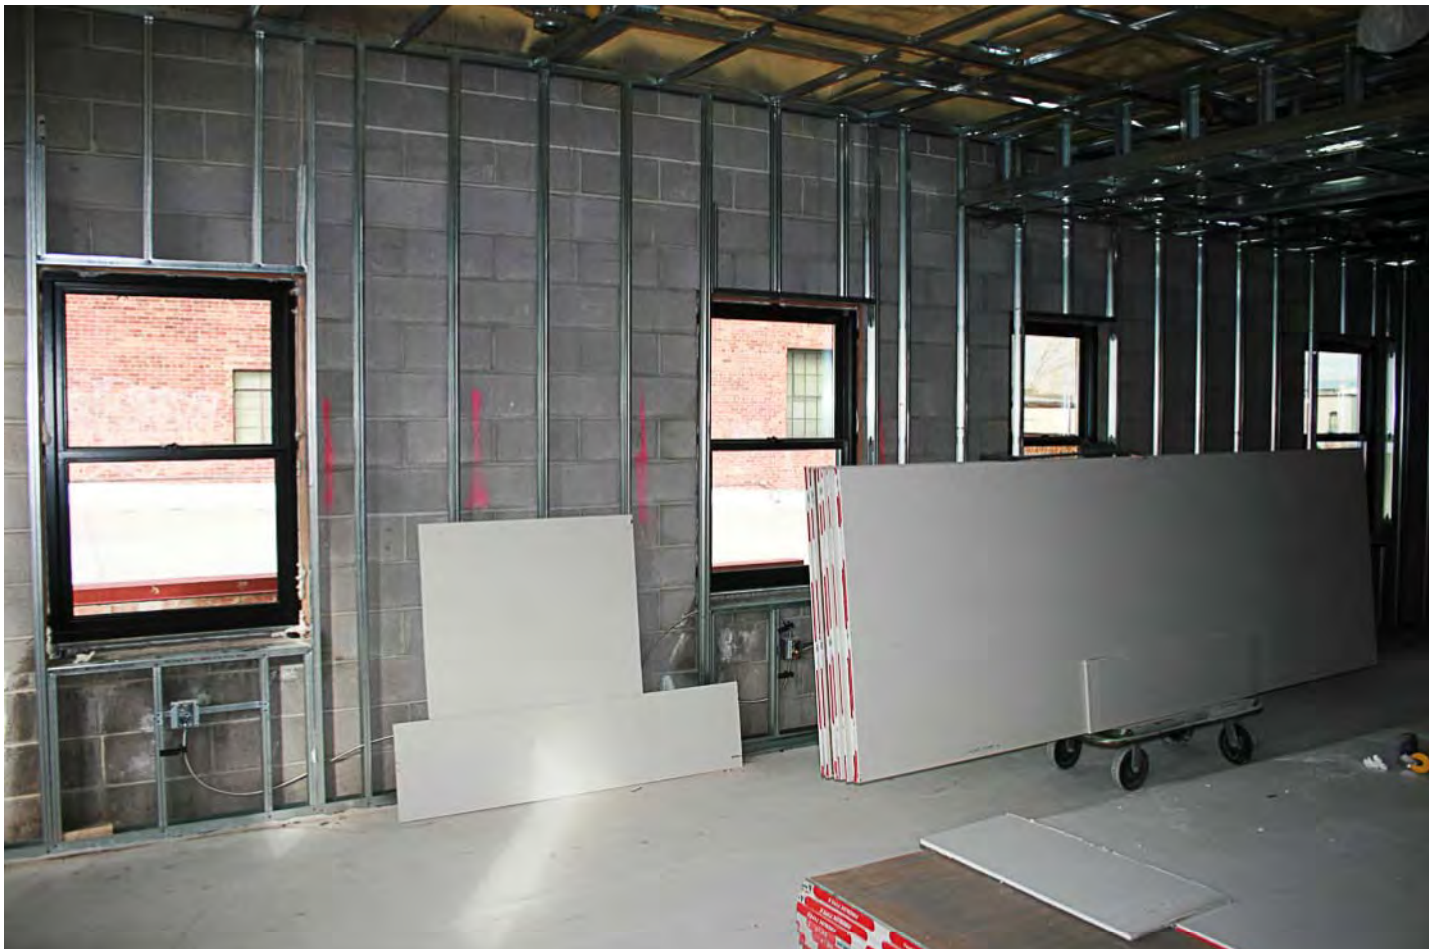
Replacement windows_Northwest elevation_Alley 2

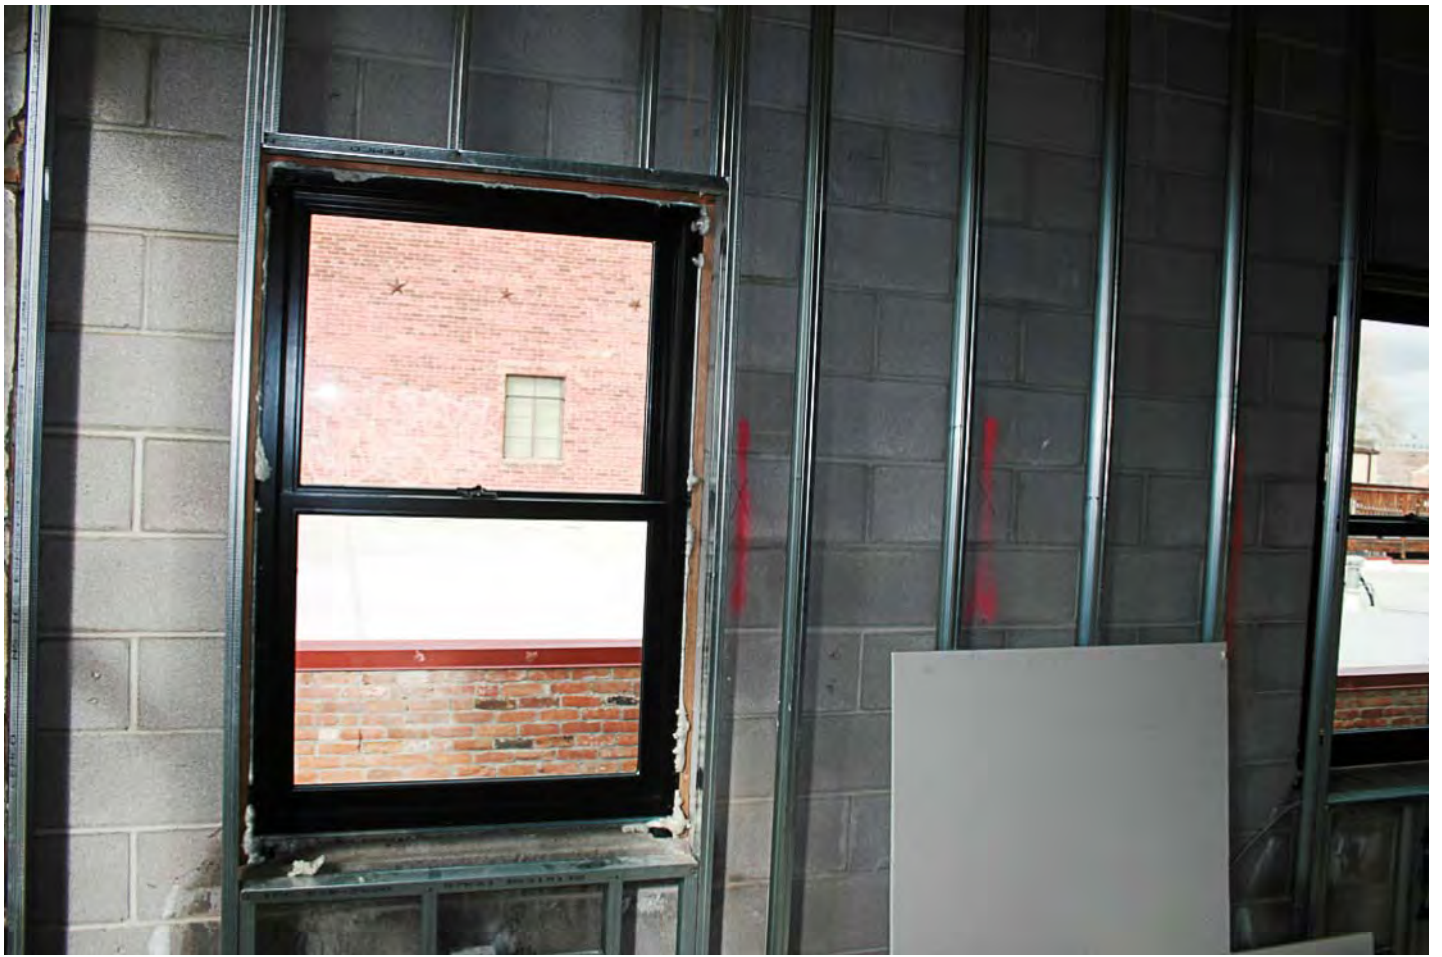
Replacement windows_Northwest elevation_Alley
