**FLORIDA DEPARTMENT OF TRANSPORTATION
BRIDGE MANAGEMENT SYSTEM****Inspection/CIDR Report
Inspection****Structure ID: 494099****DISTRICT: D3 - Chipley****INSPECTION DATE: 7/30/2020 ZKMT**

BY: CONSOR Engineers, LLC	STRUCTURE NAME: Not recorded
OWNER: 2 County Hwy Agency	YEAR BUILT: 1999
MAINTAINED BY: 2 County Hwy Agency	SECTION NO.: 49 000 005
STRUCTURE TYPE: 4 Steel Continuous - 10 Truss-Thru	MP: 4.158
LOCATION: 0.8 Mile North of Mill Rd	ROUTE: 00000
SERV. TYPE ON: 1 Highway	FACILITY CARRIED: New River Road
SERV. TYPE UNDER: 5 Waterway	FEATURE INTERSECTED: Syrup Branch

TYPE OF INSPECTION: Interim

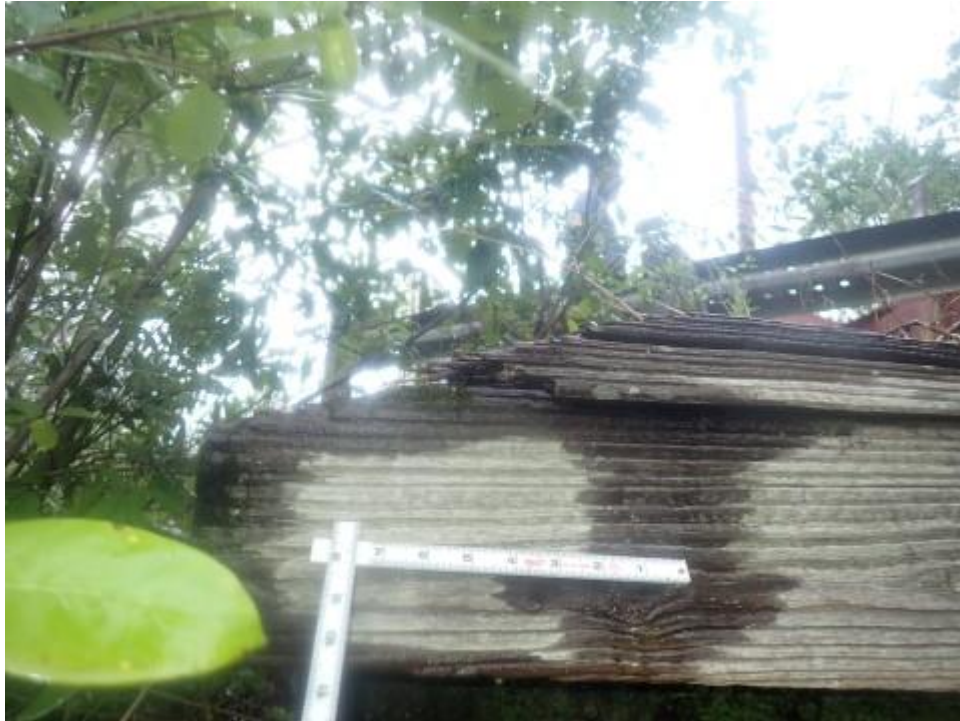
8476 - Timber Walls

- 8476/2 CONDITION STATE 3
NO CHANGE:
- 1) The near right wingwall has decay in the top board (See Photo 1). (1140 - NO QTY)
 - 2) The wingwall boards and the piles have early to moderate decay. (1140 - NO QTY)

Photo 1: Decay in top board of near right wingwall

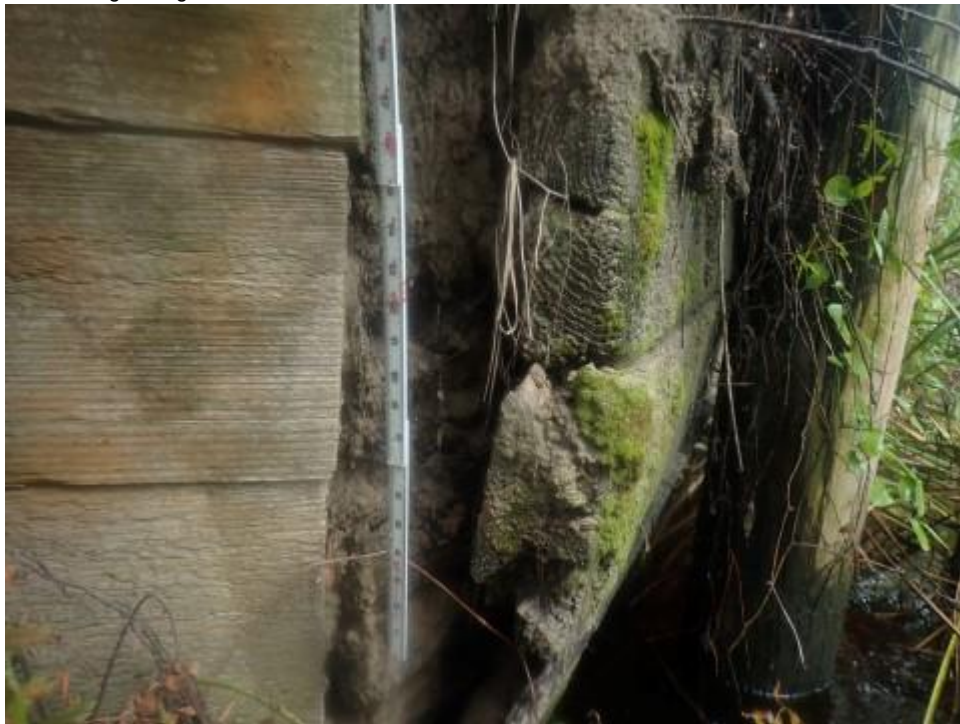
8476 - Timber Walls

- 3) The near left wingwall is bowed and leaning 10° toward the stream (See Photo 2). (4000 - 13 FT)
 - 4) The near left wingwall has three boards with advanced decay (See Photo 3). (1140 - NO QTY)

- 8) The top three boards in the far left wingwall are missing (See Photo 7). (1140 - NO QTY)
 - 9) The far right wingwall is bowed (See Photo 2). (4000 - 13 FT)

Photo 2: Typical bowing of wingwall

CONDITION STATE			PRIORITY
3	MMS Quantity: 1 mh	Element Estimated Quantity: 52 ft	3
WORK ORDER RECOMMENDATION: All wingwalls; replace.

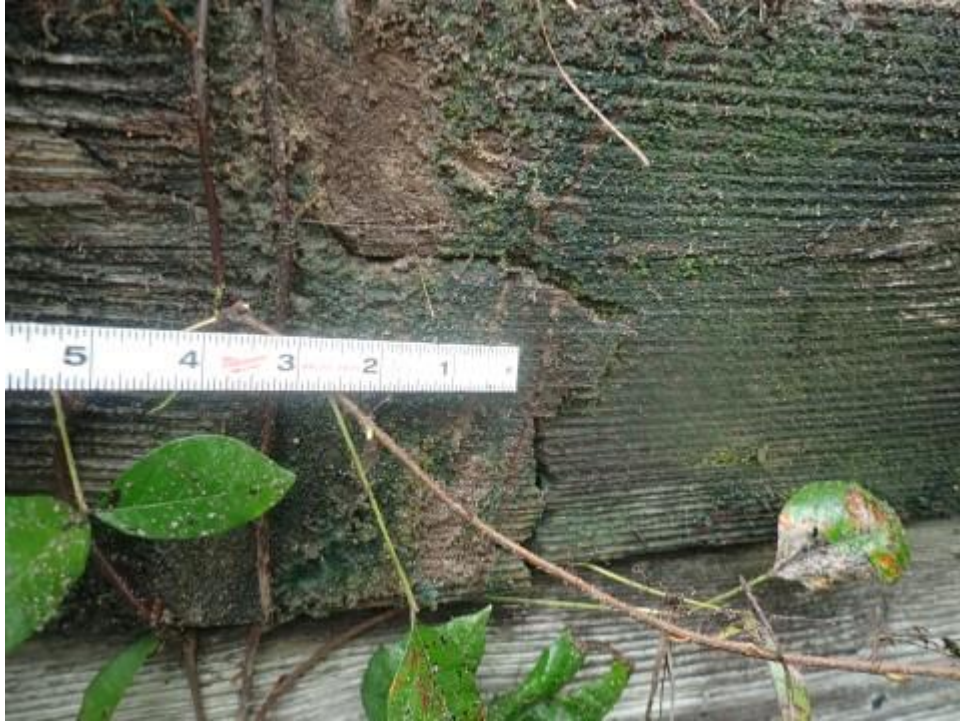
8476 - Timber Walls

- 10) The far right wingwall has one board that is broken (See Photo 3). (1170 - NO QTY)

Photo 3: Typical decayed/broken wingwall board

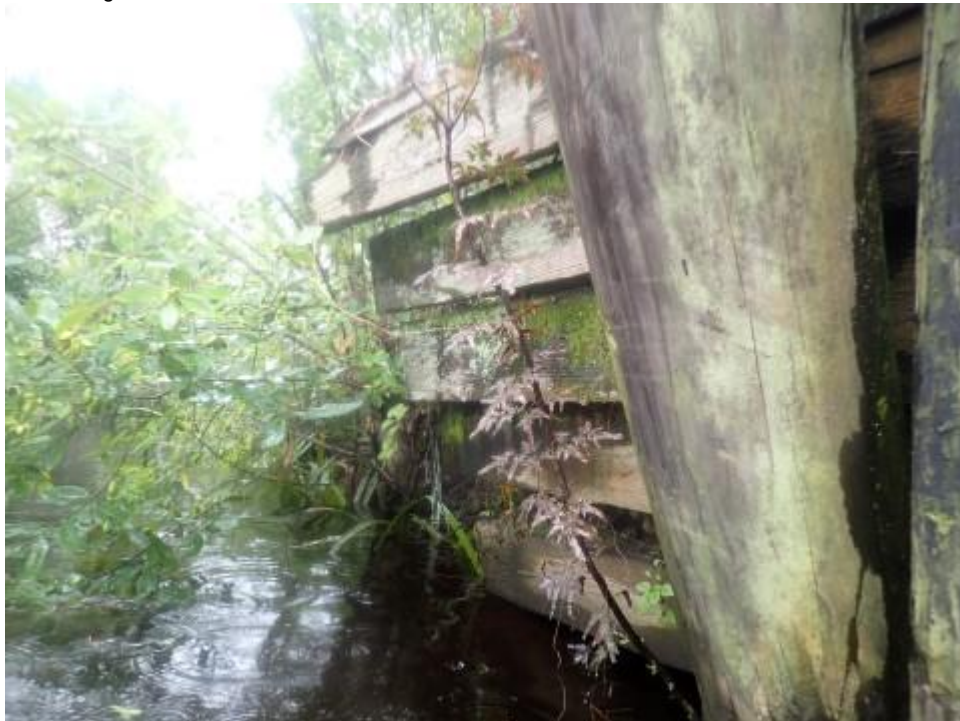
8476 - Timber Walls

- 5) The near right wingwall is leaning 10° toward the stream, has gaps between the boards; up to 0.25 ft wide, and does not extend to the groundline allowing loss of fill in the 2.0 ft opening (See Photo 4). (4000 - 13 FT)

Photo 4: Near right wingwall leaning with gaps between boards

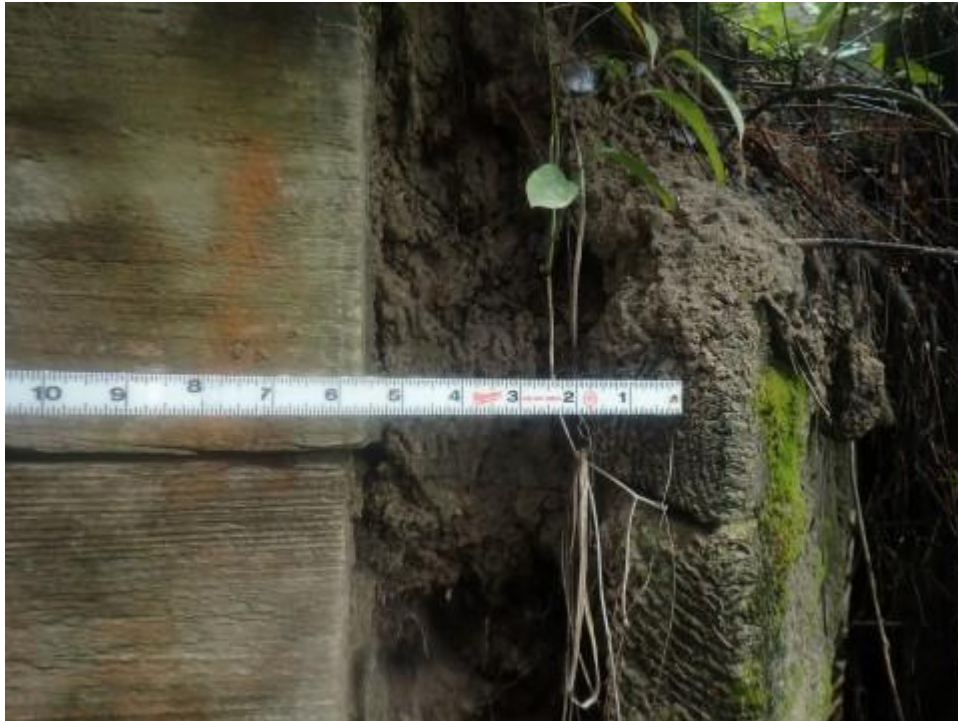
8476 - Timber Walls

- 6) The near and far left wingwalls are separating from the adjacent backwall up to 0.33 ft (See Photo 5). (4000 - NO QTY)
 - 7) The far left wingwall is leaning inward 10° toward the stream (See Photo 6). (4000 - 13 FT)

Photo 5: Typical separation of near and far left wingwalls from adjacent backwall

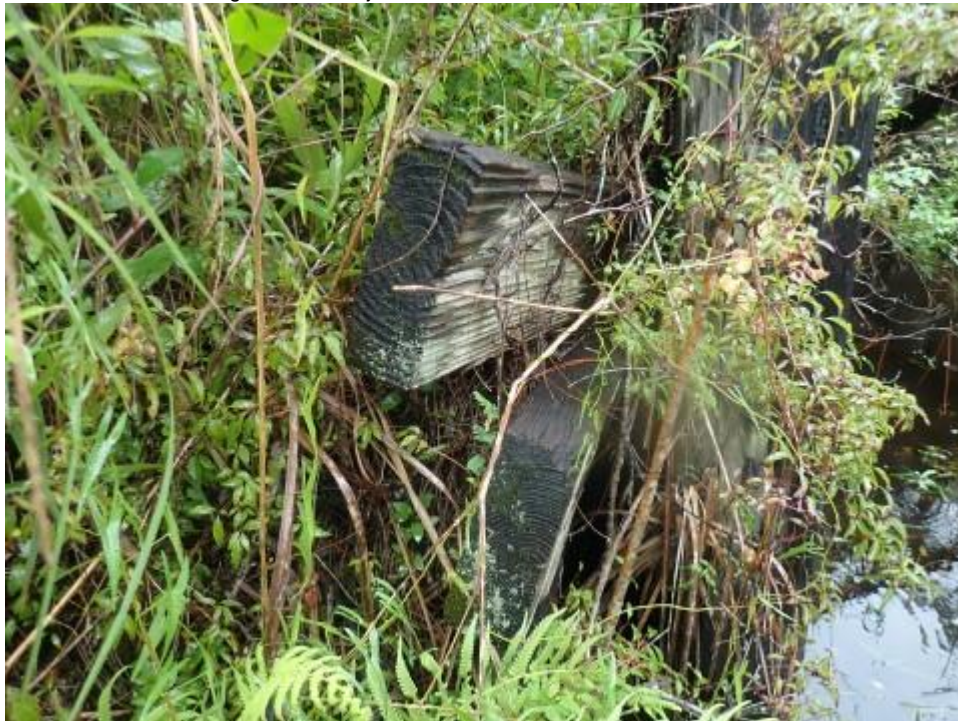
8476 - Timber Walls

Photo 6: Far left wingwall leaning inward

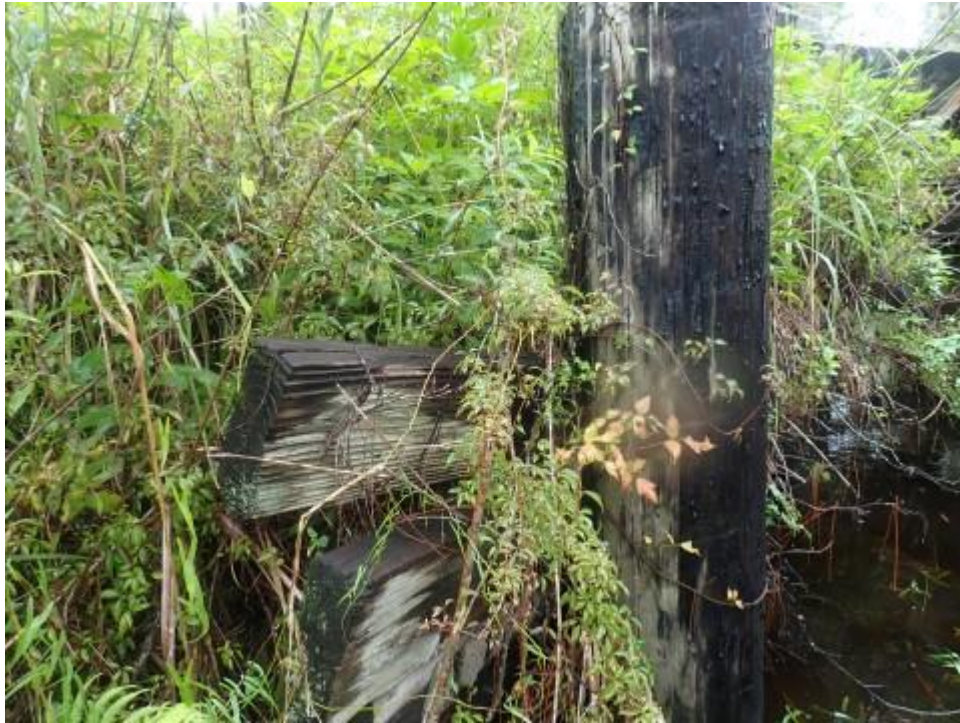
8476 - Timber Walls

Photo 7: Top three boards missing from far left wingwall

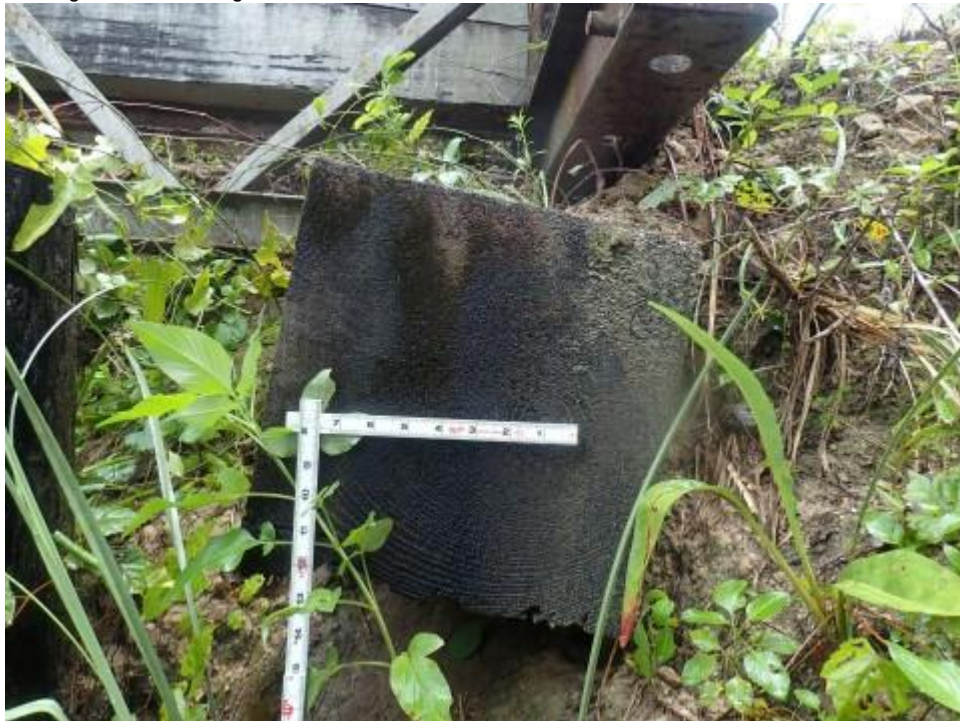
216 - Timber Abutment

- 216/2 CONDITION STATE 3
NO CHANGE:
- 1) Abutment Cap 1 is rotated 9° against station (See Photo 8). (4000 - 13 FT)

Photo 8: Abutment Cap 1 rotated against station

CONDITION STATE			PRIORITY
3	MMS Quantity: 1 mh	Element Estimated Quantity: 13 ft	3
WORK ORDER RECOMMENDATION: Abutment Cap 1; realign and secure.

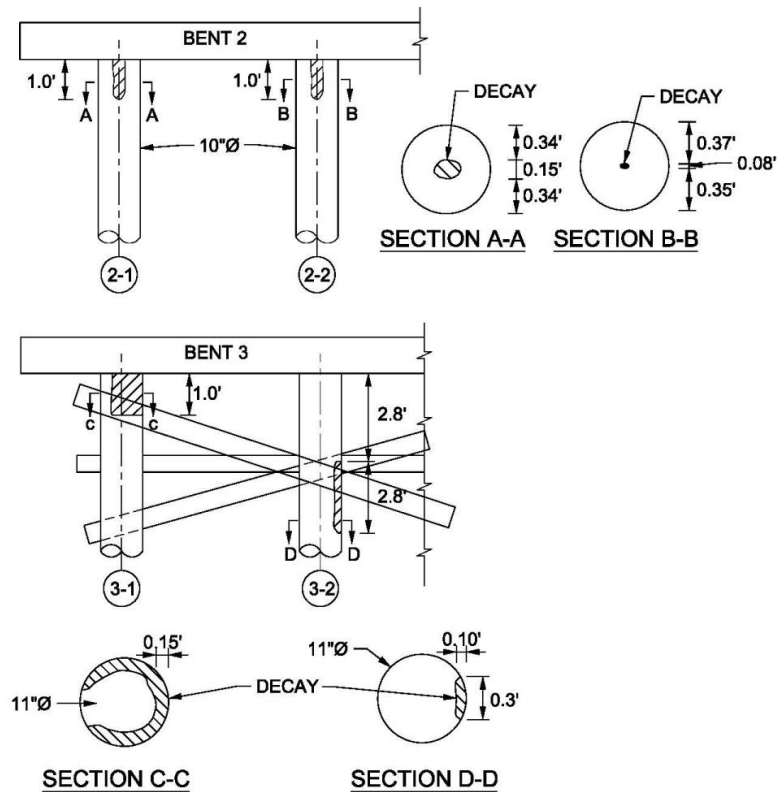
Sketch 1

228/2 CONDITION STATE 2
 NO CHANGE:
 1) The piles have seasoning checks. (1150 - 4 EA)
 2) Piles 2-1 and 2-2 have decay (See Sketch 1). (10" diameter each) (1140 - NO QTY)
 3) Piles 2-1, 2-2, and 4-3 do not provide full bearing due to cut-off angle, up to 0.03 ft gap. (4000 - 3 EA)
 4) Pile 3-2 has decay (See Sketch 1). (11" diameter) (1140 - NO QTY)
 5) Pile 4-1 has decay and a section splitting away (See Sketch 2). (1140 - NO QTY)

CONDITION STATE 3
 NO CHANGE:
 1) Pile 3-1 has decay (See Sketch 1). (11" diameter) (1140 - 1 EA)
 2) Pile 4-2 has advanced decay in the top 2.5 ft (See Sketch 2). (12" diameter) (1140 - 1 EA)

Piles 3-1 and 4-2; replace.

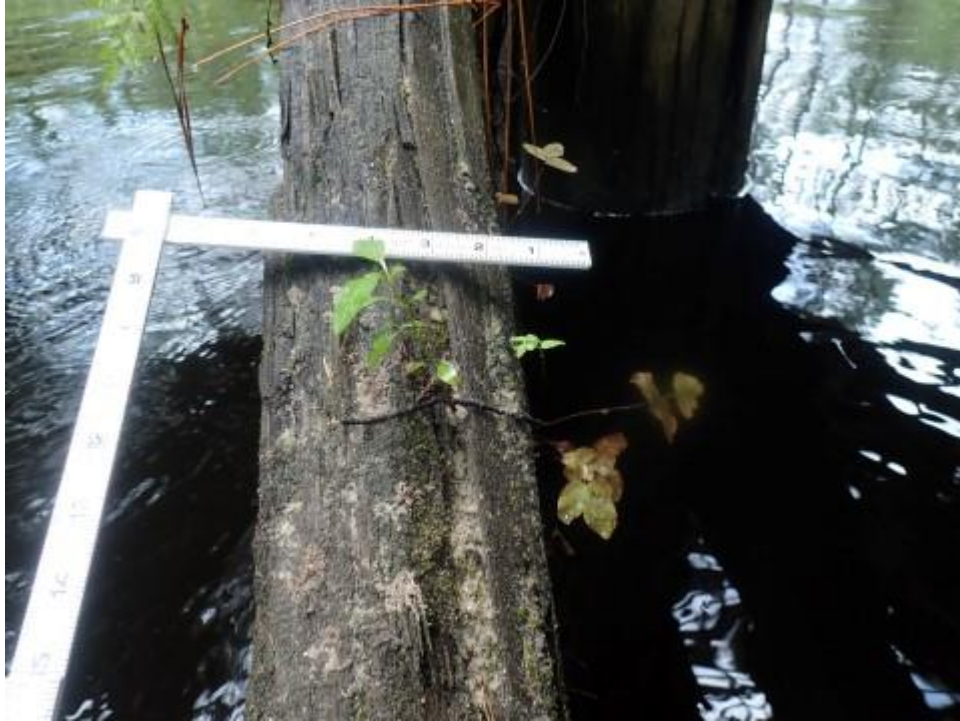
228 - Timber Pile

NOTES
 NO CHANGE:
 1) The near cross brace at Bent 3 has moderate decay (See Photo 9).
 2) The piles at Abutments 1 and 5 are not visible and could not be inspected.

Photo 9: Decay of near cross brace at Bent 3

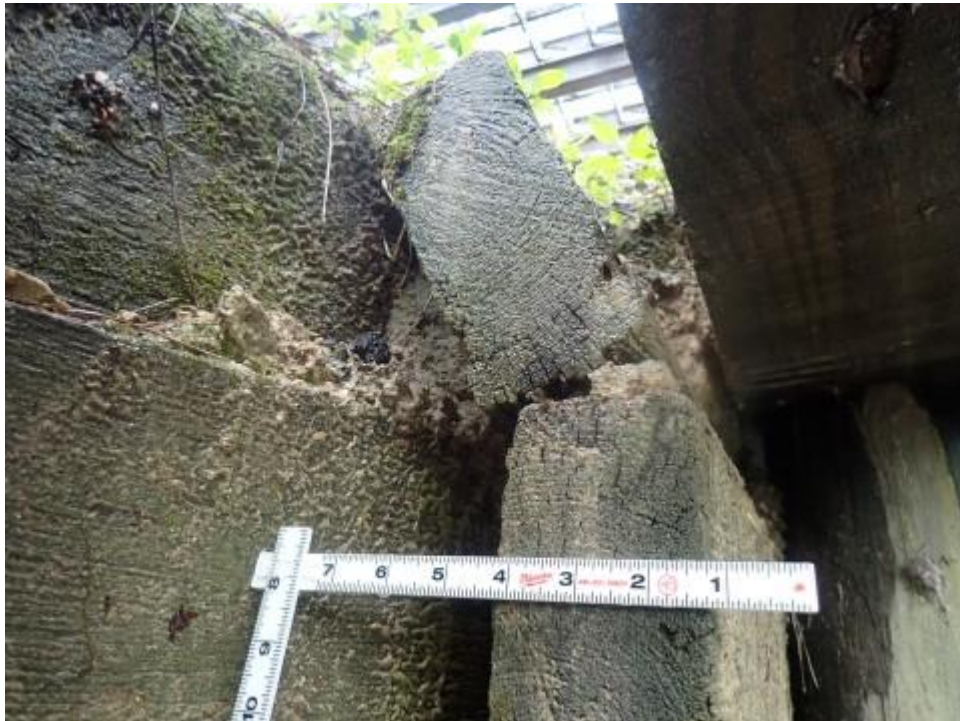
8395 - Timber Abutment Slope Protection

- 1) The top board of the near backwall has rotated 20° against stations (See Photo 10). (4000 - 12 SF)
- 2) The top board in the near backwall is split at Pile 2-1 (See Photo 11). (1150 - NO QTY)
- 3) The near and far backwalls have isolated areas of moderate exterior decay (See Photo 12). (1140 - 20 SF)
- 4) The top board of the far backwall has rotated 20° with stations (See Photo 10). (4000 - 12 SF)

Photo 10: Typical rotation of top backwall board

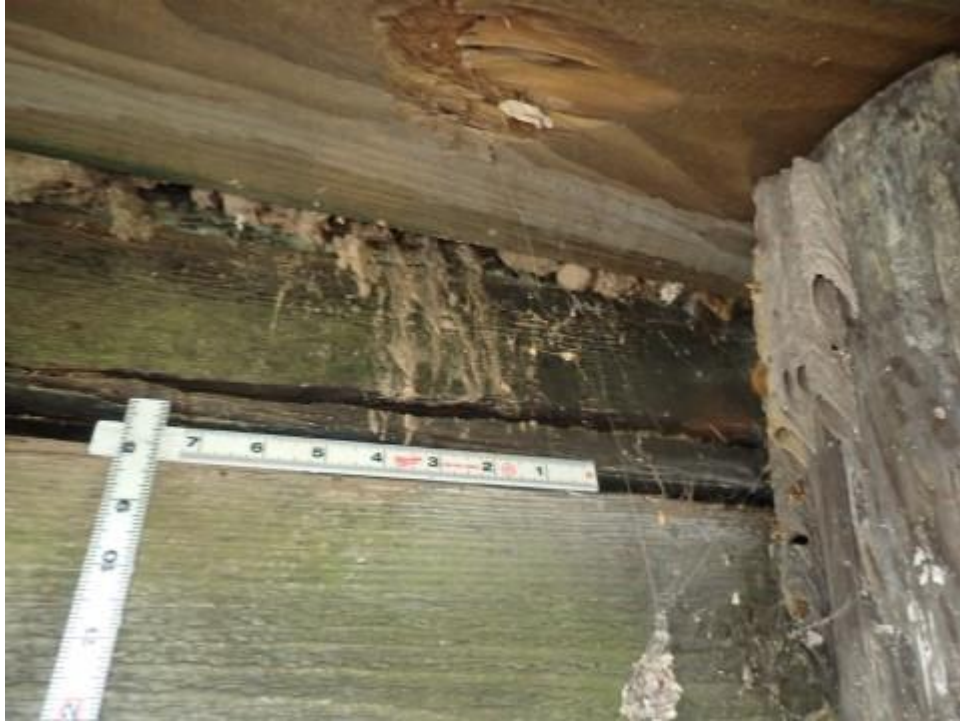
8395 - Timber Abutment Slope Protection

Photo 11: Split in top board of near backwall at Pile 2-1

Top board of near backwall at Pile 1-2; replace.

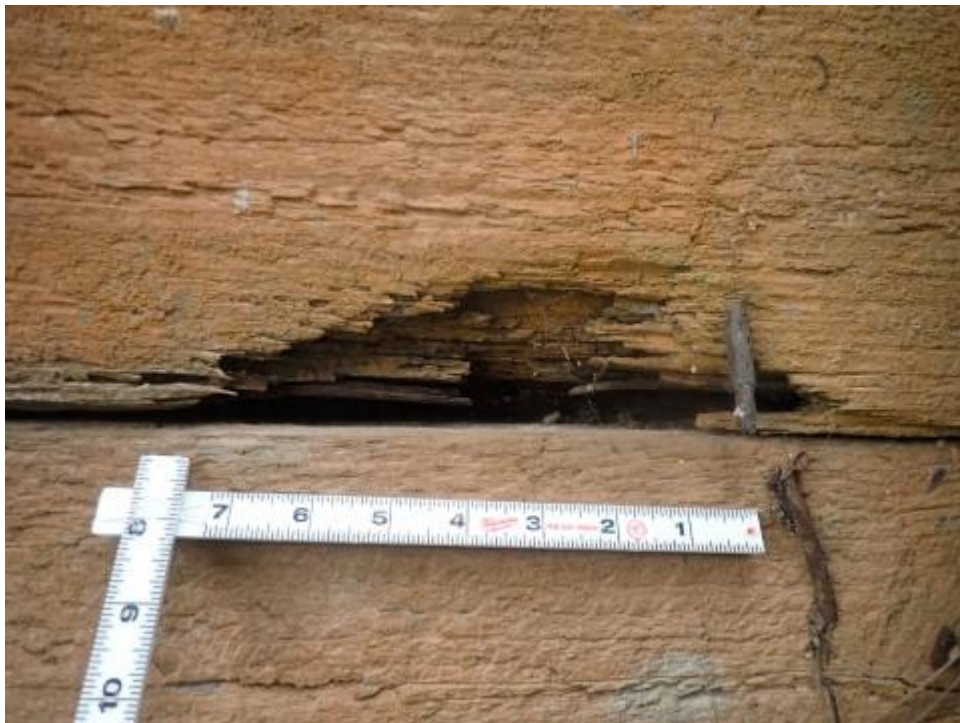
8395 - Timber Abutment Slope Protection

8395/2 CONDITION STATE 2
 NO CHANGE:
 1) (UW) The near and far backwalls have areas of early to moderate decay and

deterioration. (1140 - 50 SF)
2) The near and far backwalls have seasoning checks randomly located. (1150 - 100 SF)

Photo 12: Typical decay in backwalls

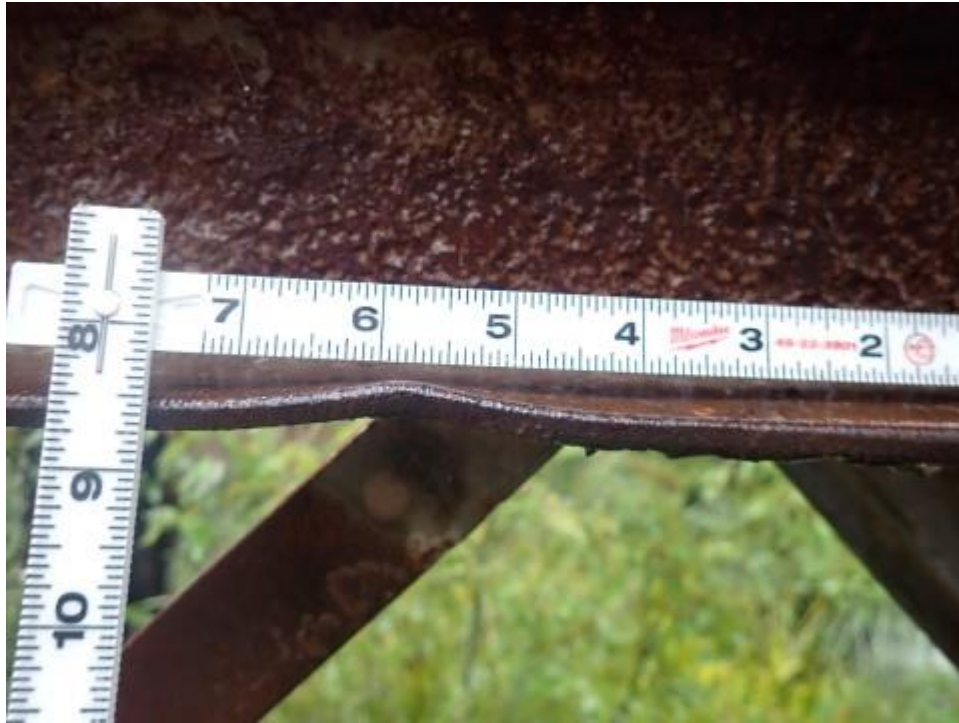
120 - Steel Truss

- 120/2 CONDITION STATE 2
NO CHANGE:
1) There are minor bends throughout the top chord (See Photo 13). (1900 - 8 FT)
2) There is corrosion along the steel truss members (See Photo 14). (1000 - 32 FT)

Photo 13: Bends throughout top chord

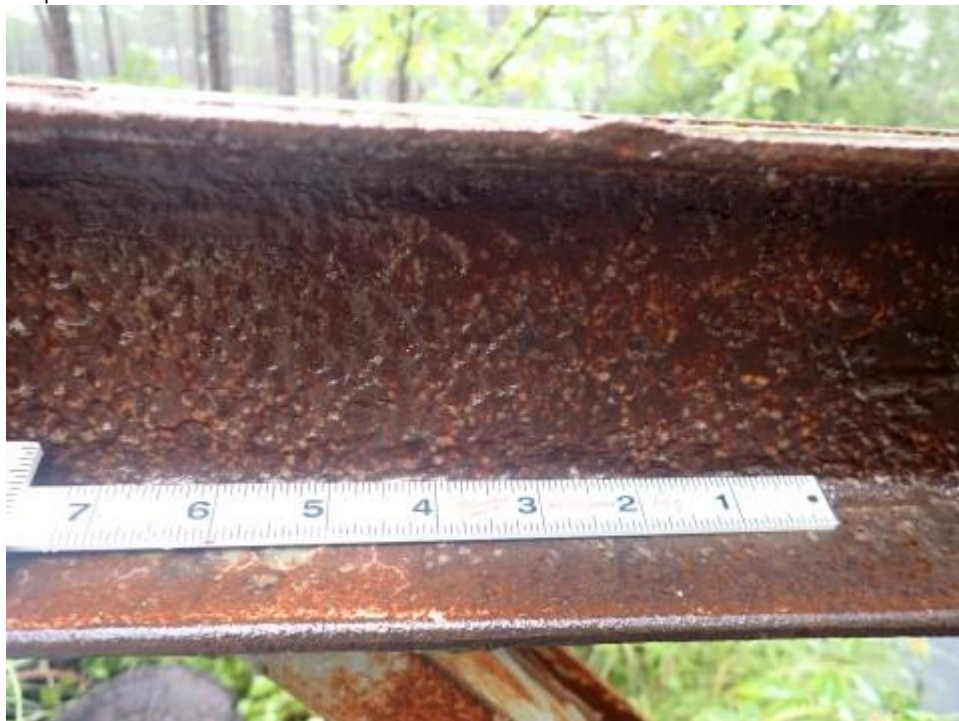
120 - Steel Truss (8516 - Painted Steel)

- CONDITION STATE 3
NO CHANGE:
1) There are isolated areas of pitting and section loss, up to 0.09 in deep, randomly located along truss members (See Photo 14). (1000 - 10 FT)

8516/2
 CONDITION STATE 3
 NO CHANGE:
 1) The paint is losing effectiveness in some areas (See Photo 14). (3440 - 243 SF)

CONDITION STATE 4
 NO CHANGE:
 1) The paint has lost effectiveness in some areas (See Photo 14). (3440 - 162 SF)

Photo 14: Corrosion, pitting and paint failure on steel truss members

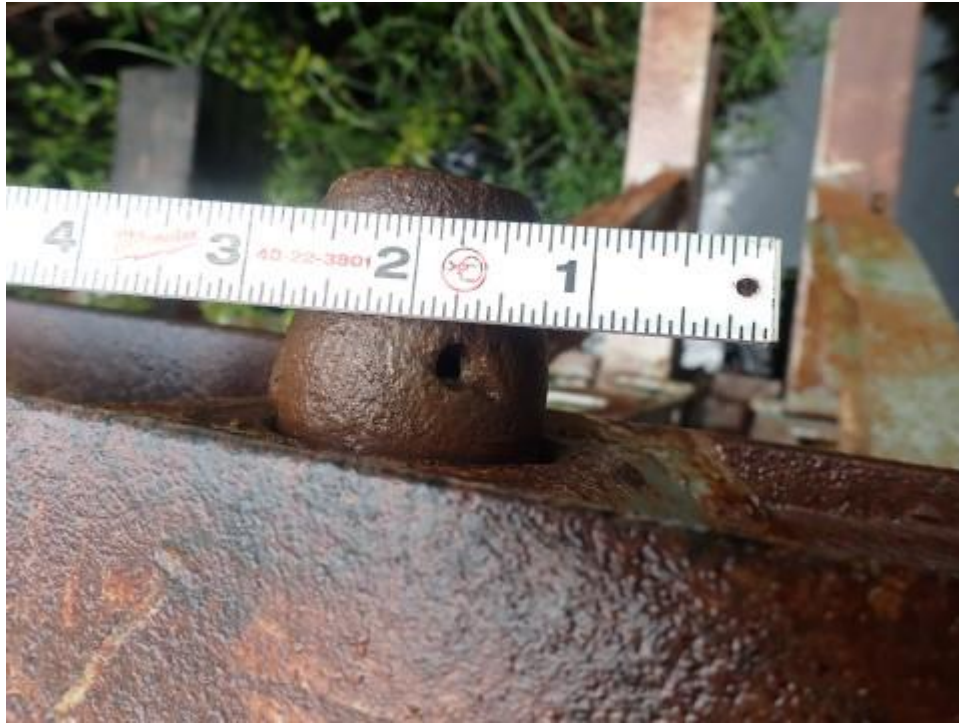
120 - Steel Truss

2) All of the connection pins are missing cotter keys along the left and right bottom chords, welds placed in lieu of the pins are cracked (See Photo 15). (1020 - 2 FT)

5) The following connection pins are missing the cotter keys (See Photo 15 and Table 1). (1020 - 2 FT)
6) The bottom chord in Panel 3 on the right side has a bend and a tear in the steel, 0.15 ft at the connection pin of Panels 2 and 3 (See Photo 18). (1900 - 1 FT)

Photo 15: Cotter key missing from connection pin

Missing cotter keys; replace.

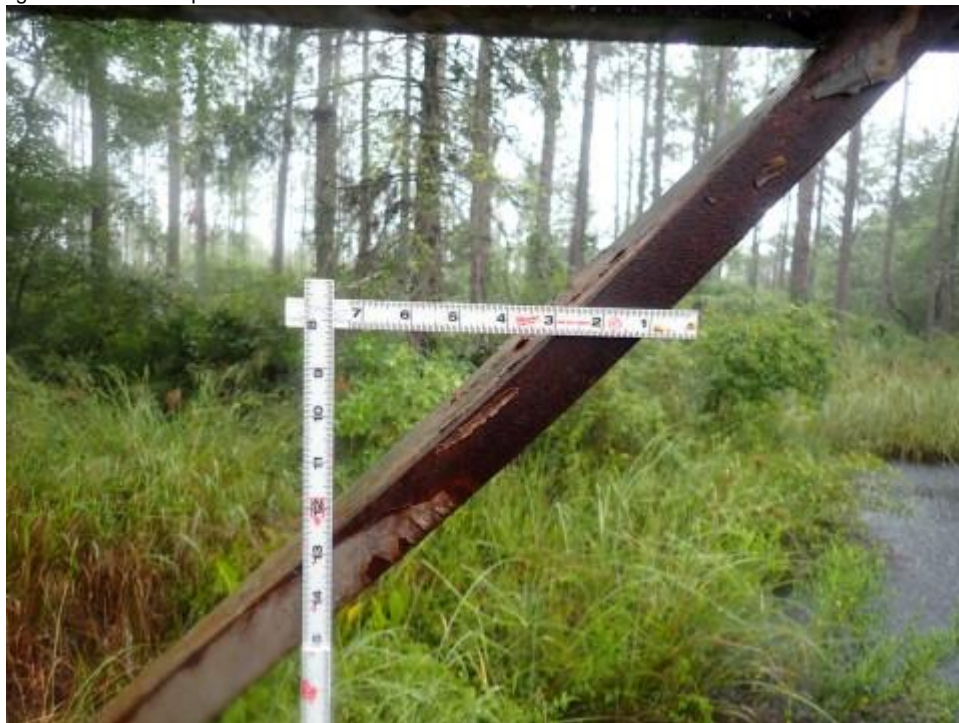
120 - Steel Truss

3) Left truss, Panel 1, Member M2 to U3 has a 0.05 ft downward bend, also Member U3 to M4 has a 0.03 ft upward bend (See Photo 16). (1900 - 4 FT)
4) Right truss, Panel 1, Member U2 to M2 has a 0.03 ft bend with stations (See Photo 17). (1900 - 1 FT)

Photo 16: Typical bend in left truss member

Deficiency Notes:
Left member, M2-U3, has an 0.05 ft downward bend.

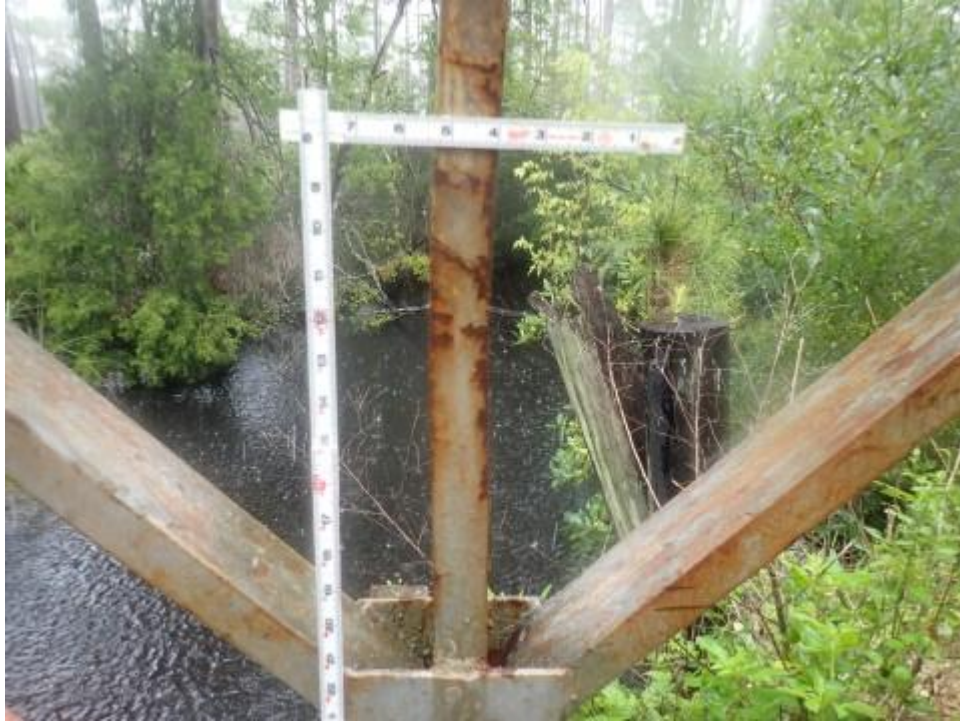
120 - Steel Truss

Photo 17: Bend in right truss member

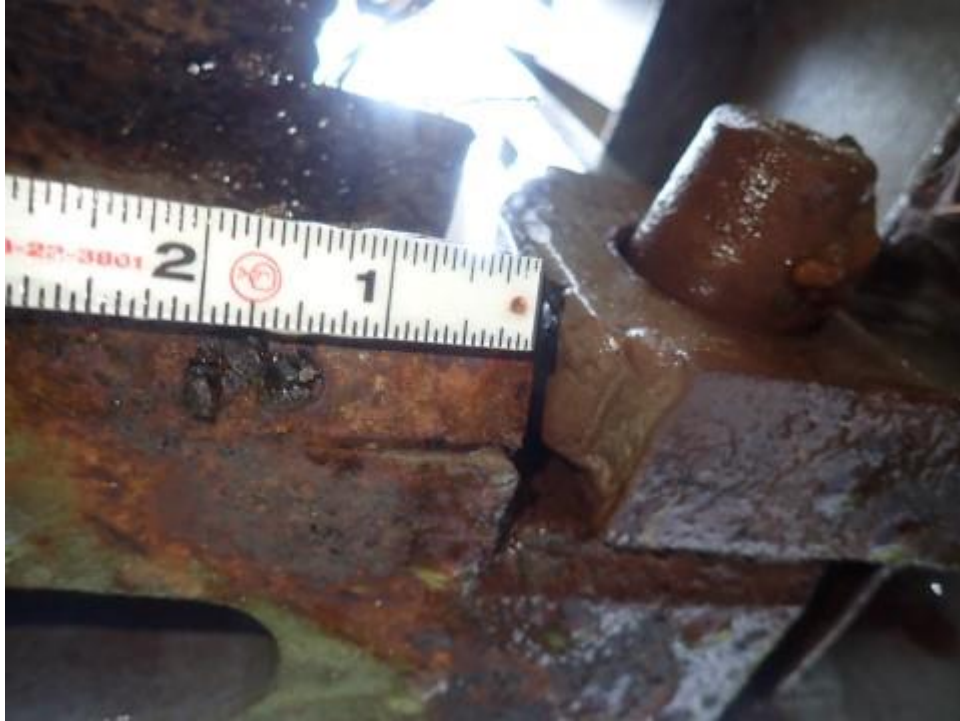
120 - Steel Truss

Photo 18: Bend and tear in bottom chord in Panel 3, right side

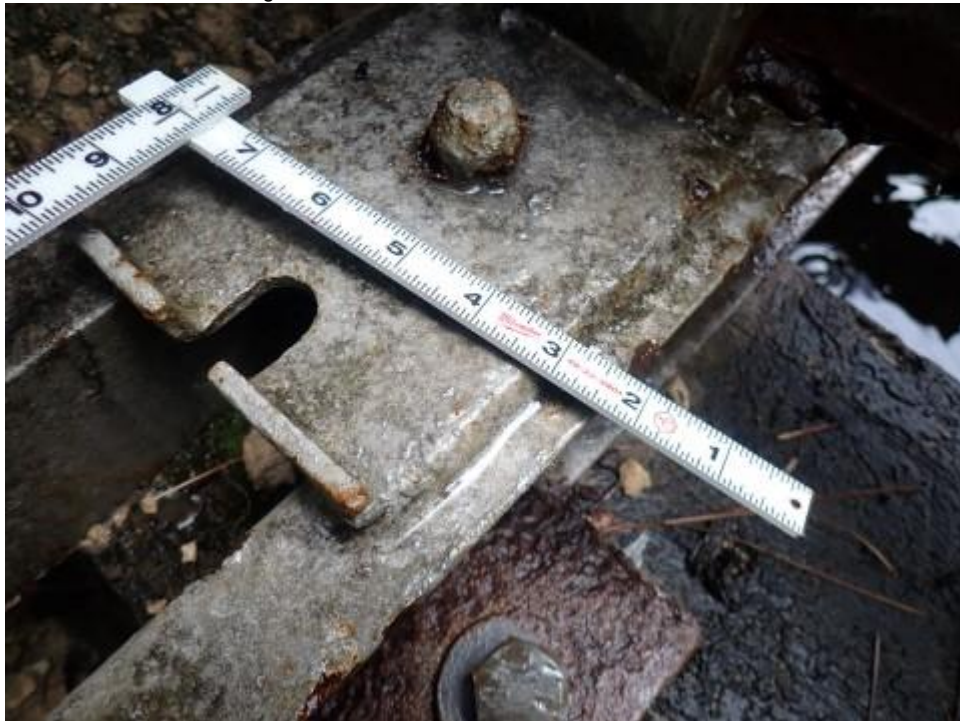
120 - Steel Truss / 152 - Steel Floor Beam

- NOTES
NO CHANGE:
1) The lateral cross bracing in Spans 1 and 4 are covered by fill which could promote corrosion.
2) The floor beam/transoms have been welded to the lower chords in lieu of the designed transom clamps. This induces stress onto the lower chord (See Photo 19).

NOTES
 NO CHANGE:
 1) The floor beams have been welded to the lower chord in lieu of the designed transom clamps this induces undesired stress onto the lower chord.

Photo 19: Typical floor beam/transom welded to lower chord in lieu of designed transom clamp

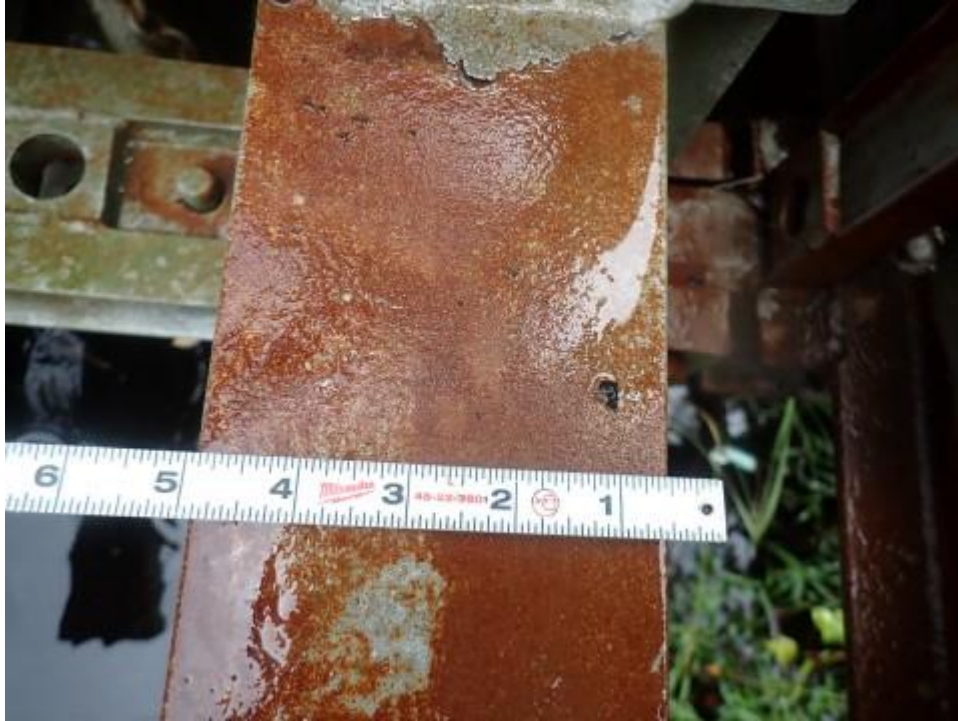
152 - Steel Floor Beam (8516 - Painted Steel)

152/2
 CONDITION STATE 2
 NO CHANGE:
 1) There is corrosion along the floor beams (See Photo 20). (1000 - 116 FT)

8516/2
 CONDITION STATE 3
 NO CHANGE:
 1) The paint is losing effectiveness in some areas (See Photo 20). (3440 - 230 SF)

CONDITION STATE 4
 NO CHANGE:
 1) The paint has lost effectiveness in some areas (See Photo 20). (3440 - 100 SF)

Photo 20: Corrosion and paint failure along floor beams

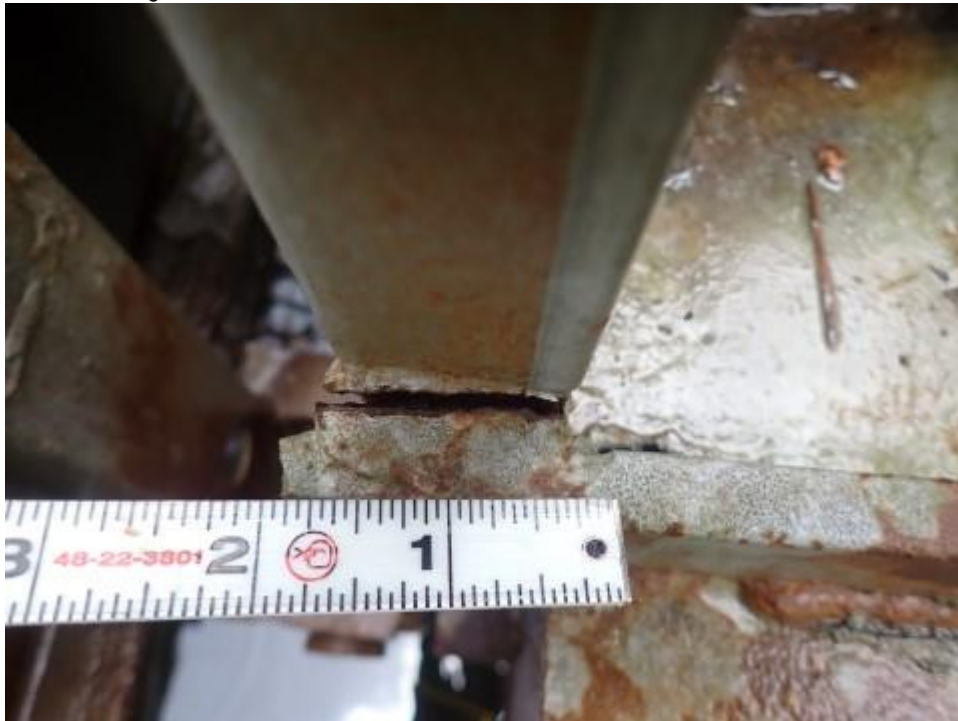
152 - Steel Floor Beam

CONDITION STATE 3
 NO CHANGE:
 1) The connection welds for Floor Beams 3 and 7, right truss are cracked (See Photo 21). (1020 - 2 FT)

Photo 21: Typical cracked connection weld for Floor Beams 3 and 7, right truss
