**FLORIDA DEPARTMENT OF TRANSPORTATION**  
**BRIDGE MANAGEMENT SYSTEM**  
**Inspection/CIDR/Bridge Profile Report**  
**Inspection**

**Structure ID: 494096****DISTRICT: D3 - Chipley****INSPECTION DATE: 7/30/2020 NNHH**

BY:	CONSOR Engineers, LLC	STRUCTURE NAME:	Not recorded
OWNER:	2 County Hwy Agency	YEAR BUILT:	1959
MAINTAINED BY:	2 County Hwy Agency	SECTION NO.:	49 000 005
STRUCTURE TYPE:	4 Steel Continuous - 10 Truss-Thru	MP:	3.293
LOCATION:	5.0 Mi N of US98/SR30	ROUTE:	00000
SERV. TYPE ON:	1 Highway	FACILITY CARRIED:	Mill Road
SERV. TYPE UNDER:	5 Waterway	FEATURE INTERSECTED:	Trout Creek

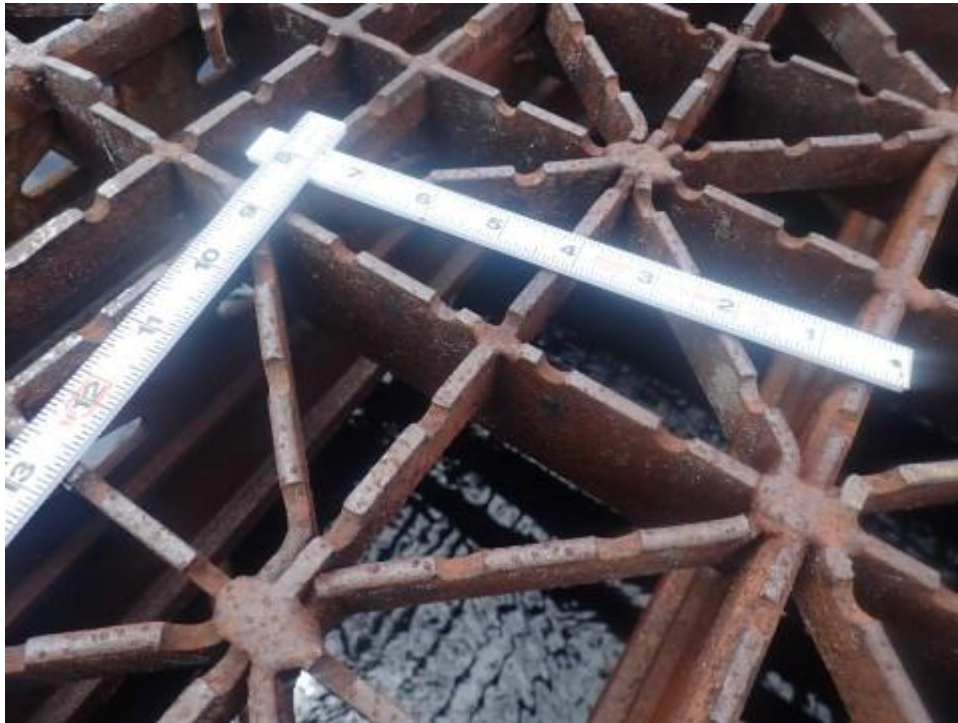
- 1) Surface corrosion has formed on the steel grid deck (See Photo 1). (1000 - 1022 SF)

- 1) The paint system on the steel grid deck has failed allowing corrosion to form (See Photo 1). (3440 - 1584 SF)

Photo 1: Typical corrosion and paint failure along the deck

<b>ELEMENT/ENV: 28:1000 / 3 Corrosion</b>		<b>ELEM CATEGORY: Decks/Slabs</b>	
CONDITION STATE			PRIORITY
2 , 3	MMS Quantity: 1 sf	Element Estimated Quantity: 1052 sq.ft	3
WORK ORDER RECOMMENDATION:			
Deck; clean and paint.

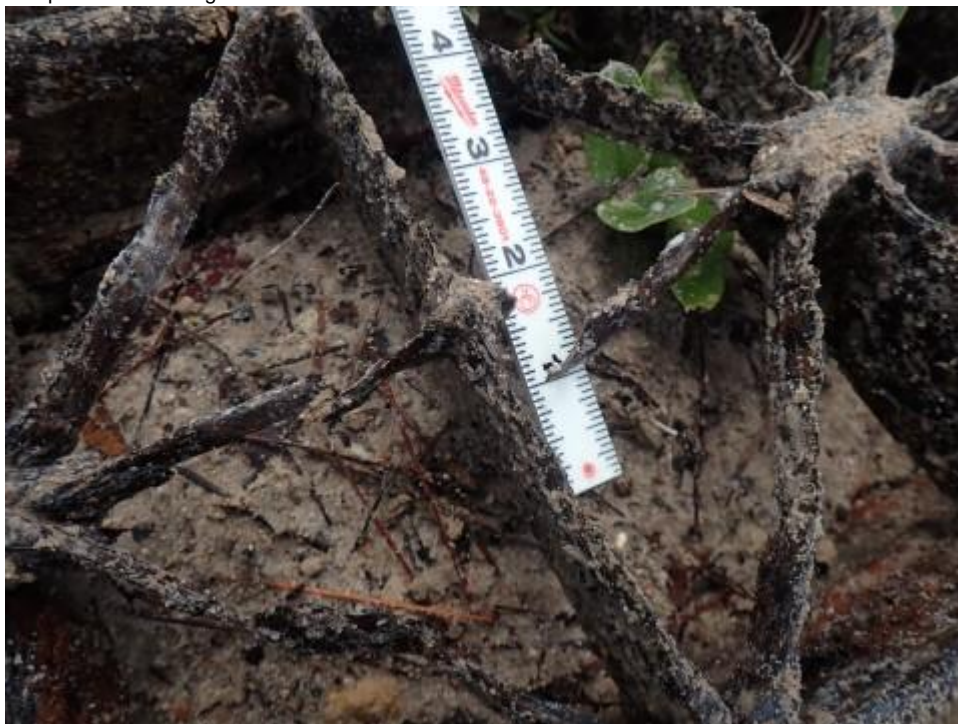
- 1) The ends of the deck have areas of advanced corrosion with up to 100% section loss where the dirt has built up (See Photo 2). (1000 - 30 SF)

Photo 2: Typical advanced corrosion and section loss along deck end

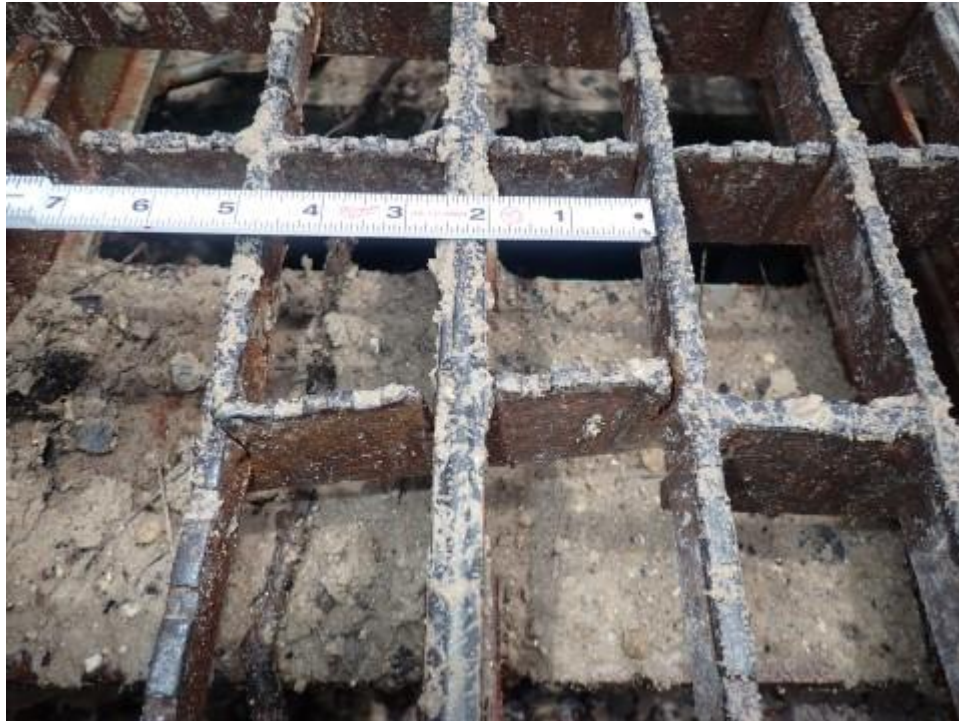
- 1) There are randomly located, cracked welds and bent sections in the grid deck (See Photo 3). (1010 - 35 SF)

Photo 3: Typical cracked welds and bent sections along deck

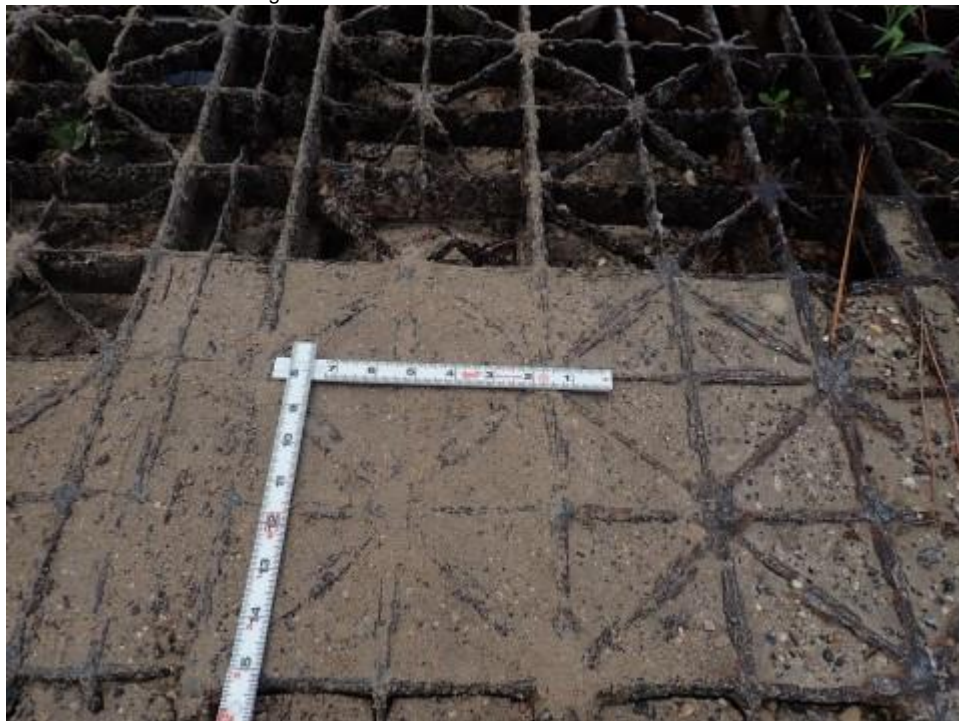
- 1) Dirt has collected in the grid deck at both ends of the bridge (See Photo 4).
- 2) Reflectors are not provided on the ends of the wheelguards to define the potential roadway hazards.
- 3) Approach guardrails are not capable of redirecting traffic (See Photo 5).
- 4) The approach guardrails do not have end terminals and are not connected to the bridge (See Photo 6).
- 5) Several timber wheelguards have advanced decay in the ends (See Photo 7).
- 6) There are several wheelguards that are insufficient in height and misaligned (See Photo 8).
- 7) The left wheelguard in Span 1 has one broken and settled timber (See Photo 9).
- 8) The near approach ONE LANE BRIDGE sign is faded and has gunshot damage.
- 9) The far ONE LANE BRIDGE sign has gunshot damage.
- 10) The timber wheelguards have checks, splits, and moderate decay.
- 11) Bridge rails are not provided (See Photo 5).

Photo 4: Dirt along deck end

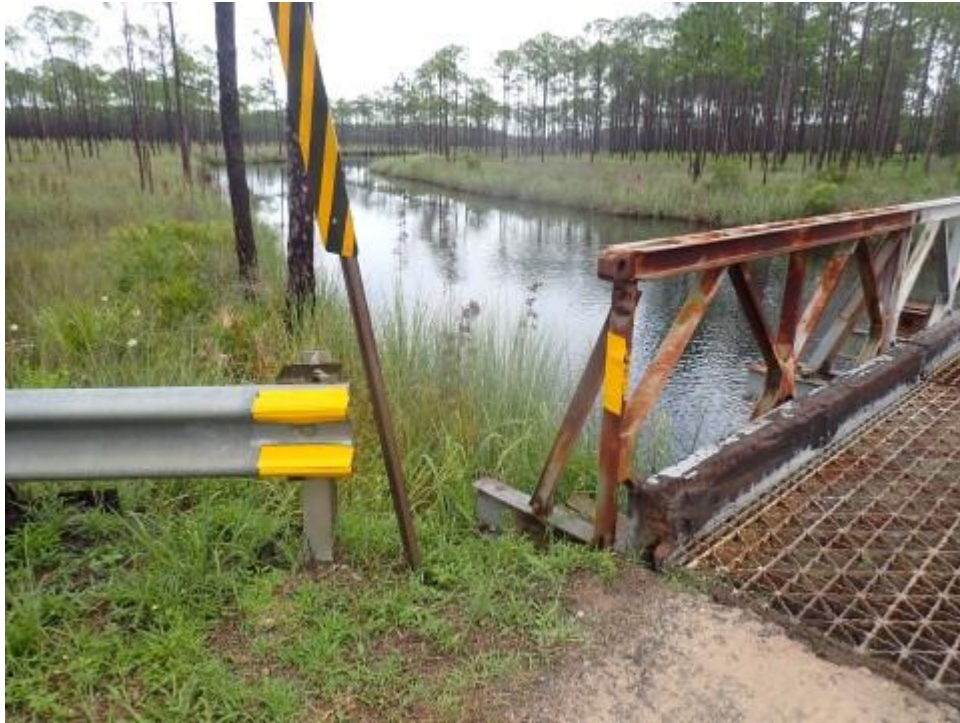
Photo 5: Approach guardrails are not capable of redirecting traffic; Bridge rails are not provided

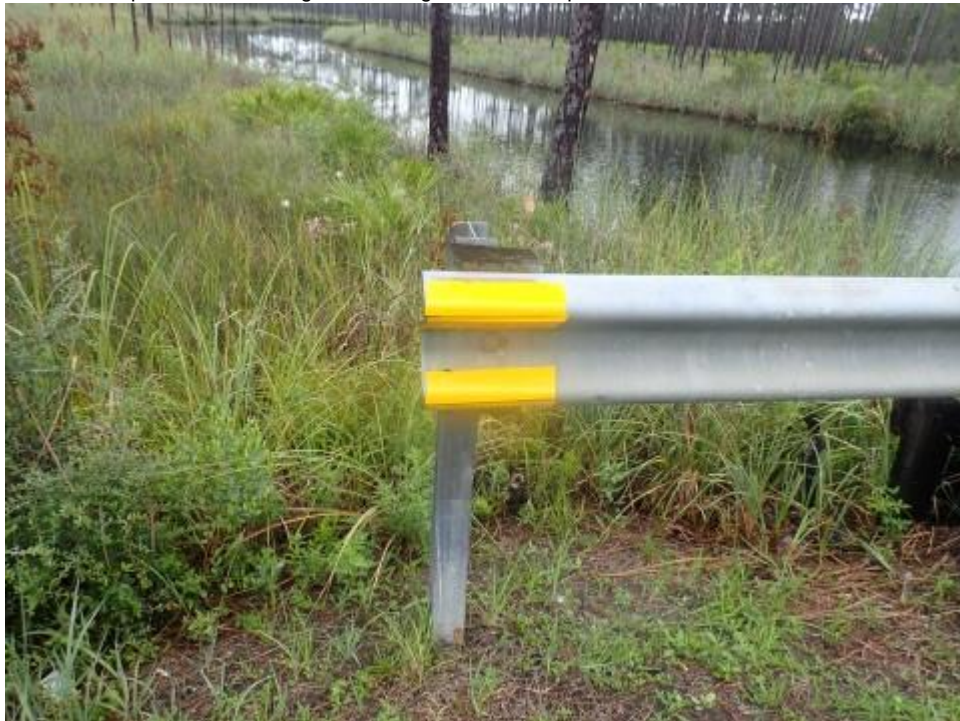
Photo 6: Approach guardrail end terminals are not provided

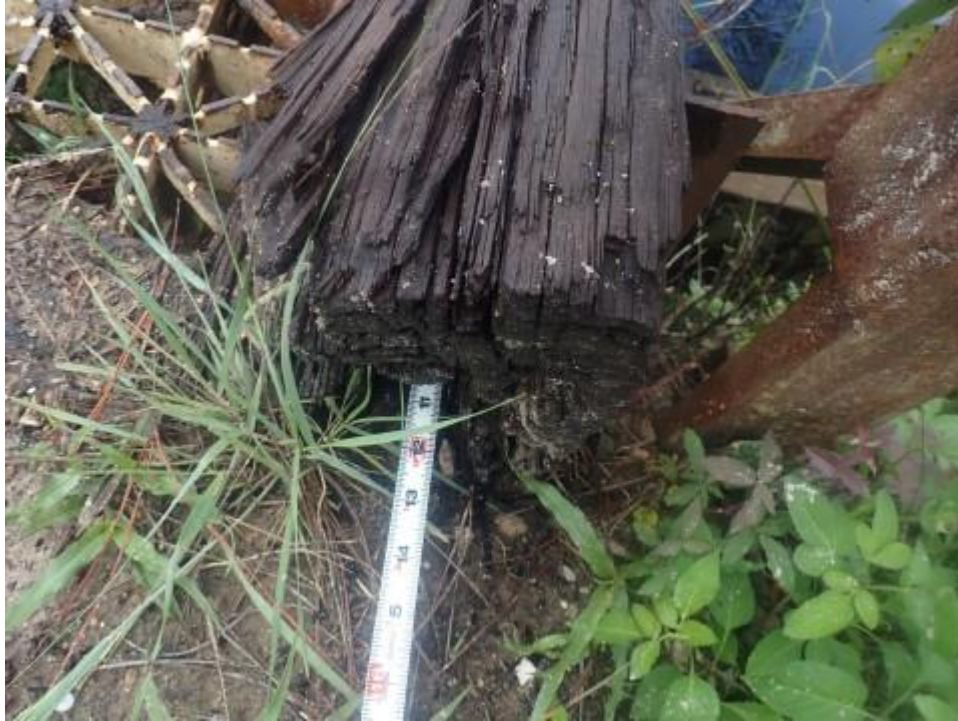
Photo 7: Typical decay in wheelguard

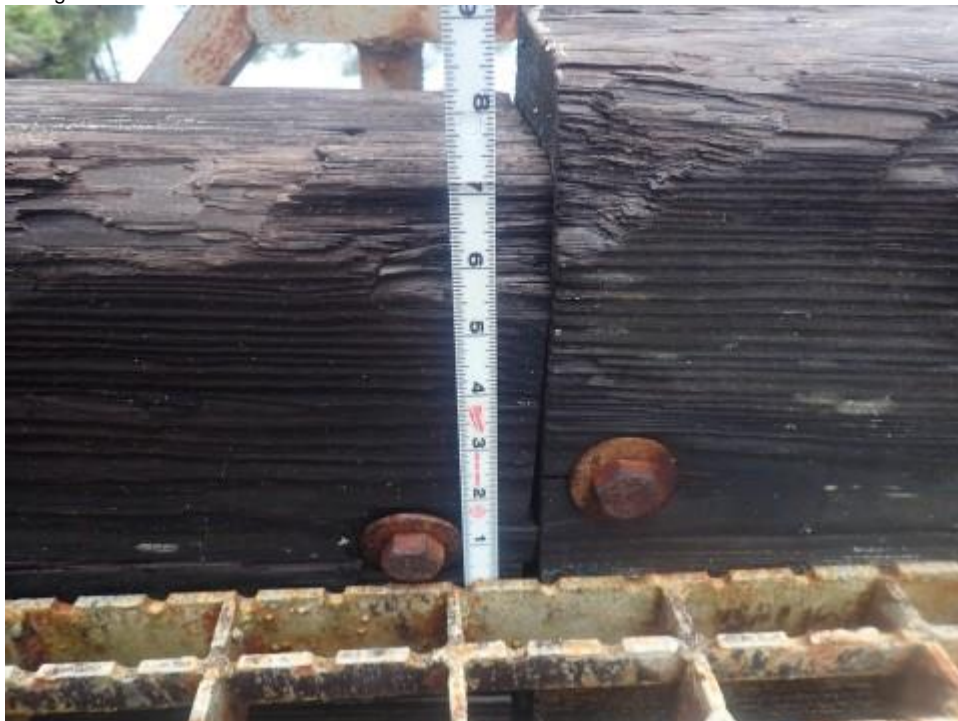
Photo 8: Typical wheelguard insufficient in height and misaligned

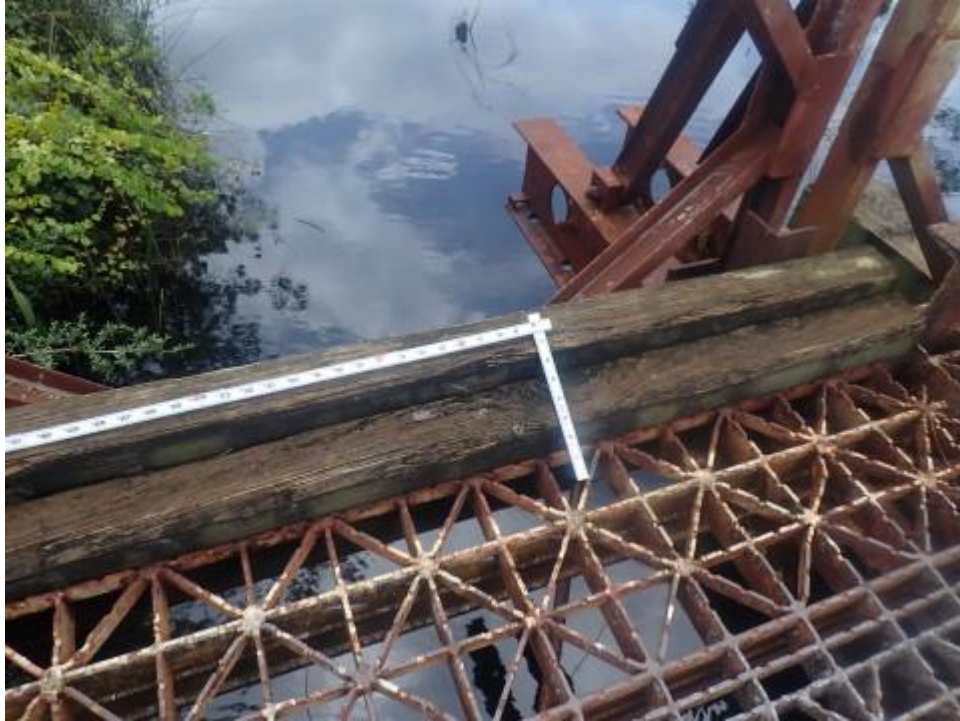
Photo 9: Span 1 wheelguard is broken and settled

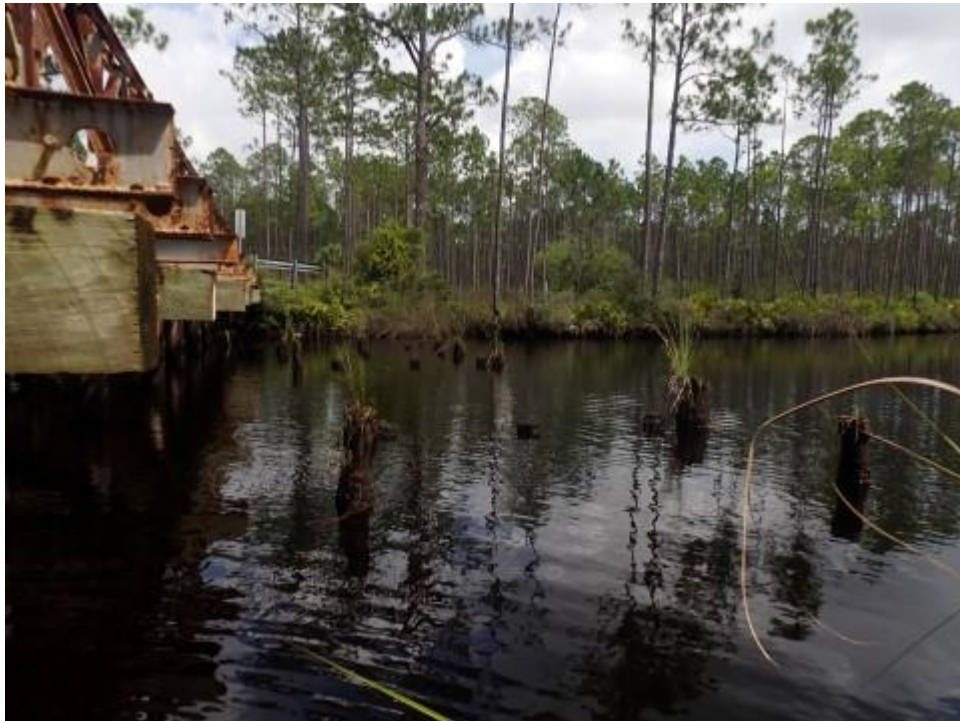
Photo 10: Piles from previous structure in channel

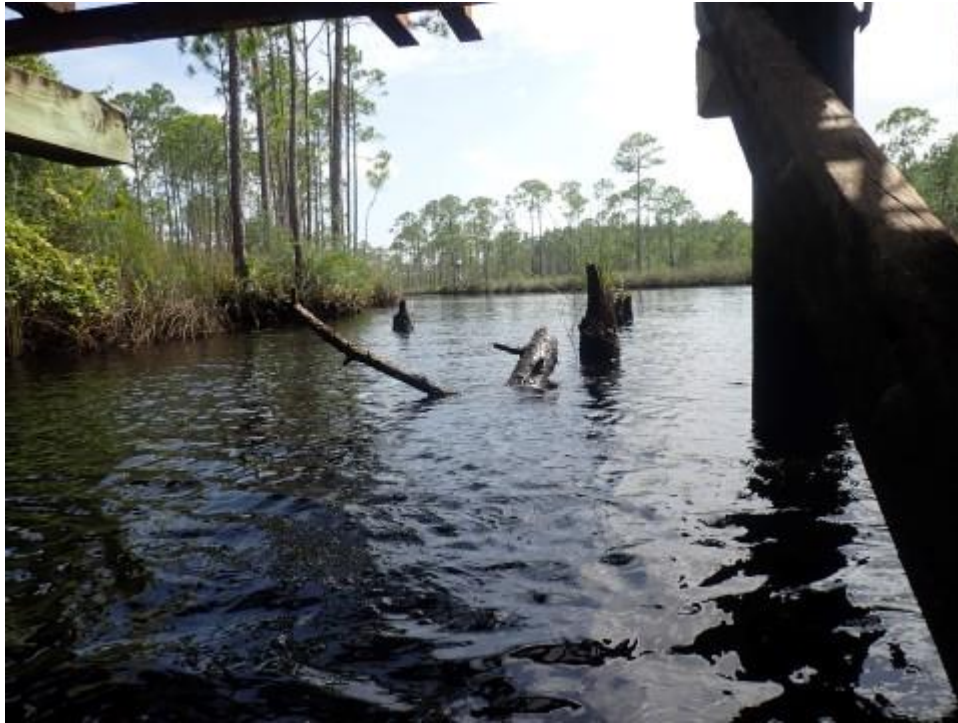
Photo 11: Drift along bent in channel

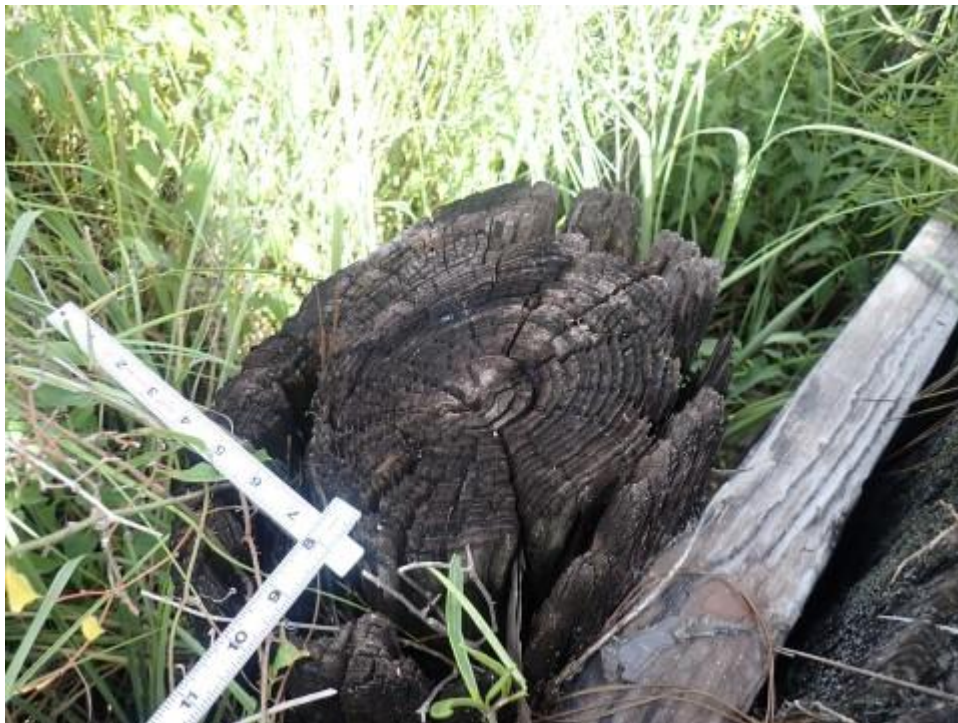
1) The near right and far right wingwalls and piles have sustained fire damage and have advanced decay (See Photo 12). (1140 - 12 FT)  
 2) The near right wingwall has separated, up to 0.4 ft, from the top of the backwall allowing loss of fill (See Photo 13). (4000 - 13 FT)  
 3) The wingwall boards have moderate to advanced decay (See Photo 14). (1140 - 24 FT)  
 4) All wingwall piles have advanced decay (See Photo 14). (1140 - NO QTY)

Photo 12: Typical decay in wingwall pile

Near right and far right wingwalls; replace boards with fire damage.

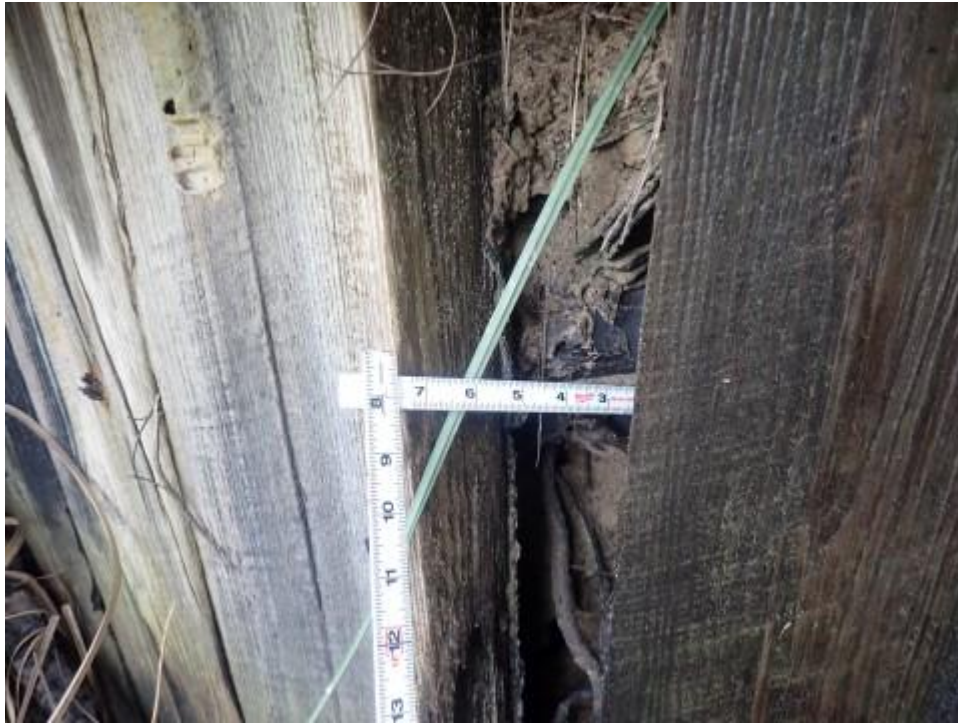
Photo 13: Separated near right wingwall from backwall

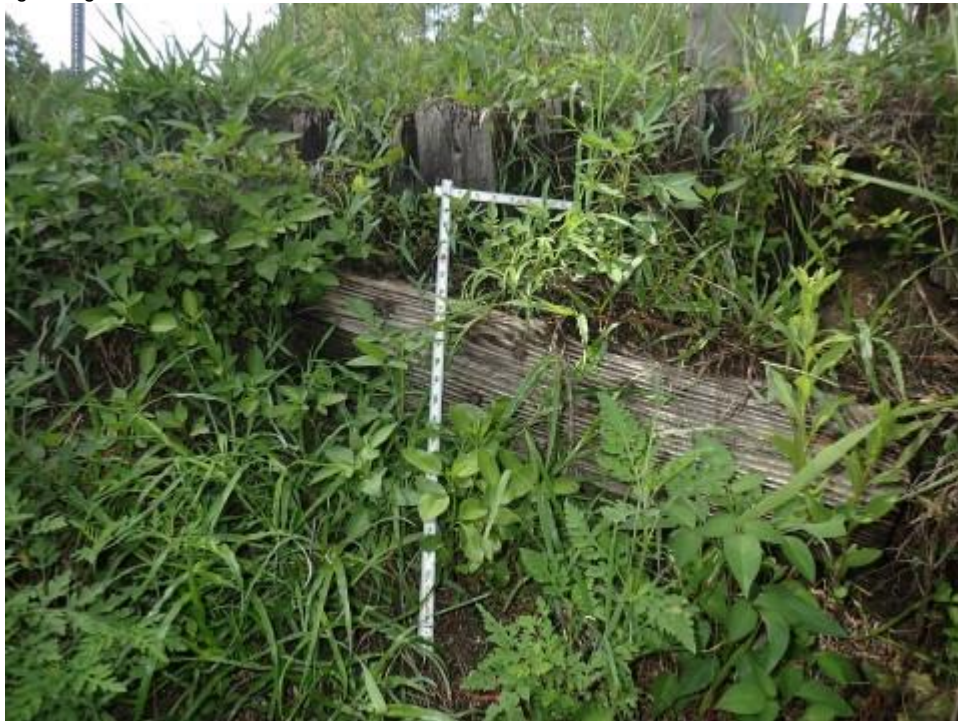
Photo 14: Typical decay along wingwall

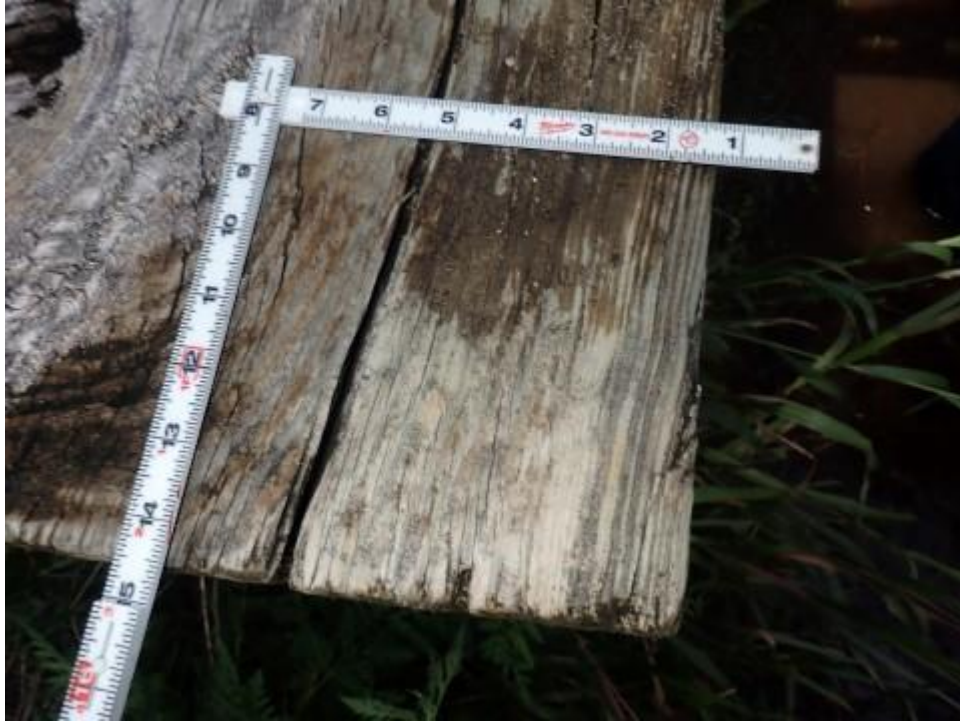
1) The far abutment has an impending shake forming, 5.0 ft L x 0.42 ft H 0.50 ft W, with associated cracks, up to 0.13 in wide, in the near top face (See Photo 15). (1150 - NO QTY)

Photo 15: Shake in far abutment

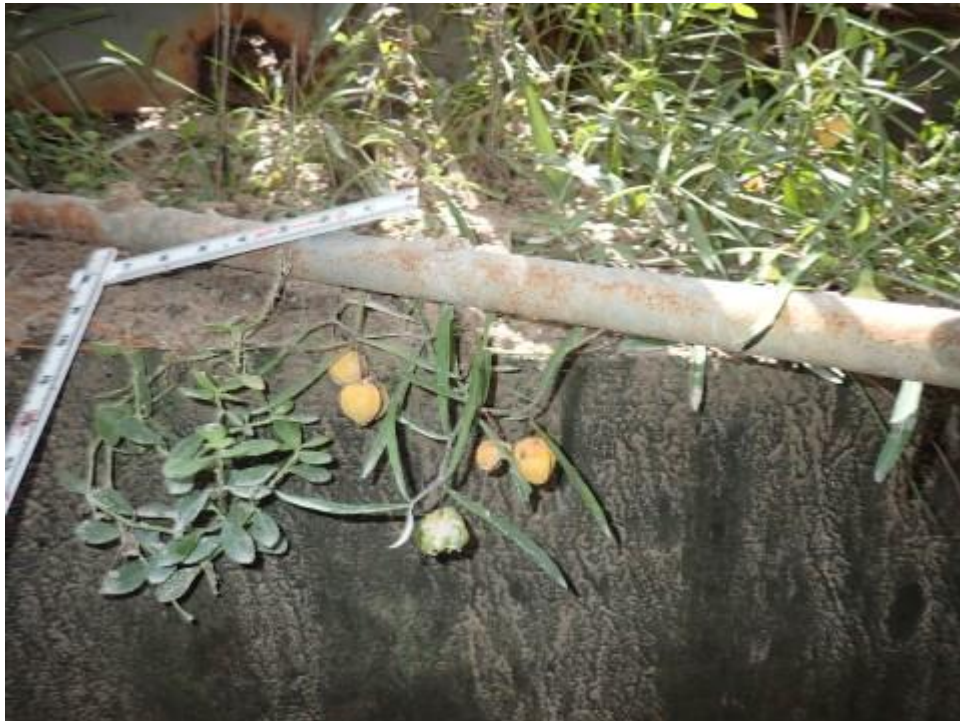
1) Dirt has collected on the abutment caps, which could promote decay in the caps (See Photo 16).

Photo 16: Dirt on abutment cap

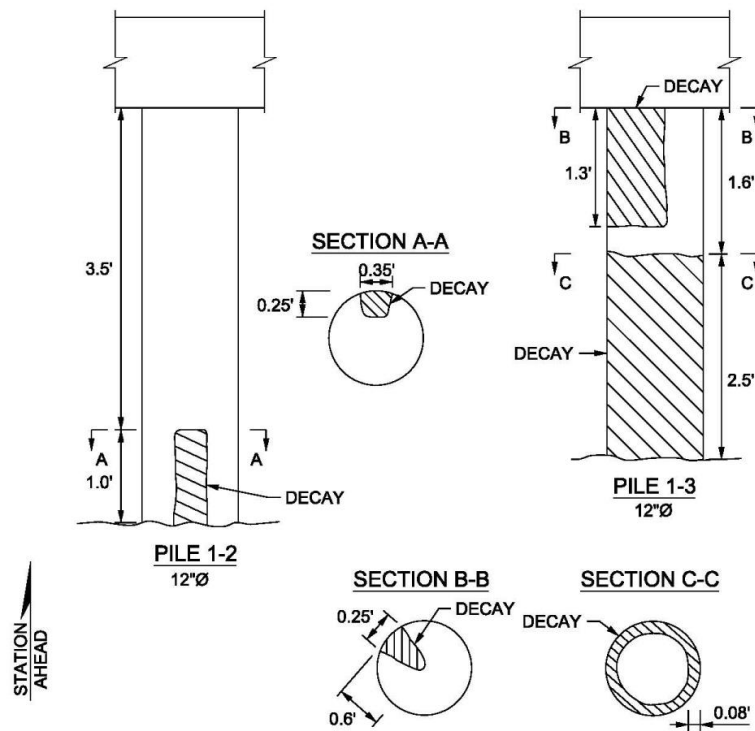
Sketch 1

- 1) Pile 1-2 has decay (See Sketch 1). (12" diameter) (1140 - 1 EA)
- 2) Pile 1-3 has decay (See Sketch 1). (12" diameter) (1140 - 1 EA)
- 3) Pile 2-1 has early exterior decay in the far face beginning 4.0 ft below the cap and extending down 2.0 ft, and a split in the far face, 0.5 in W x 0.5 in D, beginning 3.2 ft below the cap and extending down to the groundline. (11" diameter) This pile does not provide pile to cap bearing (See Photo 17). (0.03 ft gap) (4000 - 1 EA)

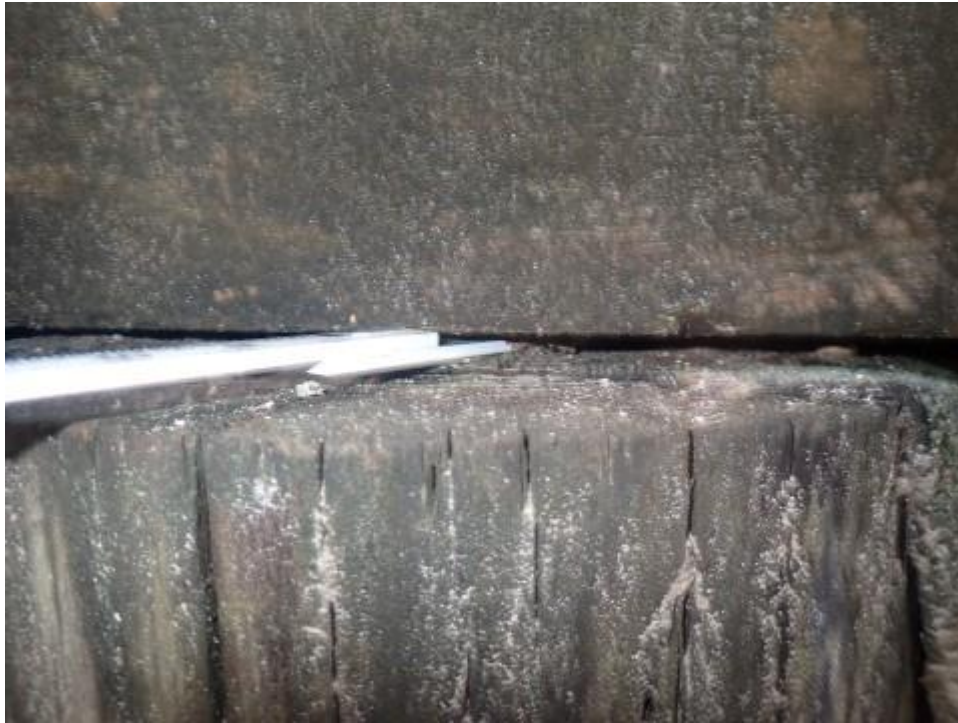
- 4) Pile 2-2 has decay. (10" diameter) This pile does not provide pile to cap bearing (See Photo 17 and Sketch 2). (4000 - 1 EA)
- 5) Pile 3-2 has decay. (11" diameter) This pile does not provide pile to cap bearing (See Photo 17 and Sketch 3). (0.03 ft gap) (4000 - 1 EA)

- 8) Pile 5-2 does not provide pile to cap bearing (See Photo 17). (0.03 ft gap) (10 1/2" diameter) (4000 - 1 EA)
- 9) Pile 5-3 has decay (See Sketch 2). (13" diameter) (1140 - 1 EA)

- 12) Pile 7-2 does not provide pile to cap bearing (See Photo 17). (0.03 ft gap) (11" diameter) (4000 - 1 EA)
- 13) Pile 7-3 has exterior decay, up to 0.2 ft deep, in the near and right faces, beginning 2.0 ft below the cap and extending down 1.0 ft (See Photo 18 and Sketch 5). (13" diameter) (1140 - 1 EA)

- 15) Pile 9-2 does not provide pile to cap bearing (See Photo 17). (0.02 ft gap) (11" diameter) (4000 - 1 EA)  
 16) Pile 9-3 has decay (See Sketch 4). (11" diameter) (1140 - 1 EA)

Photo 17: Typical point with no pile to cap bearing

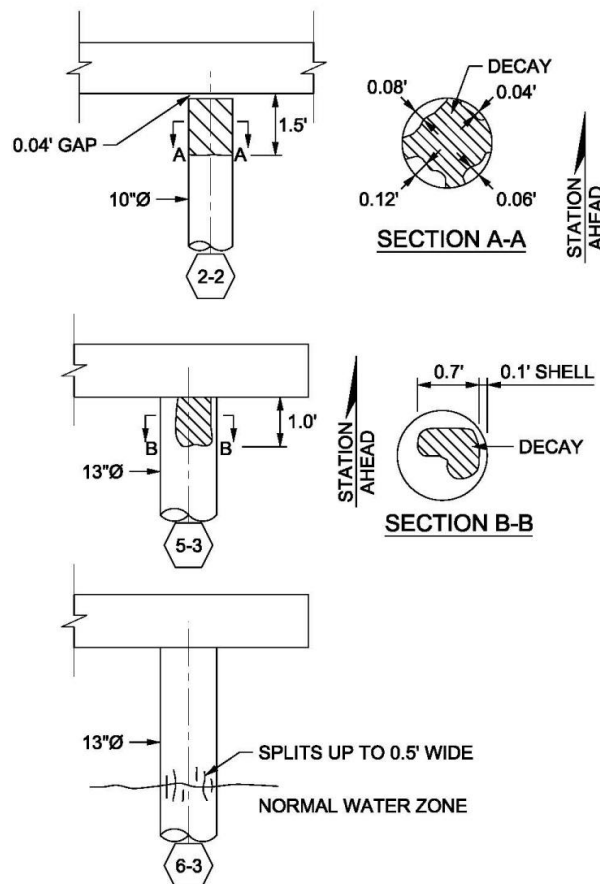
Sketch 2

- 10) Pile 6-3 has checks, up to 0.5 in W x 0.5 in D, in all faces at the normal water zone (See Sketch 2). (13" diameter) (1150 - 1 EA)
- 11) Pile 7-1 has exterior decay, up to 0.08 ft deep, beginning 2.2 ft from the top, extending down 1.2 ft (See Sketch 5). (12" diameter) (1140 - 1 EA)

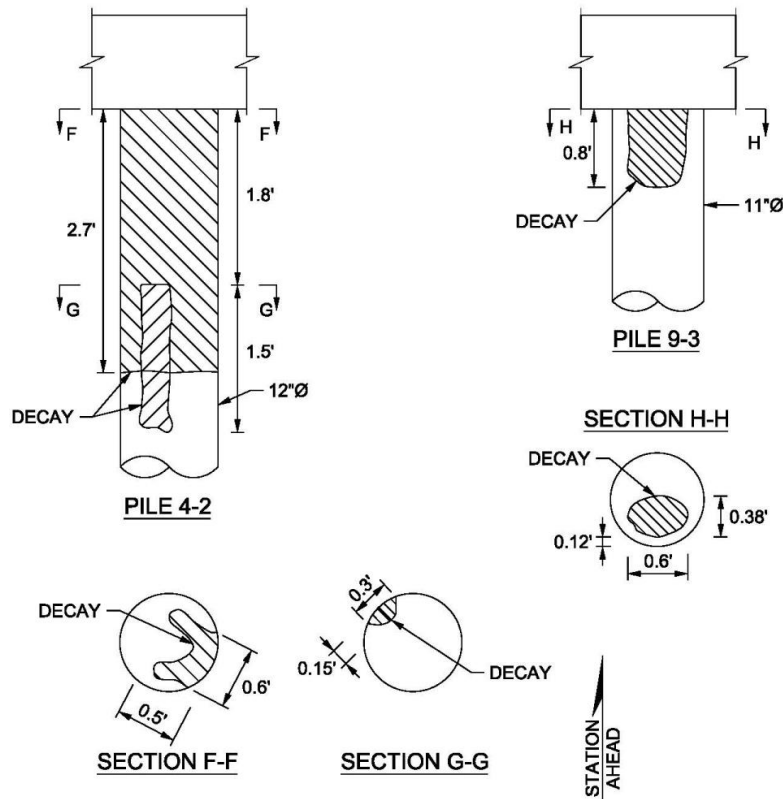
Sketch 4

- 6) Pile 3-3 has decay (See Sketch 3). (9" diameter) (1140 - 1 EA)
- 7) Pile 4-2 has decay. (12" diameter) This pile does not provide pile to cap bearing (See Photo 17 and Sketch 4). (0.04 ft gap) (4000 - 1 EA)

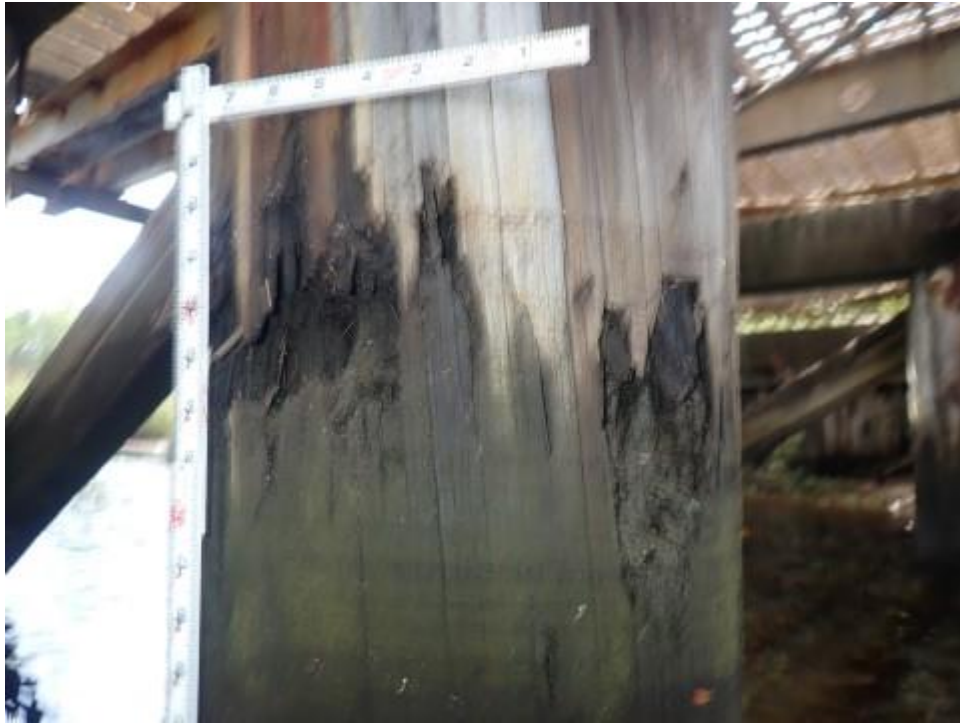
Photo 18: Decay in Pile 7-3

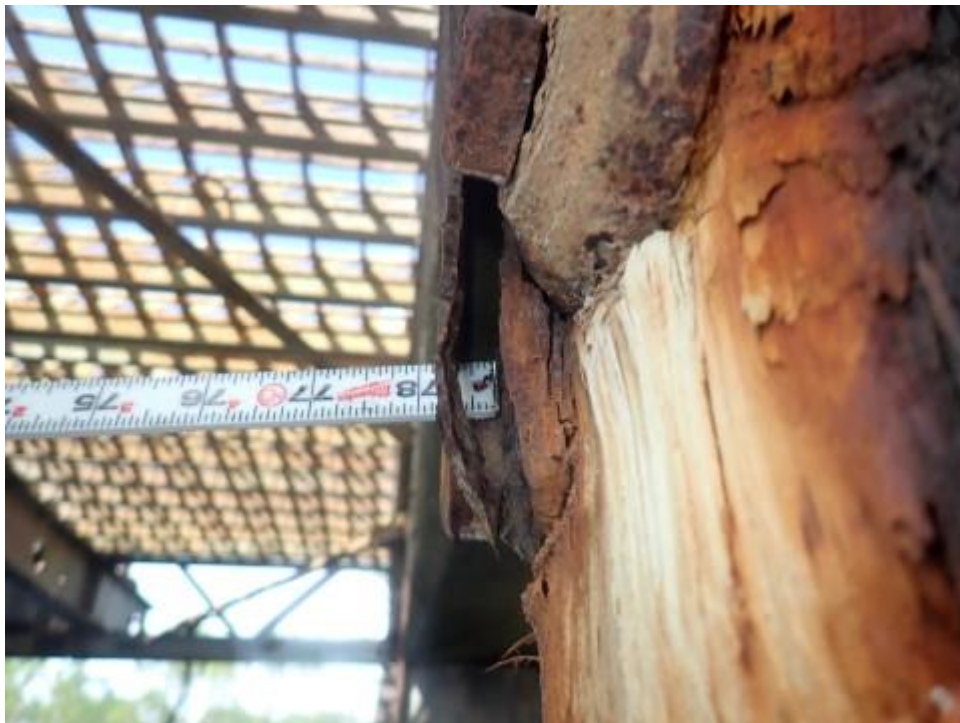
- 1) The far cross bracing for Bent 7 is not anchored on Pile 7-1. It appears the anchors were not installed.  
 2) The pile strapping for Pile 4-1 is broken on the far side (See Photo 19).

Photo 19: Typical broken pile strapping

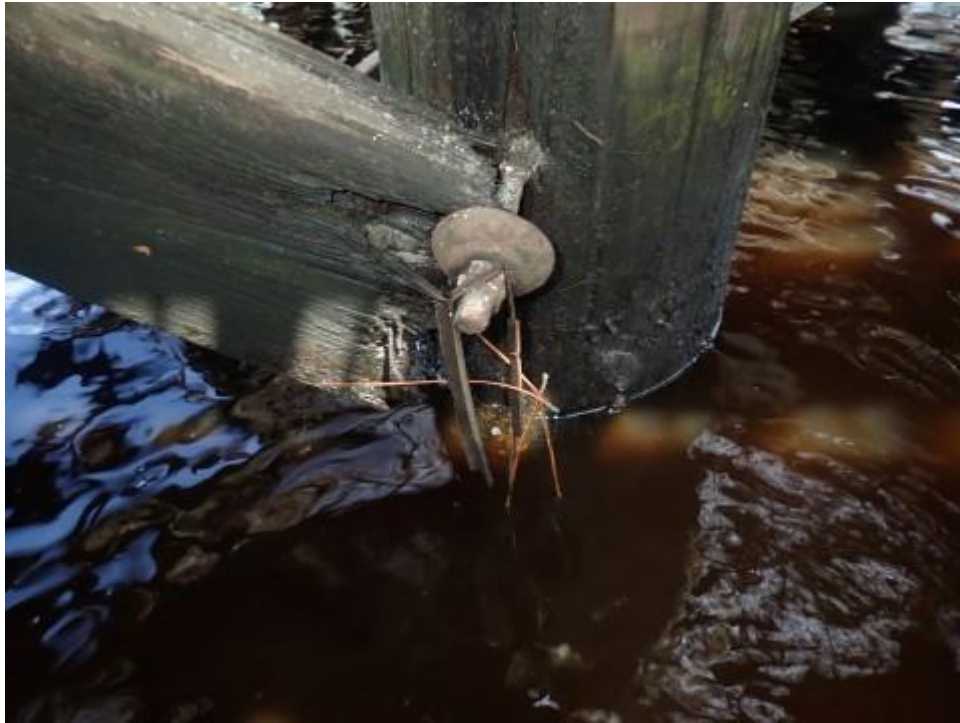
- 1) The far cross brace at Bent 8 is broken and not attached to Pile 8-1 (See Photo 20).  
 2) The cross braces have early exterior decay.  
 3) Due to bridge design and pile bent configurations, Pile 2 (center pile) in all bents is not load bearing.

Photo 20: Broken/detached far cross bracing at Pile 8-1

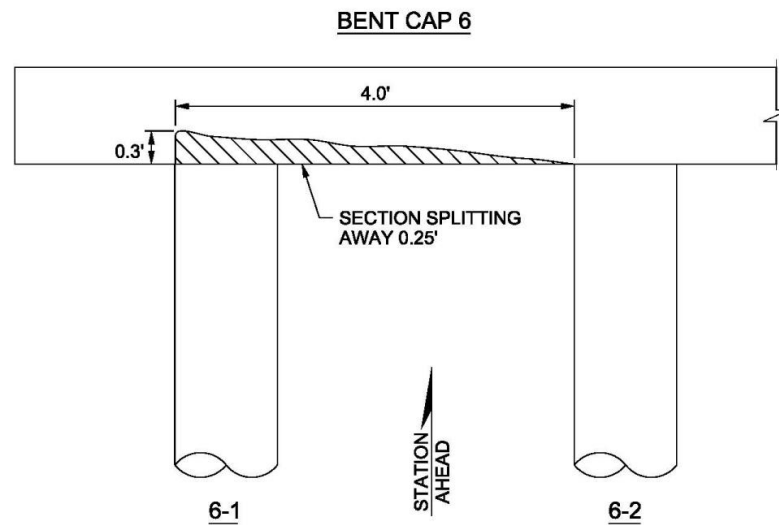
Sketch 6

- 235/3      **CONDITION STATE 2**  
**NO CHANGE:**  
 1) The bent caps have seasoning checks. (1150 - 128 FT)  
 2) Bent Cap 6 has a section splitting away from the bottom of the near face between Piles 6-1 and 6-2 (See Sketch 6). (12" x 12") (1150 - NO QTY)

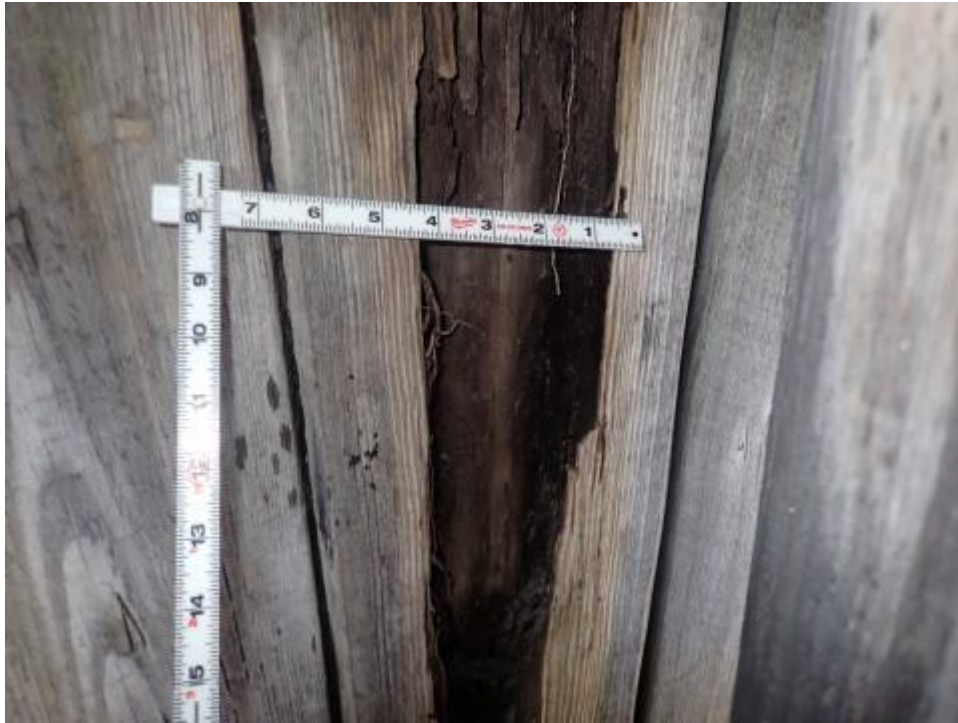
- 1) The near backwall has one vertical board with advanced decay (See Photo 21). (1140 - 1

Photo 21: Decay in near backwall board

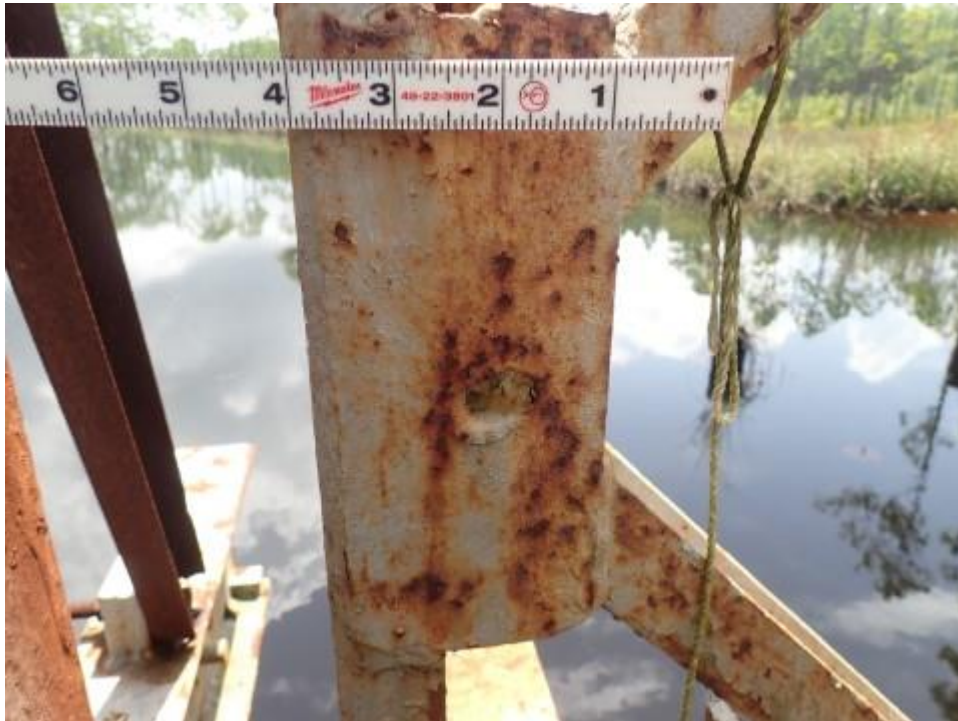
Photo 22: Typical bullet hole in left truss, Panel 6

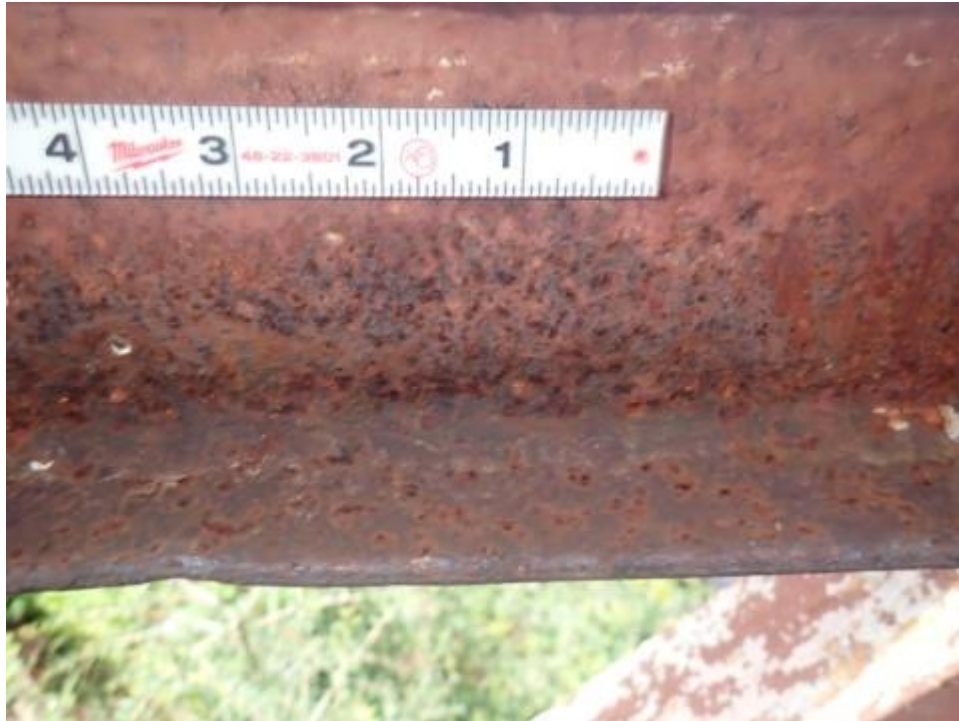
- 1) Corrosion has formed on the truss members allowing pitting, up to 0.06 in deep (See Photo 23). (1000 - 158 FT)
- 2) Panel 1, right truss has a rod welded as a repair to one of the top flanges; however, the weld is broken on one side (See Photo 24). (1900 - 1 FT)

1) The paint system on the truss members has failed (See Photo 23). (3440 - 1147 SF)

Photo 23: Typical corrosion, pitting and paint failure along truss

CONDITION STATE			PRIORITY
3	MMS Quantity: 1 mh	Element Estimated Quantity: 178 ft	3
WORK ORDER RECOMMENDATION: Steel truss; clean and paint.

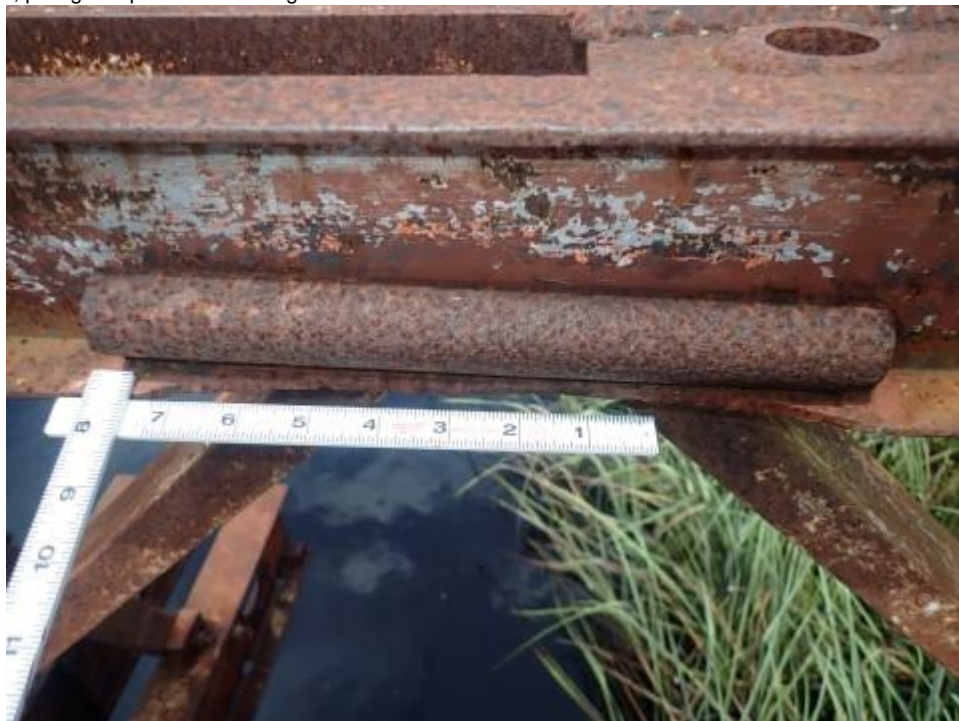
Photo 24: Broken weld on right truss rod repair, Panel 1

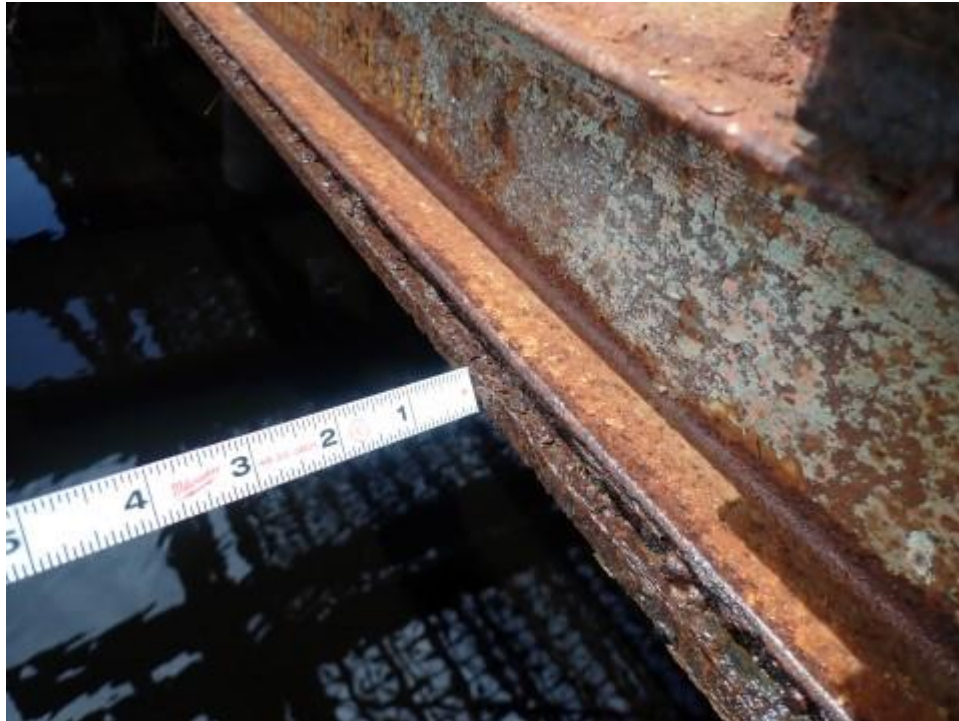
- 3) Panel 1, left truss and Panel 6, right truss have pack rust between the repair plate and the original bottom chord (See Photo 25). (1000 - 20 FT)
- 4) Panel 2, left truss has bends throughout the bottom chord (See Photo 26). (1900 - NO QTY)

Photo 25: Typical pack rust between repair plate and bottom chord along truss

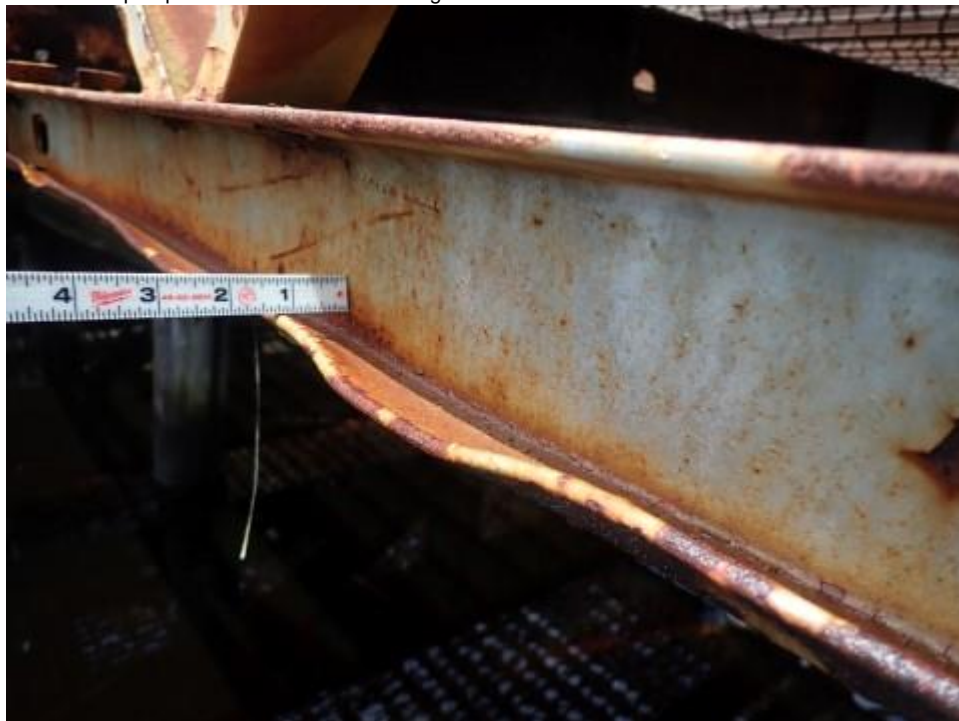
Photo 26: Typical bend in truss

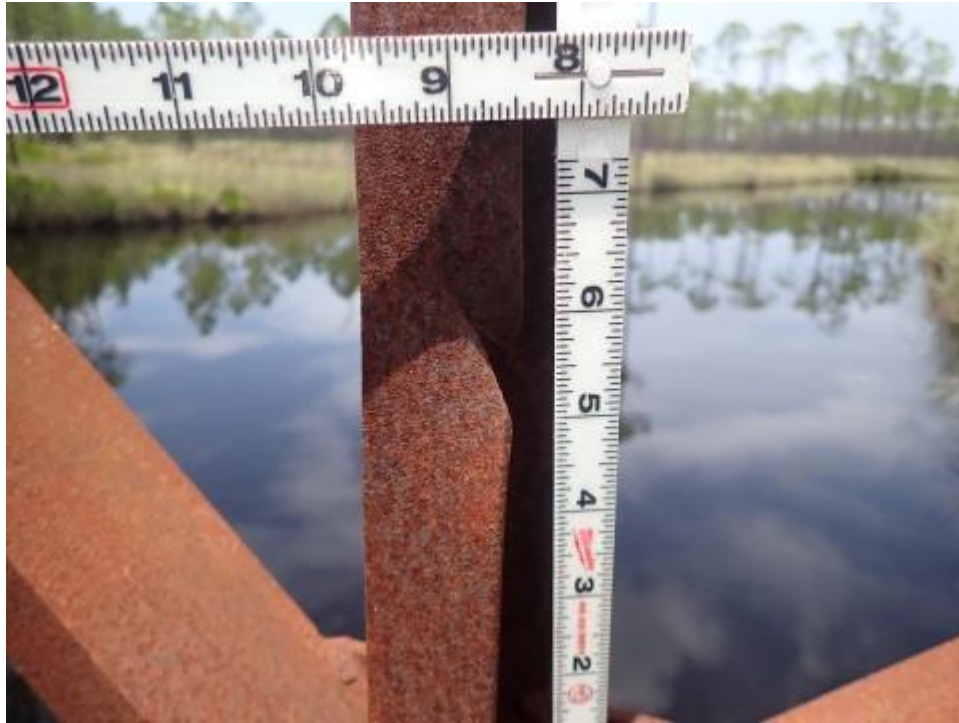
Photo 27: Tear in right truss Vertical Member M2-U2, Panel 2
