**FLORIDA DEPARTMENT OF TRANSPORTATION**  
**BRIDGE MANAGEMENT SYSTEM**  
**Inspection/CIDR/Bridge Profile Report**  
**Inspection**

**Structure ID: 494096****DISTRICT: D3 - Chipley****INSPECTION DATE: 7/30/2020 NNHH**

BY:	CONSOR Engineers, LLC	STRUCTURE NAME:	Not recorded
OWNER:	2 County Hwy Agency	YEAR BUILT:	1959
MAINTAINED BY:	2 County Hwy Agency	SECTION NO.:	49 000 005
STRUCTURE TYPE:	4 Steel Continuous - 10 Truss-Thru	MP:	3.293
LOCATION:	5.0 Mi N of US98/SR30	ROUTE:	00000
SERV. TYPE ON:	1 Highway	FACILITY CARRIED:	Mill Road
SERV. TYPE UNDER:	5 Waterway	FEATURE INTERSECTED:	Trout Creek

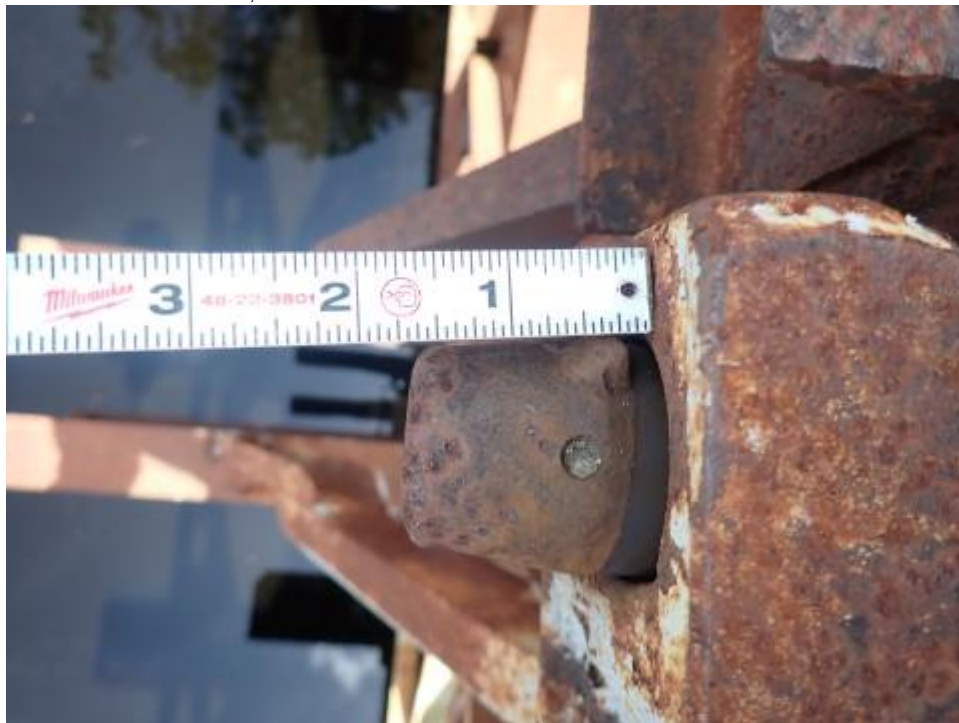
Photo 28: Typical connection pin welded into place

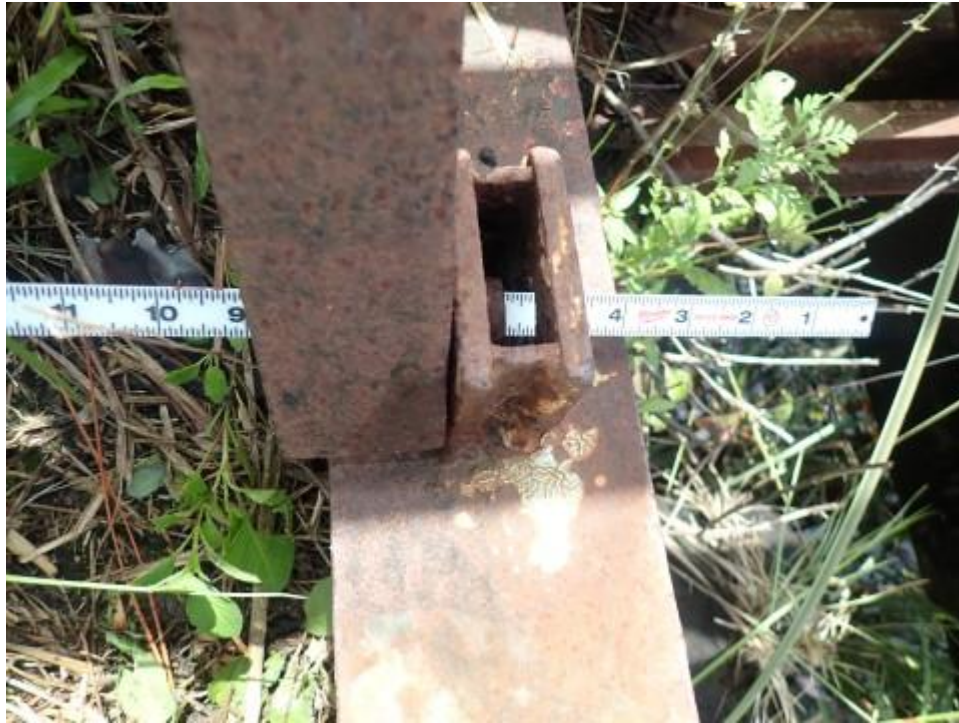
- 1) The near right raker at Panel 1 is missing the bottom connection bolt (See Photo 29).
- 2) The near left raker at Panel 8 is distorted 0.03 ft.
- 3) The floor beam/transoms have been welded to the lower chords in lieu of the designed transom clamps. This induces stress onto the lower chord (See Photo 30).
- 4) The lateral bracing under the truss has bends throughout.
- 5) There is a 32 ton weight limit sign at the near approach.

Photo 29: Near right raker at Panel 1 missing bottom connection bolt

CONDITION STATE			PRIORITY
1 , 3	MMS Quantity: 1 mh	Element Estimated Quantity: 1 ft	3
WORK ORDER RECOMMENDATION: Near right raker at Panel 1; install bottom connection bolt.			
1 , 3	MMS Quantity: 1 mh	Element Estimated Quantity: 1 ft	3
WORK ORDER RECOMMENDATION: Panel 1 at right truss; replace steel rod a top flange with steel cover plate.			
1 , 3	MMS Quantity: 1 mh	Element Estimated Quantity: 1 ft	3
WORK ORDER RECOMMENDATION: Upper and lower chords; install cotter pins.

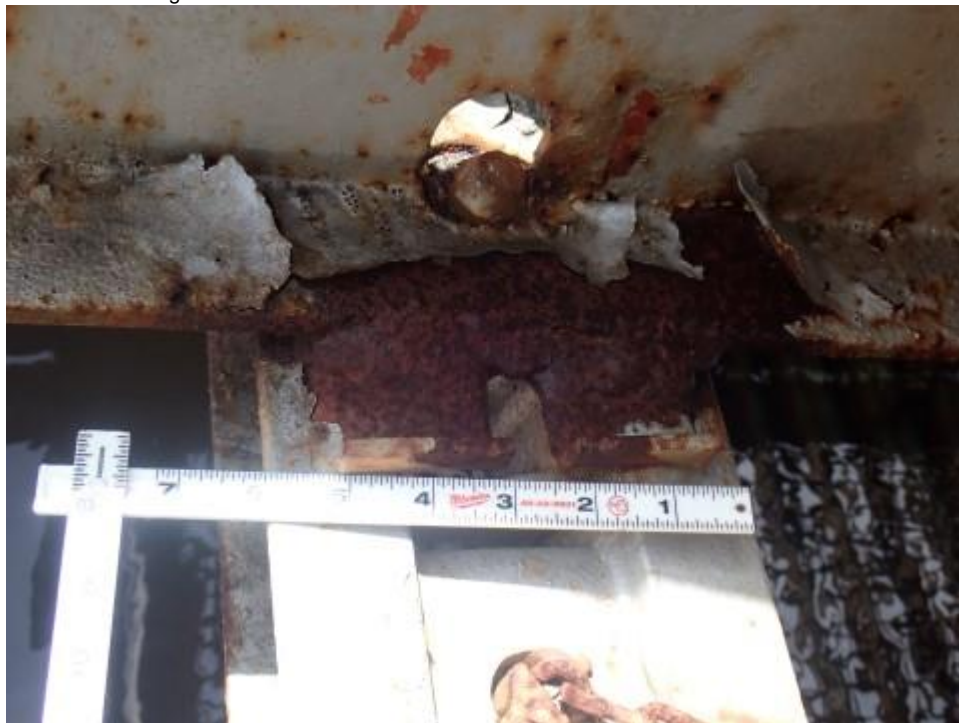
Photo 30: Transom weld to lower chord in lieu of transom clamp

CONDITION STATE			PRIORITY
2 , 3	MMS Quantity: 1 mh	Element Estimated Quantity: 1 ft	3
WORK ORDER RECOMMENDATION: Floor beams; remove welds and install transom clamps.

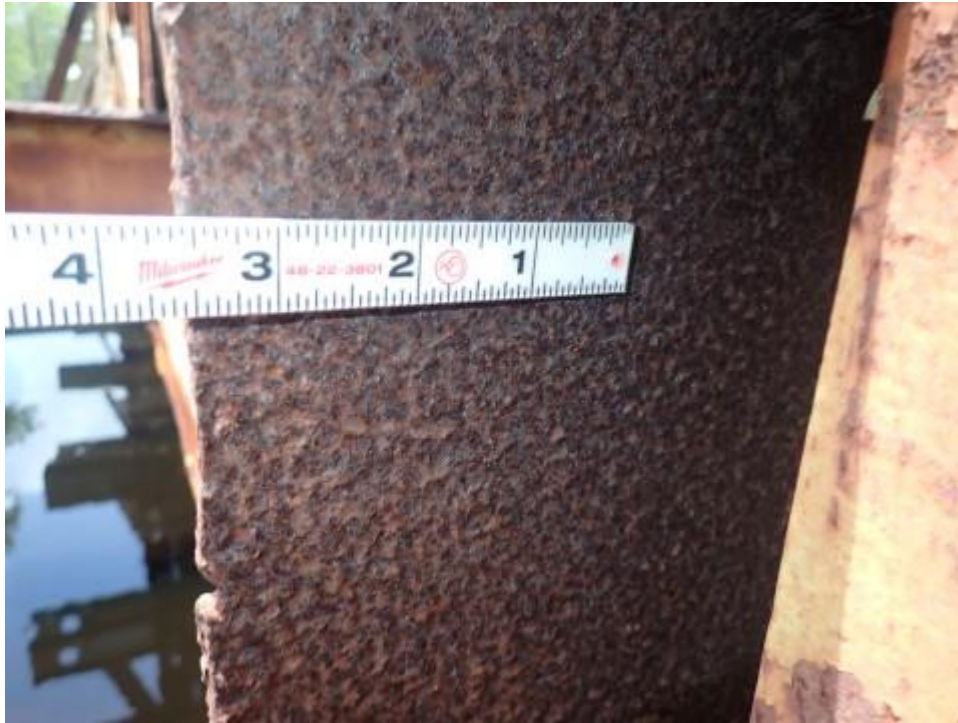
1) Corrosion has formed on the floor beams (See Photo 31). (1000 - 272 FT)

1) Corrosion has formed on the floor beams allowing pitting, up to 0.25 in deep (See Photo 31). (1000 - 190 FT)

1) The paint on the floor beams has failed (See Photo 31). (3440 - 990 SF)

Photo 31: Typical corrosion, pitting and paint failure along floor beam

CONDITION STATE			PRIORITY
2 , 3	MMS Quantity: 1 mh	Element Estimated Quantity: 462 ft	3
WORK ORDER RECOMMENDATION: Steel floor beams; clean and paint.

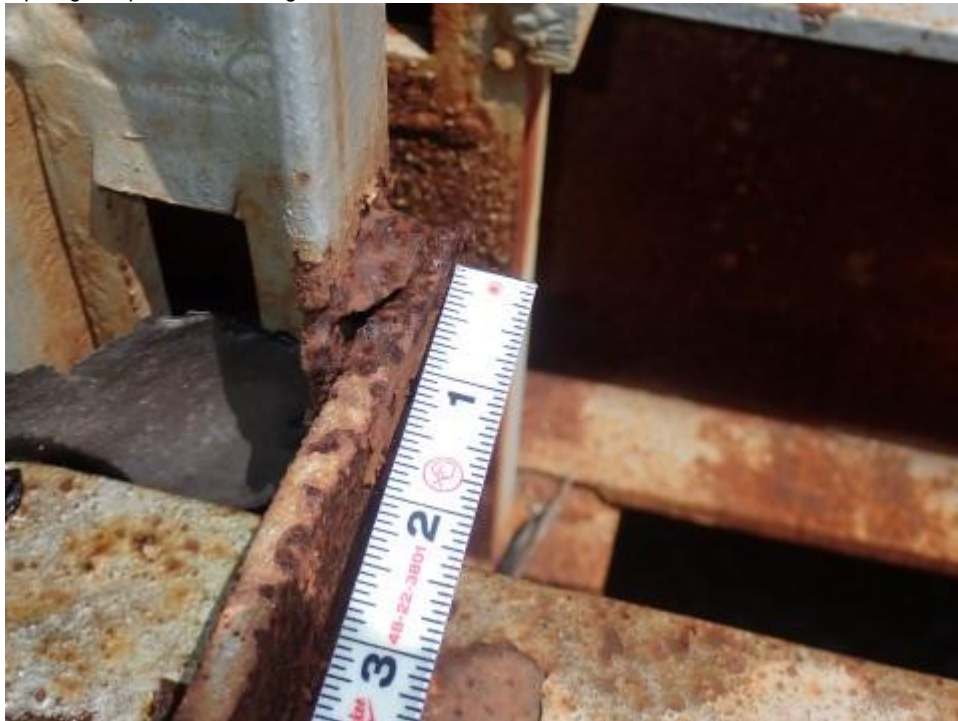
2) Several floor beams have cracked welds (See Photo 32 and Table 1). (1020 - 13 FT)

Photo 32: Typical cracked weld along floor beam

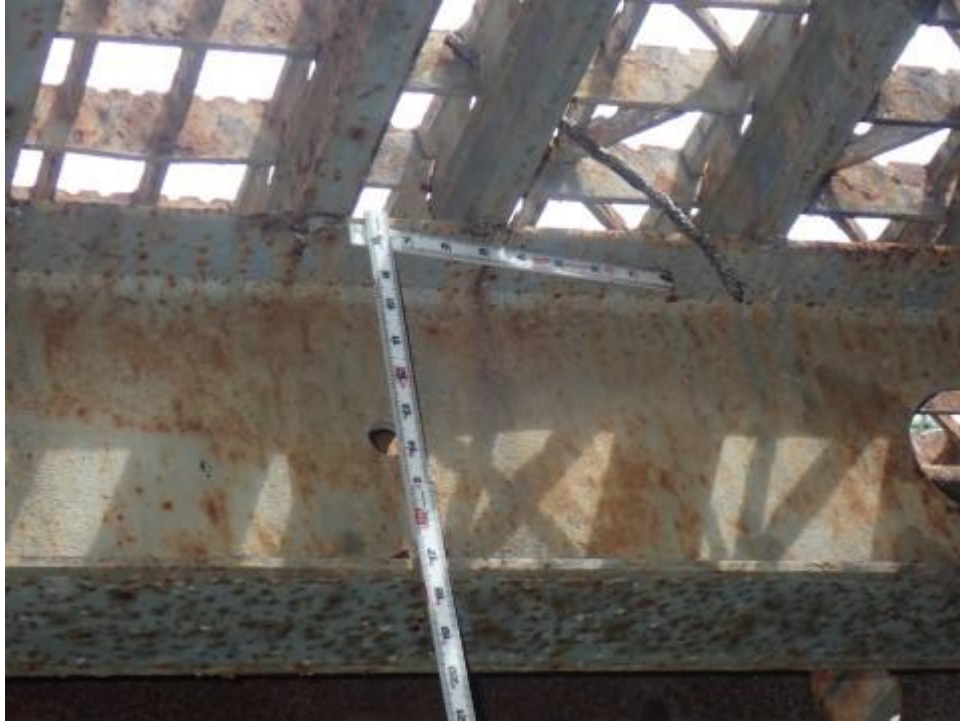
3) Floor Beam 22 has a crack in the center of the far top flange, due to deck welding (See Photo 33). (1010 - 1 FT)

Photo 33: Crack in Floor Beam 22
