**SGAID:** 600025000106081

**Location:** Just before Mailbox 642

**Assessment:** 5/24/2012

**Road:** SILVER LAKE RD,

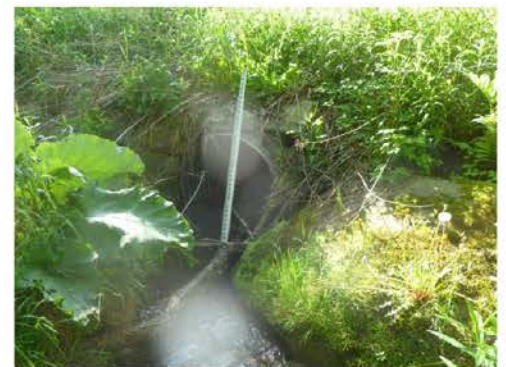
### Inlet

| Number of culverts: | 1 | Inlet obstructions: | Wood<br>Debris |

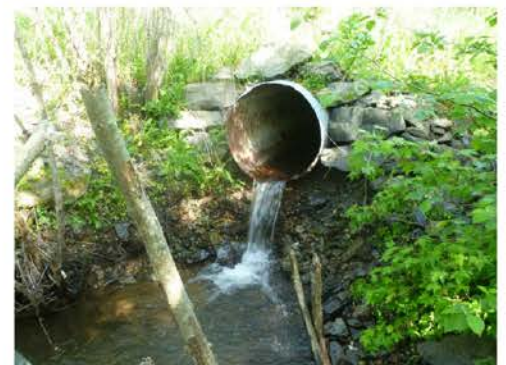
### Downstream

**Comment:** Pool created due to fallen tree. No struct\_num
