FAIRVIEW MANOR FOUNDATION EVALUATION

December 5, 2018

**RE: FAIRVIEW MANOR
FOUNDATION EVALUATION**

Fairview Manor
Foundation Inspection 11-9-18

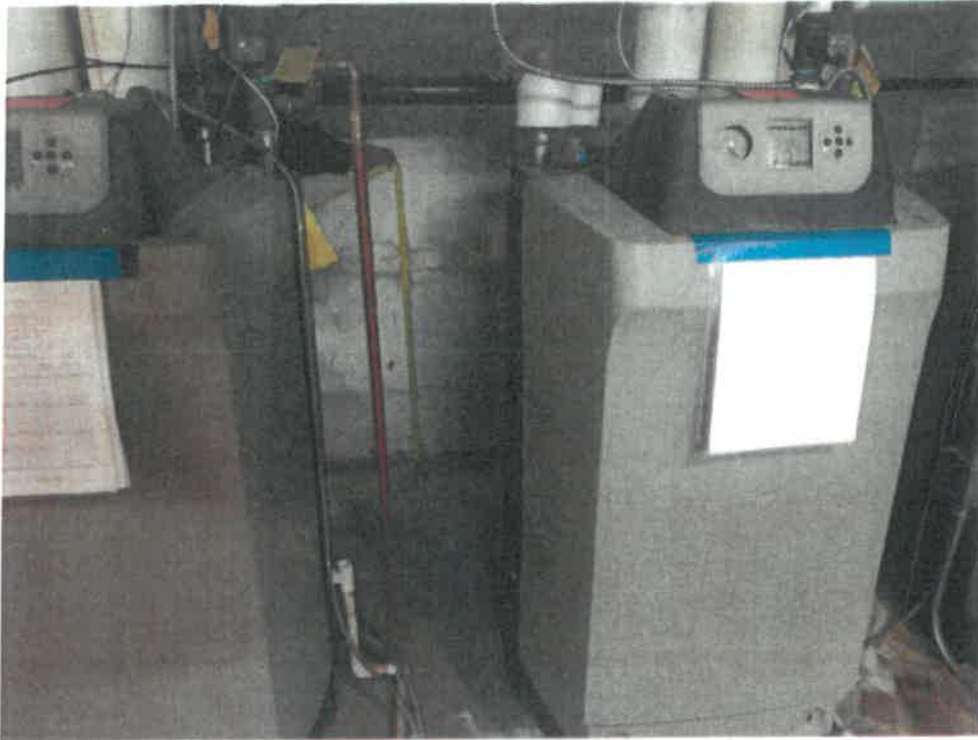
- 2) Based on water markings along the walls and reported information, water has flooded the basement multiple times up to approximately 2'-6" above the basement slab (see photo 1).

Photo 1: Height of water stains approximately 2'-6"

- 2) With the water table being so high, there is nothing else you can do to control the water besides what is currently being done with pumps. Therefore, in addition to reinforcing the columns as noted, it is recommended to enclose the boiler area with a water tight wall that is 2'-6" to 3'-0" high. That way the boilers are still accessible but are less susceptible to water damage. Another sump pit could also be installed within this wall so that any water that may come up through the floor could be drained into the pit and pumped out. Also, electrical wires and

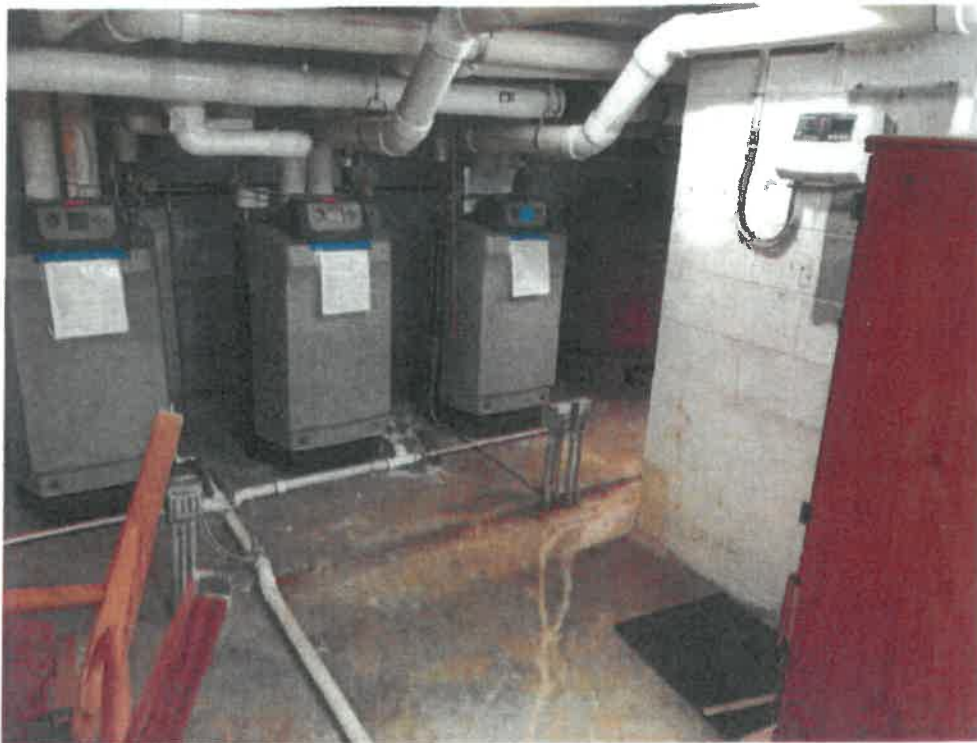
- 3) The basement is housing boilers and electrical breakers among other things (see photos 2-3).
- 4) Water flows into the basement sump continuously, **an approximate rate of 27 gallons per minute during average conditions.** The sump contains two pumps in which the lower pump often has to run continuously since it cannot keep up with the flow. It is apparent that the water table elevation is higher than the basement floor slab elevation.

Photo 2: Boilers

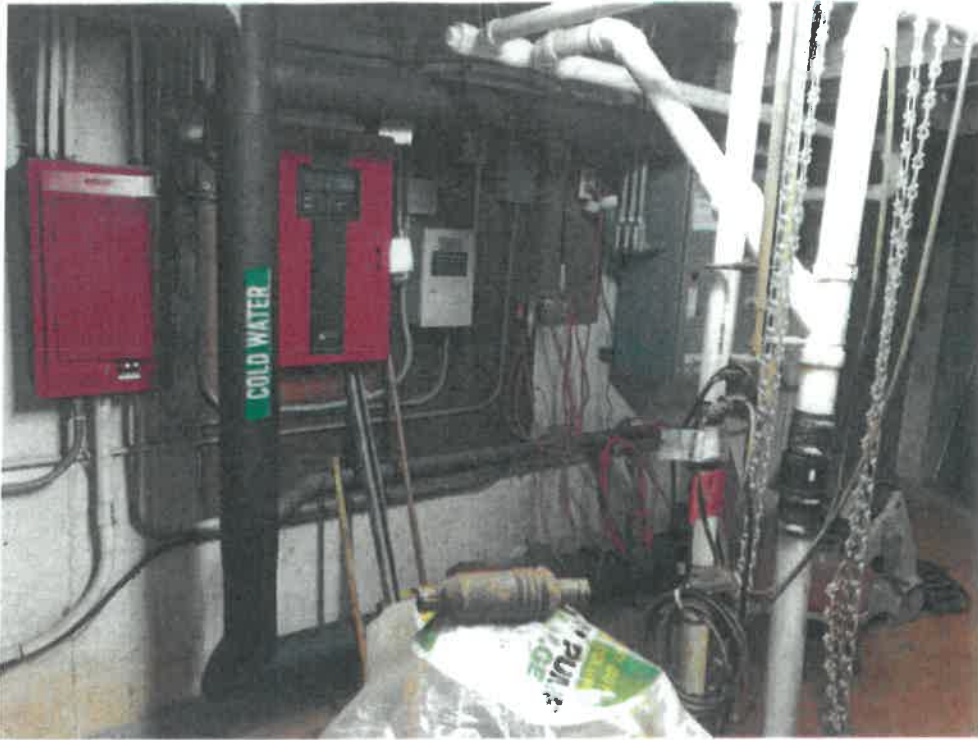
Photo 3: Electrical breaker boxes etc.

breakers should be stored above anticipated flood waters. Additionally, the basement walls, floor, and columns should be coated with a waterproofing paint. These remedies do not prevent water from flooding the basement, but they help to resist problems due to those flood waters. Given that water would need to be continually pumped as it is currently, it may be cost prohibitive for the Housing Commission to continue building operations.

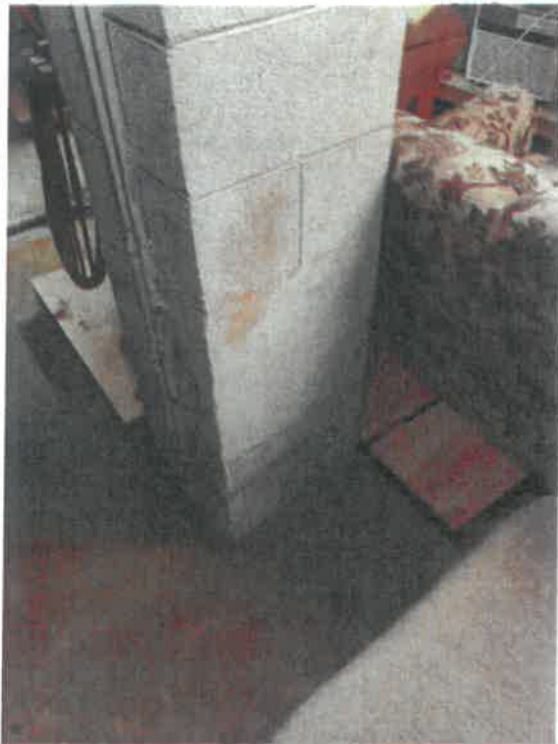
- 5) The masonry columns in the basement have been patched up their faces with mortar to the approximate height of the apparent maximum water level of roughly

2'-6" (see photo 4). Although it was difficult to tell the condition of these patched up columns, it appeared that the masonry may have some loss of structural section based on soundings. No other structural deficiencies have been noted in the walls such as cracking or bowing.

- 1) It is questionable whether the foundation will last another 15 years in its current state. Reported information is that the groundwater has some contaminants that has worn out pumps quickly and has clogged discharge pipes. The presence of these contaminants could explain the wear of the masonry columns mentioned in #5 above. Masonry block is porous and therefore water can enter and when contaminated can cause adverse reactions with the cement mixture in the block and thus deteriorating the block.
- 2) The functionality of the basement is limited. As mentioned above, the basement is home to boilers and electrical breakers. Significant flooding in the basement would pose a severe threat to damaging expensive boilers or starting an electrical fire. Flooding of the basement will continue to happen during heavy rains or when the sump pumps fail.

Photo 4: Patched masonry column (typ)

- 1) It is recommended to reinforce the masonry columns with a 6 inch thick concrete "shell" with #3 vertical reinforcing bars for their lower 3'-0". This will give the columns good protection from further deterioration and add stability. It is not recommended to fill in the entire basement area with concrete up to the apparent water table level of 2'-6". This would add an extreme amount of weight to the structure and would likely cause the building to settle. The additional concrete weight would transfer through to the perimeter and interior footings and thus add loading to the underlying soil that it hasn't seen throughout its life. Additionally, filling in the basement would require that the boilers and electrical equipment are moved to an upper floor. This would be a very expensive and exhaustive process to move all of the piping, wiring, and equipment.

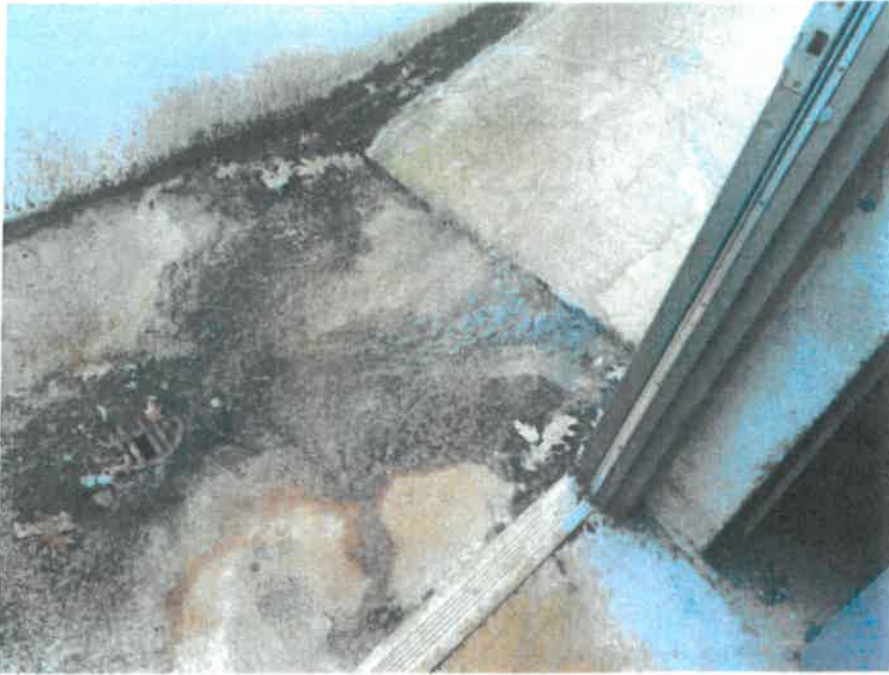
- 6) At the basement door to the exterior, the walkway is steep and drains storm water directly toward the doorway. One small drain is located at the landing, but it was reported that water floods the basement in this manner as well (see photos 5-6).
- 7) Perimeter French drains have been installed in several locations in the basement to keep flood water levels down when the basement does flood (see photos 7-8).

Photo 5: Exterior drain at landing of exterior walkway

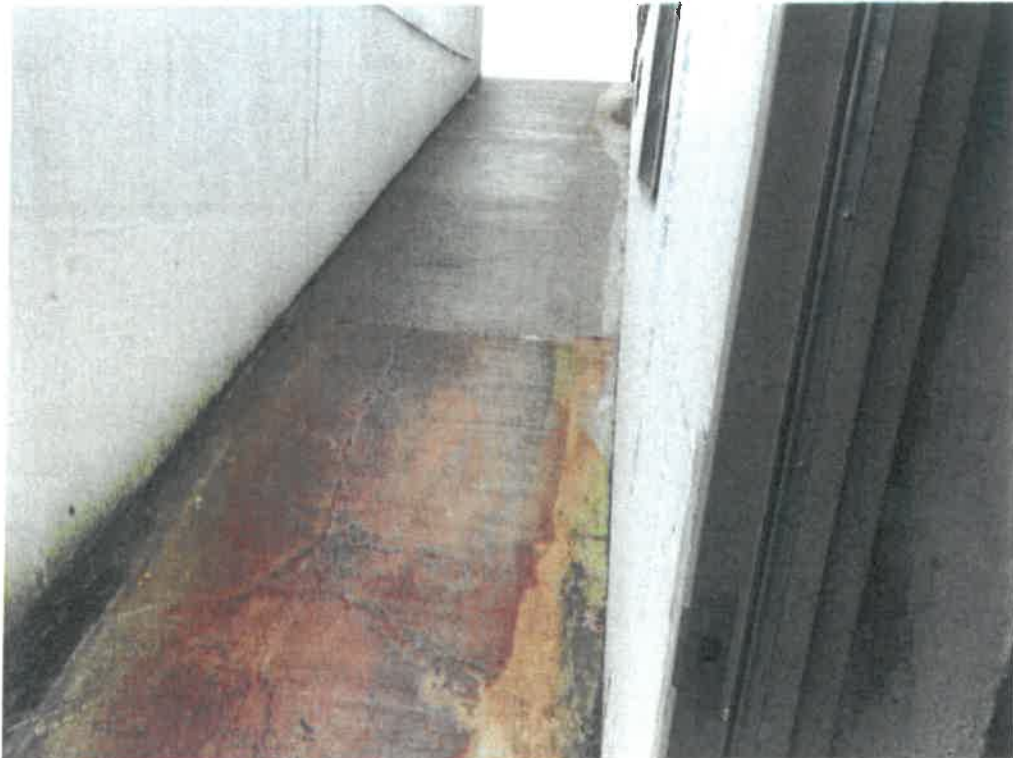
Photo 6: Exterior walkway from photo 5

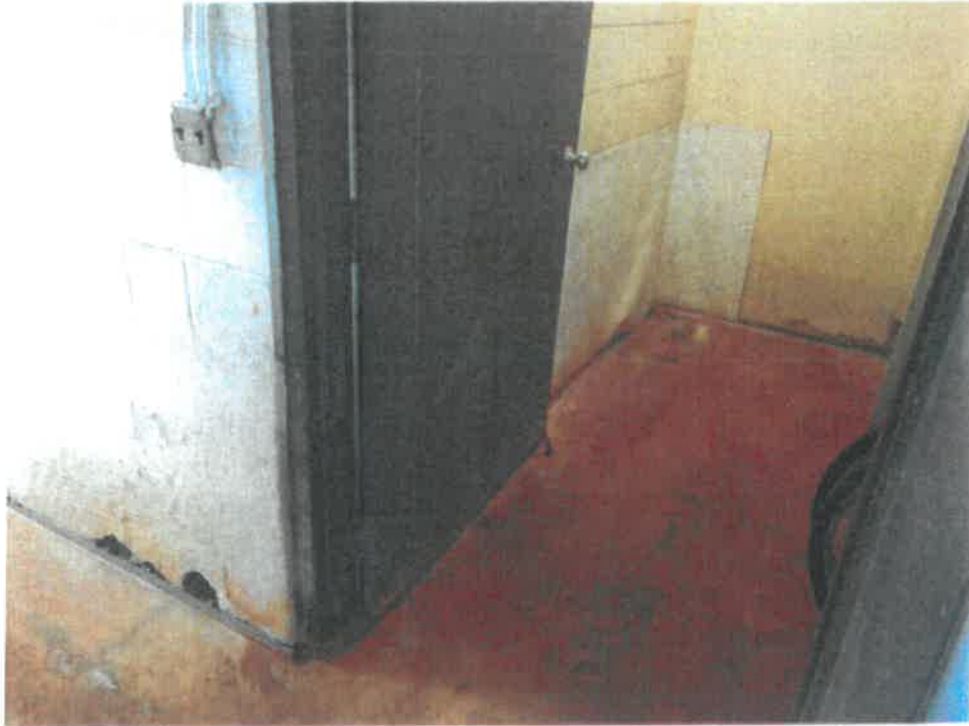
Photo 7: Perimeter French drains or baseboard drains

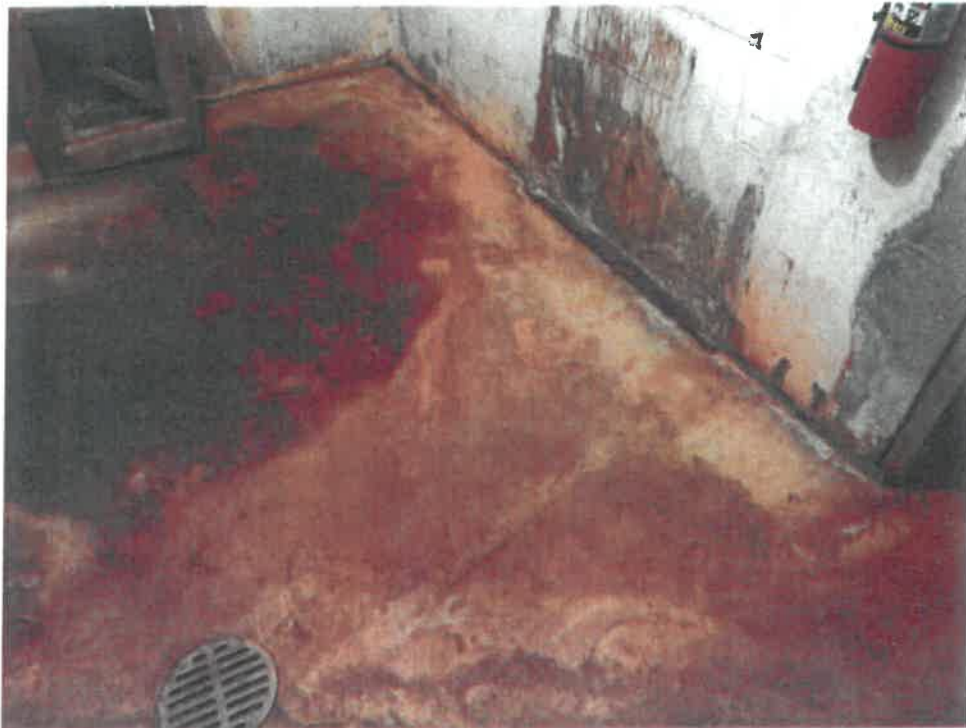
Photo 8: Perimeter French drains or baseboard drains and floor drain
