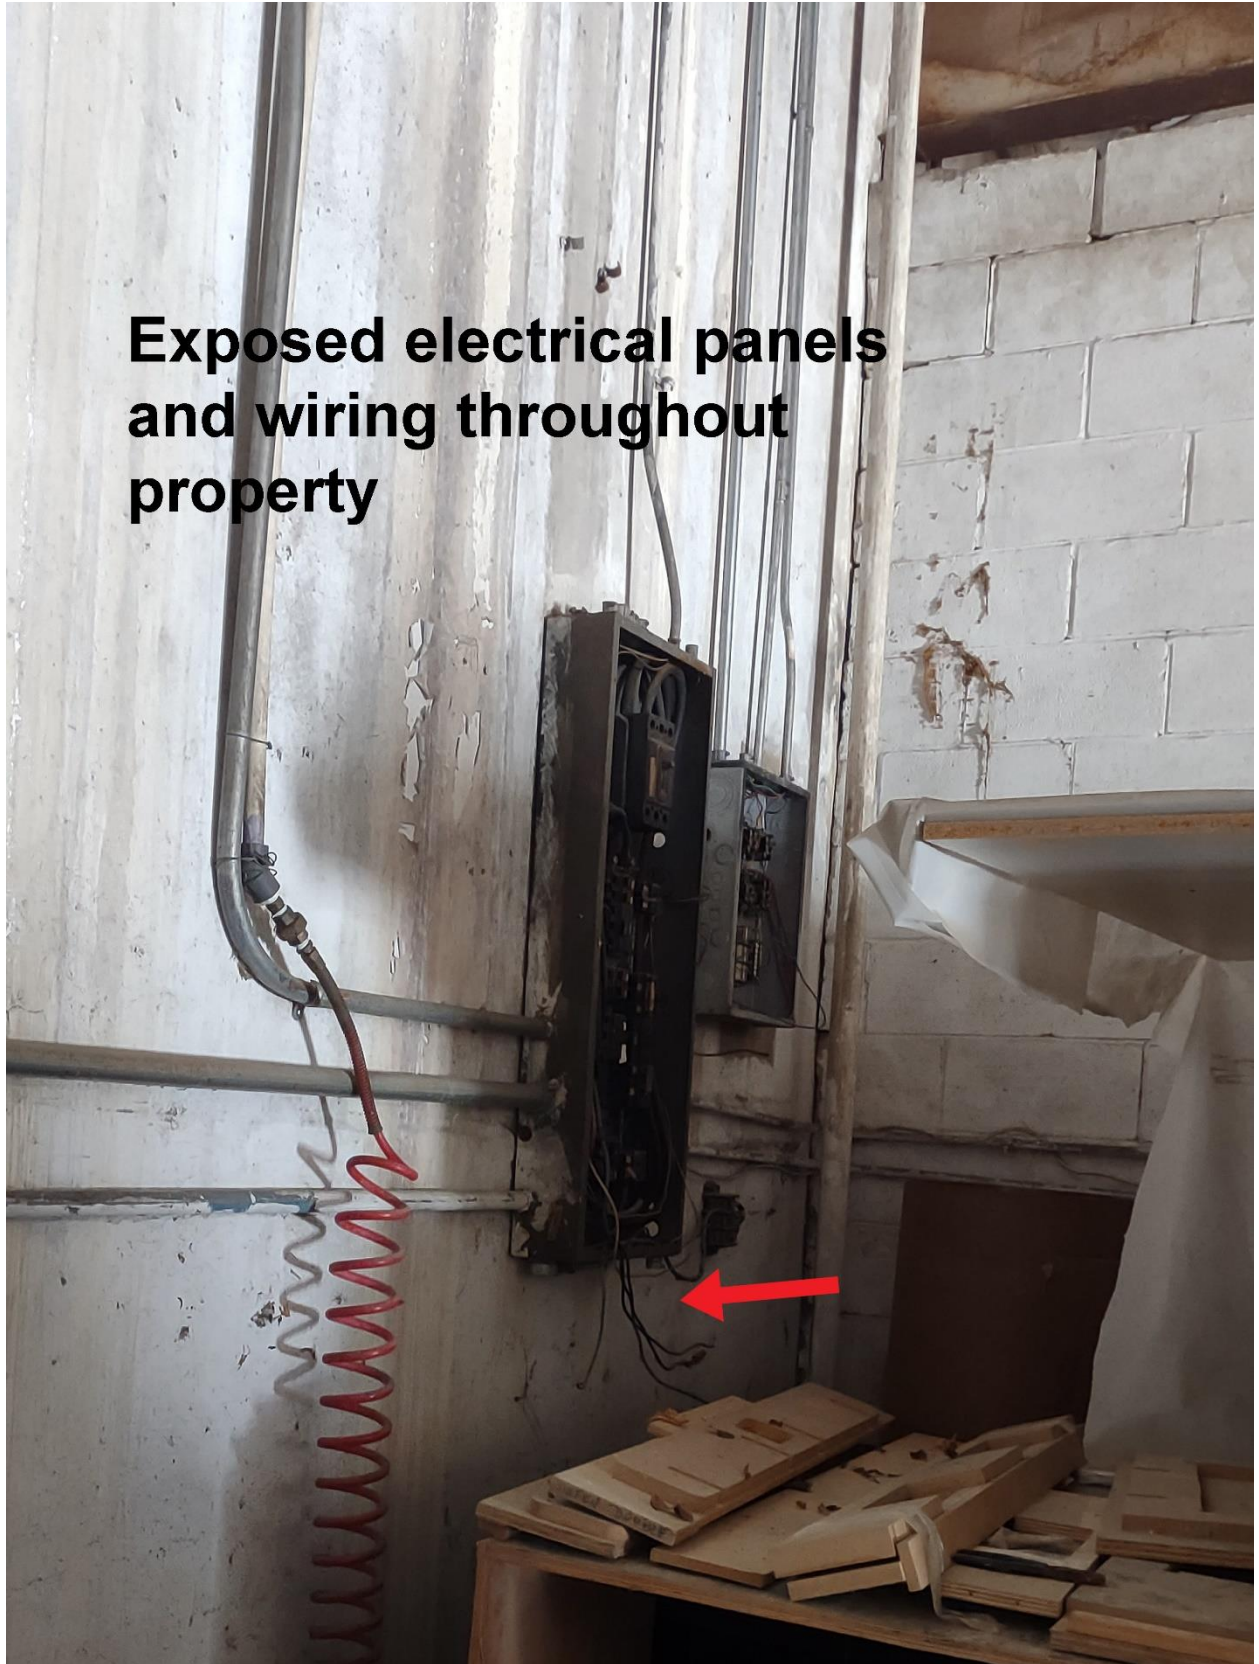
**More open electrical panels  
and unlicensed  
work**

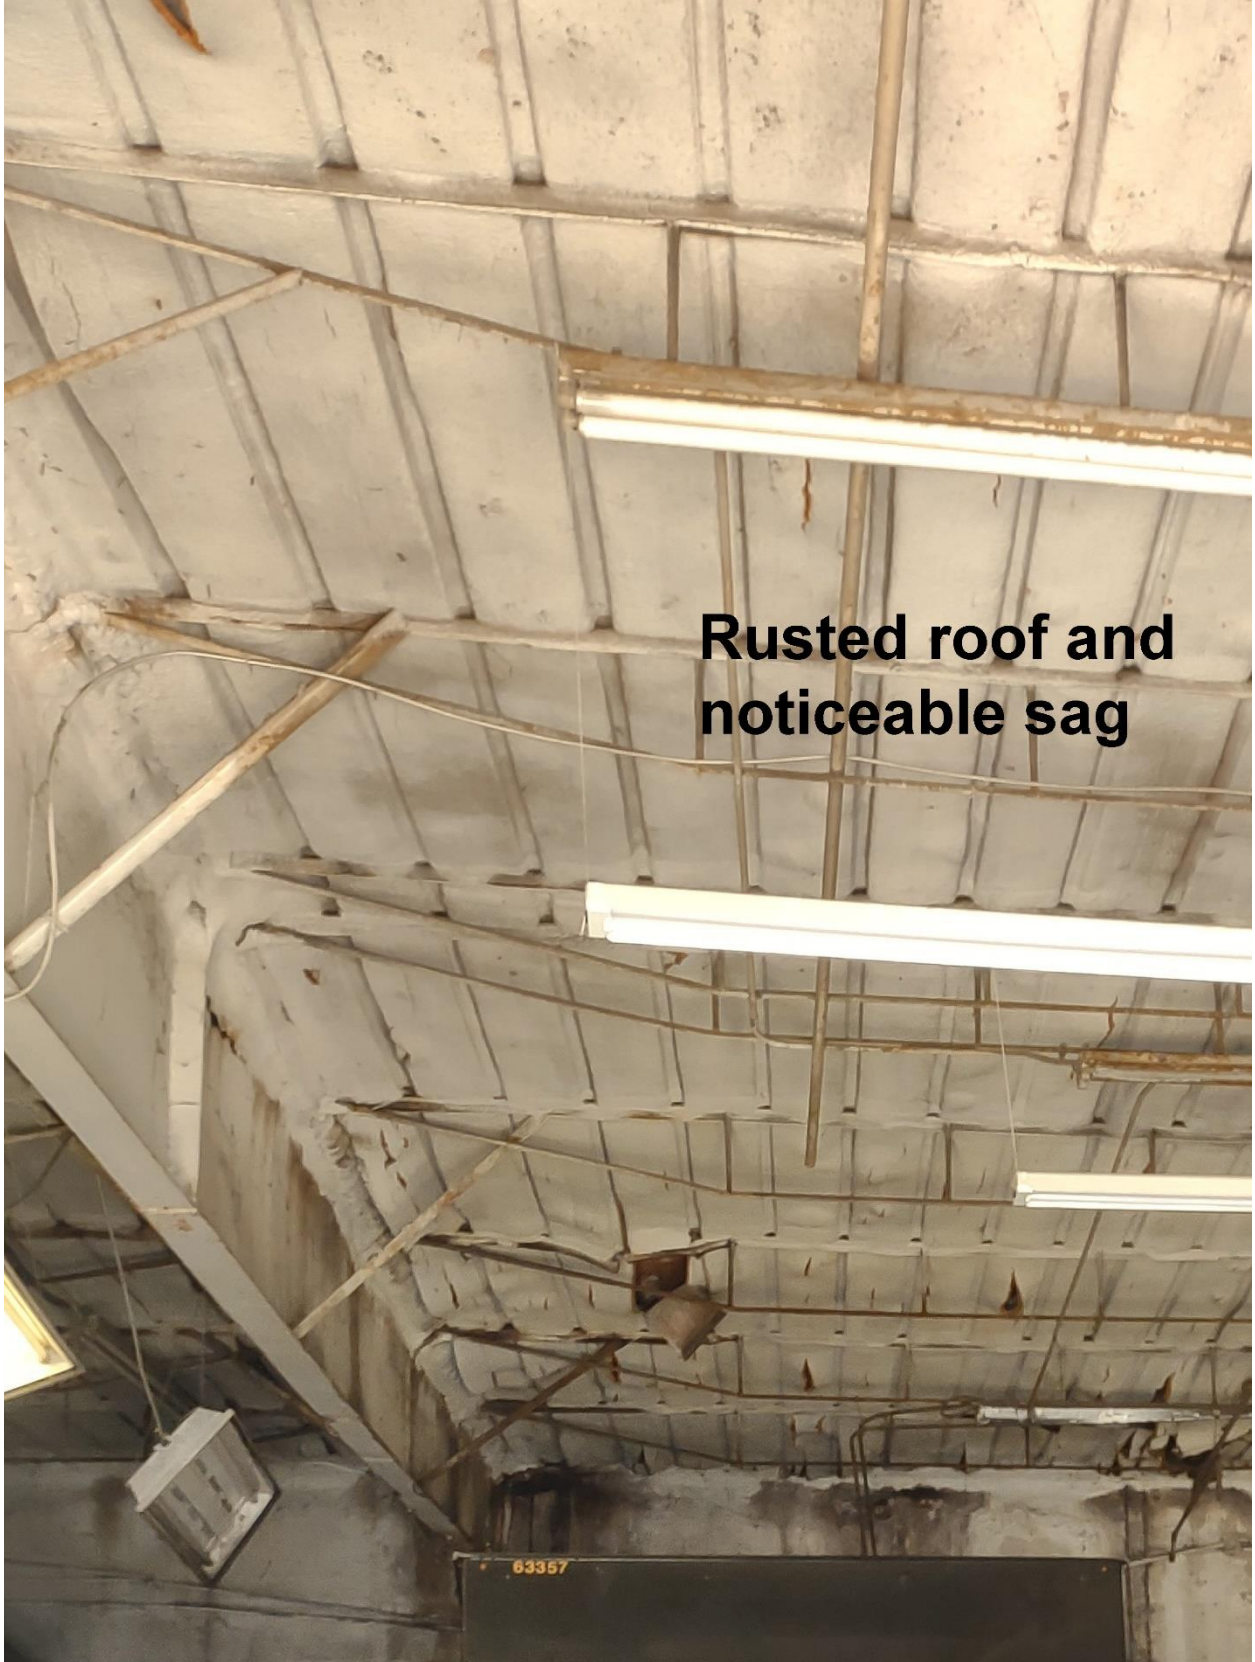
**Rusted roof and noticeable sag**

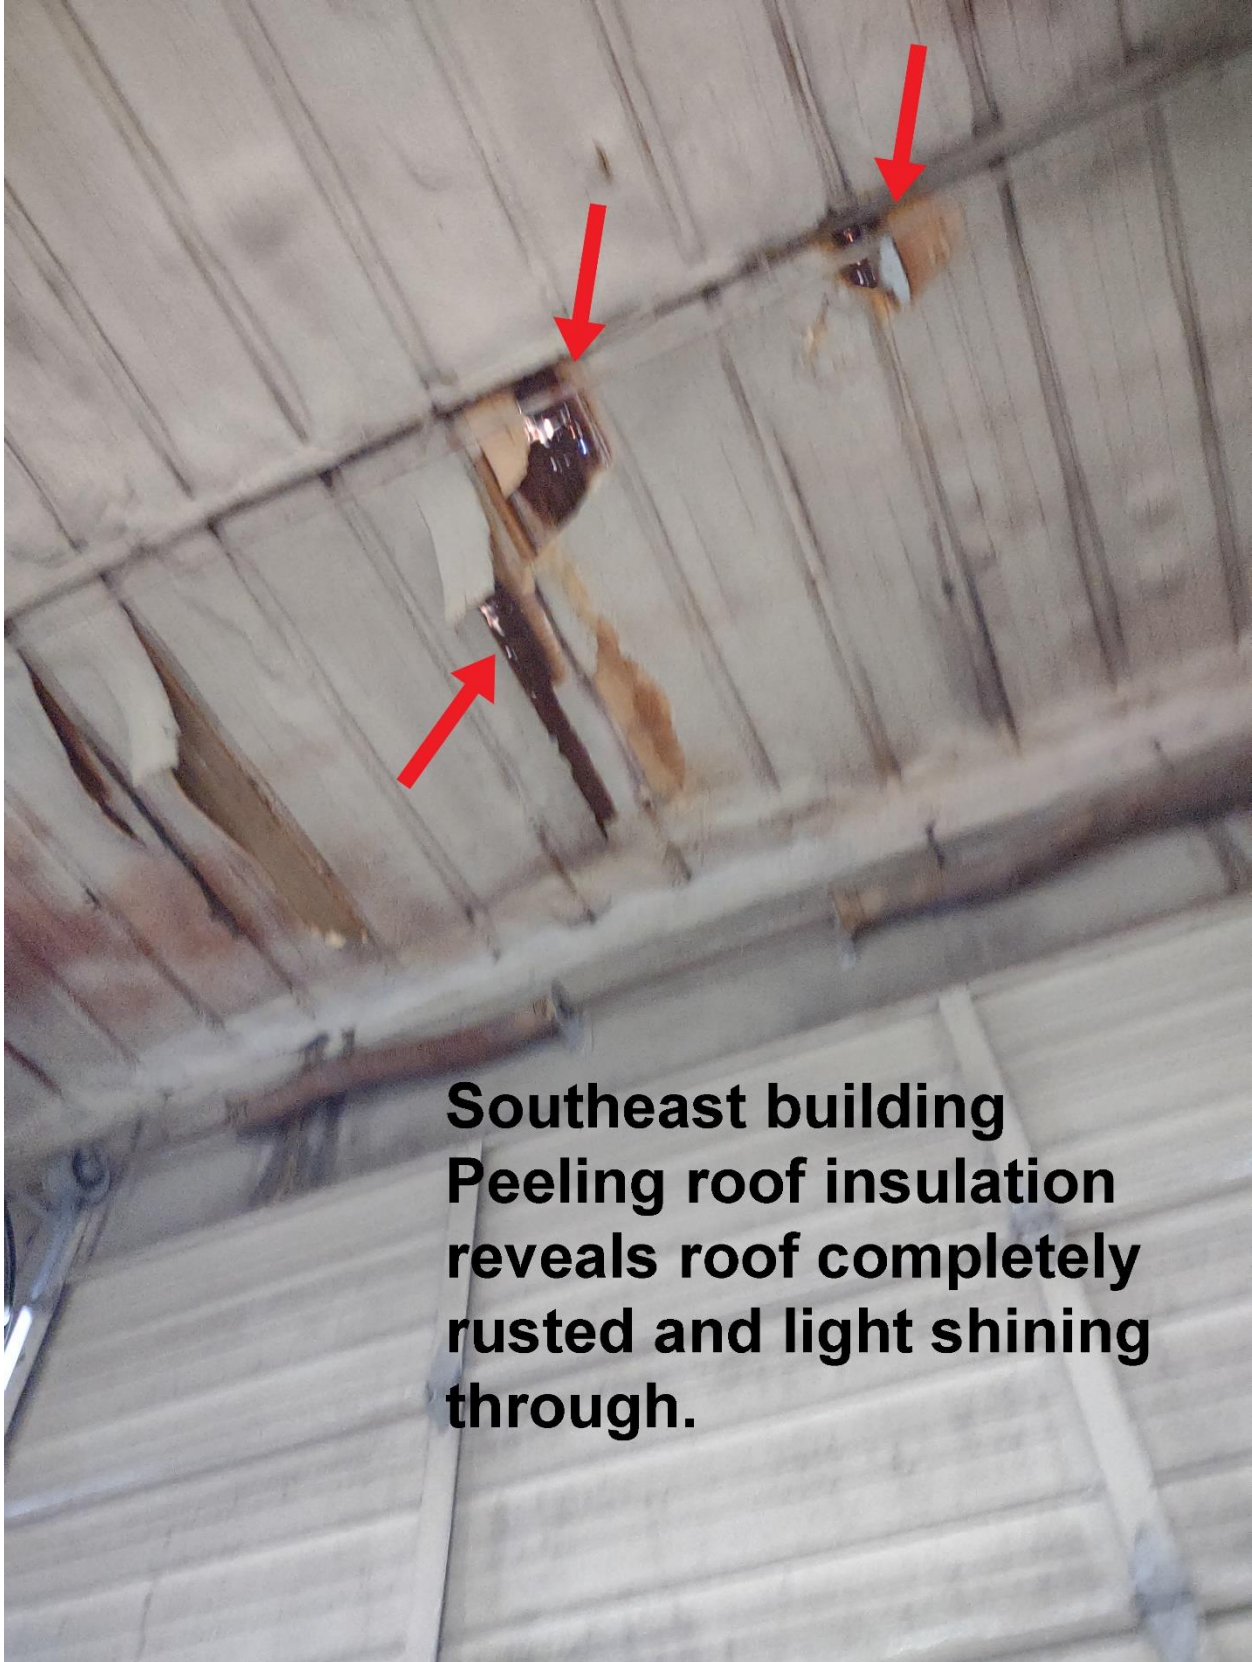
**Southeast building  
Peeling roof insulation  
reveals roof completely  
rusted and light shining  
through.**

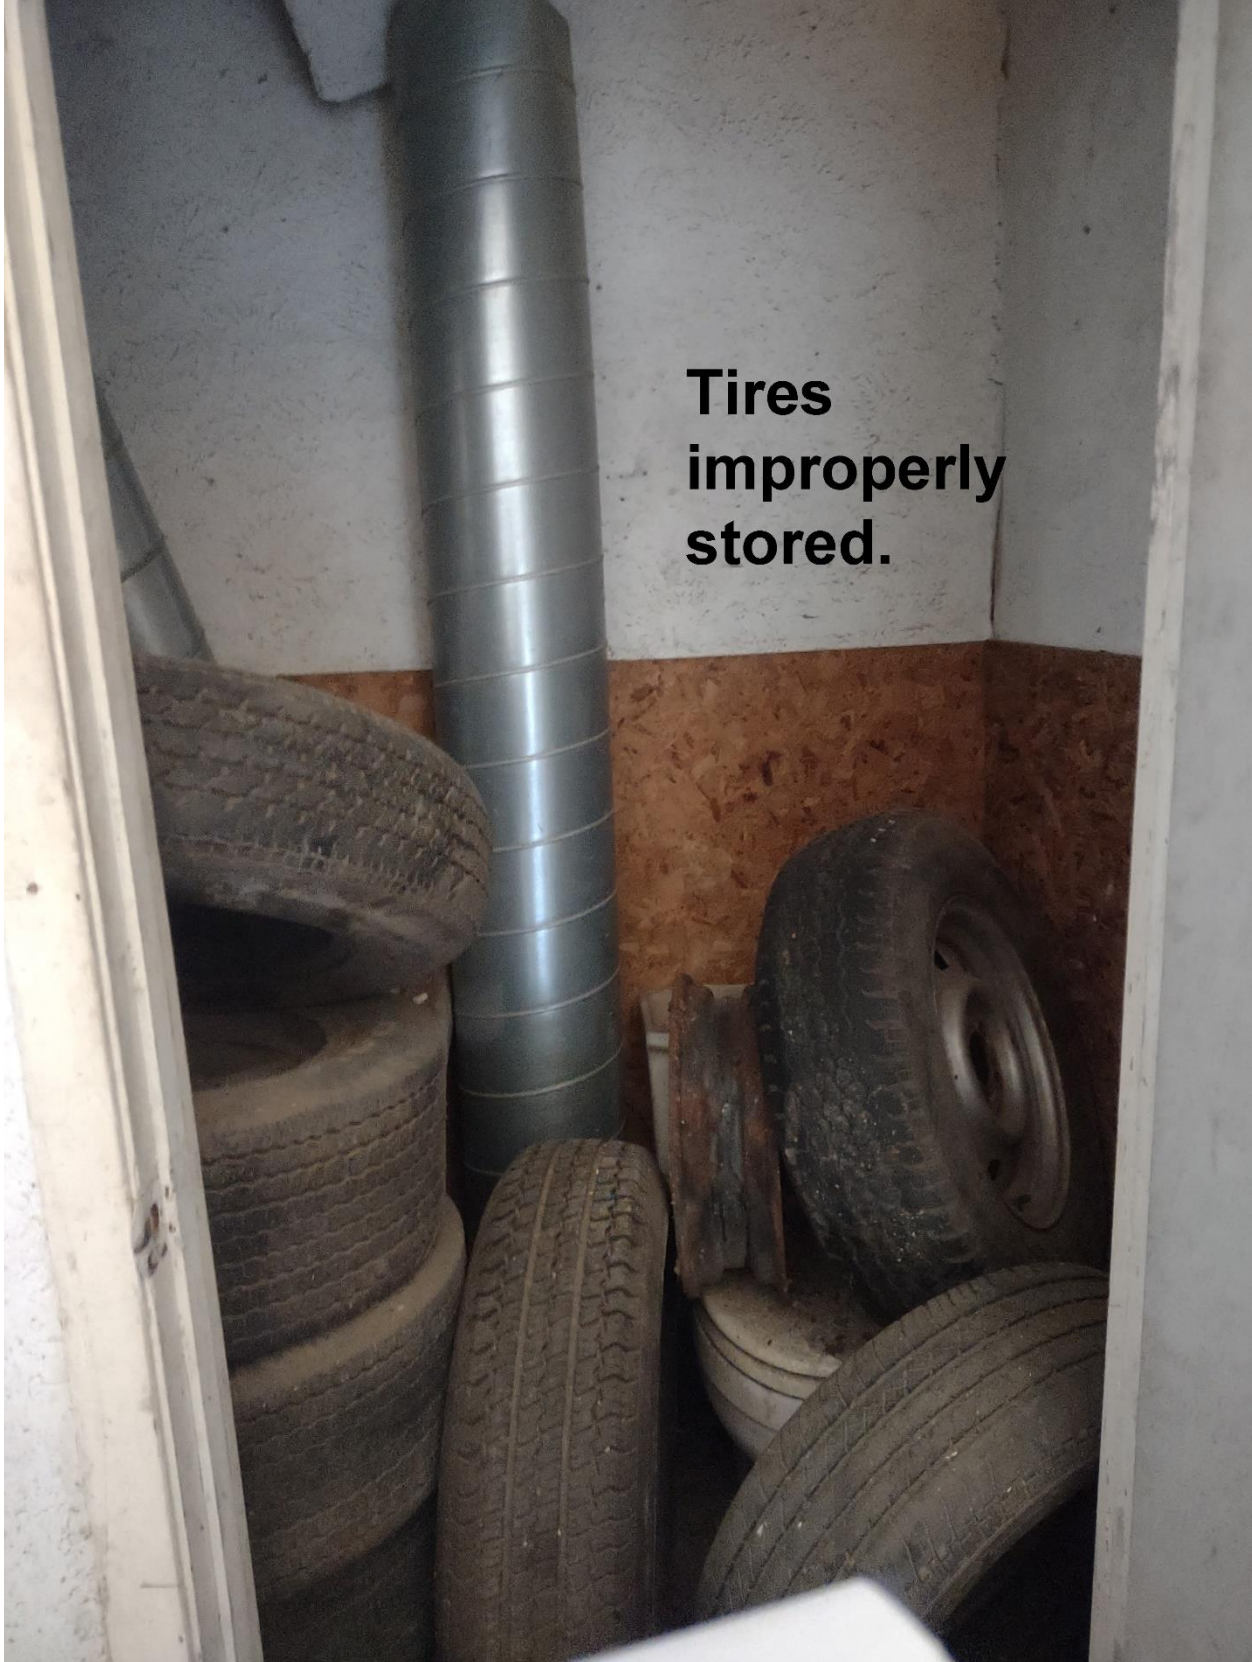
**Tires  
improperly  
stored.**

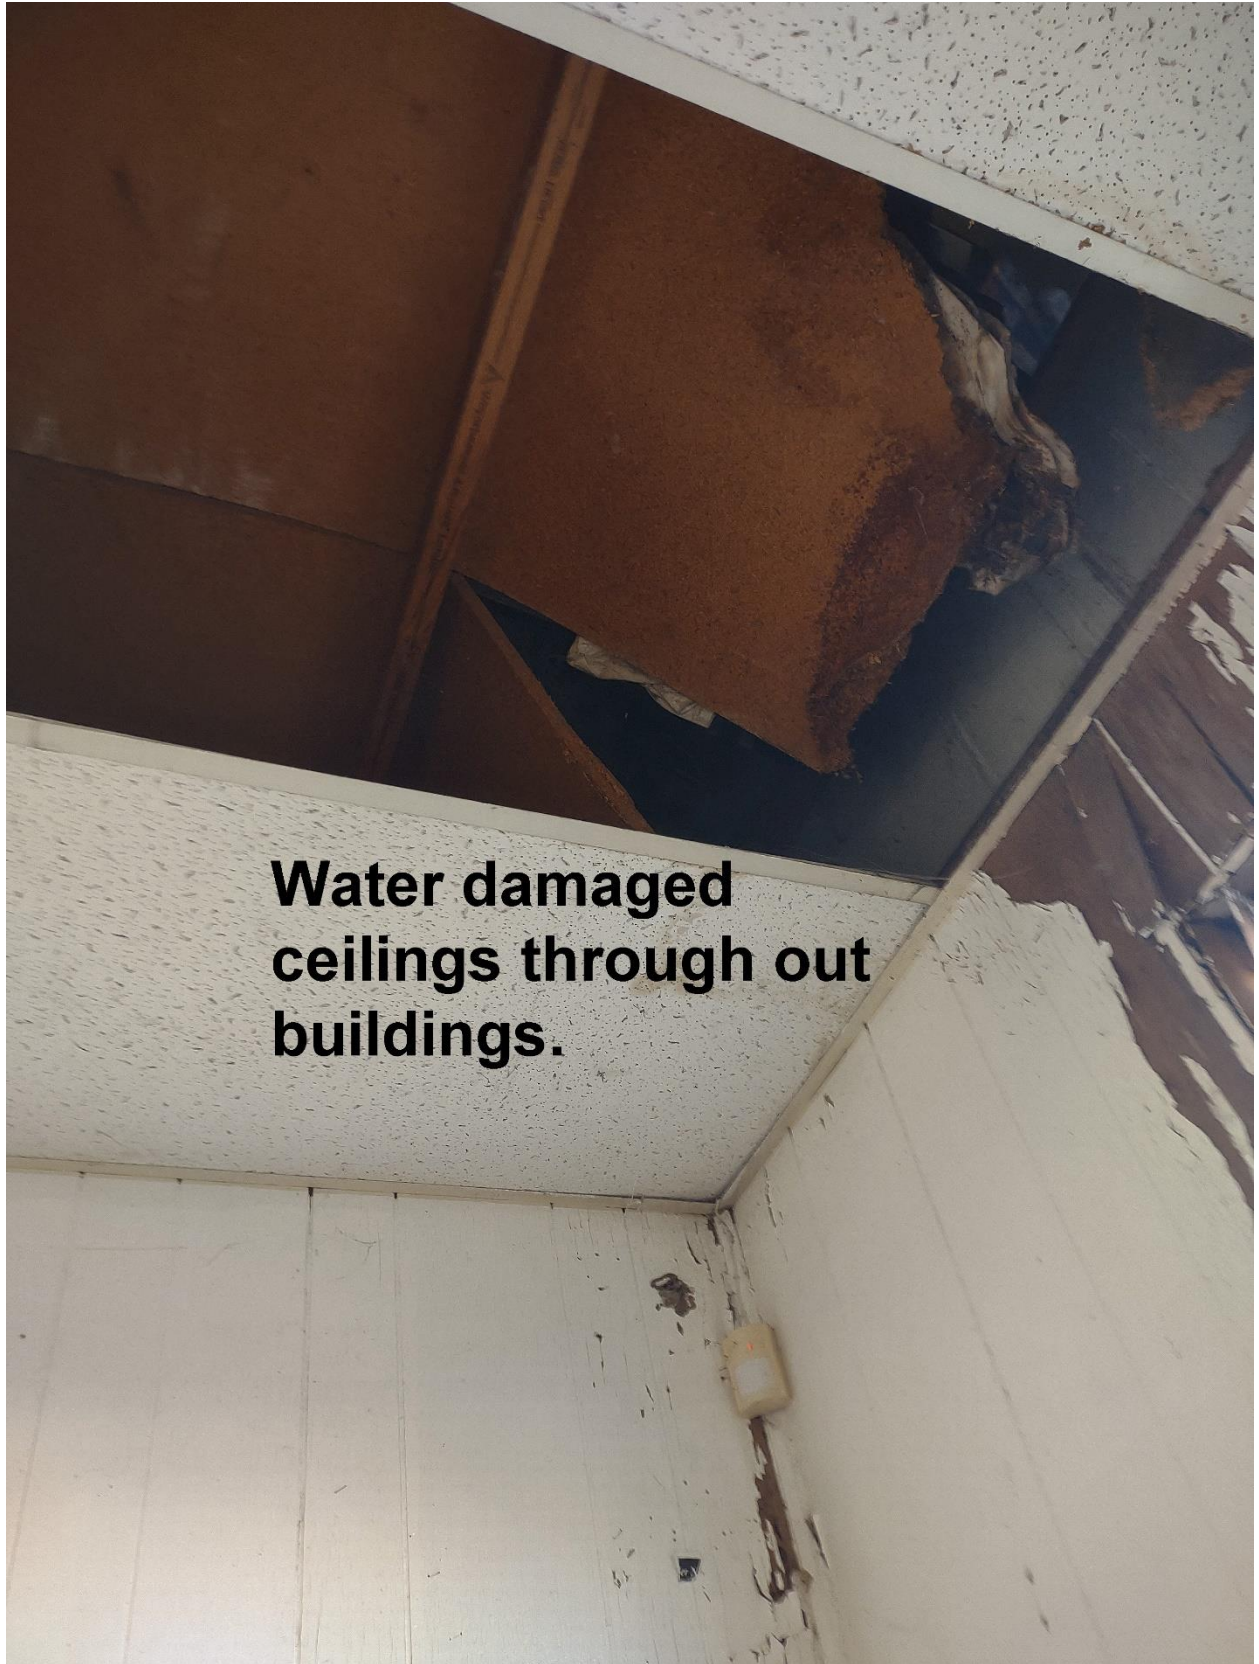
**Water damaged  
ceilings through out  
buildings.**
