EXTERIOR ENVELOPE REVIEW

**CITY OF GRAND RAPIDS
GRAND RAPIDS AREA LIBRARY BUILDING
140 NE 2nd STREET
GRAND RAPIDS, MINNESOTA 55744**

Project # 22-8040

September 16, 2022

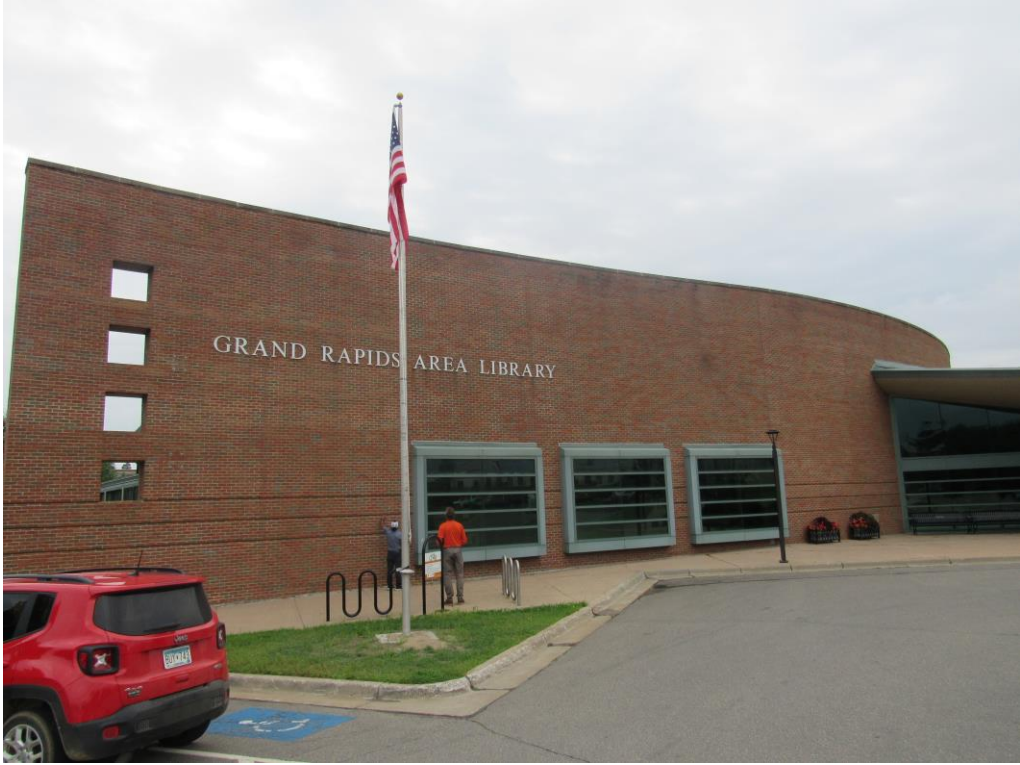
Photograph 1 – The east (front) elevation of the library building.

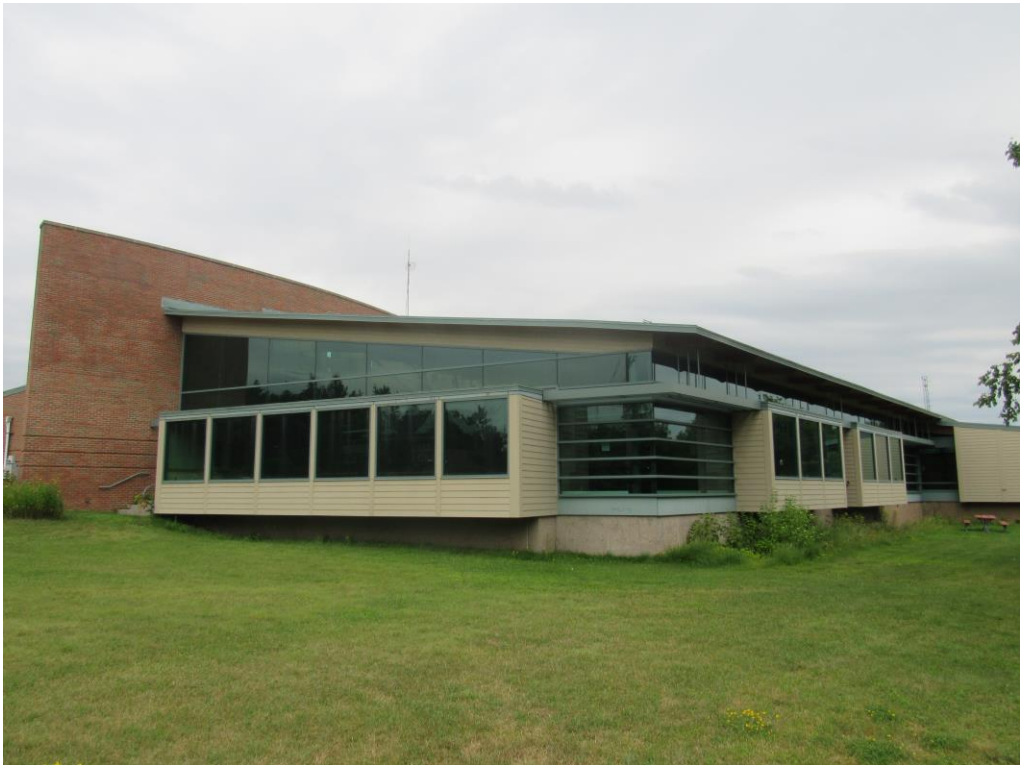
- 3.2.1 Horizontal lap siding is installed at the rear of the building in different locations, primarily at the large bumpout features (see photo 2). The siding is an engineered product that is coated. The exterior siding has been replaced recently, according to building management.
- 3.2.2 Wood siding and wood soffits are present at the roof overhangs at all elevations. Minor water stains were noted at some of the exposed wood soffits (see photo 17).

Photograph 2 – The west elevation of the library building.

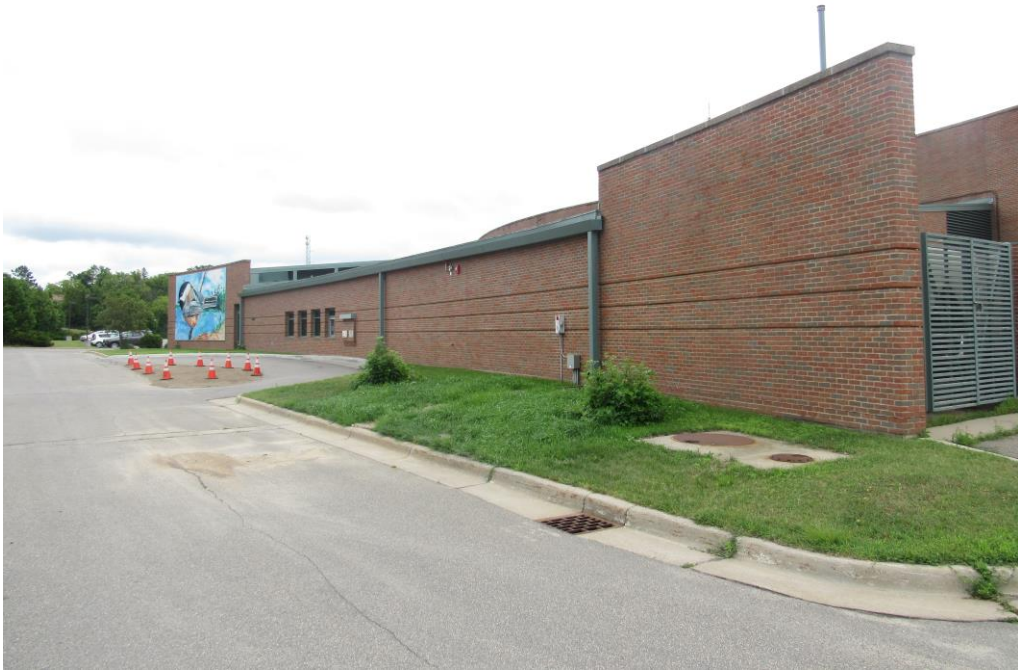
Photograph 3 – The north elevation of the library building.

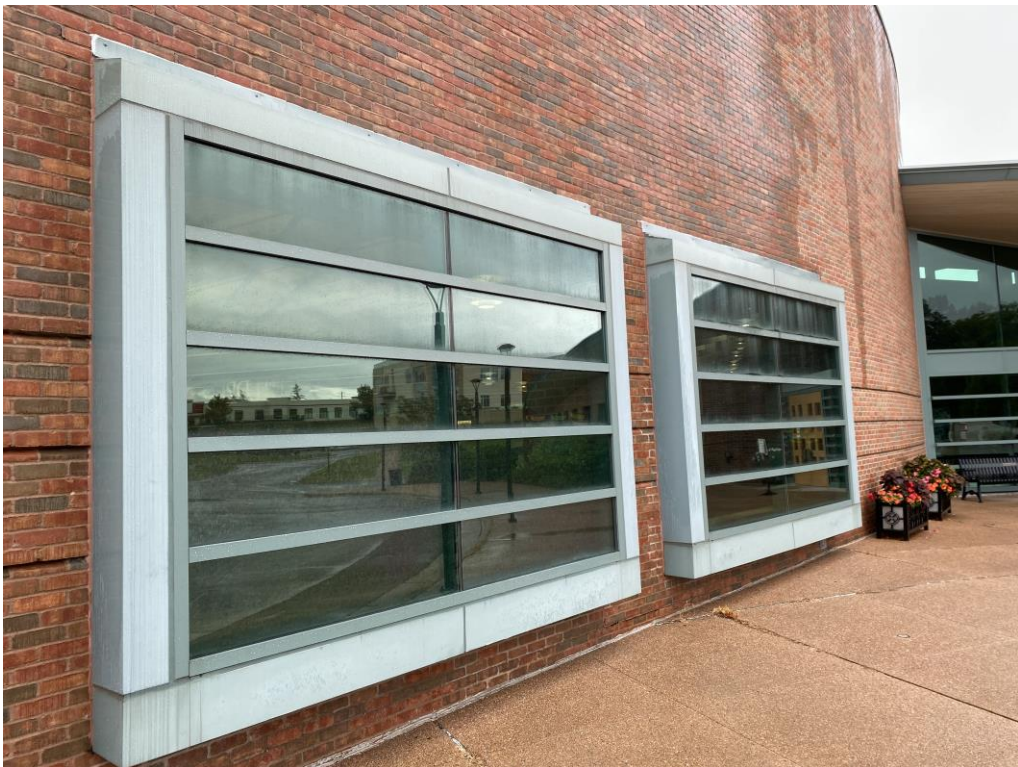
- 2.2 Bumpout Windows – Water testing was conducted at the front bumpout windows near the main entrance (see photos 1 and 4). Water leaks were reported from the top of the window frames at the interior.

Photograph 4 – Bumpout window assembly near the main entrance.

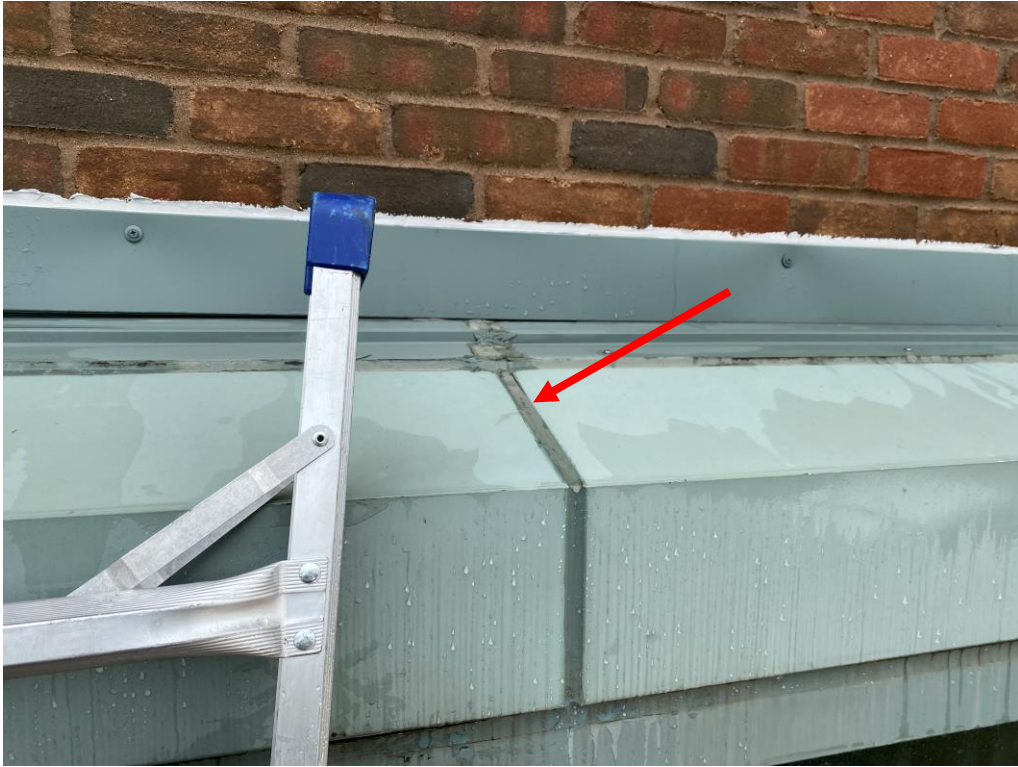
- 2.2.1 Water spray was applied to the sealant joints above the head of the window in the overhang assembly. Water spray was applied to the vertical, skyfacing joint at the center of the window (see photo 5) and leaks were observed at the interior window framing.

- 2.2.3 Analysis
 - The failed sealant at the window head assemblies allowed water entry into the overhead framing above the widows. Due to the existing construction,

water that enters the overhead framing will drain into the window assembly and leak into the interior.

Photograph 5 – Joint above window head, note failed sealant, testing location is noted by arrow.

5.1.2 Replace all joint sealant at the windows. Remove all existing joint sealants and install new joint sealants.

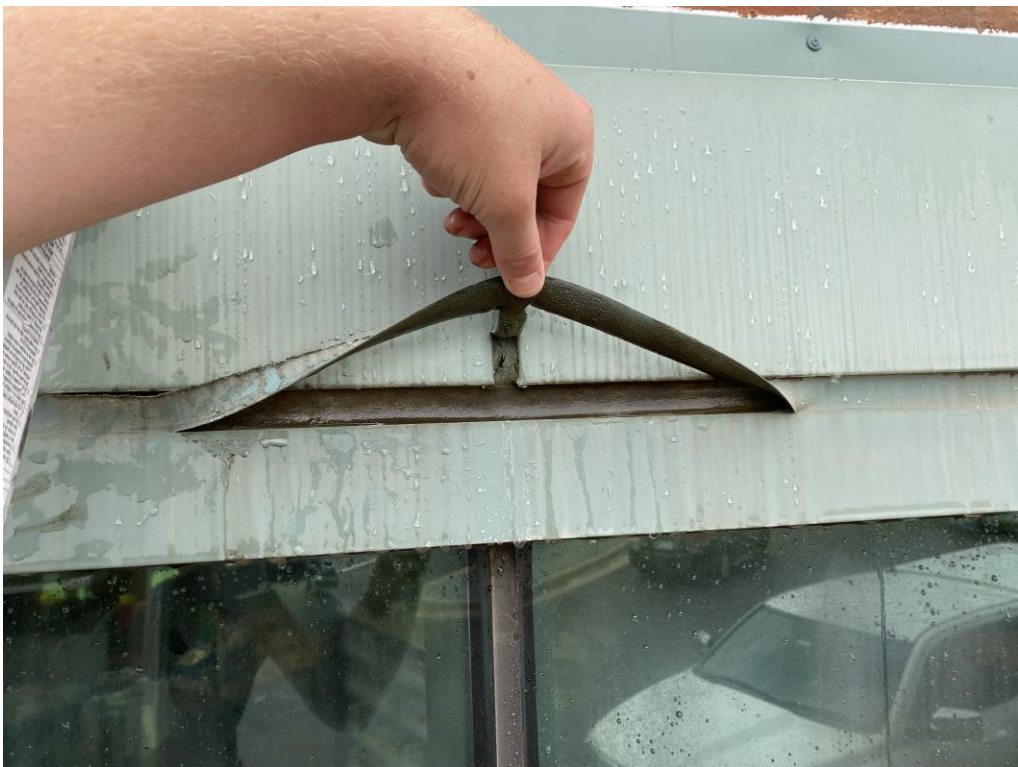
- 2.2.2 The sealants were typically failed at the center joint and at others. Joint sealant had been applied over older sealant without removing the older sealant, which results in a poorly performing joint (see photo 6). Many joints were debonded and easily removed.

Photograph 6 – Failed sealant at joints in the bumpout window overhang assembly.

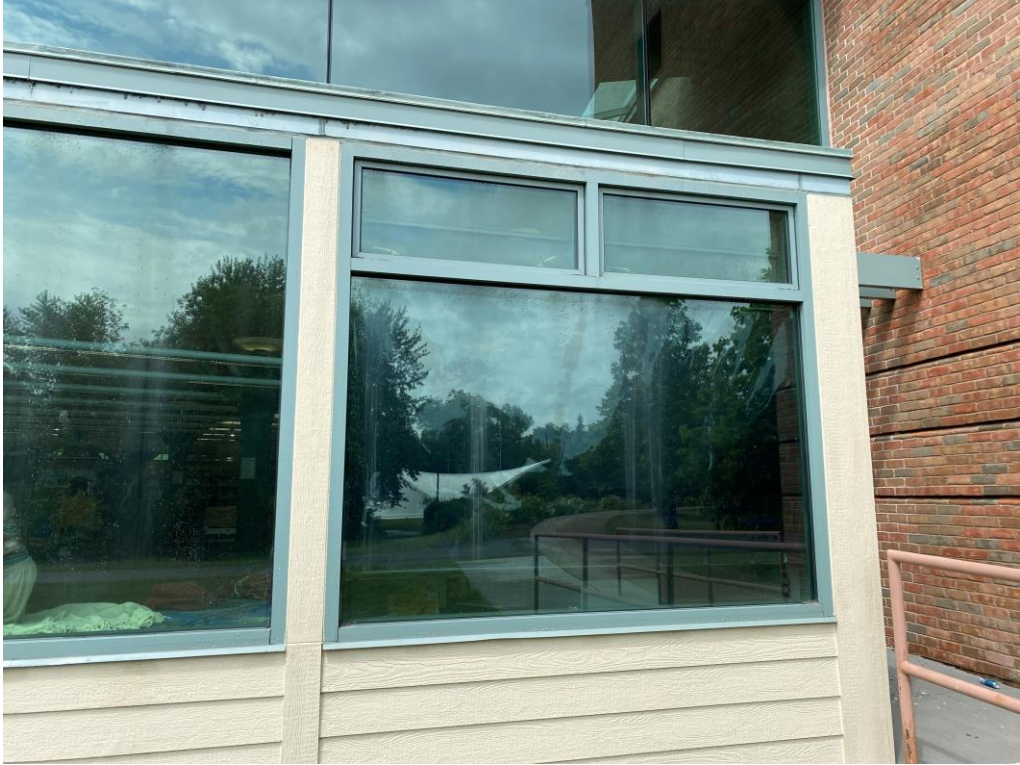
2.3 Office Window – Water testing was conducted at an office window near the east entrance (see photo 7). Water leaks were reported at the window jambs at the interior, below the operable window unit.

Photograph 7 – Office window with leaks reported at the interior jamb.

5.2.1 Disassemble the exterior frame around the operable window units and remove the operable units. Repair the frame seals and zone dams around the operable window units. Repair any flashings around the operable unit framing to seal the window frame and reassemble the window.

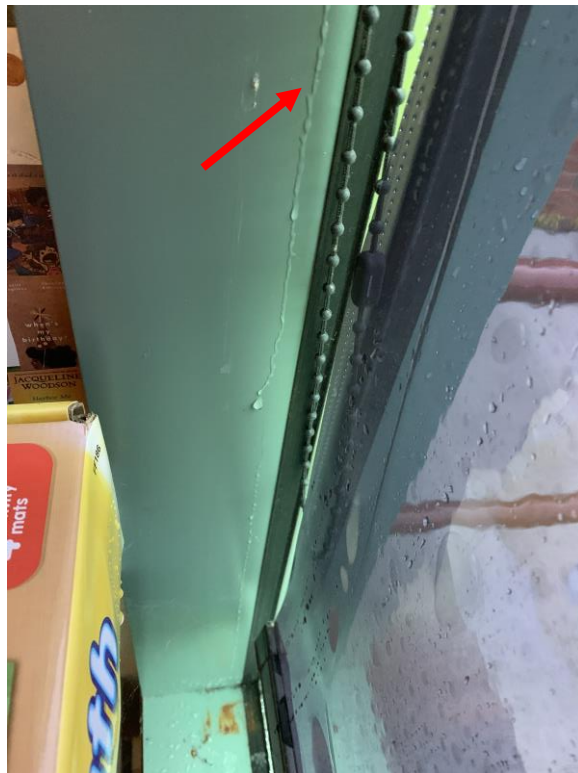
2.3.1 Water spray was applied to the horizontal mullion below the operable window unit. Leaks were observed at the interior window framing after a few minutes of testing (see photo 8).

- Water testing at the mullion indicates that there is a seal failure within the window frame assembly. Internal frame seals and/or seals around the operable units are failed. Previous sealant repairs have been attempted at this location which have not resolved the issue.

Photograph 8 – Leak location at the office window.

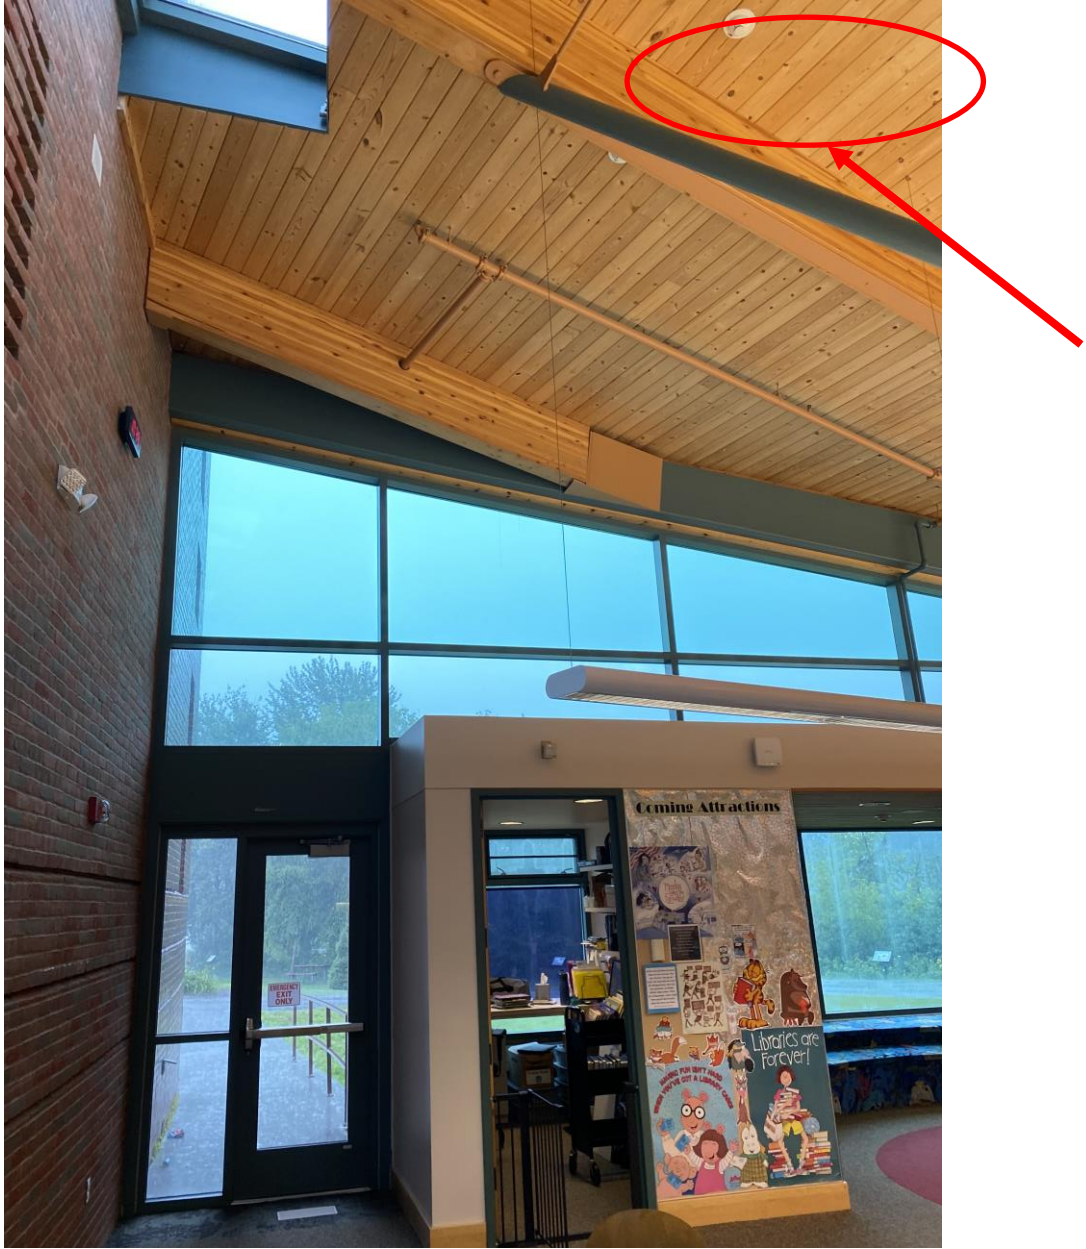
2.4 Ceiling Leak – Water Testing was conducted around a ceiling leak that was reported near the east entrance (see photo 9). Water dripping from the wood ceiling had been reported by building users, but the exact location was not confirmed.

2.4.1 Water testing was conducted at the facade and roof areas around the ceiling leak for 90 minutes and no interior leaks were detected. Testing areas included the skylights, transition flashings, masonry, roofing, window frames, and soffits.

Photograph 9 – Reported leak location at the ceiling near the east entry doors.

5.3.1 No leaks were detected during testing and no repairs can be recommended at this time.

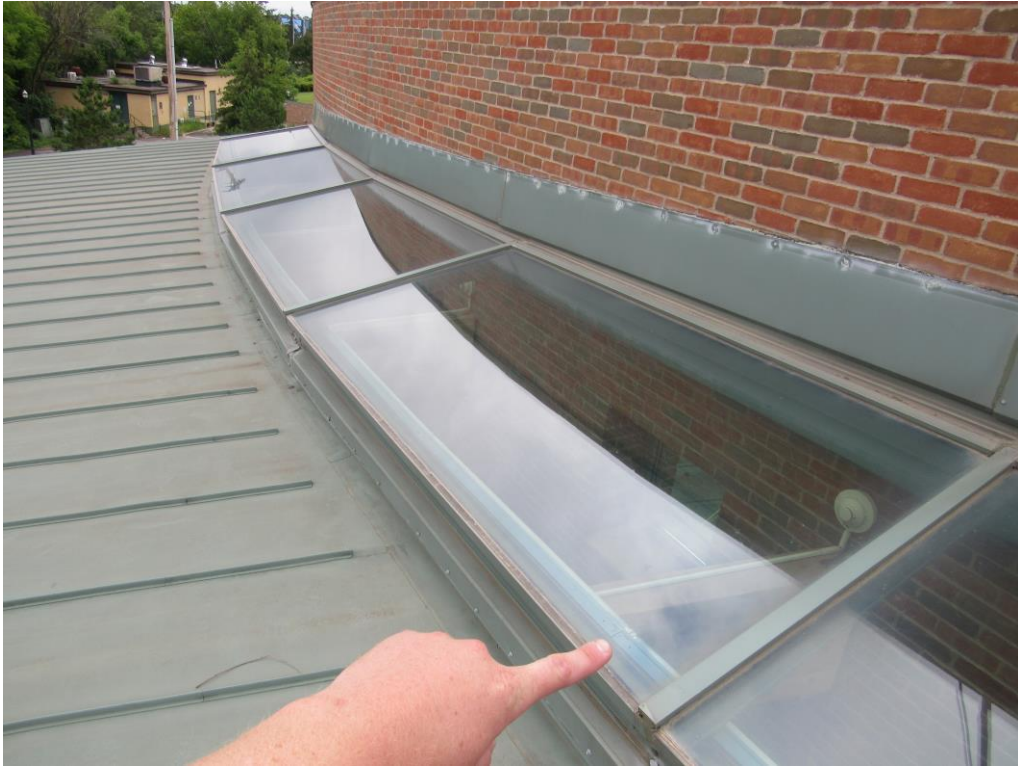
2.5.1 Water testing was conducted at two primary areas of the skylights where leaks have been reported in the past, at the center and the east end of the skylight assembly (see photo 10). Water testing consisted of applying water spray to all parts of the skylight in a sequential fashion, starting at the base of the assemblies up to the masonry walls.

2.5.2 Water testing was conducted at the two locations for approximately 60 minutes each and no leaks were detected.

Photograph 10 – Water testing location at the skylights.

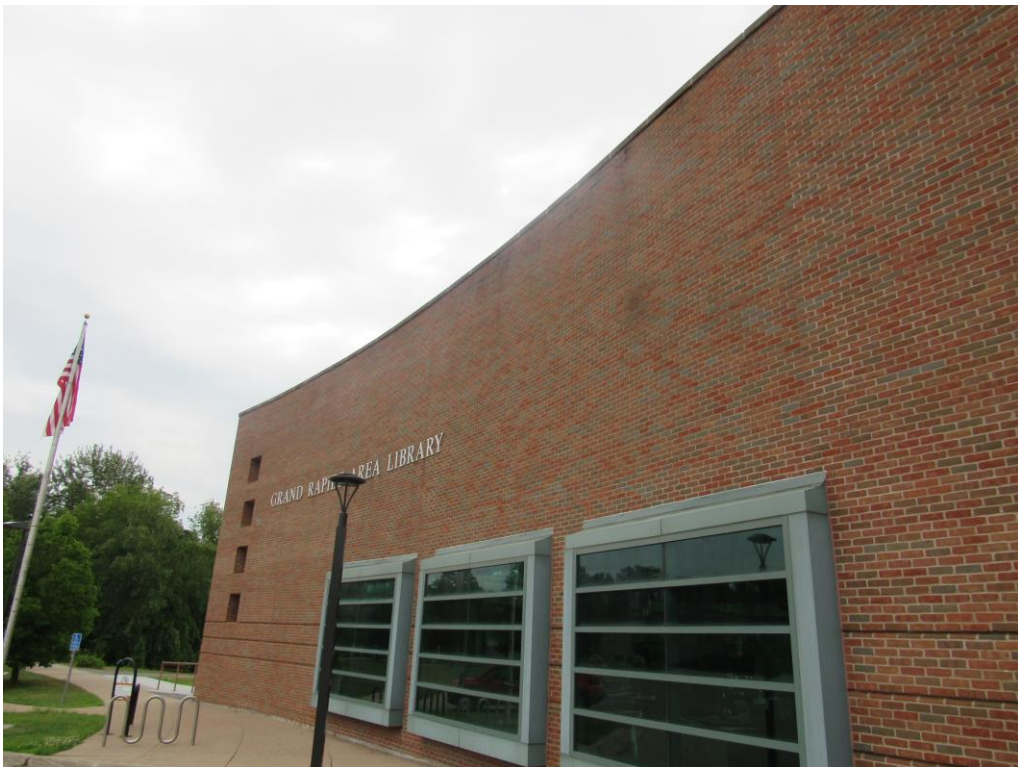
- 3.1.1 The façade primarily consists of red brick masonry units and mortar (see photos 1 through 3 and 11). The masonry is the exterior barrier component of the cavity wall system.

Photograph 11 – Typical masonry conditions at the north elevation.

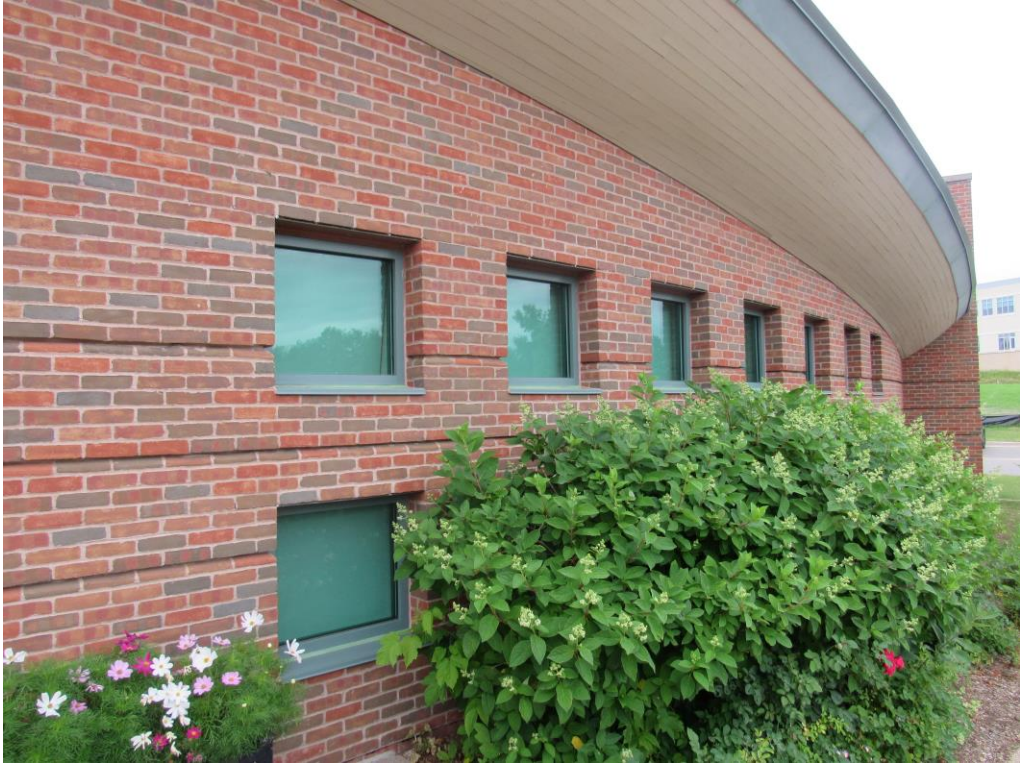
- 3.1.2 Through wall flashings are installed throughout the façade to drain and divert moisture out of the wall assembly (see photo 12).
- 3.1.3 Flashing is typically installed over the brick lintels (see photo 13). Some window and door location did not include a drip edge.

Photograph 12 – Typical lintel details at masonry window fenestrations.

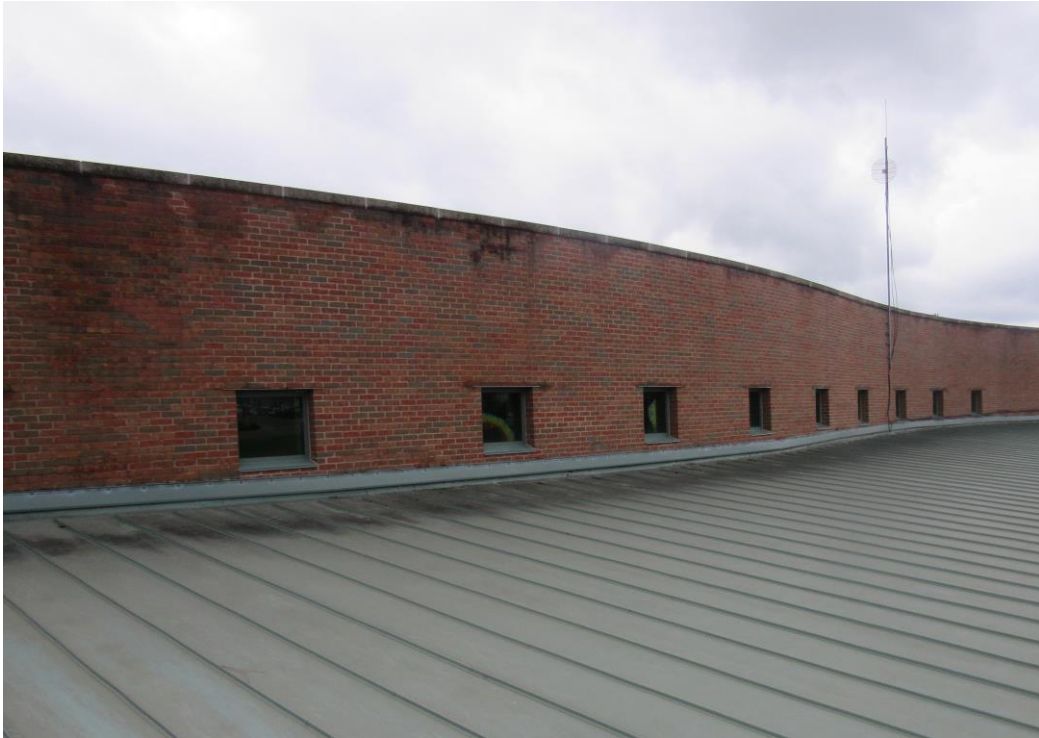
Photograph 13 – Water-stained masonry wall (north facing).

5.5.2 Use a masonry cleaner, power washing, hot water washing, or other means necessary to clean the stained masonry below the concrete wall caps.

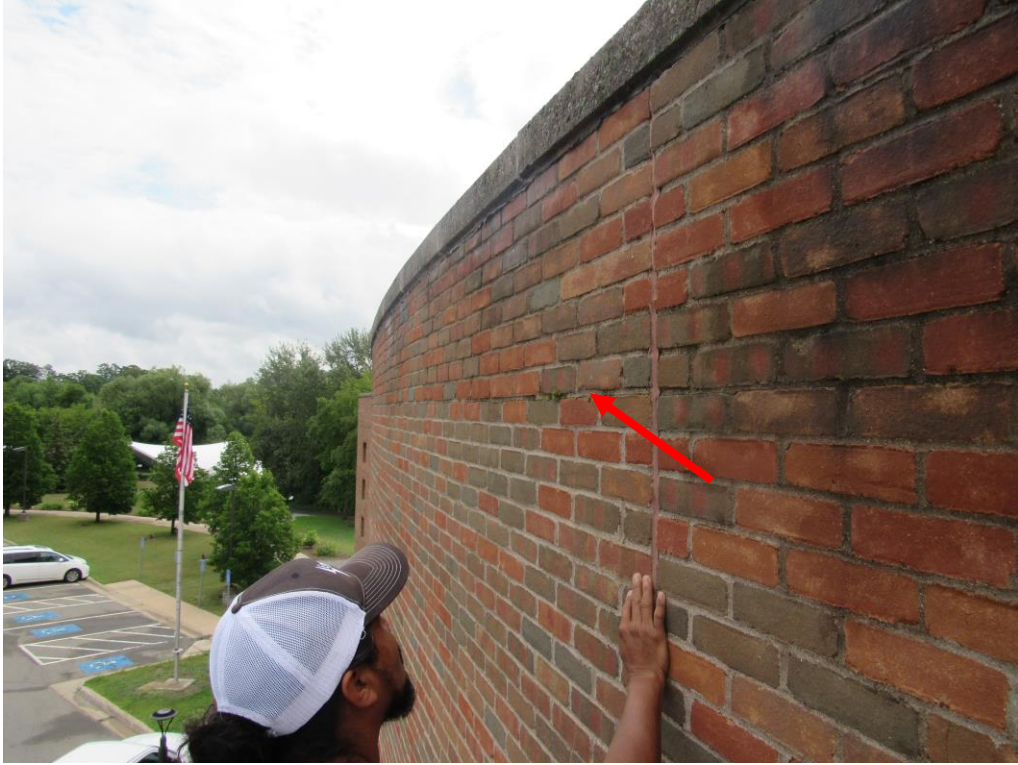
- 3.1.4 Water staining was observed at north facing brick at stem walls above the roof (see photo 14). Water stains were typically located within 10-15 brick courses from the top of the walls. The tops of the brick walls are covered with prefabricated concrete cap panels and flashing. The flashing is installed under the caps and appears to be a copper membrane product. The flashing does not have a rigid drip edge (see photo 15).

4.1.2 Water stains at the masonry are the result of moisture collection and saturation on the masonry. The saturation has resulted in isolated masonry damage at mortar joints at select areas.

Photograph 14 – Water-stained masonry with cracking at bed joint. Moss formation is also noted.

5.5.4 Perform localized tuckpointing at cracked or damaged locations, estimated to be less than 5% of the façade.

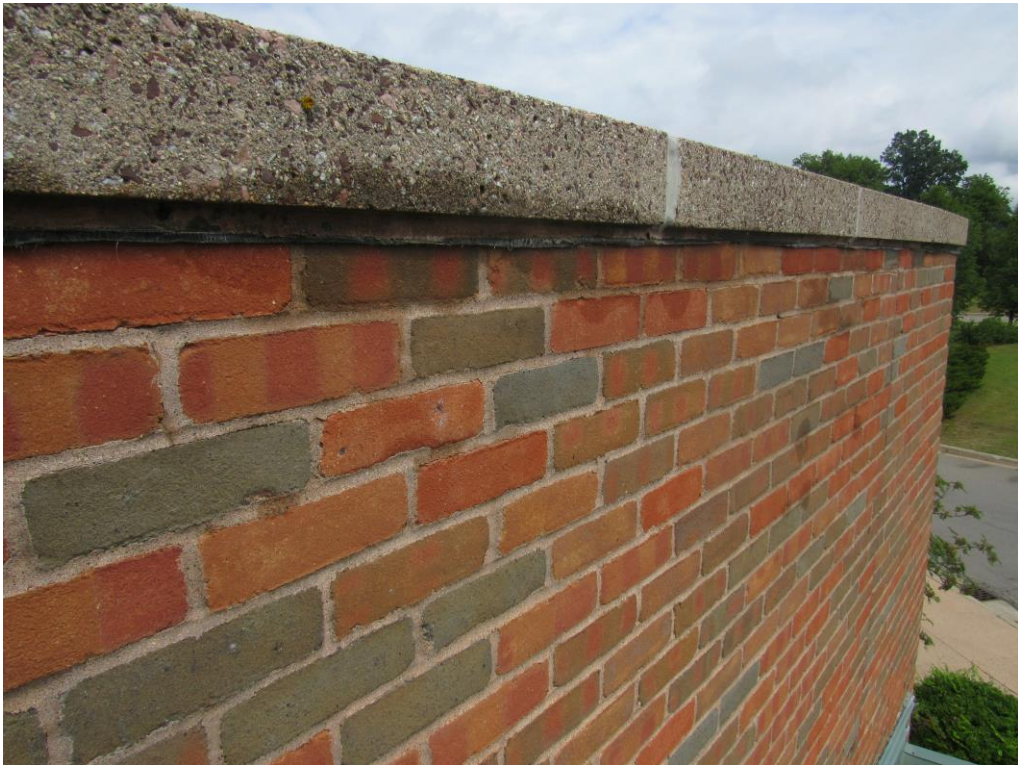
Photograph 15 – Wall cap details showing flashing conditions.

5.5.1 Remove the existing concrete caps and remove the existing flashings. Install new membrane flashing with a stainless steel, hemmed drip edge at both sides that drains water off the masonry wall. Reinstall the caps and seal the panel joints with sealant and weep ropes.

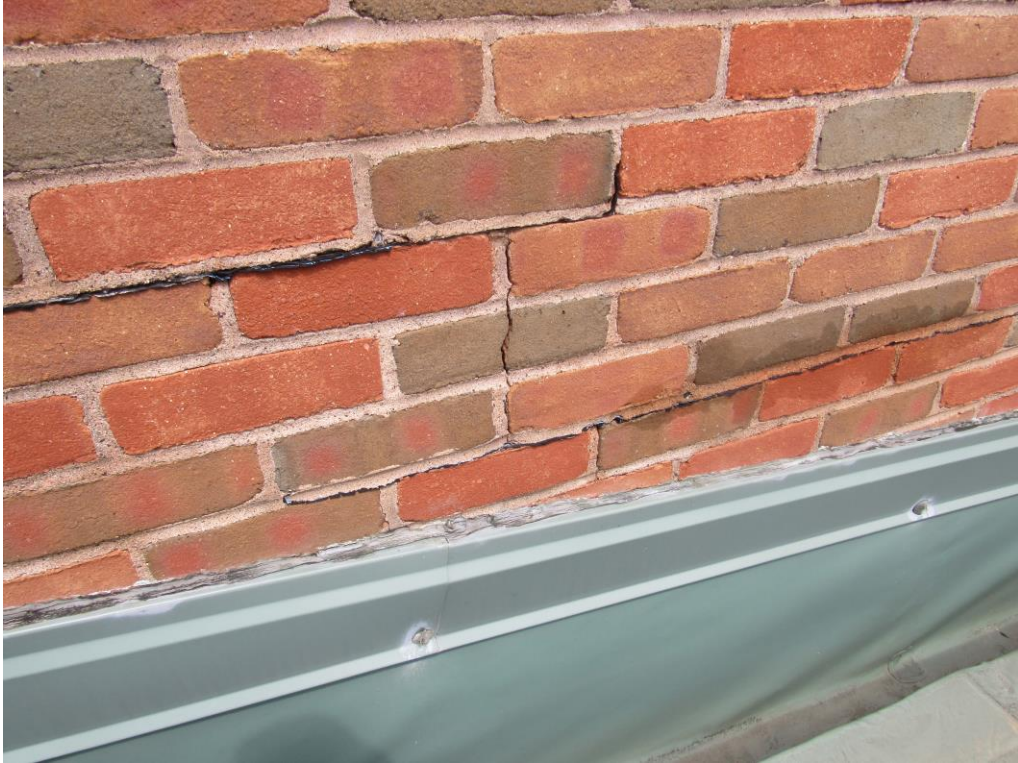
- 3.1.5 Generally, the masonry is in good condition with only minor deterioration or damage observed at isolated locations (see photo 16).

Photograph 16 – Brick crack around through wall flashing details.

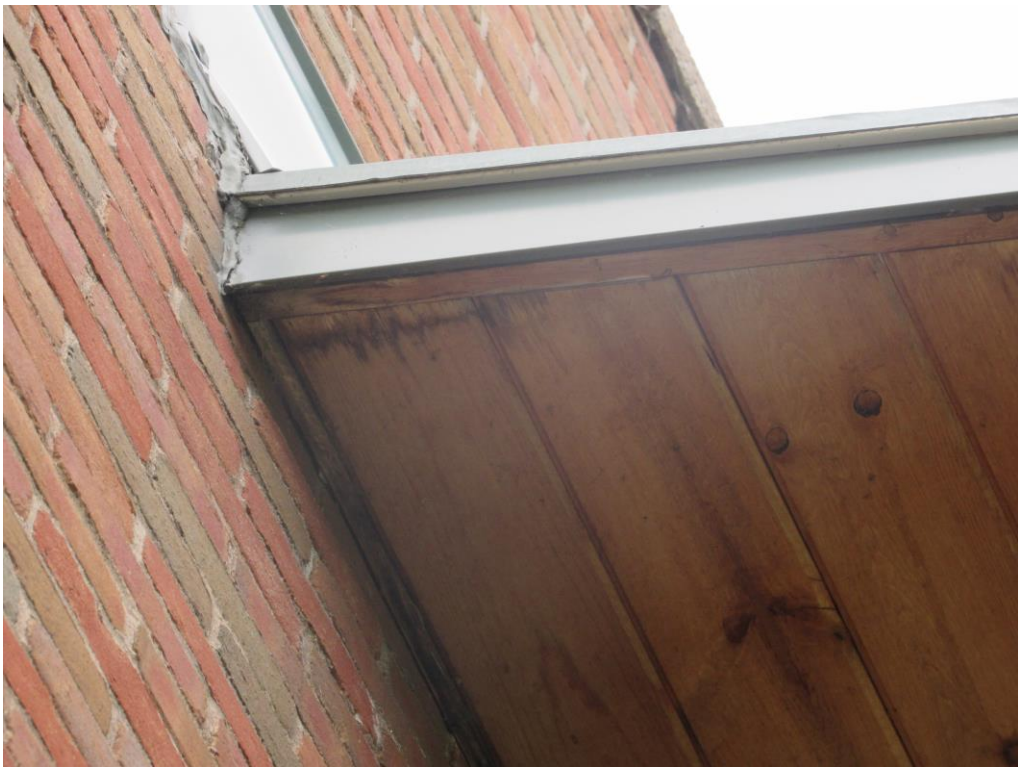
Photograph 17 – Water stains at a wood soffit.

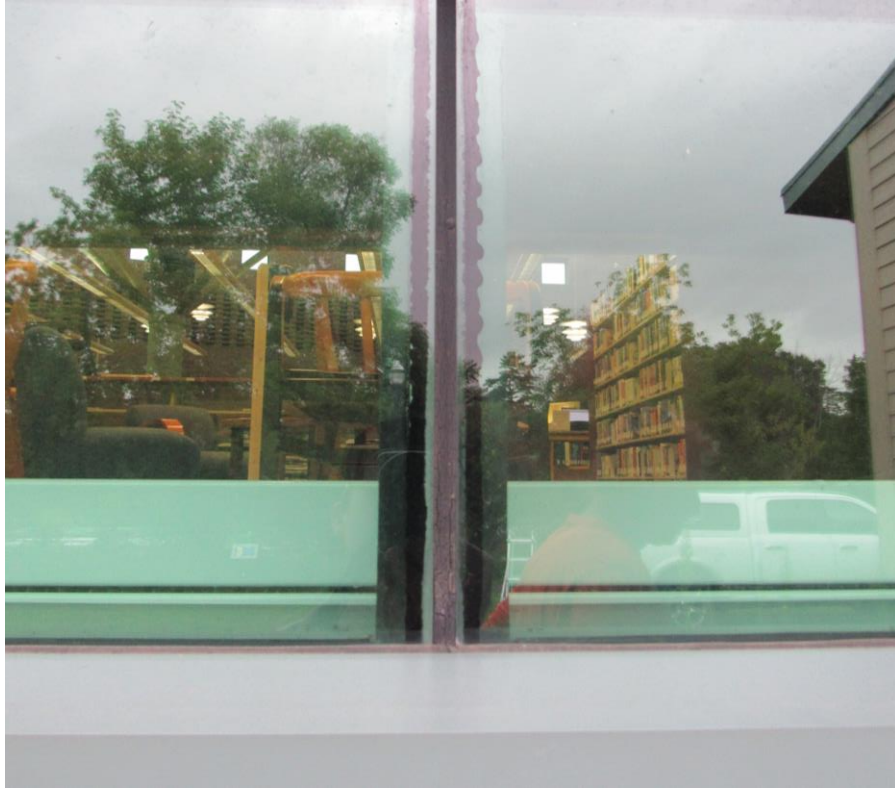
- 3.3.1 Window units are installed at the library building in various, unique configurations. The majority of the windows are curtain wall assemblies constructed with aluminum framing. Seals and joints around the windows and glazing are in fair condition, with some failures observed (see photo 18).

Photograph 18 – Cracking sealant at a window assembly.

5.6.1 Remove and replace all existing exterior joint sealants at the windows, doors, masonry joints, and wall penetrations. Provide drainage and/or weep mechanisms at façade material transitions as applicable.

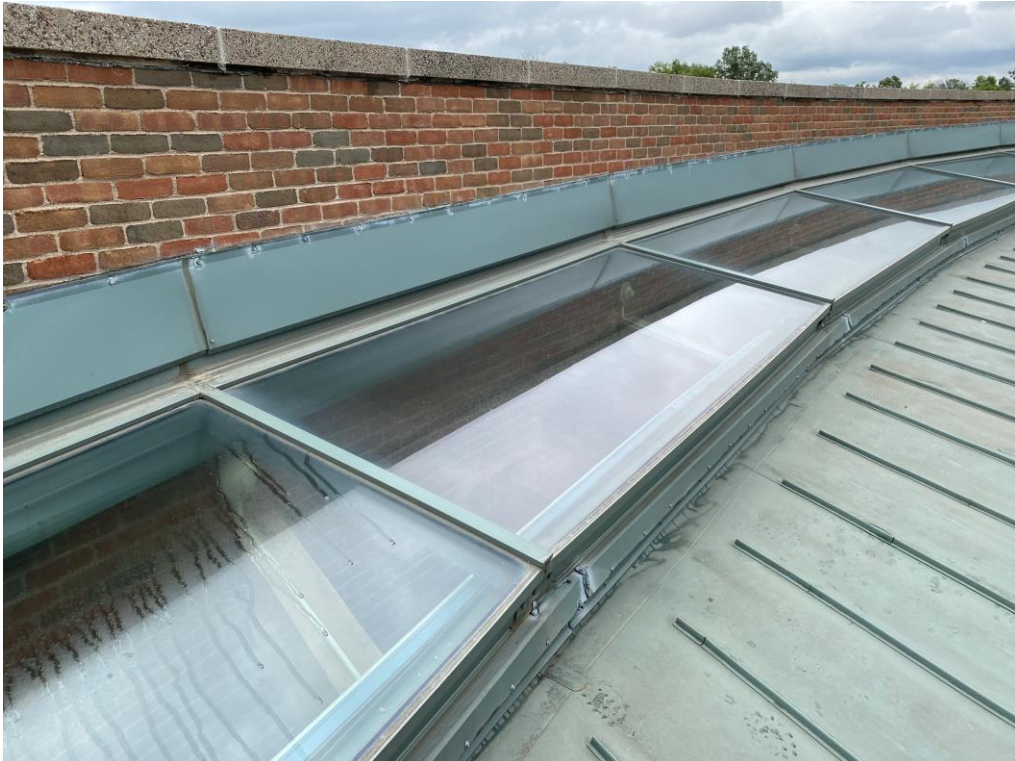
Photograph 19 – Skylight assembly at the roof.

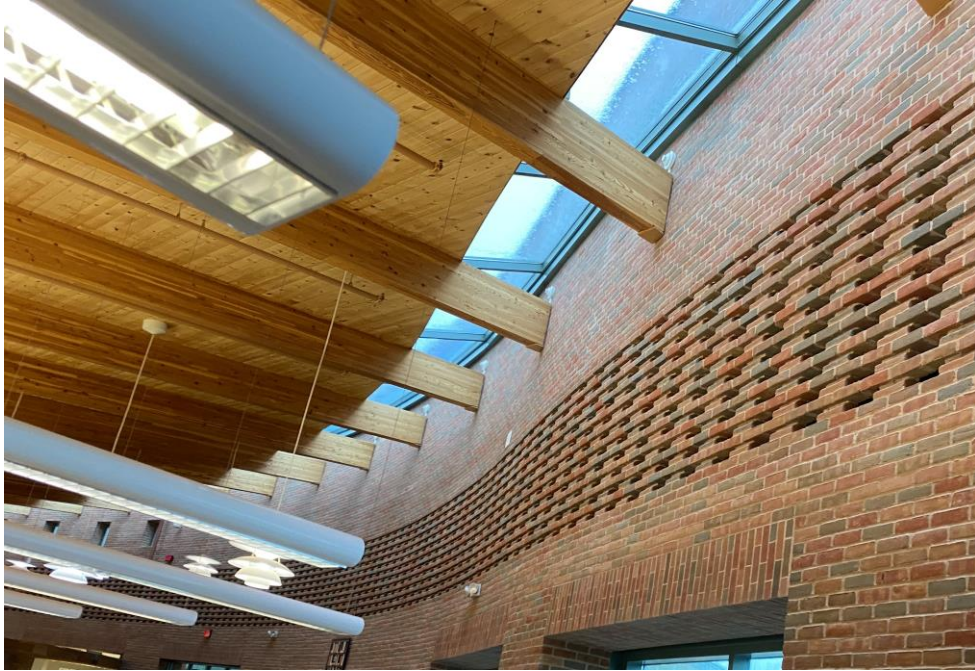
Photograph 20 – Interior view of skylight assemblies.

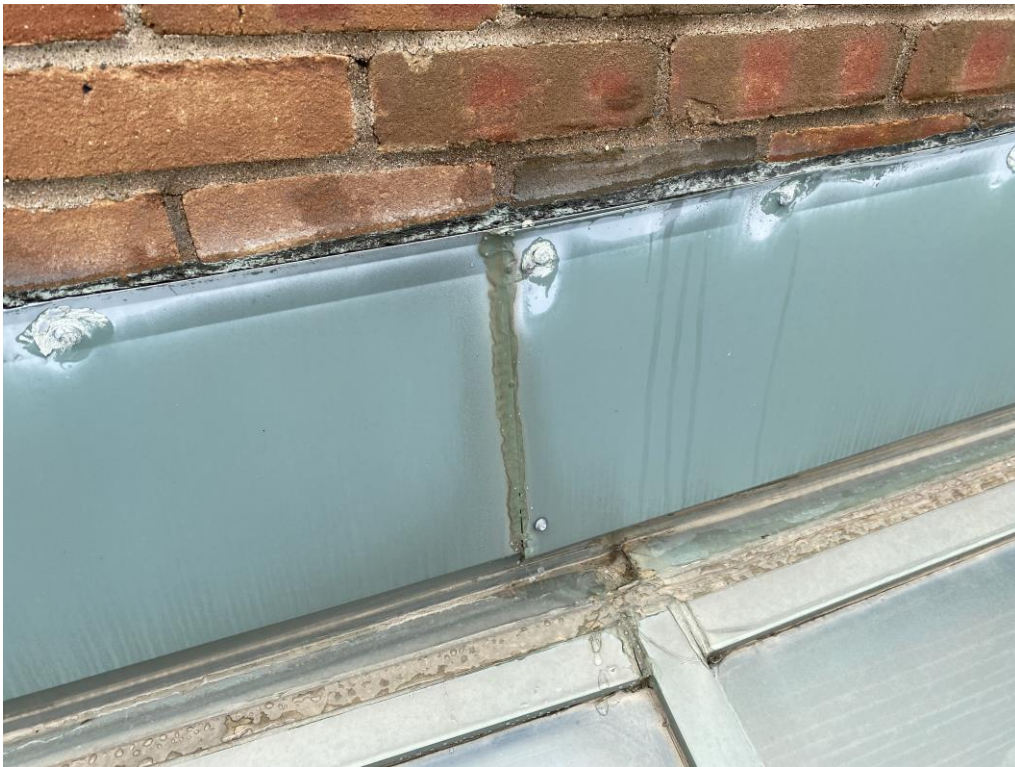
4.4.3 The sealants at the skylight frames and flashings are at or near the end of their useful life.

Photograph 21 – Failed sealant joints at the skylight wall flashing, no through wall detail is visible with existing wall flashing.

5.4.1 Replace all joint sealant at the skylight frames and adjacent flashings.

5.4.2 Remove the existing wall/head metal flashing at the skylights. If through wall flashing is present, inspect it for deficiencies and install flashing to lap under it and over the skylight heads. If through wall flashing is not present, install it into the masonry wall and over the skylights.

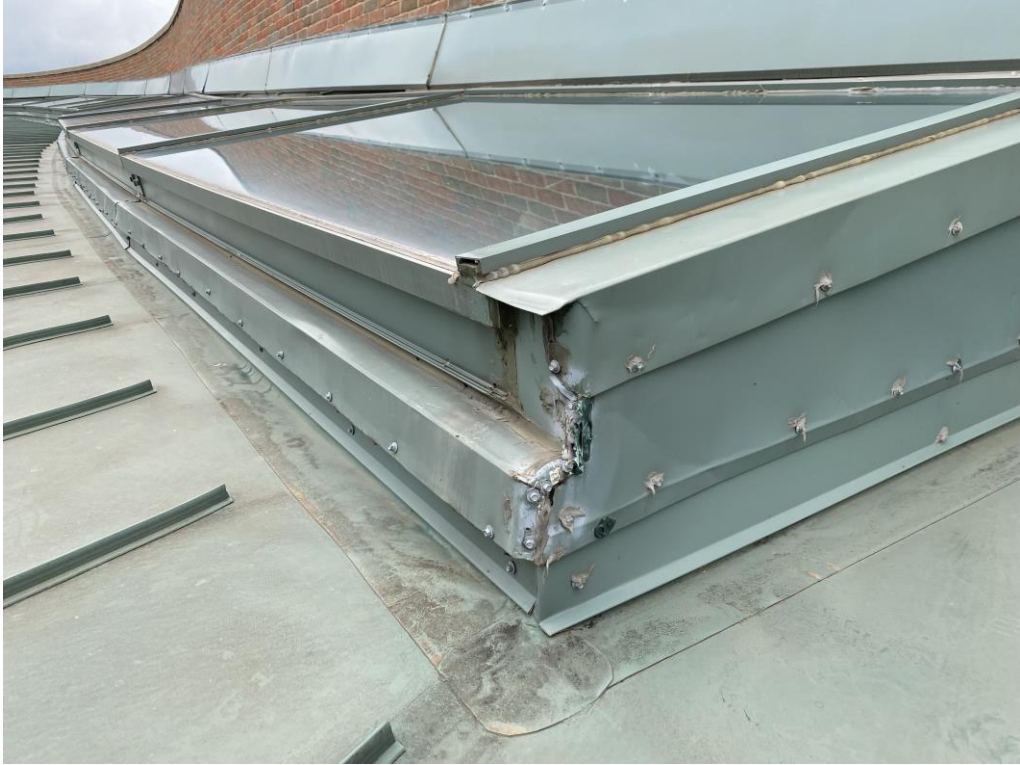
Photograph 22 – Repairs at the skylight joints.

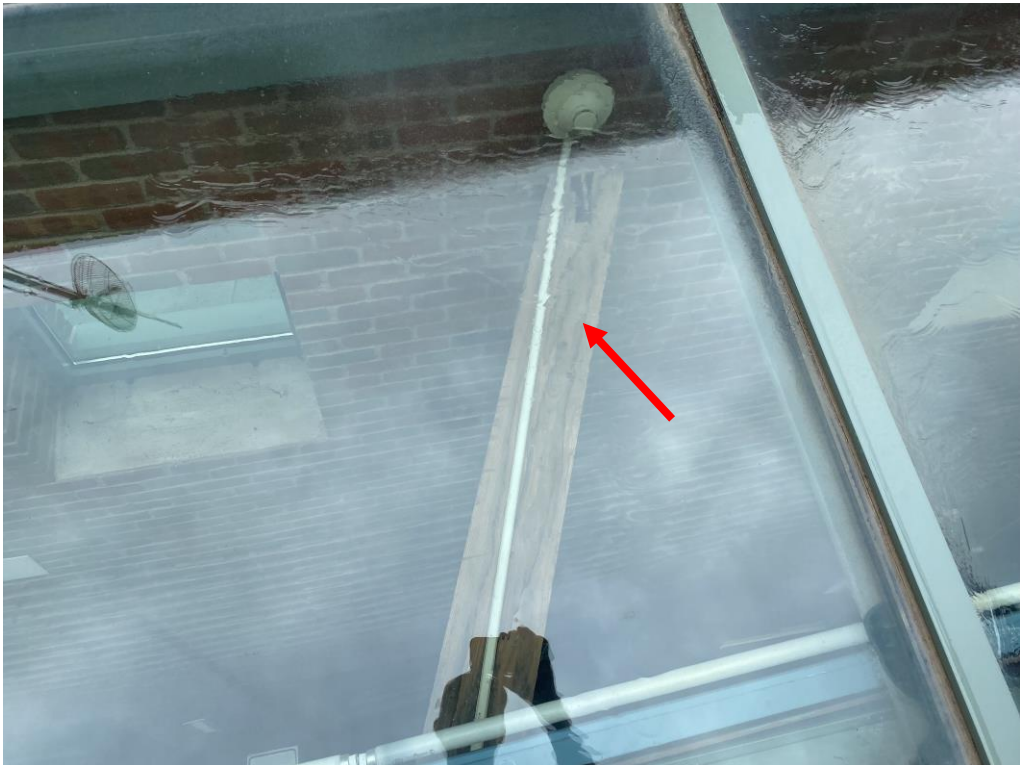
4.4.2 The roof skylights are not currently exhibiting any leaks, although they have leaked in the past. No leaks were detected with water testing that was conducted, but signs of water intrusion were noted around the skylights. Deficiencies at the window and adjacent brick flashings may be contributing to moisture intrusion. Monitoring of the skylights may assist to confirm the presence of leak issues.

Photograph 23 – Water stains at the wood beam beneath the skylight.

5.4.3 Monitor the skylights for any leaks until repairs can be completed and evaluate them immediately if leaks occur.

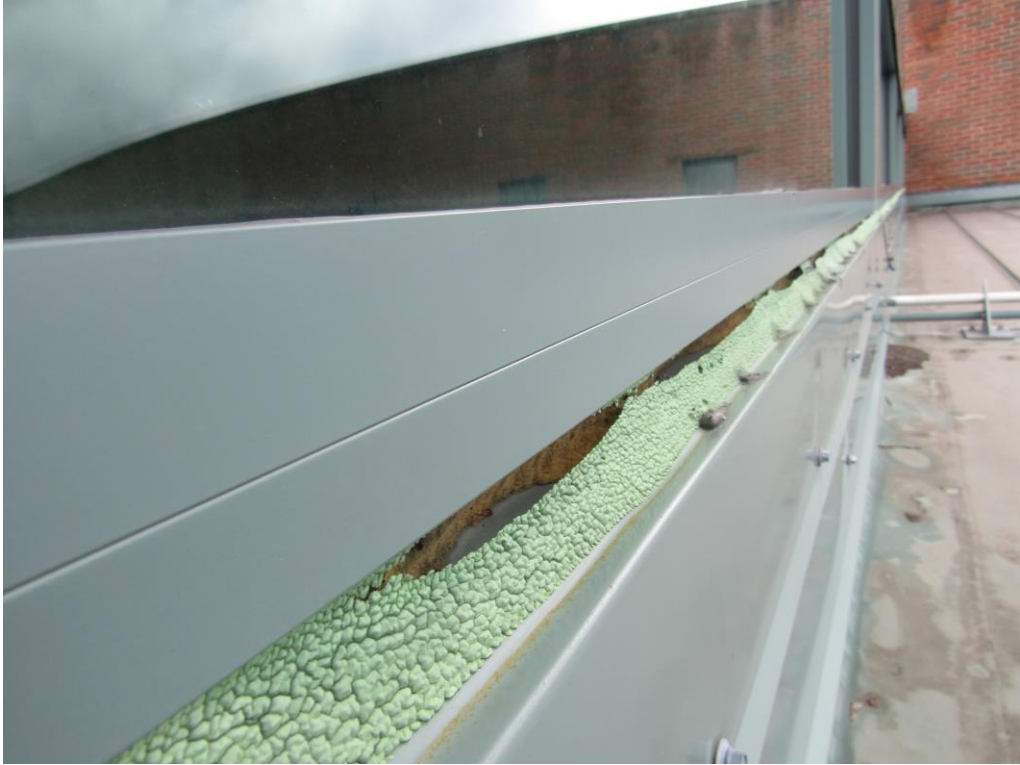
- 3.4.1 Joint sealant is present at the perimeters of the window and door frames. The window/door perimeter sealant was typically deteriorated and was cracking or failed at various locations (see photos 24).
- 3.4.2 Joint sealant was installed at the base of exterior siding at the window heads with no weep or drainage above the window (see photo 25). At some locations this sealant was failed.
- 3.4.3 The sealant at masonry and concrete cap joints was typically in fair condition, with localized failures noted (see photo 26).
- 3.4.4 The joint sealants at metal flashings were typically in poor condition (see photo 27).

Photograph 24 – Failed sealant at a windowsill joint.

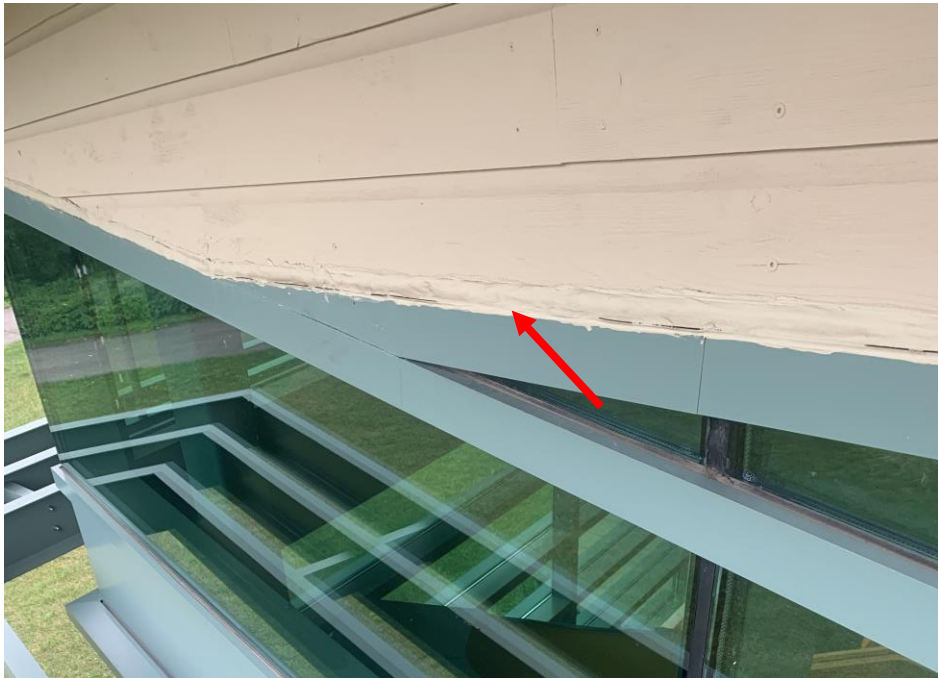
4.3.2 The heads of windows were typically sealed with no drainage path or weep mechanism (see photo 25). The termination of any façade element such as siding, metal, or brick, where it meets a window or penetration, should have a means to drain water to the exterior.

Photograph 25 – Sealant installed at window head/base of siding, with failures observed.

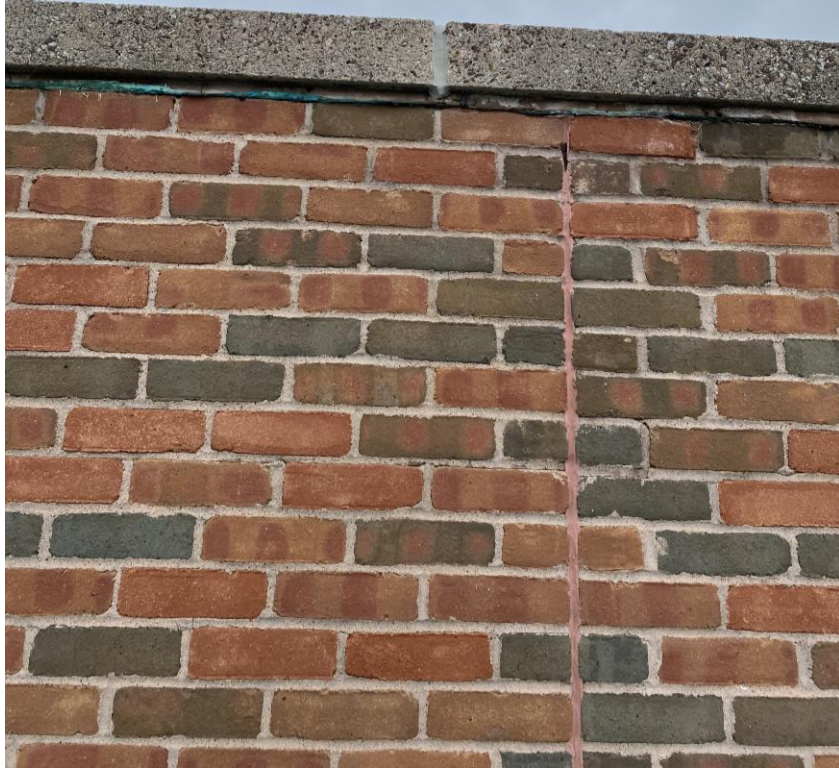
Photograph 26 – Sealant at masonry joints.
