EXTERIOR ENVELOPE REVIEW

**CITY OF GRAND RAPIDS
GRAND RAPIDS AREA LIBRARY BUILDING
140 NE 2nd STREET
GRAND RAPIDS, MINNESOTA 55744**

Project # 22-8040

September 16, 2022

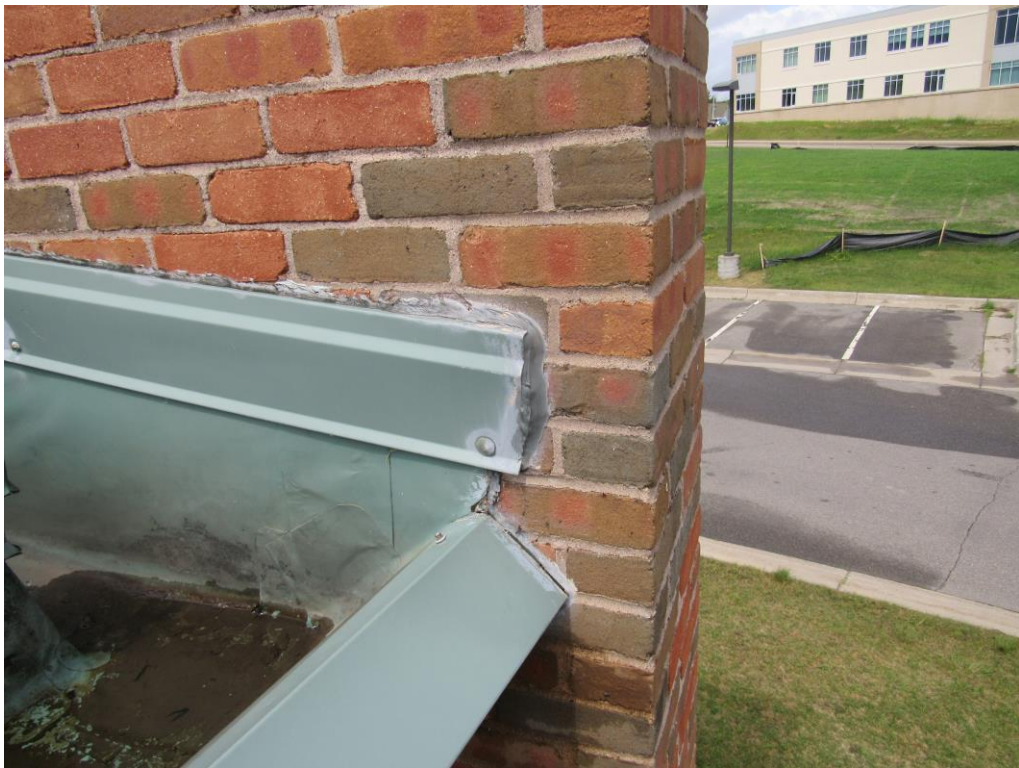
Photograph 27 – Failed sealants at metal flashings.

5.6.1 Remove and replace all existing exterior joint sealants at the windows, doors, masonry joints, and wall penetrations. Provide drainage and/or weep mechanisms at façade material transitions as applicable.

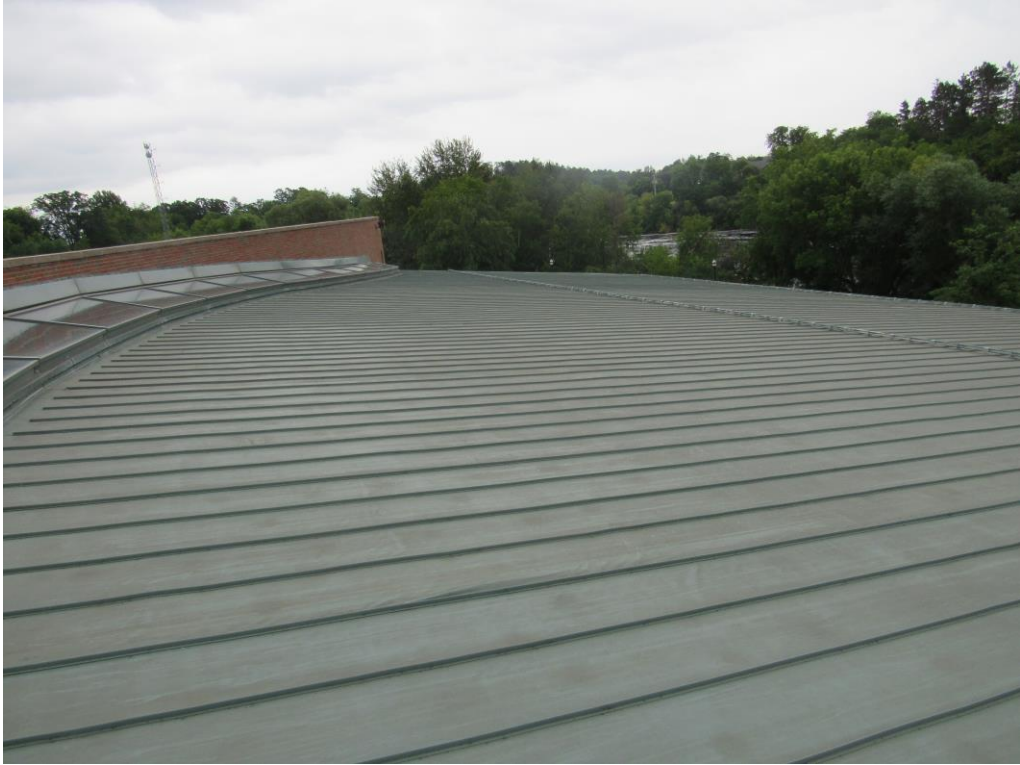
- 3.5.1 The roofing installed at the library is a green PVC membrane roofing material (see photo 28). The roofing is installed with ridge pieces adhered to the membrane which visually produces a look like a metal roof with seams, and snow guards are also present at the ends of the roof. The existing roofing was reportedly installed to replace the original roof soon after initial construction.
- 3.5.2 Isolated patch repairs were noted at the roof membrane in several locations. Various roofing seams exhibited some minor wear and deterioration (see photo 29), as well as corners and terminations (see photo 30). Water stains, discoloration, and organic growth was also present on the north roof elevations where less sun exposure is lower. No other deficiencies were observed at the membrane.

Photograph 28 – Roofing at the south roof elevation.

5.7.1 Roofing replacement should be considered within the next 5 years.

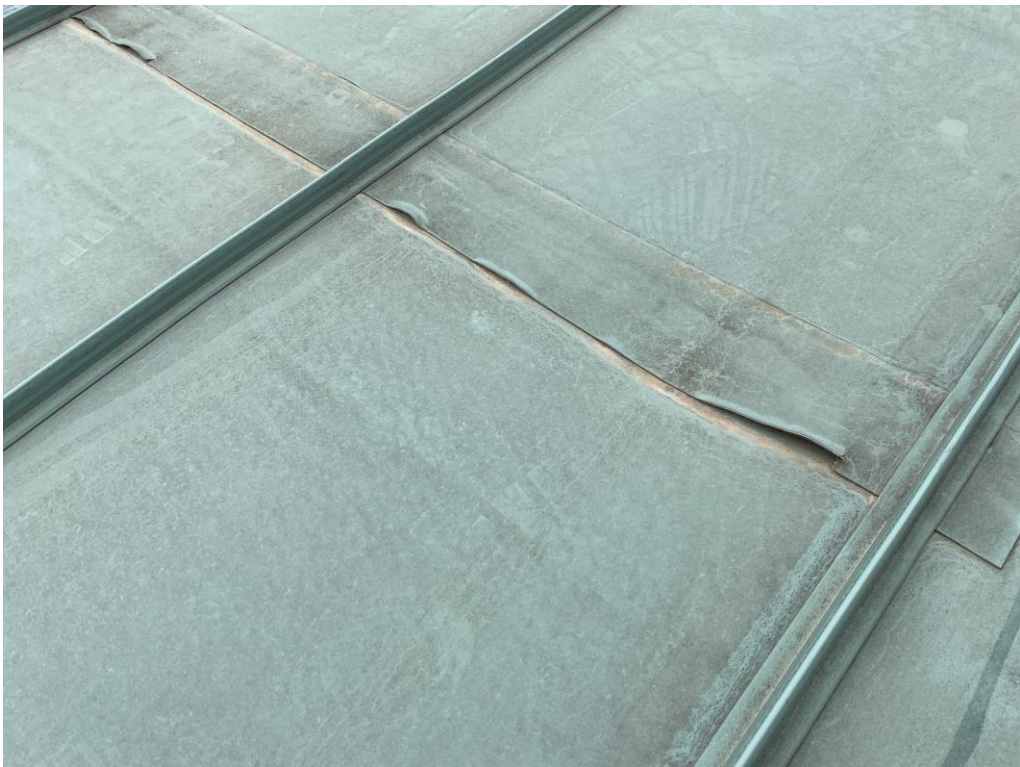
4.5.1 The roofing at the building is generally in fair condition, with localized areas of failure due to wear or material degradation. The expected service life of typical membrane roofing can be expected to be between 20 to 25 years.

Photograph 29 – Deteriorated roofing seam location.

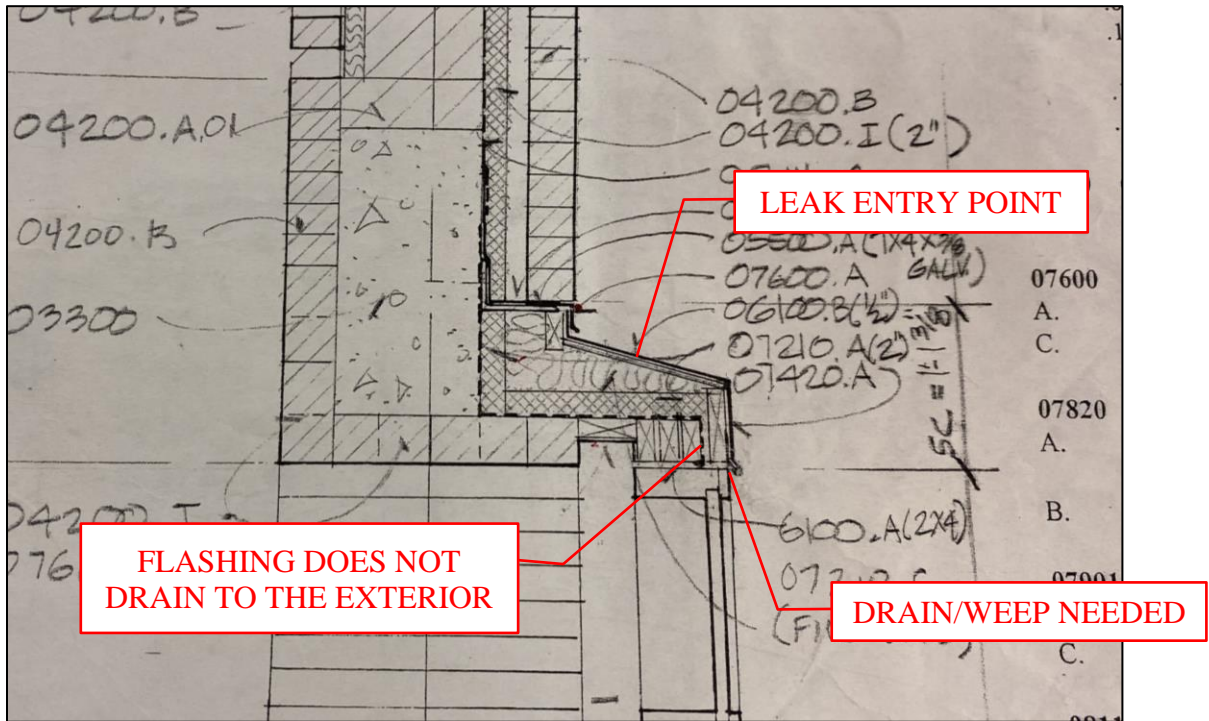
- According to the existing details, flashing is installed within the overhang assembly, but the flashing does not have a means to drain to the exterior. See Figure 1 for the original window head and overhang detail.

Figure 1 – Original detail at the head of the bumpout windows.

5.1.1 In order to allow the wall assembly to drain properly above the window, revise the window head configuration to weep/drain at the window head (see Figure 1). This will require disassembly and modification of the sheet metal coverings and framing above the windows. The sheet metal assembly may also be modified to conceal the exposed sealant joints to extend their lifespan and improve performance.

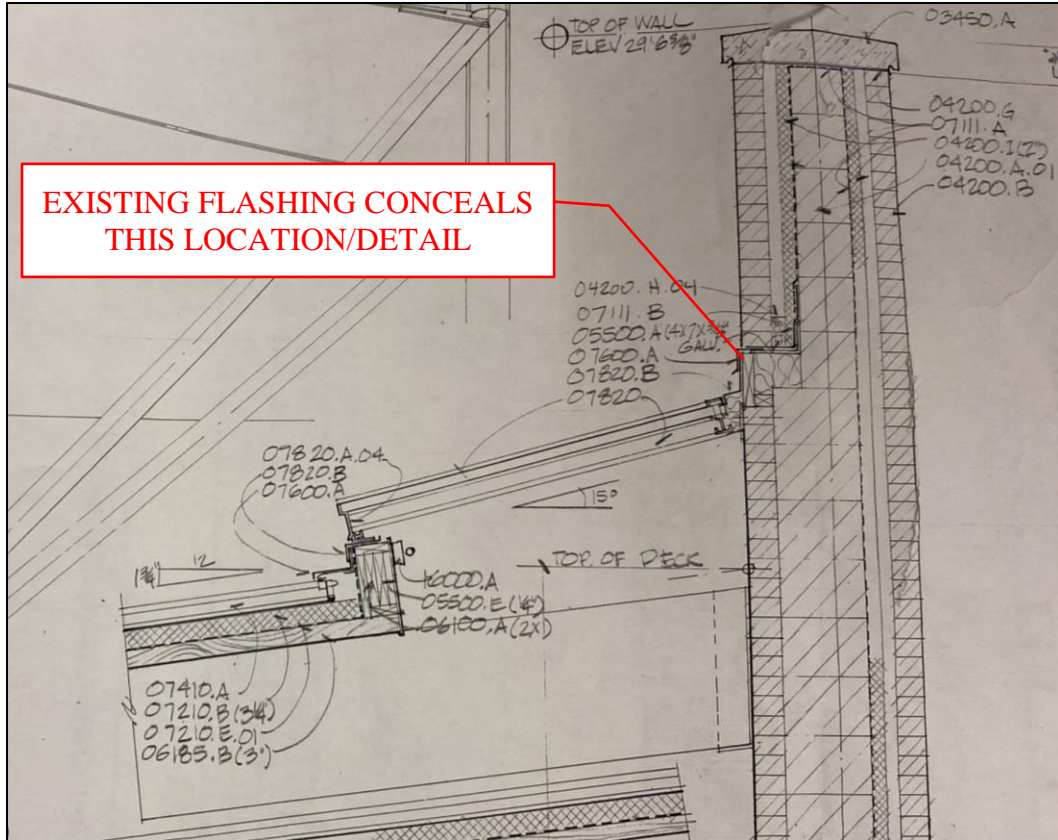
- The existing sealants are in poor to fair condition at the skylights, with failures noted. Various sealant repairs have been executed at the skylights in the past.
- Existing drawings show a through wall flashing detail at the heads of the skylights which is different than what is currently installed. The current flashings terminate at the wall exterior which rely on a sealant joint that is currently failed (see photo 21). Failed sealants and the existing configurations at the existing flashings could be contributing to moisture intrusion.
- The skylights should be monitored for ongoing issues, and they should be maintained properly to extend their performance.

Figure 2 – Original detail at the skylights.

5.4.2 Remove the existing wall/head metal flashing at the skylights. If through wall flashing is present, inspect it for deficiencies and install flashing to lap under it and over the skylight heads. If through wall flashing is not present, install it into the masonry wall and over the skylights.
