EXTERIOR ENVELOPE REVIEW

**CITY OF GRAND RAPIDS
GRAND RAPIDS AREA LIBRARY BUILDING
140 NE 2nd STREET
GRAND RAPIDS, MINNESOTA 55744**

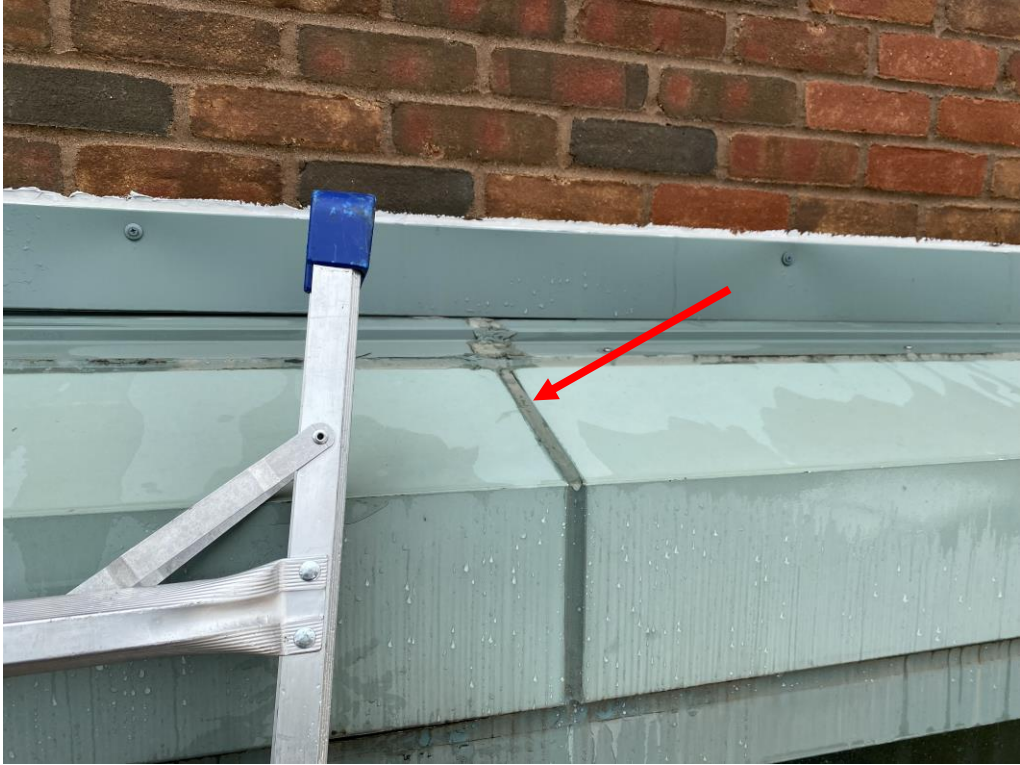
Photograph 5 – Joint above window head, note failed sealant, testing location is noted by arrow.

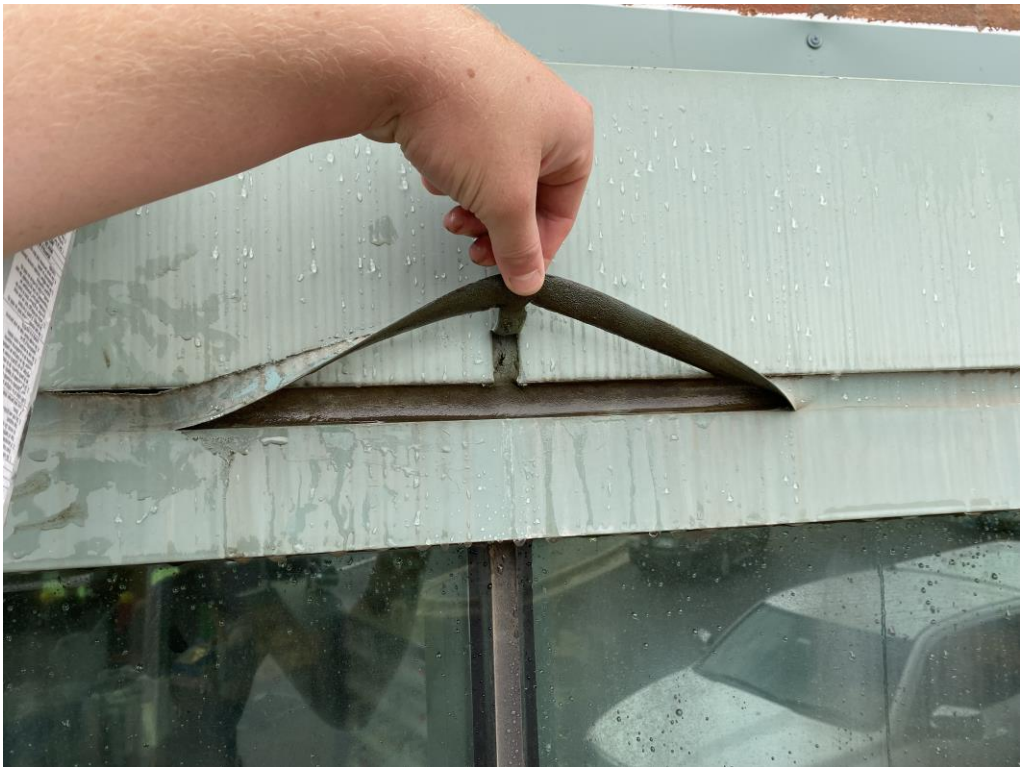
Photograph 6 – Failed sealant at joints in the bumpout window overhang assembly.

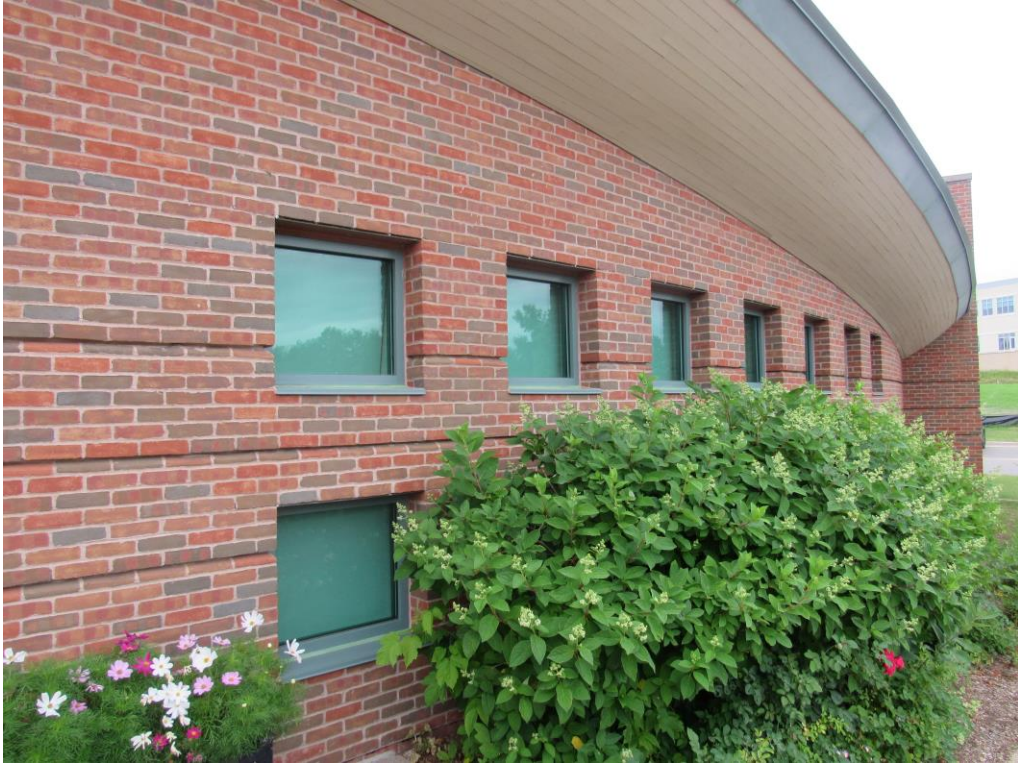
Photograph 12 – Typical lintel details at masonry window fenestrations.

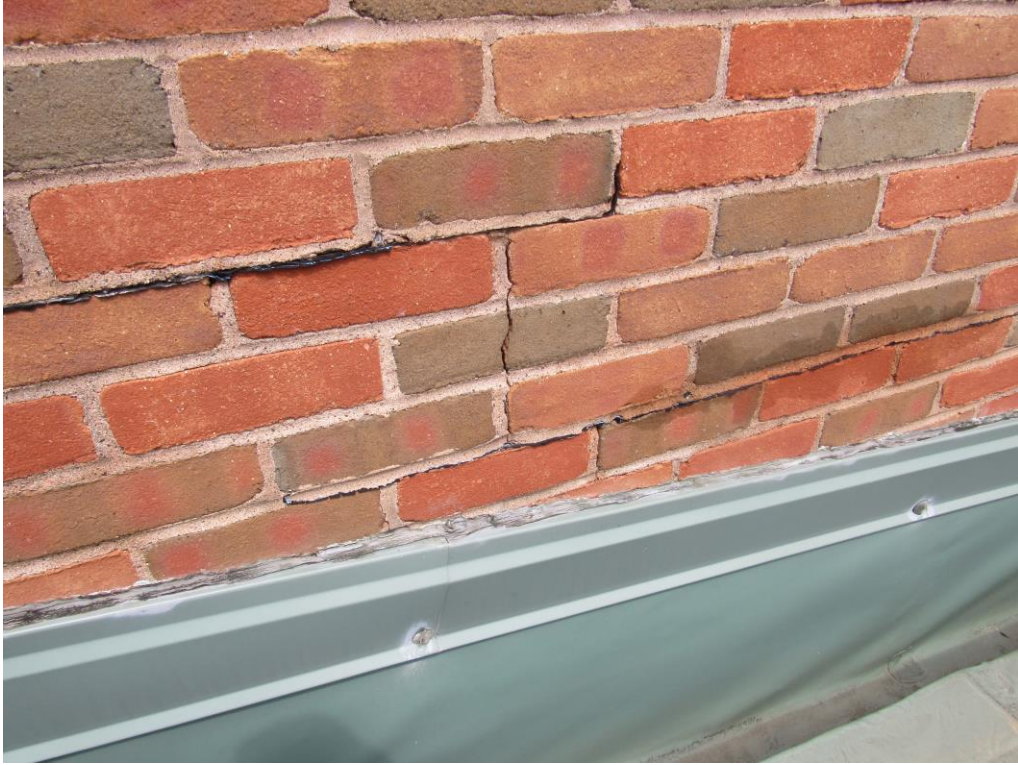
Photograph 16 – Brick crack around through wall flashing details.

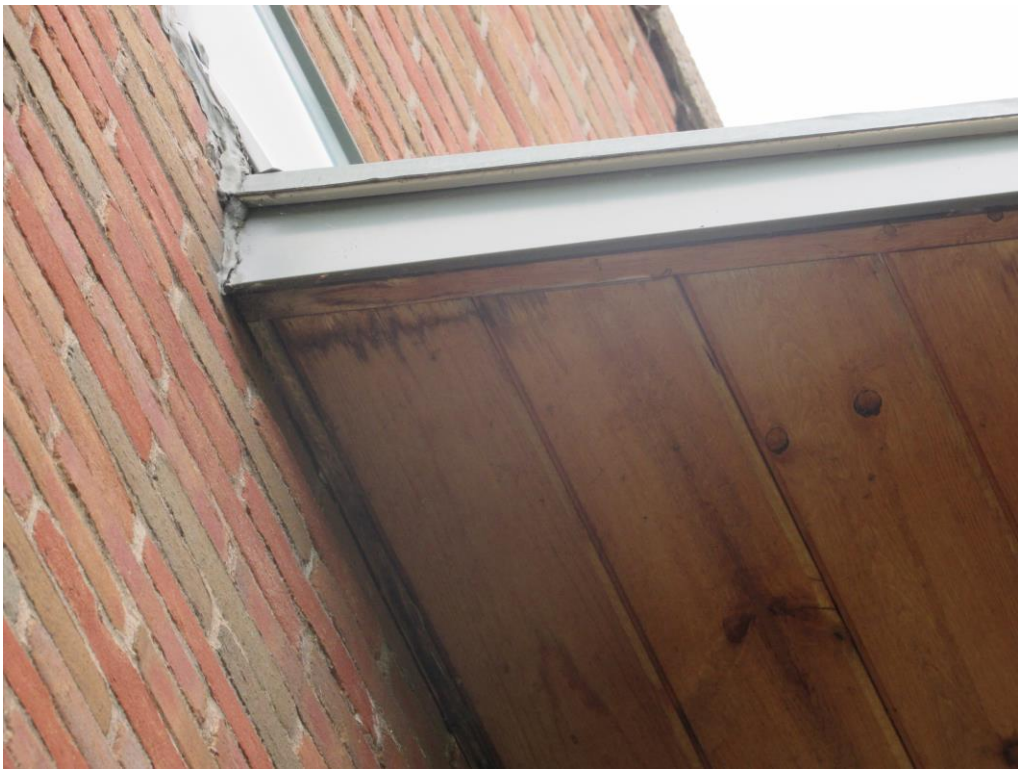
Photograph 17 – Water stains at a wood soffit.

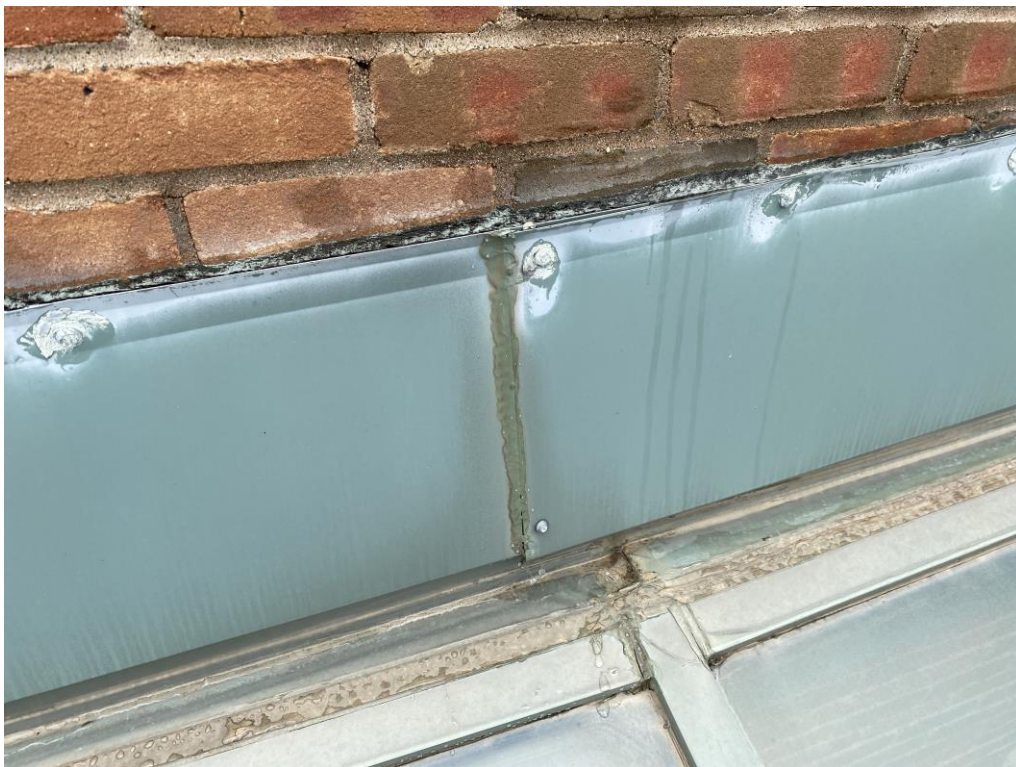
Photograph 21 – Failed sealant joints at the skylight wall flashing, no through wall detail is visible with existing wall flashing.

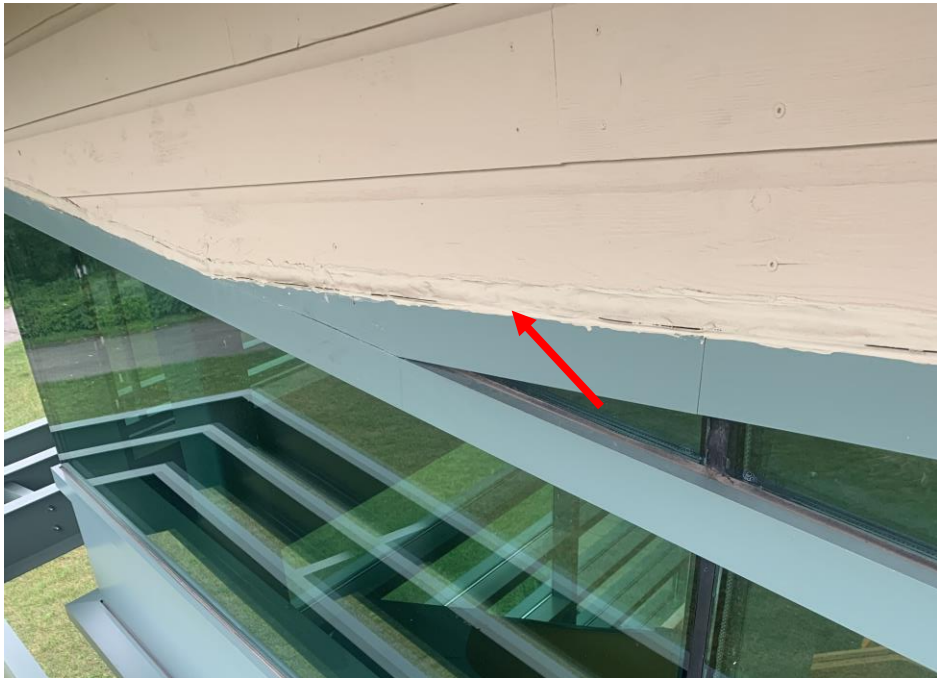
Photograph 25 – Sealant installed at window head/base of siding, with failures observed.

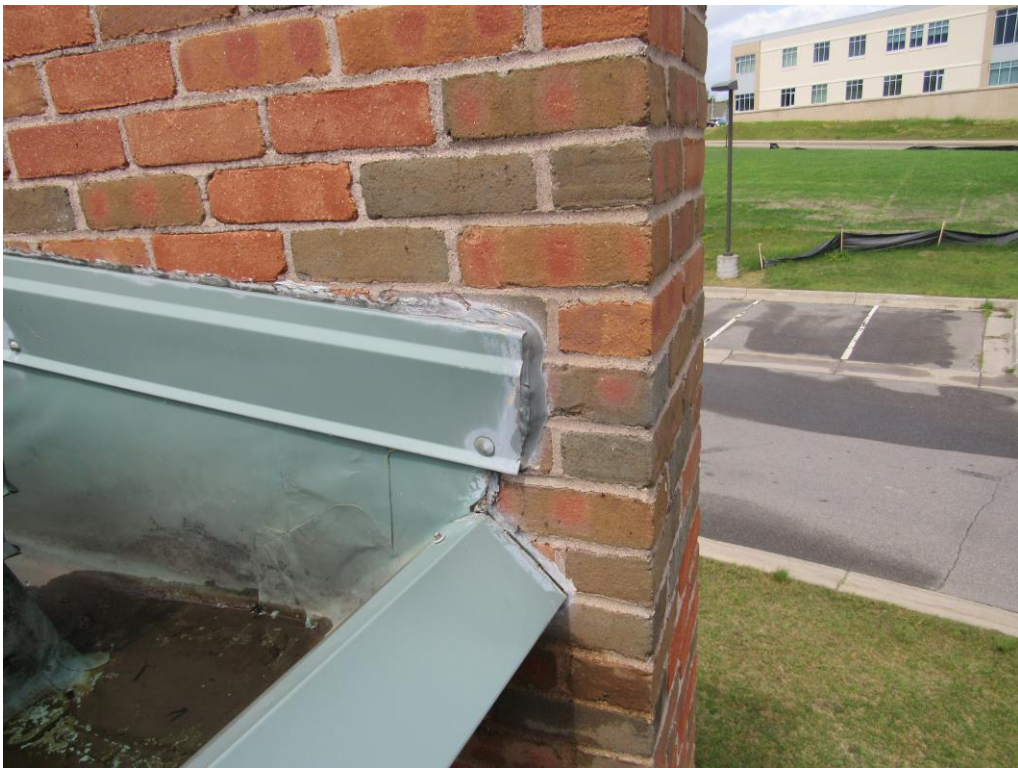
Photograph 27 – Failed sealants at metal flashings.

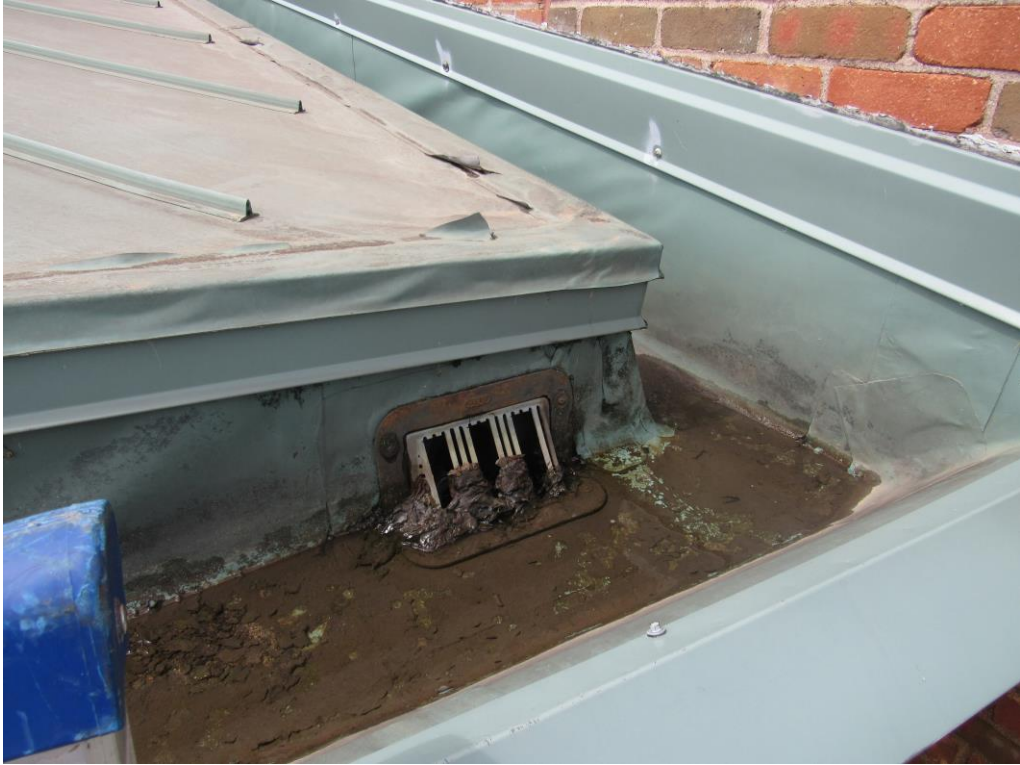
Photograph 30 – Roofing at the north roof elevation, with peeled terminations at the corner.
