Job#: 25-118  
Project Address: 236 S Church St Grass Valley

Jackson & Sands Engineering, Inc. was contacted to provide engineering oversight of the dryrot repair to the bell tower located at the northeast corner of the main building at the project address referenced above. During preliminary investigations, it was found the south corner of the tower at the 2nd floor level settled by greater than 1" due to crushed and deteriorated wood members (Figures 1 and 2). While discussing methods to shore the tower and repair this section the integrity of the lower columns were investigated. The corner columns appear to be constructed of wood framing with a stucco wrap. The wood framing in the easternmost column has deteriorated beyond recognizable shape (Figure 3) and the southernmost column wood has retained its shape but lost the majority of its structural value (Figure 4). Figure 5 further clarifies the location of the eastern and southernmost corners.

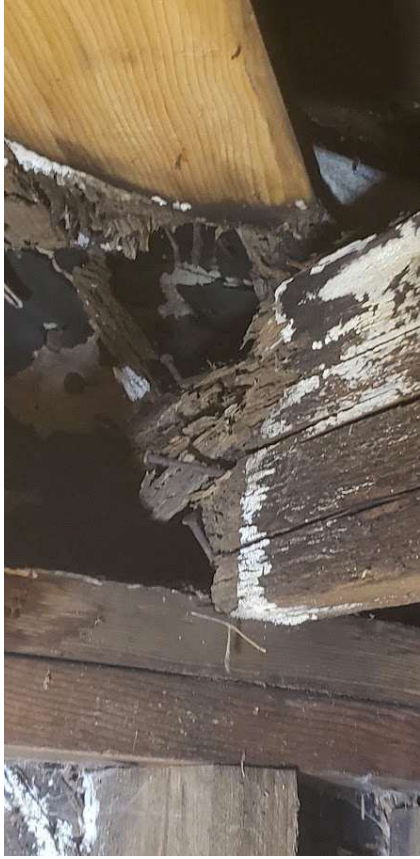
Figure 1- Deteriorated Floor Joist

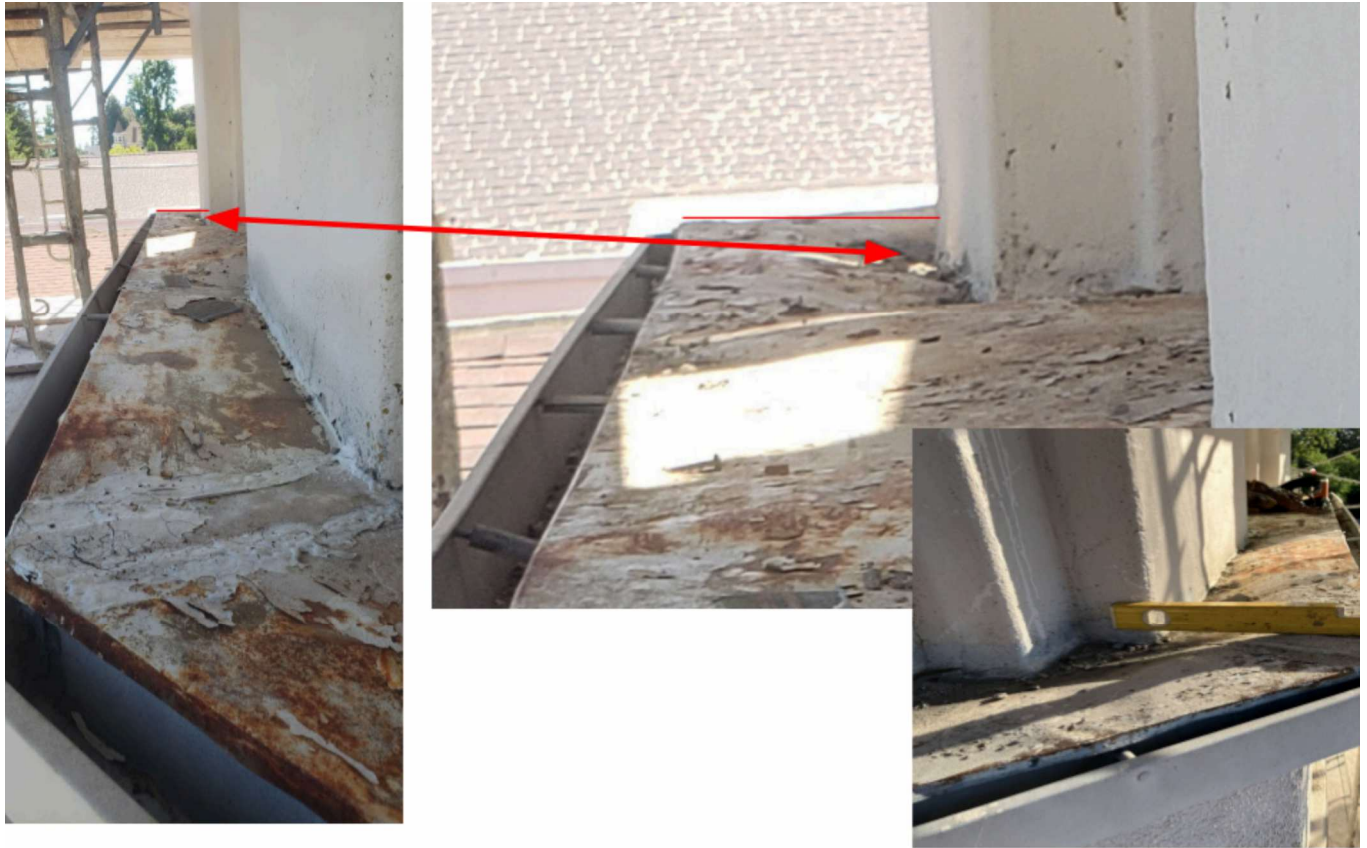
Figure 2- Greater than 1" settlement in the upper level of photo

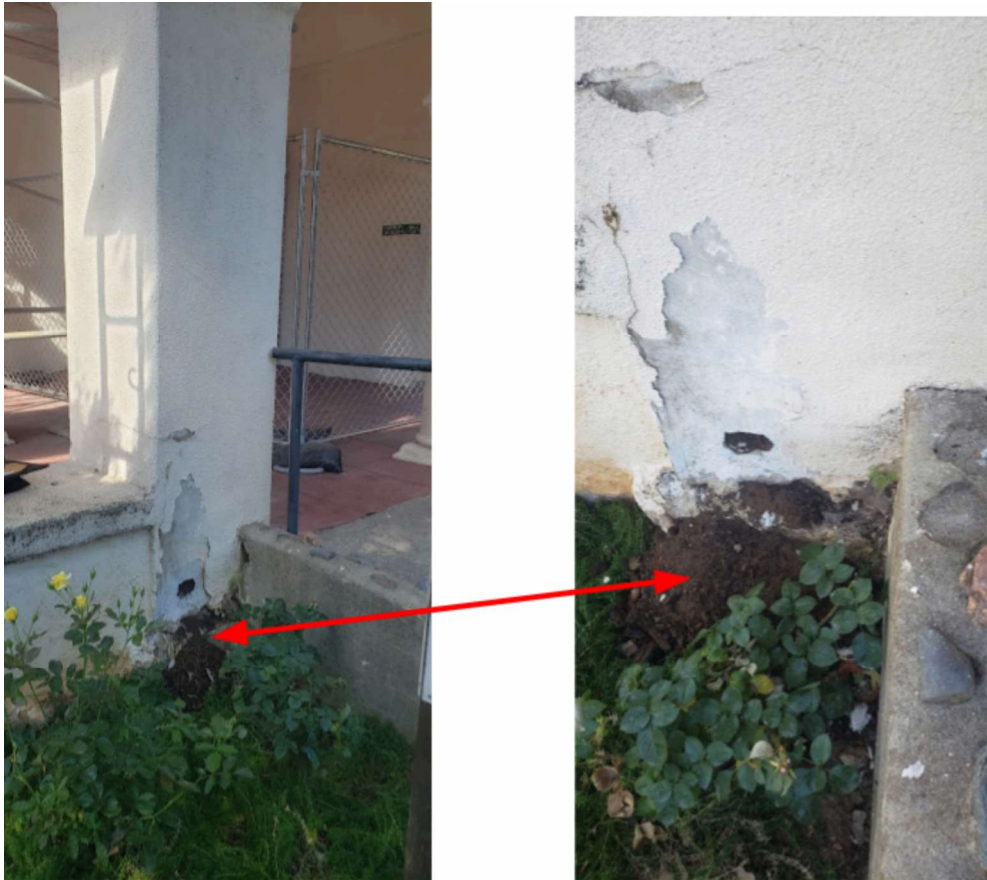
Figure 3- Wood debris from inside the easternmost column

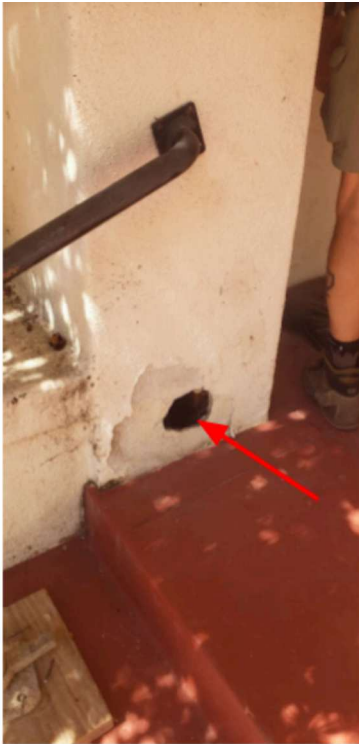
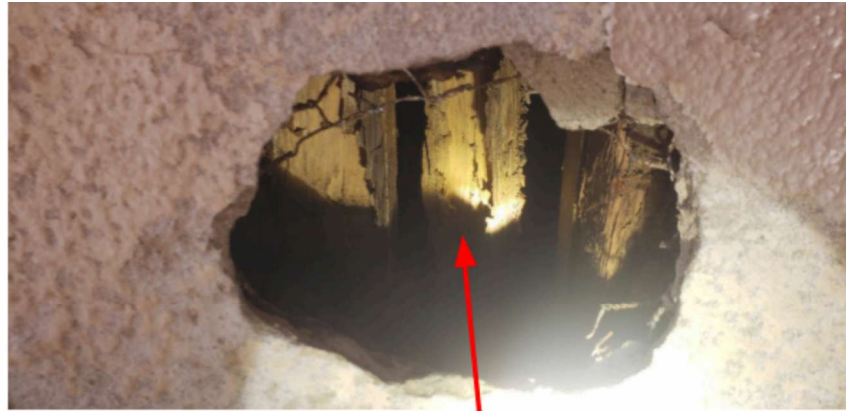
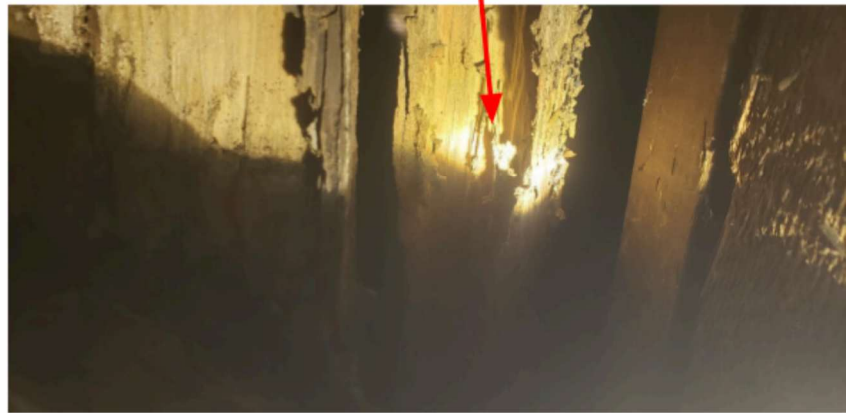
Figure 4- Decayed wood in southernmost column

Through verbal conversation with the building contractor, I understand the building owners do not have sufficient funds to repair the bell tower appropriately, therefore I recommend the bell tower be immediately dismantled to a height where the owner does have funds to adequately repair the remaining portion. The remaining portion of the bell tower will be required to meet current building standards as the extent of the current damage qualifies as substantial structural damage per the California Existing Building Code.

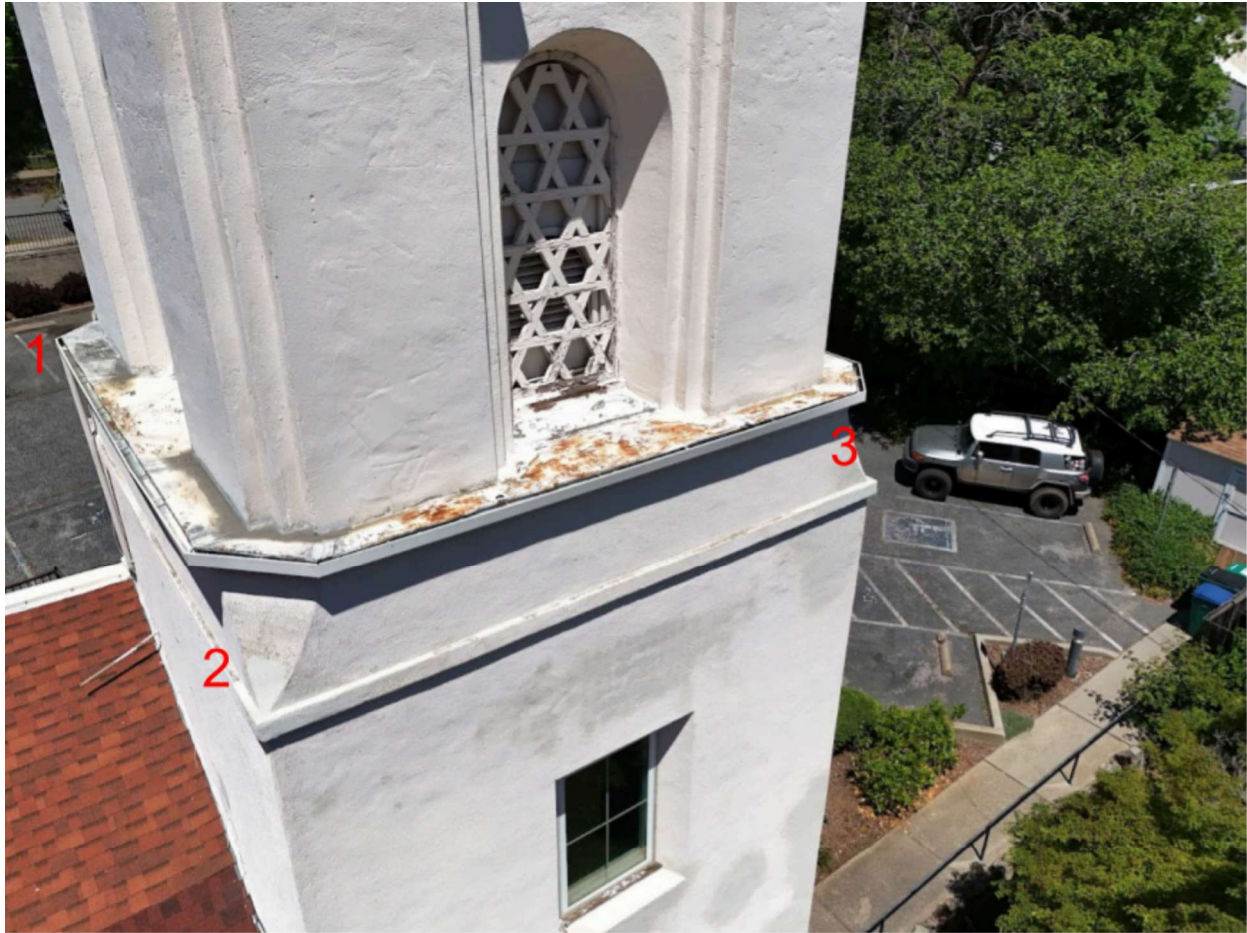
Figure 5- Bell Tower Layout

1-Westernmost corner. 2- Southernmost corner. 3- Easternmost corner.
