June 16, 2023

**Re: Report of Limited Structural Assessment  
219 Spring St, Green Cove Springs, FL 32043**

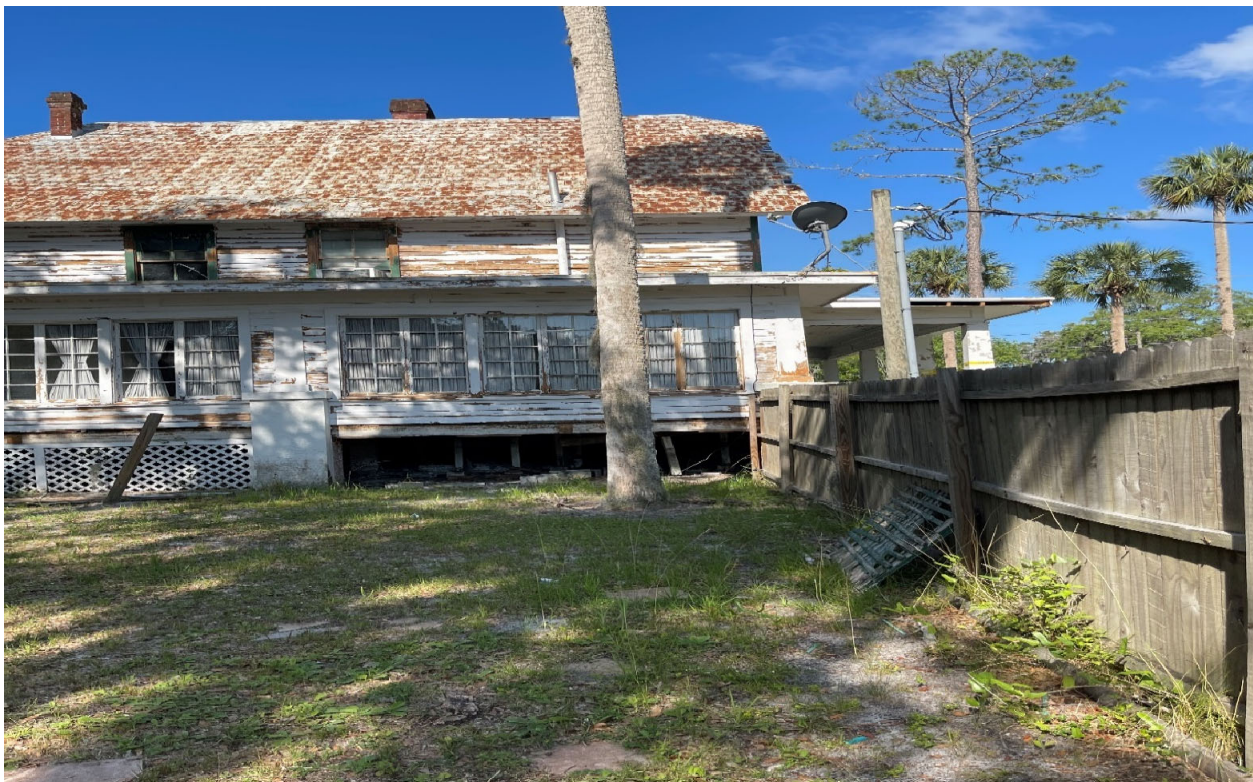
window and door openings. The roof rafters within the attic appeared to be in good condition with no obvious signs of distress; however, the spaced boards used to support metal roof covering were observed to have multiple areas of rot from the exterior. The metal roofing displays signs of rust. The ground floor framing generally felt sturdy when walking around the home. This is consistent with our observations of the crawl space beneath the main home, which revealed conditions to be expected under a home of this age (i.e. evidence of minor termite damage, isolated areas of moisture-related damage, etc.), but no significant structural deficiencies. From the exterior, multiple areas of rotten and/or damaged wood siding were observed around the perimeter of the home.

Photo 2: Left Side Main Home/Enclosed Porch – Note Rust to Metal Roofing

- The spaced boards supporting the metal roofing, as well as the metal roofing itself, will require replacement.
- Our observations revealed that the existing building is severely lacking in lateral wind resistance. Should it be required to meet current wind load demands in the building code, the installation of wood structural panel sheathing around the building exterior, along with metal tie-downs throughout the home, would be required.

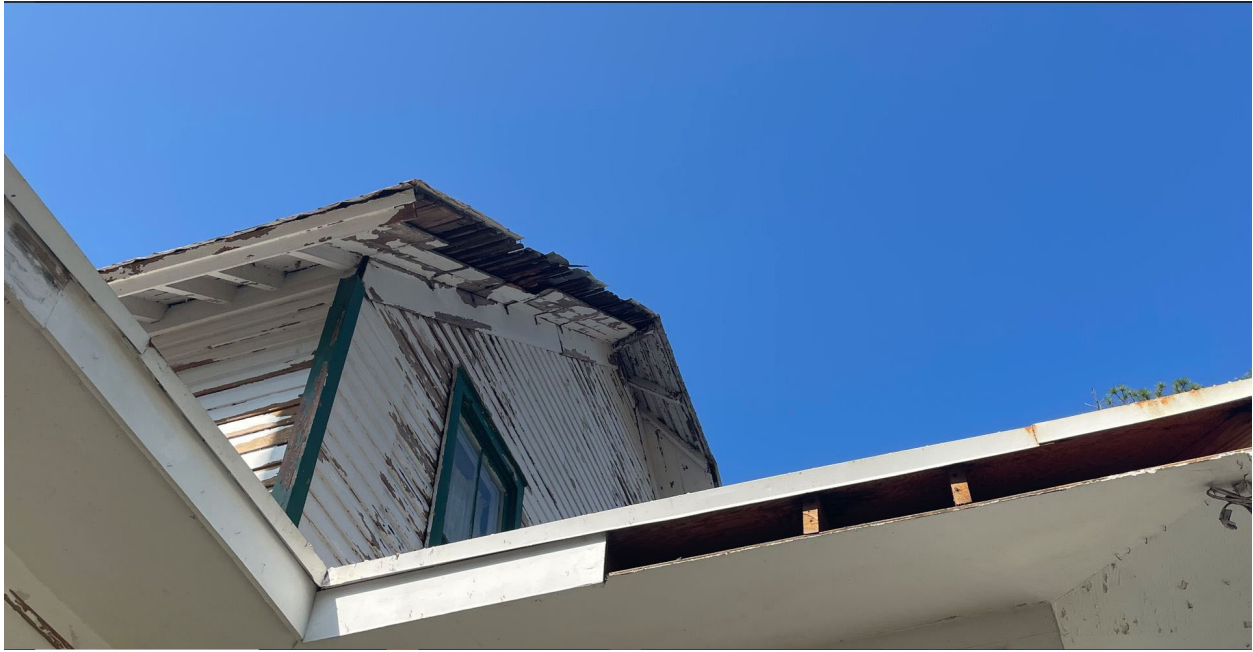
Photo 4: Deteriorated Boards Supporting Metal Roof

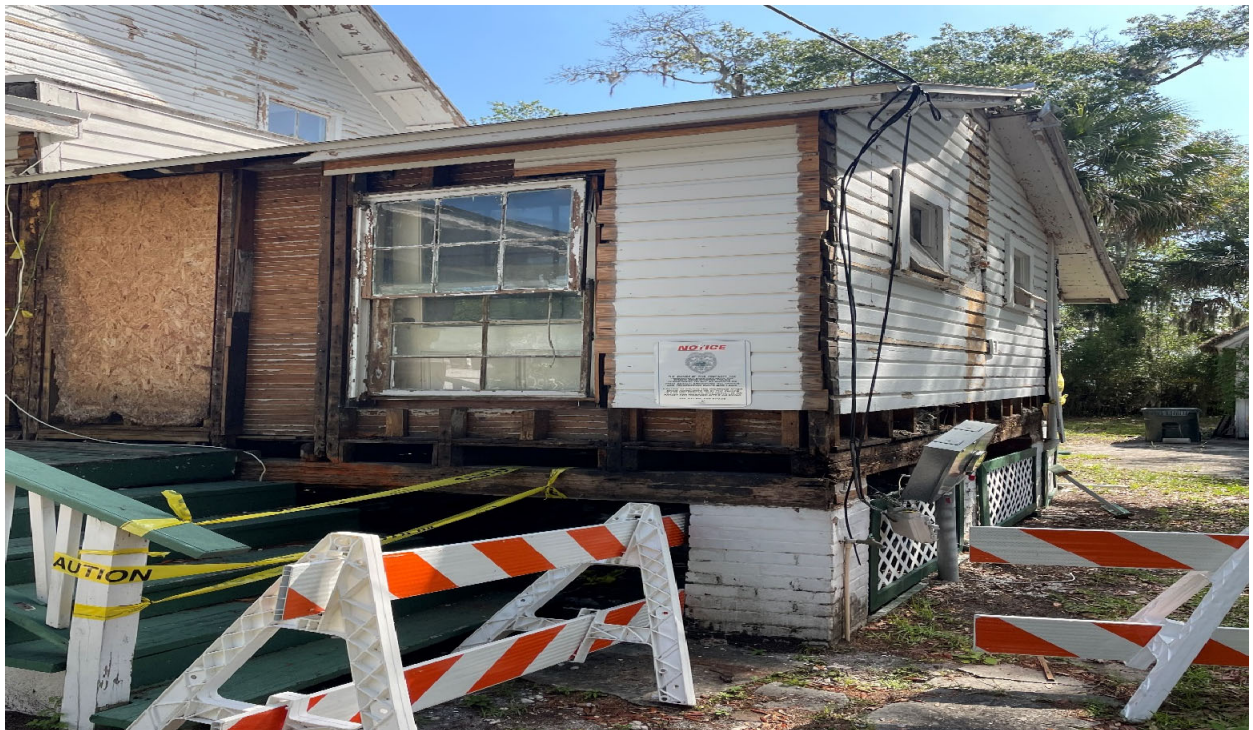
Observations of the rear additions revealed these portions of the home are in severe state of disrepair. Several of the wall studs, as well as the floor beams, display varying degrees of moisture damage, as well as evidence of past wood destroying organism (WDO) related damage. The perimeter floor beams under the exterior walls are severely deteriorated. Large sections of the exterior siding have either rotted away or been removed, revealing that the underlying framing is insufficient or missing around some of the windows. There is a wood deck along the rear and left side of the additions that appeared unsafe to walk on. Limited observations into the deck crawl space revealed overspanned and rotten floor framing.

Photo 5: Dilapidated Rear Addition

- Much, if not all, of the exterior wood siding will need to be replaced.
- The perimeter floor beams and rotten floor framing observed in the rear additions will require replacement. The observed damaged wall framing in the additions will require replacement. Additional damage outside of what was observed should be expected as more of the existing framing is exposed. Due to the potential for collapse, the deck areas along the rear and left sides of the additions should be cordoned off and demolished.

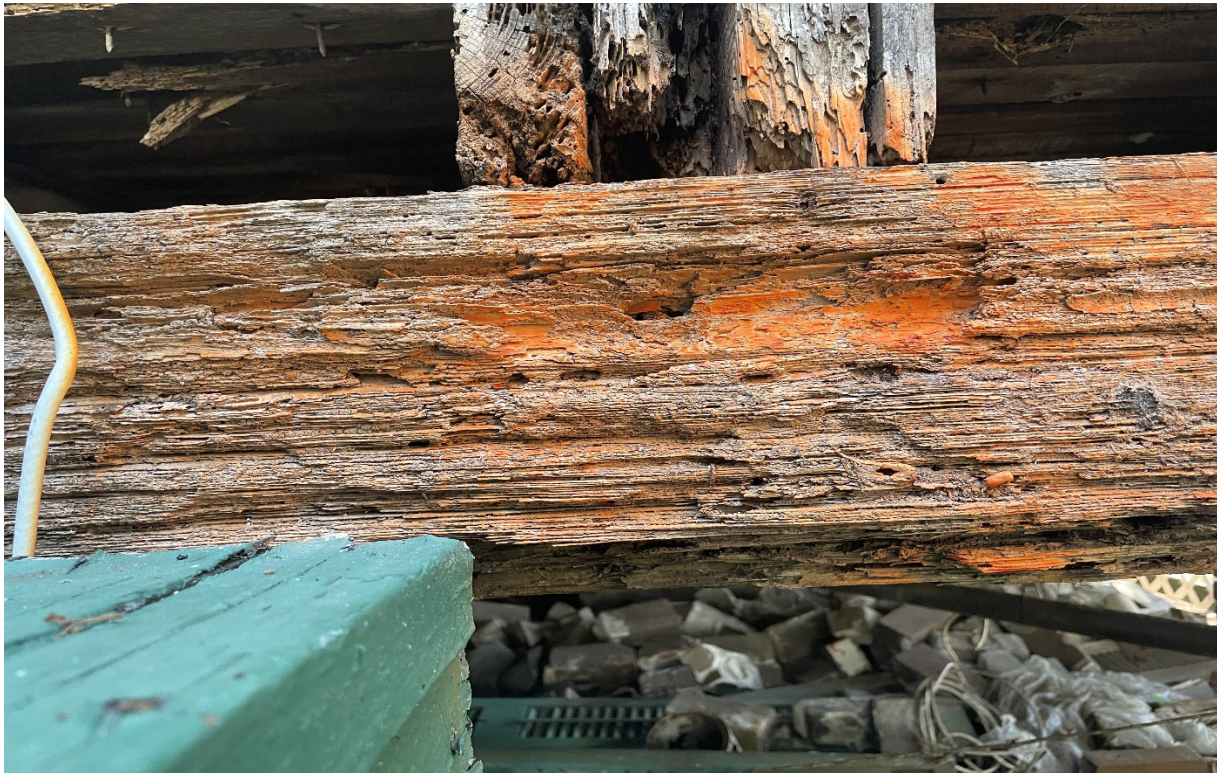
Photo 6: Rear Addition – Deteriorated Perimeter Beam

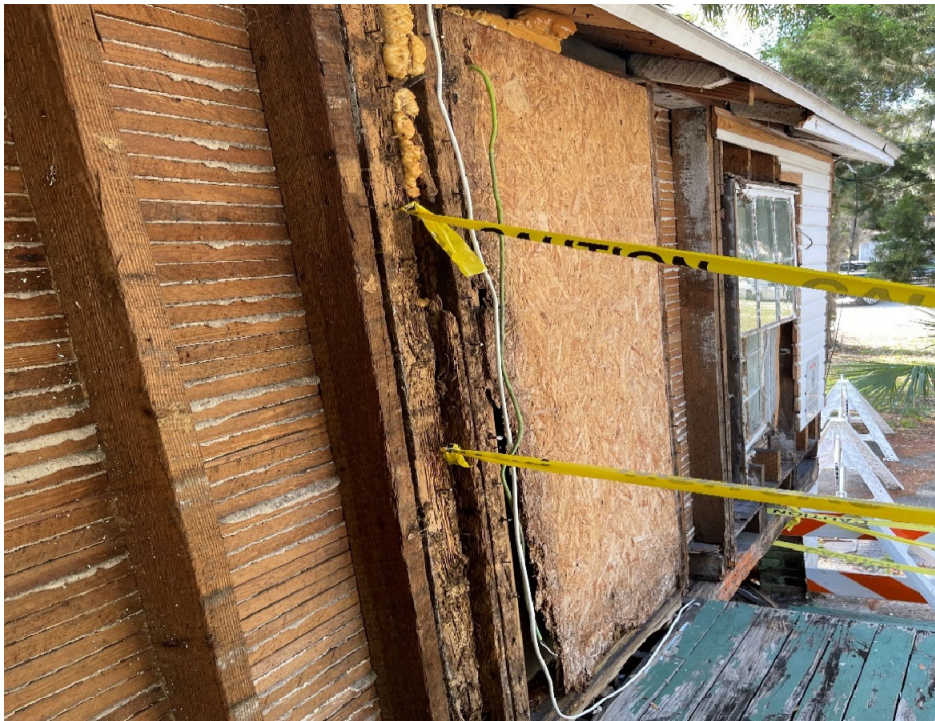
Photo 7: Rear Addition – Damaged Studs

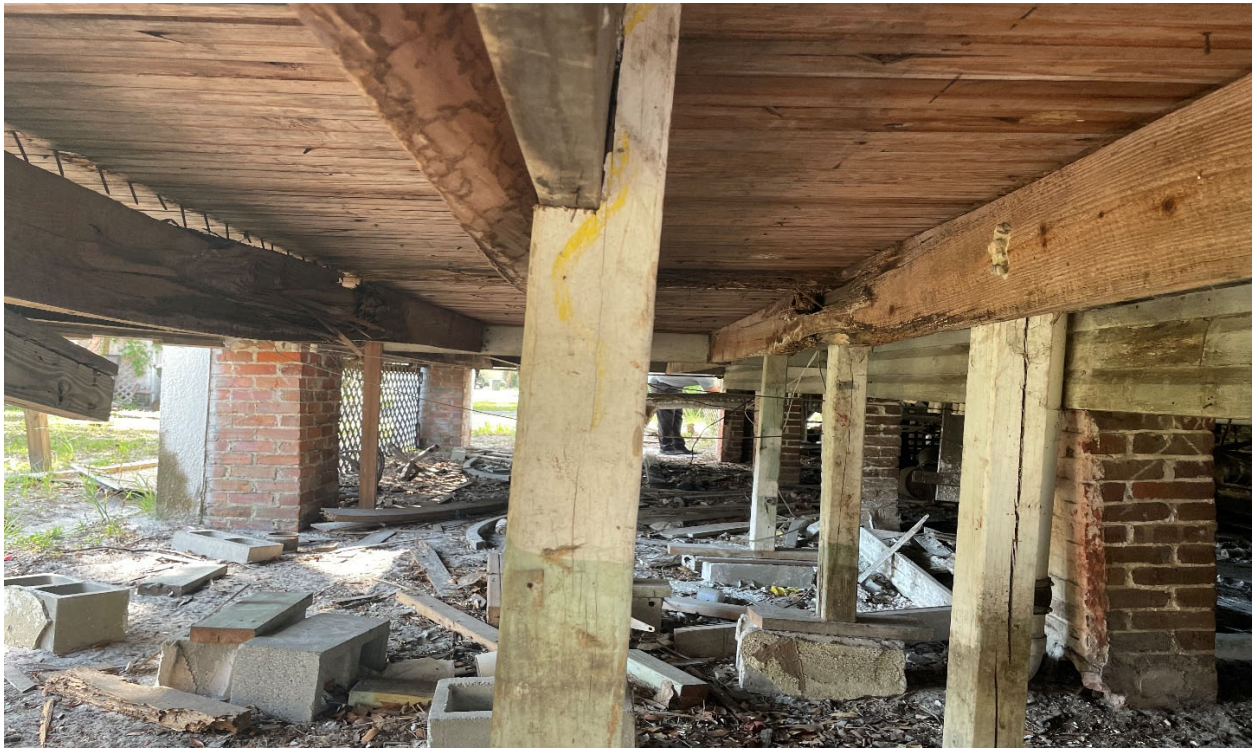
Observations of the enclosed covered porch along the left side of the home revealed multiple structural issues in the floor framing. The floor felt extremely soft and “spongy” with noticeable deflection when walking along the front left portion of the porch. Moisture related staining was also observed to the flooring in this area. Our crawl space observations revealed that the floor system is in a severe state of disrepair. The level of deterioration is to such an extreme that little to no wood material remains in several of the joists. The existing joists also appear to be overspanned, with even the less damaged members displaying a sagging appearance. Multiple previous repairs appear to have been attempted to this area over the years using improperly supported wood posts. Many of the posts have rotted and collapsed.

Photo 8: Enclosed Porch Floor Framing – Improper Wood Post/Damaged Floor Joist

- The entire ground floor of the left side enclosed porch can be presumed to be deficient and will require complete replacement.
- The overspanned floor members of the open, covered porches will require strengthening at various locations. This strengthening can consist of replacing the existing lumber with larger, stronger members and/or adding supplemental supports (i.e. additional beams, CMU piers, and footings) to shorten the existing member spans.

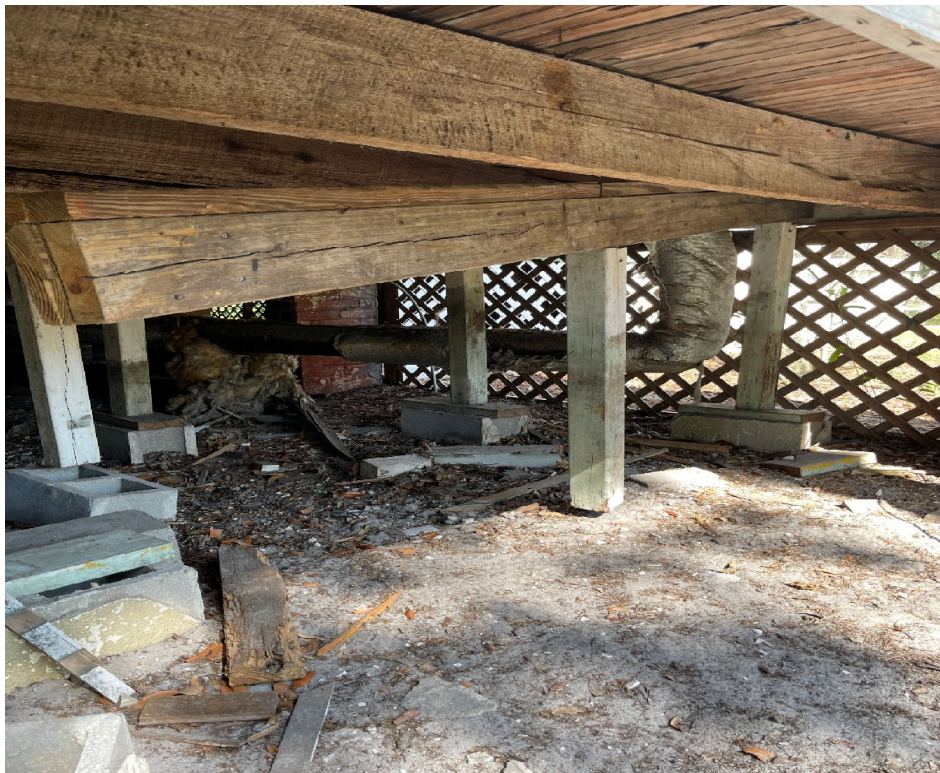
Photo 9: Enclosed Porch Floor Framing – Previous Repair/Unsupported Beam
