Routine Inspection Report

Date: 5/17/2019

Br No 445

GOOD RIVER

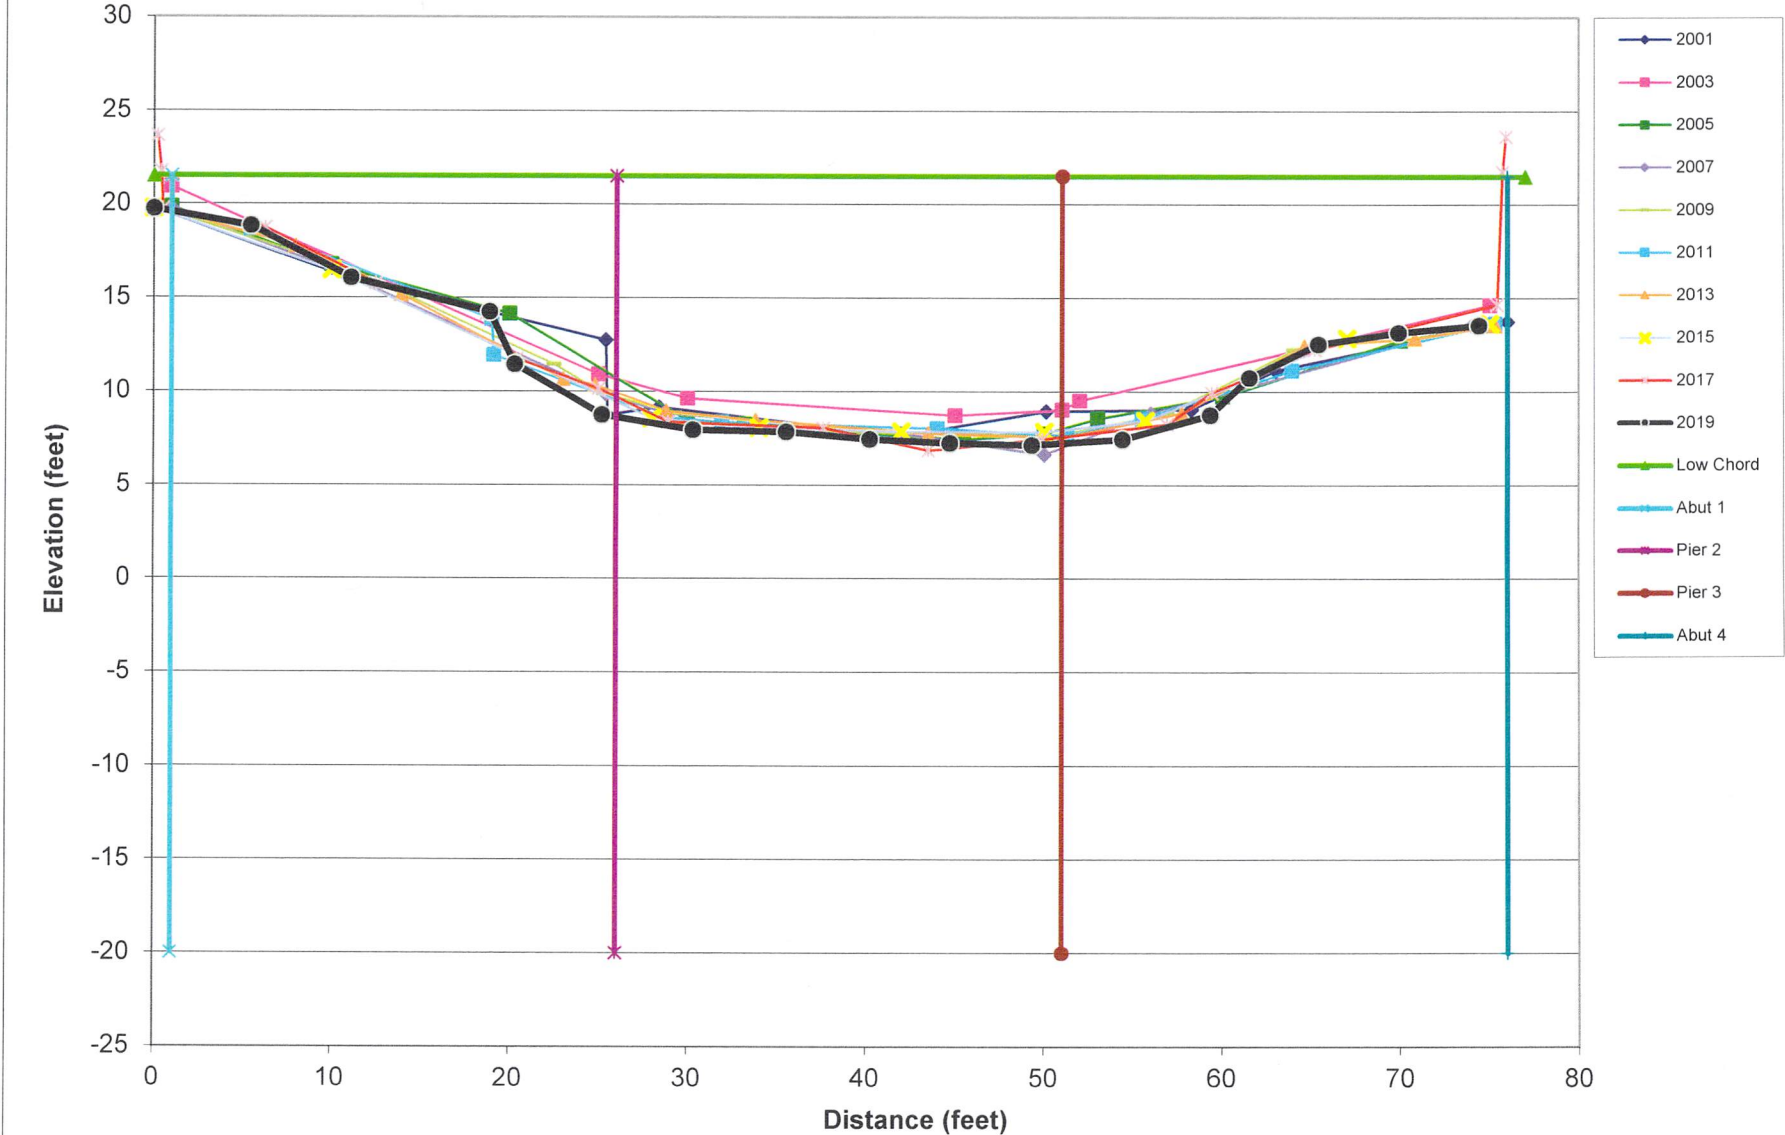
BN 445 Good River Soundings

Soundings Report				
All measurements in feet				
09 Odd 2019 445				
Horiz Dist from NE	Substr Unit No.	Vert Dist to Water Surface	Vert Dist to Stream Bottom	Remarks
0.00	1	0.0	6.0	Begin Bridge
5.50	1	0.0	6.9	
11.10	1	0.0	9.7	
18.90	1	0.0	11.5	
20.30	1	0.0	14.3	
25.20	1	0.0	17.0	P2 EOW
30.30	1	0.0	17.8	
35.50	1	0.0	17.9	
40.20	1	0.0	18.3	
44.70	1	0.0	18.5	
49.30	1	0.0	18.6	P3
54.40	1	0.0	18.3	
59.30	1	0.0	17.0	EOW
61.50	1	0.0	15.0	
65.40	1	0.0	13.2	
69.90	1	0.0	12.6	
74.40	1	0.0	12.2	End Bridge

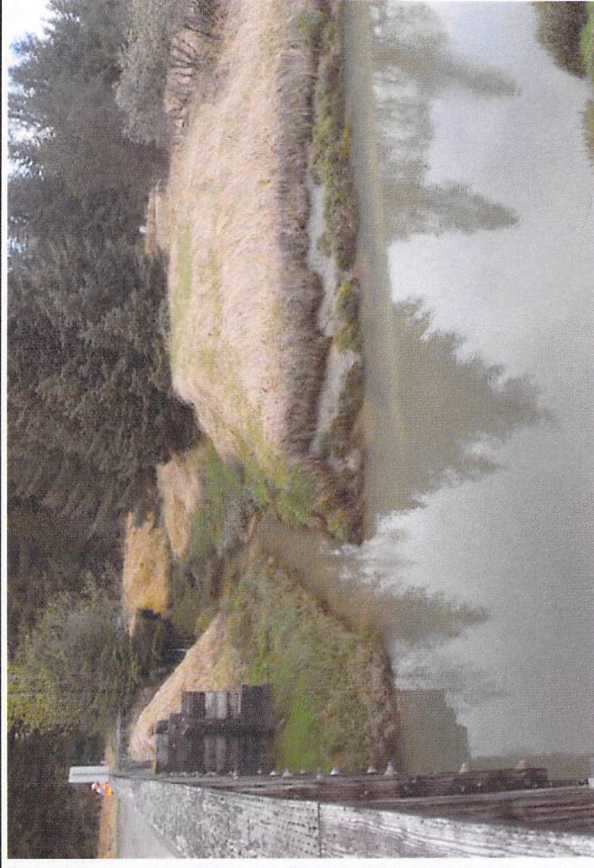
Inspection To Mudline At All Piers and Abuts? <input checked="" type="checkbox"/> Yes	Apparent HW <input checked="" type="checkbox"/> No	Stream Bottom Material
	AHW Comments <input type="text"/>	
	Bank Erosion <input checked="" type="checkbox"/> Yes	<input type="text"/> Sand
	Erosion Comments <input type="text"/>	<input type="text"/> Silt
	NE and FE banks cut and sloughing, extending far US and DS. Secondary channel at FE DS has undercut the FE US wingwall.	
Activities <input type="text"/> None.	Drift Comments <input type="text"/>	<input type="text"/>
Drift <input type="text"/> None		
Riprap Condition <input type="text"/> None visible.	Other Hydraulic Comments	
	Losing fill at FE US from wingwall to Pile 2; lagging is undermined. FE approaches have retaining walls; FE US wall has erosion ~ 15 feet x 8 feet; the lagging is split, separated, and vegetated.

Bridge No.	0445	Br. Name	Good River	Date	05/17/19
Inspector	FE US bank	McRae / Murray		Frame	8
				File	P5170603.JPG

Priority	Description	Quantity	Work Needed
High	Bridge Rail-Replace	24	FE US bull rail: Replace last 24 feet. DS: Replace posts 7 and 10.
High	Approach Railing (EA)	5	NE US: Repair 1 W-beam lapped in wrong direction and loose end treatment cable. NE DS: Replace 1 rotted post. FE DS: Replace 1 post rotted. FE DS: Repair damaged end treatment and tighten cable. FE US: Replace 6 rotted posts and 2 damaged spacers.
High	Misc-Install Sign (EA)	3	Install FE name place sign and one lane bridge sign at FE.
High	Channel-Repair Washouts / Erosion	1	Place material behind FE US soldier pile wall. Fill erosion hole with riprap at FE US embankment
Medium	Substructure-Repair (EA)	1	Replace rotten and loose lagging.

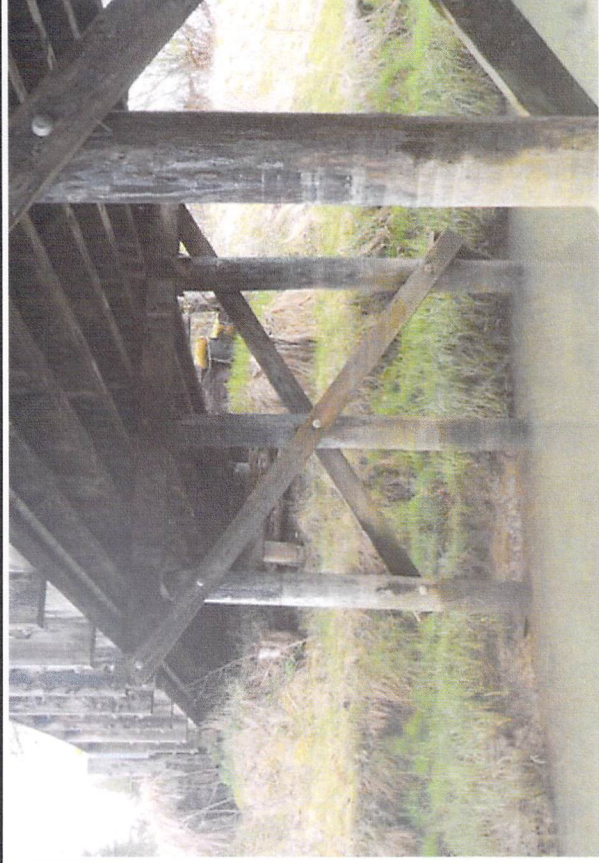
Bridge No. 0445 Br. Name Good River
Inspector McRae / Murray Date 05/17/19
P2 FE face Frame File P5170614.JPG

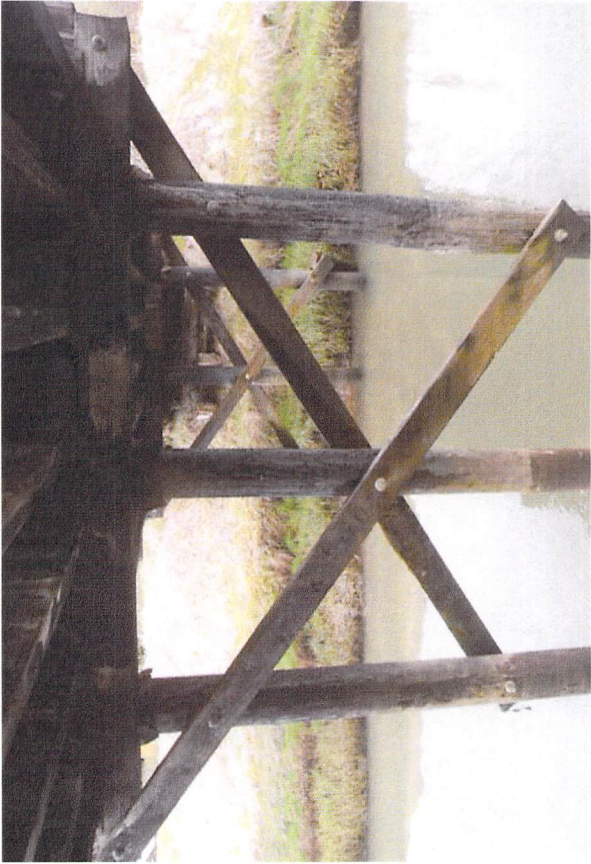
Bridge No.	0445	Br. Name	Good River	Date	05/17/19
Inspector		McRae / Murray		Frame	13
	P3 FE face			File	P5170612.JPG

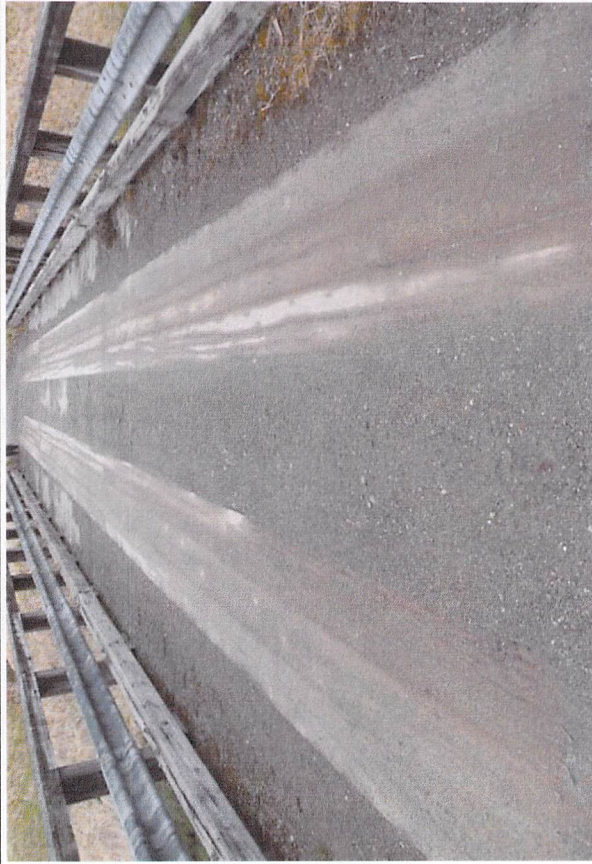
Element	Description	Observations
31	Timber Deck	Sand and gravel accumulated between planks, depth of running planks on most of deck. Approximately 25% of deck planks split at ends full depth. Bottom of deck water stained with isolated areas of minor section loss.
> 510	Wearing Surfaces	Typical: Running planks split and gouged. Nail heads are starting to protrude. Rot initiating at some of the splits. NE: 1 board rotted for 5 feet.
111	Timber Open Girder/Beam	Beam 1 S3: 6 inch x 1 inch deep split at 2/3 height. Beam 3 S1: 7 foot long x 1 inch deep x 3 inch wide split at bottom. Minor section loss (1 inch or less) to bottom corners on approximately 5 percent of beams.
206	Timber Column	The pier piles sound a little soft near the water level. Lower ends of diagonal braces are starting to rot. P2 Center Pile: Split at NE bottom third with 1/2 inch probe penetration. P2 DS Pile: Old pile immediately adjacent to current pile. P3 US Pile: Split NE and below cross bracing.

Bridge No.	0445	Br. Name	Good River	Date	05/17/19
Inspector		McRae / Murray		Frame	15
	Wearing surface, typ.			File	P5170610.JPG

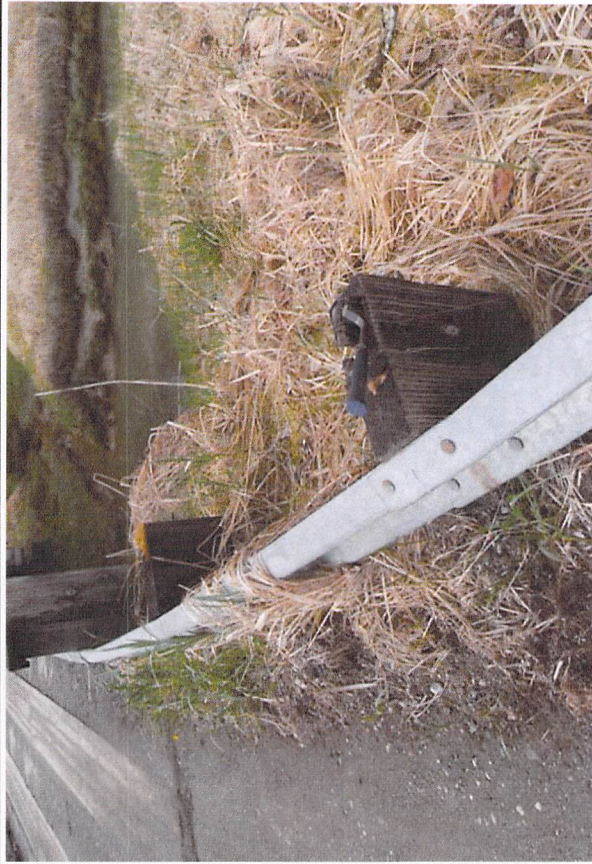
602	Approach Rail Smart Flag	<p>DS: 6 inch berm at bottom of W-beam.</p> <p>NE US: 1 W-beam lapped in wrong direction and end treatment cable loose.</p> <p>NE DS: 1 rotted post. End treatment 16.5 inches at top.</p> <p>FE DS: 1 post rotted.</p> <p>FE DS: End treatment damaged and cable loose. Retaining wall piles all rotten at top with approx. 2 inches remaining section of a 12 inch diameter pile.</p> <p>FE US: 6 rotted posts and 2 damaged spacers.</p>
606	Approach Fill Erosion Smart Flag	<p>FE US embankment erosion and settlement behind wingwall. It appears an attempt was made to place some material in the erosion area; however, the material looks to be susceptible to further erosion. Riprap appears to be needed at this location.</p> <p>Retaining wall and soldier pile retaining wall lagging displaced and losing fill. Vegetation growing from cracks and piles rotting at top. 15 feet x 8 feet of erosion behind US soldier pile retaining wall with tie backs. Some planks show deterioration, vegetation and moss growth on and between planks.</p>

Bridge No.	0445	Br. Name	Good River	Date	05/17/19
Inspector		McRae / Murray		Frame	16
	NE US approach railing post, typ.			File	P5170622.JPG

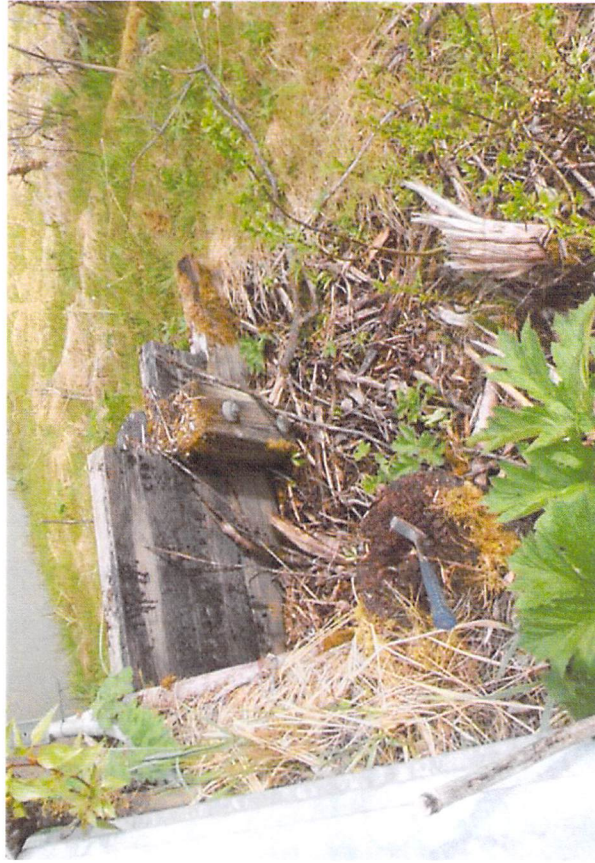
Bridge No.	0445	Br. Name	Good River	Date	05/17/19
Inspector		McRae / Murray		Frame	17
	FE DS wingwall pile			File	P5170623.JPG

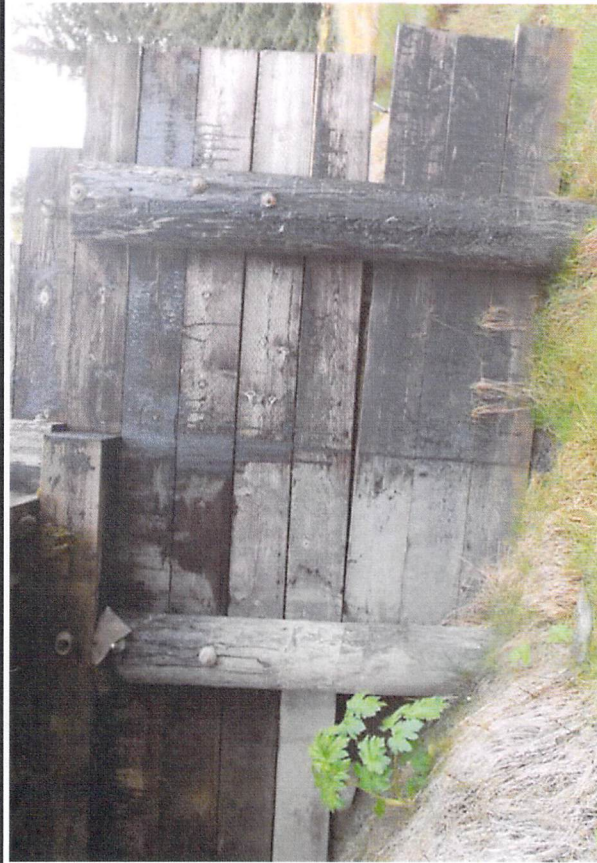
Bridge No.	0445	Br. Name	Good River	Date	05/17/19
Inspector		McRae / Murray		Frame	19
	FE US backwall			File	P5170613.JPG

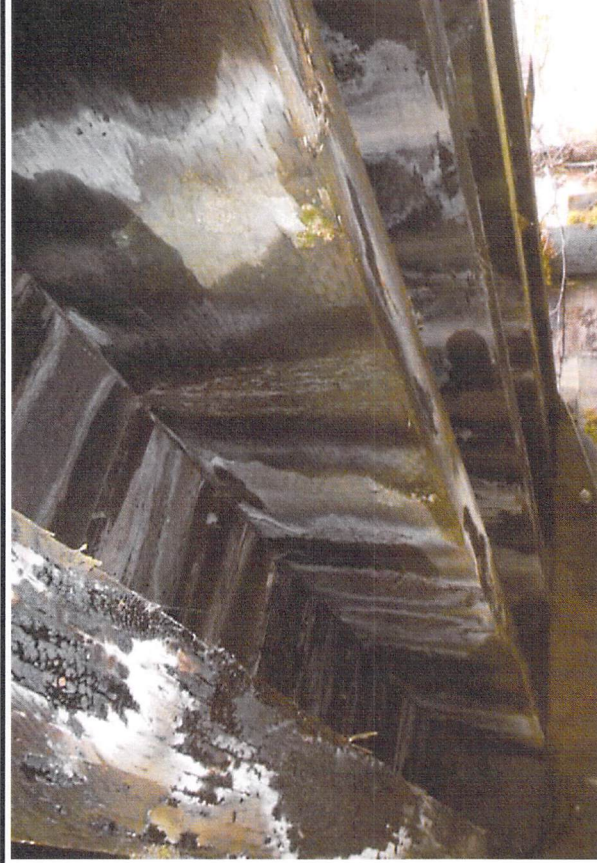
Bridge No.	0445	Br. Name	Good River	Date	05/17/19
Inspector		McRae / Murray		Frame	20
	Beam condition, typ.			File	P5170617.JPG

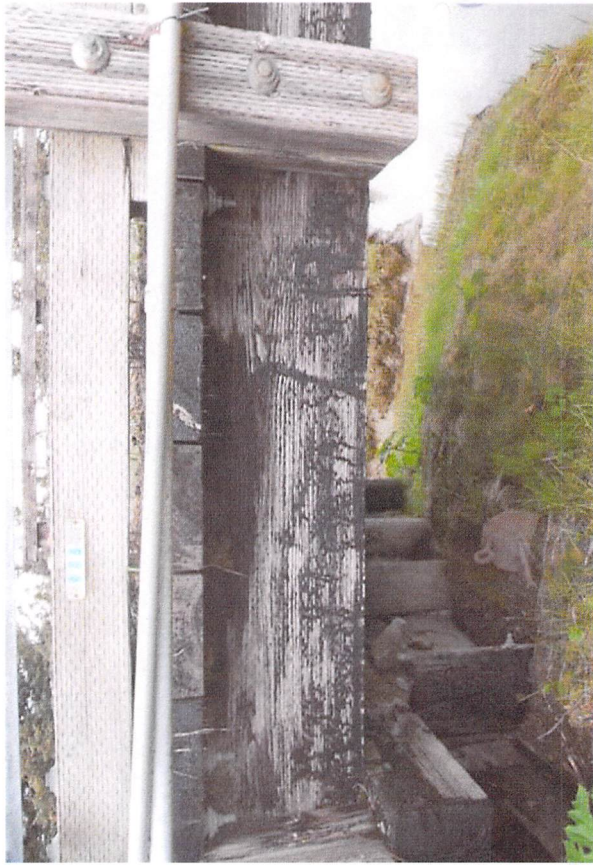
Bridge No.	0445	Br. Name	Good River	Date	05/17/19
Inspector		McRae / Murray		Frame	21
		FE DS split in beam		File	P5170624.JPG

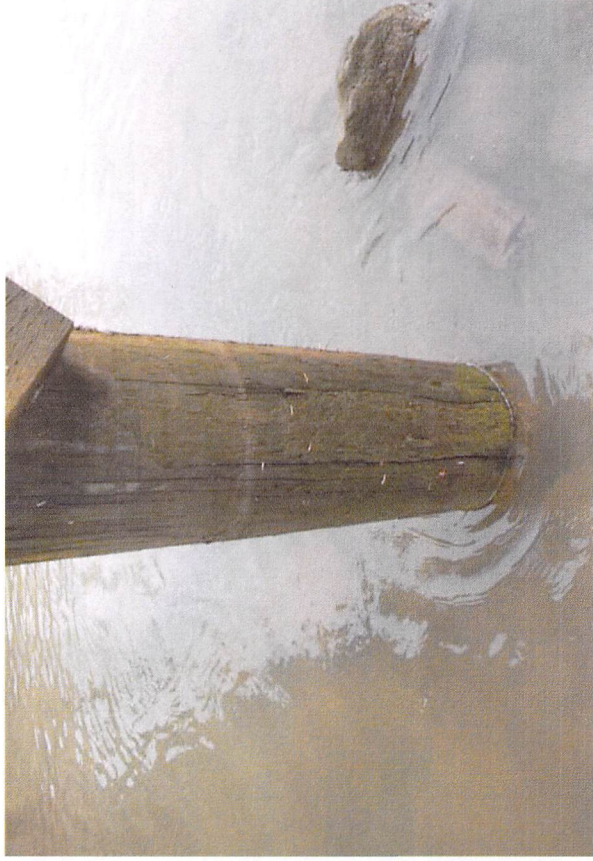
Bridge No.	0445	Br. Name	Good River	Date	05/17/19
Inspector		McRae / Murray		Frame	22
		P3 DS pile vertical splits		File	P5170625.JPG

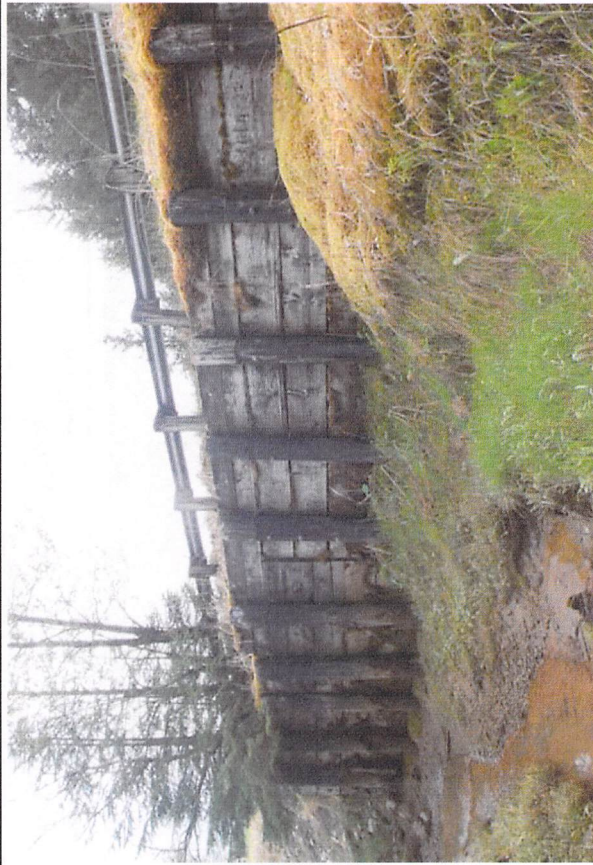
Bridge No.	0445	Br. Name	Good River	Date	05/17/19
Inspector		McRae / Murray		Frame	23
		FE US retaining wall		File	P5170626.JPG
