November 28, 2025

RE: Boardwalk Evaluation  
Manly Bennett Park  
Hamburg, MI  
IMEG #25006430.00

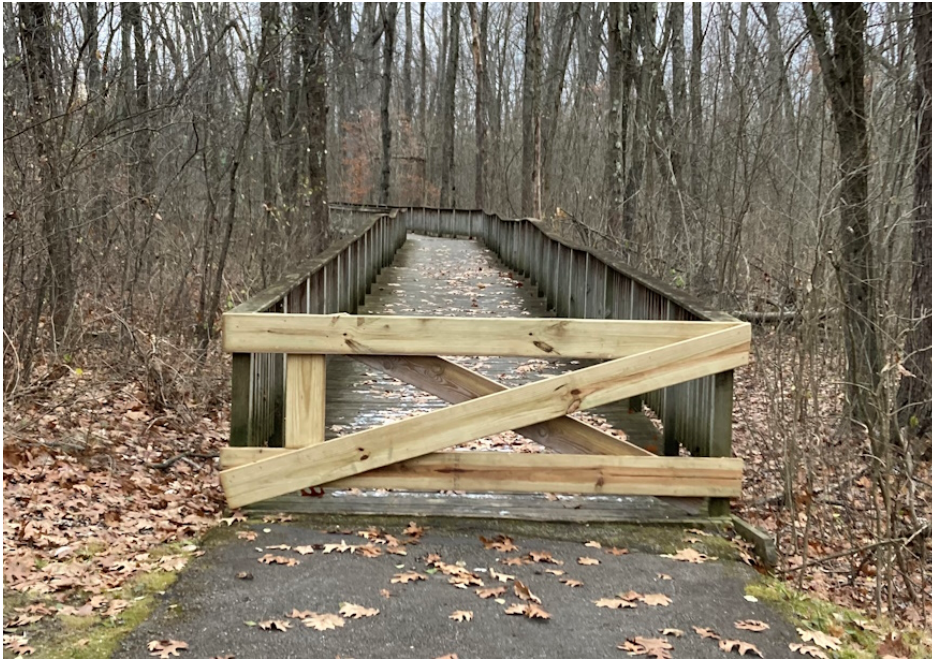
*Figure 2: Beginning of boardwalk, currently closed to public access*

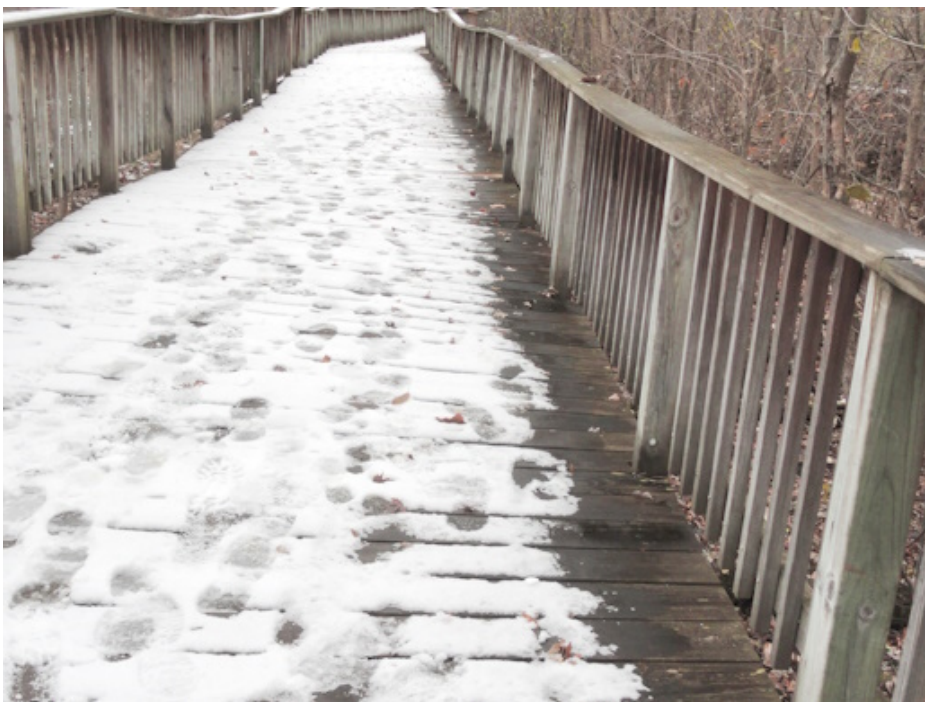
The post heaves have led to large cross-walk slopes in some areas (Figs. 3, 5). I also noted the section approximately 200 – 400 feet from the boardwalk start has a pronounced lean to the south (Fig. 2).

*Figure 1: Sidesway displacement, towards right in photo*

The observed side-lean does not appear to be extreme enough yet to compromise lateral stability but should be monitored over time to note if the condition progresses. Short of re-framing this section, some type of wood or steel braces or kickers might be considered as a less expensive solution.

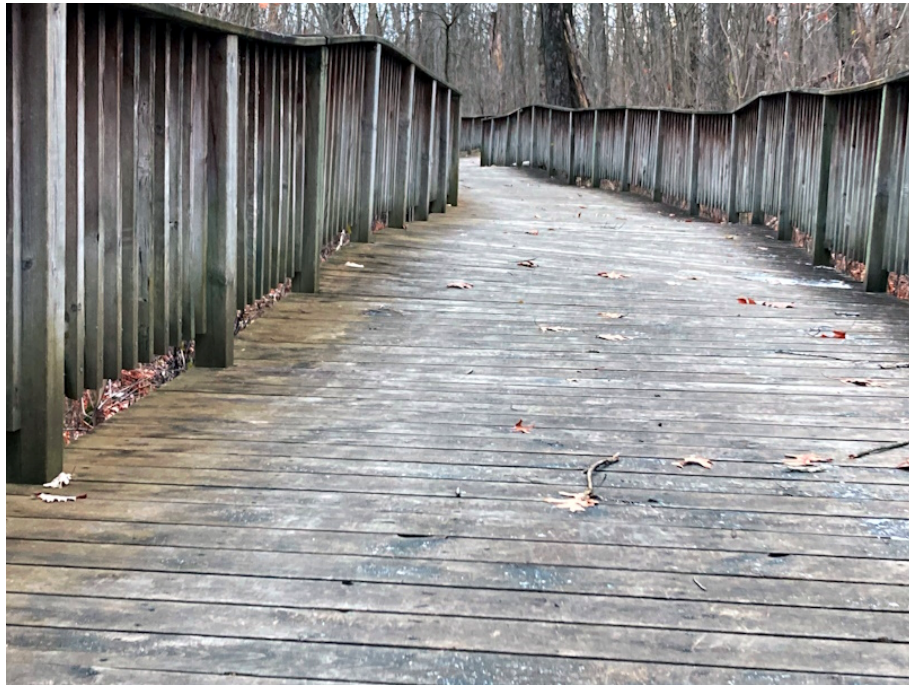
The concrete surrounds are typically shallow and do not extend to frost depth. As a result, many of them have been heaved up above grade, in some cases completely exposing them (Fig. 5). This action has similarly affected many posts, leading to substantial humps along the length of the boardwalk (Figs. 2,3,4).

*Figure 4: Humps and excessive cross-slope*

Based on the above observations I conclude that it should be possible to re-open boardwalk for public access with a limited range of immediate repairs. Any loose or popped-up deck boards should be replaced or re-fastened to eliminate all trip hazards. The more extreme humps and dips associated with high cross-walk slopes should be leveled. The simplest method for this may be to re-set the cross beams lower on the heaved posts by re-drilling holes for the carriage bolts and trimming the post top. Alternately, at the repaired posts, the post may be trimmed at the splice, lowered and re-fastened with new wood or steel straps.

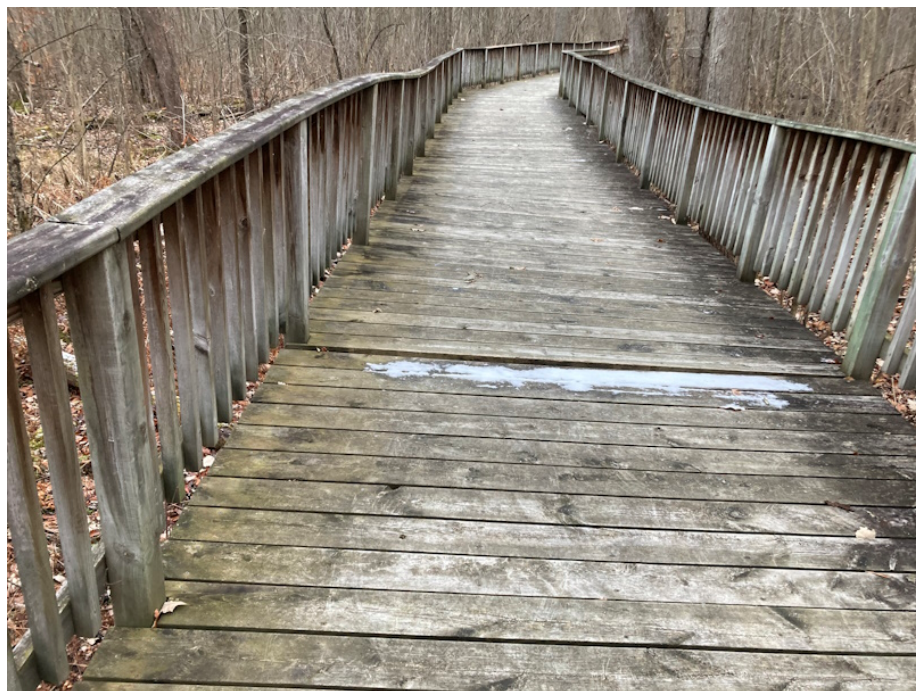
The overall condition of wood members is typically good. The deck boards are in generally good condition but loose and popped-up deck boards were observed at various locations (Fig. 4). Some posts had small amounts of sponginess near the soil line but were in general fairly sound despite frost heave. No significant degradation of cross beams or stringers was noted. Handrails were typically in good condition.

*Figure 3: Trip hazard at raised deck board*

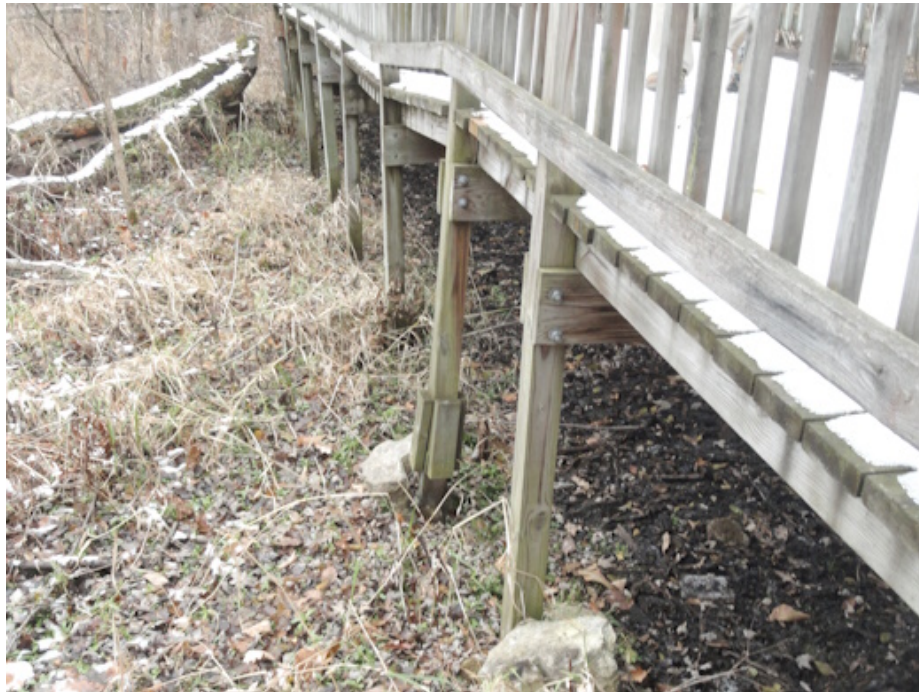
A series of posts approximately 700 feet from the walk end have been repaired by splicing new segments above heaved footings (Fig. 5). A particularly sharp hump occurs here.

*Figure 6: Existing post repairs with heaved concrete surrounds*

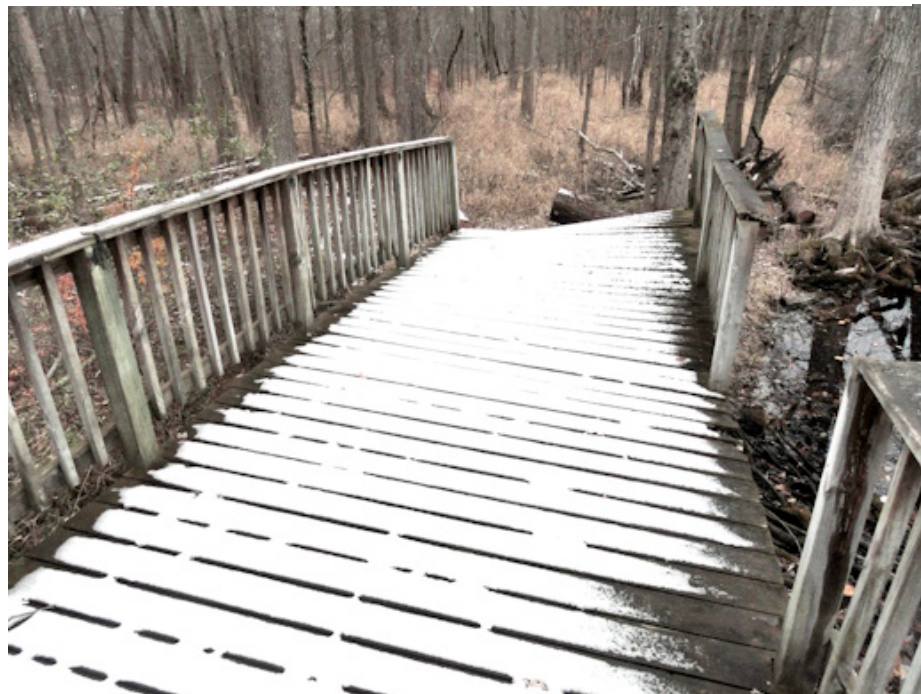
A T-section occurs where the boardwalk meets the Huron River. The north portion of this has collapsed, apparently due to a tree fall, and is blocked off (Fig. 6).

*Figure 5: Collapsed end at river*

The collapsed portion at the river verge is in a challenging location for replacement. Full repair may be costly so the township may consider abandoning this portion.

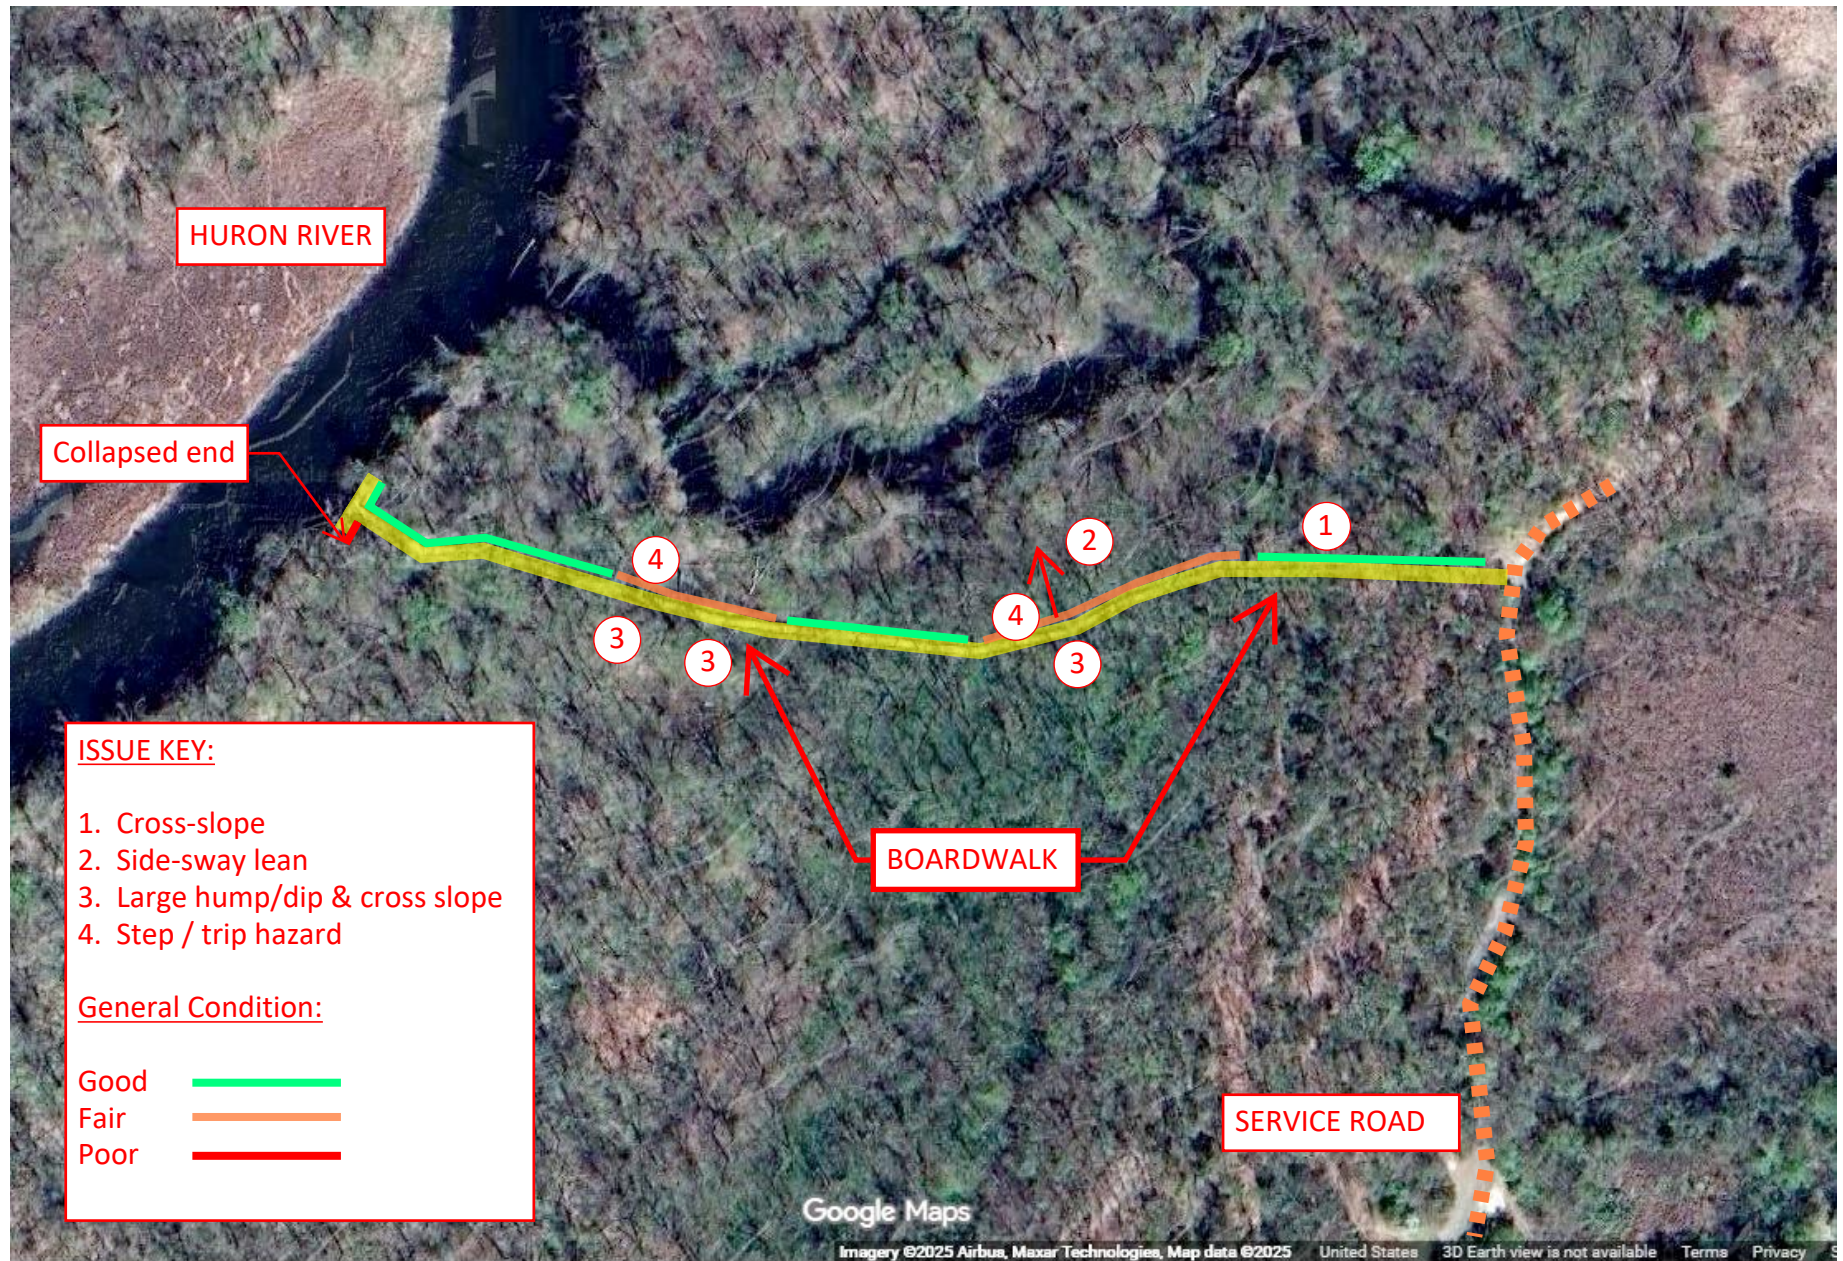
**FIGURE 7: MANLY BENNETT PARK BOARDWALK  
CONDITION SURVEY**  
Nov. 28, 2025

On Tuesday, November 11 2025 I conducted a structural observation of the Manly Bennett park boardwalk with a follow-up visit on November 28. The boardwalk is a timber structure approximately 1,000 ft. long originating at a paved maintenance trail and extending across a section of low land to the edge of the Huron River. It is currently closed to public access (Fig. 1). The diagram below summarizes my field observations (Fig. 7).
