Re: 5 Main Street Structural Evaluation
Hartford, Michigan
B/A Project #21100184

This letter is to report on our structural assessment of the building located at 5 Main Street in Hartford Michigan. It is our understanding that the building was connected to a collapsed and now demolished adjacent building via a shared brick bearing wall.

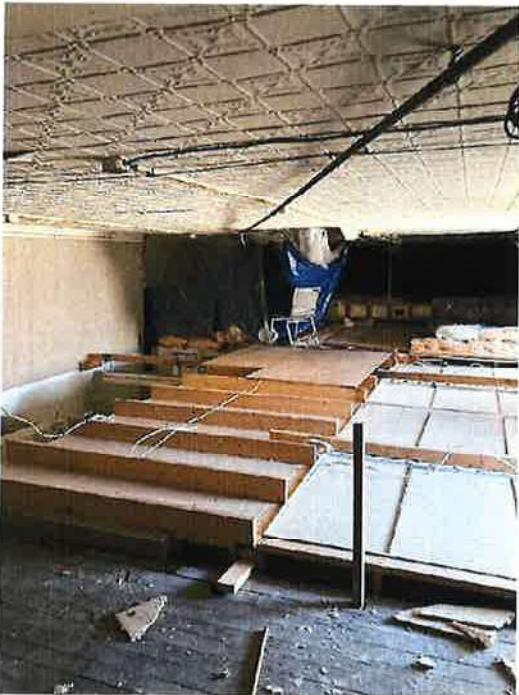
Photograph #5: Above First-Floor Ceiling

2. The structure of the second floor is largely covered by ceiling. There was no significant settling of the second floor from visual inspection. The first-floor ceilings in the commercial space are apart from the second-floor framing, and so have not impacted the condition of the joists.

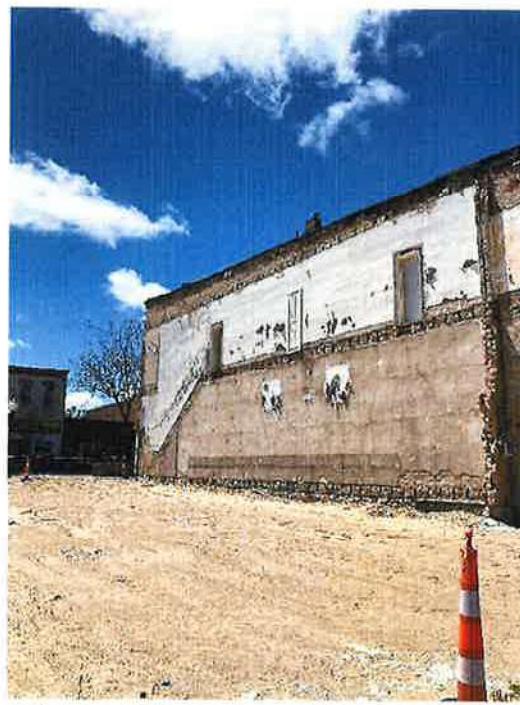
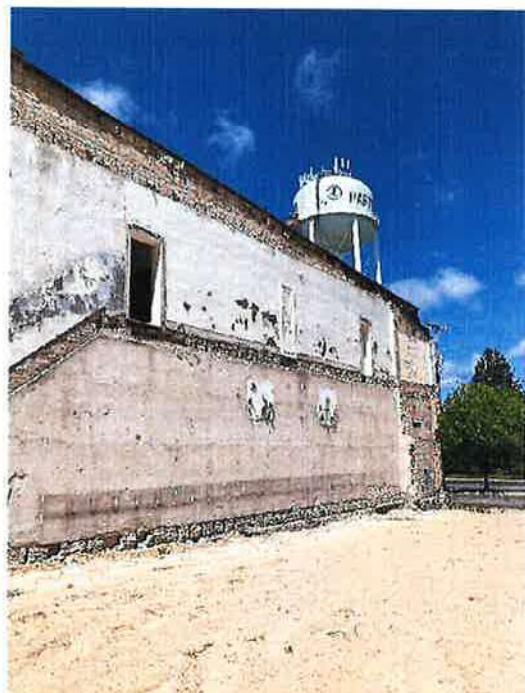
4. The exposed shared brick bearing wall is visible from the outside. The brick is uncovered and exposed to the elements. The joist seats from the collapsed building are visible. At the base of the brick wall, there is a wood plate that runs the full length of the building. This wood plate is rotted and, in many cases, falling apart. It is unclear how far into the brick wall the wood plate extends, but we believe all but interior brick course bears on the wood plate. Much of the brick directly above the wood plate is loose with failed or deteriorated mortar joints.

Photograph #7: Exposed Brick Shared Wall

Photograph #8: Exposed Brick Shared Wall

3. Cover the exposed brick with siding to protect it from the rain and potential freeze/thaw damage. One option for covering the wall would be to anchor horizontal wood furring strips to the brick wall at about 4'-0" on center and cover the wall with vertical metal siding. Rigid insulation could be added between the furring strips as well. Design of these details for cladding the wall is beyond our scope of this report; however, we can assist with this effort upon request.

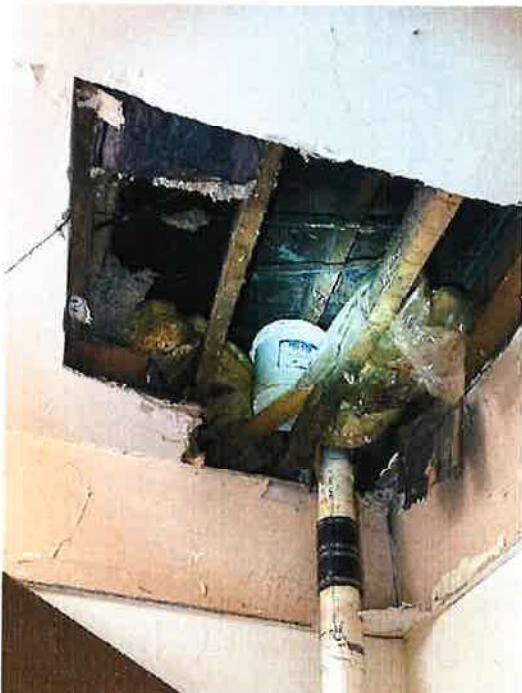
Photograph #6: Roof Framing & Ceiling Joists

3. The roof framing is largely covered by ceiling. The original roof framing appears to consist of wood joists @ 16" on centers. Below the roof joists appears to be wood ceiling joists with a hard ceiling lid and insulation above. It is unclear if the hard ceiling is hung from the roof joists. Below the older hard ceiling is a lay in ceiling. There are a couple of skylights that appear to have been part of the original framing. During the site visit, there were no signs of water damage, though the season was notable dry.

4. Investigate the roof for any water damage and repair or replace any roof framing that has become damaged. We were unable to observe the condition of the roof covering itself, but suspect that replacement of the roofing will be required.

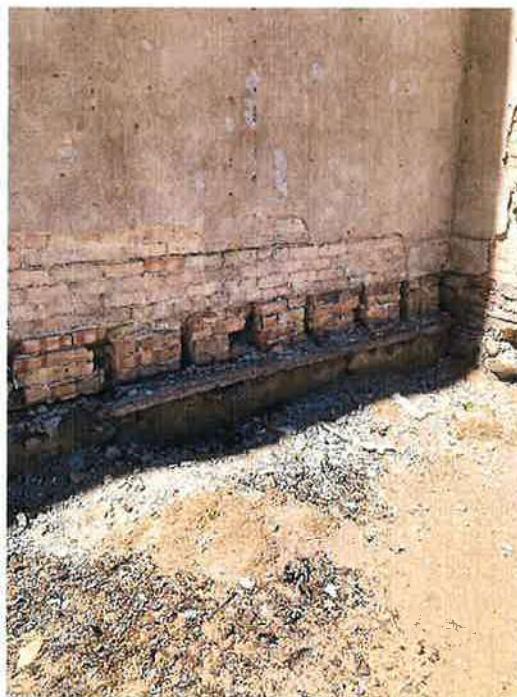
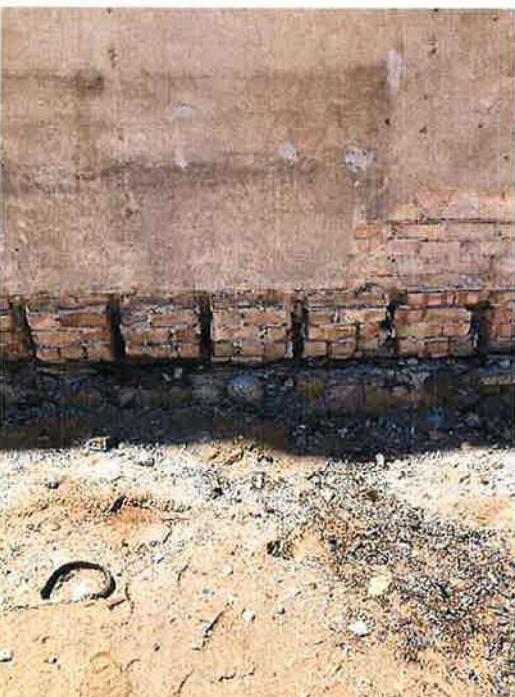
Photograph #11: Rotted Wood Plate

Photograph #10: Rotted Wood Plate

2. Replace exposed wood plate at the base of the brick wall with brick and mortar to match existing construction. There are also many loose bricks at the base of the wall that need to be removed and reset. See attached detail.

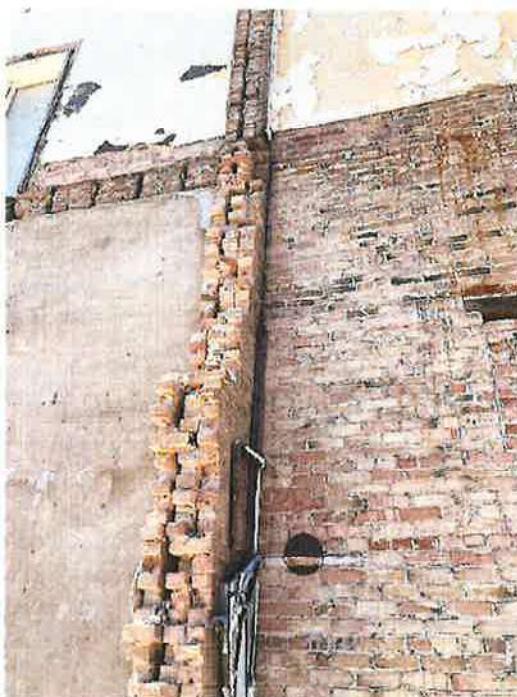
Photograph #12: Exposed brick
