LIMITED PHASE II ENVIRONMENTAL SITE ASSESSMENT

WATER CREEK HOMES

PROJECT
14920 WASHINGTON STREET
HAYMARKET, VIRGINIA 20169

OCTOBER 14, 2024

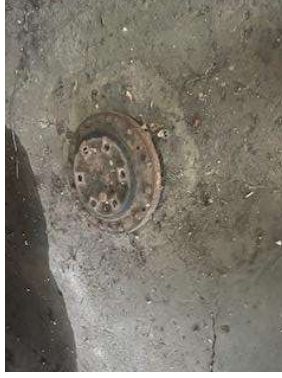
In the rear room of the front building, there was evidence of a hydraulic lift. The owner, Russell Lane, who was present at the Physical Site Assessment, confirmed the presence of a hydraulic lift under the slab in the rear room of the front building on the subject property. He indicated that the lift was installed in the late 1950s and was out of service in approximately 2003. To the best of his knowledge, he believed that there was hydraulic fluid/oil in the lift and based upon the condition at the time of the termination of service, it had most likely been leaking.

The Physical Site Assessment and interview with the current owner, Russell Lane, prompted the recommendation for Phase II Environmental Site Assessment.

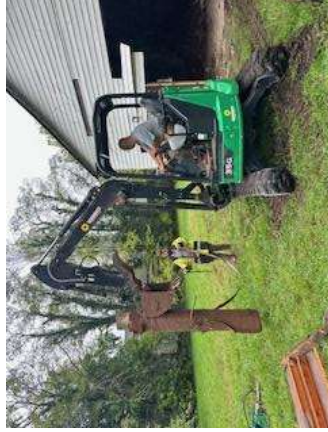
- 1) The hydraulic system and cylinder were full of hydraulic fluid/oil.
- 2) The hydraulic cylinder has leaked a significant amount of hydraulic fluid/oil.
- 3) The soil sample was obtained at a depth of 7 feet below grade.
- 4) The soil sample was tested by HP Environmental Incorporated for Total Petroleum Hydrocarbons – Oil Range Organics (TPH-ORO).
- 5) The results indicate no detection to a reporting limit of 20 mg/kg

- 1) Penetration and removal of the slab.
- 2) Hydraulic fluid removed. Fluid Manifest (Appendix G).
- 3) Hydraulic lift system removed.
- 4) Visually impacted soil removal.
- 5) Soil sample collection beneath and adjacent to the location of the hydraulic lift system.
- 6) Backfill to grade with evacuated soils.
