## **Architectural Assessment Report**

**Address** - 14841 Washington Street Haymarket VA 20169

**Date** - 7/9/2025

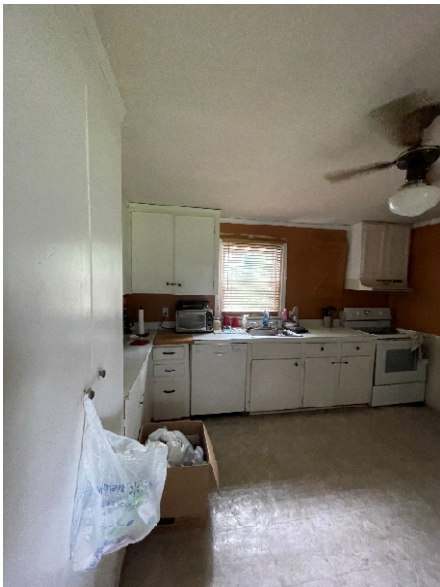
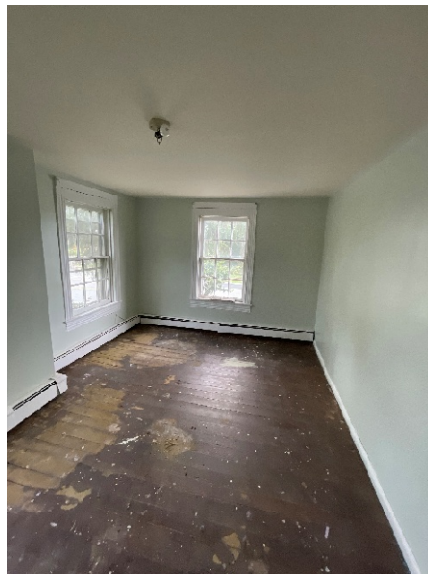
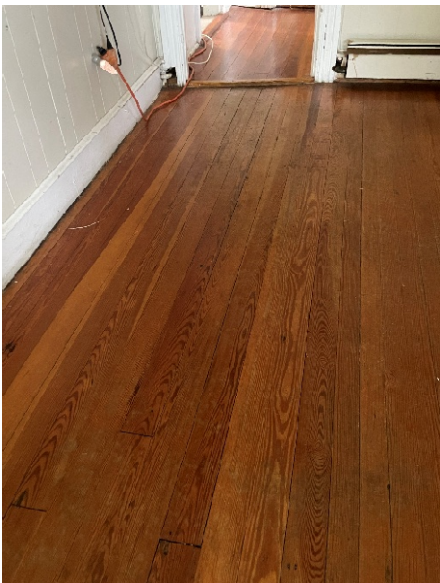
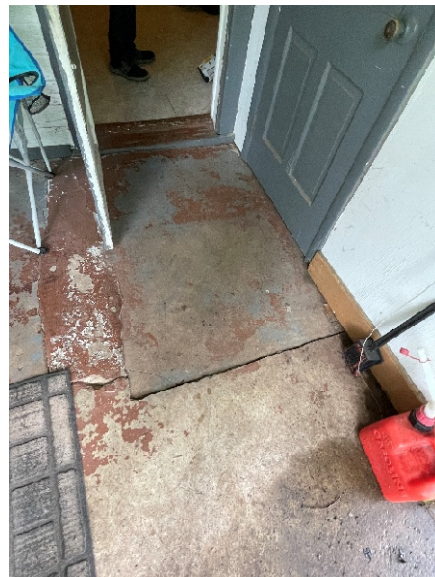
### a. Structural Condition

- The foundation exhibits significant settlement, with evidence of cracked masonry and sloping floors in multiple locations.
- The wood framing system, including joists and wall studs, shows signs of prolonged moisture intrusion and insect damage.
- The roof structure is visibly sagging and displays active water infiltration, contributing to widespread interior decay.
- On the second floor, extensive floor deflection and soft spots render the level unsafe per current standards

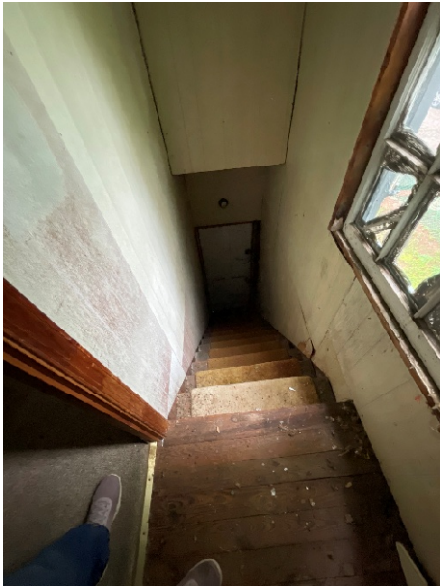
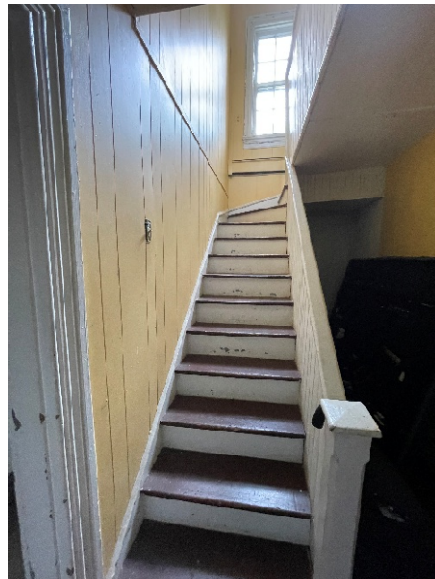
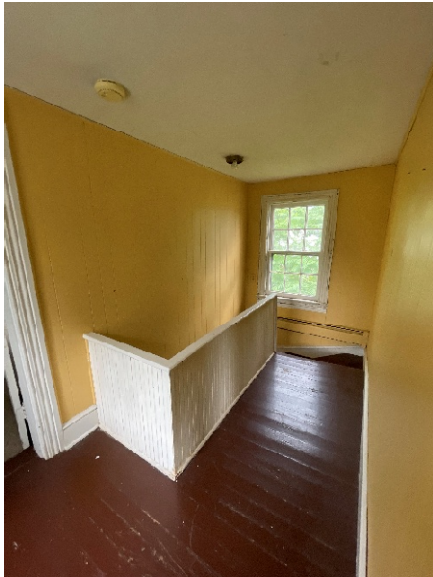
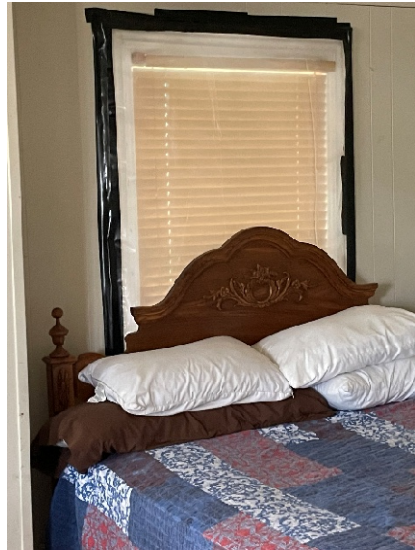
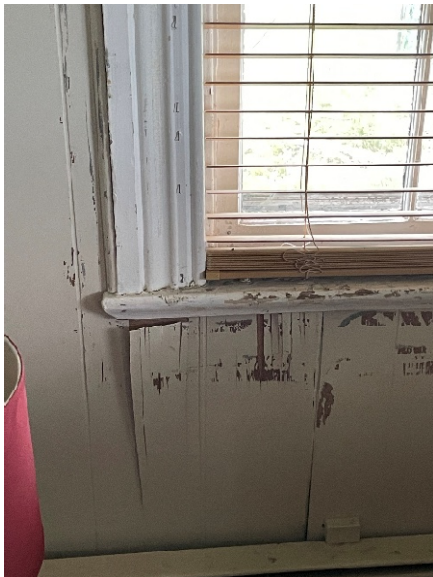
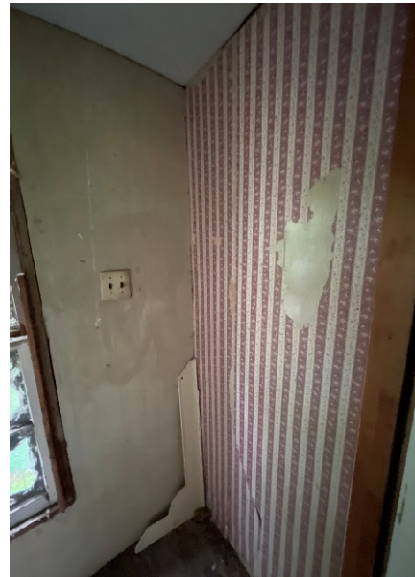
**b. Interior Systems and General Conditions**

- The second floor appears uninhabitable, with no active power or water supply—likely due to degraded or damaged electrical and plumbing systems.
- There is no cooling in the home; the heating system consists of outdated baseboard units, which appear to be non-compliant with current code.
- Two window-mounted A/C units are the sole source of cooling for the first floor.
- Active roof leaks have caused rot and potential mold growth within ceilings and wall cavities.
- All major systems—mechanical, electrical, and plumbing—are outdated, in disrepair, and non-compliant with current Virginia Uniform Statewide Building Code (VUSBC) standards.
- Several life-safety concerns are present, including some exposed wiring, deteriorated stairs and railings, and a lack of energy efficiency
- leaky drafty openings

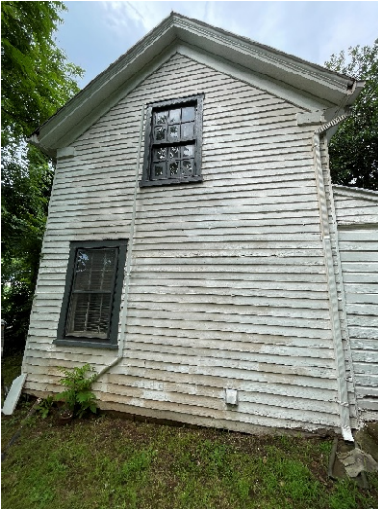
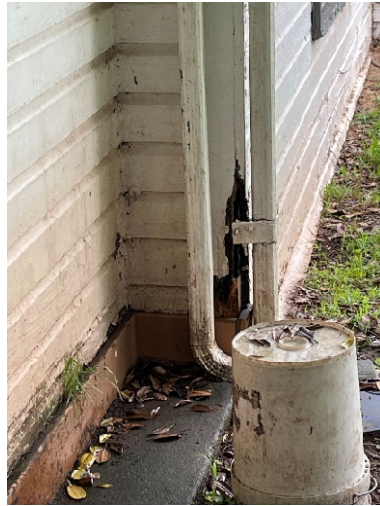
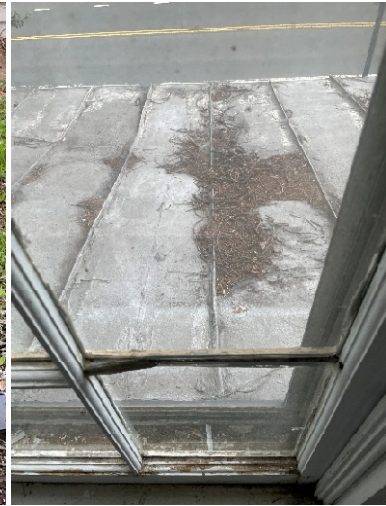
**c. Exterior Conditions**

- Wood siding is visibly failing in several locations, leaving the structure vulnerable to further water intrusion.
- Windows are single-pane, aged, and drafty, with rotted sashes and poor energy efficiency.

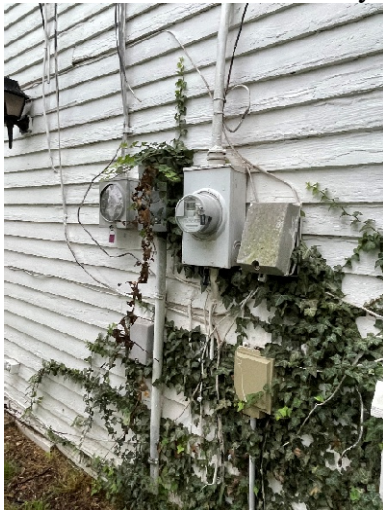
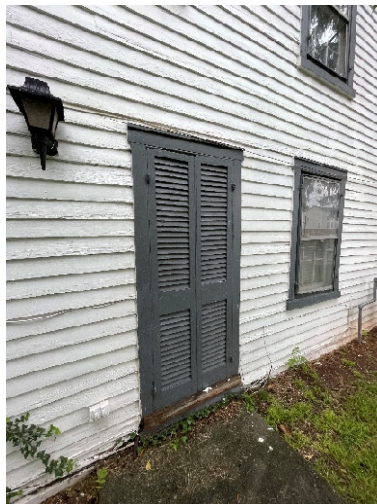
**d. Occupancy Status**

- The first floor is currently occupied; however, due to the structure's many safety, health, and code deficiencies.
- The second floor is entirely unoccupied and unsafe for use. The property poses risks to both current and future occupants if not remediated or removed. It seems the house is used as a multifamily unit with visible two electric meters
