# Inspection Report

### Property Condition Assessment

## Water Creek Homes

14920 Washington Street  
Haymarket, VA 20169

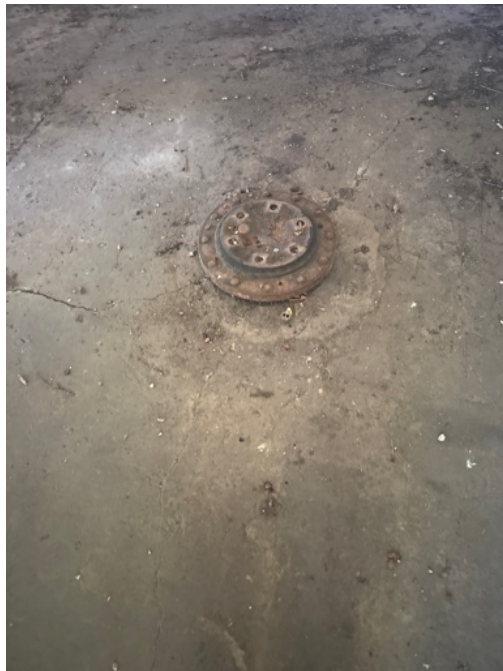
**3.3) Automobile Lift**

The only issue that is considered a Recognized Environmental Concern is an under slab hydraulic lift and hydraulic tank. The system was installed in the 1950s and has not been utilized in over 20 years due to failure of the system at that time. The tank is reported to have hydraulic fluid. A Phase 2 ESA is recommended.

It is recommended that a IPhase 2 Environmental Site Assessment be conducted in the area of the hydraulic system. This will include:

- 1) Removal of the slab as necessary to access the hydraulic system.
- 2) Removal of the hydraulic lift and tank
- 3) Disposal of the system, tanks and fluid under the auspices of the Virginia DEQ.
- 4) Removal of contaminated soil.
- 5) Testing of remaining soil.
- 6) Reporting results to all parties to include the Virginia DEQ for case closure.
- 7) Backfilling the tank area but not replacing the slab.

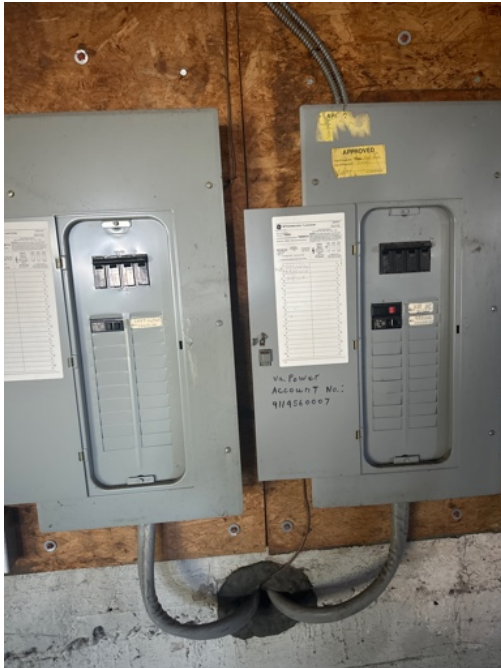
**3.4) Electrical - Lighting Conditions**

Power was off at the time of inspection.

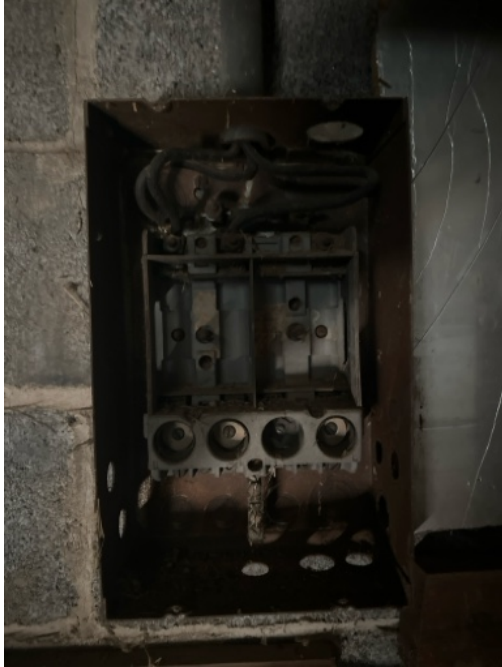
#### 4.3) Electrical - Lighting Conditions

Electric was off to the building.

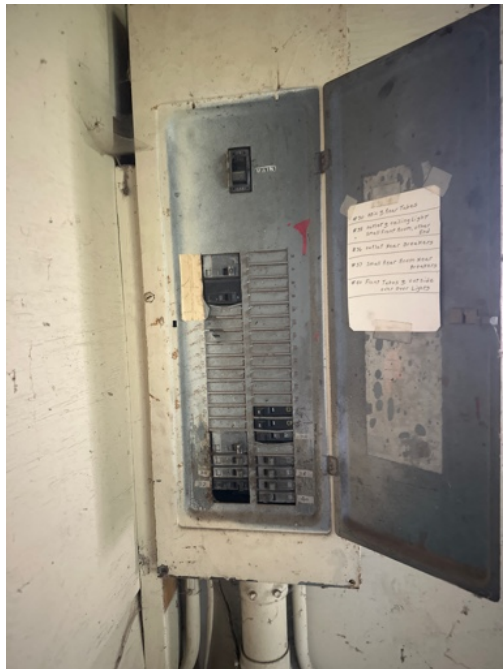
**5.3) Electrical - Lighting Conditions**

Electric was off to the building.
