Structural Evaluation of Shed/building on 6796 Fayette St.

Analysis of Current Condition and Recommendation for Demolition

Structural Evaluation of Small Shed on 6794 Fayette St.

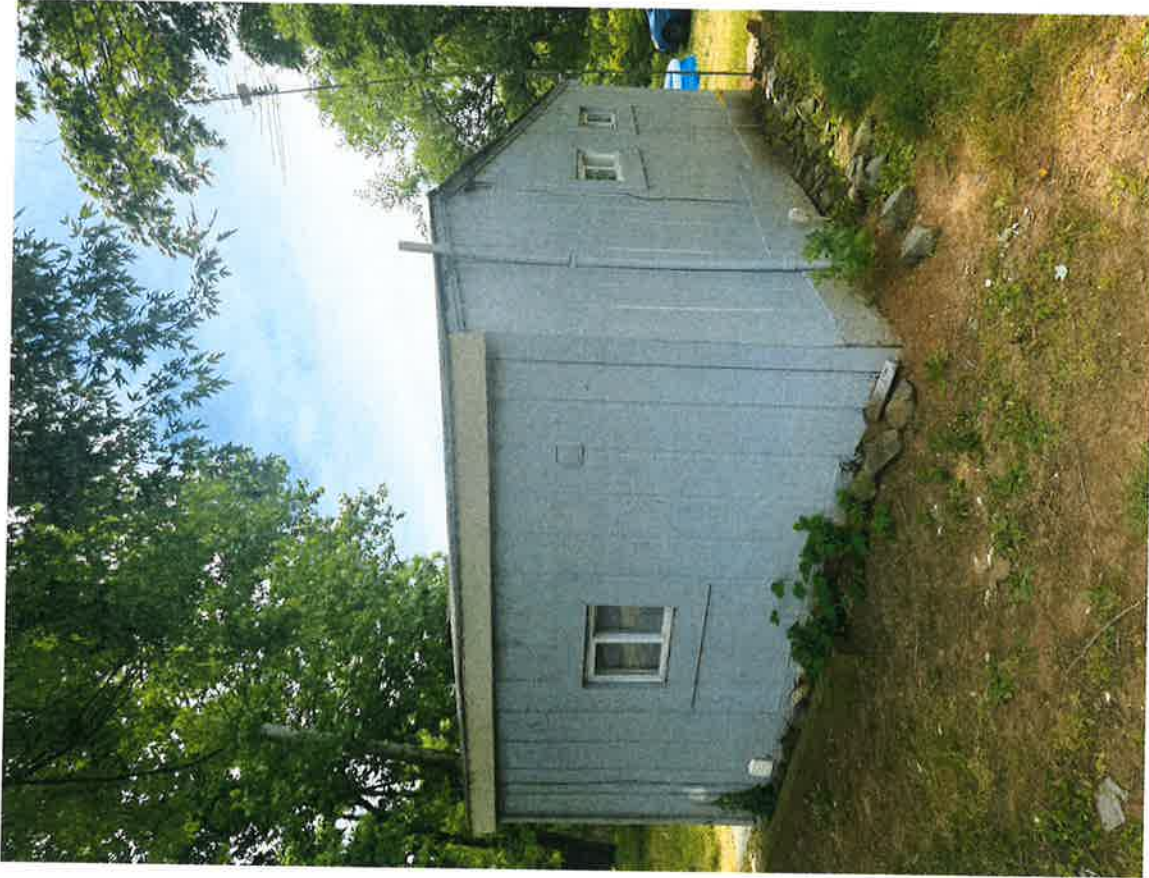
Photograph 1

- View of Shed/Structure on subject property. The exterior walls show significant cracks and structural damage, making the building unsafe for occupancy.

- This structure has no relevance to the current development plans and poses a significant hazard due to its poor condition. The extensive structural damage, including cracks in the exterior walls, unstable foundation, water-damaged roof, and compromised eaves and soffits, renders the building unfit for use. Given its location, the run-down structure would make it challenging for the town to approve building plans on the adjacent properties being developed. Demolition of this structure is necessary to ensure the safety of the area and to facilitate further development on Fayette Street.

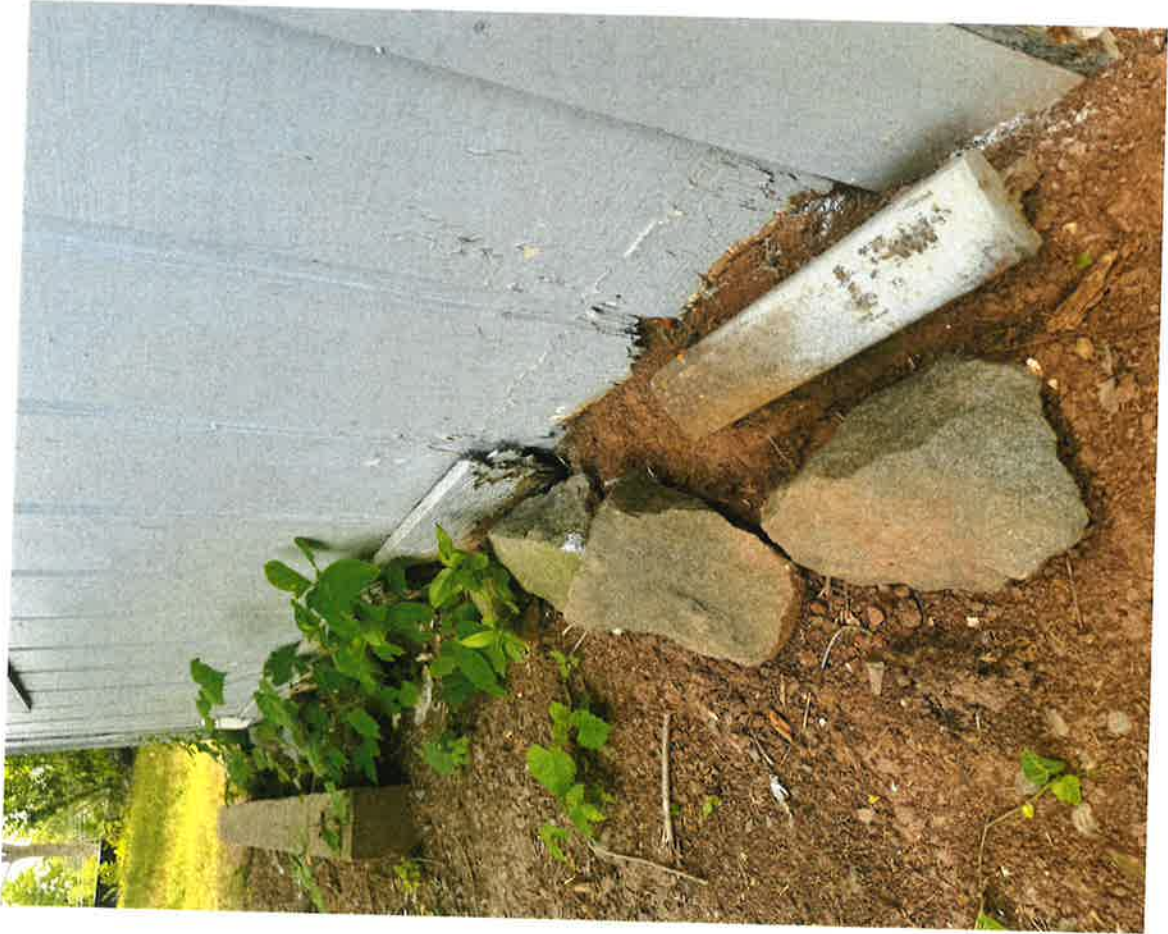
Photograph 2

- The foundation is visibly unstable with signs of shifting

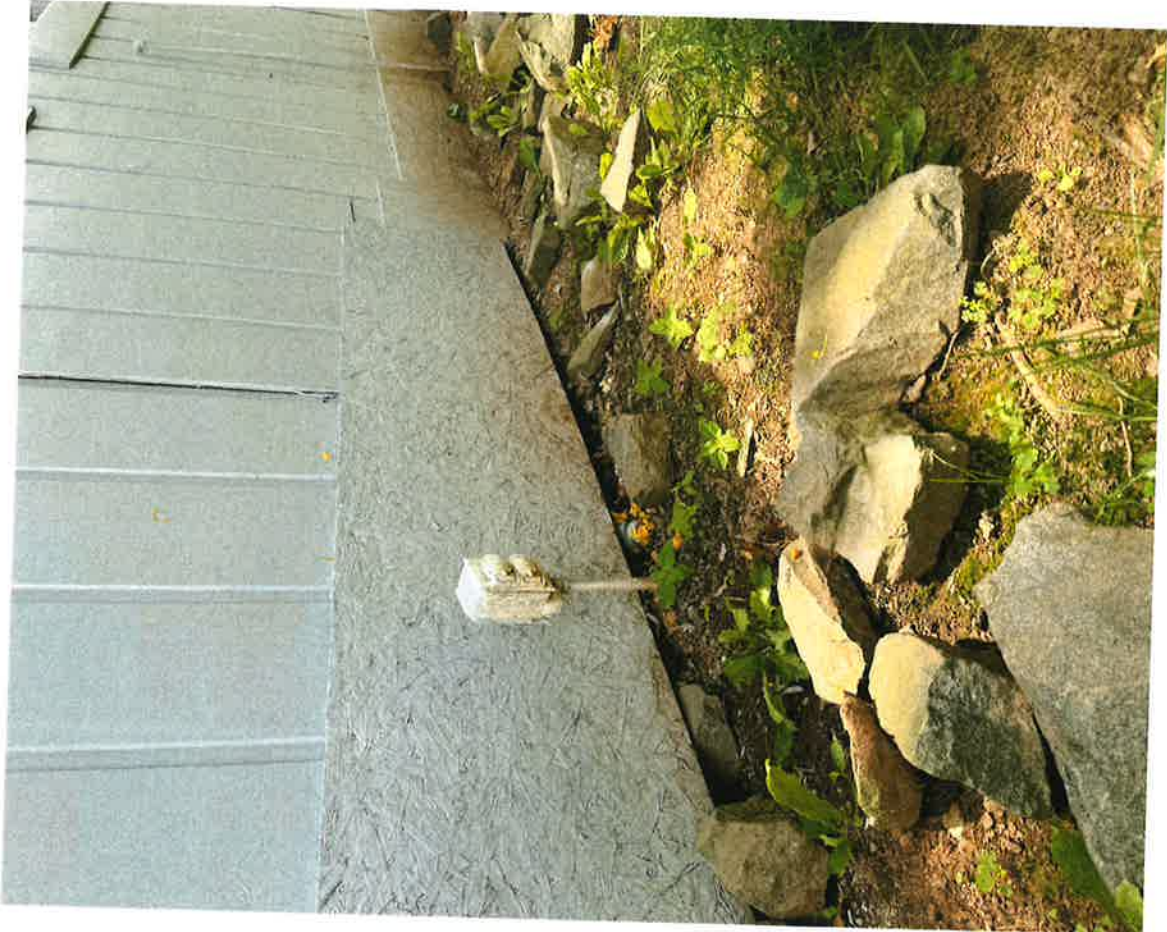
Photograph 3

- Additional signs of foundation is visibly unstable with signs of shifting and settling, compromising the integrity of the structure

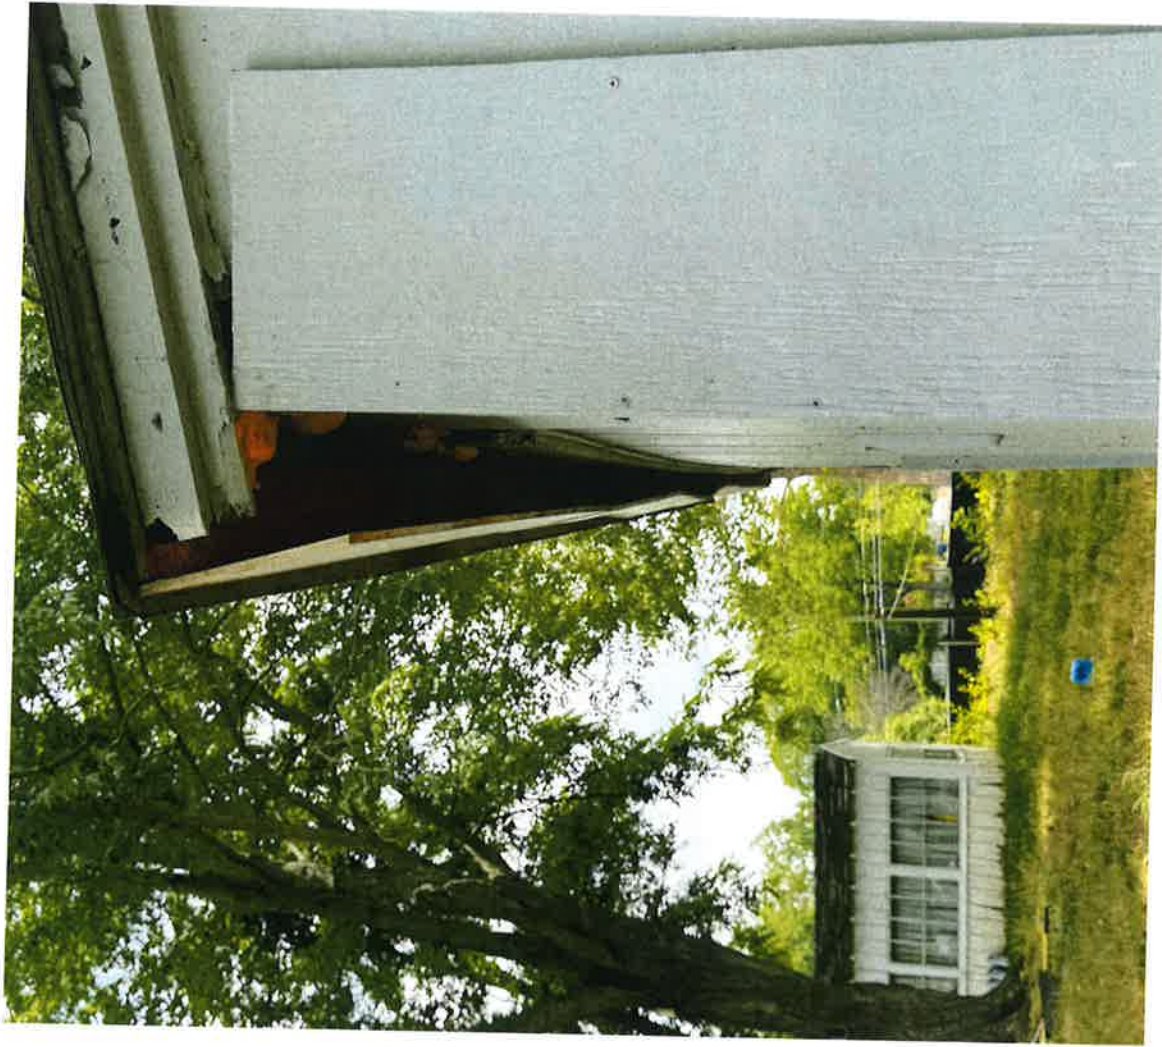
Photograph 4

- Roof shows extensive water damage and is partially collapsed, posing a risk of further deterioration

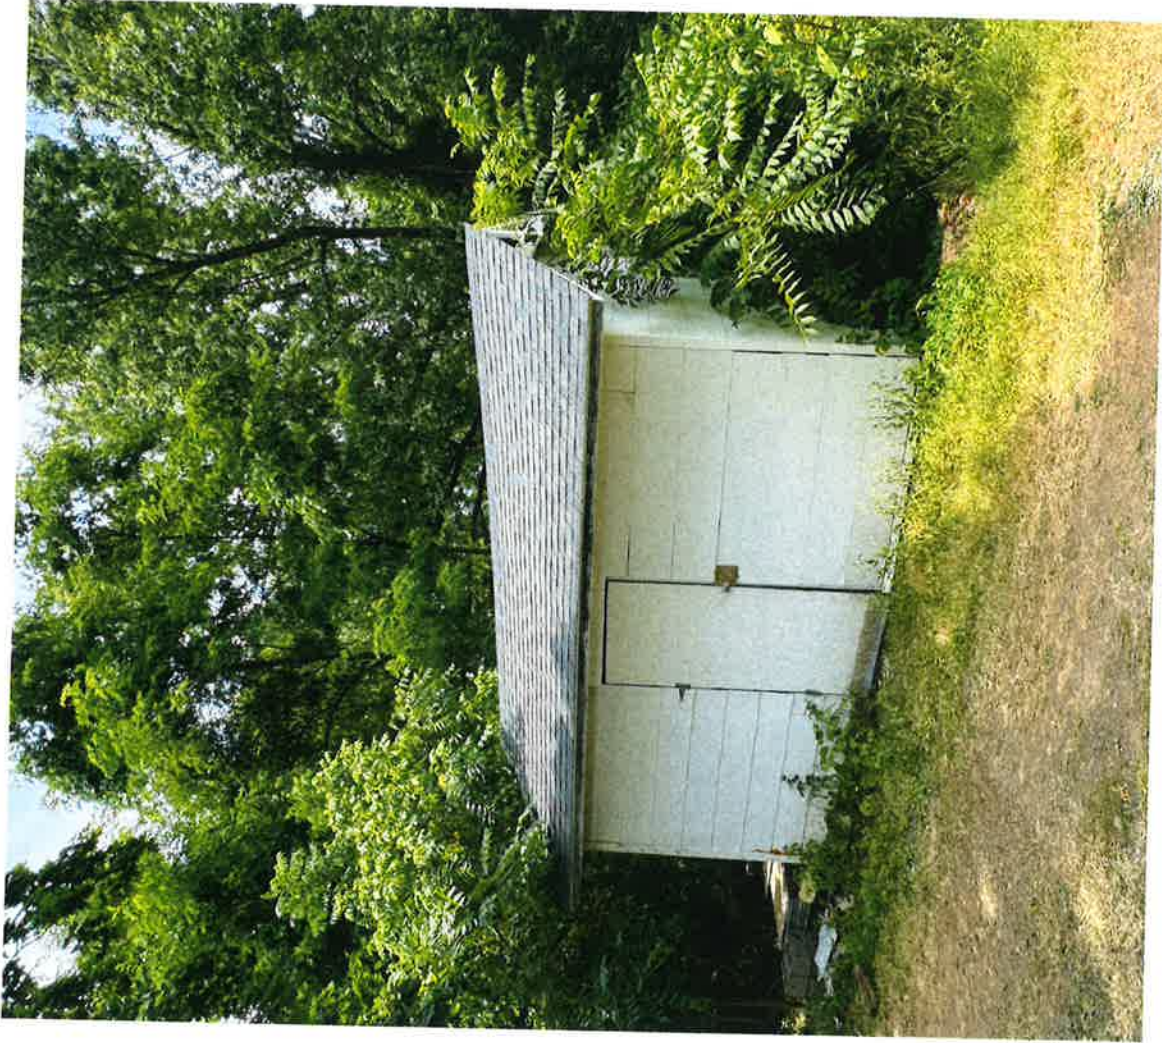
- Shed is structurally compromised with signs of significant wear and tear. The exterior walls exhibit peeling paint and visible cracks, indicating prolonged exposure to the elements and lack of maintenance.

- The existing shed at 6794 Fayette Street, in its current dilapidated state, poses a significant impediment to the planned development of the property. The structure's advanced decay and the surrounding overgrowth not only detract from the aesthetic appeal but also present potential hazards. Its removal is imperative to facilitate the new development, ensuring both safety and visual harmony with the planned enhancements. Demolishing this outdated shed will pave the way for a more cohesive and attractive property layout, aligning with the town's vision for progressive and responsible development.

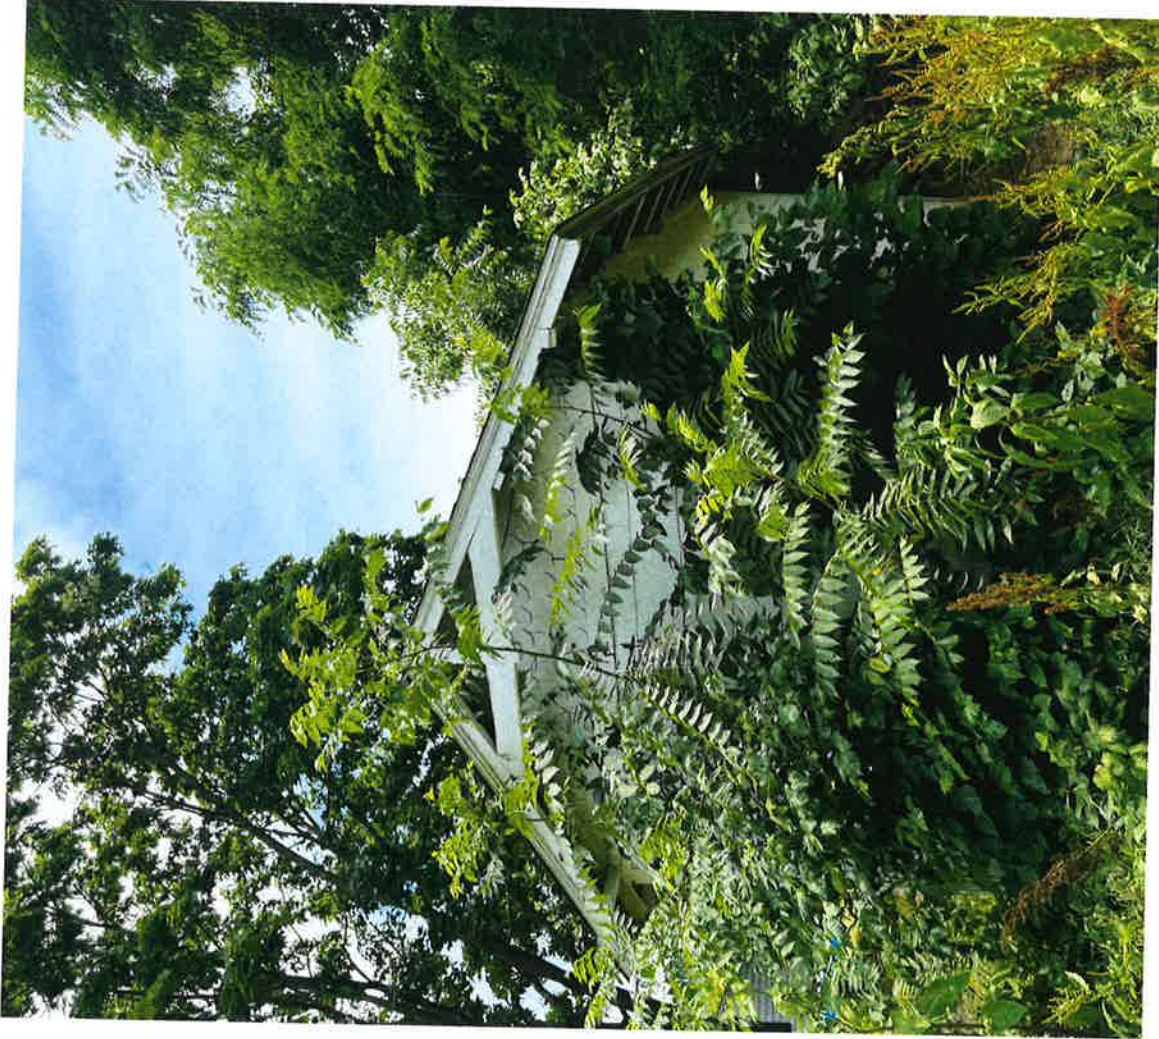
- The roofline shows clear signs of deterioration, with damage to the shingles. The shed's exterior walls are severely compromised, exhibiting extensive damage and structural weakness that make it a safety hazard.

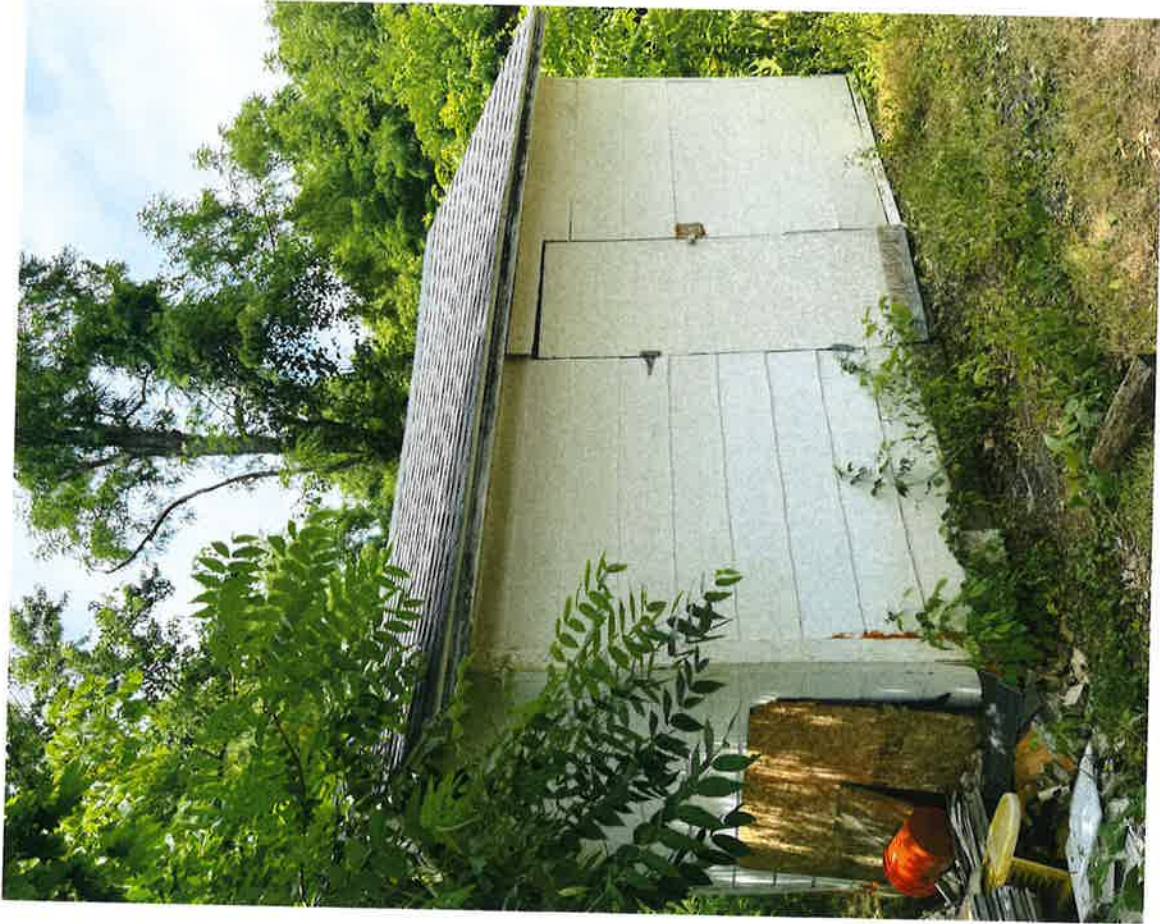
- The base of the shed is particularly concerning, with evidence of foundational instability. The door is misaligned and possibly damaged, indicating a lack of security and structural integrity.
