**TOWN OF HIGHLAND BEACH
BEACH RESTORATION FEASIBILITY STUDY
2023**

**Prepared By:
Aptim Environmental & Infrastructure, LLC
6401 Congress Avenue, Suite 140
Boca Raton, FL 33487**

January 2024

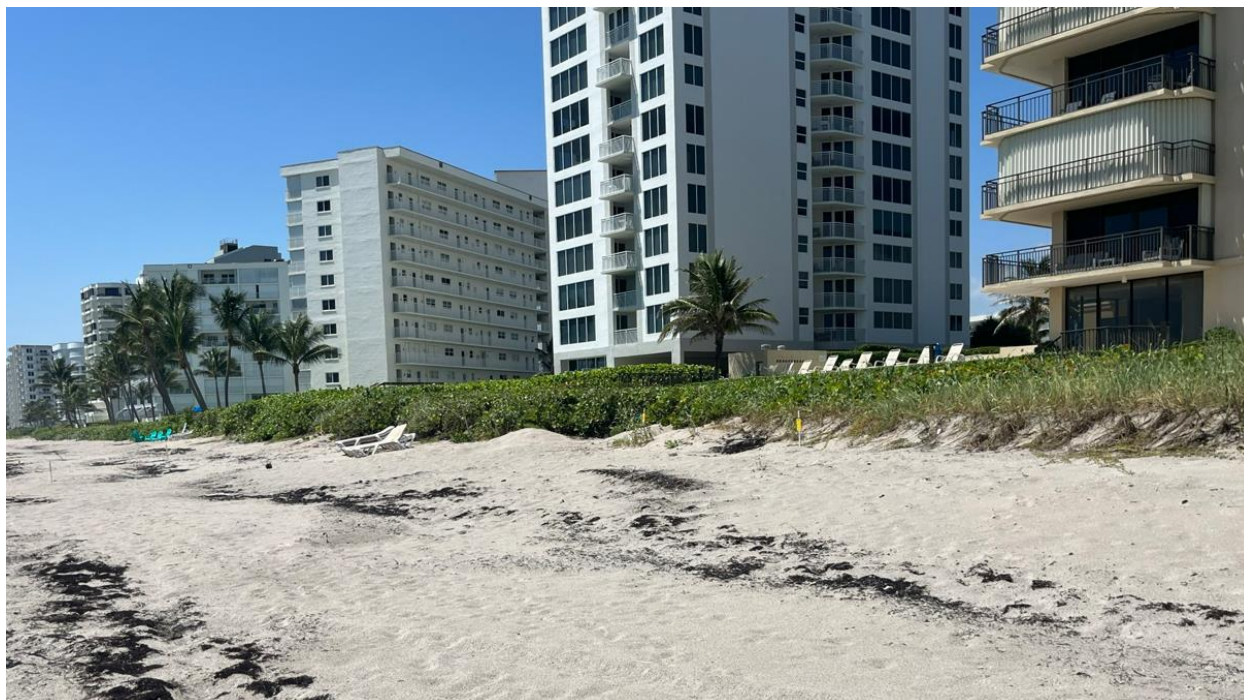
Photo 3. (From right to left) The scarped dune toe in front of Ocean Pines Condo. The scarped dune toe is hidden behind the seagrasses in front of Ocean Dunes Condo.

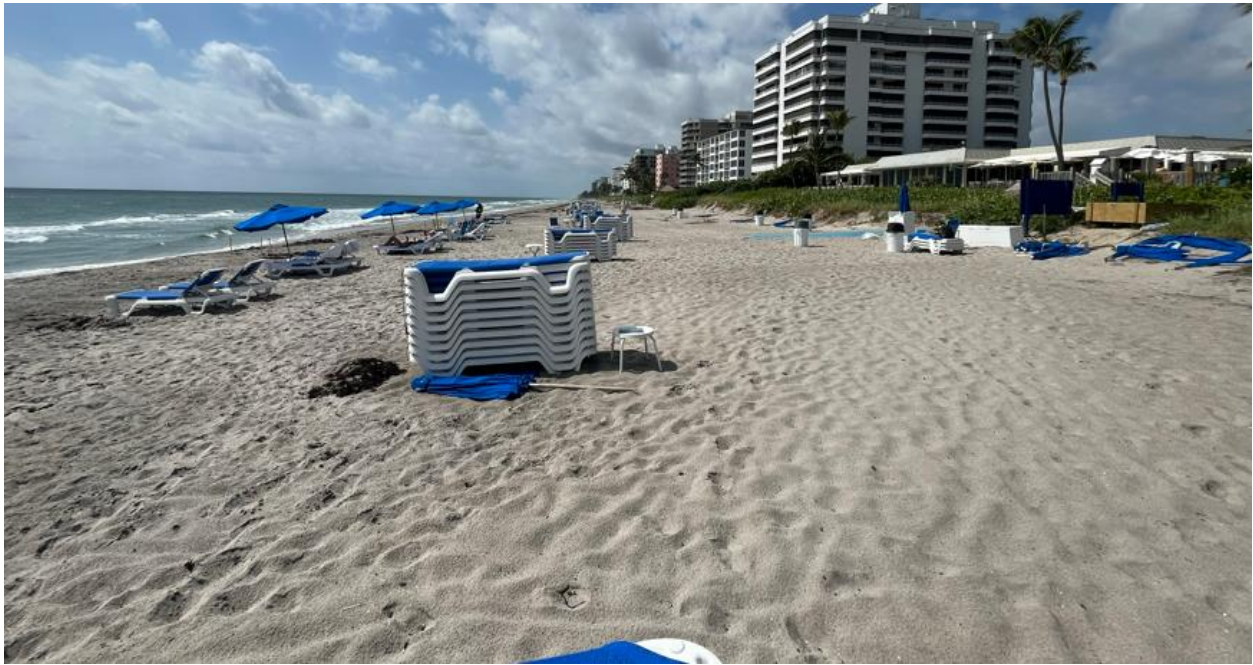
Photo 6. View looking south along the beach in front of the Delray Sands.
Note the berm and mild foreshore slope.

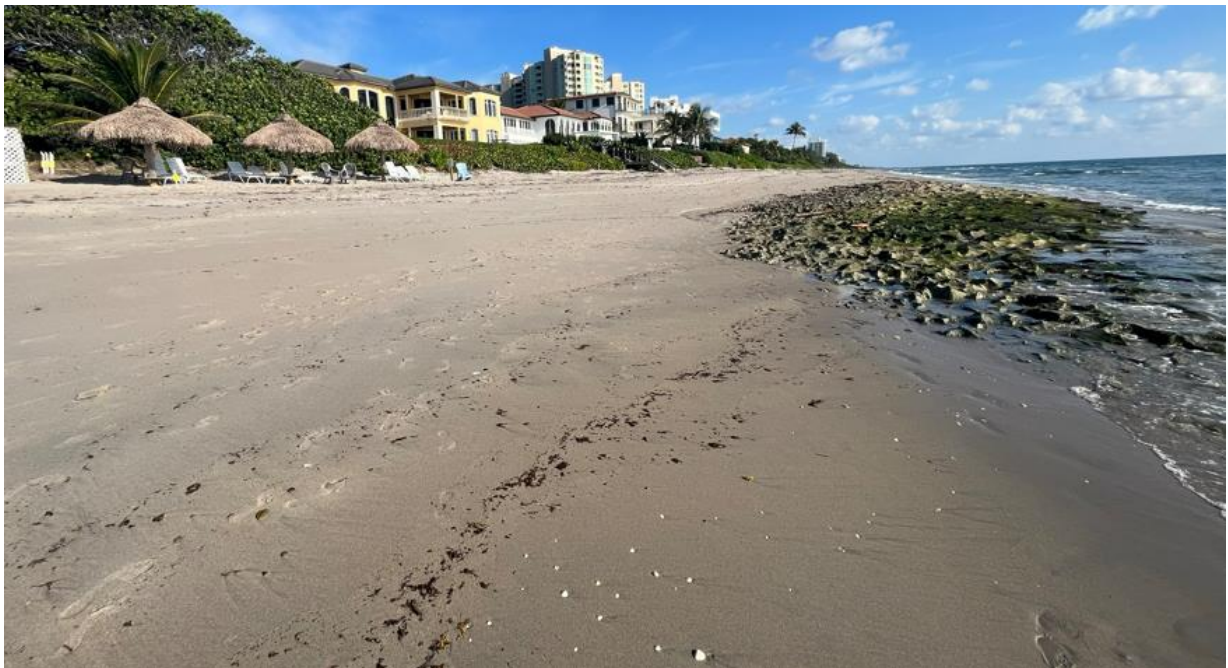
Persistent hardbottom first appears in this reach (Photos 9 and 10). In Photo 9, the outcrop in this area acts as a breakwater, holding the sand up on the adjacent property. In Photo 10, the rock outcrop functions more like a low-profile groin with a wider beach on the north side of the outcrop fronting 4201 and a receded shoreline on the south side of the outcrop, fronting Ocean Place Villas.

Photo 9. Looking north, the exposed hardbottom observed in front of the Regency Highland Club and 3907 South Ocean Boulevard.

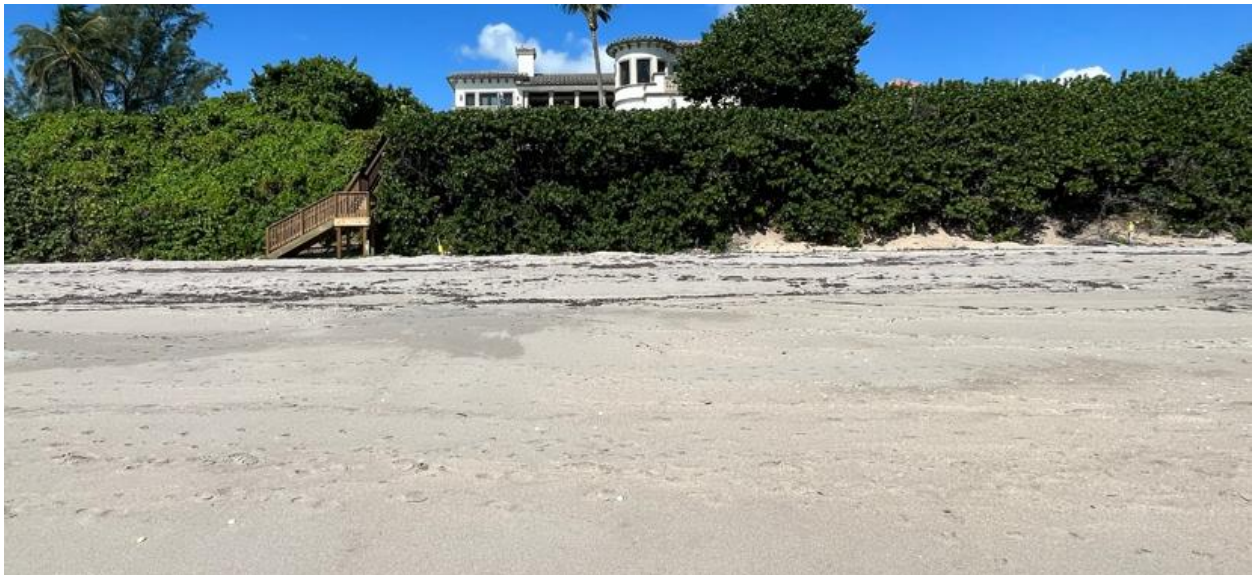
The next stretch of properties located to the north of Yamato Rock, consist of single-family homes, townhomes, and the Parker Highland Condominium. These properties have higher, vegetated dunes, except for the 4515-4519 townhomes, where the dune fronting this property is approximately 3-4 feet lower than the adjacent properties. Although the remaining properties have densely vegetated, high dunes, undermining is occurring at the base of these plants, with ~4-5 feet of scarp in some areas (Photo 12).

Photo 12. Some properties to the north of Yamato Rock have densely vegetated, high dunes; however, undermining is occurring at the base of these plants, with ~4-5 feet of scarp in some areas north of the stairs.

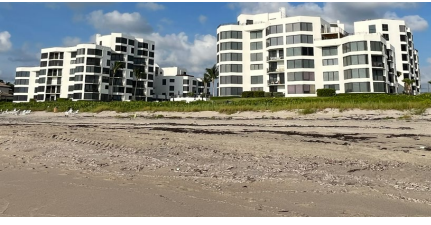
Townhouses of Highland Beach 2575 S Ocean Blvd

<ul style="list-style-type: none"> - Wide beach - Delray gray sands - ~6-8" berm scarp north-to-mid property, & ~8-10" berm scarp mid-to-south property - Historical wrack line at the toe of the dune - Mid-berm has 2 additional wrack line 	<ul style="list-style-type: none"> - Dune crest elevation is ~2.5-3' above berm elevation - The dune in front of the N. building is positioned more landward than the dune in front of the S. building; the southern dune falls in line with adjacent northern properties - Dune crest elevation lower in the middle of the property (~2' above berm) compared to the edges - ~1.5-2' of dune washout/scarp, with a 2H:1V seaward slope - Seaward vegetation up to the dune crest is thinned out, ~5-6' of front dune veg before dense sea grape back dune; especially the south dune - Dune comprised of panic grass, sea oats; sea grape 	No	No	Restore dune toe with 2cy/ft of sand along east dune toe. Revegetate dune toe with pioneer zone dune vegetation.

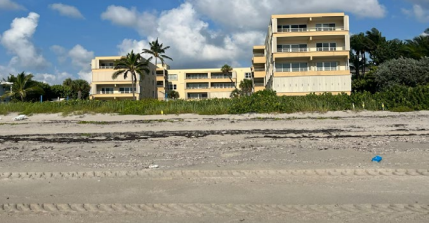
Carlton House 2701 S Ocean Blvd

<ul style="list-style-type: none"> - Wide beach - Delray gray sands - Berm scarp leveled off - Historical wrack line at the toe of the dune - Mid-berm has additional wrack line 	<ul style="list-style-type: none"> - Dune crest elevation is ~1-1.5' above berm elevation from north-to-mid property, and is ~2-2.5' from mid-to-south property - No dune scarp but rather wave runoff to ~2' above the berm, only observed mid-to-south; the northern dune is at a lower elevation and has been washed over, with little/thinned vegetation before back dune - 2H:1V seaward slope where vegetation remains than gradually 3H:1V slope to the toe/wrack line - North property edge has sea grapes rather than a planted dune - Dune comprised of ~5-10' of thinned sea oats before the dense back dune vegetation (sea grape); railroad vines growing in wrack line 	No	No	<p>Restore dune toe with 2cy/ft of sand along east dune toe.</p> <p>Revegetate dune toe with pioneer zone dune vegetation. Consider raising the crest elevation of the dune.</p>

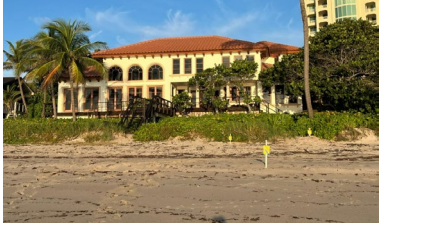
<ul style="list-style-type: none"> - 6-8" berm scarp, smoothed by runup - Historical wrack line at the toe of the dune extending to waterline - More Highland brown sands and shell hash visible - Dune overwalk is ~8' above the berm 	<ul style="list-style-type: none"> - Dune crest elevation is ~3-3.5' above berm elevation with ~2.5-3' scarp; wave runup of dune extends ~5' landward in some areas - The north dune has a 2H:1V slope up to crest with level top; the back dune has 4H:1V slope - The dune, south of the steps, has a 1H:2V slope, with more scarp - Dune sparsely comprised of panic grass, naupaka, and misc. vegetation on dune's scarped slope and dune crest. Denser sea grapes in the back dune 	No	No	Restore dune toe with 2cy/ft of sand along east dune toe. Revegetate dune toe with pioneer zone dune vegetation.

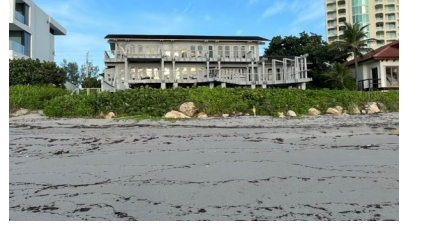
3817 S Ocean Blvd

<ul style="list-style-type: none"> - 8-9" berm scarp - Historical wrack line at the toe of the dune extending to waterline - More Highland brown sands and shell hash visible - Armoring with 2.5-3.5' wide boulders present in front of the dune, more so from north-to-mid property 	<ul style="list-style-type: none"> - Dune crest elevation is ~3-3.5' above berm elevation with ~3' scarp where no armoring is present - The dune has a 2H:1V slope but exhibits a 1H:3V slope where dune scarp is present (mid-south property) - Dune comprised of grasses, sea grapes, naupaka, and misc. vegetation on dune's scarped slope and dune crest 	No	No	Restore dune toe with 2cy/ft of sand along east dune toe. Revegetate dune toe with pioneer zone dune vegetation.
3833 S Ocean Blvd

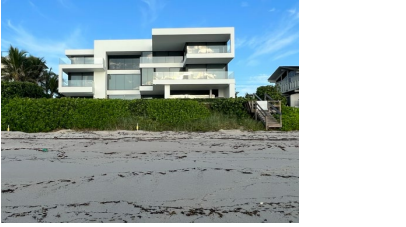
<ul style="list-style-type: none"> - 4-6" berm scarp, smoothed by runup - Historical wrack line at the toe of the dune extending to waterline - More Highland brown sands and shell hash visible 	<ul style="list-style-type: none"> - Dune crest elevation is ~2-2.5' above berm elevation with ~2' scarp/runup to crest - The seaward dune has a 1H:2V slope up to crest - The back dune is 5-6' above berm elevation - Dune comprised of sea oats and grasses fronting a denser sea grape and naupaka back dune 	No	No	Restore dune toe with 2cy/ft of sand along east dune toe. Revegetate dune toe with pioneer zone dune vegetation.

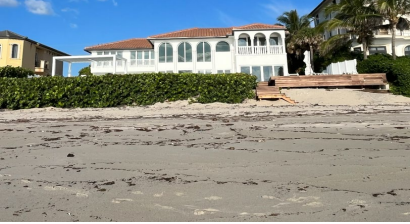
3905 S Ocean Blvd

<ul style="list-style-type: none"> - Berm scarp leveled off - Historical wrack line at the toe of the dune extending to waterline - More Highland brown sands and shell hash visible 	<ul style="list-style-type: none"> - North dune crest elevation is ~3' above berm elevation and is positioned under the deck structure and no vegetation - Mid-to-south dune crest elevation is ~4' with ~2.5-3' scarp/runup to base of vegetation - The seaward dune has a 2H:1V slope up to crest - Dune comprised of sparse grasses and denser sea grape - Only ~20' of vegetation between beach and seaward edge of the patio 	No	No	<p>Restore dune toe with 2cy/ft of sand along east dune toe. Revegetate dune toe with pioneer zone dune vegetation.</p>
3907 S Ocean Blvd

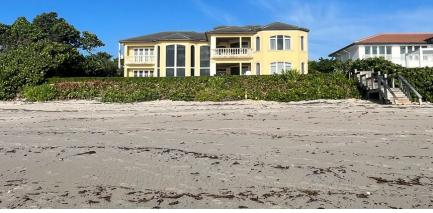
<ul style="list-style-type: none"> - Berm scarp leveled off - Berm appears higher north-to-mid property compared to mid-to-south property - Historical wrack line at the toe of the dune extending to waterline - More Highland brown sands and shell hash visible - Rock outcrop visibility extends into 1-2' deep water of swash zone 	<ul style="list-style-type: none"> - Not much of a pioneer dune present - Dune crest elevation is ~3' above berm elevation with a 2H:1V slope and ~1.5' scarp and at south end of property - Back dune has a 1H:1V slope to crest at ~8' above berm elevation - North-to-mid property, the dune is ~15-20' wide - Mid-to-south property, the dune narrows to ~10' wide - Dune comprised of sea grape and sparse sea oat vegetation 	Yes; on dry beach, acts like groin	No	<p>Restore dune toe with 2cy/ft of sand along east dune toe. Revegetate dune toe with pioneer zone dune vegetation.</p>

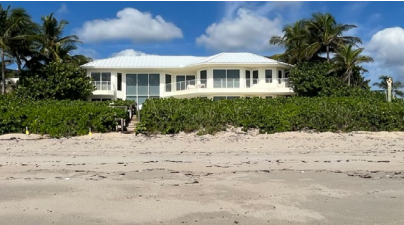
<ul style="list-style-type: none"> - Berm scarp leveled off - Historical wrack line at the toe of the dune extending to waterline - More Highland brown sands and shell hash visible - Rock outcrop visibility only in 2-3' deep water of swash zone 	<ul style="list-style-type: none"> - Front dune crest elevation is ~3-3.5' above berm elevation with ~2-2.5' scarp/runup at base of vegetation - The seaward dune has a 1H:2.5V slope up to crest - Dune comprised of some sea oats with some denser sea grape and naupaka vegetation extending from the back dune to the dune toe - ~40-45' of dune fronting the patio structure 	Yes; visible in 2-3' deep water, from mid-to-south property; no effect.	No	Restore dune toe with 2cy/ft of sand along east dune toe. Vegetate dune toe with pioneer zone dune vegetation.

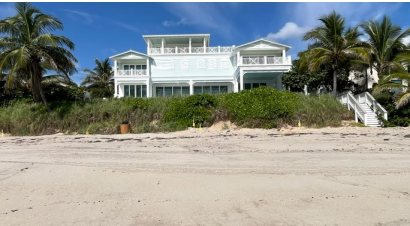
<ul style="list-style-type: none"> - Berm scarp leveled off - Historical wrack line at the toe of the dune extending to waterline - More Highland brown sands and shell hash visible - Rock outcrop visibility only in 1-2' deep water of swash zone 	<ul style="list-style-type: none"> - Pioneer dune has been mostly washed over; some vegetation remains on the slipped seaward face - Dune crest elevation is ~10' above berm elevation with ~3-5' of scarp/runup - ~4.5' of runup behind the beach access steps - Erosion along landward side of steps - The northern dune has a 1H:3V slope up to crest - The southern dune has a 1H:4V slope to from ~5-10' above the berm and then the slope becomes 1H:1V down to the dune toe - Dune comprised of some sea oats with dense naupaka growing mid-property - ~20' of dune fronting the grass yard 	Yes; rocks up on beach and also visible at waterline and shallow water of swash zone; no effect.	No	Restore dune toe with 2cy/ft of sand along east dune toe. Vegetate dune toe with pioneer zone dune vegetation.

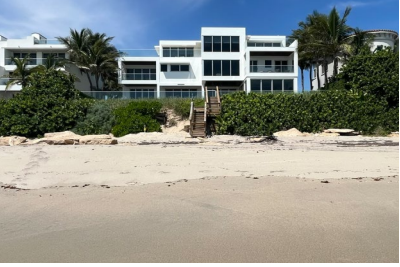
4205 S Ocean Blvd

<ul style="list-style-type: none"> - Berm elevation is ~0.5' higher than southern adjacent property - Historical wrack line at the toe of the dune extending to mid-berm - More Highland brown sands and shell hash visible - Visible, partially buried rocks dune toe (Armoring boulders?) 	<ul style="list-style-type: none"> - Not much of a pioneer dune present due to severe erosion, especially at mid-property near the steps - Dune has a 1H:5V slope, with 2' of scarp at the base of the vegetation - Dune comprised sea grape, naupaka, and misc. vegetation - Northern dune vegetation extends seaward ~10' compared to the rest of the dune 	Yes; some rocks buried at the dune toe. Some of the rock outcrop along the north edges of the property act as breakwater for this property. No exposed rocks in the berm fronting property, but another outcrop is exposed along the south property edge.	No	Restore dune toe with 2cy/ft of sand along east dune toe. Revegetate dune toe with pioneer zone dune vegetation.

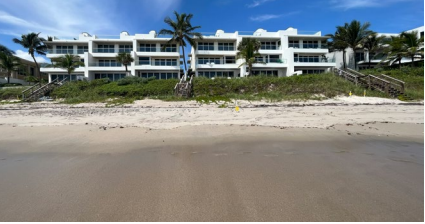
<ul style="list-style-type: none"> - Very narrow beach, <40' from waterline to dune toe -Berm scarp is ~6" at waterline Historical wrack line at the toe of the dune extending to mid-berm - More Highland brown sands and shell hash visible - Northern steps are the most seaward and tapers landward at each location. -Rock outcrop only present at north end of property 	<ul style="list-style-type: none"> - Not much of a pioneer dune present; appears flattened with some grasses only ~2' above berm elevation - The dune appears to be severely eroded, with 4-6' of wave run-up and 2' to 5' scarp in areas - Dune position tapers landward between each walkover staircase; 20' from north-to-mid steps; 10' from mid-to-south steps; 10' from south steps to property line - North dune has a 1H:2V slope, Mid dune has a 1H:3V slope, and South dune has a 1H:5V slope - Dune comprised of sea oats, grasses, sunflowers, and misc. vegetation 	Yes; rock outcrop at north end of property acts as a groin. Visible into 2' deep water	Yes; visible at south property edge. ~10' tall, concrete cap	Restore dune toe with 2cy/ft of sand along east dune toe. Revegetate dune toe with pioneer zone dune vegetation.

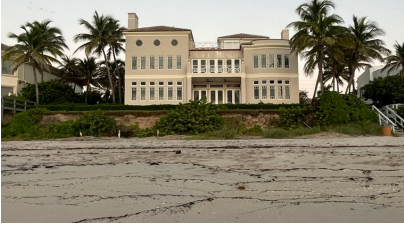
<ul style="list-style-type: none"> - Berm scarp leveled off - Narrow beach - Historical wrack line at the toe of the dune extending to waterline - More Highland brown sands and shell hash visible 	<ul style="list-style-type: none"> - Severe dune erosion present, with scarp of ~10' up to top of dune face - Fallen slope/front dune has elevation of ~1' above berm elevation - Dune is setback 10-15' landward compared to neighbors - Dune comprised sea oat, sea grape and misc. vegetation - Dune slope has 1H:8V slope at it's most extreme sheared face - The seaward face of the home/structure is <10-15' from the scarped dune face 	No	Yes; buried SSP	<p>Restore dune toe with 2cy/ft of sand along east dune toe. Revegetate dune toe with pioneer zone dune vegetation.</p>
2 Ocean Place

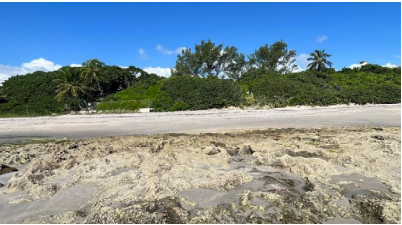
4705 S Ocean Blvd PARK

<ul style="list-style-type: none"> - Beach is relatively wide at the north side of the property and becomes narrow south of Yamato Rock - Historical wrack line at the toe of the dune extending to mid-berm - Highland brown sands with shell hash more prominent 	<ul style="list-style-type: none"> - Base of the vegetation is ~3' above the berm elevation (1H:2V slope) - There is ~6-7' of wave run-up around the end wall, with ~4-5' of scarp exposing the base of the vegetation to the north of the end wall - Back dune has a 1H:2V slope under the vegetation and extends ~30-40' above the berm elevation - South of end wall, the property tapers landward 20-25' compared to north end of property - Dune comprised of dense sea grape, naupaka, and misc. grasses 	Yes; Yamato Rock North end acts as a breakwater, south end acts like a groin	Yes; a short wall, 2.5-3' above berm. SSP with 1.5' concrete cap at base of the dune	<ul style="list-style-type: none"> Restore dune toe with 2cy/ft of sand along east dune toe. Revegetate dune toe with pioneer zone dune vegetation. Consider reducing the seagrape and planting pioneer dune species.

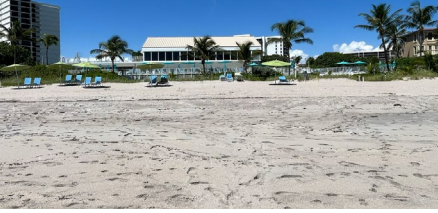
<ul style="list-style-type: none"> - Beach is relatively wide at this property - Historical wrack line at the toe of the dune extending to waterline - Highland brown sands with shell hash more prominent - Nearshore bar extends from Yamato Rock, ~20' from shoreline 	<ul style="list-style-type: none"> - Dune elevation is 1.5-2' above berm elevation with ~1' scarp/wave run-up over the front of dune - Dune is ~30-40' wide from the beach to the seaward edge of the structures - The back dune is a lower elevation than the front dune (appears to be the same elevation as the berm) - Front dune is comprised of sea oats and grasses before a denser sea grape and naupaka back dune 	No	Unknown	<ul style="list-style-type: none"> Restore dune toe with 2cy/ft of sand along east dune toe. Revegetate dune toe with pioneer zone dune vegetation. Consider raising dune crest elevation for increased storm protection.
