Corbinton Commons Final Punchlist updated 2/6/2023

Planning Punchlist- Tom King 919-296-9475 Tom.King@hillsboroughnc.gov

Public Works Punchlist Dustin Hill 919-296-9602 Dustin.Hill@hillsboroughnc.gov

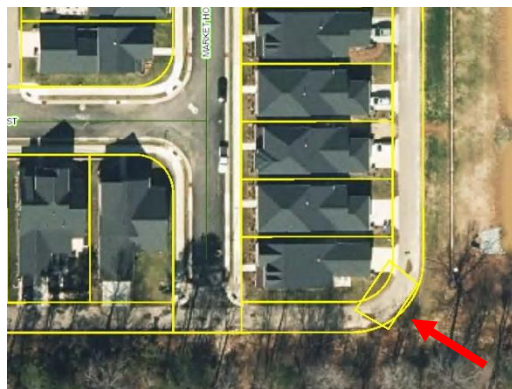
1. Damage to the alleys will need to be repaired consistent with on-site communication. There is some significant cracking occurring that needs fixed, there are raised manholes in some alleys that need additional asphalt.
2. Since so much time has lapsed an additional final walk-through inspection of all curbing, sidewalks, gutters, drains will need to take place before the town will accept these improvements.
3. The low spot in the southern turn of the easter alley needs to be corrected as water ponds there.

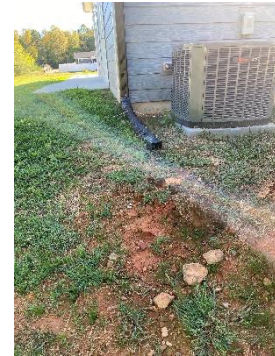
B. Clubhouse Area

1. The roof drain outflow on the northeast corner of the clubhouse is eroding the slope. Stabilize area, add protection measures, and re-vegetate.

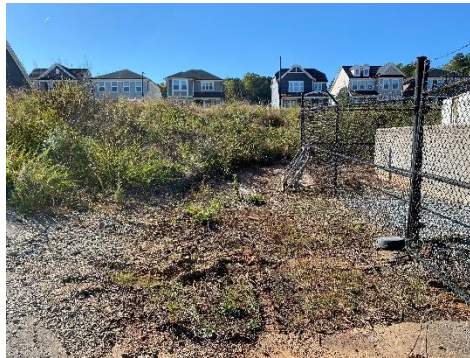
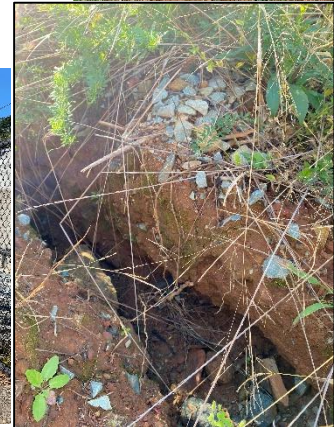
C. Pump Station Drive, Open Space, and Parking Area

Runoff from the clubhouse parking, adjacent grass area, and alley/driveway has formed a gully on the hill above the pump station. This flow is also depositing sediment in front of the pump station and eroding an area past the pump station just before the flow enters the stream. Redirect this concentrated flow to the pond and repair gully using the following measures:

1. Re-grade open space so that runoff from the parking area and open space is directed to the berm or otherwise reaches the pond.
2. Add curbs along the driveway/alley way to direct flow to pond.
3. Repair gully, including filling and compacting as appropriate, and stabilize and revegetate area. Compost or topsoil amendment may be necessary to re-establish vegetation.

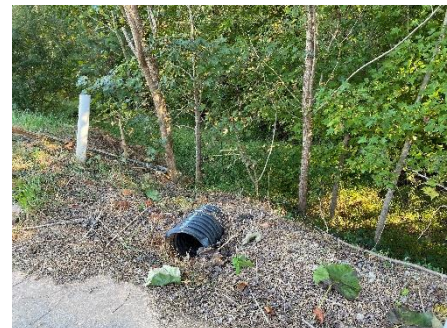
E. Main Pool Area

2. The permanent grass cover will need to be fully established on all side slopes and both sides of the dam prior to close-out. Re-seeding is needed near the inlet to the forebay where a significant bare area exists and along the western cut slope.

3. Vegetation is currently well-maintained. If any trees or shrub seedlings establish within the SCM area, these will need to be removed by the developer prior to SCM close-out.

1. Install aquatic plants and irrigate until established. Reference: Aquatic shelf plants are required to be planted per the State's 1999 stormwater BMP manual: <https://deq.nc.gov/about/divisions/energy-mineral-land-resources/energy-mineral-land-permit-guidance/stormwater-bmp-manual/archive> To be spaced 2 feet apart, recommended species are *Juncus effusus*, *Hibiscus coccineus*, *Carex grayi*, and *Saururus cernuus*. Evidence of plant survival and establishment will be necessary prior to close-out.
