# Corbinton Commons Update

Board of Commissioners

June 24, 2024

TOWN OF  
HILLSBOROUGH

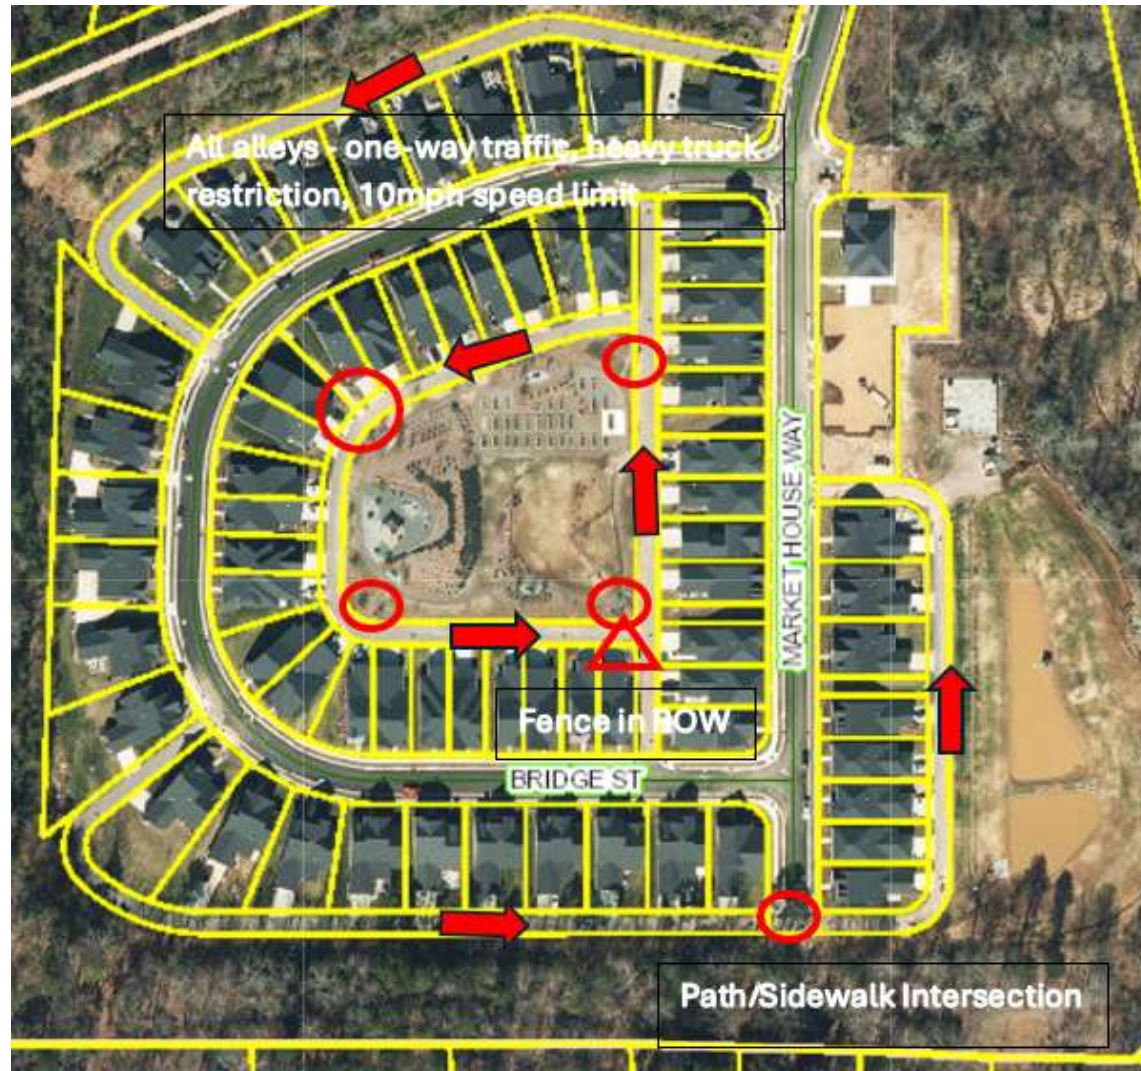
- Arrows denote one-way traffic
  - All alleys to be signed for no heavy trucks and 10mph speed limit
- Circles denote areas of intersections between private paths and what will be public right of way that need ADA compliance
- Triangle denotes area of fence in what will become public right of way
