Hilshire Village Municipal Utility District

Fire Hydrant Inspection & PM Report

May 2024

Hilshire Village
Fire Hydrant Survey Summary
May 2024

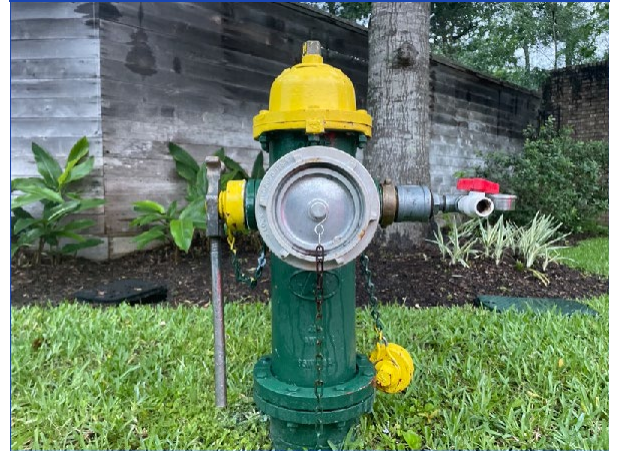
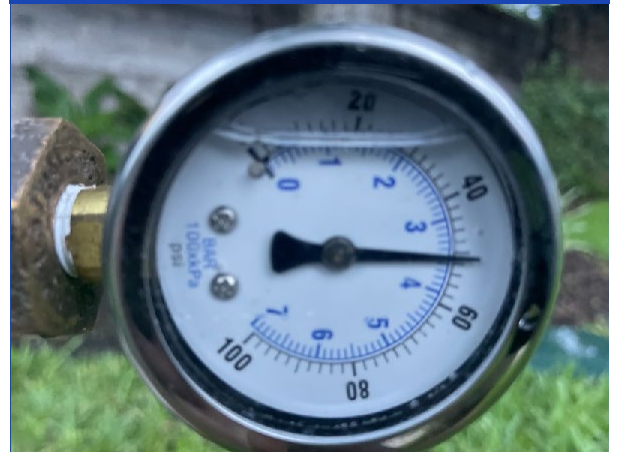
1

Low pressure , quick connection cap leaking.

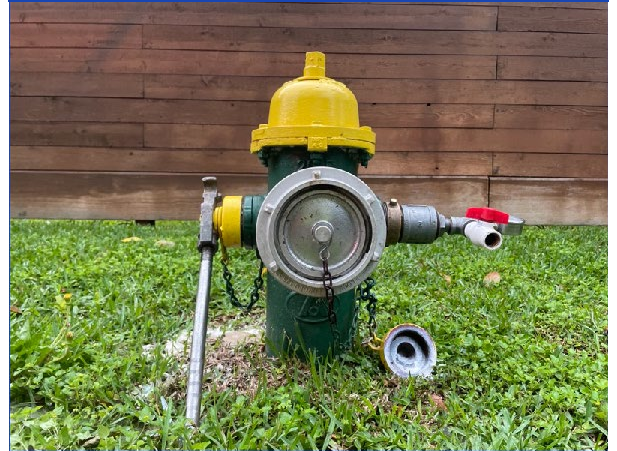
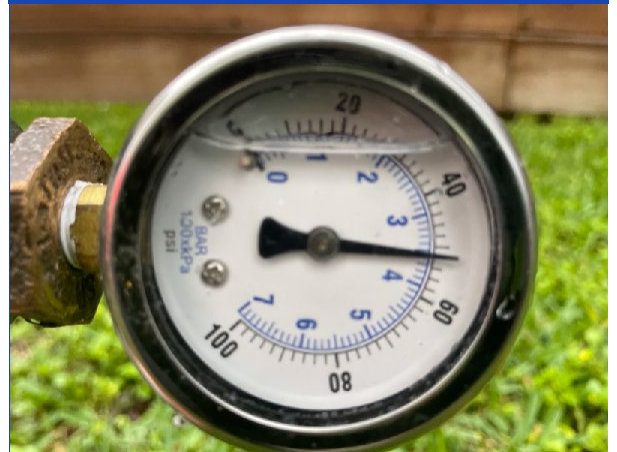
2 - Schedule repair

Ok Hydrant wrench will not turn freely.

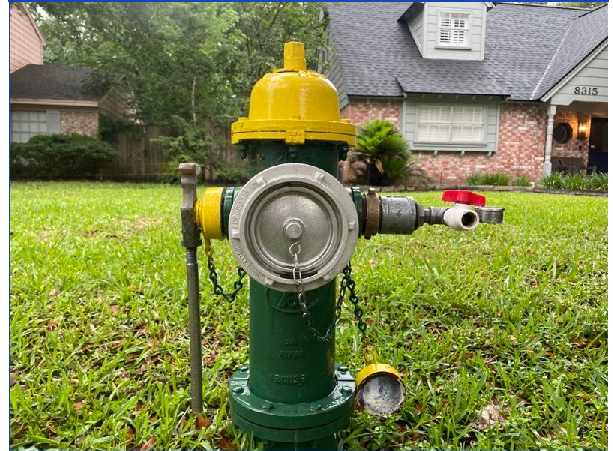
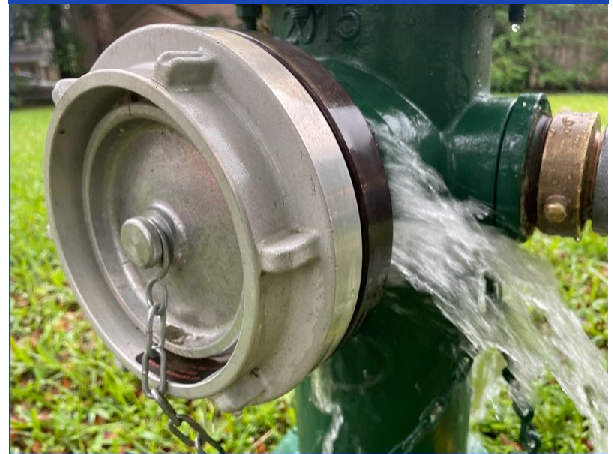
3

2 - Schedule repair

Front quick connection leaking.

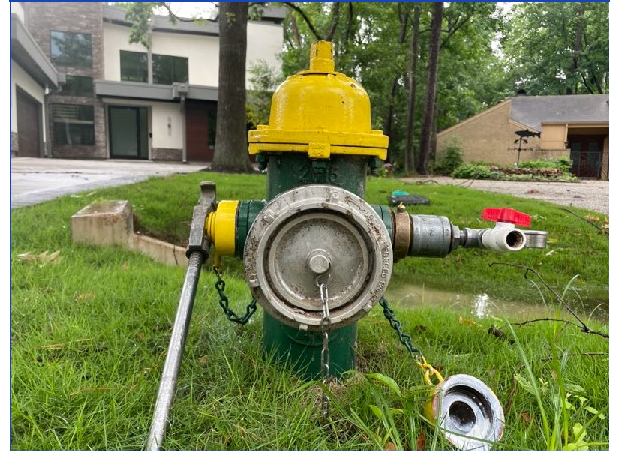
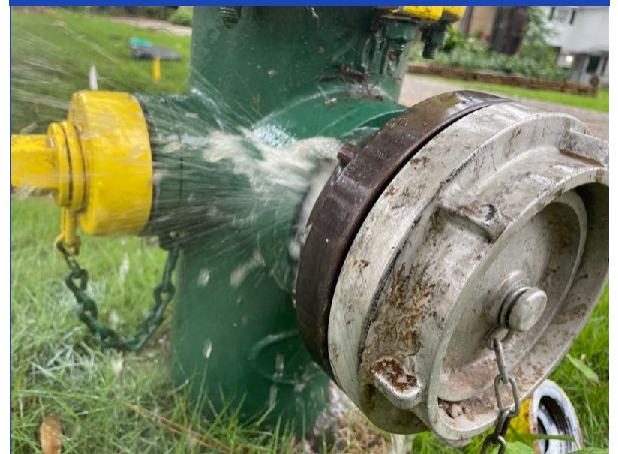
5

2 - Schedule repair

**Front quick connect cap leaking.
Hydrant wrench will not turn freely.**

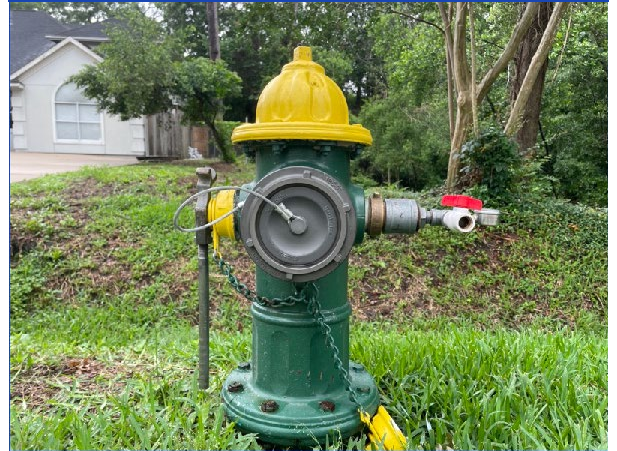
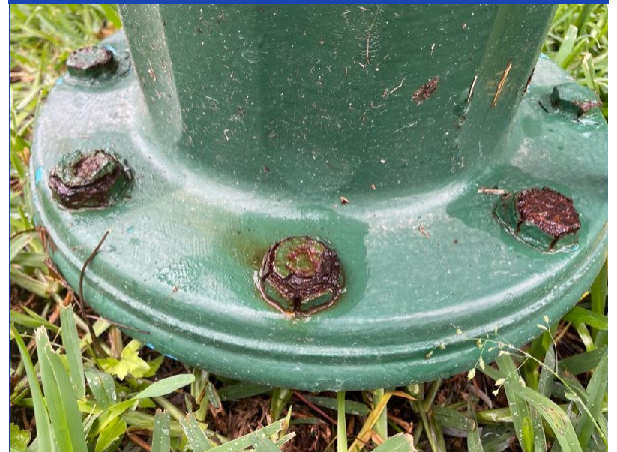
Address:
1209 Archley Dr.

2 - Schedule repair

Lower flange bolts rusted.

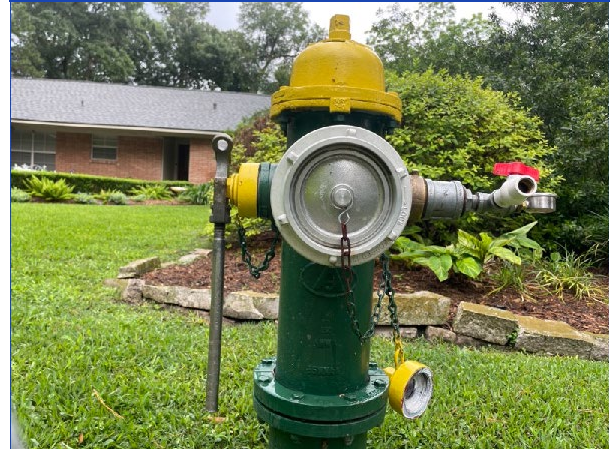
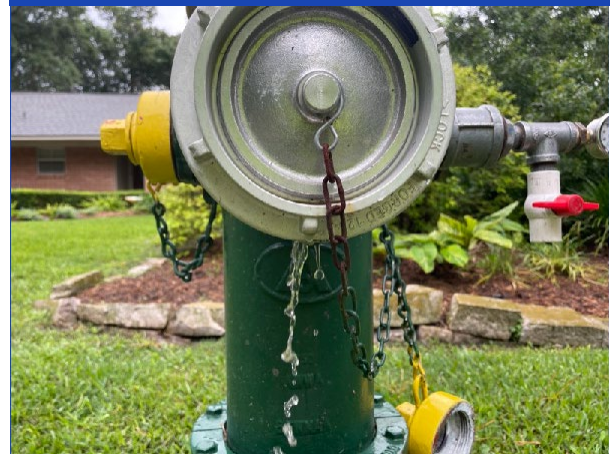
**Address:
1318 Glourie Dr.**

2 - Schedule repair

Front quick connection cap leaking.

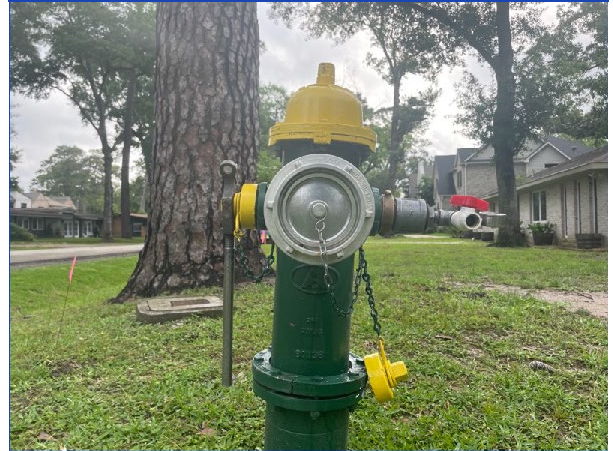
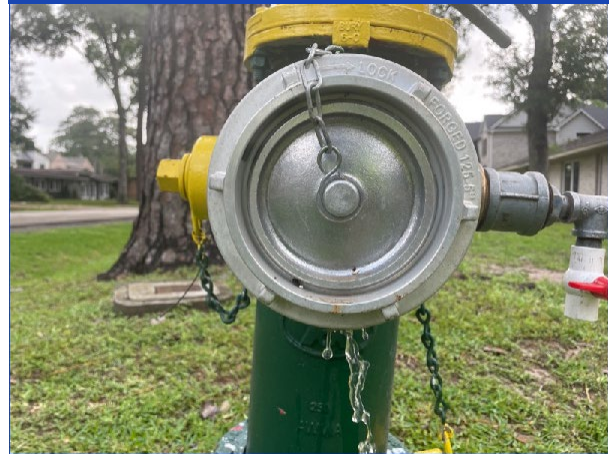
**Address:
8013 Anadell St.**

2 - Schedule repair

Front cap quick connect leaking.

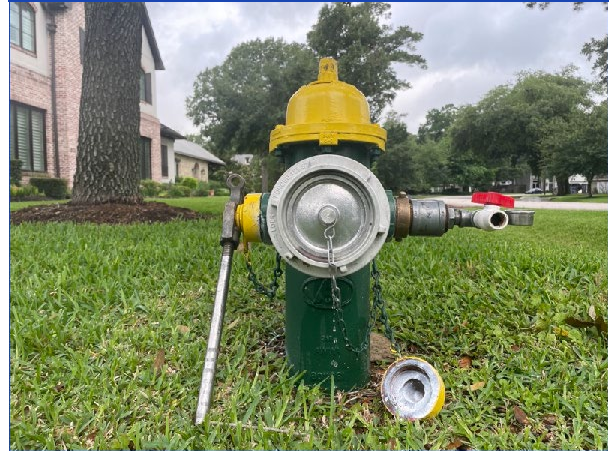
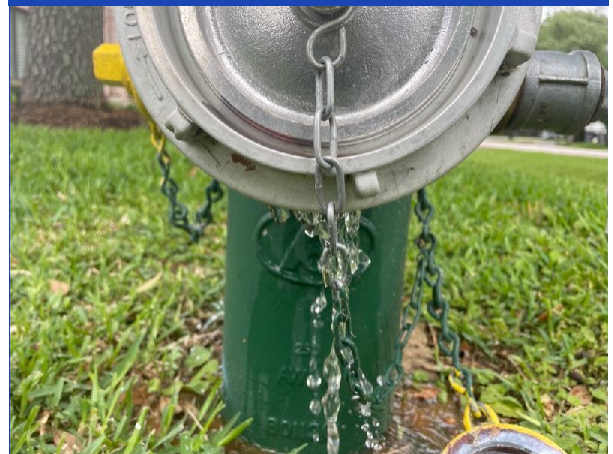
Address:
1201 Pine Chase Dr.@Glourie Dr.

2 - Schedule repair

Front quick connect cap leaking.

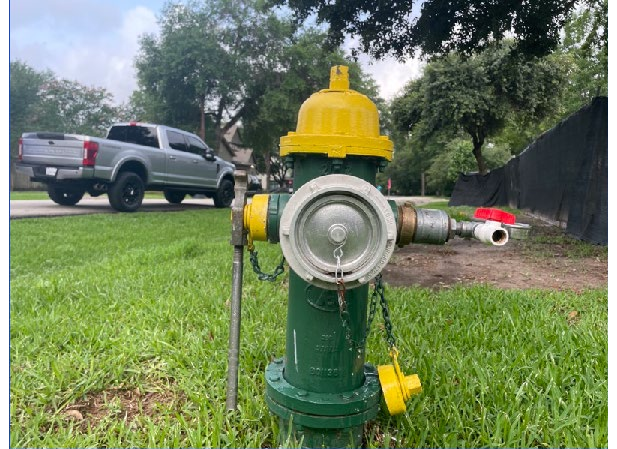
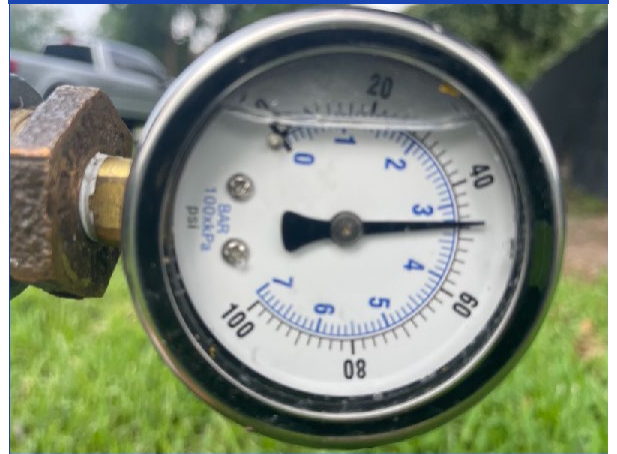
Front quick connect cap leaking.

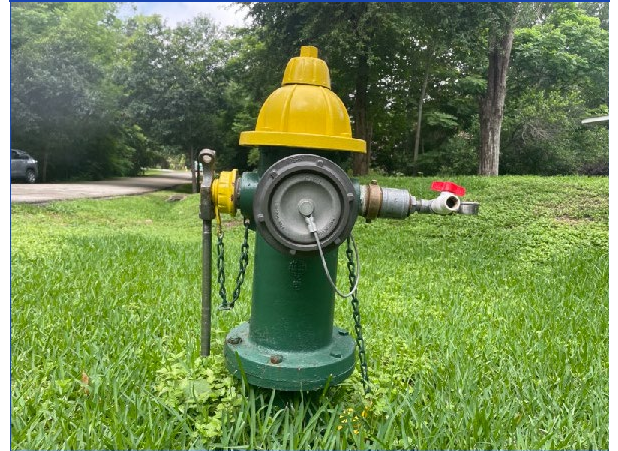
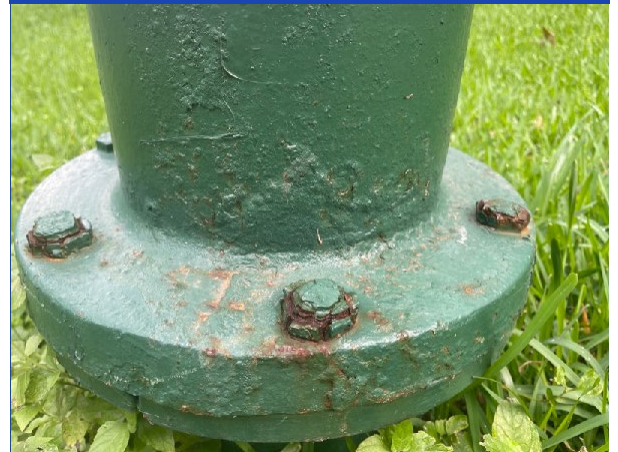
2 - Schedule repair

Lower flange bolts rusted.

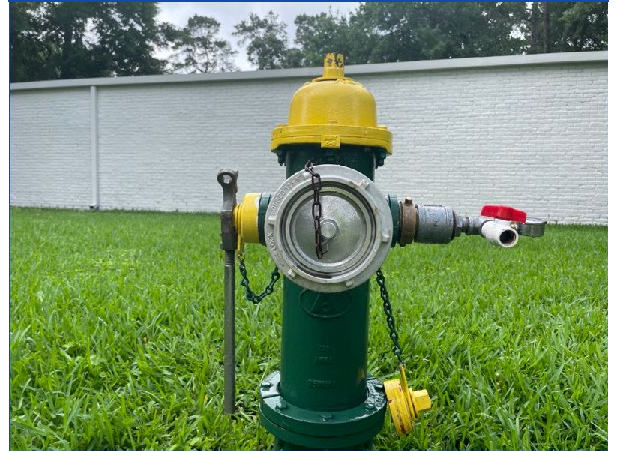
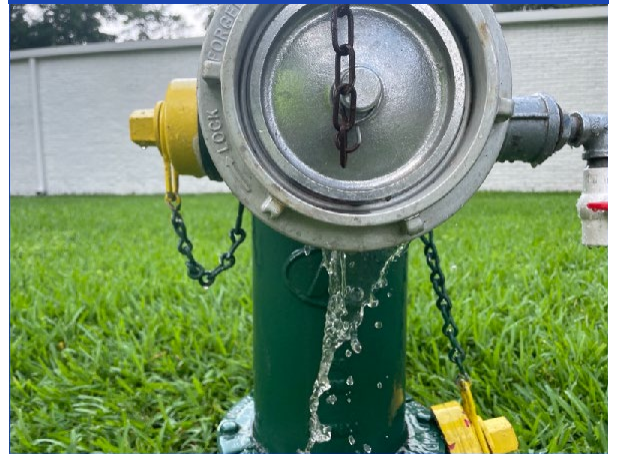
Address:
Ridgeley Dr.@ Glourie Dr.

Front quick connect cap leaking.

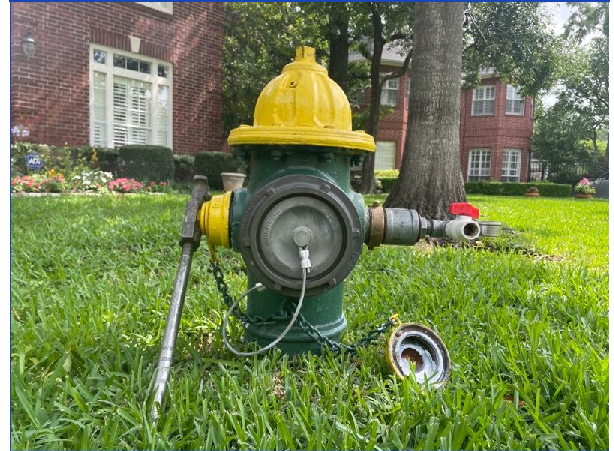
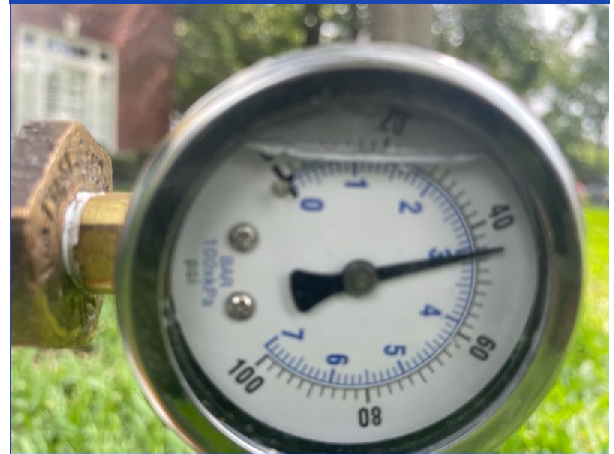
Address:
8 Hillshire Oaks Ct.

2 - Schedule repair

landscape hydrant

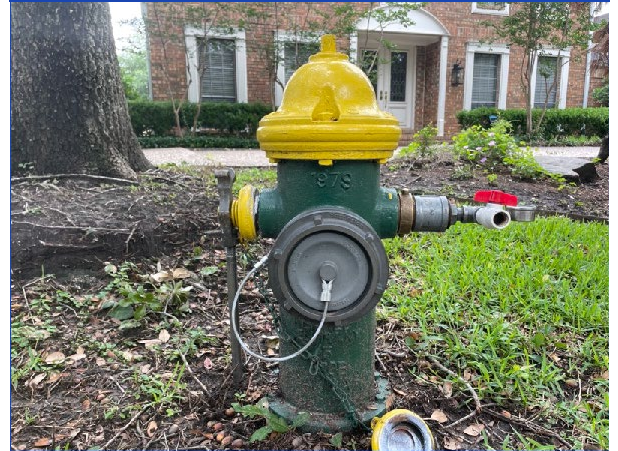
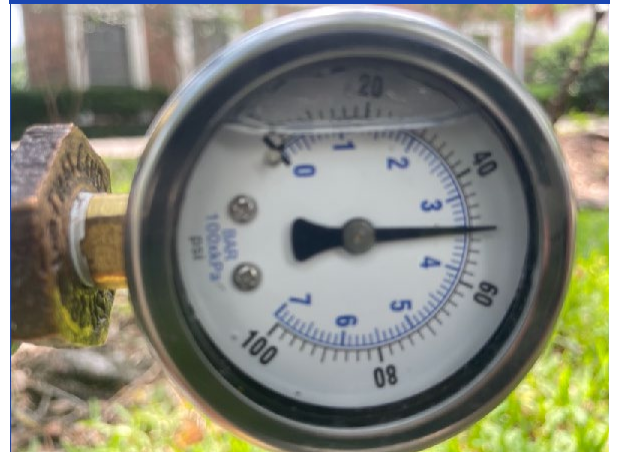
Address:
7 Hickory Shadows Dr.

2 - Schedule repair

Greas plug bad.

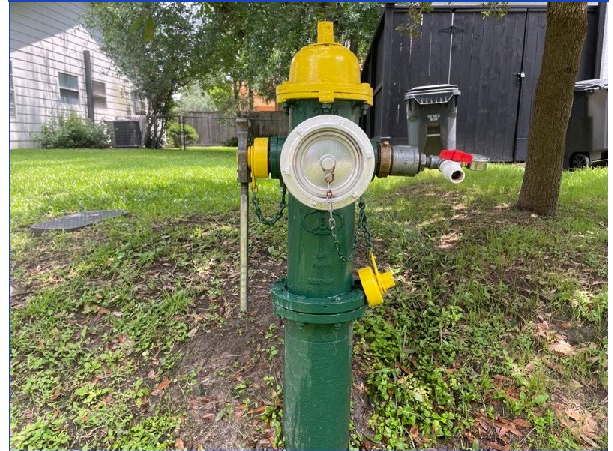
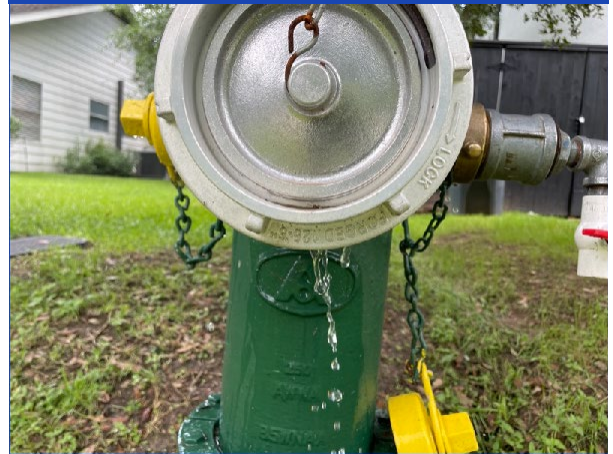
Address:
1306 Bridle Spur St.

Front quick connect cap leaking.
