Re: **GOTTSCHALK HOUSE [B1-1 DOWNTOWN CORE]**  
**18101 MARTIN AVE HOMewood, IL 60430 [29-31-311-003-0000]**  
**HISTORIC RESIDENTIAL BUILDING PORCH ASSESSMENT REPORT**

Ioannis Davis Architecture PC (ID Architecture) has prepared this report as an analysis of a deteriorating wood porch system at an existing multi-family apartment building in Homewood, Illinois to satisfy Homewood Building Inspector's violations.

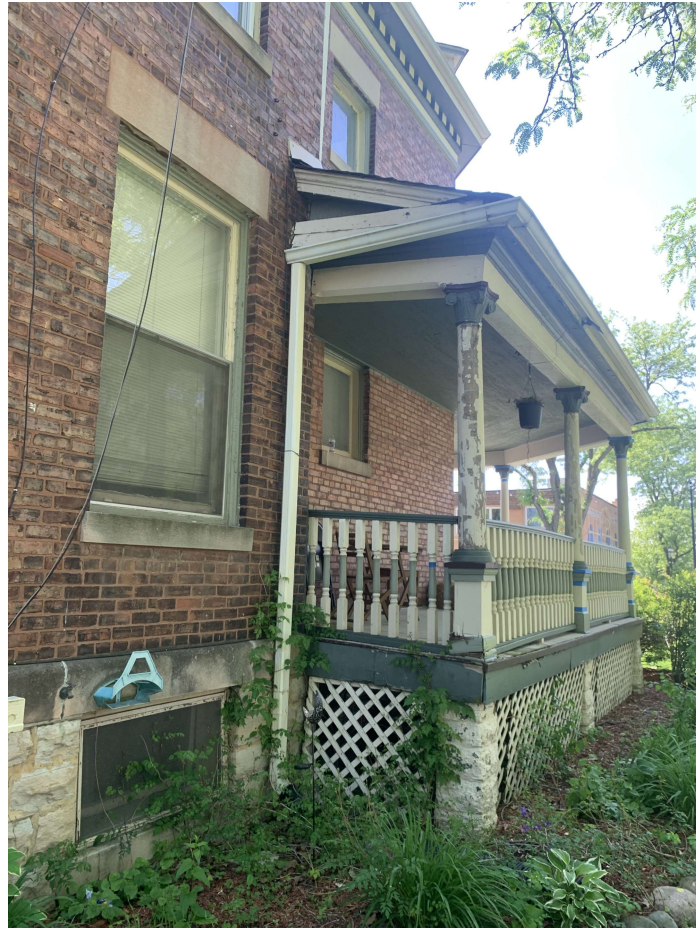
**1. PORCH FRONT STAIR:** Wood stair flight from grade is rotating into porch, creating a downforce that is pulling the porch away from the building. Additionally, the porch deck beams are loosely set on the existing stone piers with blocking. While the existing stone piers appear to be sound and plumb, the beams can slip on the blocking. The entire porch should be jacked up level and then new blocking placed on top of the existing stone piers.

VIEW OF SIDE OF PORCH & SLIPPAGE

**B. Repairs:** The stair flight from grade should be replaced - remove existing wood stair treads & risers.

1. Set existing stone step on new concrete pedestals to eliminate heaving.
2. Build new stair flight with historically accurate newel posts & handrailing. Note that historic railing would be lower than current code.
3. Install retrofit guard railing per Illinois Accessibility Code (IAC) & ICC.

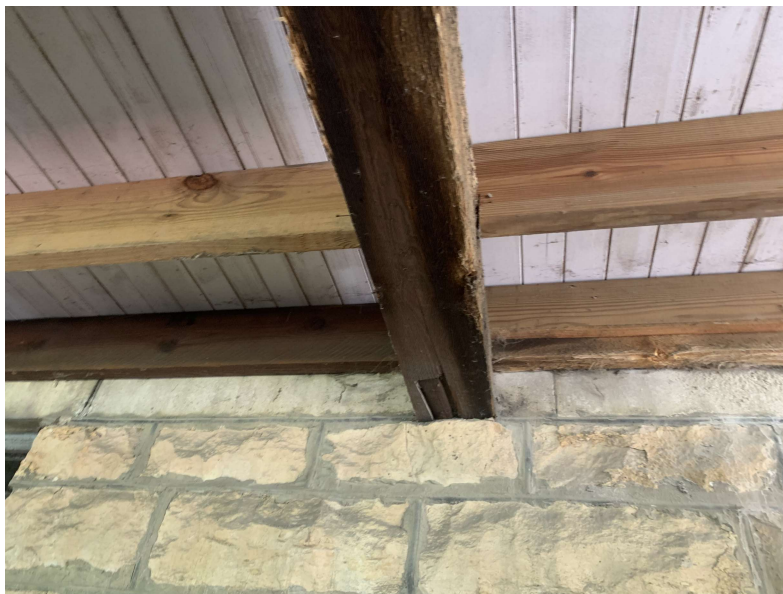
**1. WOOD BEAM TO STONE PIERS:** The wood beams that are pocketed into the masonry walls of the building at one end bear on stone piers at the other. The bearing at the stone piers is set on blocks and not anchored. Some beams need replacement due to cracks (stress) and rot.

TYPICAL POCKETED BEAM & NOTCHED DECK JOISTS

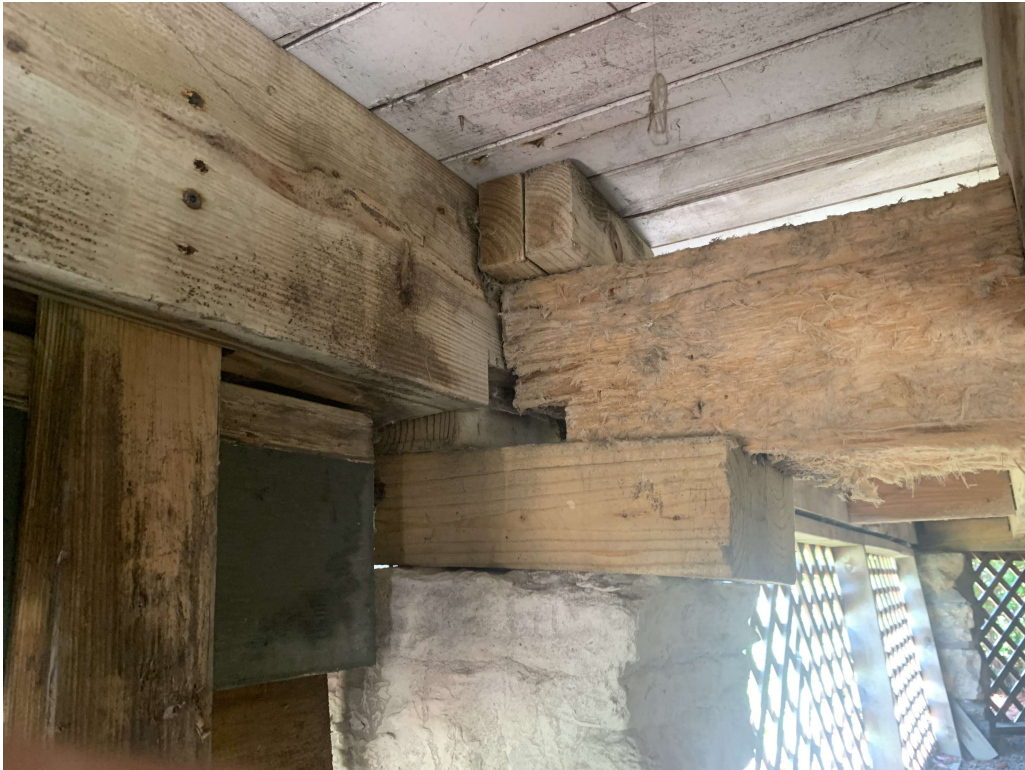
BEAM ON STONE PEDESTAL & BLOCKING

**B. Replace Cracked and Rotting Beams:** Replace beams with same size wood beams (treated)

1. Brace all construction and level entire porch
2. Replace beams noted on drawings
3. Install wd anchor plate & blocking on top of stone piers to nail new beams to.

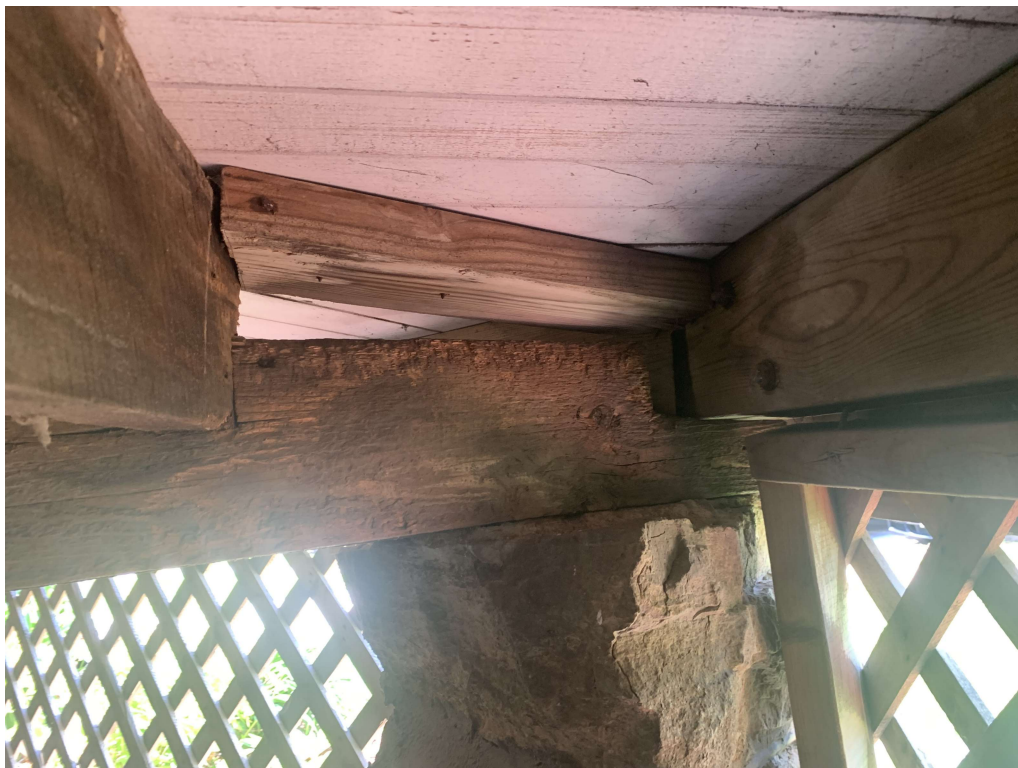
BEAM ON STONE PEDESTAL & BLOCKING

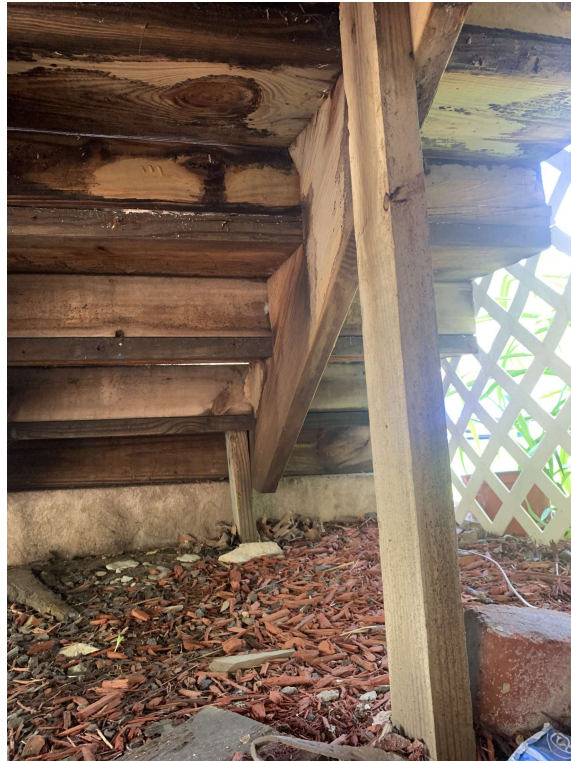
STAIR FLIGHT W/ POSTS ON GRADE

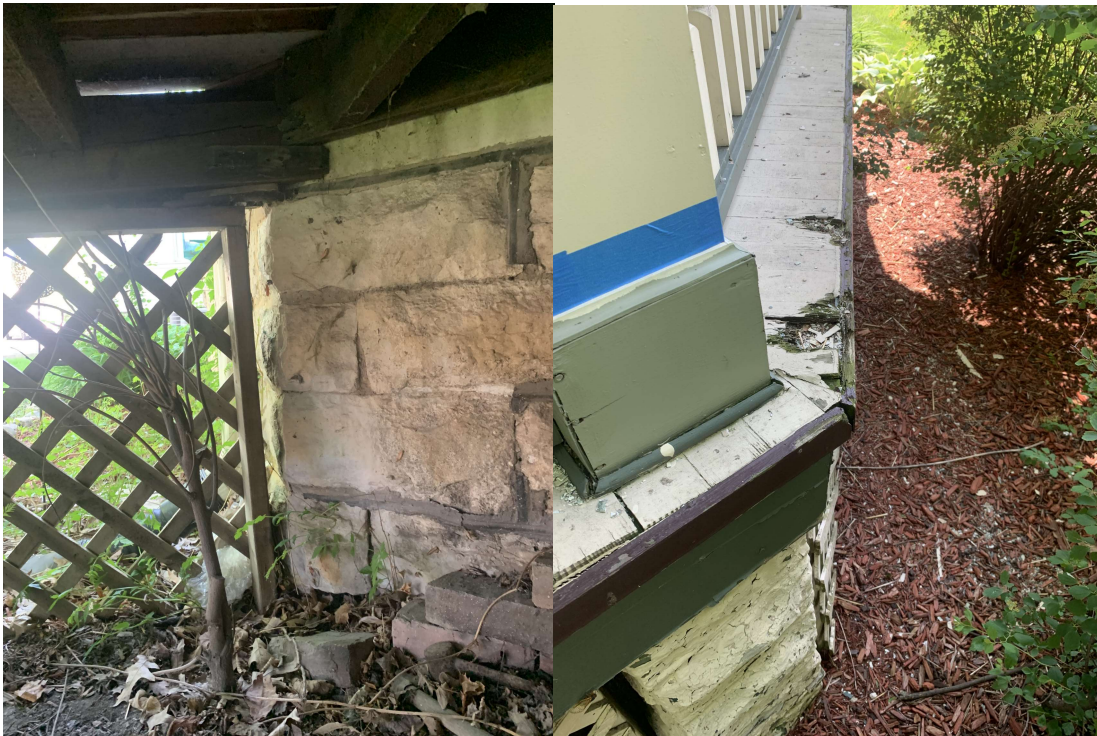
EXAMPLES OF ROTTING WOOD ELEMENTS

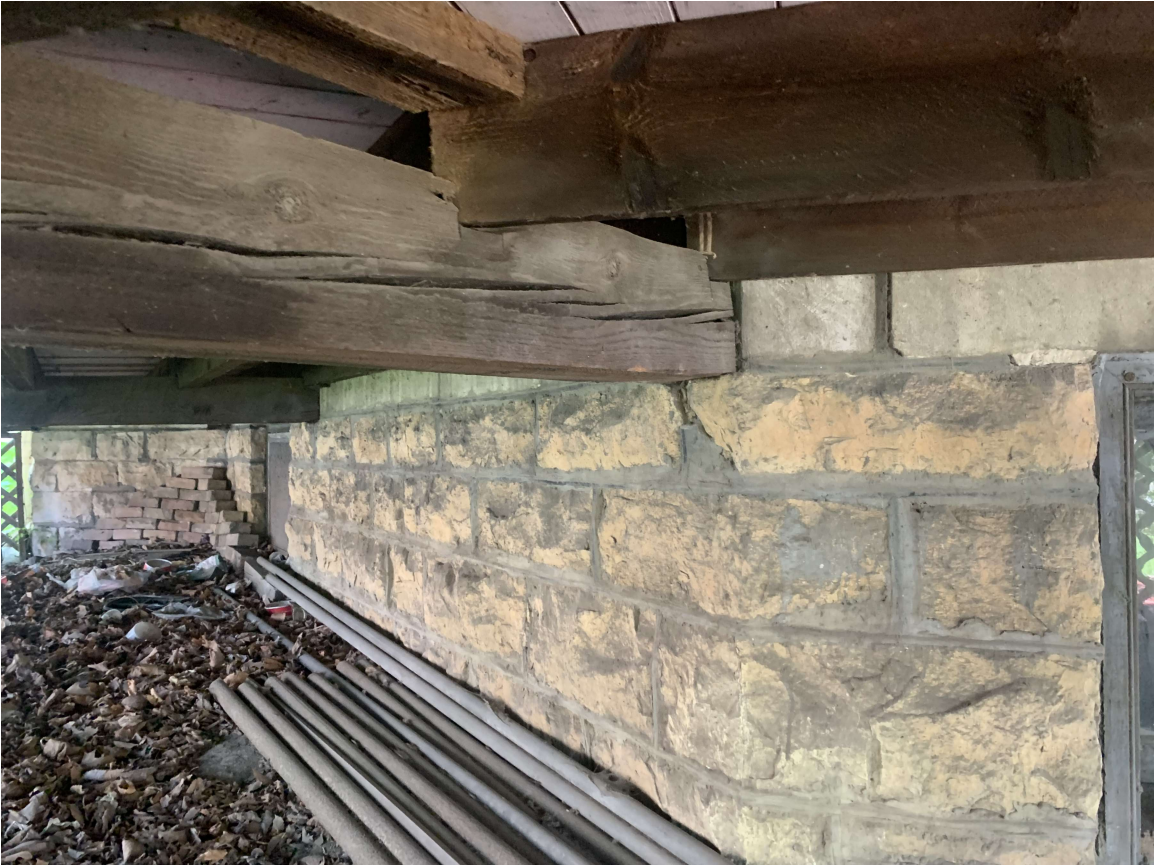
SPLITTING BEAM
