# Building Condition Assessment

## Hermiston Carnegie Library

**Hermiston Carnegie Library  
Building Condition Assessment**

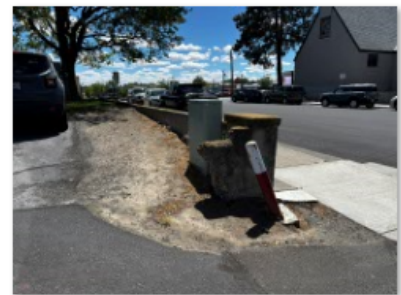
HCL\_Site\_09

- There is a 2.5' - 4' high concrete retaining wall along Gladys and 2<sup>nd</sup> Street. There are apparent patches in the sidewalk and portions of the wall. Refer to images HCL\_Site\_01, 03, 05, 06, 07, 08.
- The NW corner of the retaining wall is in dire need of repair due to excessive water intrusion. Refer to image HCL\_Site\_06.
- The north corner of the retaining wall as it dies into the driveway entrance needs minor repair. The protective bollard needs to be reset into the concrete foundation. Refer to image HCL\_Site\_09.

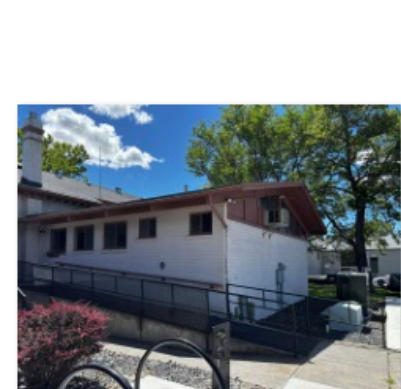
HCL\_Site\_12

- There are above ground utility boxes on the rear (north) of the addition that are in good condition. Refer to images HCL\_Site\_11 and HCL\_Site\_12.
- We did not assess the existing utilities. It is suggested to request a utility locate.

- Access via a concrete ramp and stairs from the parking area at the rear of the building is deteriorated and needs to be replaced to comply with ADA. There are guardrails on each side of the ramp. Refer to image HCL\_Site\_12.
- We did not fully assess the condition of these stairs or for the compliance of ADA requirements.

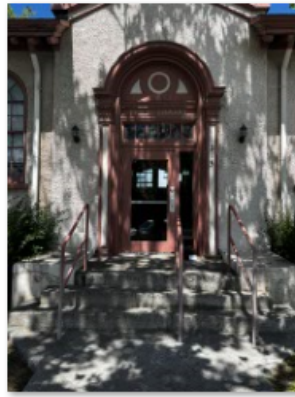
HCL\_Ext\_01

- e. Windows
- There were sets of two arched windows set within the rusticated stucco walls with tear-drop medallions at the windowsills on all sides of the original building prior to the addition at the rear. Currently, the north elevation has a single arched window on the west of the addition and a single arched window on the east of the addition that has been changed out to a door. Refer to images HCL\_Ext\_01, 09, 12, 26, 28, 29.

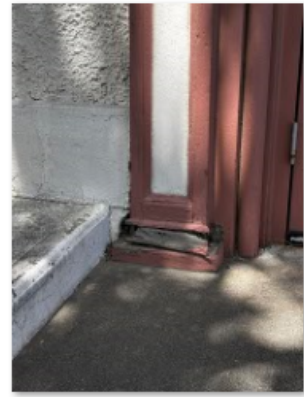
HCL\_Ext\_02

- The original main entrance double doors have been replaced with a single fully glazed metal door and small fixed sidelight. This door is in good condition. Refer to image HCL\_Ext\_02.
- The rear door is a solid metal door in good condition. Refer to image HCL\_Ext\_28. However, the threshold is too high to meet ADA and has been modified to provide a slope.
- There is a solid metal door to the basement via a recessed stairs at the east side of the building. This door is in poor condition and should be replaced. Refer to image HCL\_Int\_Rm\_B05\_03.
- There are no doors in the addition.

- The central entry on the front (south) façade has an arched pediment above the doors under a gable parapet with metal coping, all in good condition. Refer to image HCL\_Ext\_02.
- “PUBLIC LIBRARY” is etched into the crosshead wood trim over the front entry door and is in good condition. There is circular motif in the center of the pediment reflecting the circular windows in the gable ends. The exterior trim of the pediment needs minor repairs at the horizontal surfaces due to water intrusion. Refer to images HCL\_Ext\_05, 06.
- The wooden base blocks of the door casing need repair and some trim pieces replaced. Refer to images HCL\_Ext\_03, 04.

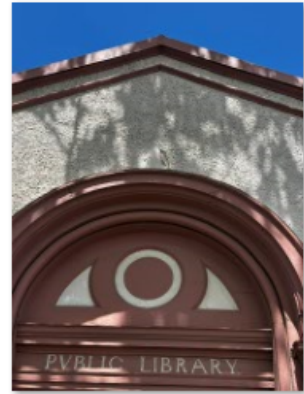
HCL\_Ext\_05

- The wood trim around the windows, doors, roof corbels, and entry pediment are all still original and in decent condition. The painted wood would benefit from a new coat of paint, with some minor repair work. Refer to images HCL\_Ext\_03, 04, 05, 07, 08.

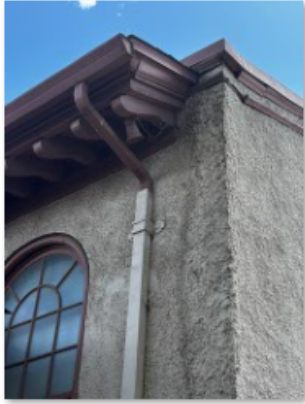
HCL\_Ext\_12

- There are gutters on the building in select locations which are in good condition. The downspouts should have extensions on the ends to direct the rainwater away from the foundation and base of the building. Refer to images HCL\_Ext\_12, 17, 20.

- d. Exterior Building Finishes
- The original portion of the building is wood framed with rusticated stucco cladding. Overall, the stucco is in decent condition but should be cleaned. There are a few areas that have been repaired or need repair. Refer to images HCL\_Ext\_10, 12, 13, 27.

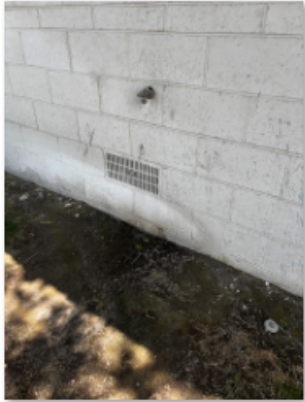
HCL\_Ext\_15

- The addition is built out of CMU which is painted to match the stucco color. The walls appear to be in good condition but could use a fresh coat of paint. Refer to images HCL\_Ext\_15, 18, 21.

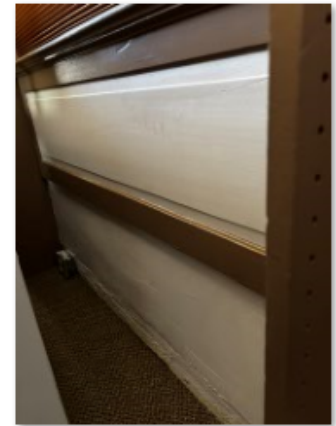
HCL Int Rm 02 03.1

- There is portion of base trim missing under the right window on the east wall. Refer to image HCL\_Int\_Rm\_02\_03.1.

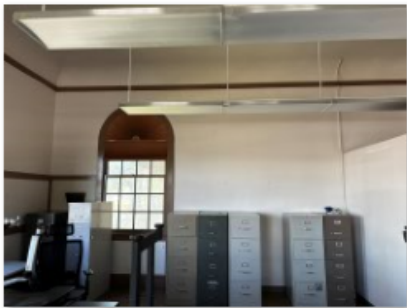
HCL\_Int\_Rm\_03\_01

- The partial height partition wall is on the left of the vestibule creating a private room (Room 03). HCL\_Int\_Rm\_03\_01.
- The flooring is a combination of original wood, carpeting, and vinyl in high traffic areas. The carpet and vinyl are well worn and should be replaced.

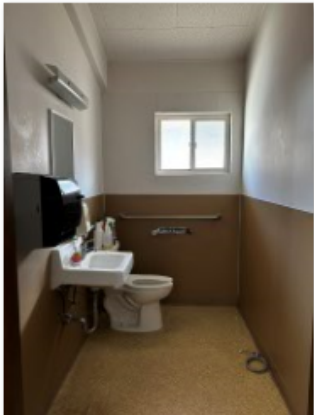
- The walls framing the two restrooms are wood stud, extending to the ceiling structure, with 12x12 acoustic tiles directly applied, all good condition.
- The walls have 4' high fiber-reinforced paneling (FRP) on all four sides, all good condition.
- The flooring is vinyl in decent condition.
- The floor-mounted toilet and wall-mounted sinks are ADA compliant in their shape and size, although their clear spaces where currently installed do not meet current ADA code requirements. The grab bars also do not comply with the current ADA code.
- Both rooms have a small wall-mounted mirror above the sink with a wall sconce above that. There is paper towel dispenser to the side of the sink.
- Refer to images HCL\_Int\_Rm\_05\_01 and HCL\_Int\_Rm\_06\_01.

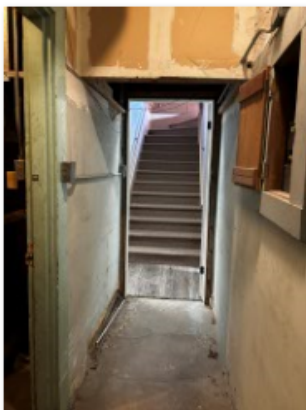
HCL\_Int\_Rm\_B05\_01

- The basement was recently remodeled into two main rooms on either side of the stairway, the left room (Room B01) also has two individual offices on the far-left wall (Rooms B03 and B04). These spaces are finished with new gypsum board walls and ceilings, vinyl plank flooring, flush wood doors, and ceiling mounted fluorescent tube lighting. All materials are in great condition. Refer to images HCL\_Int\_Rm\_Boo\_01, HCL\_Int\_Rm\_B01\_01, 02.1, 02.1, HCL\_Int\_Rm\_B02\_01, 02, HCL\_Int\_Rm\_B03\_01, HCL\_Int\_Rm\_B04\_01.
- Adjacent to the stairs from the main entry, is a door to the unfinished portion of the basement housing the mechanical and electrical systems. There is also an exit hallway to the exterior west side of the building. Refer to images HCL\_Int\_Rm\_B05\_01, 02, 03.

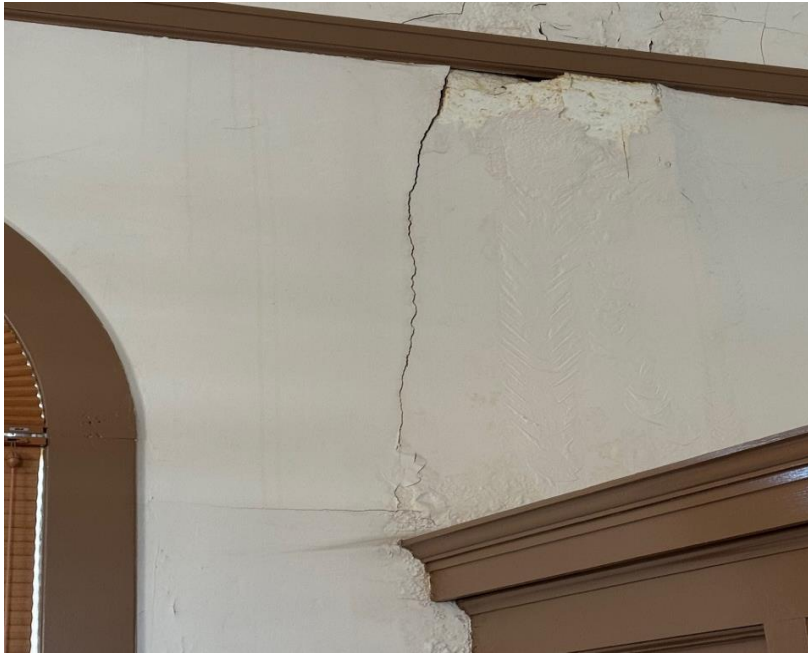
1. Visible water damage to the wall plaster from a roof leak above the main entry at the roof intersection was observed. When the plaster was removed the wall framing appeared adequate but only the upper 1/3 was visible. We understand this leak has been repaired. (Ref Photo 1)
2. The roof girder referenced above supporting the ridge beam loading from the '60's addition as well as roof framing from the original building is sagging with a viewable crack in the sheet rock. The beam sags approximately 1/2" and based

← Water damage at  
exterior wall @ main entry  
Photo 1

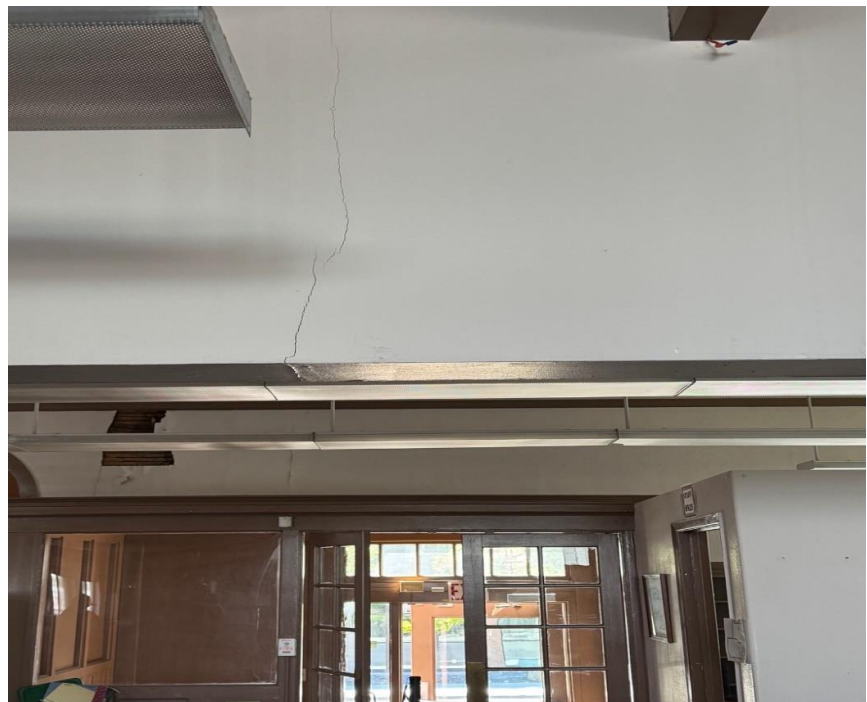
on the beam's span is within allowable deflection tolerance of the current Building Code. This is most likely due to long term deflection of the girder and can be repaired. (Ref Photo 2)

Crack in sheet  
rock @ Roof  
Girder →  
Photo 2

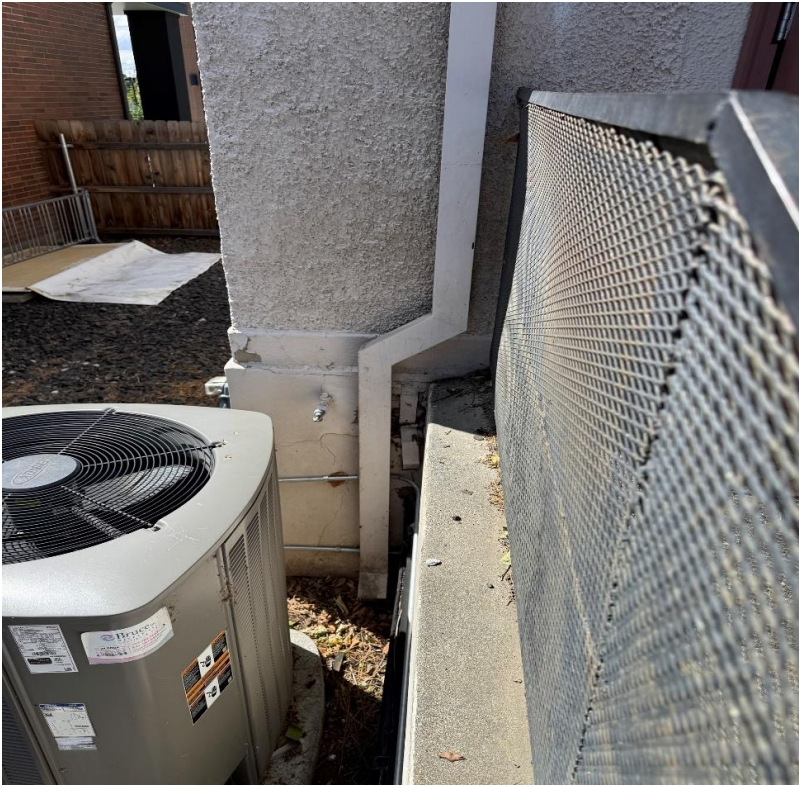
Photo 3

3. Multiple downspouts terminate at the base of the perimeter walls and are not connected to a storm drainage system to divert water away from foundation. (Ref Photo 3)
4. Water damage was viewable on the West CMU stem wall of the '60's addition adjacent to the basement entry. No gutter system exists at this eave and this appears to be a low area where water could accumulate. (Ref Photo 4)
5. Potential water damage (dry rot) appears on the wood fascia at both the South and West eaves as the exterior paint is peeling revealing wood that has darkened. (Ref Photo 5)
6. The upper wall section of the North wall of the addition is glazing with no shear wall sections to transfer force from the roof diaphragm to the CMU wall. (Ref Photo 6)

← Improper downspout termination

1. Install storm drainage system to divert storm water away from building foundation. If not diverted, storm water will erode quality of perimeter concrete and CMU stem walls and lead to settlement of the foundation and cracks in the exterior walls.
2. Expose wall framing where roof leak occurred to ensure both framing and sill plate are undamaged. Further, review of framing to wall connections, both floor and wall, should be reviewed by a Structural Engineer to ensure proper load transfer.
3. Replace damaged wood where required at eave sections and repaint all damaged areas.
4. Install small shear wall sections at both the East and West ends (between window sections) of the North wall of the addition for proper shear transfer to existing CMU walls.

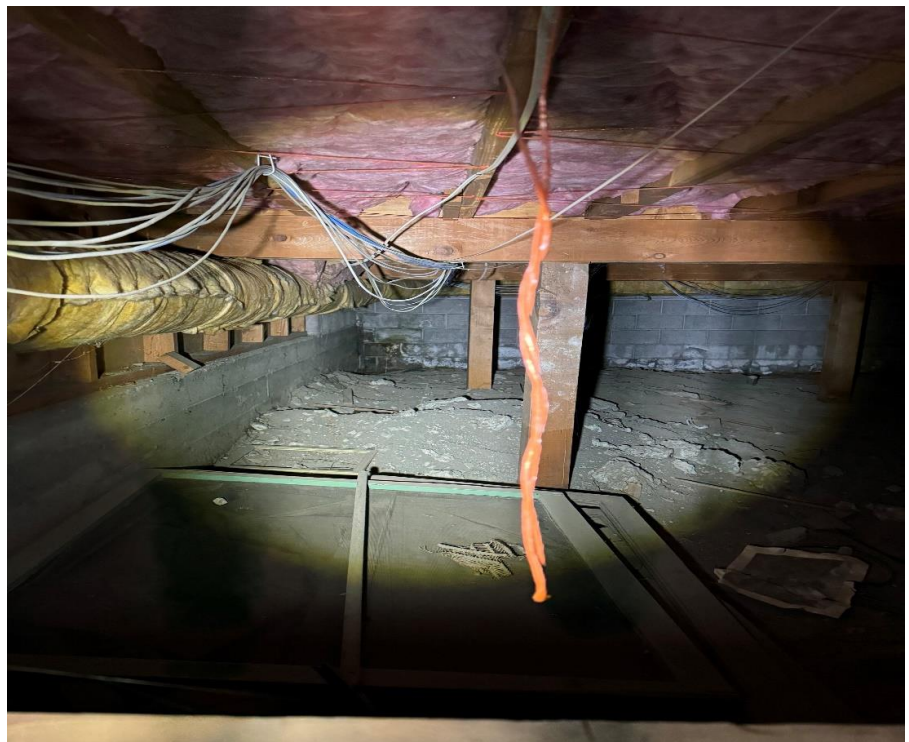
Photo 4

Water damage @  
Existing CMU Stem  
Wall →

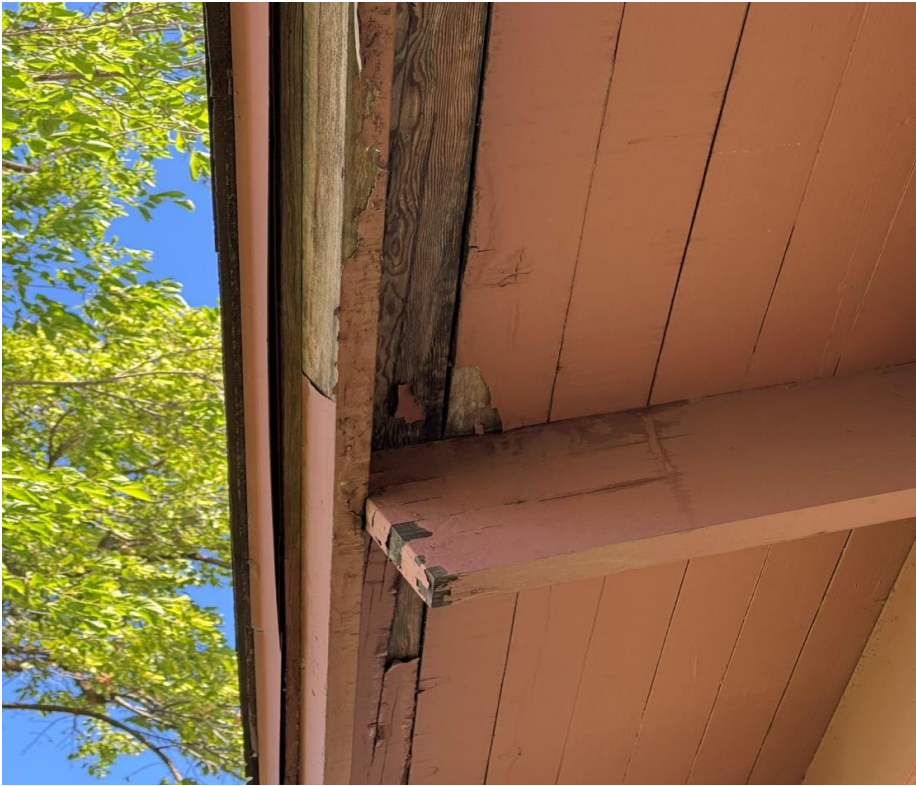
← Water damage @  
Existing Eave  
Photo 5

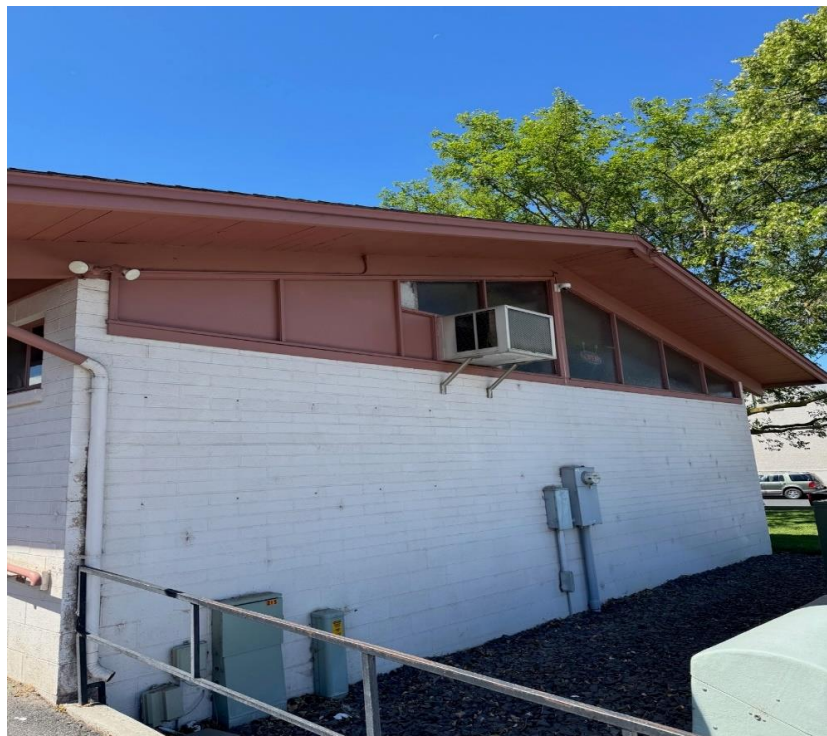
Glazing at upper  
section of North  
wall→  
Photo 6
