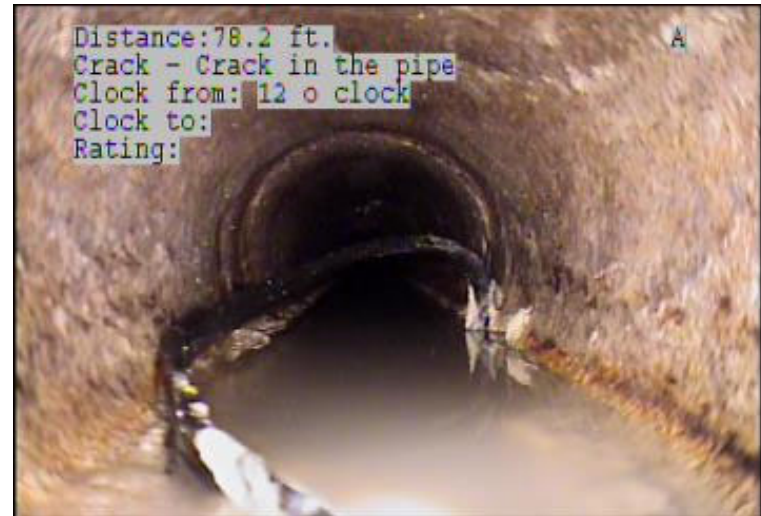
Photo 61: Structural damage (crack in pipe) (Basin E4).

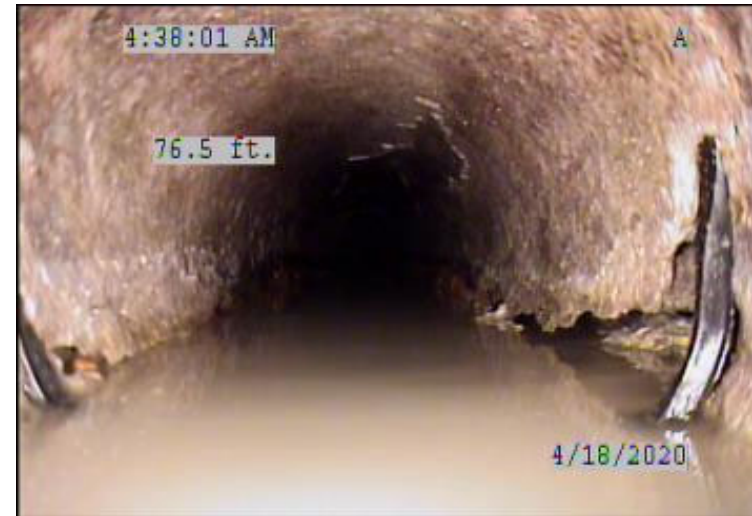
Photo 62: Structural damage (pipe deterioration) (Basin E4).

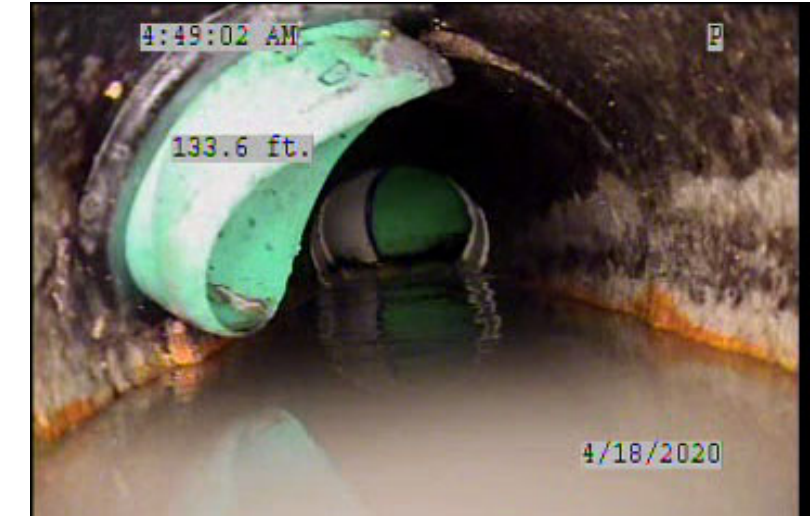
Photo 63: Protruding lateral (Basin E4).

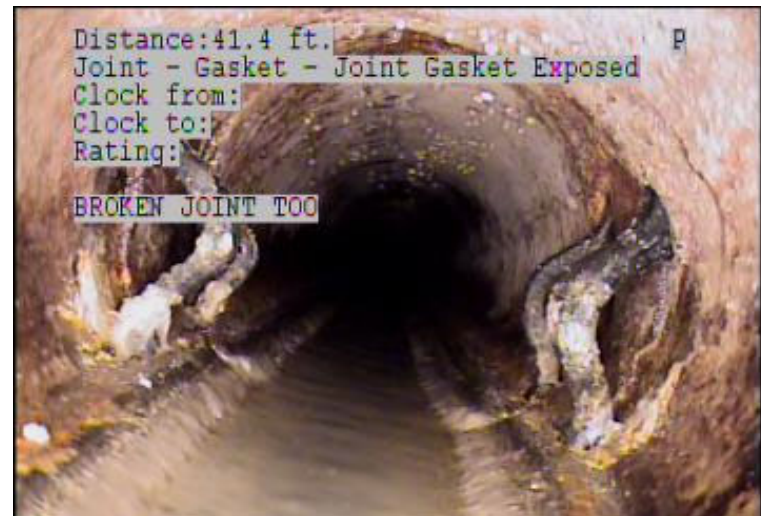
Photo 64: Structural damage (exposed gasket) (Basin E4).

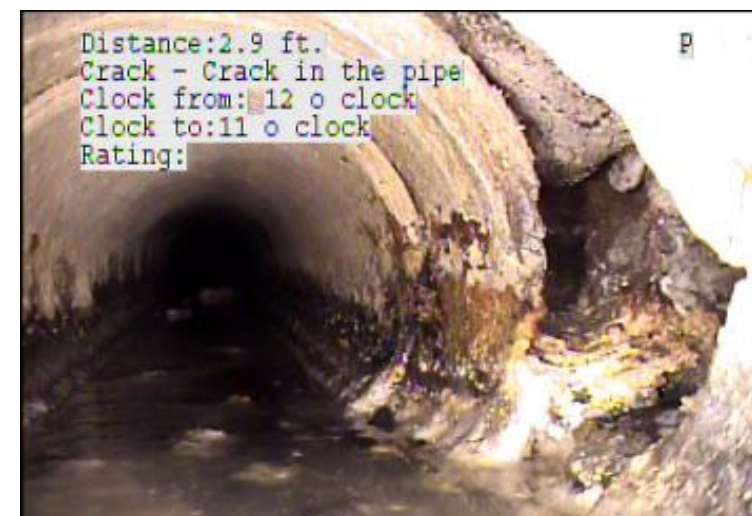
Photo 65: Structural damage (hole in pipe) (Basin E4).

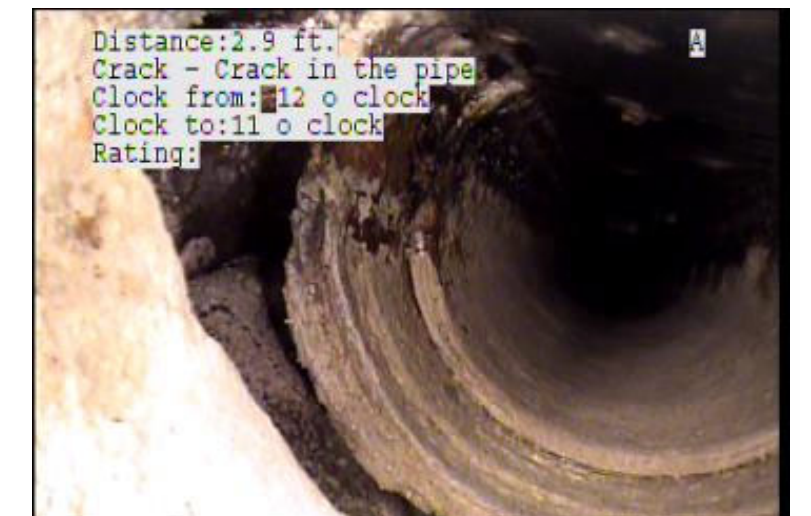
Photo 66: Structural damage (hole in pipe) (Basin E4).
