**DATE:** January 6; 10:00 am – 11:00 am

**WORK IN PROGRESS:** Cutting out of existing mortar joints for repointing; removal of non-original stone at cheek walls; removal of stone specified to be replaced

End of Field Report No. One

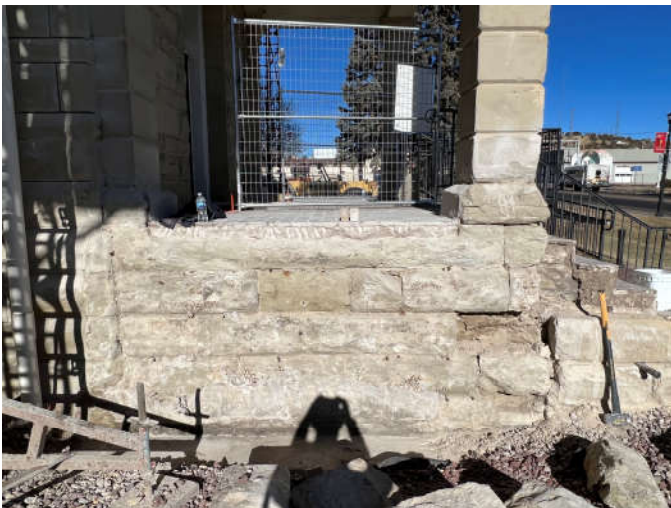
1. The primary purpose of this site visit was to review the condition of the cheek walls at the main east entry. Upon removing the outer layer of non-original stone, the original sandstone was found underneath; the original cheek walls align with the north and south tower walls.

- a. The original sandstone at both the north and south walls is in poor condition with significant surface spalling and damage from the installation of the outer layer of non-original stone. It was determined during this site visit that the sandstone should be replaced in-kind, matching the sizes as closely as possible. (Re: Photos #1 - #4.) Temporary shoring to support the porch columns and floor will be required when the stones are replaced in order to prevent any settlement.

Photo #1: West end of south cheek wall with original sandstone exposed after the outer layer of non-original stone was removed.

- b. Removal of the original sandstone revealed a rubble stone back-up. All voids should be filled with mortar or stone if the voids are large, similar to the treatment of the rubble at the tower.

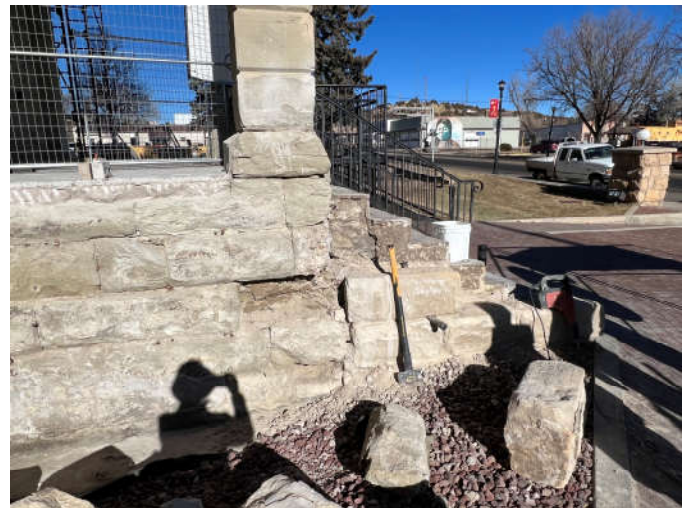
Photo #2: East end of south cheek wall showing deteriorated condition of original sandstone.

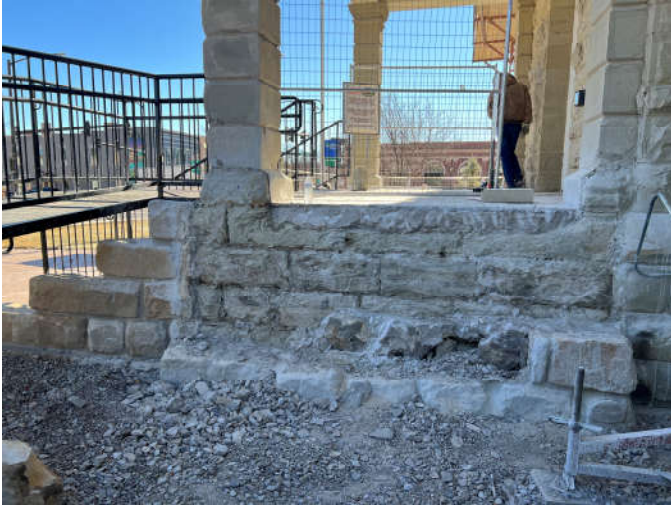
Photo #3: East end of north cheek wall with exposed original sandstone.

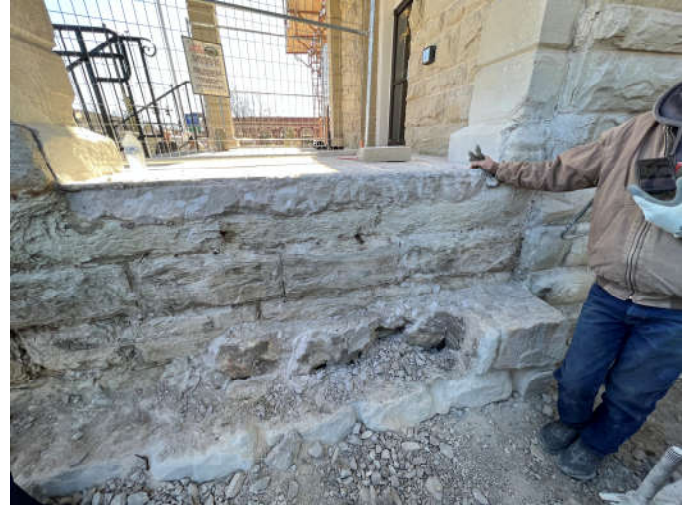
Photo #4: West end of north cheek wall. Some of the non-original stones have not yet been removed.

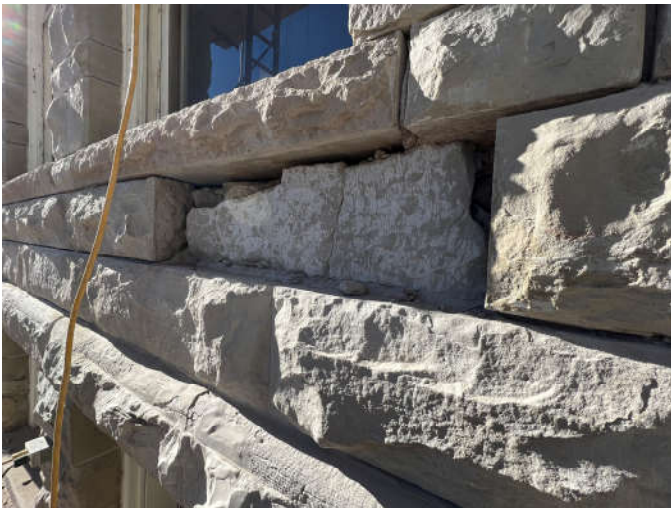
2. A stone at the south side of the east wall was called out to be refaced. When the stone was removed, it was discovered that it is too thin to reface so the consensus was to replace the stone in its entirety. (Re: Photos #5 & #6.) Dan reported that he has found that the stones vary in thickness so there may be other similar conditions where refacing was specified but replacement will be required.

Photo #5: The stone at this location at the south side of the east wall was specified to be refaced.

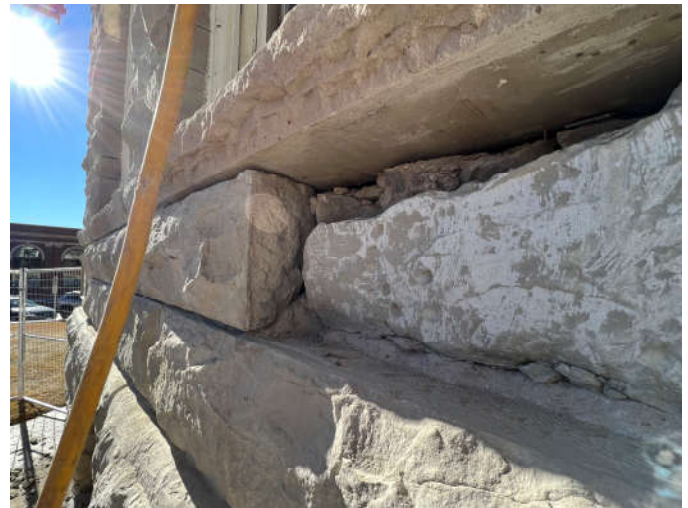
Photo #6: The stone is not thick enough to be refaced so it will be replaced instead.

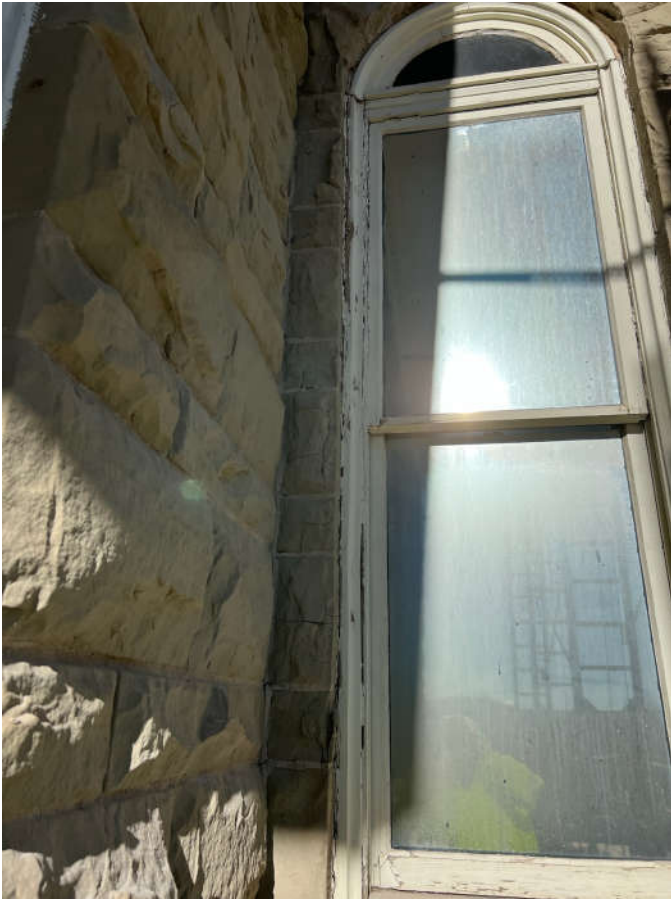
3. One of the masons noted that stones on the west jamb of the second floor window on the south tower wall are deteriorated. These stones were not called out on the drawings to be replaced but it was agreed that they should be as part of this project. (Re: Photo #7.)
4. The condition of the stones below the first floor window on the south wall of the tower was reviewed because the documents call for all of the stones at the infilled opening to be refaced; Dan thought one

Photo #7: The stones on the west jamb require replacement. (Photo by Mountain Masonry)

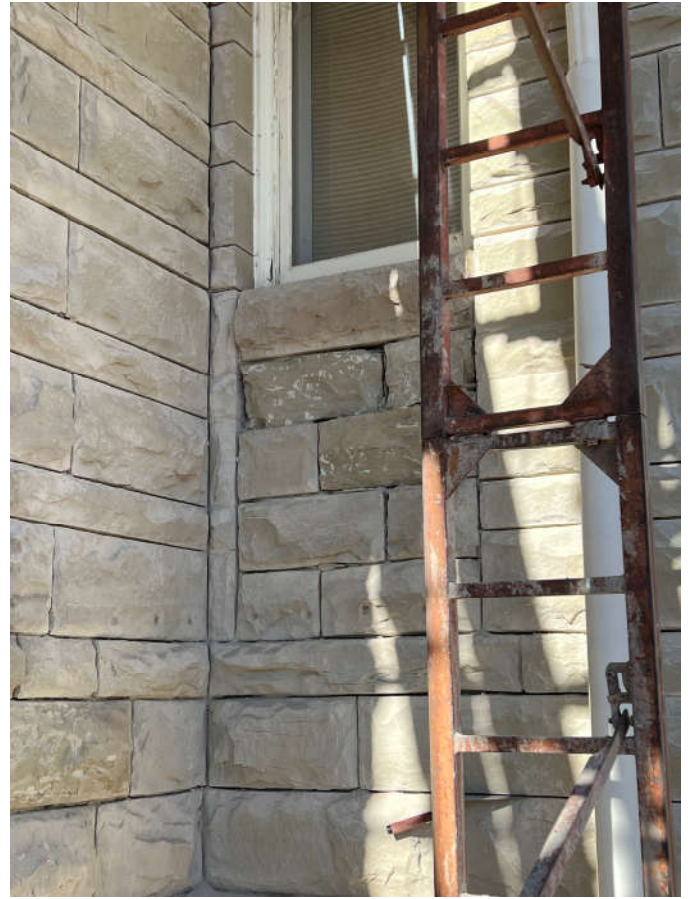
Photo #8: The stones below the window at the infilled opening are specified to be replaced.

or two of the stones could possibly be salvaged. Following review, it was decided to reface all of the stones as called for on the drawings. (Re: Photo #8.)
