DATE: October 16, 2023; 10:15 am – 11:15 am

WORK IN PROGRESS: Installation of replacement stone

End of Field Report No. Four

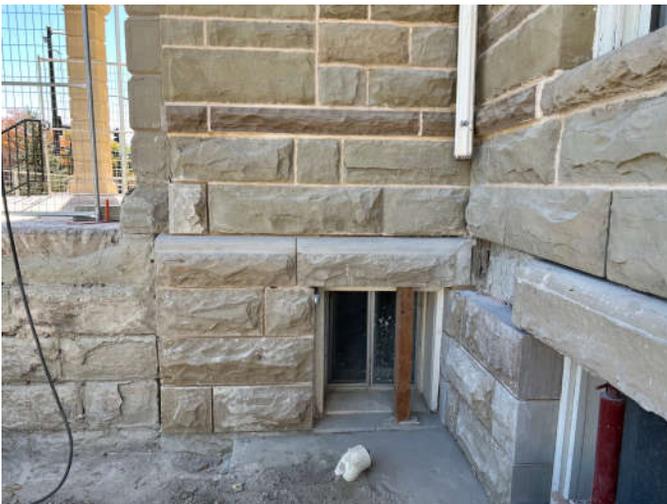
1. The replacement and refacing of the stone on the north face of the tower is underway. The stone at the bottom of the wall has been installed, ready for retooling and repointing. (See Photo #1.) Stones remaining to be installed include the lintel above the main level window and the stones immediately below the tower cornice.

Photo #1: The stones at the bottom of the north tower wall have been replaced. Remaining required effort includes retooling the radiused water table stones and repointing.

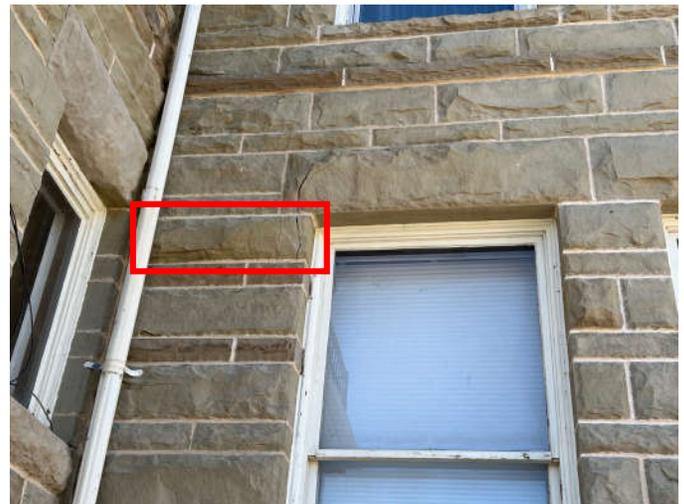
3. A question arose about a treatment specified for a stone at the southernmost main level window on the north side of the east elevation; the stone in question is located immediately below the lintel stone. The drawings show two stones rather than one, with the shorter stone adjacent to the window; in addition, the drawings call for the shorter stone to be both refaced and pinned to the longer stone. However, the treatment will require a deep reface for the single stone, given its location at the window jamb. The masons asked that the stone not be pinned since it will require a deep reface and is one stone rather than two. The proposed change was approved with the condition that the lintel stone be shored prior to refacing the stone in question. (See Photo #2.)

Photo #2: The south bearing stone at this window will receive a deep reface. No pinning is required. However, the lintel stone should be shored prior to refacing.

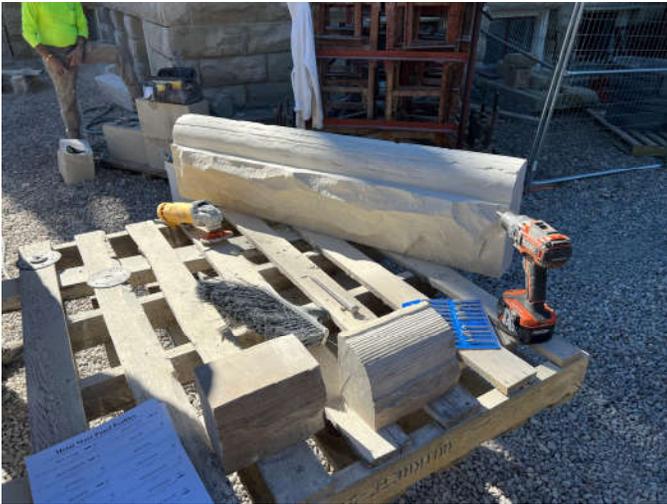
4. Some of the water table stones with radiused tops, located above the garden level windows, have been installed; the execution of the tool marks that duplicate the original are underway. (Re: Photo #3.) Mike noted that the replacement stone is much harder than the original.

Photo #3: The process for achieving tool marks similar to the original on the radiused top surface of this stone is being tested here.

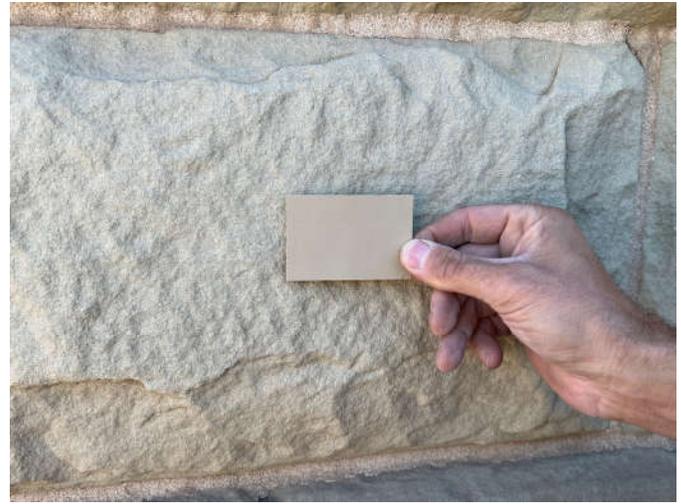
5. The color of the replacement flashing required at the second floor balcony was selected. Rather than matching the existing dark brown flashing, the replacement flashing will more closely match the color of the stone. The color “Surrey Beige” was selected. (See Photo #4.)

Photo #4: The sheet metal flashing required at the second floor balcony will closely match the color of the stone.

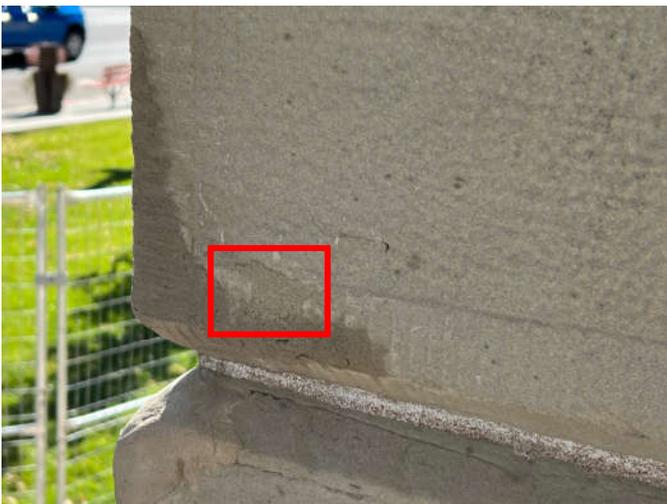
6. A small sample of the Jahn M70 patching mortar to be used at the main entry columns was available for review. It was approved. (See Photo #5.)
7. The repointing of the stone at the south end of the east elevation is mostly completed. The stones at the bottom of the southeast corner will be replaced when the next shipment of stone is delivered. (Re: Photo #6.)

Photo #5: A new sample of patching mortar was available for review and approval.

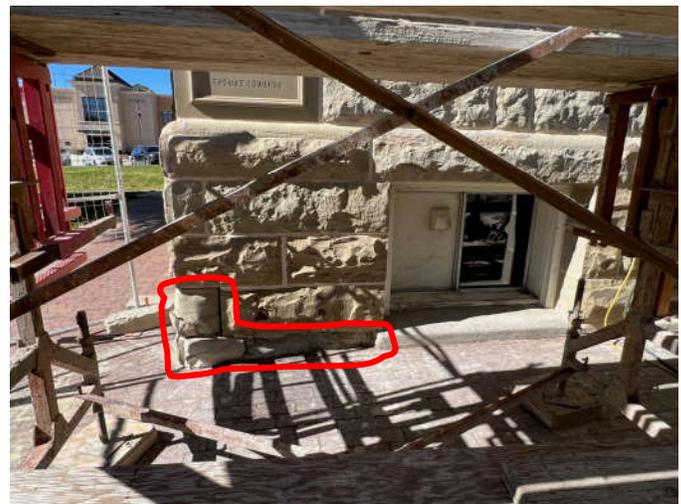
Photo #6: The stones at the bottom of the southeast corner still require replacement. The water table stones above the garden level windows are in poor condition.

8. It was observed that the water table stones with radiused tops, located above the garden level windows at the south side of the east elevation, are in poor condition. (Re: Photo #6.) No treatment was specified on the drawings for this course of stone. Mike is going to provide pricing for the fabrication and installation of the deep refacing of these stones. An amount of \$37,808 remains in the contingency budget.
9. The required work at the first and second floors of the tower's east face, including the plaster sign, will occur next. The reconstruction of the main entry's cheek walls will be addressed last. Mike anticipates that the project should be completed by year's end.

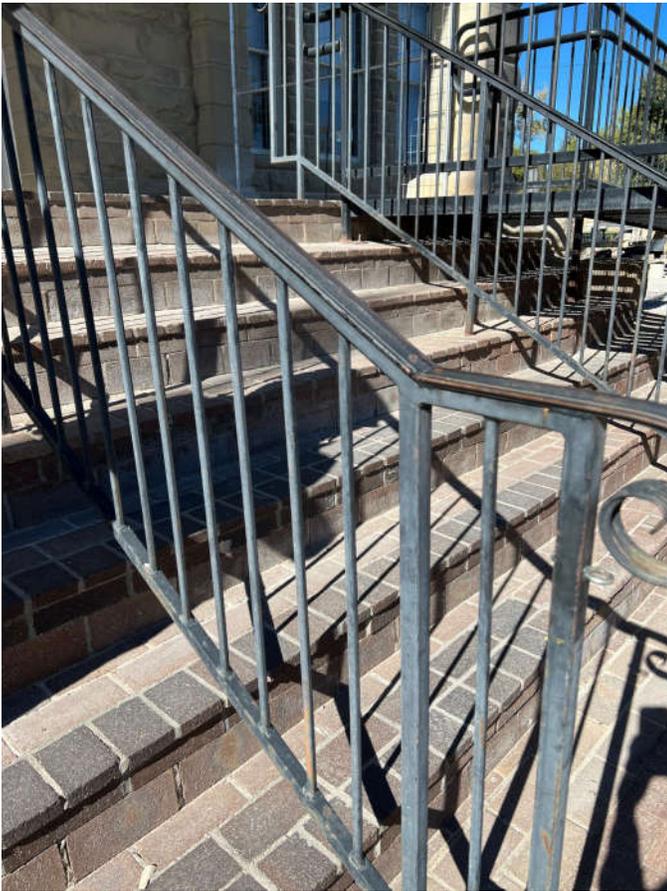
Photo #7: Guardrails are needed along the north and south sides of the main entry porch. Their design should match the existing railing system.

10. Earlier during construction, Carl requested that guardrails be installed at the north and south sides of the main east entry. The new guardrails should match the existing railings. (Re: Photo #7.) Mike offered to put together a budget for their fabrication and installation. Since the guardrails are not part of the SHF scope of work, the cost will have to be borne by the County.
