DATE: August 17, 2023; 10:45 am – 12 noon

WORK IN PROGRESS: Cutting out of existing mortar joints

PRESENT AT SITE: Mike Madone/Mountain Masonry; Tim and Kris Hoehn/HAPC

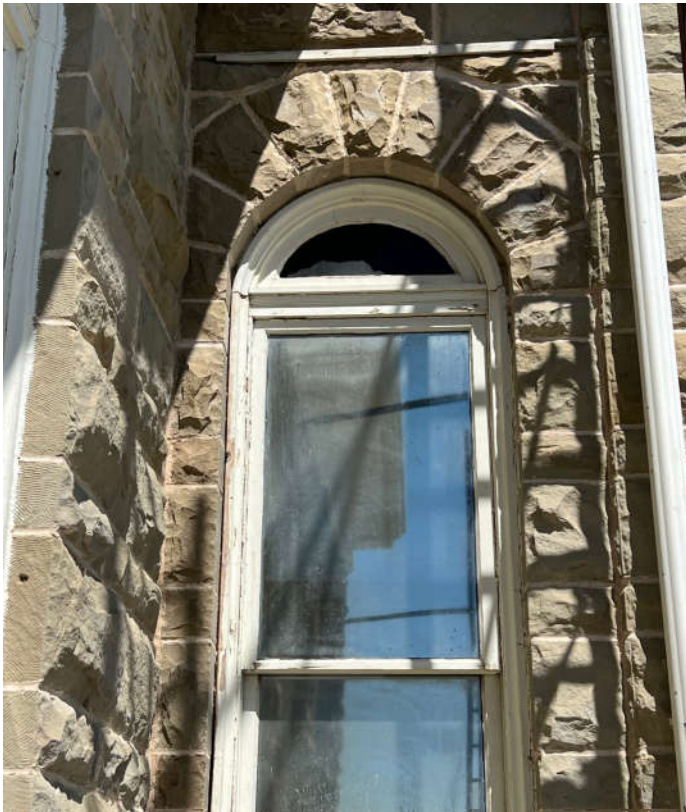
1. The cutting out and repointing of mortar joints is in progress. Most of the joints from the top of the walls to the second floor window sills have been repointed. (Re: Photo #6.)
2. On the south wall at the second floor window, the stones at the arched head have been replaced along with the stones at the west jamb. Backer rod, if required, and sealant will be used to fill the joint between the stone and the brick mould. The steel plate above the arch will remain in place; it may have been installed to serve as support for the arch below when the gutter was leaking, causing damage to the stone. (See Photo #1.)

Photo #1: Replacement stone was laid at the arched head and west jamb of this second floor south facing window.

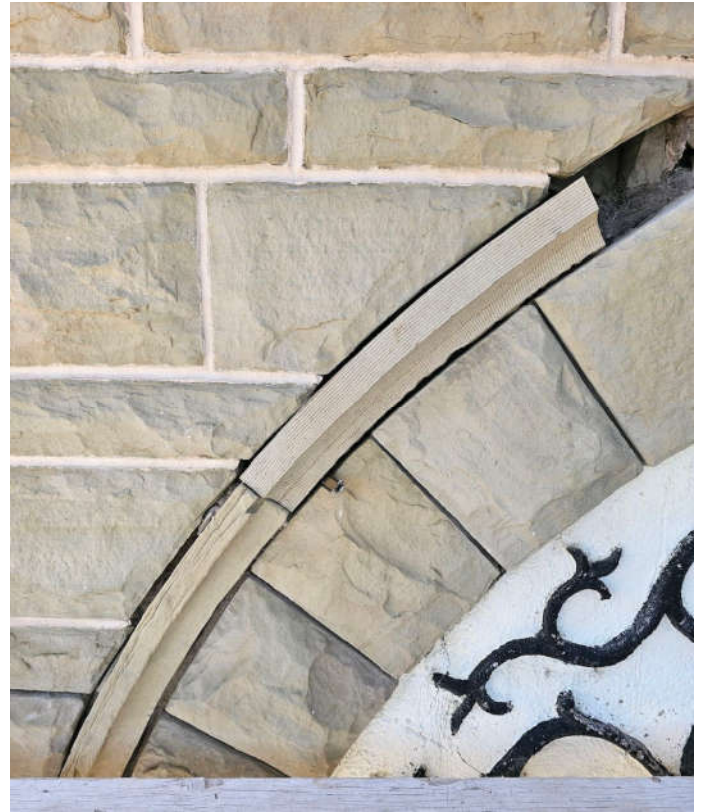
Photo #2: A replacement piece of radiused stone moulding above the plaster sign was fabricated by Mountain Masonry. (Photo Source: Mountain Masonry)

- d. Two stones that form part of the arch above the plaster sign were called to be replaced. They are in good condition and will be retained.
 - e. The decorative stone moulding that wraps the top of the stone arch above the plaster sign was found to be in poor condition; more stones require replacement than what was called out on the drawings. Consequently, all of the stones will be replaced. Mike had a replacement stone on site that he made; he placed it in the arch following the site visit. (Re: Photo #2.) The small, eroded stones below the third floor center window will also be replaced. (Re: Photo #4.)

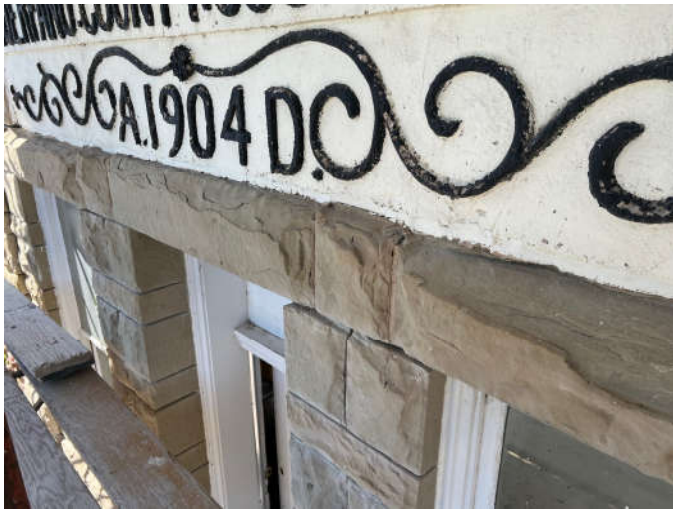
Photo #3: This course of stone, which includes lintels above the window and door openings on the tower's second floor, will be retooled rather than refaced to avoid damage to the plaster sign.

- c. The course of stone at the tower's east face, located immediately below the decorative plaster sign, was specified to be refaced; a deep reface would be required, given their function as window and door lintels. Concerns were raised about disturbing the plaster sign, which has wood lath as its backup. To avoid damage to the plaster, these stones will be retooled instead, followed by the application of a breathable siloxane repellent, specified in the Project Manual. (Re: Photo #3.) The specifications also call for stones with skyward faces to be pointed with a non-staining silicone sealant.

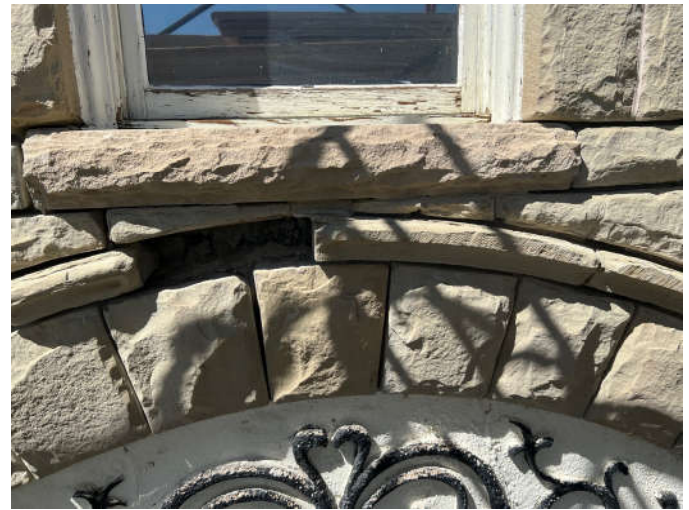
Photo #4: The decorative stone moulding and the small stones below the window sill are eroded. They will be replaced.

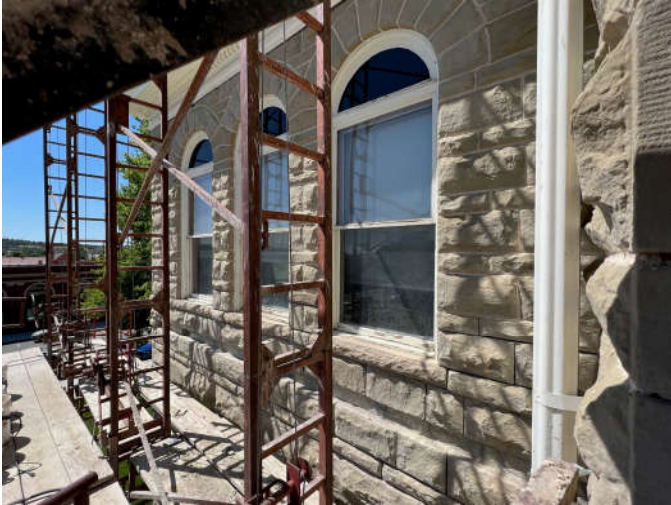
- a. The string course of projecting stone, located below the second floor windows, was called to be refaced. Most of the existing stones have been removed and will be replaced. (Re: Photo #5.) Mike is waiting for the next load of stone, which will include smaller stones for this use.

Photo #5: Most of the existing stones that form the projecting string course below the second floor windows have been removed. They will be replaced in-kind.

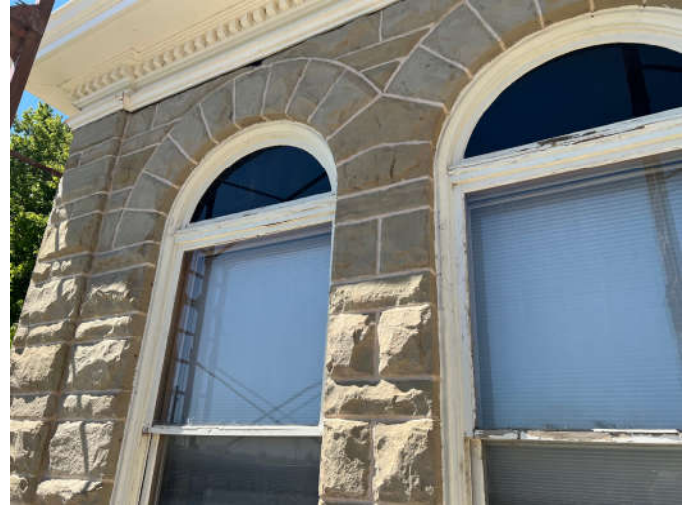
Photo #6: Repointing of the mortar joints is underway, with most joints repointed from the top of the walls to the second floor window sills.
